Geological Survey of Canada
Paper 84-16

Destructive Mass Movements in High Mountains: Hazard and Management

G.H. Eisbacher and J.J. Clague

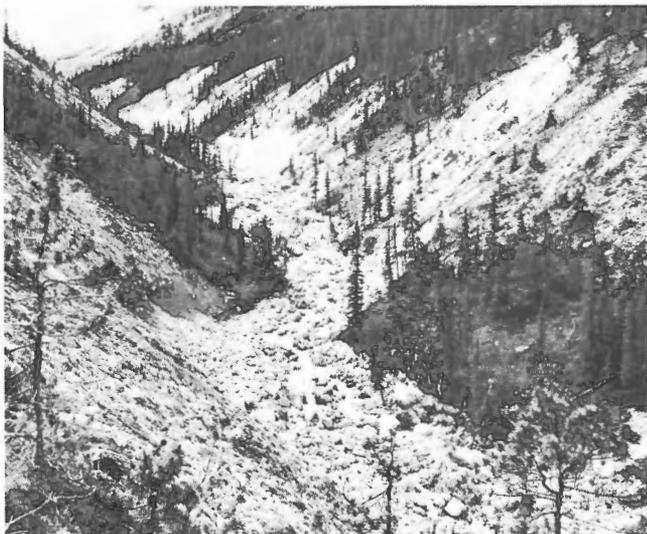
Figure 7: Channel of torrent flanked by bluffs of relict surficial deposits composed of bouldery gravels which serve as source for occasional debris flows in the Muncho Lake region of British Columbia. (GSC 204165)

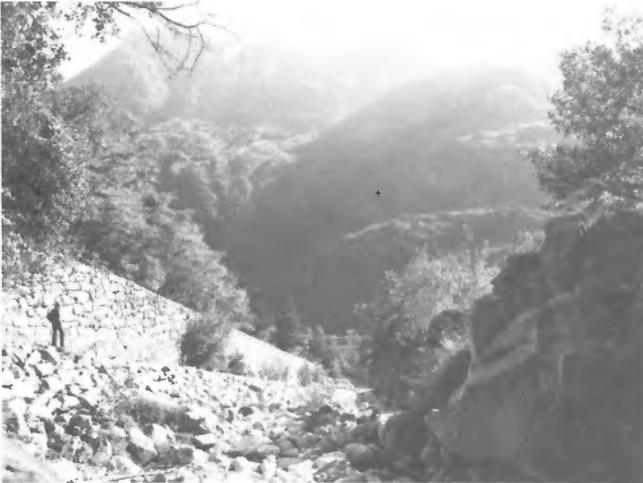
Figure 16: Debris deflection dam with strong stone-block armour (near Chiavenna, Italy). (GSC 204165-D)

the torrent channel. The curved side of the dam facing the torrent generally has to be reinforced with a stone-block armour (Fig. 16); tree belts may supplement the structure to soften its visual impression and to allow for the inevitable spillover of fines during flows.

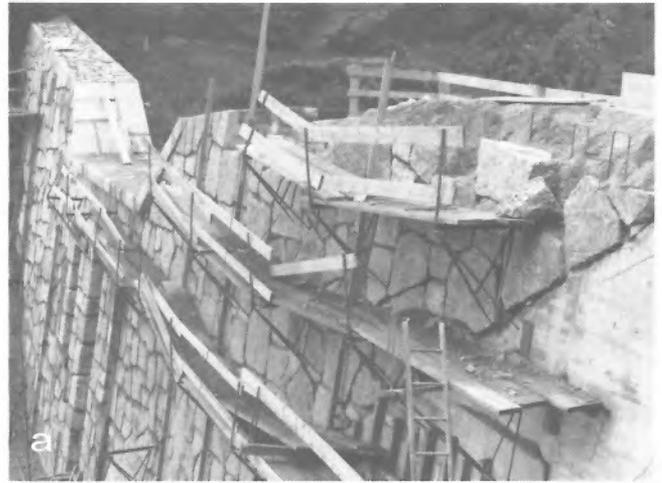
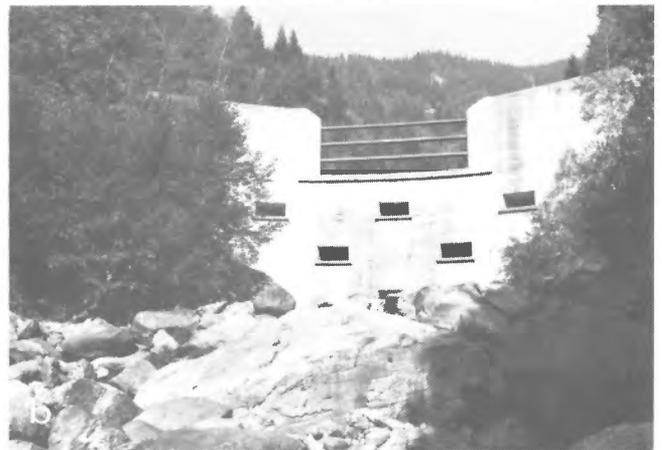
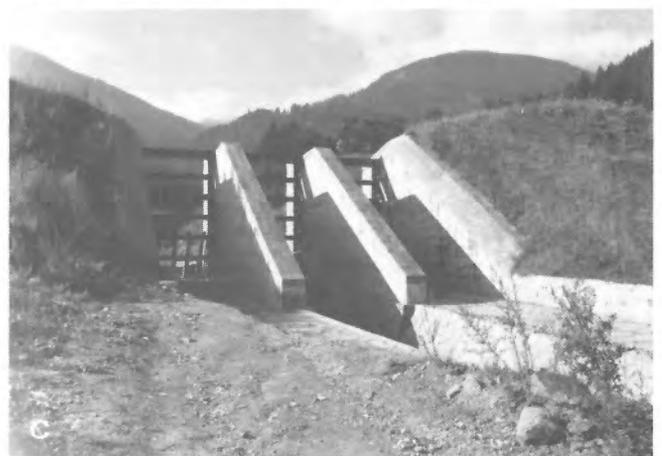
Figure 17: Examples of protective debris retention dams: a) masonry-lined steel concrete dam with vertical selective discharge slits under construction (near Innsbruck, Austria) (GSC 204165-E); b) steel-concrete dam; note drains in the lower half and selective discharge section of steel beams above (near Caoria, Italy) (GSC 204165-F); c) buttressed selective discharge section of an earth-rockfill dam (near Innsbruck, Austria) (GSC 204165-G).

Transverse debris retention dams are erected across the torrent at or immediately above the apex of a debris cone or fan (Fig. 17). Modern transverse protective structures incorporate steel, concrete, and masonry. The foundation sills and abutments are preferably emplaced on bedrock or are at least anchored to the channel substratum by sheet piles. Since they have to withstand the direct thrust of the moving frontal debris wall the design has to be safe against shear and toppling of the structure. The concrete wings are therefore generally provided with downstream-pointing steel or concrete buttresses (Fig. 17c). The central discharge section of a protective dam consists either of steel or steel-concrete beams. The slits or openings between the beams of the discharge section are wide enough to permit passage of normal bedload through the dam, thus preventing premature aggradation behind it. However, they are narrow enough to block a potentially destructive debris flow. Screens, rakes, and braced steel grids may serve as central discharge sections where design of the dam is directed mainly against organic (timber) debris. The crest of the dam is commonly provided with a strong masonry armour and downstream-projecting carapaces that prevent damage to the structure due to spillover of debris when, during debris flow events, the space behind the dam fills up. Road access to the retention space on the upstream side of the dam permits maintenance and cleanup after debris flows. Available space at the apex of debris cones and/or the economics rarely permit construction of protective dams against design debris flows in excess of 300 000 m³.

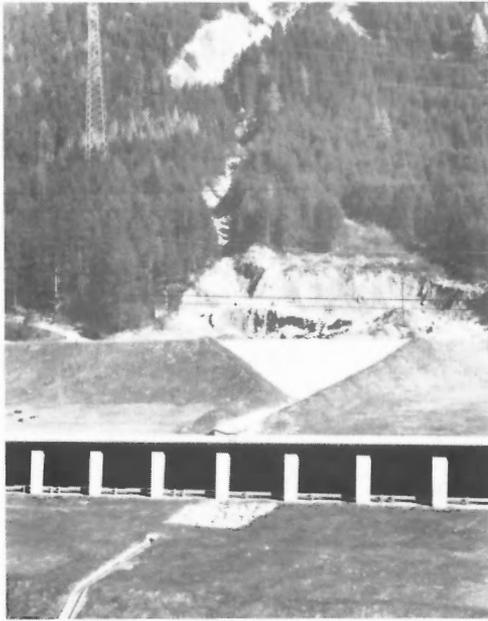
Figure 18: Combination of debris retention basin and gallery designed to protect major mountain highway from recurrent debris flows (Arlberg Highway, Austria). (GSC 204165-H)

Galleries are built over highways which cross steep debris cones; they are commonly supplemented by debris guiding walls or retention basins (Fig. 18).

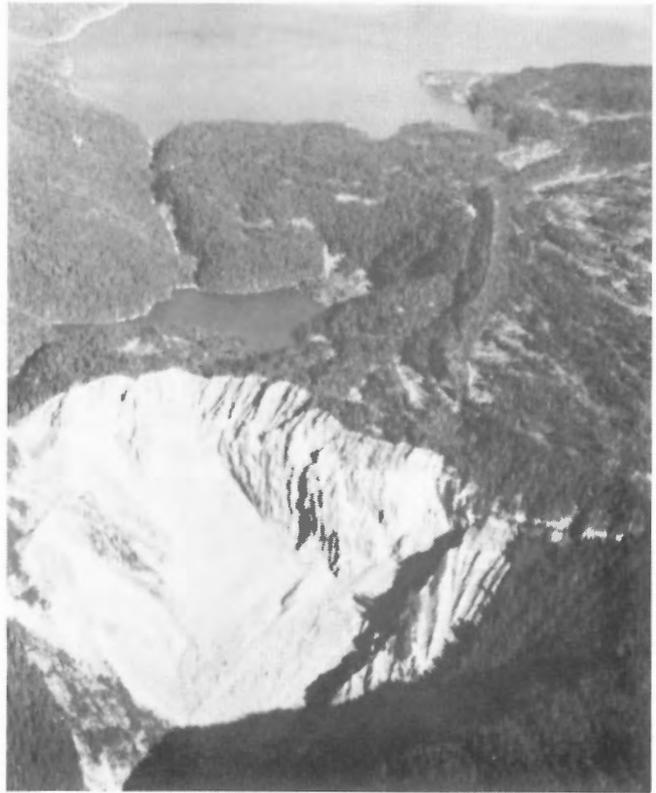
Figure 25: View of "The Barrier", source of the 1855-1856 Rubble Creek slide in British Columbia. This near-vertical cliff is the ice-contact front of a late Pleistocene lava flow. (GSC 204165-1)

The Rubble Creek slide resulted from a failure of "The Barrier", a 500 m high face marking the front of a lava flow that cooled in contact with a late Pleistocene glacier (Fig. 25). During the winter of 1855-1856, a major section of The Barrier failed along a near-vertical composite fracture zone causing a stream of rock rubble, 25×10^6 m³ in volume, to flow down the valley of Rubble Creek and across the debris fan at the mouth of the valley. Traces of rubble at the edge of the debris track and superelevation at its bends suggest that the front of the mobile mass flowed down Rubble Creek valley at high velocity, locally in excess of 20 m/s, and lapped up to 80 m on the valley walls. The main debris stream, carrying slabs of volcanic rock several metres in diameter, spread over the northern half of the Rubble Creek fan and blocked Cheakamus River. Subsequent bouldery flows, composed of reworked slide material and rockfall talus from the toe of The Barrier, covered the southern sector of the fan. Debris floods, launched when the debris dam was overtopped by the impounded Cheakamus River, buried tracts of forest on the floor of Cheakamus Valley below Rubble Creek. The Barrier probably failed in a similar fashion several times prior to 1855. This is indicated by the unusually large size of the Rubble Creek debris fan and by the presence of pre-1400 A.D. landslide deposits beneath the 1855 debris lobe. The trigger mechanisms for both the 1855 landslide and earlier failures are unknown.

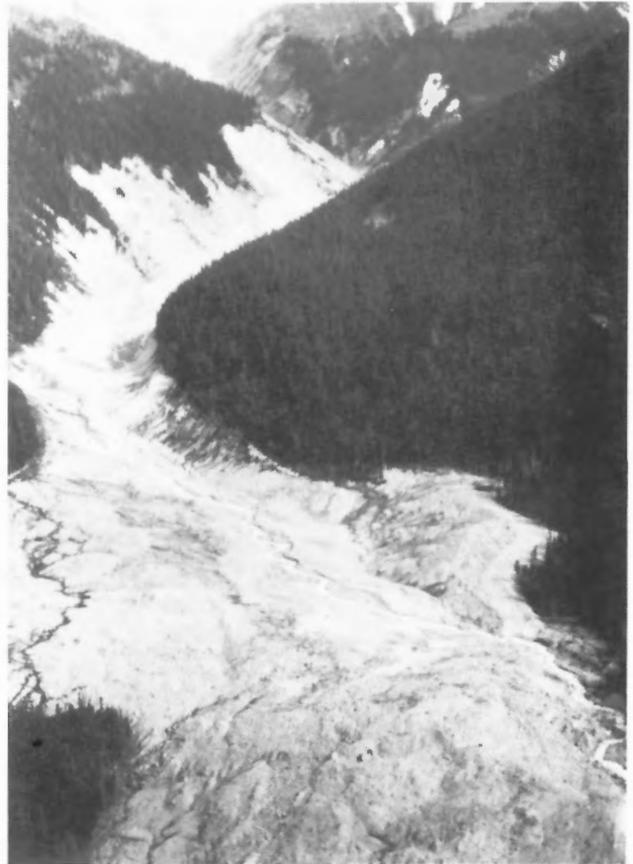
Figure 27: The valley of Devastation Creek, British Columbia, shortly after the Devastation Glacier slide of 22 July 1975. Note the sharp trimlines which delineate the upper limit of the flowing mass of volcanic debris in the valley. (GSC 204165-J)

On 22 July 1975, an estimated 2.5×10^6 m³ of ice and 26×10^6 m³ of weakly consolidated pyroclastic rocks broke away from the northwest slope of Pylon Peak near Meager Mountain, slid across the stagnant toe of Devastation Glacier, and flowed at high velocity over 6 km down Devastation Creek to its mouth (Fig. 27). As the debris descended Devastation Creek, it banked up the valley walls at each bend

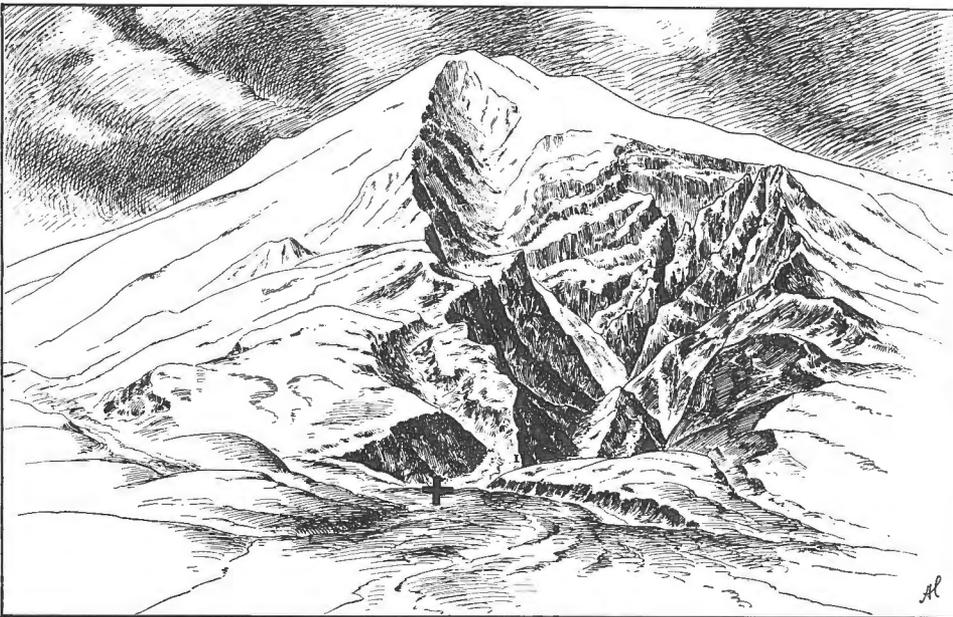
Figure 30: Sketches of the northeast face of Mount Ararat, Turkey, a) before and b) after the catastrophic debris flow of 1840 which erased the village of Achury (location of village indicated by a cross; from Ebeling, 1899).

waters burst through the debris dam, and an ice-debris flow moved rapidly downvalley, erasing a village and monastery near the base of the mountain (Abich, 1847). Sketches of the northeast face of Mount Ararat before and after the catastrophe of 1840 are shown in Figure 30 (Ebeling, 1899).

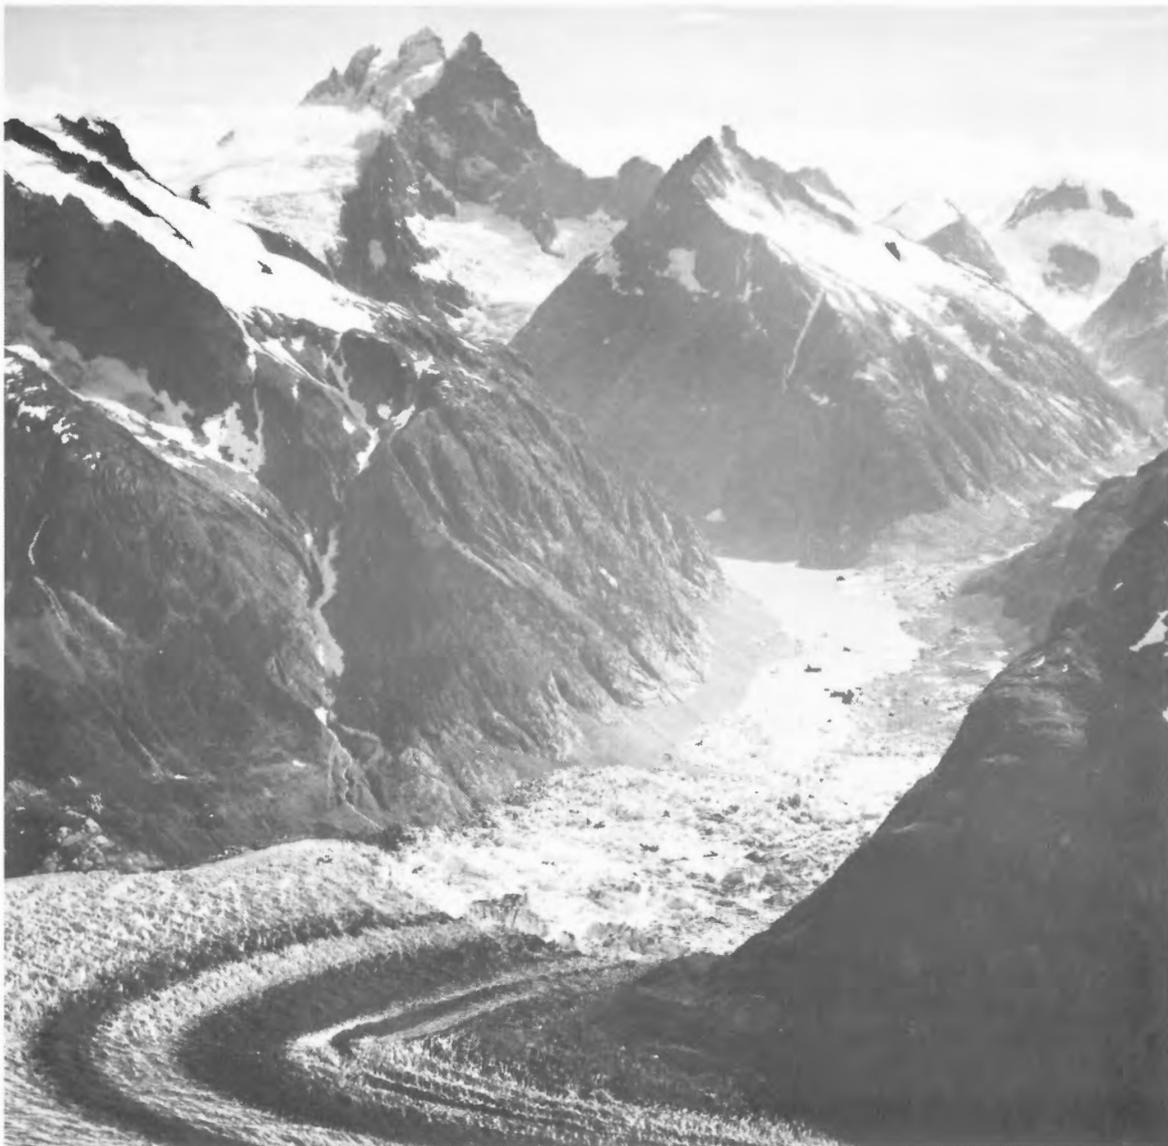
Figure 34: Lake Tulsequah in the northern Coast Mountains of British Columbia shortly after it emptied during a jökulhlaup. The lake is dammed by a lobe of Tulsequah Glacier (foreground). Photo by Austin Post.

See Fig. 34, page 45 for description

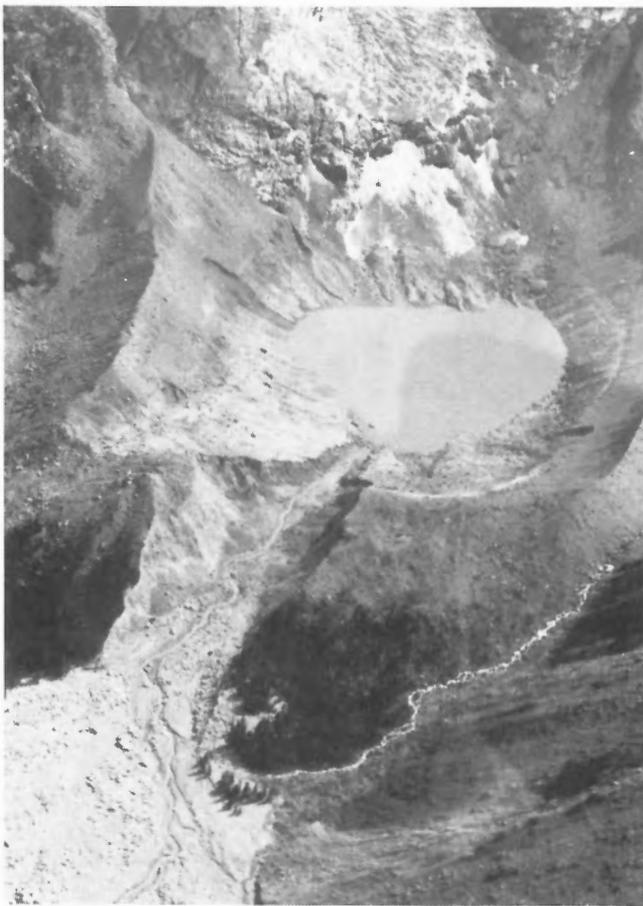
Figure 35: Nostetuko Lake and the breached late Neoglacial end moraine of Cumberland Glacier in the southern Coast Mountains of British Columbia. The lake drained catastrophically in July 1983 when a wave overtopped the moraine. Escaping waters rapidly cut down through the loose morainal debris, producing an *alluvión*. Photo courtesy of British Columbia Hydro and Power Authority.

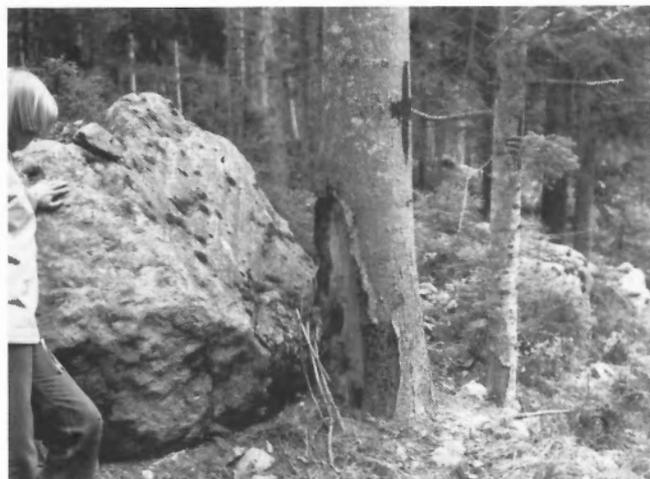
Figure 38: Tree scarred by impact of a rockfall. New growth of tree rings around the scar permits dating of the impact. (GSC 204165-K)

trees (Fig. 38). Careful analysis of trees may give a hint as to the frequency of the falls, if such information cannot be obtained from local newspapers or other accounts. Accelerating rockfall activity from steep cliffs also tends to precede major slope failures; rockfall activity thus can guide a closer inspection of the area in which the rockfalls originated. The possibility of a major failure that might result in a rock avalanche with a reach beyond the foot of the talus slope is real when crown cracks and open fractures delimit an incipient slide mass in excess of 0.5 to $1 \times 10^6 \text{m}^3$. Under such conditions detailed monitoring by surveys and/or evacuation of settlements may be required.

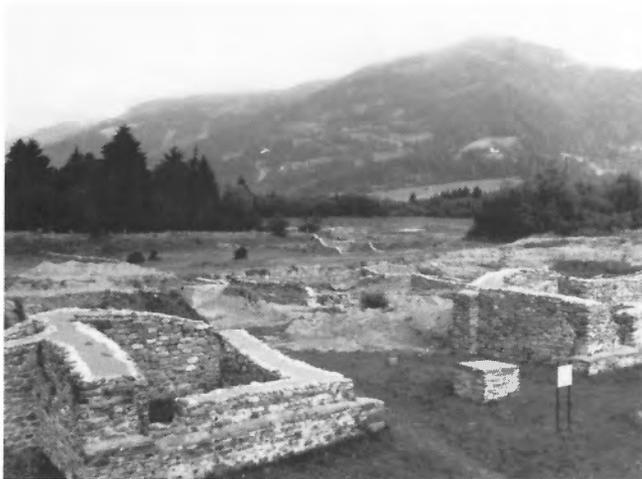
Figure 55: The recently excavated ruins of the Roman town of Aguntum near the axis of the Debant fan. The strip of forest in the background indicates the position of the dyked braided channel of the Debant Torrent which is now several metres above the level of the Roman streets. (GSC 204165-O)

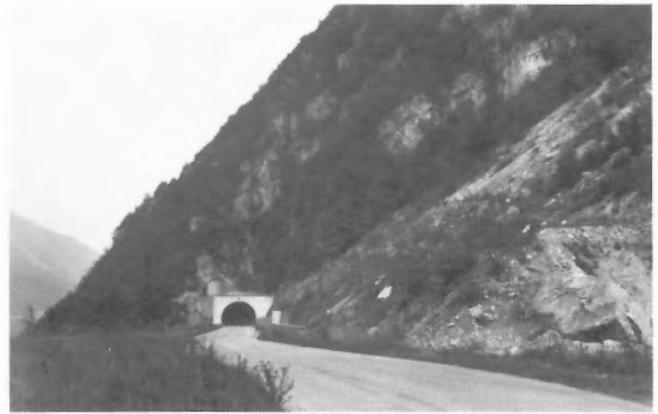
Figure 57: View to the north along the shore of Lago di Santa Croce. A recent highway tunnel pierces the northern flank of the Fadalto slide scar following the strike of the dip slope in massive carbonate rock. (GSC 204165-P)

(Fig. 57). Some difficulties were encountered during construction.

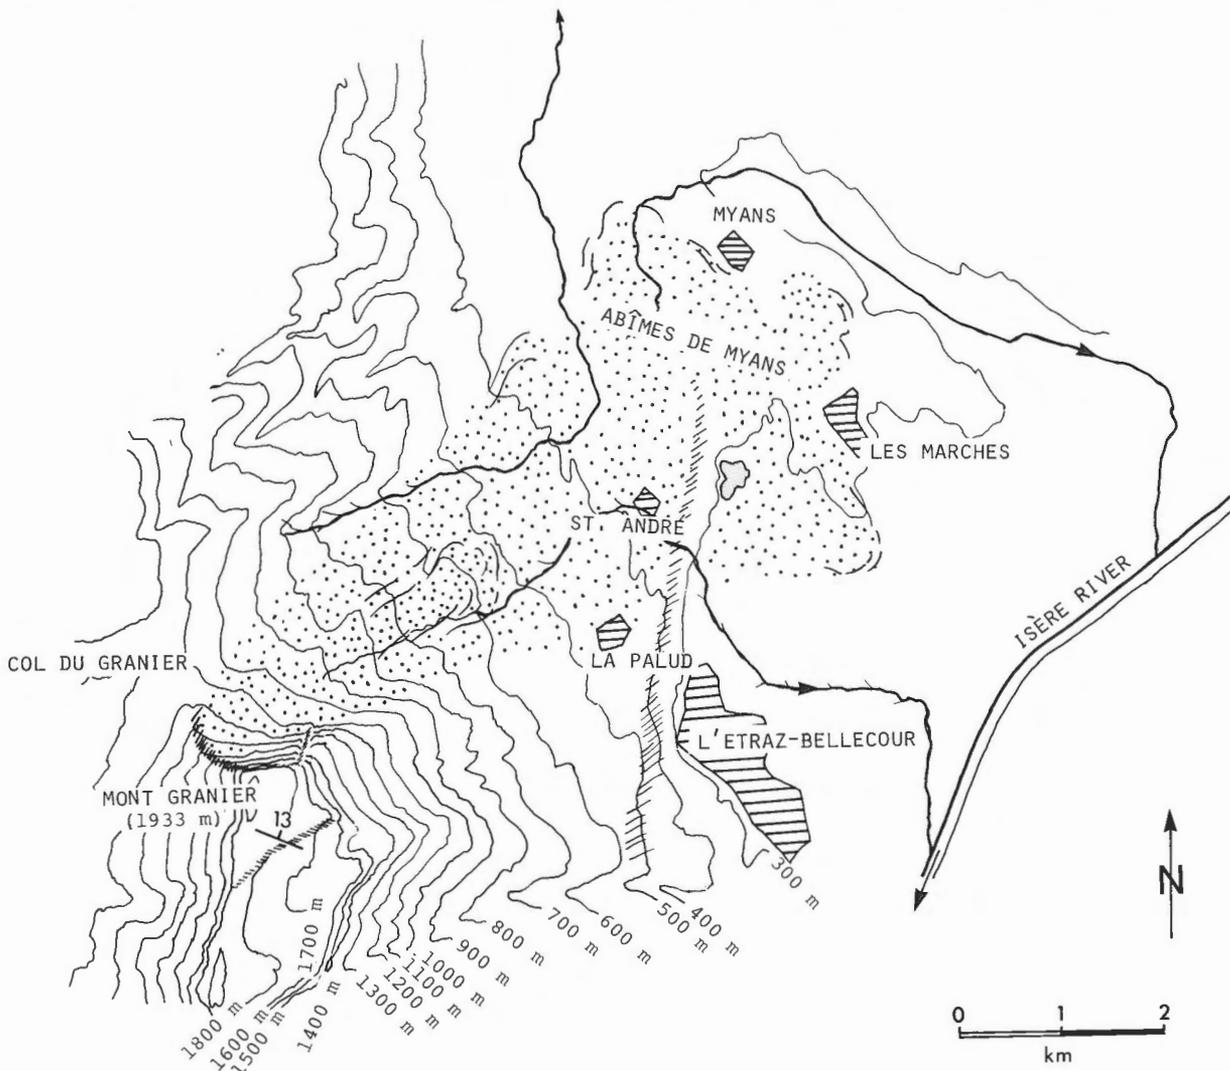
Figure 62: Sketch map of the blocky lobe of Abîmes de Myans (dotted), which resulted from a dip slope failure along the northern promontory of Mont Granier.

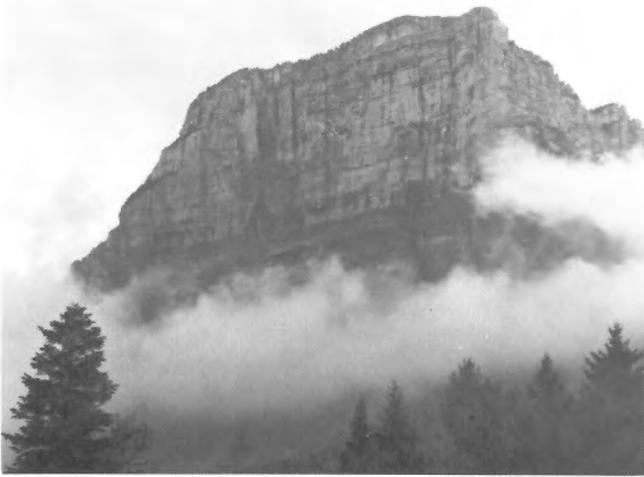
Figure 63: View of the joint-controlled vertical headwall of the Mont Granier rockslide detachment zone. (GSC 204165-R)

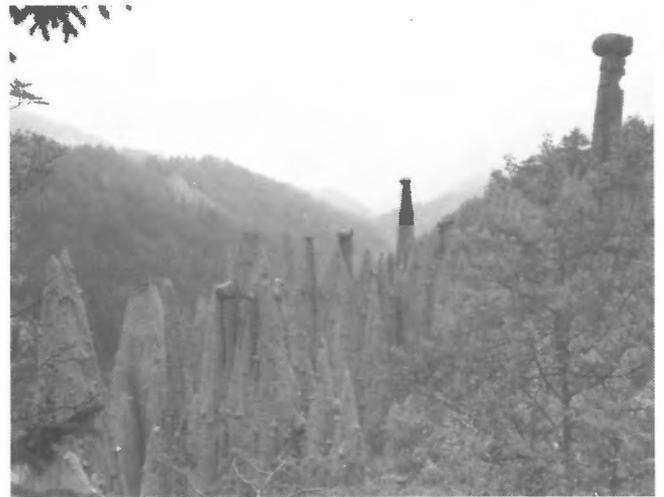
Figure 65: Earth pyramids carved from Pleistocene morainal deposits along the flanks of the Riveaun Torrent. View downstream along the torrent. (GSC 204165-S)

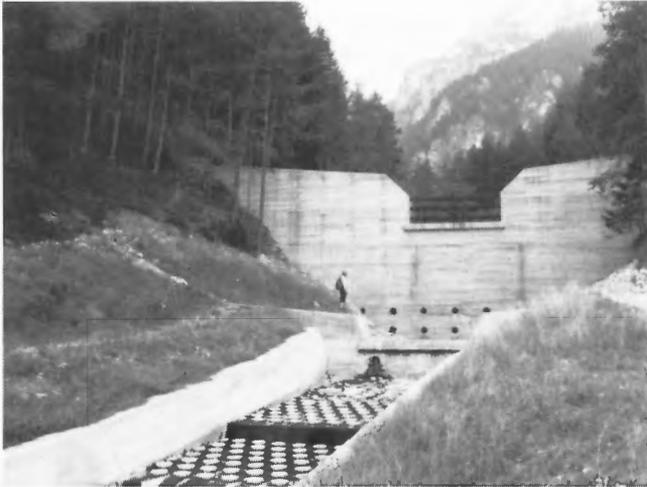
Figure 71: Protective steel-concrete dam at the mouth of Val Bonetta. The lined channel permits nondestructive discharge of small debris floods spilling over from major flows that would be retained behind the structure. Note drainage bores at the base and selective discharge section ('filter dam') at the crest. (GSC 204165-Y)

The cone has been avoided as a building site for many centuries in spite of the fact that Ziano has had to contend with repeated floods of the Avisio Torrent. In recent years a solid protective concrete dam, approximately 10 m high, has been constructed across the mouth of the Val Bonetta ravine (Fig. 71), and the first vacation homes have sprung up below. The old village of Ziano faces another more direct threat: a precariously tilted pinnacle of dolomite which has separated from the main rock wall hangs over the town. A large cross has been erected on the top of this spire.

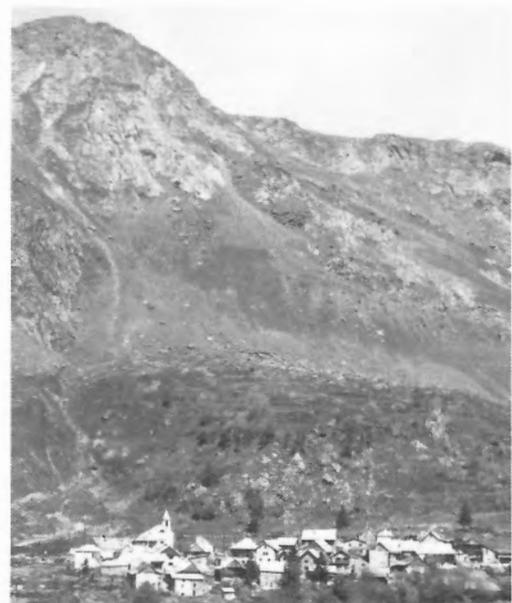
Figure 73: View of the slide lobe composed of quartzitic rubble behind the community of Clavans-le-Bas. (GSC 204165-Z)

In 1418 a third of the community of Clavans was destroyed by a rockslide which also caused the death of several people (Allix, 1929, p. 38, 189, and 204). The lobate slide mass, approximately $3 \times 10^6 \text{ m}^3$ in volume, can still be seen between the two groups of buildings constituting the small settlements of Clavans-le-Bas and Clavans-le-Haut. (Fig. 73). Fresh rockfall deposits on the valley wall behind the two hamlets attest to continued slow deterioration of the bare upland ridge.

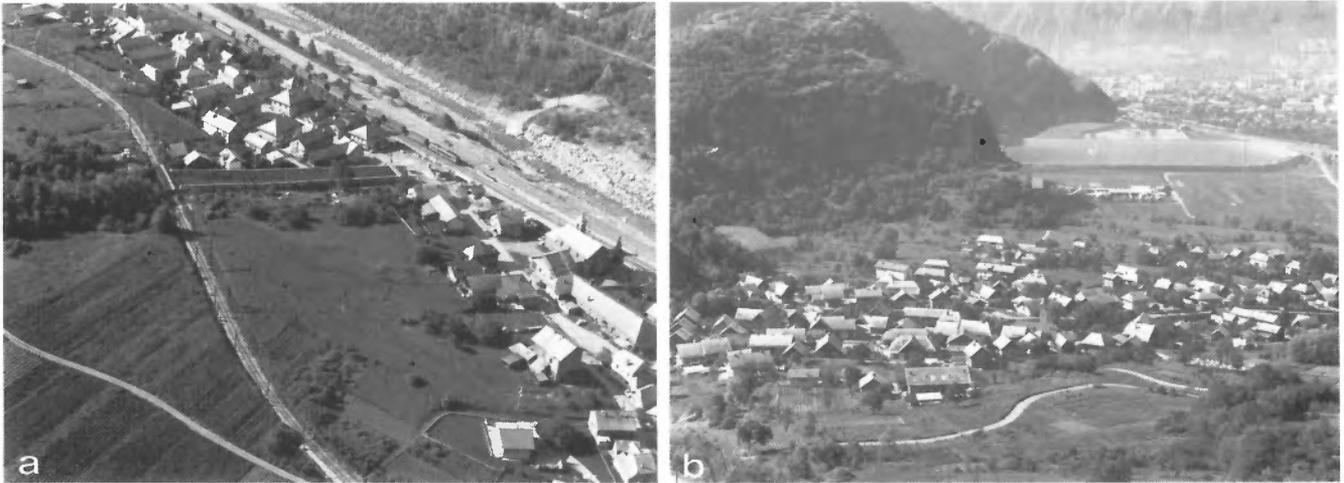
Figure 82: a) Walled channel of the Ravoire Torrent at Pontamafrey along the banks of the Arc River (centre of photo) (GSC 204166-D). b) View southward from above the apex of the Hermillon fan towards St. Jean-de-Maurienne; note flood retention basin in the background; the channel of the Hermillon Torrent is in the built-over area in the foreground (GSC 204166-E).

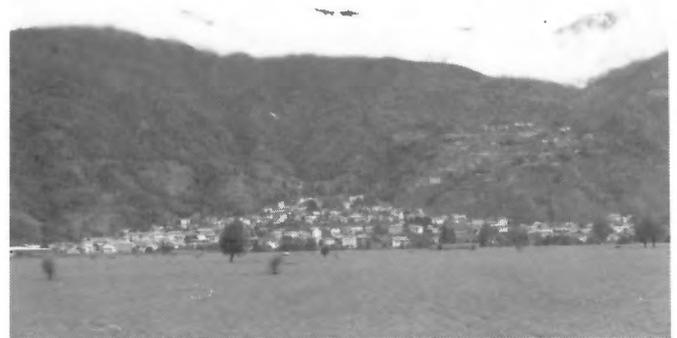
Figure 89: View of the built-over cone of Ardenno as seen from the Adda floodplain; note vegetated ravines above the town. (GSC 204166-1)

Today much of the floodplain of the Adda has been brought under cultivation. Settlements continue to cluster near fans and cones along the sides of the valley. The small fan of Ardenno is now completely built over (Fig. 89).

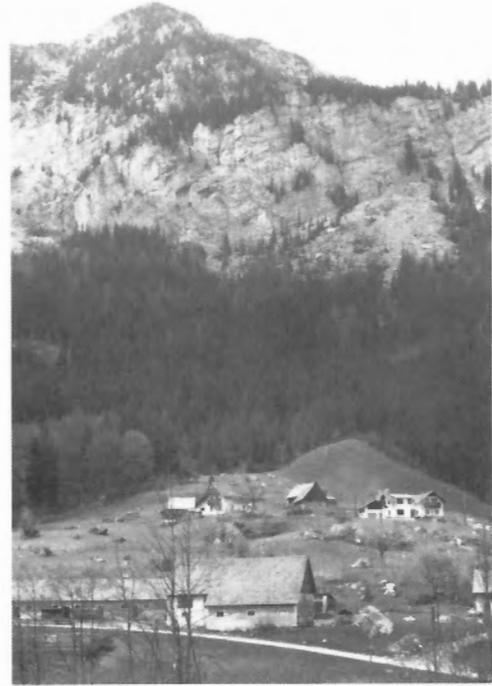
Figure 91: View of the western half of the built-over rock avalanche lobe at Radmer an der Hasel; note the thoroughly shattered bedrock spur overlapped by fresh rockfall debris and the flanks of the historical detachment zone on the west (left background) (GSC 204166-J).

Today the houses of the village and a castle rest on the rubbly surface of the slide mass (Fig. 91); above the settlement two fresh rockfall cones extend far into steep ravines cut into a shattered bedrock spur that borders the backwall of the 1540 slide.

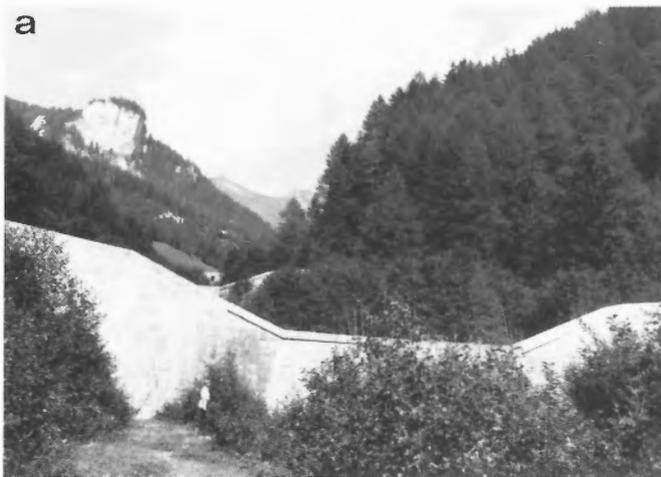
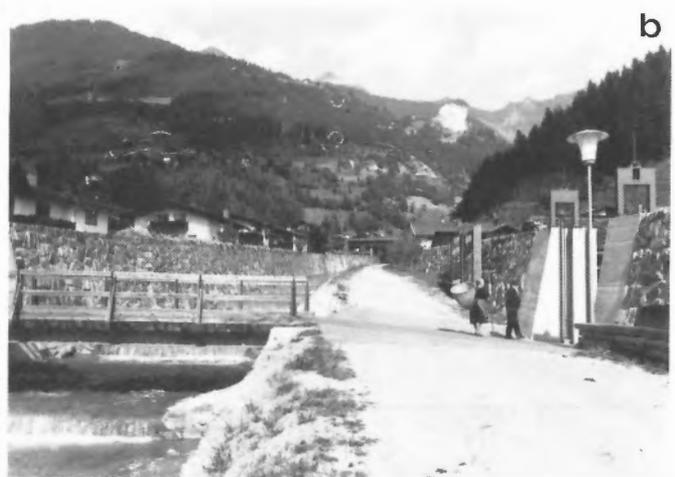
Figure 93: a) Concrete-masonry check dams spanning the lower part of the Bretterwandbach gorge above Matrei (person on the lower left for scale). Dense alder growth attests to present channel stability. In the background is a leaning limestone cliff forming part of the sagging Glunzerberg (GSC 204166-K). b) Protective masonry-concrete dykes flanking the Bretterwandbach channel in Matrei. The bridge can be raised mechanically during times of heavy runoff or threatening debris flows (GSC 204166-L).

Debris flows from the Bretterwandbach gorge also have shifted the channel of the Isel River; thus programs to stabilize the channel of the torrent have paralleled efforts to train the receiving river. In the upper parts of the torrent a spectacular array of check dams has now been maintained for more than 80 years to prevent excessive erosion along the unstable bedrock embankments (Fig. 93a). A paved channel, flanked by strong stone-masonry walls 4 to 5 m high, escorts the torrent through Matrei to the dyked riverbank (Fig 93b). The two bridges crossing the torrent in Matrei can be raised mechanically to prevent blockage of debris and breaching of the walls during floods and debris flows. Matrei is a growing tourist centre at the entrance of a proposed national park. Residential buildings now cover almost the entire surface of the debris cone.

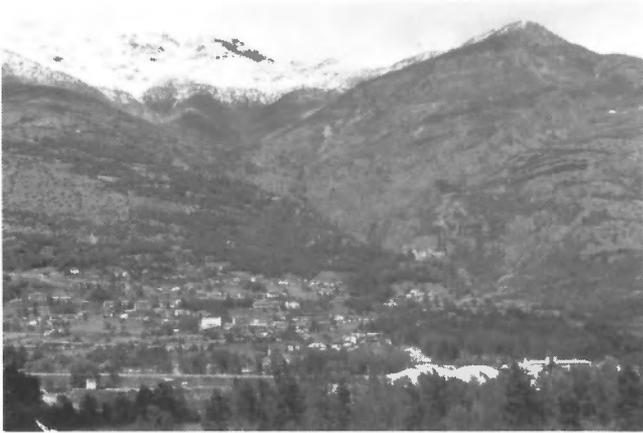
Figure 95: View of the cone and catchment area above Quart east of Aosta; a protective forest covers most of the axial sector of the cone and sparse vegetation has reconquered the denuded uplands. Suburban residential development has begun to spring up on the flanks of the cone. (GSC 204166-M)

In spite of great development pressure in this region the axial sectors of the most notorious debris cones have been left undeveloped and several host protective forests. Modern residential construction skirts the fringes of bouldery debris flow deposits of the past. In recent years, extensive reforestation work has been carried out in some denuded upland basins.

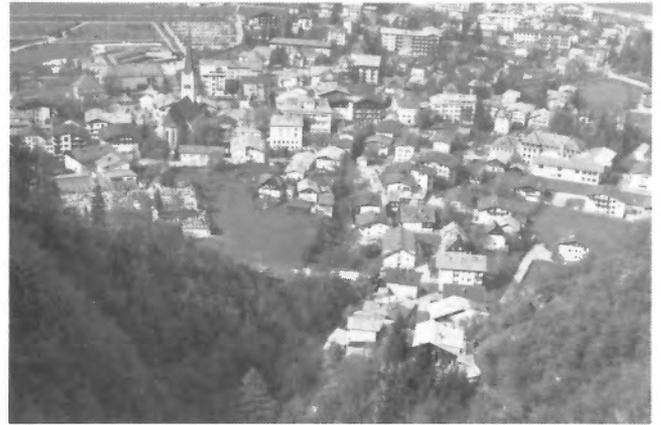
Figure 98: View of Hofgastein from above the gorge of the Rastötzenbach. Most of the buildings near the apex of the fan are of relatively recent date. (GSC 204166-N)

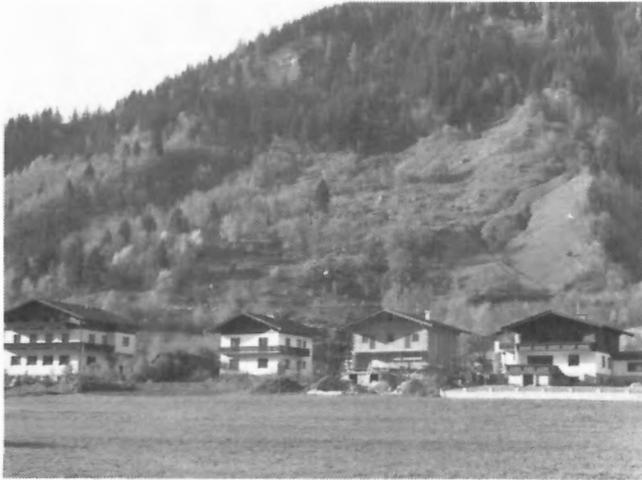
Figure 99: Typical slump in low grade metamorphic rocks of the Gastein region; note recently constructed tourist accommodations near the toe of the slide (GSC 204166-O).

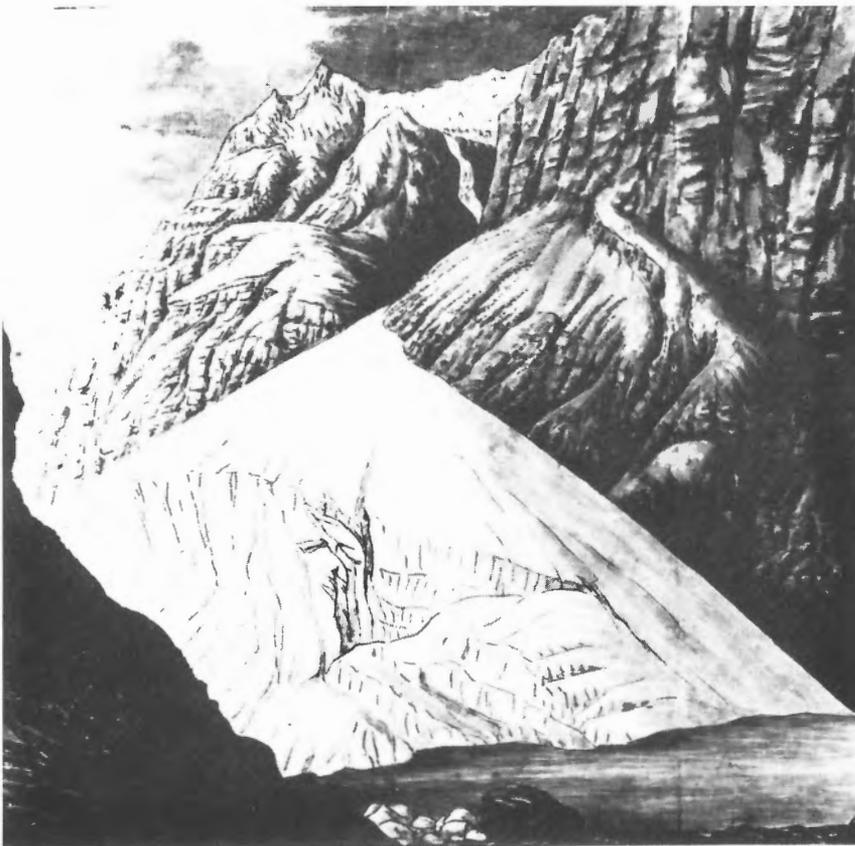
Figure 106: The ice cone at the foot of the Giéthro Glacier at the narrows of Mauvoisin as depicted by H.C. Escher in 1818 (from Bachmann, 1978).

The Giéthro Glacier again accumulated its cone of remolded ice across the gorge of Mauvoisin during the early 19th century (Fig. 106). In spring of 1818 the normally torrential Dranse River diminished to a trickle, an unusual situation for the season, immediately noticed by the townspeople in Martigny. A group of them went up the valley to investigate. Upon reaching Mauvoisin, they were confronted with the gigantic wedge of ice that by now had grown more than 100 m above the channel of the river. Aware of the catastrophe of 1595, the authorities immediately called upon Ignaz Venetz, an energetic public engineer, to excavate a tunnel through the ice and thus forestall the eventual overtopping and failure of the dam. Venetz and his 50 helpers worked frantically from both ends of the cone, using experience gained during the construction of rock galleries along the Simplon Pass route a few years earlier. Meanwhile, the lake continued to rise at a rate of about 0.5 m a day; the workers in the tunnel were threatened by icefalls from the glacier and by waves pounding against the upstream side of the cone. After about a month of incredibly hazardous work, the tunnel, now 200 m long, was nearly complete. Unfortunately, the upstream and downstream approaches did not meet at precisely the same level and the floor of the upper tunnel had to be lowered 6 m. The adjustments, which resulted in a downward tapering cross-section, were barely completed when the first rush of water from the lake entered the tunnel. Blocks of ice soon jammed the lower outlet of the

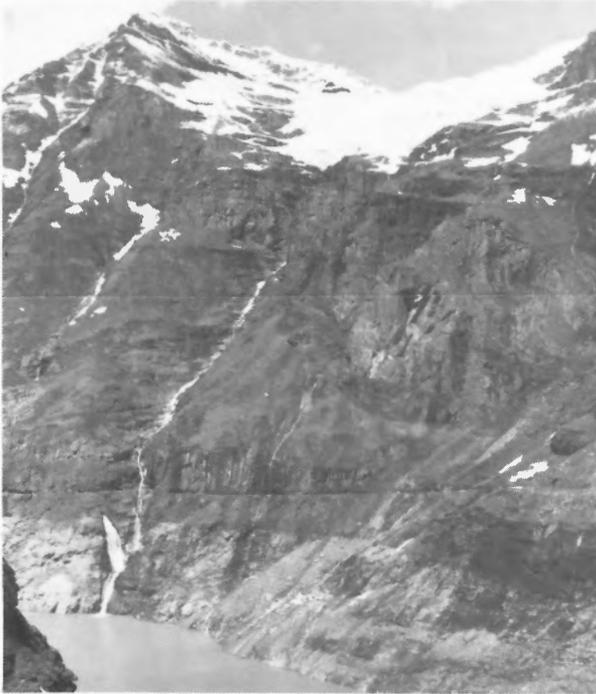
Figure 107: View of the Mauvoisin reservoir and Giétro Glacier in 1981 from the same position as that occupied by Escher in 1818. (GSC 204166-Q)

Between 1951 and 1957 the Mauvoisin hydroelectric dam was erected at the narrows that used to be the site of the threatening ice cone (Fig. 107). In recent years the snout of the Giétro Glacier again has approached the upper rim of the gorge and fragments of the glacier have tumbled into the reservoir. Its movement is now being monitored continuously by a cable device attached to the glacier. The measured displacement of the ice is recorded and relayed electronically to Mauvoisin. This monitoring system permits a timely lowering of the reservoir if major slippage of the ice mass is observed; however, even with a full reservoir an ice mass in excess of $0.7 \times 10^6 \text{m}^3$ would be required to generate a wave that would overtop the dam (Röthlisberger and Aellen, 1970; Röthlisberger, 1974).

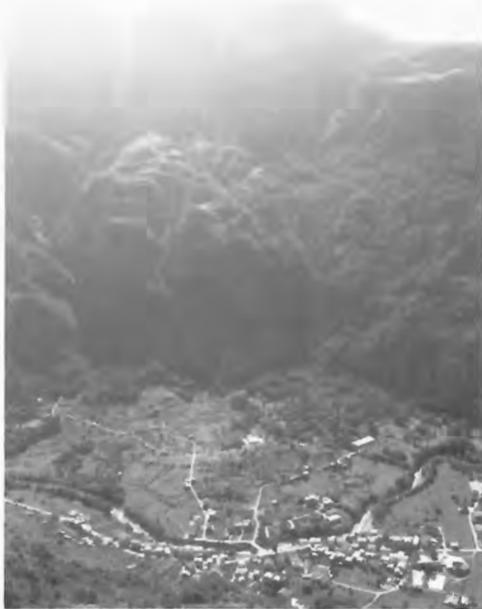
Figure 110: Southward view onto the slightly conical surface of Prati Ruina and the detachment zone of the 1618 debris-bedrock slide (on the right). The town of Piuro is at the bottom. (GSC 204166-R)

For many years, the surface of the Prati Ruina at Piuro has hosted vineyards and a few service chalets (Fig. 110). Recently, some of the ancient walls and buried artifacts of Piuro have been excavated; the retrieved objects are now exhibited in a small museum at San Abondio. New housing (Burgo Nuovo) extends onto formerly uninhabited parts of

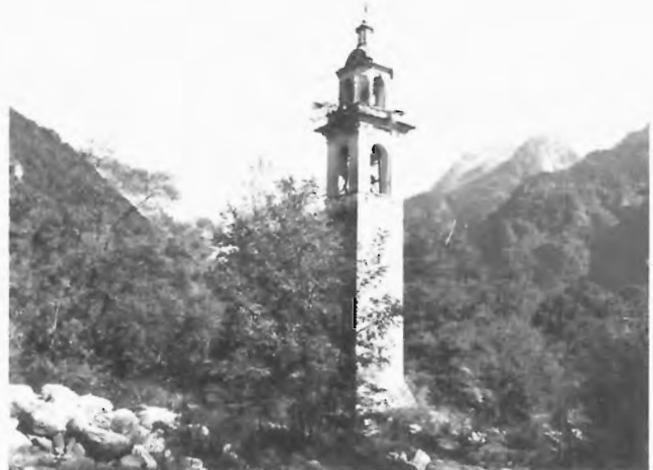
Figure 111: Church tower projecting from lobes of gneissic rubble on the cone of the Carmezzano Torrent. (GSC 204166-S)

Immediately to the west of Piuro, is the bouldery cone of the Carmezzano Torrent with the communities of San Abondio and Prosto on its flanks (Fig. 108). This cone experienced debris flows in 1675 when Prosto was buried 'to the chimneys', in 1760 when San Abondio was destroyed, and in 1858 when a hamlet by the name of Santa Maria disappeared (Beattie, 1836, v. I, p. 120; Montandon, 1933, p. 308 and 320). An isolated church tower, surrounded by boulders of granitic gneiss, bears witness to these disasters (Fig. 111).

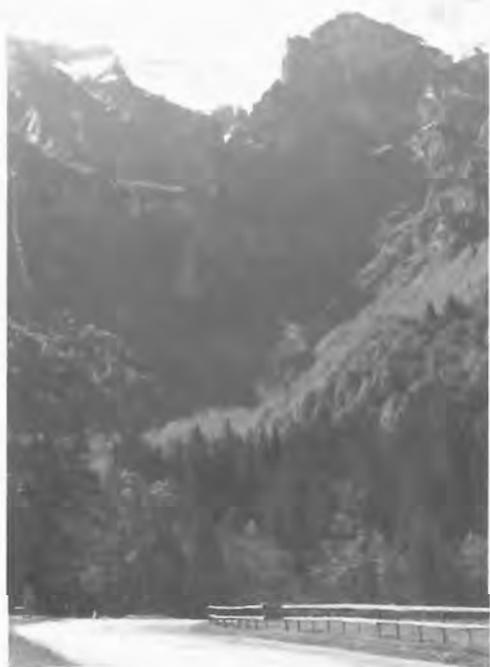
Figure 113: View of the vertical detachment wall of Tête Noire from Plan du Lac. (GSC 204166-T)

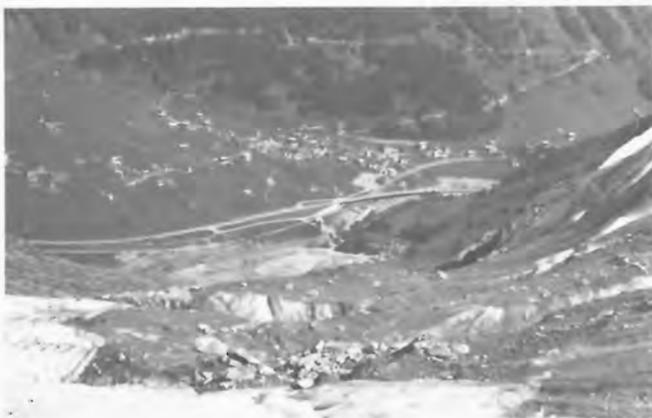
Figure 119: View of the Dorfbach cone and the community of Randa from the snout of the Bis Glacier; note several residential buildings near the axis of the cone in the runout zone of potential ice avalanches (GSC 204166-W).

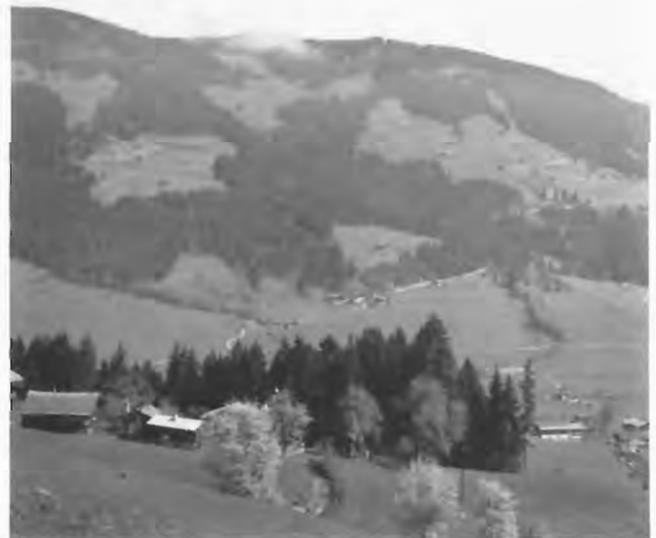
Figure 123: View of the uninhabited Rackling cone and its partly forested catchment area which is characterized by sagging slopes of phyllite; note farm located in the zone between the torrents where forests have a critical protective function. (GSC 204167-A)

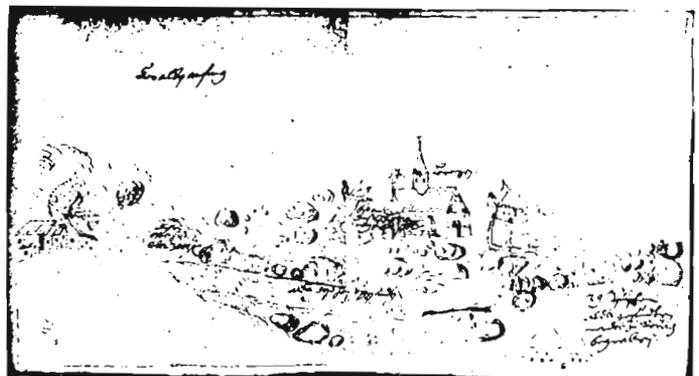
Figure 125: Contemporary illustration of the destructive bouldery debris flow which overwhelmed the village of Gemmersdorf in 1660 (from Fresacher, 1965).

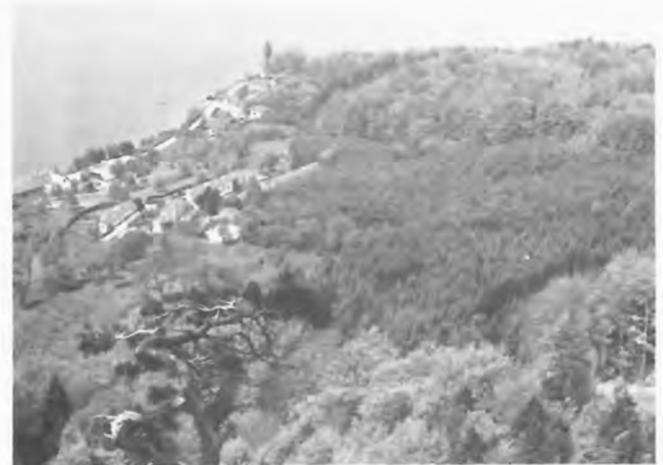
Figure 127: View across the toe of the Gschlifgraben debris lobe; note embayment marking the head scarp of the historical subaqueous slump and densely reforested zone above vacation bungalows. (GSC 204167-B)

The attractive shore front along the periphery of the Gschlifgraben cone hosts a variety of permanent dwellings, vacation bungalows, and a major hotel. Recently (1975) much of the area was zoned as being too dangerous for any kind of new residential development. Check dams have been installed along the lower reaches of the two torrents draining the debris lobe to avoid undercutting of unstable embankments. A dense protective forest of conifers has been planted above the threatened buildings (Fig. 127). In the uplands only marginally effective drainage ditches have been excavated and movement of the main contributing branches of the slow earth-debris flow is being monitored by regular surveys.

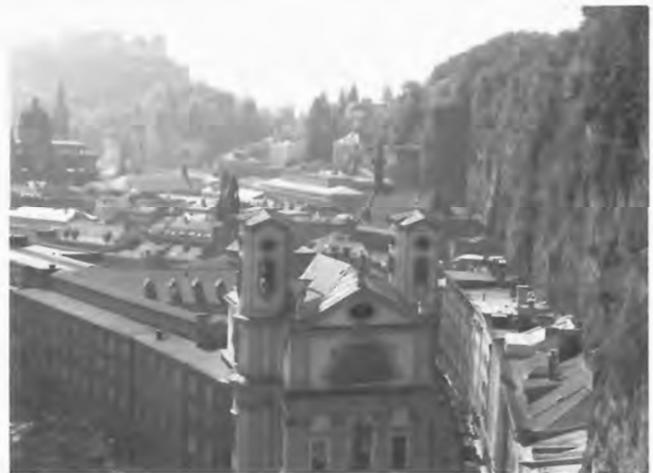
Figure 129: Southward view along the vertical Mönchsberg wall in the city centre of Salzburg. St. Marcus church in the foreground; festival theatre and castle in the background; note apartment buildings at the base of the cliff. (GSC 204167-C)

Despite the undiminished threat of rockfalls from the Mönchsberg the church and the houses were rebuilt in the same place soon after 1669 (Fig. 129). However, since the catastrophe the rock wall has been regularly inspected and scaled by teams of 'Steinputzer' (= stone cleaners). This practice, still performed today, has become an annual Salzburg folk tradition. Even the focus of Salzburg's modern cultural life, the world famous Festspielhaus (festival theatre), has been placed against the Nagelfluh wall. Numerous rock anchors, monitoring devices, and other works have substantially reduced the danger of rockfalls. In recent years a huge underground cavern has been excavated inside the Mönchsberg to alleviate the city's chronic parking problem!

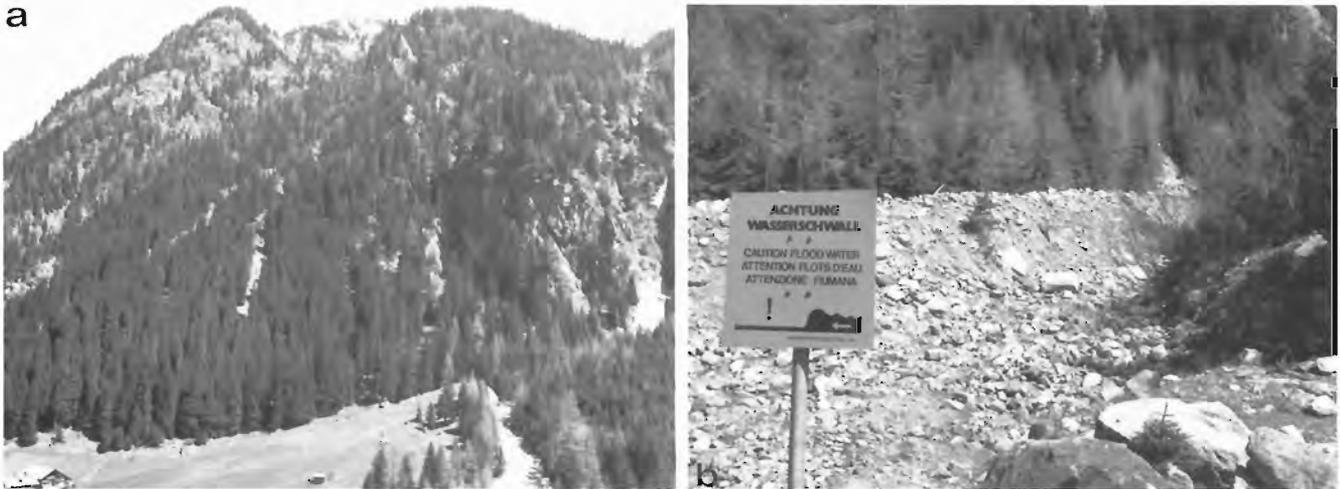
Figure 132: a) Steep debris cone of a glacial torrent (locality Am See) in the Kaunertal (GSC 204167-D). b) Warning sign along the recently active torrent channel of the cone shown above (GSC 204167-E).

Downwasting and retreat of the Ötztal glaciers, which continued until the 1960s, greatly reduced the hazard of ice-debris floods in the region. Several of the high basins are now part of complex hydroelectric reservoir-and-diversion schemes and some of the glaciers have been developed into year-round ski areas; as a result most of the communities have grown and prospered. The readvance of the glaciers in recent years may initiate a new cycle of more frequent ice floods (Fig. 132).

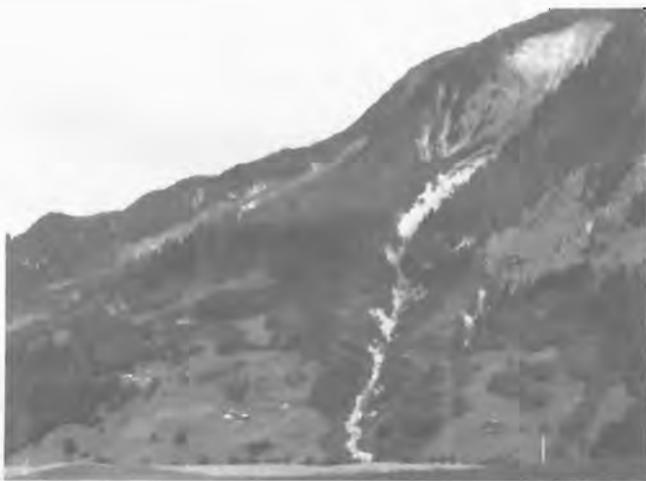
Figure 134: View of the Bova Gronda scar and slide deposits of 1683; note recent rock-debris avalanche chute below Bova Gronda, farm buildings on the slide mass, and the serrated skyline of the sagging Garvera slope. (GSC 204167-F)

an elevation of 1900 m the intensely fractured rock mass streamed to the bottom of the valley (Fig. 134), its front climbed 120 m up to the terrace of Disentis (1130 m) and temporarily halted the waters of the Vorderrhein River. The rock avalanche killed 22 people (Heim, 1921, p. 948).

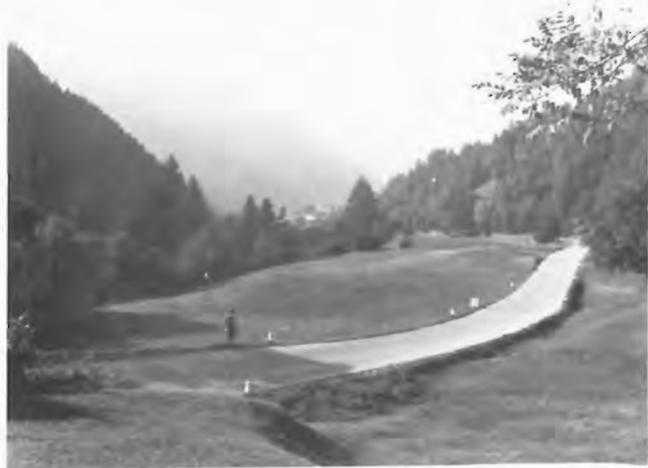
Figure 136: View down the track of the 1701 debris flow along Torrente Missiaga; La Valle Agordina in the background. Slight undulations in the meadows indicate positions of large carbonate blocks embedded in a shaly matrix (GSC 204167-G).

Agordina, erasing several buildings and leaving 48 inhabitants dead (Montandon, 1933, p. 304). The track of the debris stream can still be followed from the bedrock failure to the undulating meadows above La Valle Agordina, which gradually are being built over (Fig. 136).
