Geological Survey of Canada
Paper 84-16

Destructive Mass Movements in High Mountains: Hazard and Management

G.H. Eisbacher and J.J. Clague

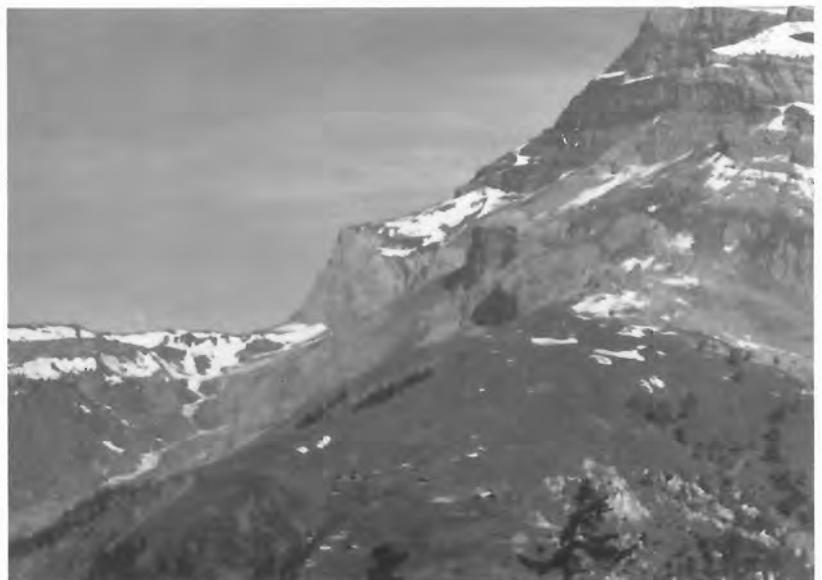
Figure 138: Northwestward view of the detachment zone of the Diablerets rock avalanches and rockfalls; note chalets on the promontory east of the blocky deposits of Le Liapey. (GSC 204167-H)

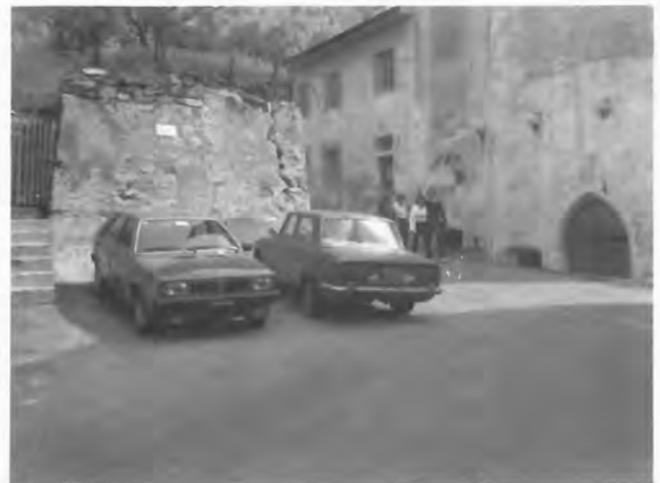
Figure 142: View of the church entrance below street level at Schlanders, indicating the incomplete excavation effort after the catastrophe of 1731. The height of the wall on the left indicates roughly the depth to which the town was buried in 1731. (GSC 204167-J)

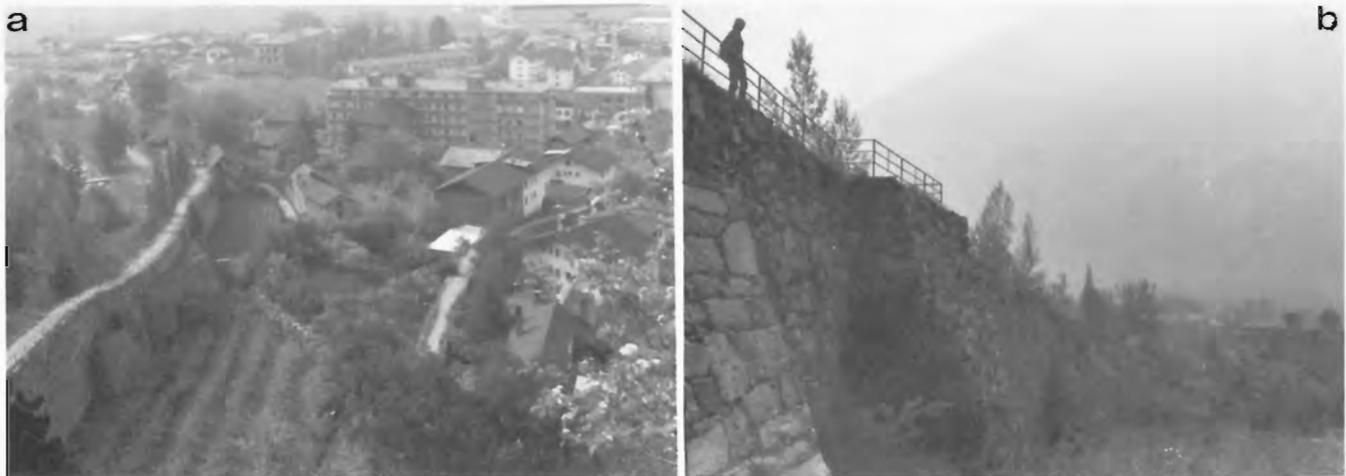
Figure 143: Two views of the protective debris deflection dam between the channel of the Schladraun Torrent and the modern buildings of Schlanders. (a. GSC 204167-K, b. GSC 204167-L)

Aggradation behind the dam since its construction has raised the eastern sector of the fan by several metres above the built-over western sector, but the dam has served well to the present day. Recently, check dams and transverse steel-beam rakes have been added along the channel. Resilient stands of pine are slowly reconquering the formerly denuded uplands, thus contributing to the stability of steep colluvial slopes. The former off-limits eastern sector of the fan now hosts the outdoor sports facilities of the town.

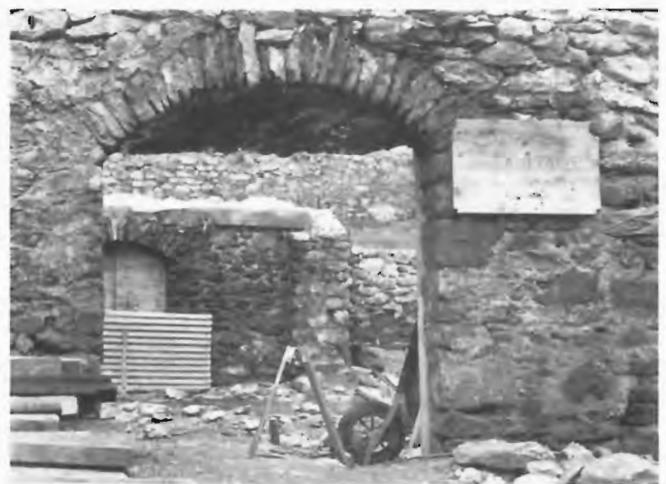
Figure 150: Recently excavated and renovated building foundations at the apex of the Nant Brun Torrent cone; note two generations of walls on the far side of the building. (GSC 204167-N)

Since 1807 stone masonry dykes along the axis of the Vorgeray cone have successfully contained minor debris flows. In the uplands reforestation has contributed to stabilizing embankments of debris chutes and ravines. In recent years residential construction has extended onto the bouldery debris of the upper cones. Here, formerly buried building walls locally serve as pedestals for new homes (Fig. 150).

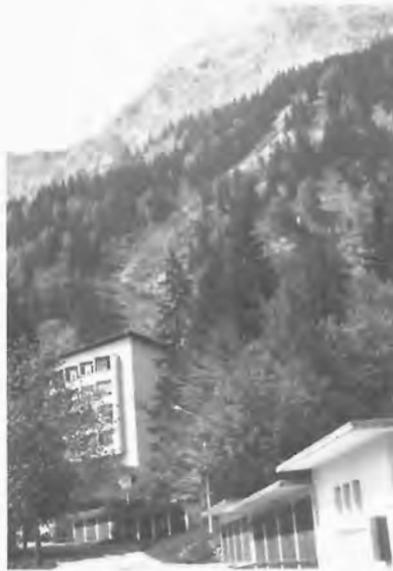
Figure 152: View of the sanatorium of Praz Coutant; note the snow-debris avalanche track behind the building. (GSC 204167-O)

During the winter of 1969-1970 most of the Savoie experienced exceptional snowpacks and snow-avalanche activity. The spring snowmelt was greatly delayed by late snowfalls. On 5 April 1970, a small wet-snow avalanche slightly damaged a sanatorium on the thinly forested bench of Praz Coutant. On 12 and 13 April 1970, about 50 mm of rain fell on the area and infiltrated the slope above Praz Coutant, which is inclined 30-40° and is underlain by slaty marl capped by about 2 m of colluvium. On 16 April 1970, a blanket of colluvial debris several tens of metres wide cracked open along a head scarp 300 m above the sanatorium of Praz Coutant. The mass of soil and trees, about 30 000-40 000 m³ in volume, followed the path of the snow avalanche and crashed in to the western wing of the building (Fig. 152). The walls that had resisted the impact of the snow avalanche collapsed under the impact of the debris, and 72 people, mostly children, lost their lives (Jail and Vivian, 1971, p. 475-482).

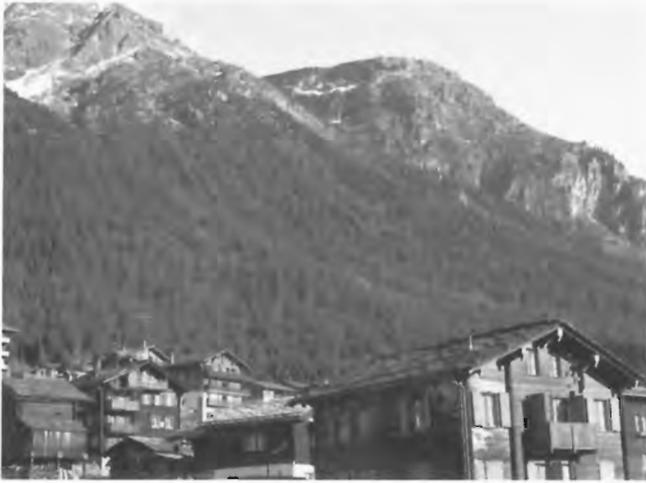
Figure 154: View of the lower slopes of the Durlochhorn and the conical rockfall deposits behind Grächen. (GSC 204167-P)

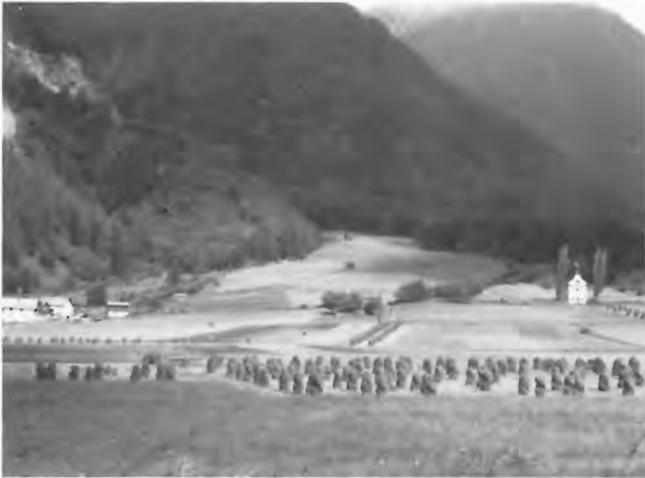
Figure 156: View of the hamlet of Östen; note dense protective forest along the axis of the cone (background), the lone church (a remnant of a former settlement), and the farm buildings on the flank of the cone. (GSC 204167-Q)

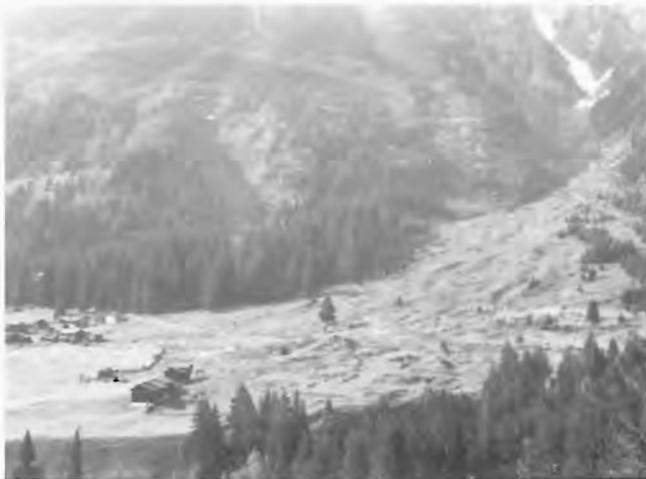
Figure 160: View of the rock avalanche lobe of 1770 on the cone of Monbiel. Farm buildings on the lower cone are located in the fall line of rare far-reaching snow avalanches from the Schildflue slopes. (GSC 204167-R)

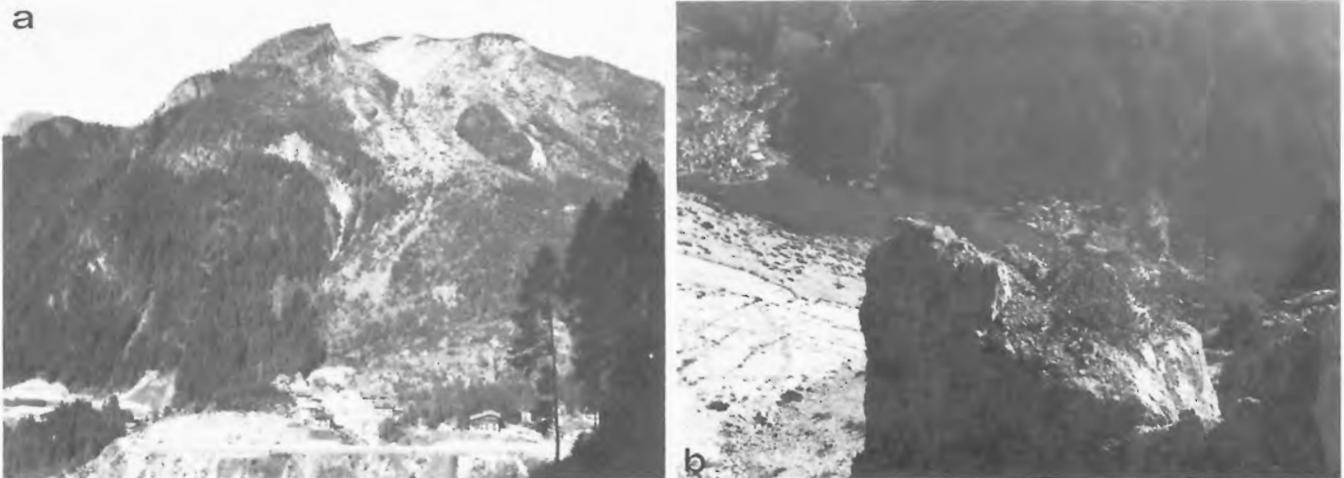
Figure 163: a) View of the Monte Forca detachment zone and rock avalanche deposits of 1771; note recently constructed vacation homes on the blocky Maserè (photo taken in 1980) (GSC 204167-S). b) View along the detachment surface of the rockslide to Lago di Alleghe; village of Alleghe on the left (GSC 204167-T).

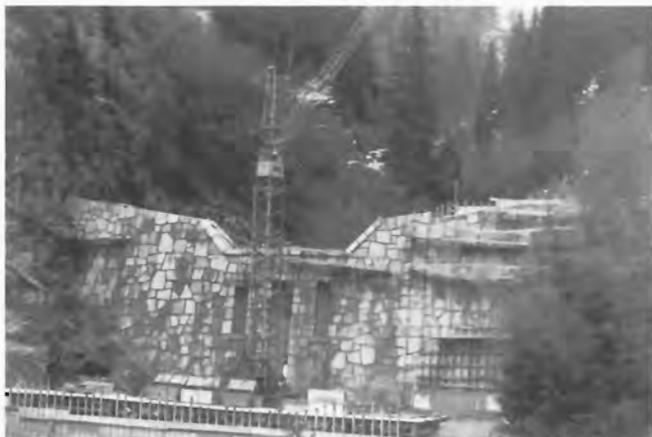
Figure 165: Protective dam under construction above the apex of the Axams cone; note vertical slits in the dam which allow selective discharge of normal bed-load and minor debris flows. (GSC 204167-U)

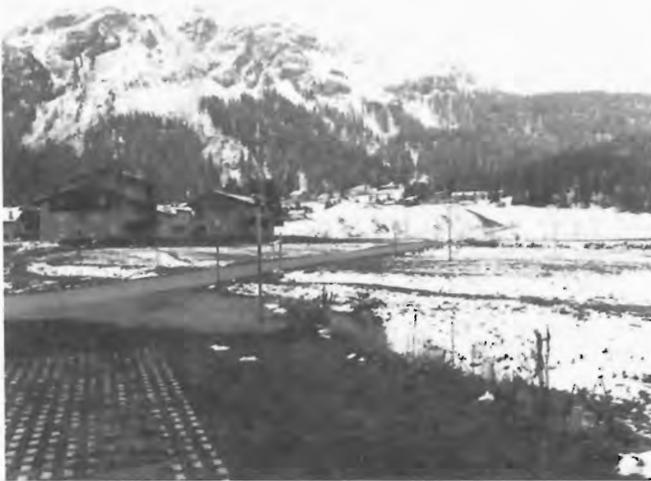
Figure 167: View towards the recently built-over segments of the Surlej fan delta. (GSC 204167-V)

In recent years the entire upper cone of Surlej has been built over with vacation homes and apartments, part of the overall development of the St. Moritz region (Fig. 167). Only the lowermost part of the debris fan is still in agricultural use.

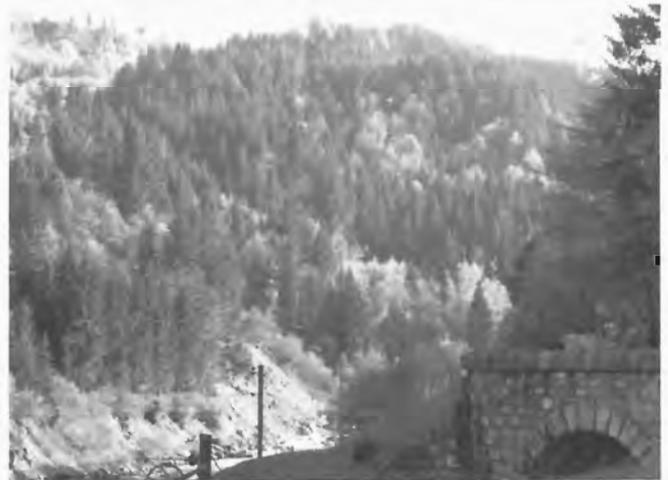
Figure 169: View of the Embacher Blaike scar; note rubbly toe zone and head scarp of the slowly moving debris slide which is covered by several generations of planted trees. (GSC 204167-W)

and railway along the busy transportation corridor were forced onto the unstable bedrock slope along the north side of the river (Fig. 169). There, as early as June 1874, the roof and wall of a railroad tunnel collapsed into the river (Wolf, 1875). The design of the modern highway has required extensive rock engineering to overcome the problems of the sagging terrain.

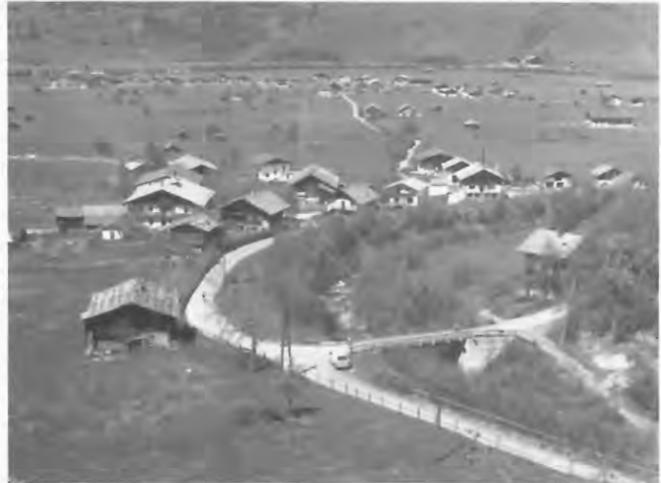
Figure 171: View of Mühlbach (foreground) and Niedernsill (background); note the sharply curved protective debris diversion dam and continuing construction activity on the upper fan. (GSC 204167-X)

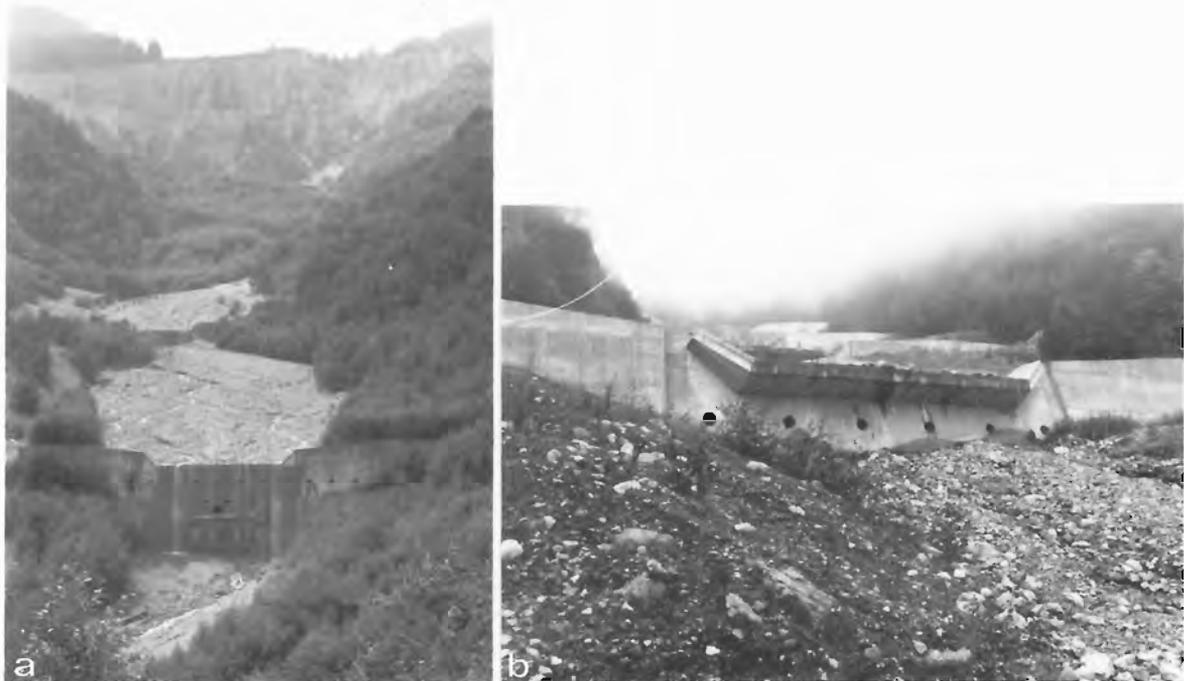
Figure 174: Two views of the large check dams along the Schesa Torrent below the erosional bowl of the Schesatobel: a) check dams confining the braided channel of the Schesa Torrent to the centre of the valley thus preventing lateral scour (GSC 204167-Y); b) steel-concrete check dam with an armoured carapace which minimizes damage to the structure from minor debris flows (GSC 204167-Z).

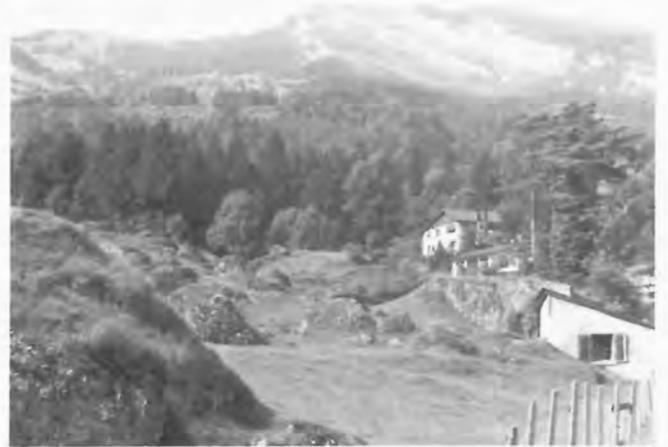
Figure 177: View northward from the town of Goldau to the detachment zone of the 1806 rockslide; note large transported blocks in the foreground. (GSC 204168-A)

Today Goldau flourishes on account of its industry and tourism. An excellent small 'Bergsturz-museum' keeps alive the memory of the disaster which so deeply affected the land and people of this beautiful part of Switzerland. The detachment zone of the rockslide has been set aside as a nature conservancy area (Fig. 177). The eastern upland slope of the Rossberg is still dotted by numerous hamlets and farms.

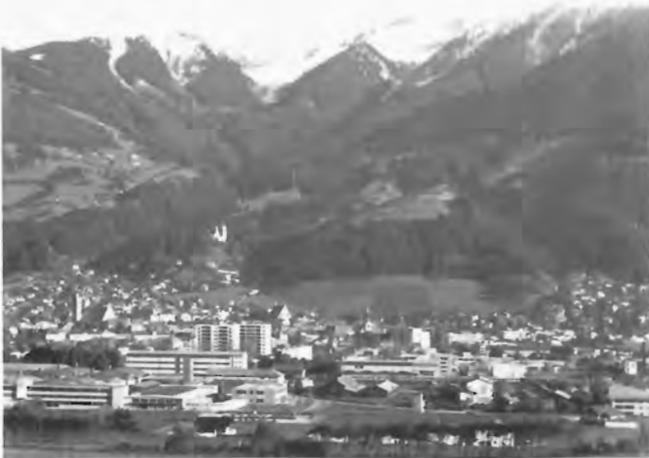
Figure 179: View of the built-over cone and the catchment basin of the Lahnbach Torrent; note farms along upland terraces, protective forests along the gorges, and snow avalanche tracks below the crest of the basin. (GSC 204168-B)

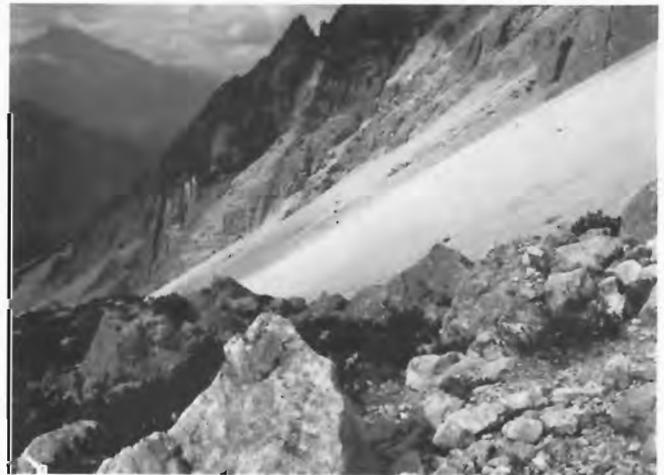
Figure 182: Part of the talus-covered basal rupture zone of the Antelao rock avalanche of 1814. (GSC 204168-C)

On 21 April 1814, a mass of carbonate rocks approximately $5 \times 10^6 \text{ m}^3$ in volume slid away above the Raibliano shale horizon. Guided by the northwest-dipping bedding and a steep northwest-trending fracture set, the disintegrating mass of dolomite first moved north-northwesterly and then cascaded westerly from the slanting terrace onto the valley floor (Fig. 182). There the lobe split into two parts: one erased the villages of Taolen and Marceana, killing 300 people; the other blocked the south-flowing Bòite Torrent temporarily (Catullo, 1814; Casal, 1898). The buried villages were not rebuilt after the catastrophe.

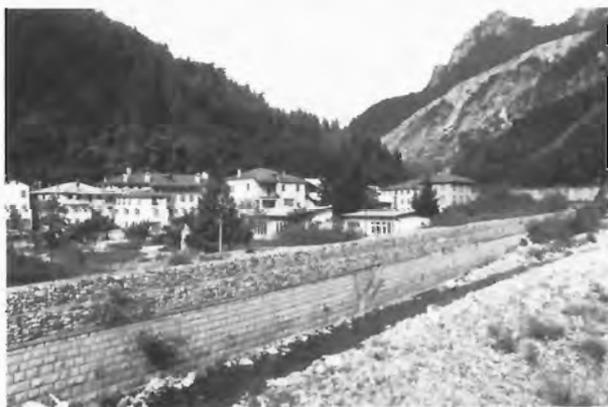
Figure 183: Masonry and gabion dyke separating the town of Perarolo from the channel of the Bòite Torrent; unstable bedrock slopes upstream from Perarolo in the background. (GSC 204168-D)

After the catastrophe, the town huddled against the steep western wall of the gorge. Today a dyke, approximately 10 m high, protects the village from the ravages of the torrent (Fig. 183). Two hydroelectric reservoirs in the upper part of the Bòite basin control seasonal discharge. A railroad tunnel also pierces the unstable formations of the gorge.

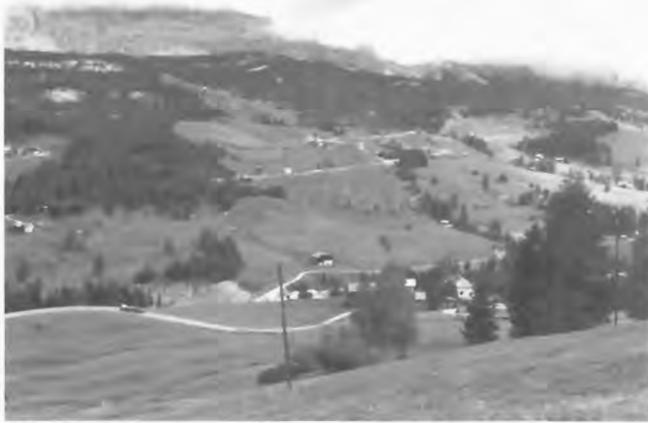
Figure 185: The unstable shale slope of Lamuda below the carbonate cliffs of the Kreuzkofel (Fanes) Massif. The toe of this slope impounded the Gader Torrent in 1821. (GSC 204168-E)

west wall of the Kreuzkofel (Fanes) Massif (2700 m) were noticed southwest of St. Leonhard (Fig. 185). Large cracks soon opened in a broad arc above the hamlets of Lazonei and Sottrú and an earth-debris mass pushed 16 buildings of Lamuda into the rising waters of the Gader Torrent whose flow had been stemmed by the advancing toe zone of the moving slope. A lake known as Lec da Sompunt eventually extended more than 1 km upstream before being drained by a cut across the debris barrier. However, the embankments along the former lake were now extremely unstable and during a sudden snowmelt and rainstorms in June 1827 the Gader Torrent carried away much of the loose slide material, devastating fields and communities in the lower valley (Stafiler, 1846, v. 2, p. 280).

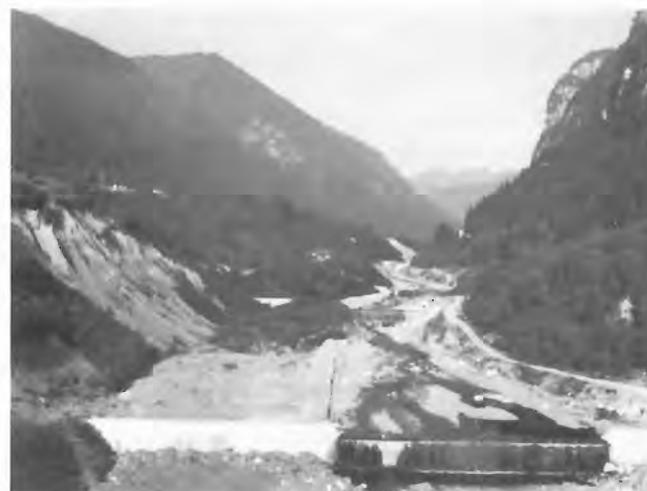
Figure 187: Northwestward view along the floodplain of the Vanoi Torrent at the toe of the Rebrutt cone (on the left); note wide-winged check dams designed to localize bedload transport and impede channel migration. (GSC 204168-F)

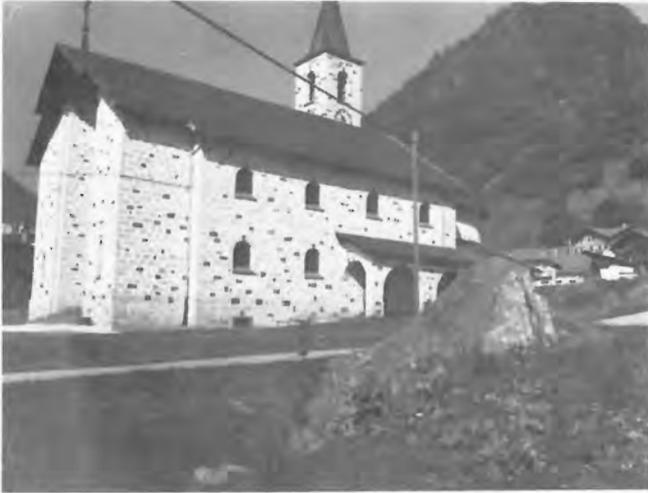
Figure 188: Recently constructed church on the cone of the Rio Valsona Torrent at Caoria; note the block of metamorphic rock marked with '1889', the date of the debris flow which deposited it. (GSC 204168-G)

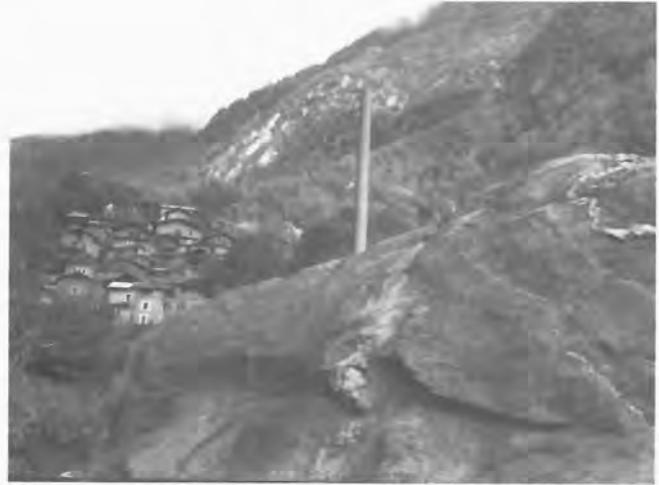
Figure 192: Steep rockfall cone and part of Spriana. (GSC 204168-J)

In 1834 a rock avalanche broke away along a composite fracture zone above Spriana and obliterated most of the village (Montandon, 1933, p. 317). Gigantic blocks of gneiss from this and possibly older falls still pierce the terraced meadows between the old stone-roofed buildings of the community (Fig. 192). Some of these houses have recently been restored into modern homes.

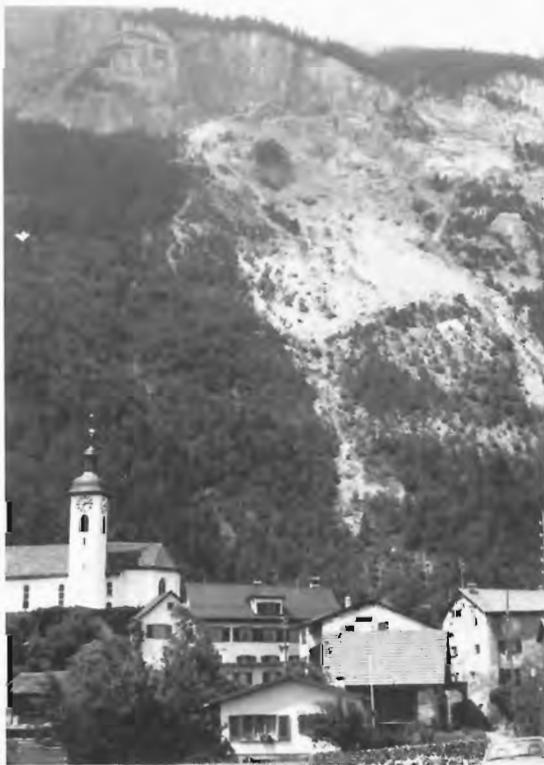
Figure 194: View of Felsberg-Altdorf and the carbonate dip slope behind the village; the church rests on a prehistorical slide block. (GSC 204168-K)

In recent years the two Felsbergs — Altdorf and Neudorf — have absorbed suburban growth from the nearby cities of Chur and Domat/Ems; most of the new homes are within reach of a major rock avalanche from the Calanda cliffs (Fig. 194).

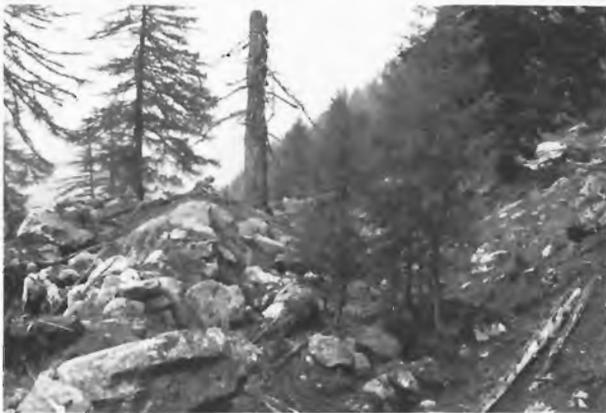
Figure 196: Deep but dormant crown cracks in massive gneisses along the headwall of the Alpe di Arena detachment zone. (GSC 204168-L)

Since that time the town has survived, perched against the precipitous and not entirely stable bedrock spur of Piano del Monte. The Maggia River has been diverted into a hydroelectric tunnel just above the slide-blocked gorge. The sagging slope now displays an undisturbed mantle of mature forest, suggesting that at present it is dormant (Fig. 196).

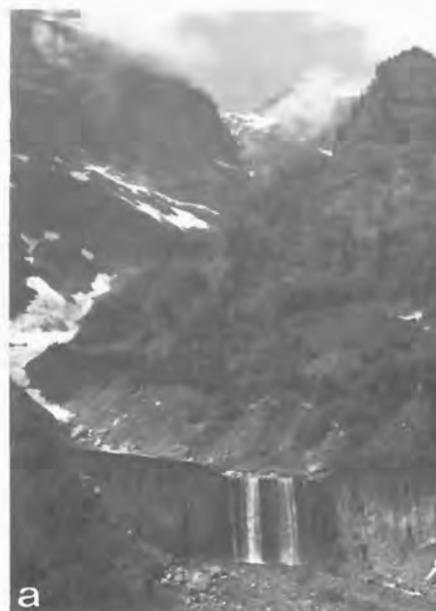
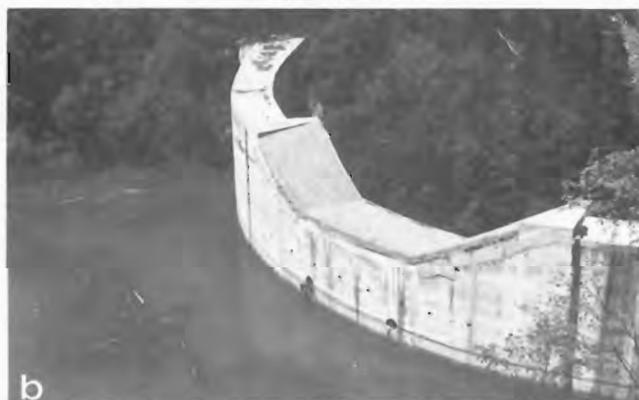
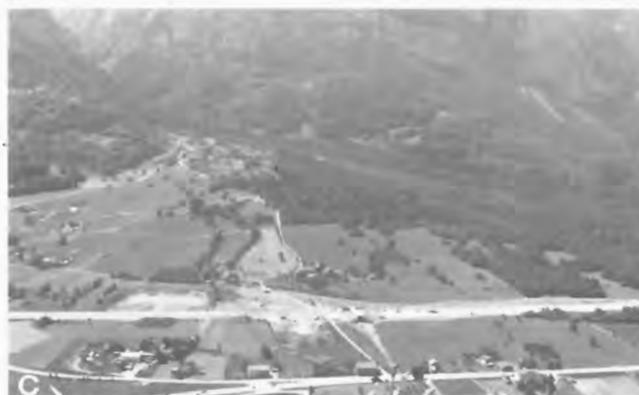
Figure 201: a) View towards the rugged summit ridge of the Dents du Midi from the top of the Gorge du Foillet; note large masonry check dam built in the 1930s (GSC 204168-O). b) Recently completed steel-concrete dam across the Gorge du Foillet; note temporarily impounded snowmelt runoff behind the structure (photograph taken in 1981) (GSC 204168-P). c) View across the Bois Noir cone; note protective pine forest on the northern sector of the cone (right); farms and residences dot the southern sector (GSC 204168-Q).

By 1939 several masonry check dams had been erected in the upper basin of the torrent to prevent undercutting of the colluvial embankments along the channel (Fig. 201a). In 1970 the torrent again showed signs of serious debris flow activity, and in 1975 a concrete dam, 45 m high, was erected across the upper gorge (Fig. 201b). Aggradation behind this structure will eventually render it ineffective. A large part of the impressive cone of Bois Noir is still covered by a pine forest (Fig. 201c); the community of Evionnaz and several recreational developments are now encroaching onto the southern sector of the cone.

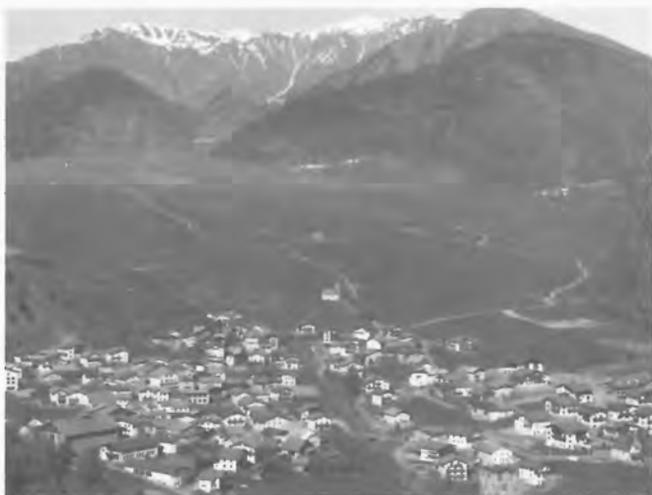
Figure 206: View of the large cone of Mals and the settlement of Burgeis in the foreground. (GSC 204168-T)

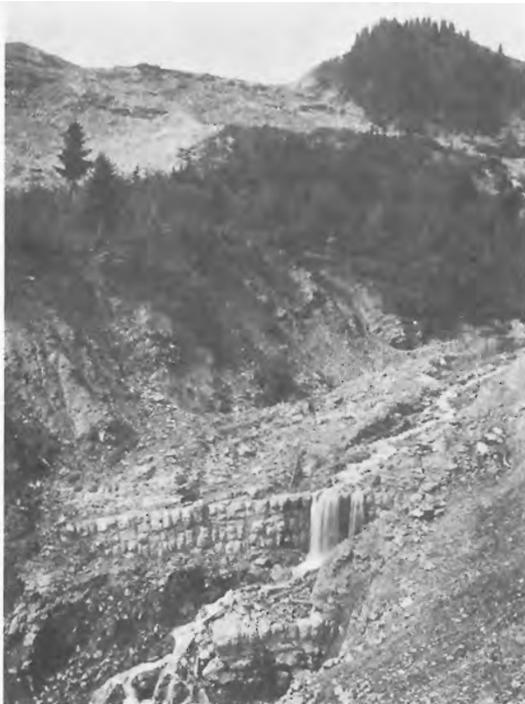
Figure 209: Slumping bedrock embankments along the Nolla channel as seen at the turn of the century; note shifted and partly crushed masonry check dams (from Salis, 1914).

It was now recognized that without a comprehensive control program along the Nolla Torrent the dyking of the Hinterrhein River was doomed to failure. Thus began a long and ultimately successful struggle against the Nolla dragon! Short-term neutralization of the main debris sources was achieved by masonry spurs and check dams along the unstable embankments of the torrent (Fig. 209). Channel revetments and flood control dykes were added farther downstream. Later, the steepest embankment sections were reforested and the Lüschersee sag pond drained. Runoff from the alpine meadows of the Heinzenberg crest has been and still is being carefully channeled along drainage ditches (Fig. 210) which are adjustable to allow for continued deep-seated creep amounting to between 10 and 20 cm/year and involving slaty bedrock to a depth of approximately 150 m (Jäckli, 1957, p. 56). Many check dams on the Nolla crack slowly under stresses propagated from the Heinzenberg slope and are buried by slumps and small debris flows. They have to be replaced from time to time by ever stronger concrete dams to maintain a reasonably 'clean' torrent.

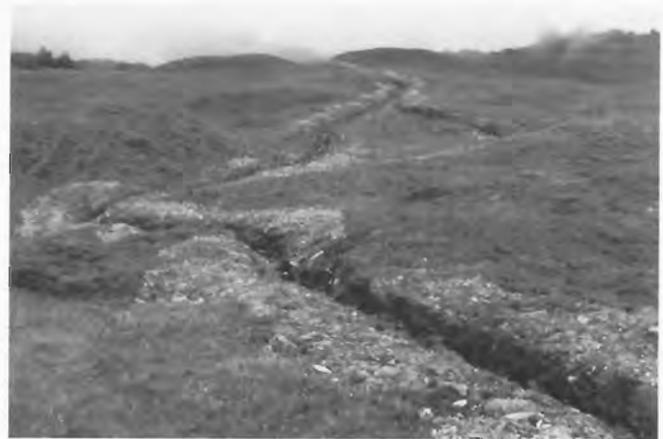
Figure 210: View of surface drainage ditches on the undulating upper part of the Heinzenberg slope; snowmelt runoff is thus prevented from accumulating in and infiltrating along sag ponds on the slope. (GSC 204168-U)

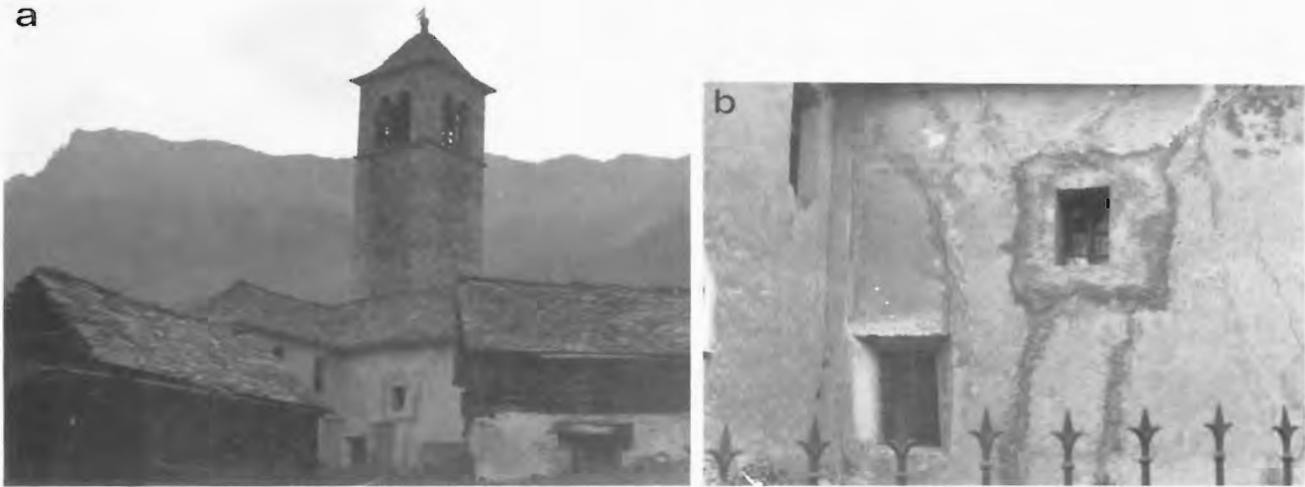
Figure 213: a) The old church of Campo which during the last century has shifted at least 15 m horizontally (GSC 204168-V). b) Close-up view of the cracked and distorted church wall (GSC 204168-W).

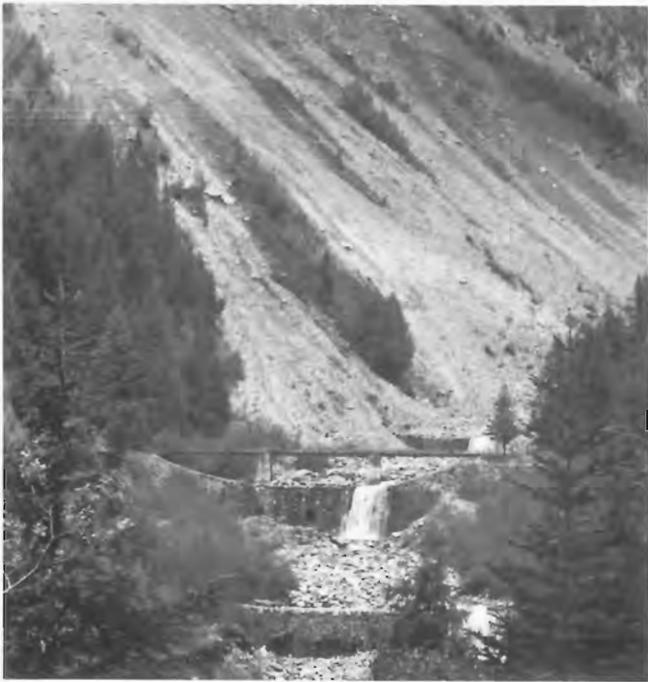
Figure 215: Masonry check dams along the rubbly toe of the Bec Rouge slide; check dams have prevented the torrent from eroding the loose landslide deposits. (GSC 204168-X)

buried the abandoned ruins of the hamlet; finally, on 20 July 1895, during a local thunderstorm, $0.6 \times 10^6 \text{ m}^3$ of debris covered the entire cone and took out the road to the upper Isère region. At this stage six transverse masonry check dams were built to prevent further erosion along the toe of the slide mass (Fig. 215). Drainage works on the landslide itself reduced continuing downward creep and reforestation impeded the development of new ravines in the scarred uplands (Mougin, 1914, p. 721-725, and 1931, p. 525-531).

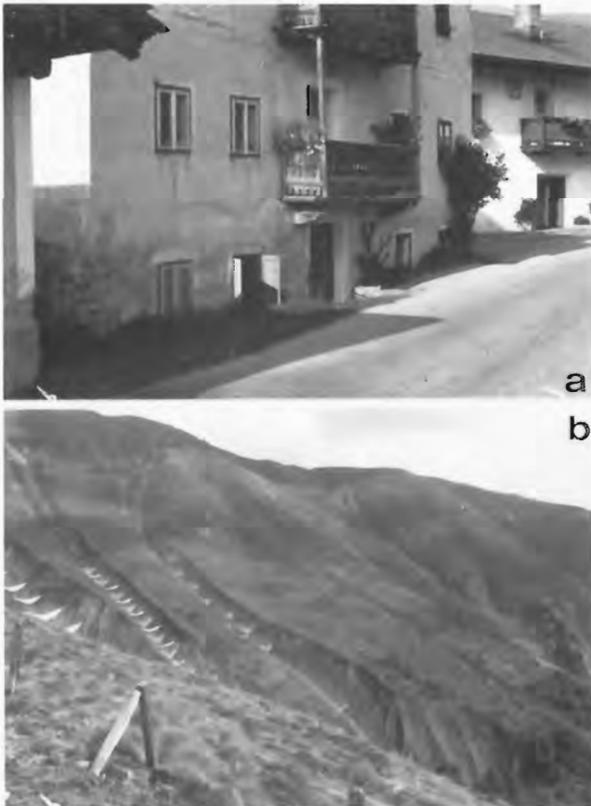
Figure 221: a) House in Toblach which survived the debris floods and flows of the late 19th century; the first floor has been converted into a basement (GSC 204169-A). b) Erosional ravines in late glacial ice-margin deposits in the Pfannbach basin; note check dams (GSC 204169-B).

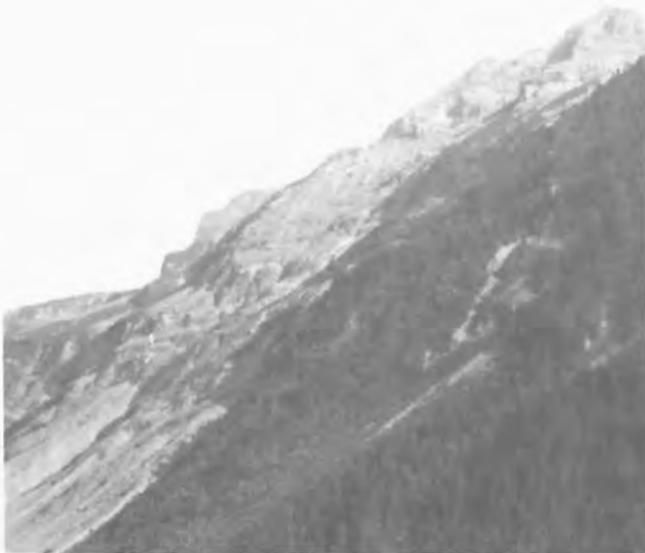
Figure 223: Detachment zone of the Spitzten rockslide; failure occurred along a stepped composite fracture surface cutting across the bedding. (GSC 204169-C)

In June 1910 the mountains of eastern Switzerland and western Austria were still covered deeply by snow when intense squalls of warm rain deluged the Schächen basin. On 14 June 1910, when 100 to 200 mm/24 h were registered in Altdorf, a total of $0.2 \times 10^6 \text{m}^3$ of debris was mobilized from the Spitzen rock avalanche deposit and surficial deposits along the Schächen Torrent. An industrial installation south of Altdorf was seriously endangered by this debris. At the same time, a rockfall from the cliffs above Altdorf descended through a chute and crashed into a building, killing its 11 occupants (Heim, 1932, p. 68).

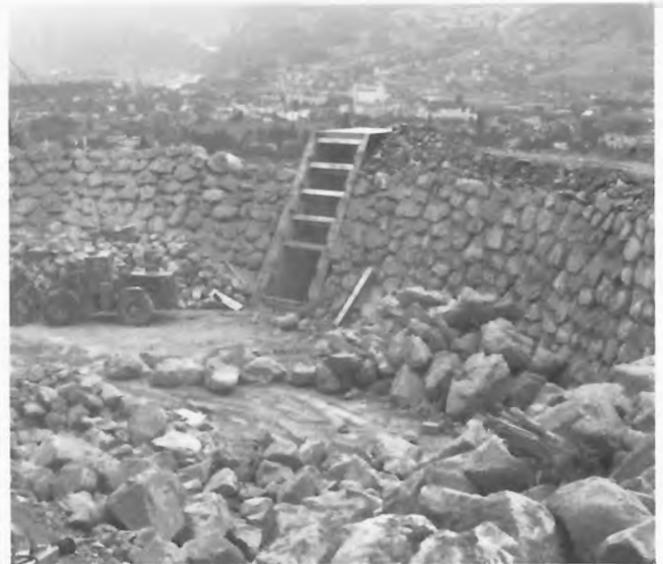
Figure 224: Protective dam against debris avalanches under construction near Altdorf; note stone block armour and discharge section designed to drain water from complex debris-snow avalanches. (GSC 204169-D)

In the aftermath of these events a large number of check dams were erected along the channel of the Schächen Torrent. They have functioned satisfactorily since then, although recently aggradation at the confluence of the torrent and the Reuss River has required modification of the channel works. Since 1972, several protective dams also have been constructed below ravines near Altdorf (Fig. 224).

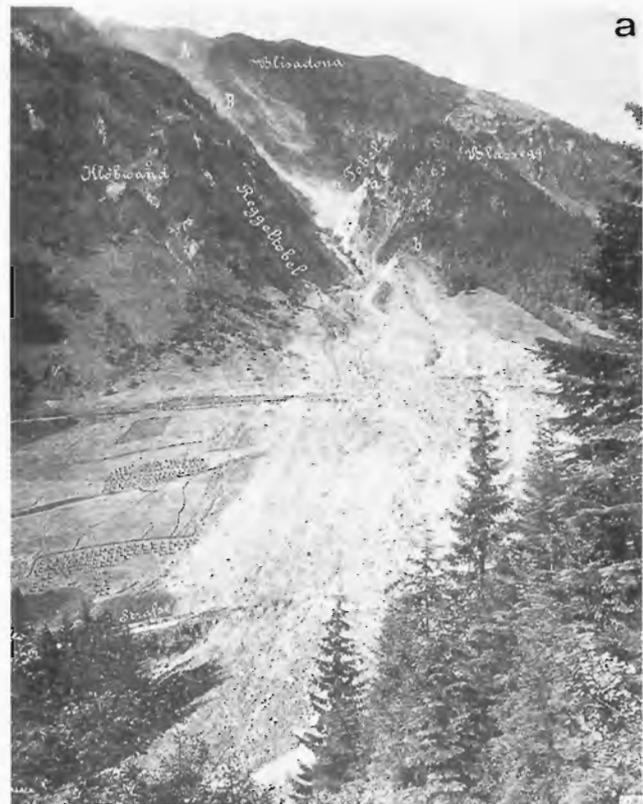
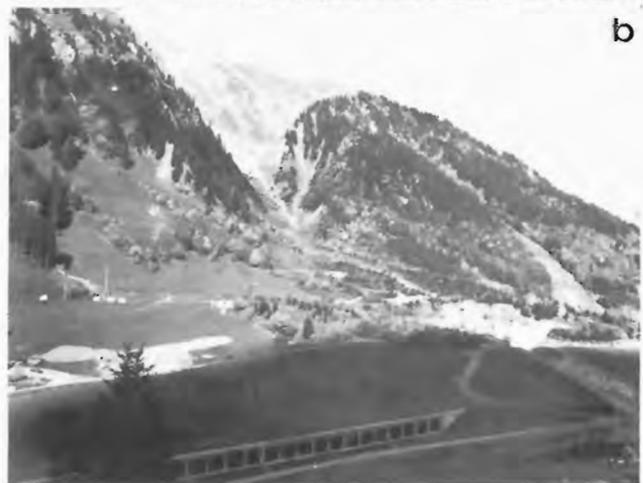
Figure 228: a) Photograph of the Blisadona rock avalanche shortly after the event (from Toula, 1893). b) The Blisadona cone today: a modern highway gallery pierces the debris cone and an armoured channel facilitates the passage of runoff, snow avalanches, and rare debris flows (GSC 204169-E).

On 9 July 1892, possibly as a result of snowmelt infiltration, the slab of carbonate strata, 240 m wide, 70 m high, and 15 m thick failed. The photographs taken before the failure indicated that failure was preceded by downward buckling ('Ausbauchen') and outward rotation ('Umkippen') of the lower part. After breaking and shearing along a ragged basal rupture zone, the panel collapsed into a downward tapering ravine filled with avalanche snow. When the rock stream burst onto the cone it spread out in two thin lobes (Fig. 228a). The western lobe buried the road and railroad, then banked

To protect the railroad from similar future events a tunnel was bored beneath the apex of the debris cone. More recently, a modern highway also has been routed via a concrete gallery along the periphery of the cone (Fig. 228b). Klösterle in recent years has grown into a prosperous tourist village. Today the green surface of the Blisadona cone hardly betrays its violent recent history!

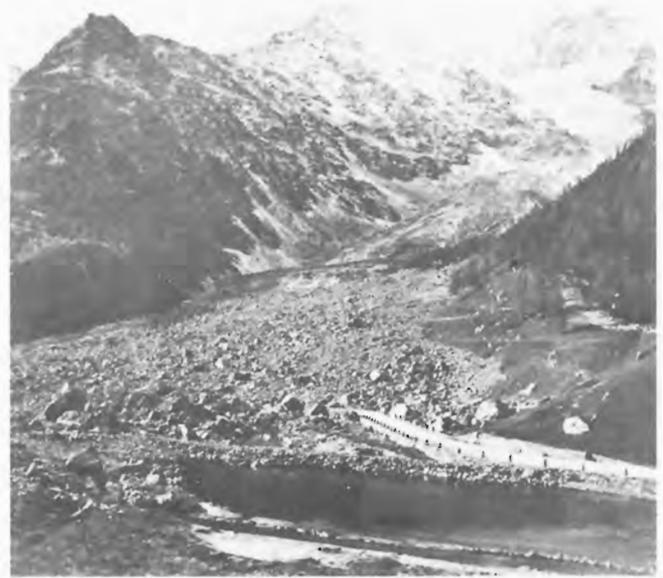
Figure 233: Photograph of the Rossbode Glacier and the 1901 rock-ice avalanche deposits shortly after failure (photo courtesy Müller).

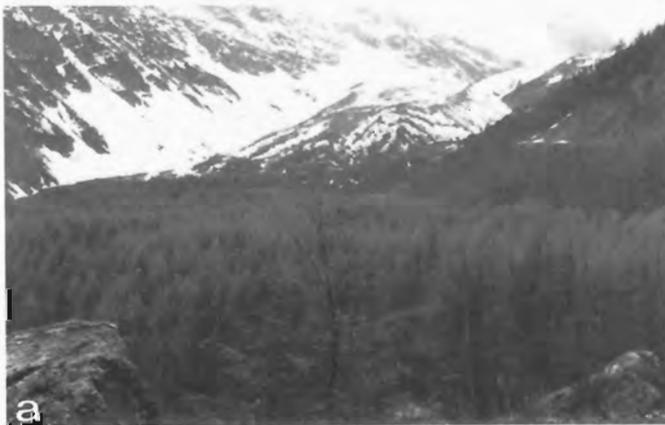
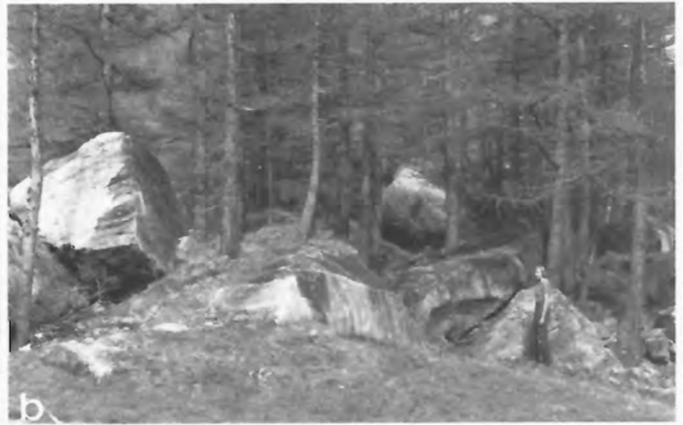
Figure 234: a) View onto the larch-covered Gletschersturz in 1981 (GSC 204169-F). b) Gneissic blocks in the frontal part of the rock avalanche deposits (GSC 204169-G).

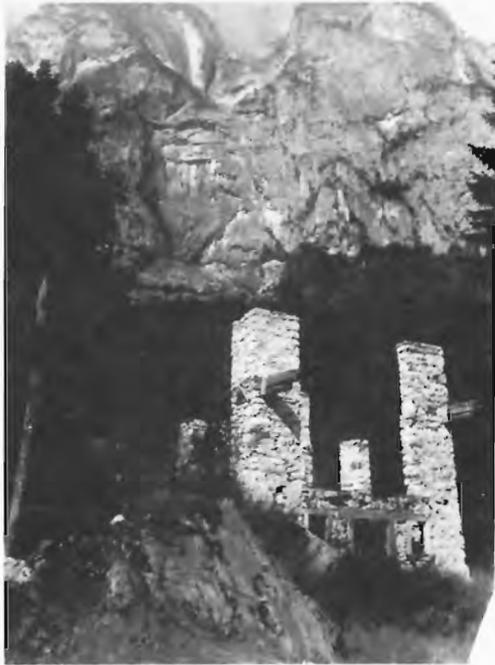
Figure 238: Blocks of the rock avalanche of 1908 (foreground) scattered among the ruins of Pra; the carbonate cliff of Cima d'Ambrosogn in the background (photograph taken in 1980). (GSC 204169-H)

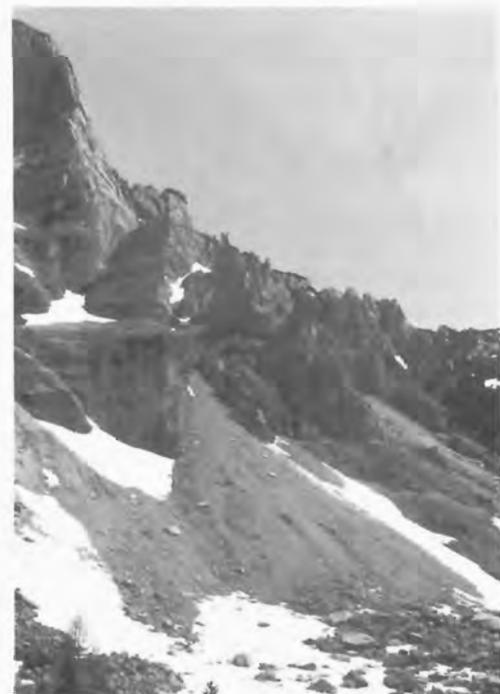
Figure 241: Remnants of the collapsed Pulverhörndl tower along the fracture-controlled west face of the Sandling Massif. (GSC 204169-1)

Pulverhörndl was shifting slowly towards the southwest. It soon became apparent to the onlookers that the rock spur, $0.2 \times 10^6 \text{ m}^3$ in volume, was gradually moving away from the main face of the Sandling along a vertical fracture trending north-northeasterly. Accompanied by rockfalls and outward flow of shale below the tower this process of detachment continued for more than twelve hours. When trees and huts of the alpine meadows began to shift as well, the people abandoned the area. Shortly thereafter, the main part of the tower crumbled completely and a lobe of blocky carbonate spread over the meadows which were underlain by water-saturated shale and surficial deposits. The frontal segment of the overloaded area began to break up into slumps which combined into a downward pressing flow of mixed shale, moraine, and rock avalanche deposits. The initial rate of displacement at the front of this flow was 11 m/s; eventually a mass of 6 to $9 \times 10^6 \text{ m}^3$ moved slowly down the tributary ravine destroying valuable forest land (Lehmann, 1926). Upon reaching the Leisling Torrent the toe of the debris lobe was reworked and transported to the cone of the torrent. During the years since then the flow slowed down and today only a small segment seems to be active. Check dams along the lower reaches of the Leisling Torrent have kept erosion of rubble along the channel within tolerable limits. Several deep cracks along the face of the Sandling indicate that not all of the Pulverhörndl was carried away in 1920 (Fig. 241).

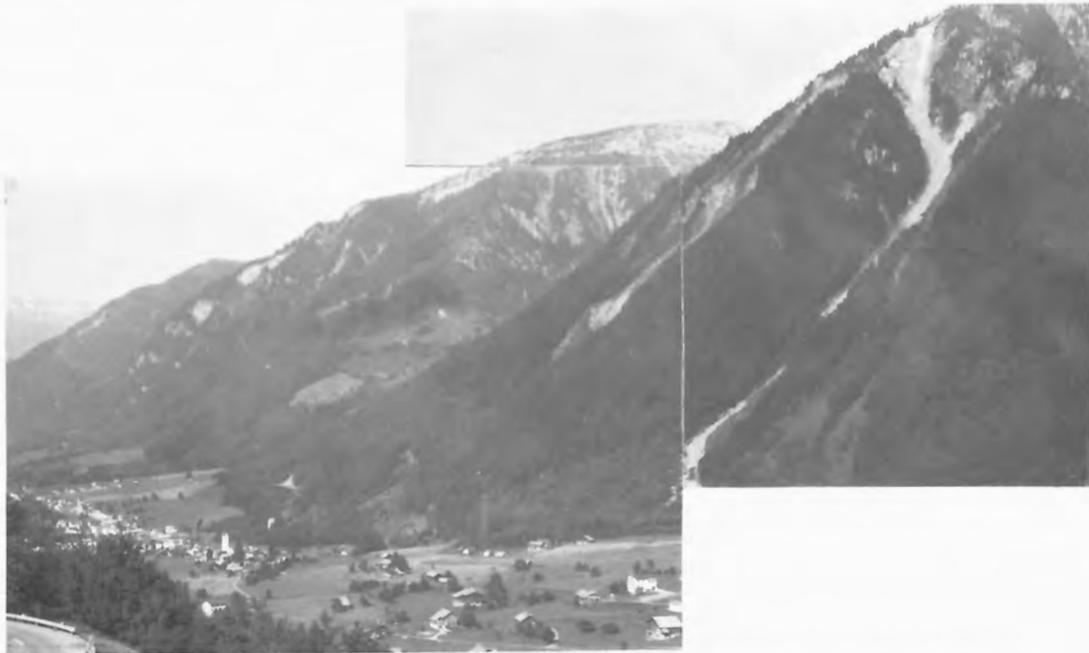
Figure 246: View of the Kilchenstock slope southeast of Linthal; note the two active rockfall chutes flanking the main unstable rock promontory. (GSC 204169-J)

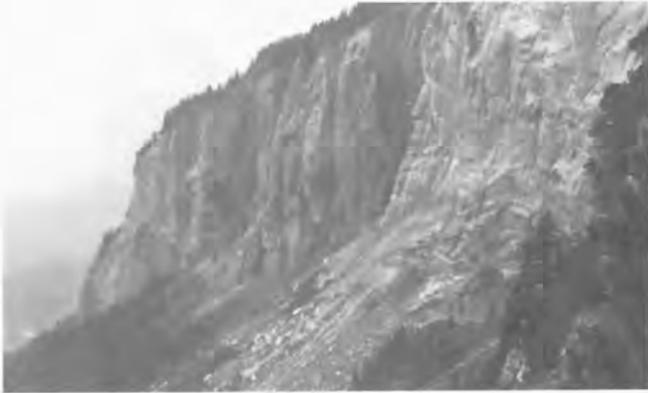
Figure 249: View westward along the steep carbonate cliff of the Flimserstein above Fidaz. (GSC 204169-K)

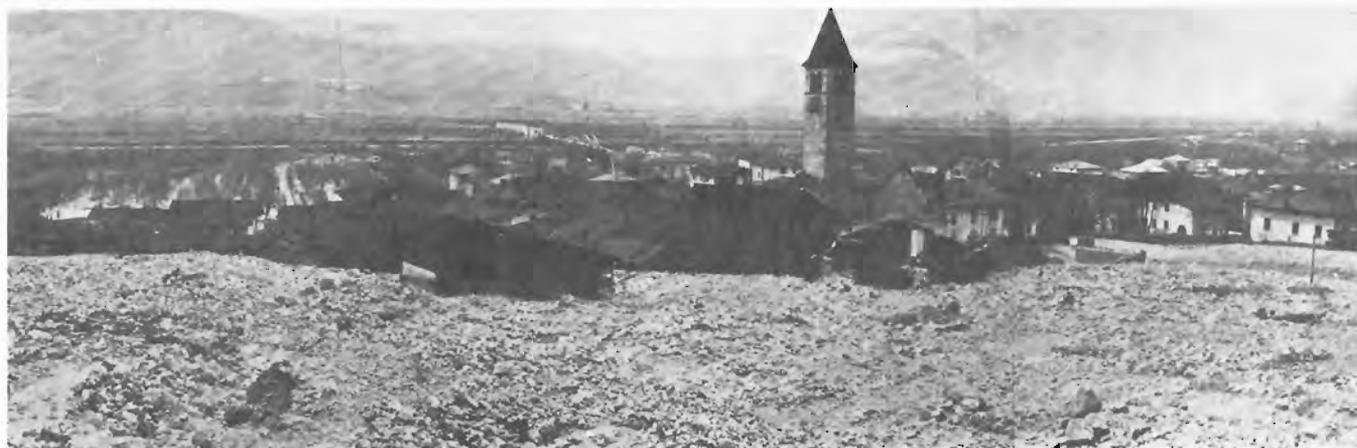
Figure 255: Debris flow deposits that engulfed Zambana in 1955 as seen from the mouth of Val Manara (from Andreatta, 1956).

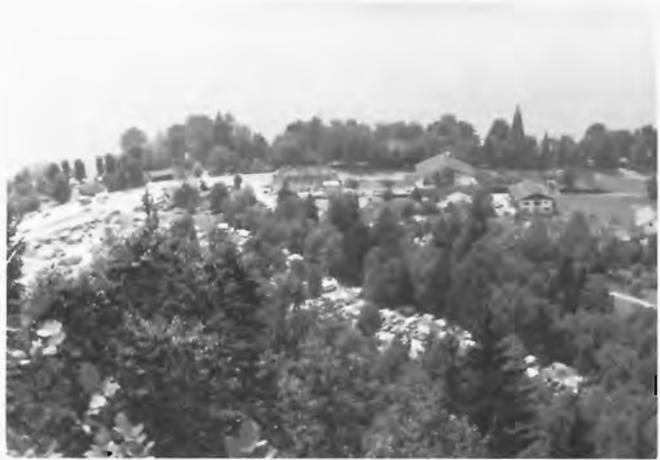
Figure 257: View of the Pesenthein cone and Lake Millstatt. Left cone sector is entirely occupied by campground facilities; right cone sector hosts several recently built hotels. (GSC 204169-N)

In recent years most of the cones in the area have been completely built over. Additional control works have been erected on some torrents, but, since the recurrence interval of thunderstorms like the one in 1958 is about 300 to 500 years (Richter, 1959) the debris flow risk on many small cones has been accepted (Fig. 257).
