Geological Survey of Canada
Paper 84-16

Destructive Mass Movements in High Mountains: Hazard and Management

G.H. Eisbacher and J.J. Clague

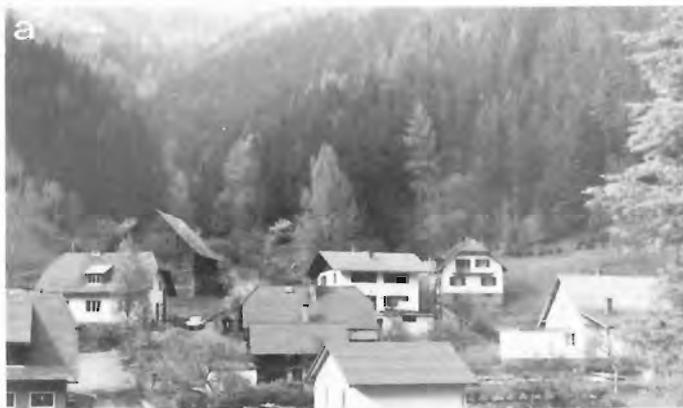
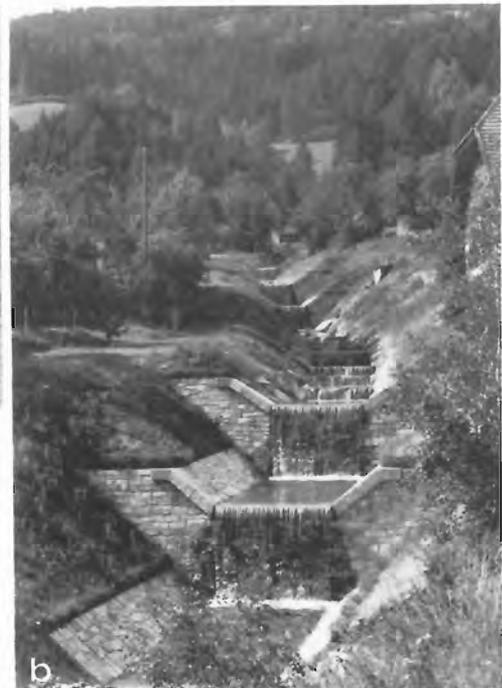
Figure 259: a) Typical V-shaped, densely forested torrent basin in the Breitenau Valley. Although normally characterized by insignificant runoff this type of basin produced large debris flows during the catastrophe of 1958. Note recently constructed buildings on the apex of the small cone (GSC 204169-O). b) Example of a check dam-revetment combination in the Mur Valley (GSC 204169-P).

Since 1958, many communities in the tributary valleys of the Mur-Mürz corridor have doubled in size. Most of the debris cones in the region have been built over (Fig. 259). The major torrents have been provided with revetments or check dams, but the smaller ravines are largely in their natural state.

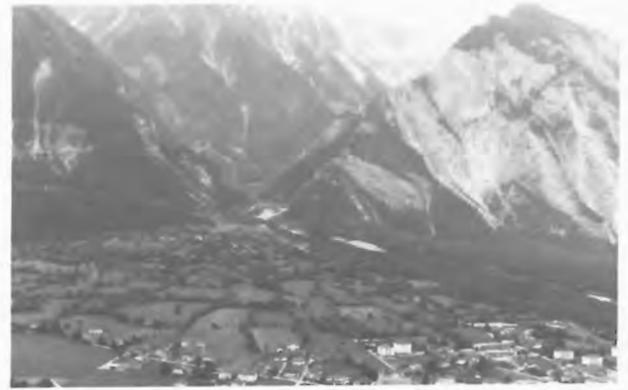
Figure 261: View of the Illgraben cone; note protective forest along the torrent channel; community of Susten at lower right. (GSC 204169-Q)

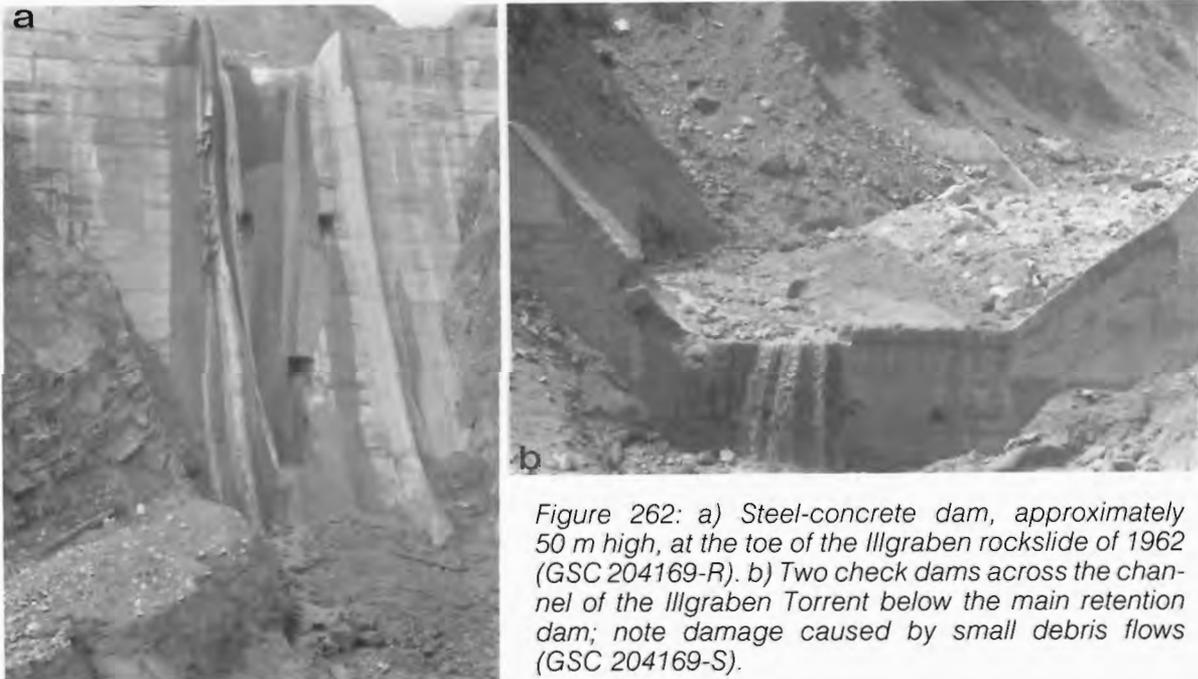
Figure 262: a) Steel-concrete dam, approximately 50 m high, at the toe of the Illgraben rockslide of 1962 (GSC 204169-R). b) Two check dams across the channel of the Illgraben Torrent below the main retention dam; note damage caused by small debris flows (GSC 204169-S).

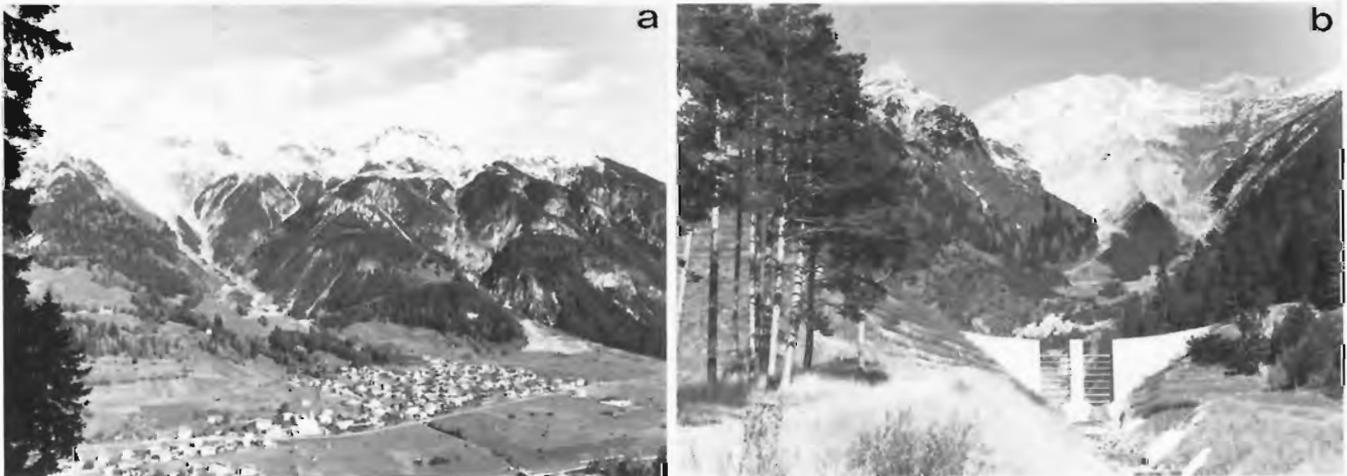
Figure 267: a) View of Pettneu from across the Rosanna Torrent; note protective forest at the apex of the cone (GSC 204169-V). b) Discharge section of the protective dam above the Pettneu cone; source area of the 1968 debris flow in the upper right (GSC 204169-W).

a dozen abandoned buildings. The total volume of the flows was estimated to have been $0.3 \times 10^6 \text{ m}^3$. A protective forest above the town prevented the debris from taking a more destructive path. After the catastrophe a large protective dam with a selective discharge section of steel beams was erected above the cone (Fig. 267). Its design capacity of $0.3 \times 10^6 \text{ m}^3$ corresponds roughly to the volume of potentially unstable debris sources remaining in the upland (Moll, 1976). The people of Pettneu contributed much free labour to the restoration of their town and also planted 15 000 extra trees in the protective forest zone above the community.

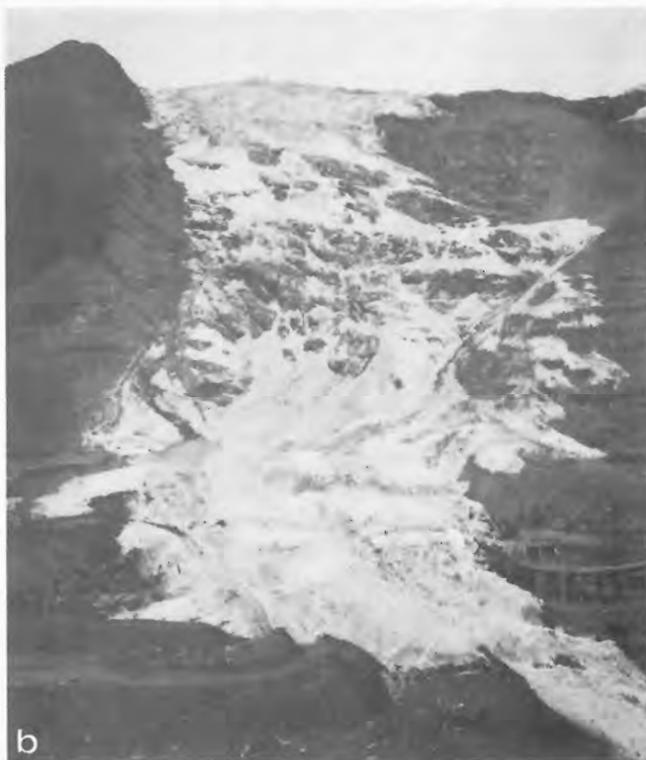
Figure 269: a) Allalin Glacier in 1981 (GSC 204169-X). b) The destructive Allalin ice avalanche of 1965 (Photo: ElectroWatt Zurich).

$1.0 \times 10^6 \text{m}^3$ of ice at the heavily crevassed front of the hanging glacier slid away. Leaving behind a downward concave fracture 40 m high at an elevation of 2500 m, the avalanche of ice, 100 to 200 m across, surged down the smooth rock slope and overwhelmed the construction camp located in its track. A powerful air blast flattened barracks and other timber structures before the camp disappeared underneath a blanket of pulverized ice and morainal debris (Fig. 269b). A total of 88 construction workers lost their lives

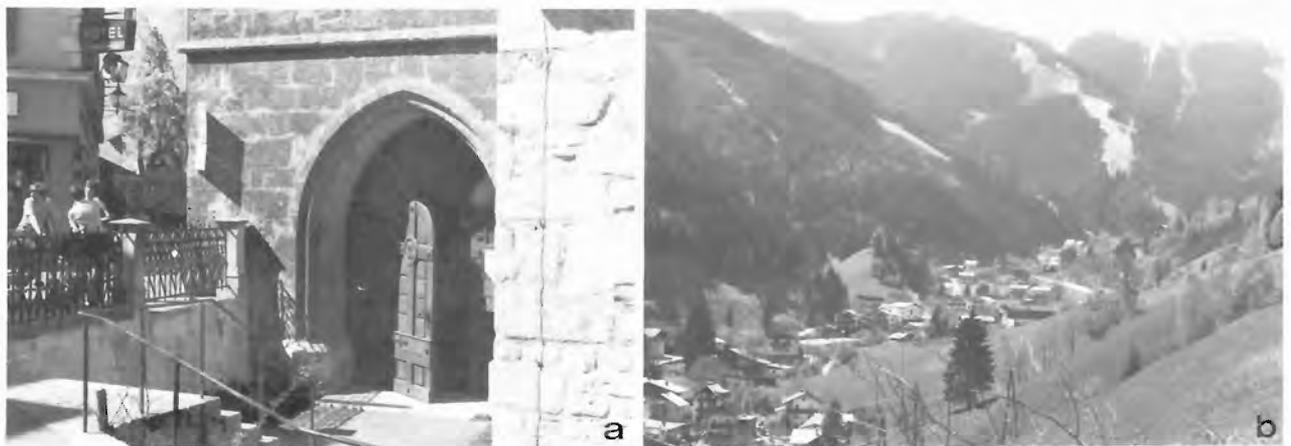
Figure 271: a) Entrance to the church of Zell am See below street level, an indication of aggradation by historical debris flows on the Schmittenbach cone (GSC 204169-Y). b) View into the intensely developed zone above the apex of the Schmittenbach cone; ski slopes and snow avalanche tracks in the background (GSC 204169-Z).

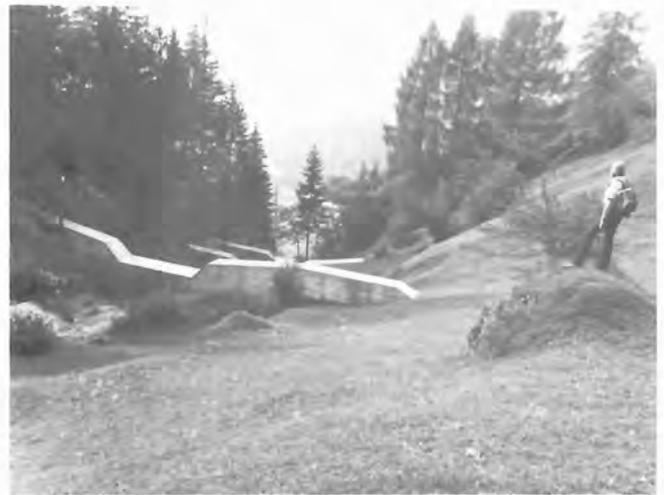
Figure 274: Recently completed array of check dams across a ravine above Siror which is carved into slump-prone relict colluvium and phyllitic bedrock. (GSC 204170-A)

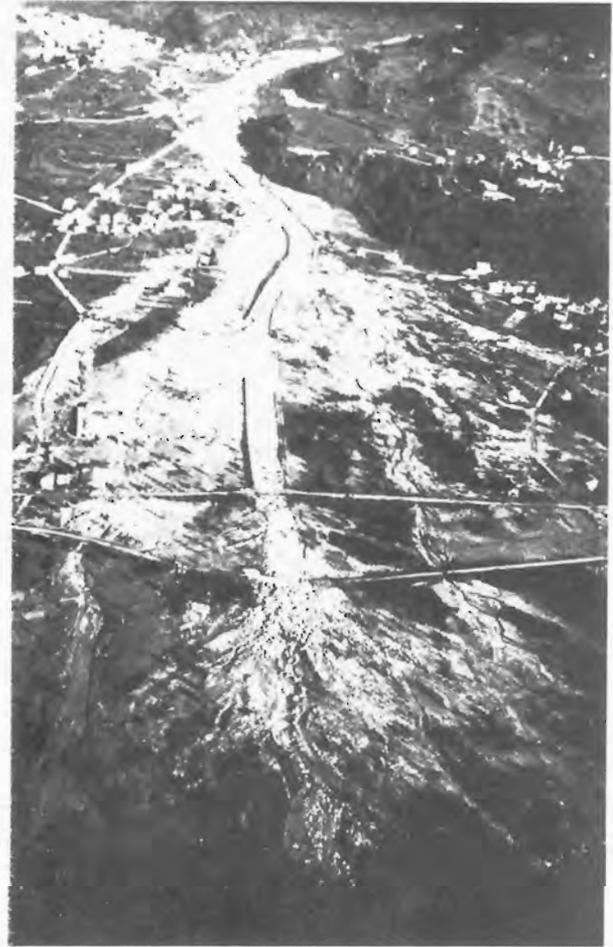
Figure 276: Aerial view of debris damage on the Chiappena fan in the autumn of 1966; note breached dykes at points of curvature in the channel (from Dragogna, 1975).

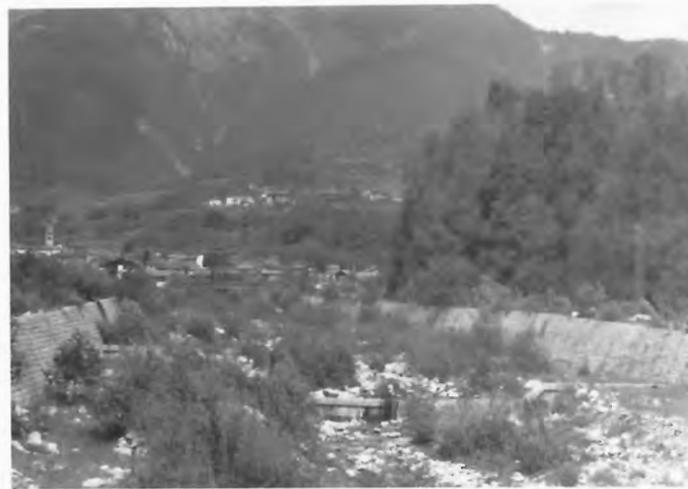
Figure 277: Reconstructed masonry-lined channel of the Chiappena Torrent below Strigno; note armoured sills defining the normal discharge section of the torrent. (GSC 204170-B)

Today many of the erosional scars created during the 1966 rainstorm are overgrown by thin stands of alder. The lower channels of the torrents have been provided with sturdy dykes and masonry revetments (Fig. 277).

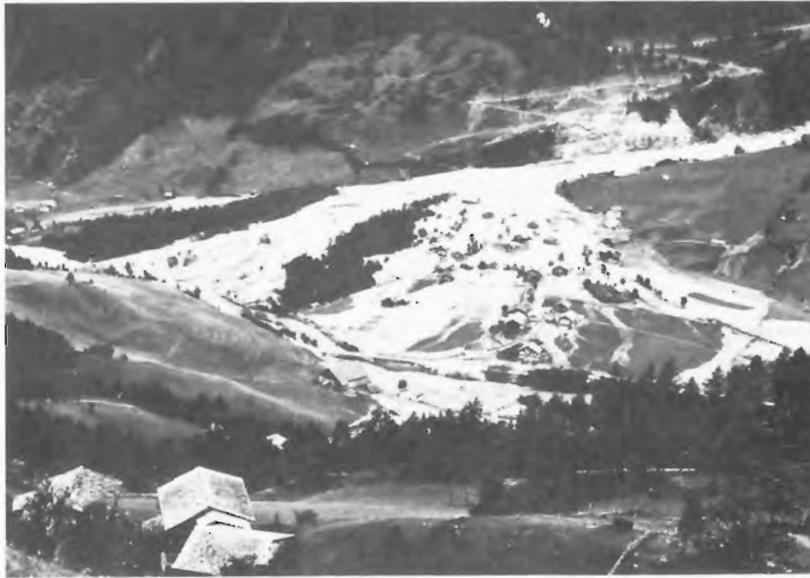
Figure 279: Debris lobes on the Gradenbach cone engulfing the community of Putschall in the autumn of 1966 (from Kronfellner-Kraus, 1974).

cone, forcing the evacuation of Putschall (Fig. 279). Huge masses of bedload also choked the channel of the Möll River. After the catastrophe an extensive research project was initiated along the Gradenbach Torrent and on the sagging slope above (Kronfellner-Kraus, 1974, 1980; Horninger and Weiss, 1980; Moser and Glumac, 1983). Detailed surveys defined the principal zones of displacement on the sagging slope. Installation of piezometers coupled with local

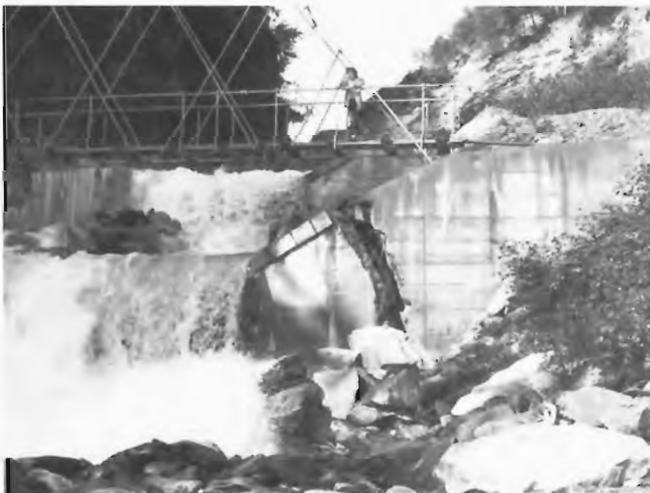
Figure 280: Check dams across the Gradenbach Torrent; note damage to the abutments of the check dams caused by lateral pressure from the toe zone of the sagging Eggerwiesenkopf slope. (GSC 204170-C)

meteorological observations established that creep rates are directly related to infiltration of surface waters from rainstorms and snowmelt. Check dams in the Gradenbach gorge were found to be strained to the point of failure by the lateral pressure exerted by the slope (Fig. 280); their reconstruction and maintenance has been found to be extremely difficult (Kronfellner-Kraus, 1980). The hamlet of Putschall continues to exist on the cone (Fig. 281).

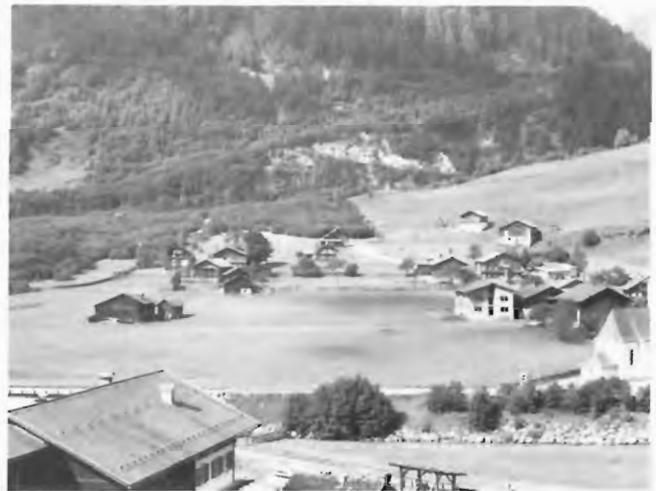
Figure 281: Putschall in 1981; note dense alder fringing the controlled channel of the Gradenbach Torrent. (GSC 204170-D)

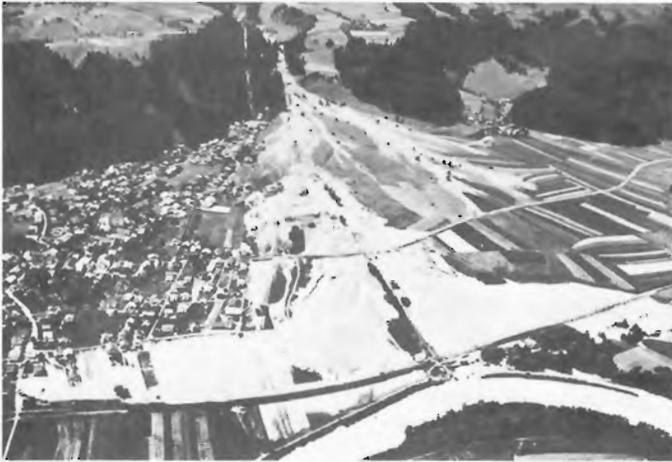
Figure 283: Impact of the 1969 debris flow on the Enterbach cone (photograph Alpine Luftbild); note the traditional land use pattern which assigned residential use to one flank of the cone and agriculture to the rest.

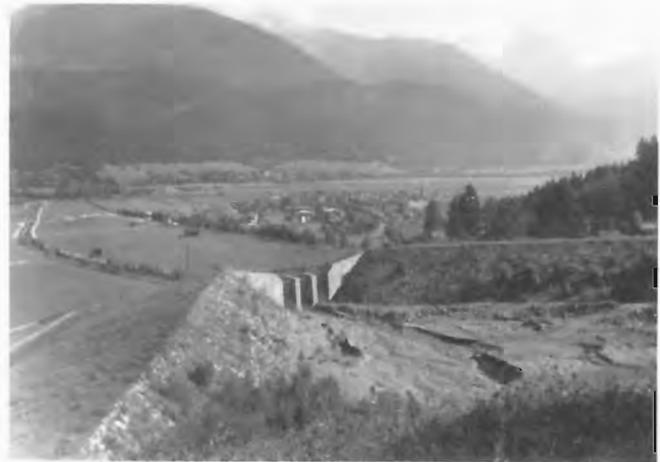
Figure 284: Protective dam above Inzing; note selective discharge section of steel beams ('filter dam') which allows passage of normal bedload. (GSC 204170-E)

After the 1969 disaster, the torrent channel on the cone was moved 150 m to the west away from Inzing. The protective dam above the community was converted into a steel-concrete-masonry structure with a retention capacity of more than $0.3 \times 10^6 \text{ m}^3$ (Fig. 284). New arrays of check dams were built in the source area below the Inzinger Alm (Fig. 285), and about $10\,000 \text{ m}^3$ of rock (used in the construction of the protective dam) were blasted away from a constriction in the lower gorge to avoid blockage of the channel during future flows (Hopf and Wanner, 1975).

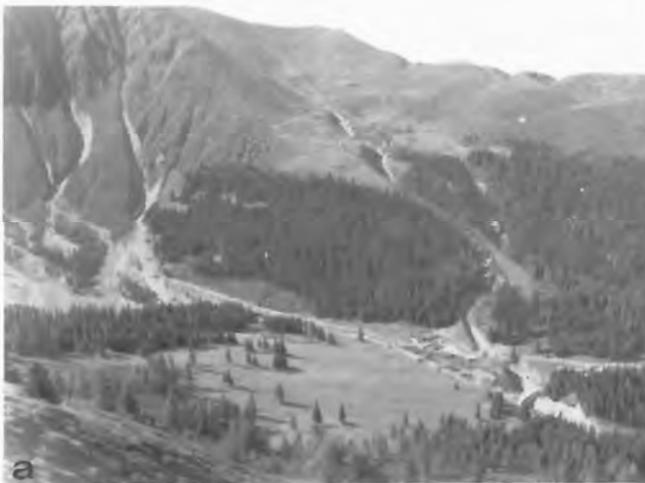
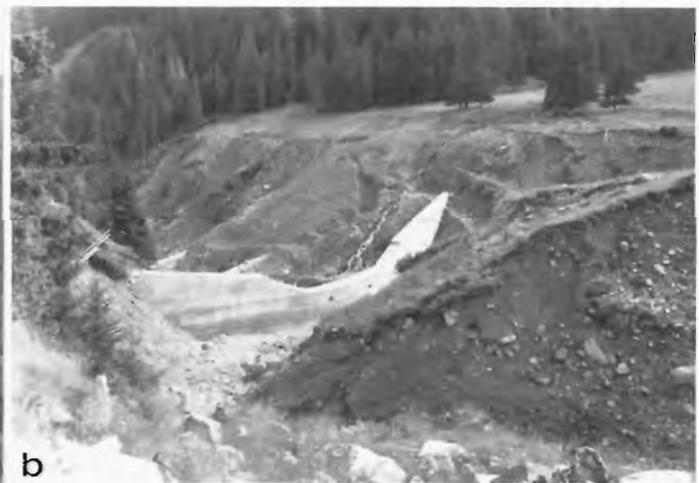
Figure 285: a) View of the crest of the Enterbach basin; note converging erosional ravines (GSC 204170-F). b) Steel-concrete check dam under construction on the Enterbach Torrent; note gently rising wings, deeply founded abutments, and drainage bores (GSC 204170-G).
