YUKON RIVER DRAINAGE BASIN
DAM SITE INVESTIGATION

SITE No. 38

LOWER LAPIE CANYON DAM SITE
(MAP AND NOTES)

E. B. OWEN

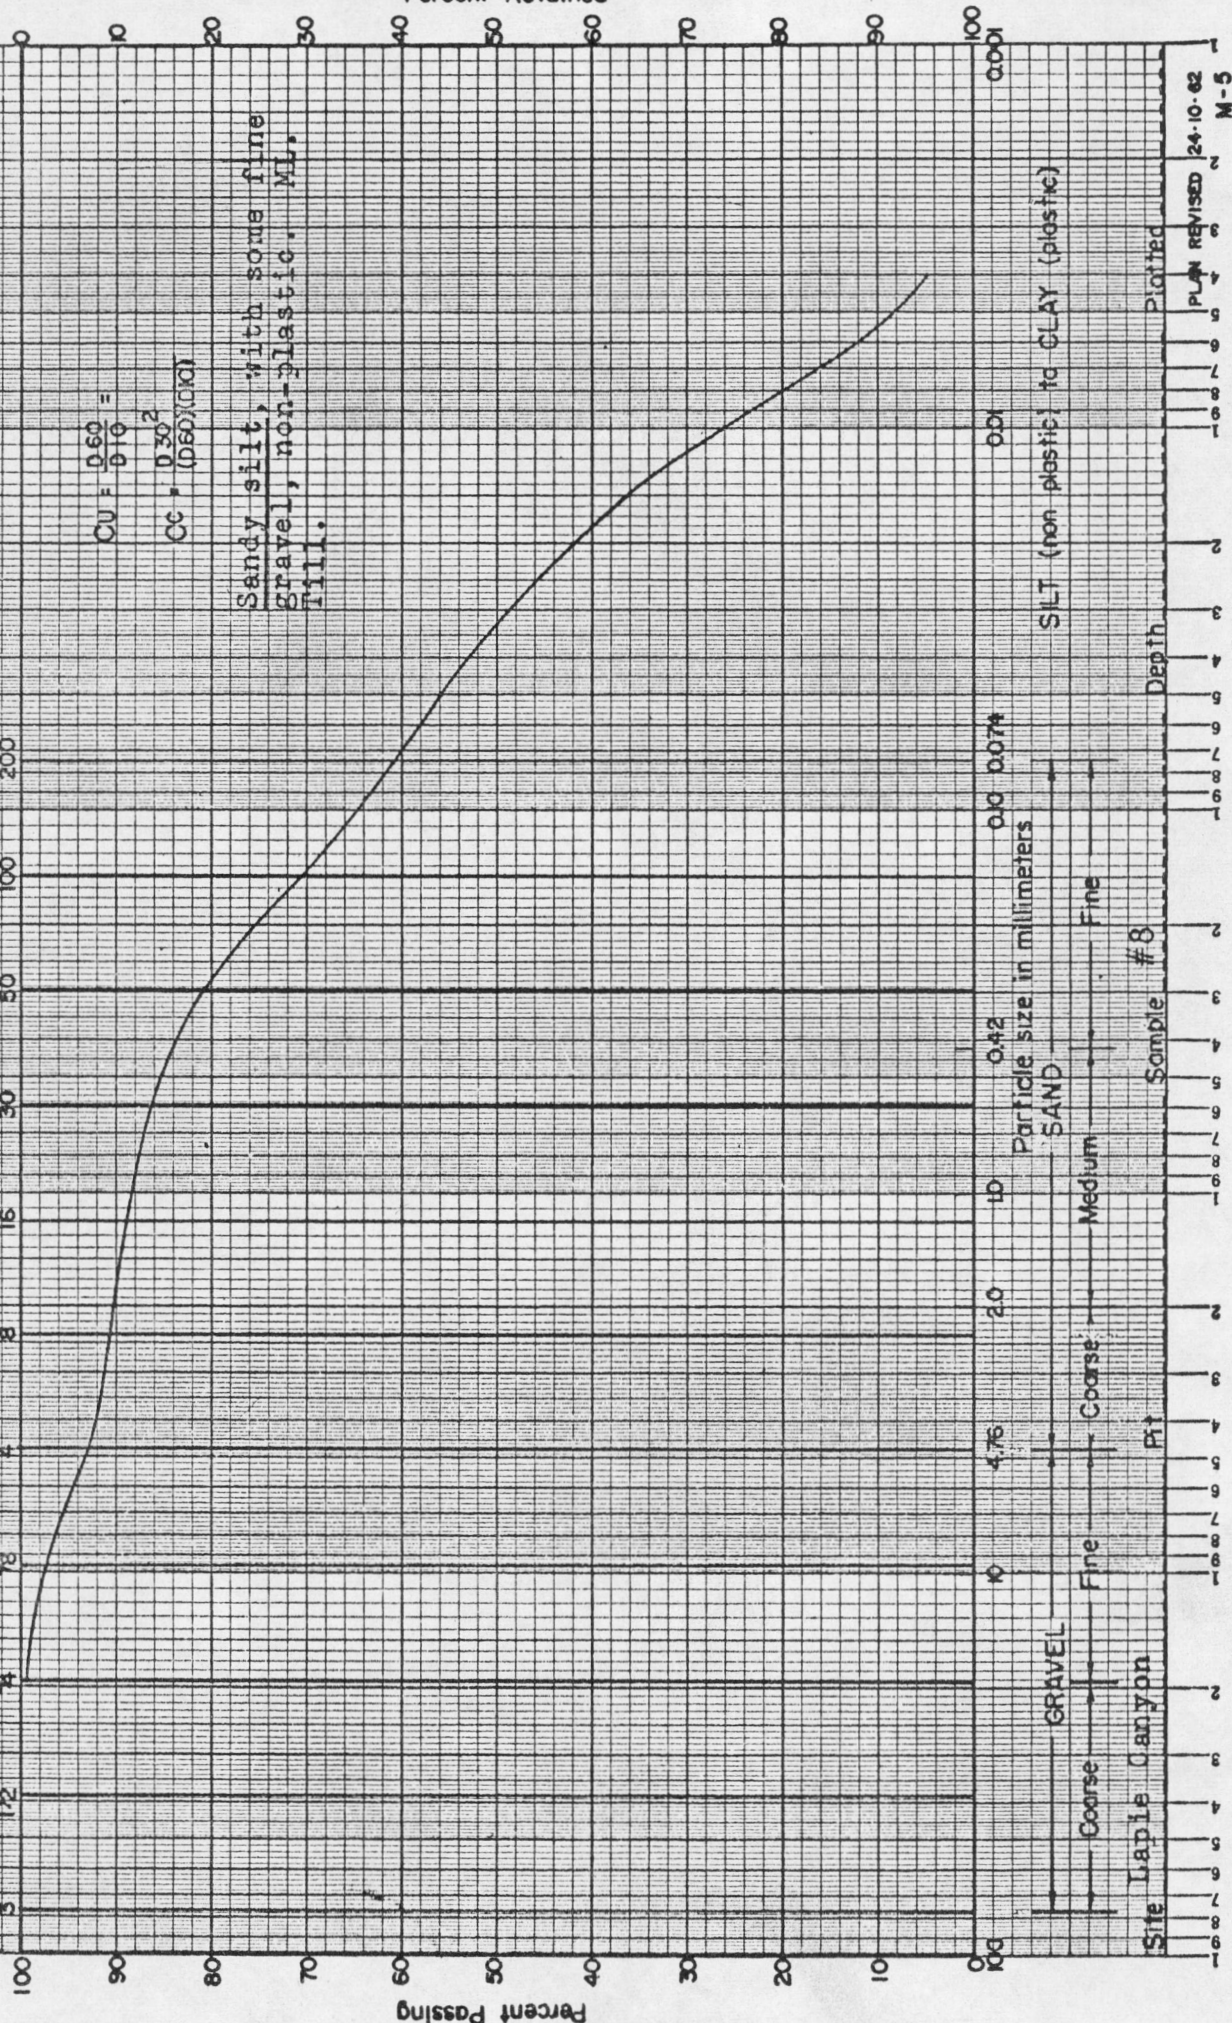
Sandy silt, with some fine gravel, non-plastic, MU, fill.

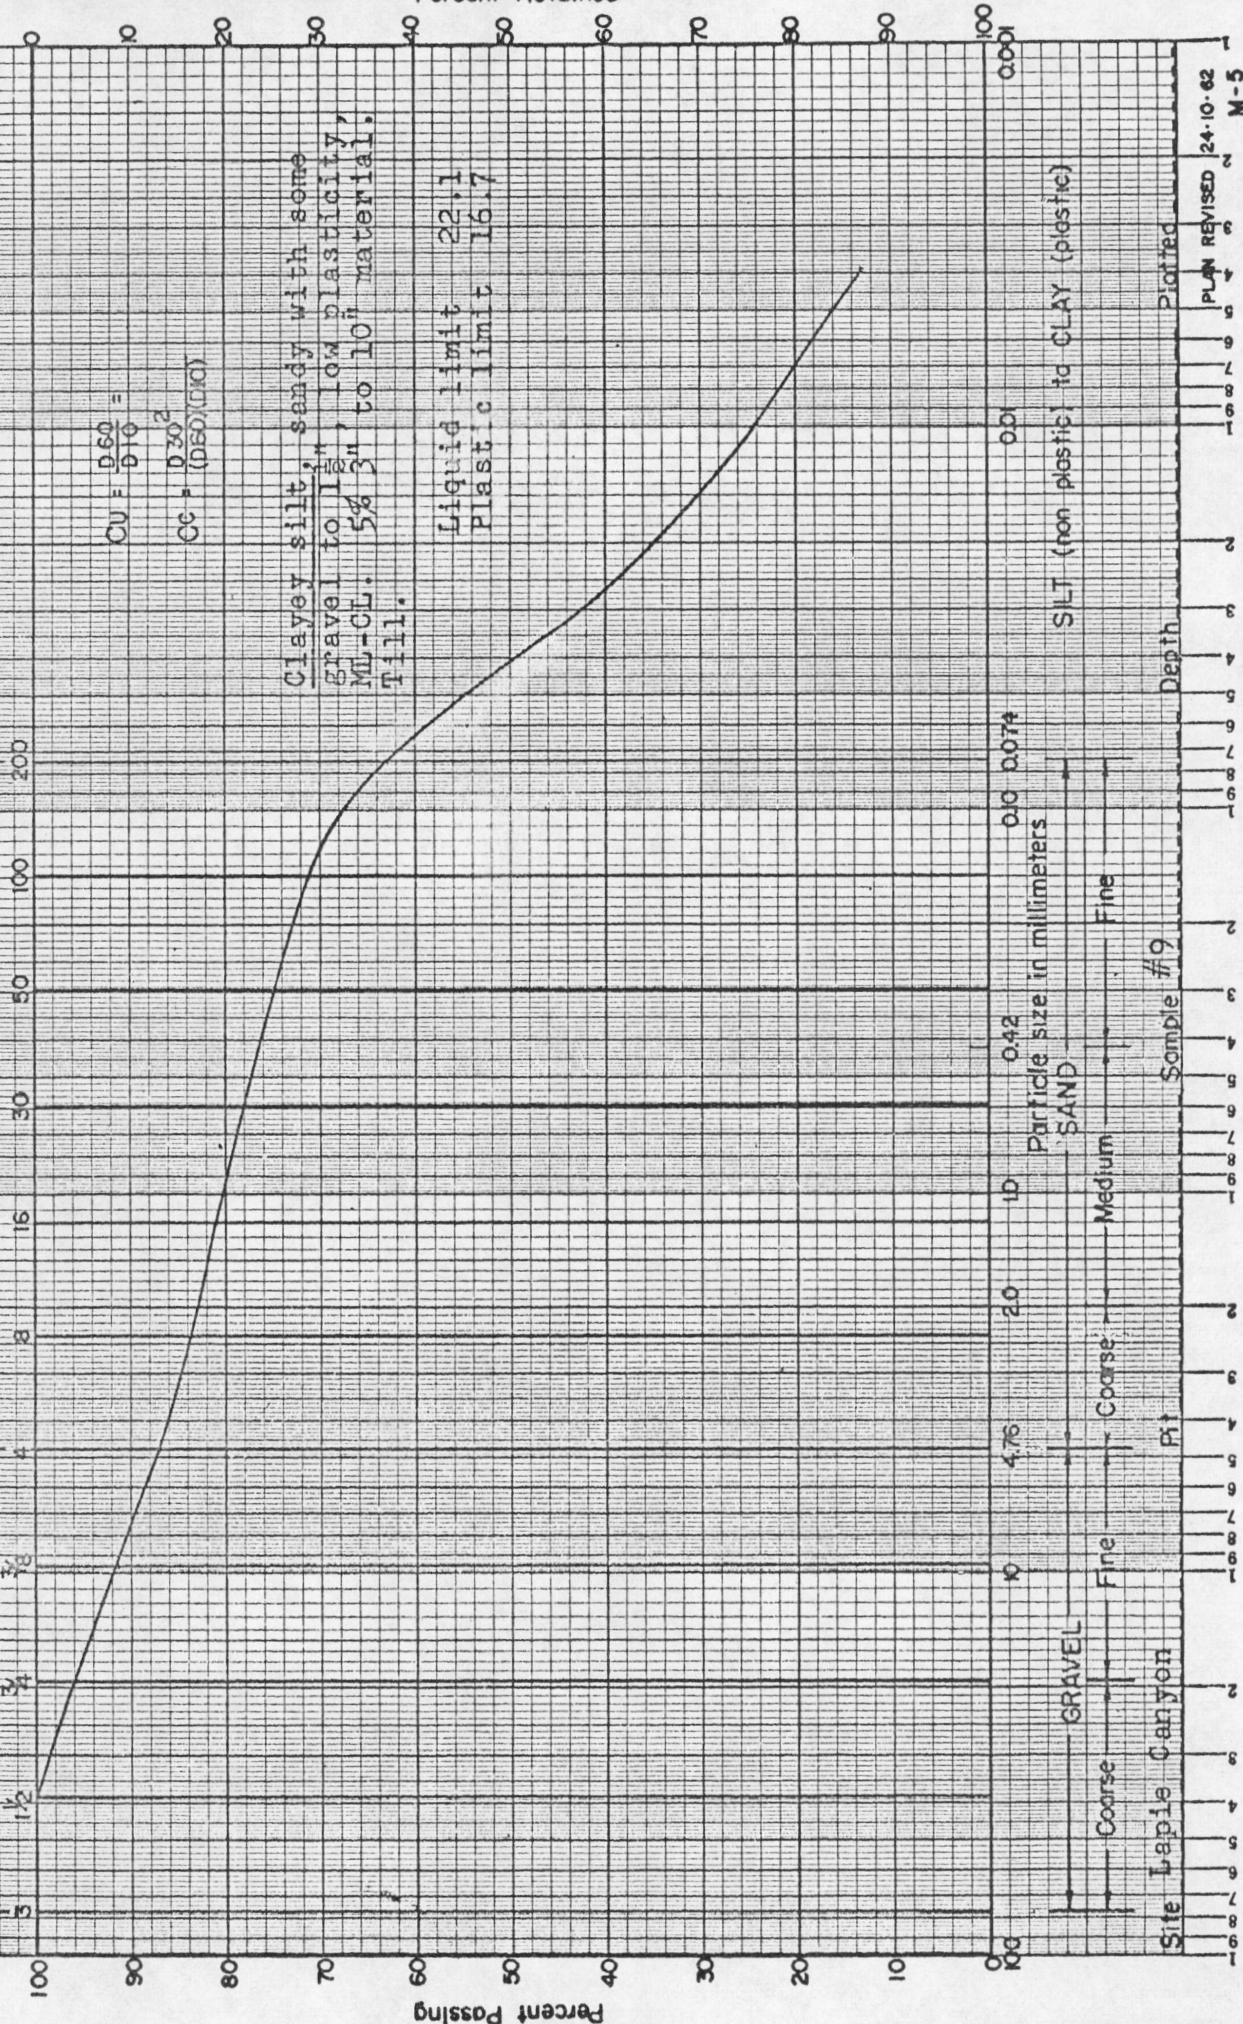
Clayey silt, sandy with some gravel to 1/2", low plasticity, MU-CL. 5% 3" to 10" material. Till.

Liquid limit 22.1
Plastic limit 16.7

9	10 - foot cut on north side of Ross River - Carmacks Road; one mile west of Canol Road; 6 feet above road; 12 inches beneath ground surface	Till: clayey, silty, sandy, dense, grey-brown, dry; angular boulders of black chert, schist and quartzite to 10 inches.	ML - CL	None	10 + feet	Unlimited	L.L. - 22.1 P.I. - 16.7 Cut is along the toe of a large, elongated till ridge.

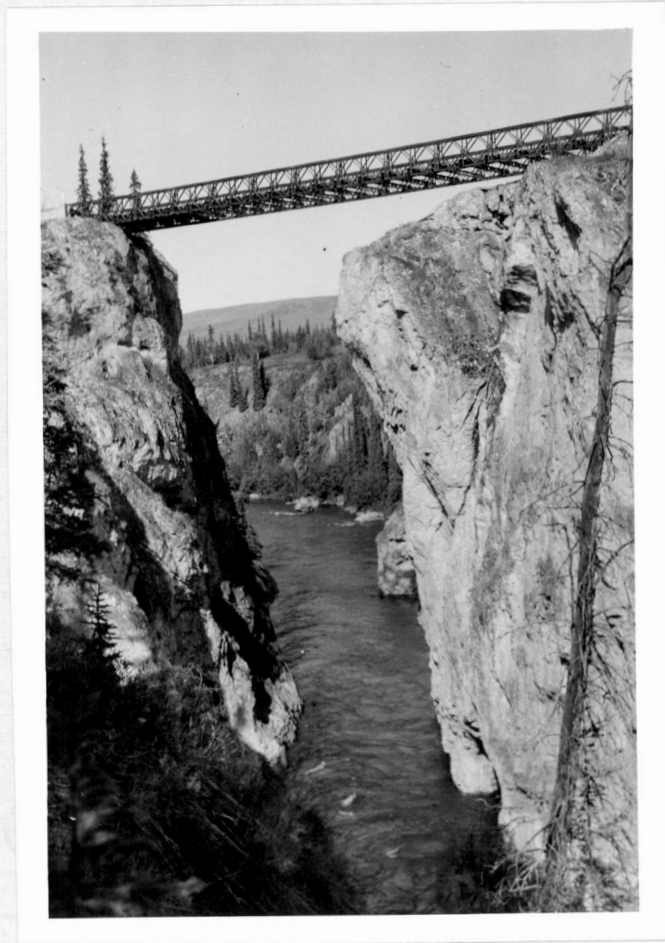
Plate 1

View looking downstream through Lower Lapie Canyon; floor
of temporary bailey bridge is 107 feet above water surface.

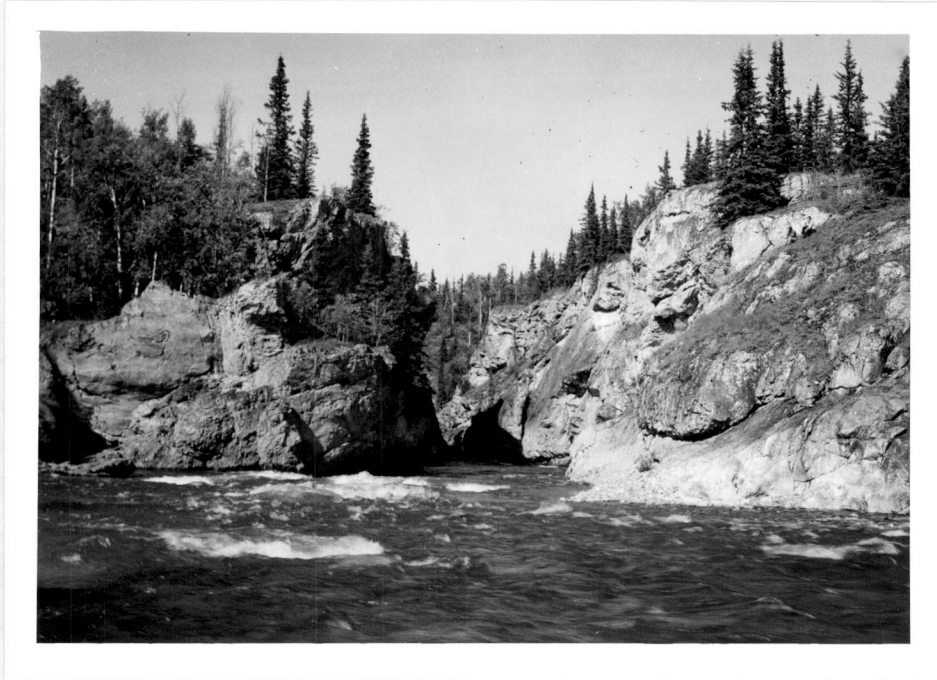
Plate 2

View looking downstream toward Upper end of Lower Lapie Canyon; photograph was taken about 1,800 feet upstream from the bridge shown in plate 1.

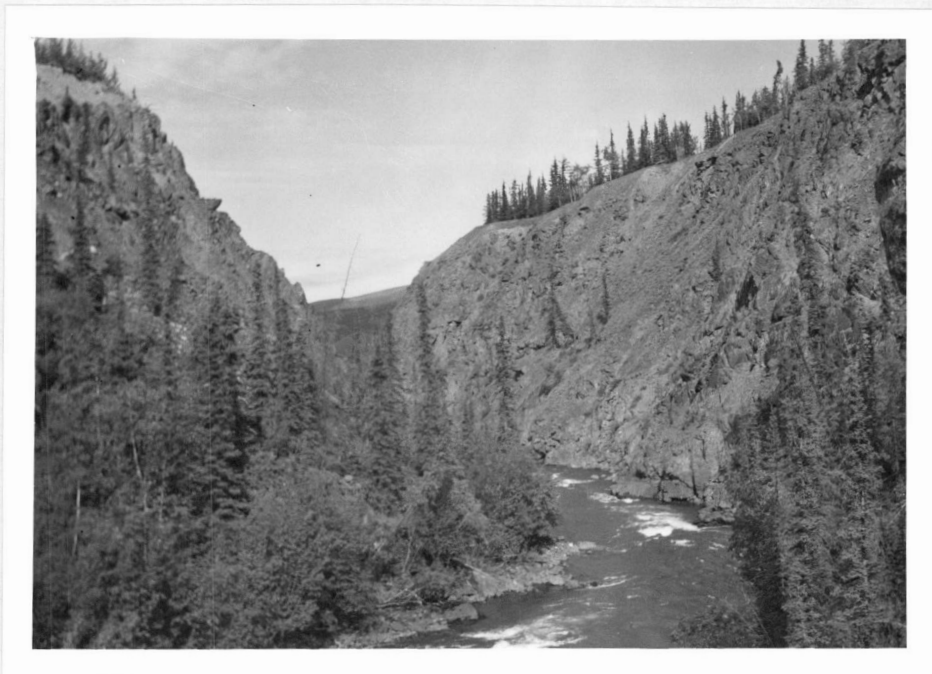
Plate 3

View looking downstream toward the lower end of Lower
Lapie Canyon.

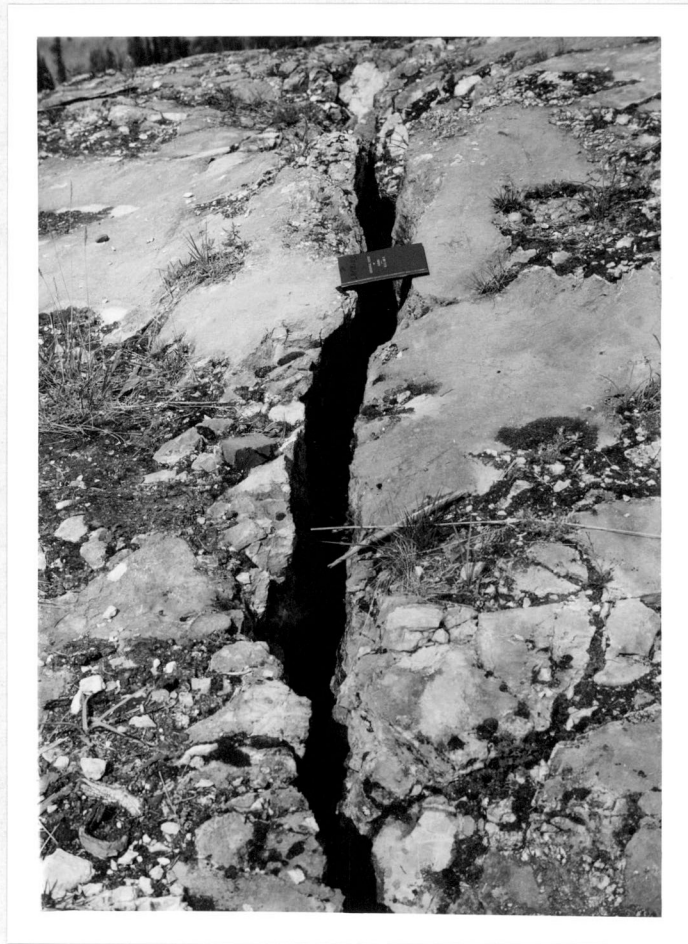
Plate 4

Fracture in bedrock in right abutment area; fracture is about 100 feet long and varies in width from 2 to 6 inches; it is about 30 feet from the wall of the canyon and is parallel to it.

One result of the drilling indicates bedrock near surface is highly weathered and incompetent. Numerous hair-thin fractures in the rock made it difficult to obtain lengths of NX core greater than 3 inches. At least 30 feet of rock will have to be removed from the canyon walls before rock suitable as abutment material for the proposed dam will be exposed. Also, about 10 feet of rock should be removed from the surface of bedrock exposed above the canyon. Descriptions of potential construction materials which are readily accessible from the site are included in this report. The following reports describing other proposed dam sites in the Yukon River drainage basin also contain descriptions of potential construction materials which may be useful at the Lower Lapie Canyon project. These sites are all within 20 air miles of Lower Lapie Canyon.

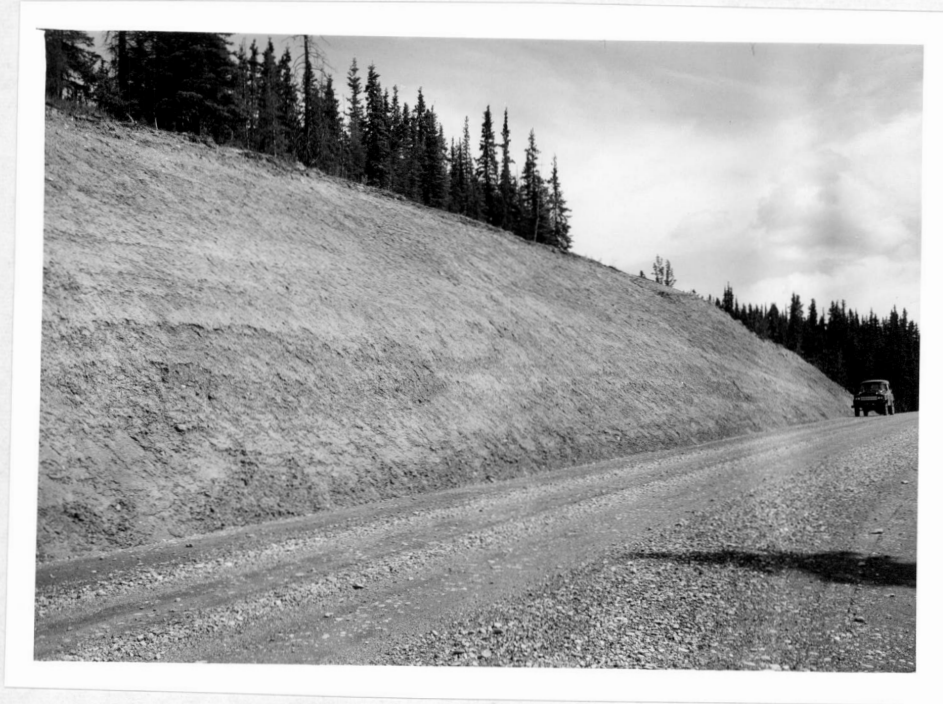
Plate 5

Till exposed in a 40-foot cut along the north side of the
Ross River - Carmacks Road; 2.7 miles west of the Canol
Road; soil sample No. 3 taken here.

Sample Number	Location	Field Description of Material	Group* Symbol	Field Description of Overburden	Thickness of Deposit	Aerial Extent (Estimated)	Remarks
3	40-foot cut on north side of Ross River - Carmacks Road; 2.7 miles west of Canol Road; 5 feet above road; 12 inches beneath ground surface	Till: Clayey, sandy, dense, brown-grey, dry; angular granitic and quartzitic boulders to 18 inches, most less than 6 inches.	GC	None	40 + feet	Unlimited	L.L. - 26.0 P.L. - 11.6 P.I. - 14.4 Cut is on the side of a large, elongated till ridge; frozen material liquifies when thawed.
8	30-foot cut on north side of Ross River - Carmacks Road; .7 miles west of Canol Road; 10 feet above road; 18 inches beneath ground surface	Till: silty, sandy, dense, brown-grey, dry; largest rock fragment is 2 inches	ML	None	30 + feet	Unlimited	Cut is along the toe of a large, elongated till ridge; excellent material on which to build a road.
