SMALL PUBLIC WATER SYSTEMS ASSESSMENT
WESTERN REGION

BEAVER CREEK GRADER STATION
BUILDING # 3123
SITE LOCATION DIAGRAM
WELL ID: 3123

Western Region – Beaver Creek Grader Station
Building # 3123

SMALL PUBLIC WATER SYSTEM ASSESSMENT

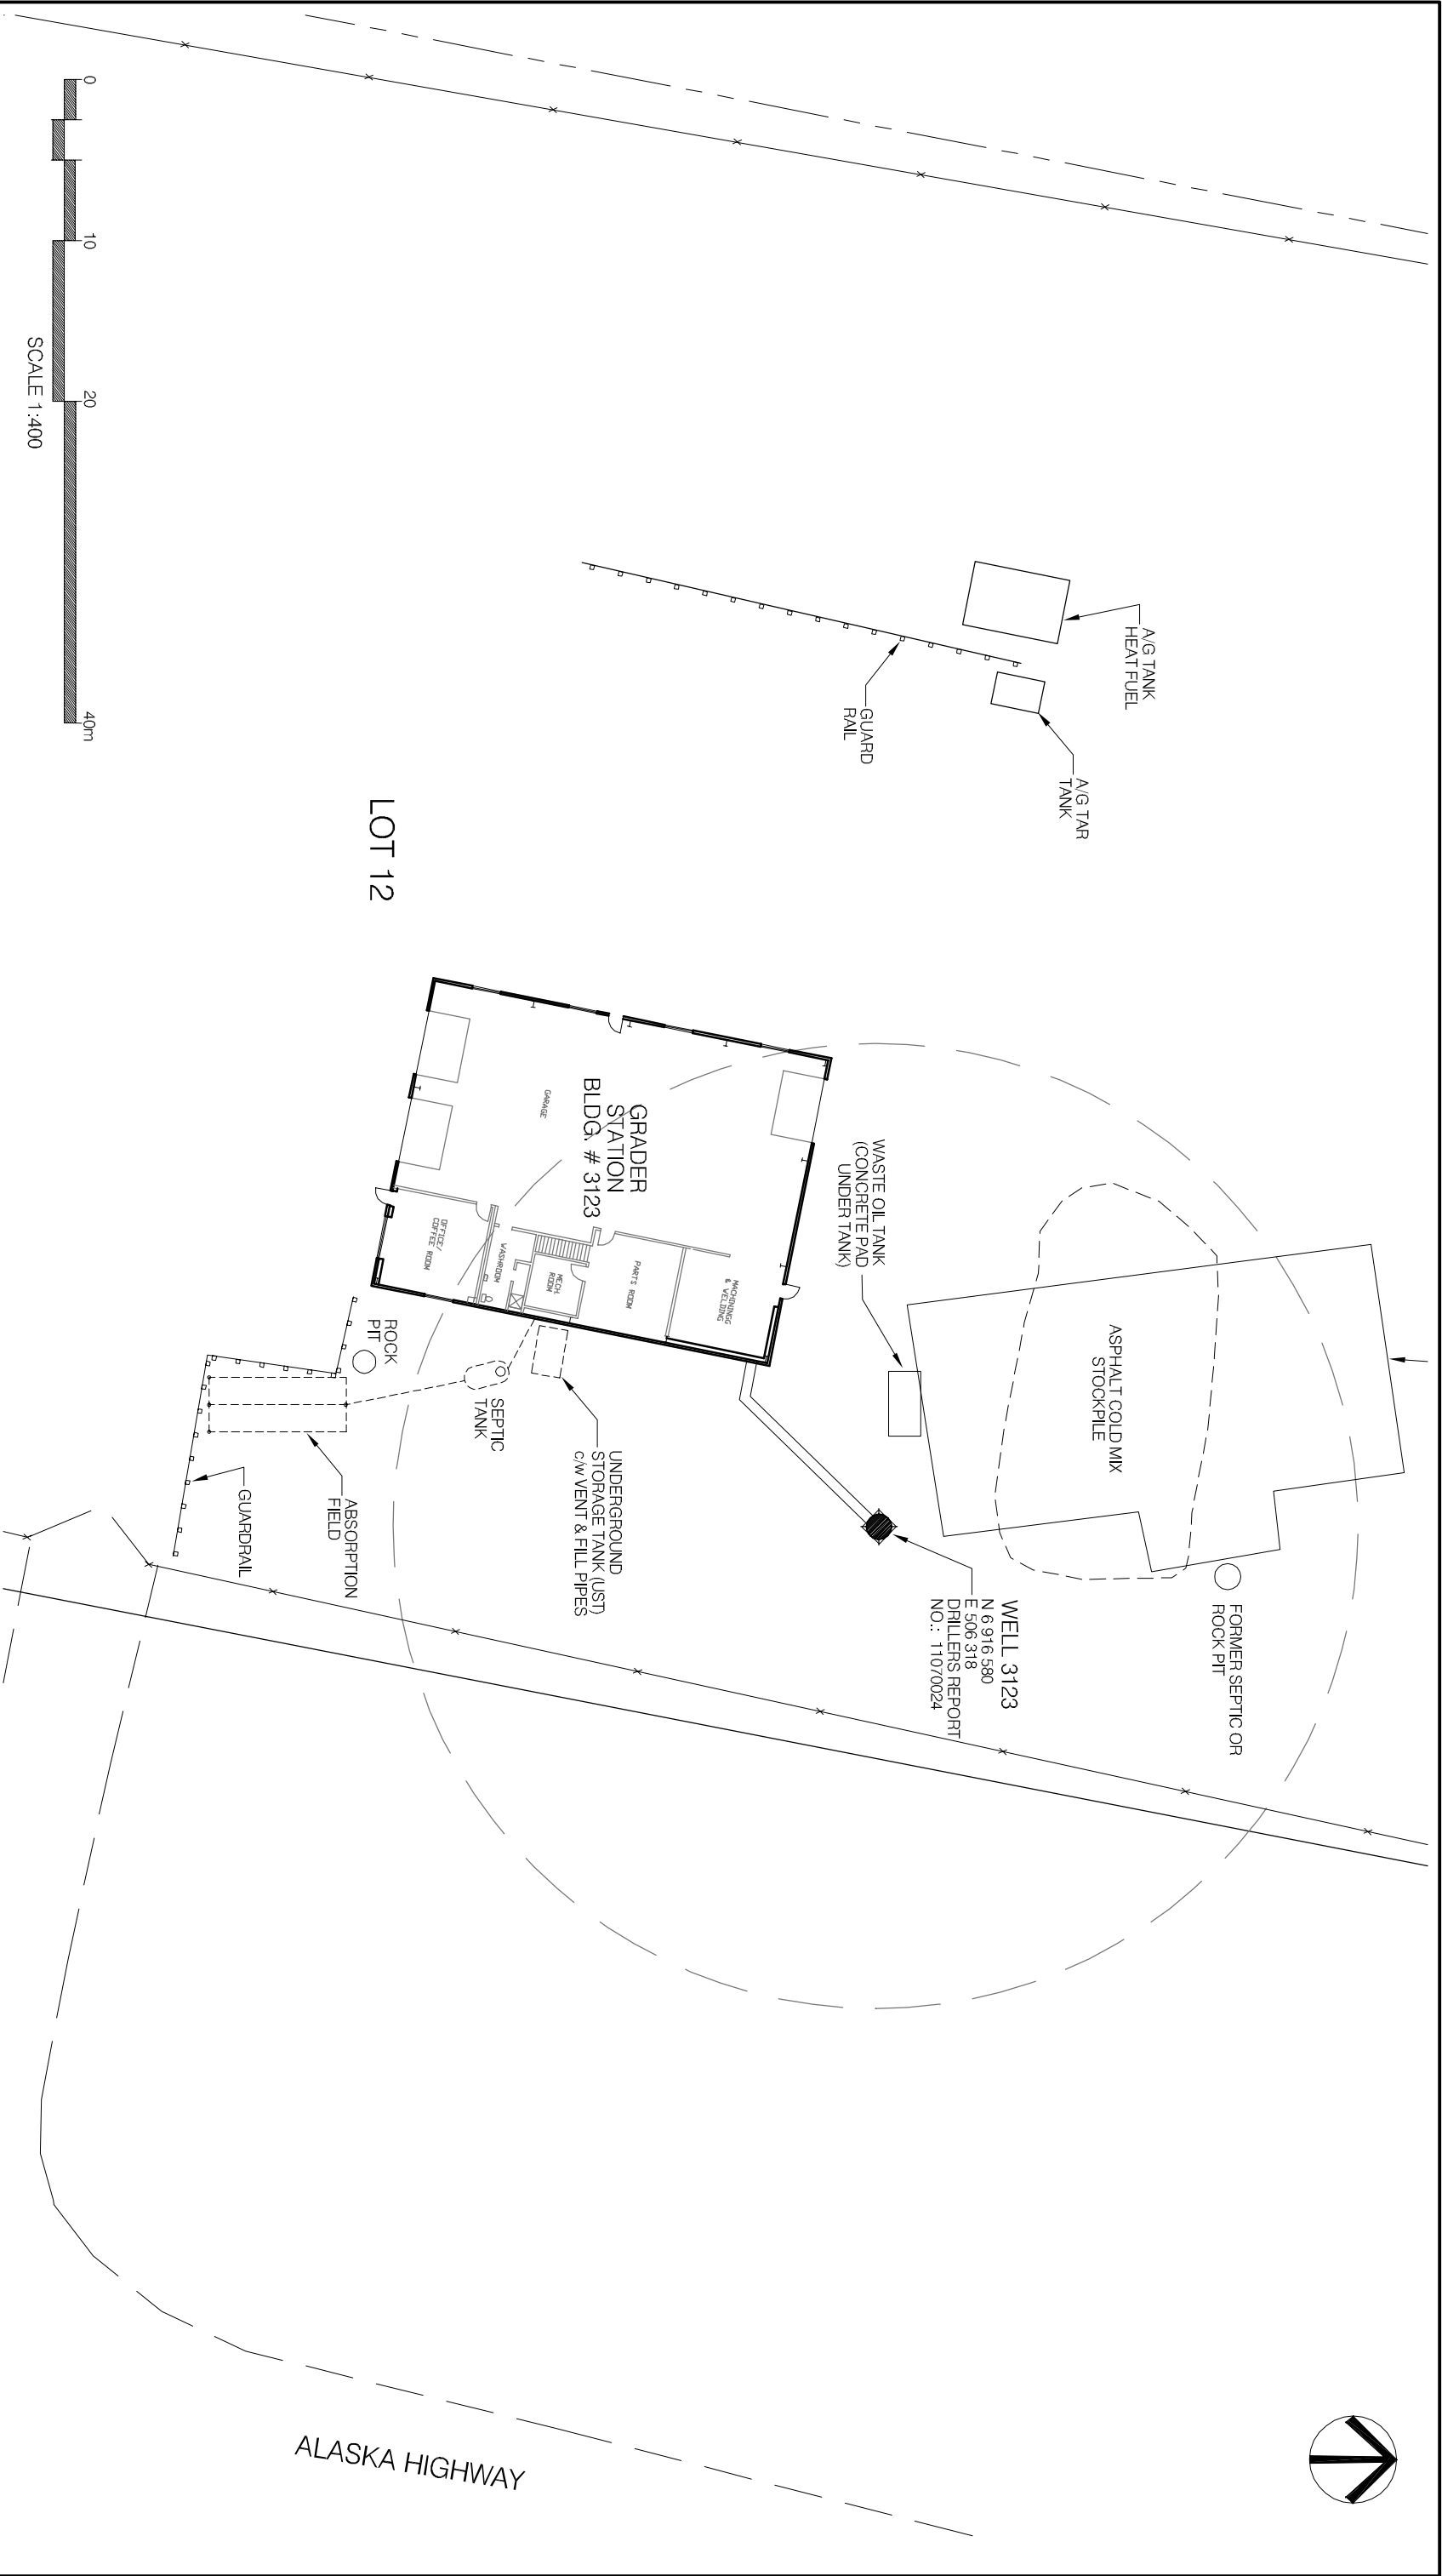
FIGURE No.
0
FIGURE 3123-A

30 m RADIUS FROM WATER WELL FOR CONSIDERATION OF PROXIMITY TO POTENTIAL CONTAMINANT SOURCES.
BUILDING STRUCTURES RELATIVE TO PROPERTY LINES ARE APPROXIMATE ONLY.

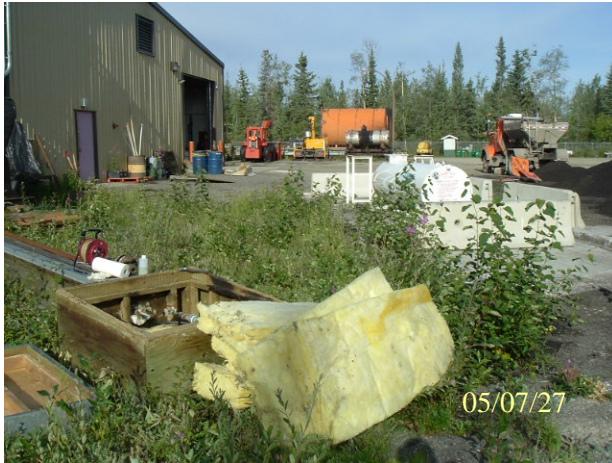
Potential Source 1: Used oil AST; Distance from well to Potential Source 1: ~ 7m

Photo 0518: 3123 Beaver Creek Grader Station maintenance garage (back left), wellhead (front left), above ground used oil storage tank (back right)

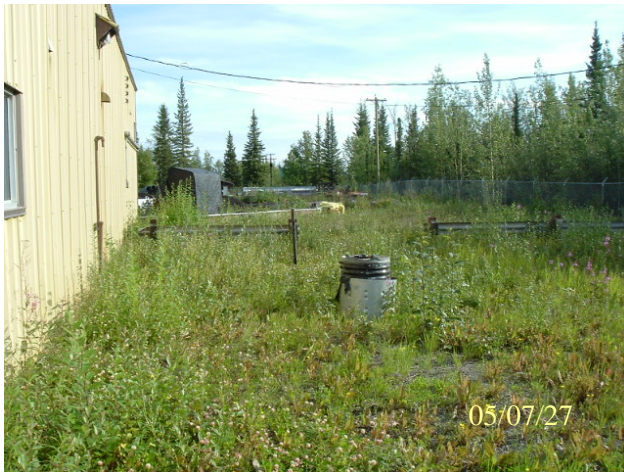
Former septic or rock pit @ ~22m. Current septic field 34-36m

Photo 0520: 3123 Leach pit (centre), maintenance garage (left), wellhead enclosure (back centre)

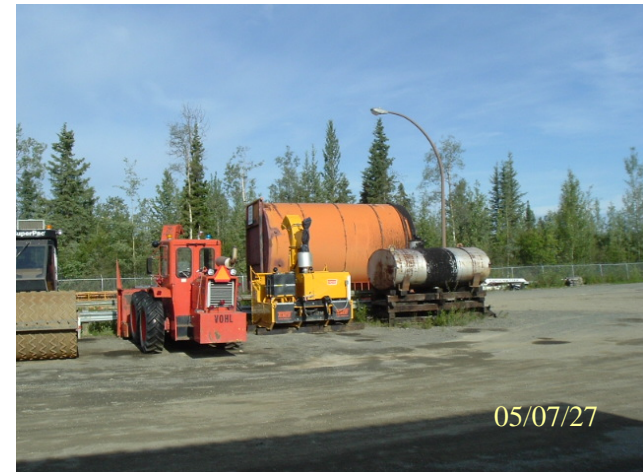
Photo 0515: 3123 Heating fuel and tar above ground storage tank
