SMALL PUBLIC WATER SYSTEMS ASSESSMENT  
WESTERN REGION

BLANCHARD CAMP GRADER  
STATION BUILDING # 3440  
SITE LOCATION DIAGRAM  
WELL ID: 3440

## SMALL PUBLIC WATER SYSTEM ASSESSMENT

WELL ID #	Owner	Location Description
3440	YTG	Blanchard Grader Station

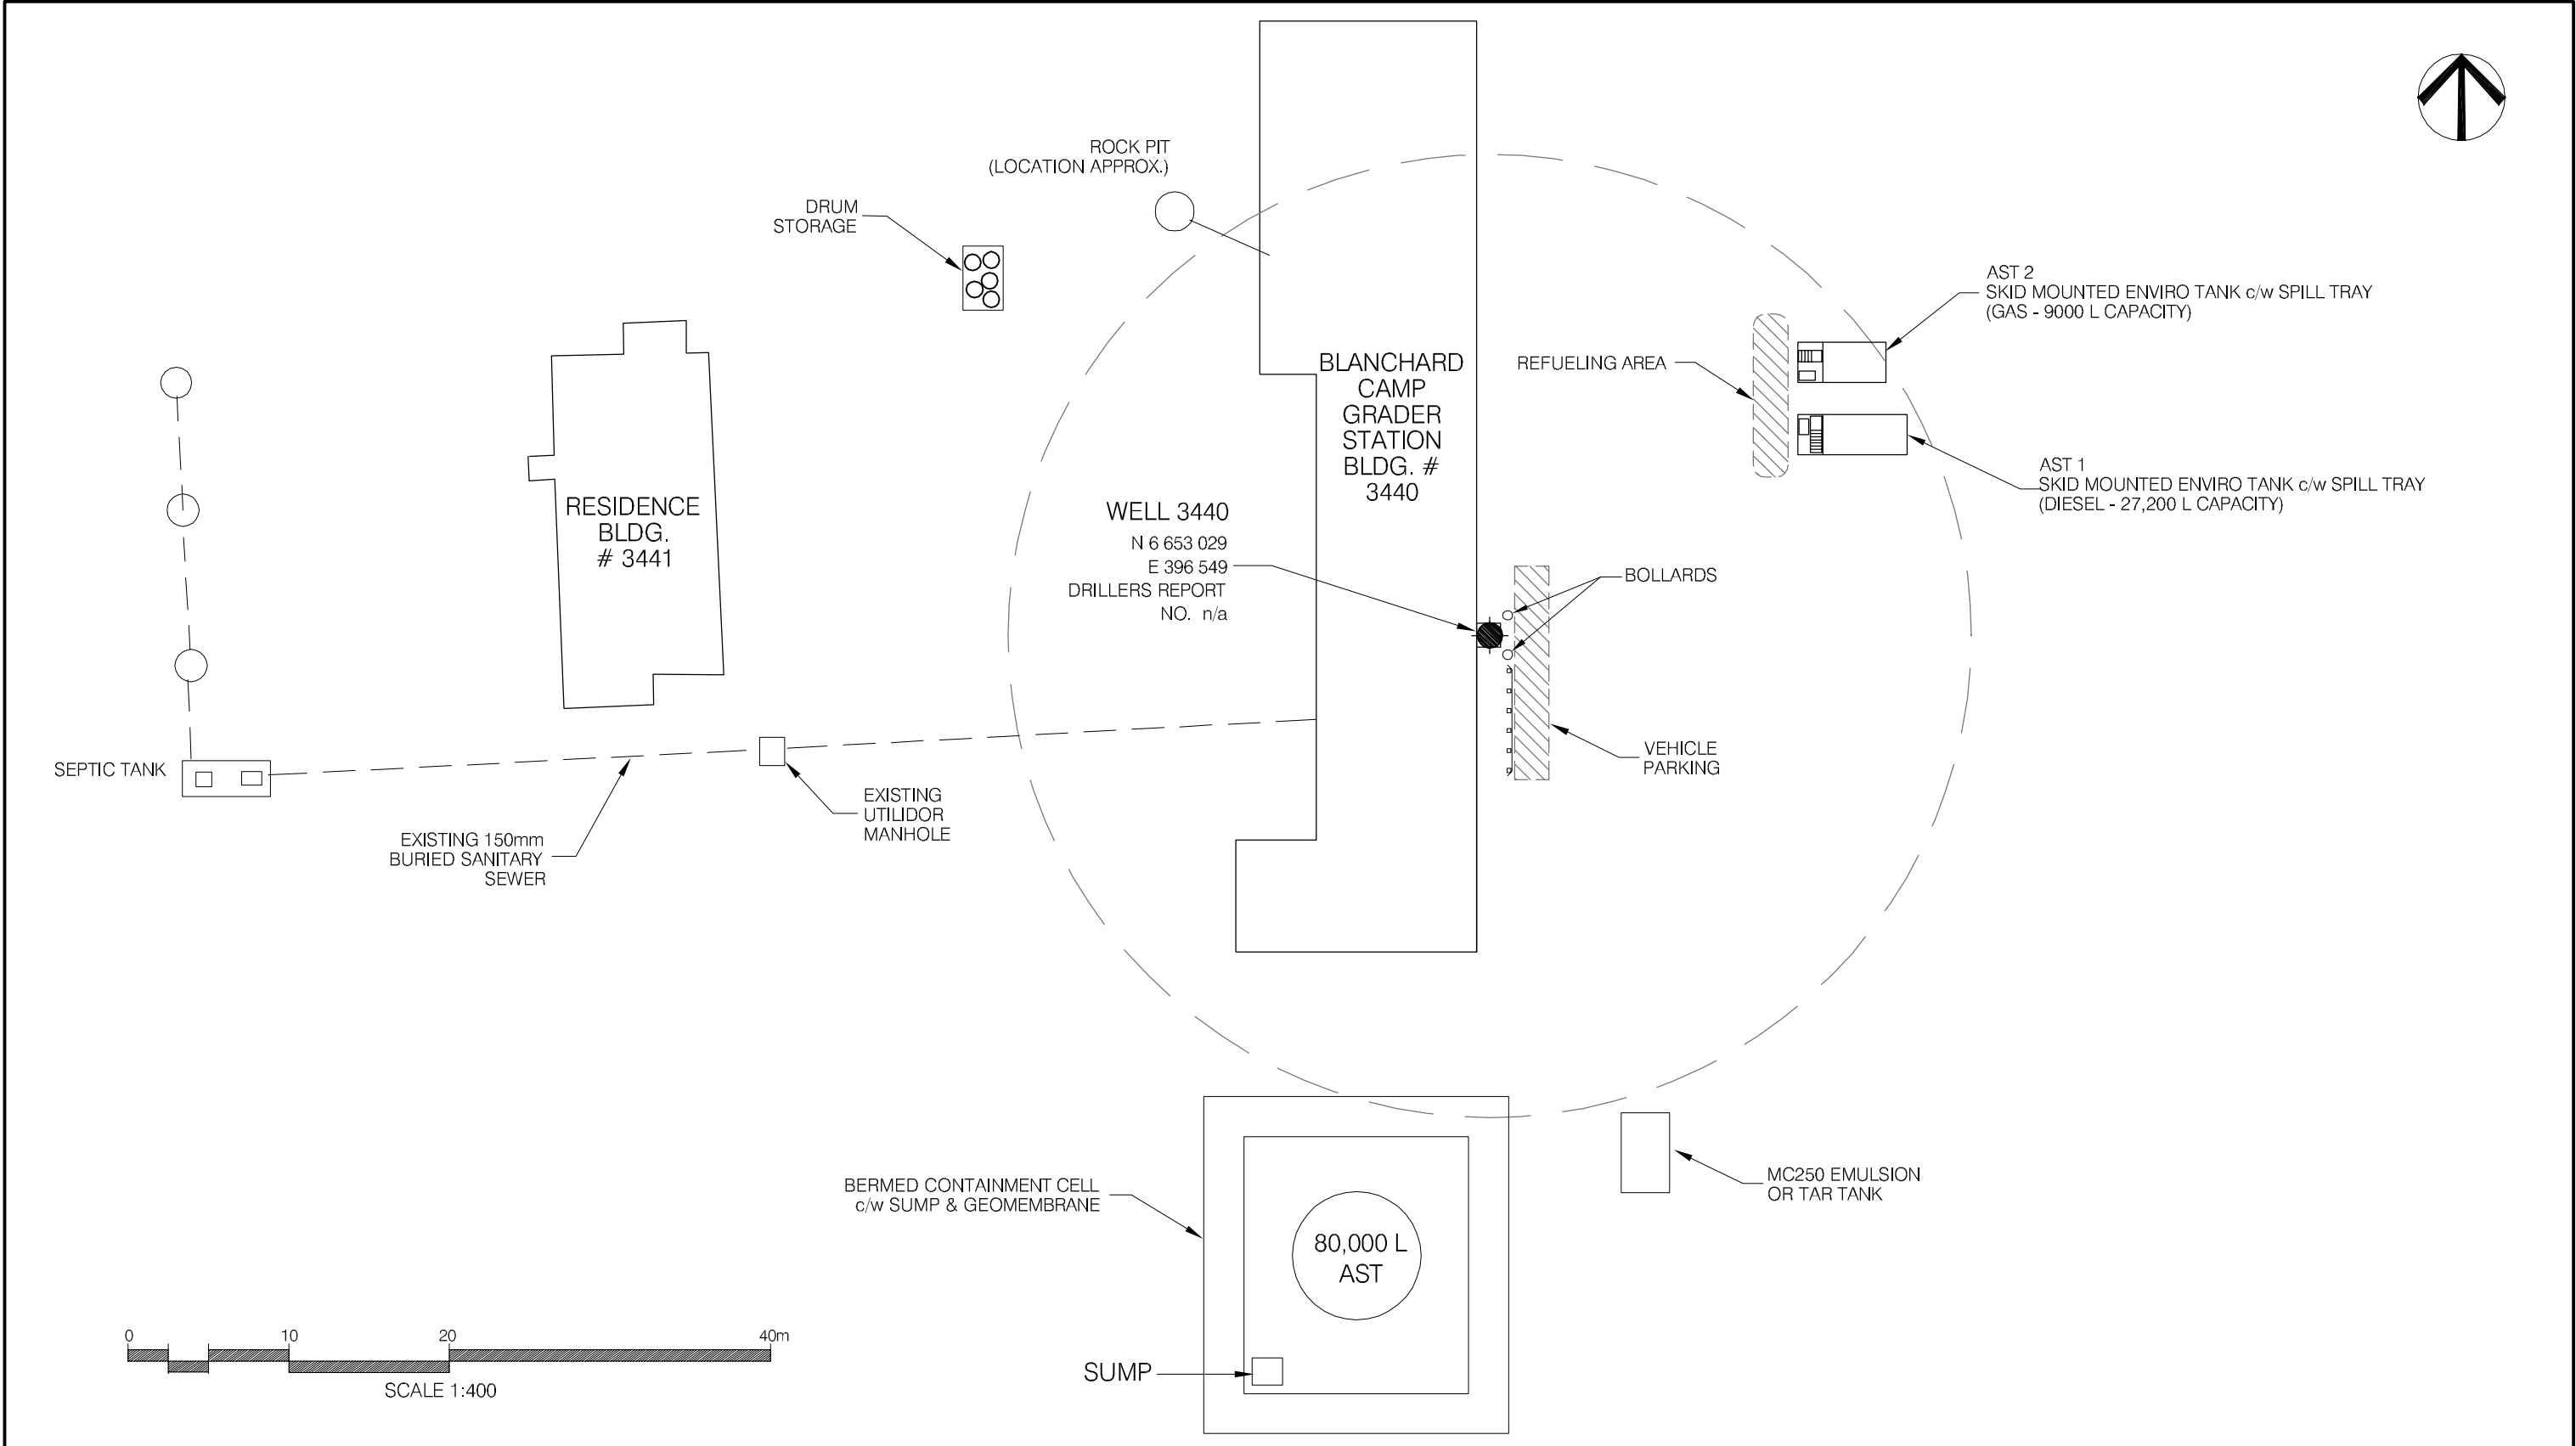
REVISION ISSUE  
0  
FIGURE No.  
FIGURE 3440-A

30 m RADIUS FROM WATER WELL FOR CONSIDERATION OF PROXIMITY TO POTENTIAL CONTAMINANT SOURCES.

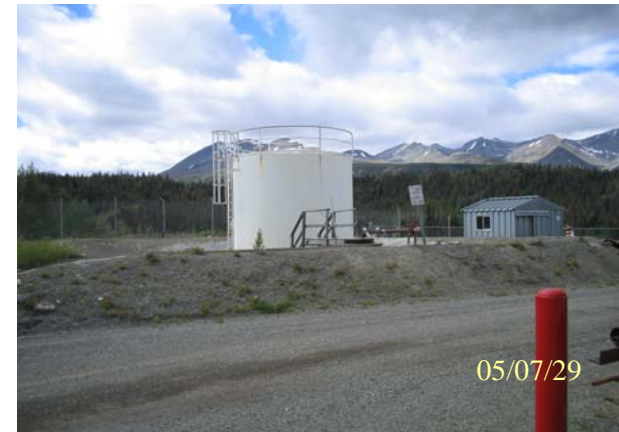
Potential Source 4: Tar or emulsion tank; Distance from well to Potential Source 4: ~31m  
*Bulk tank @ ~36m (bermed w/ berm @ ~29m)*

**Photo 0135:** 3440 Bulk fuel storage tank with geomembrane and berm
