ALEXCO RESOURCE CORP.

Brewery Creek Mine

2010 ANNUAL WATER LICENSE REPORT

2010 ANNUAL QUARTZ MINING LICENSE REPORT

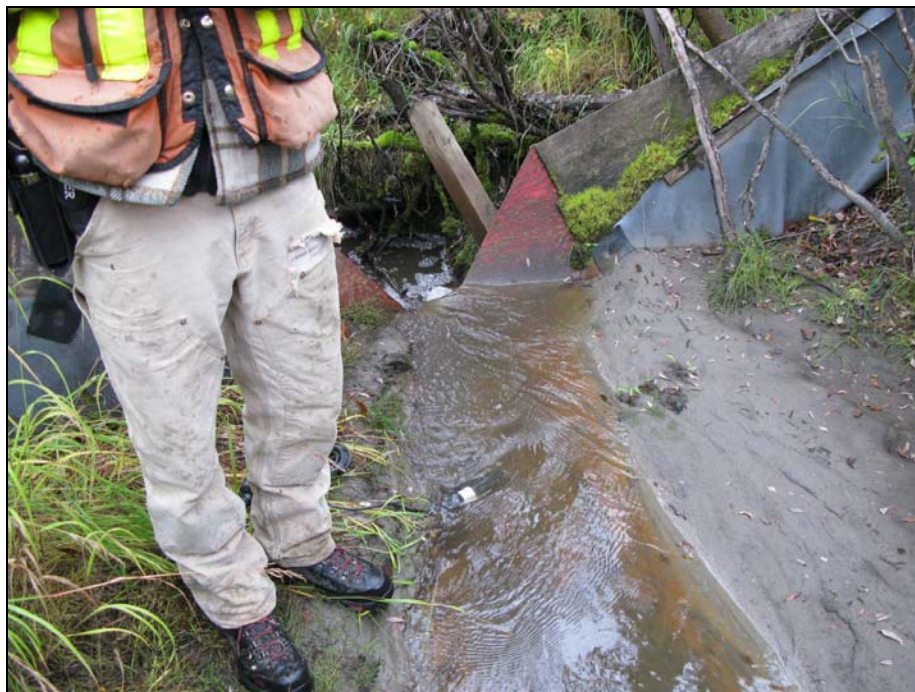
The same trends with TSS and metals were not exhibited at station BC-2 during 2010. TSS for both June and September sampling events were above 200 mg/L and Aluminum and Iron were above WQ standards in June. This is likely as a result of increased flows resuspending residual sedimentation that has collected behind a v-notch weir (located at station BC-2). Refer following picture:

Reviewing WQ data downstream of BC-2 shows that this sediment drops out of suspension shortly thereafter, where at station BC-53, concentrations of TSS were shown to be half of that at BC-2 in June. By the time flows enter Lee Creek at station BC-34, concentrations of TSS were at 34 mg/L, below that of WQ standards in the WUL. Similar trends were noted during the September sampling event.

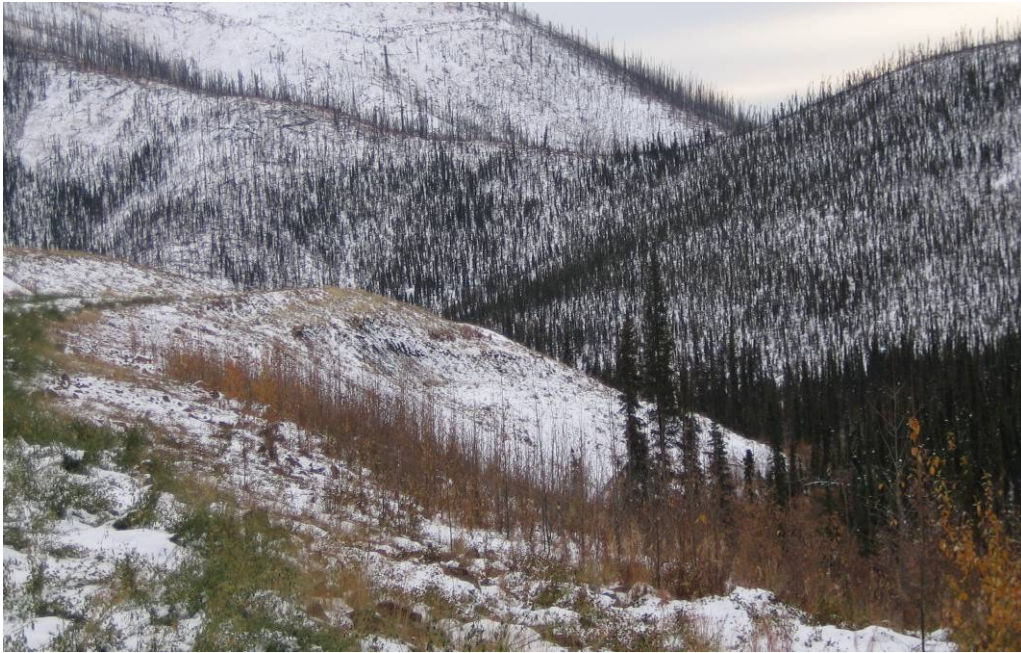
Slope movement has been observed in two locations below the Lucky Haul Road. These areas are noted in photos 14 to 19 in the attached appendix. Comparisons to previous photographs taken by SRK found it difficult to determine if there have been any changes to the slope. This was due to the recent snowfall and the large distance from the hub to and slopes. The larger western location (photos 14-15) was also difficult to inspect with the snow and vegetation making inspection for cracking impractical.

Photo 14: Taken from “Photo Hub #1”, view of the slope instability below the Lucky Dump haul road.

Consideration should be given to the establishment of settlement pins at the slope failure locations near the Lucky Haul Road. Expanding on the monitoring program consisting of a collection of a photographic record, field measurements may then be taken to track the distance between the pins versus time, observing for any change in movement. Monitoring should be completed over a period of two years. Three pins are recommended at each location, placed in a triangular shape to be able to measure movement in multiple directions.

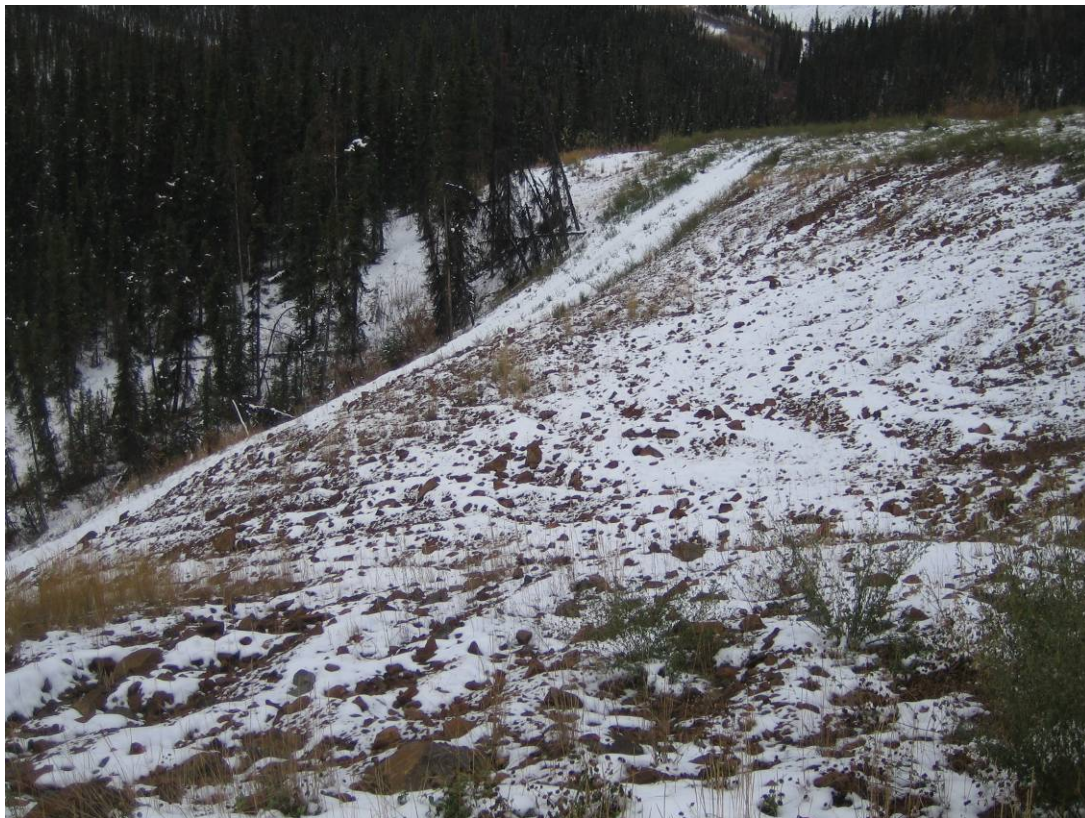
Photo 15: View of the slope instability below the Lucky Dump haul road taken from just east of the haul road crossing of Lucky Creek. Due to the snowfall/excessive vegetation, an inspection for tension cracks or recent ground movements could not be completed.

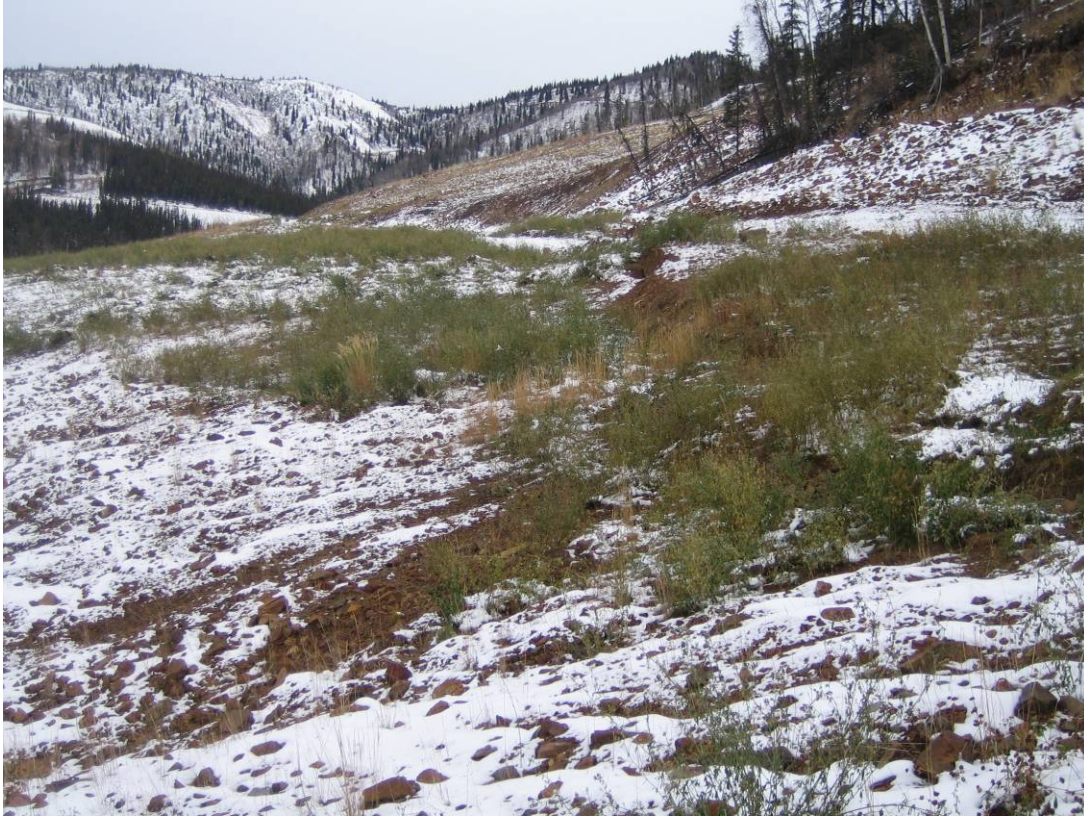
The second location (photos 16-19) is located between the Lucky Haul Road and the Bohemian Access Trail. The scarp in this area is up to 1 m in height. No sign of ground movement was observed near the base of the slope. The slope appeared to be steeper at its base compared to the top, but due to unfamiliarity with the site, it was not possible to determine if bulging was occurring.

Photo 16: View of the second failure location by the Lucky Dump haul road above the Bohemian Access Trail, taken from “Photo Hub #4”.

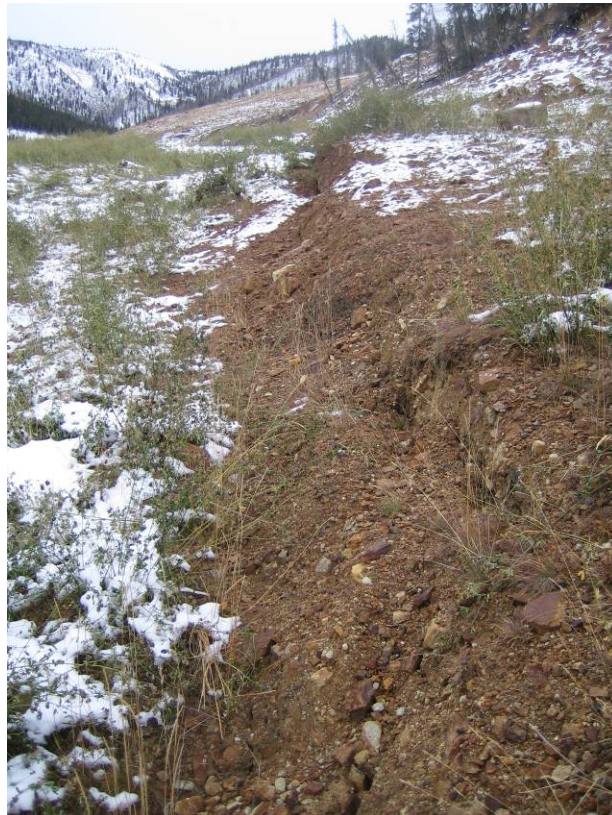
Photo 17: View of the scarp at the second failure location. The scarps are up to 1 m in height.

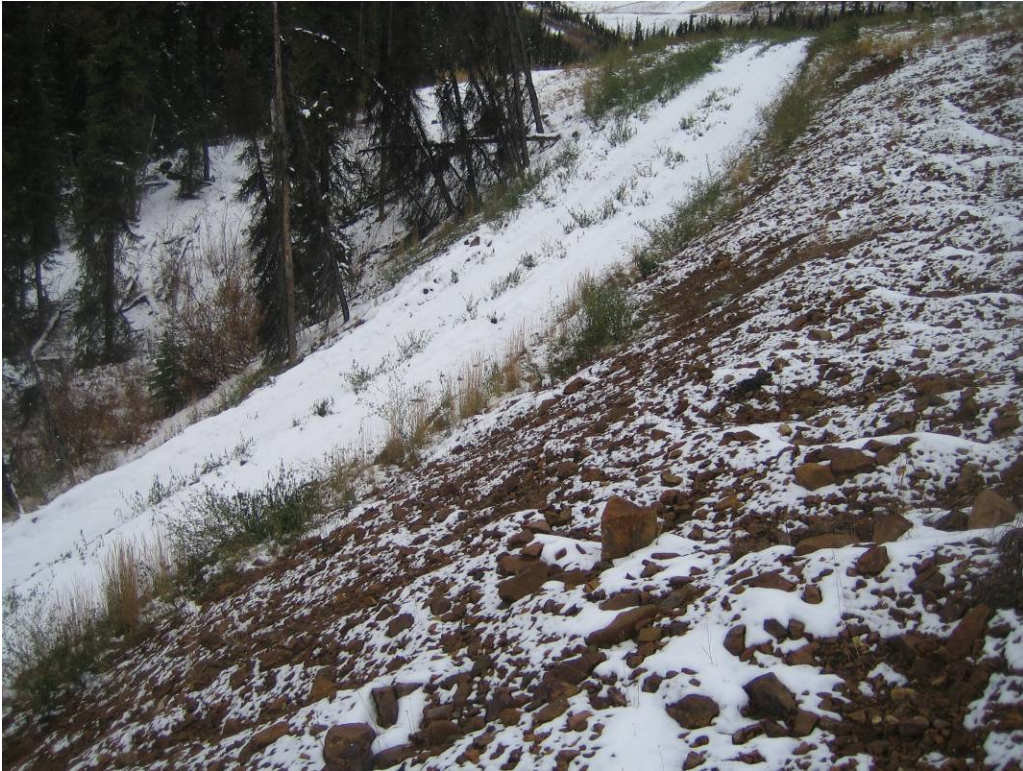
Photo 18: Second view of the scarp at the second failure location.

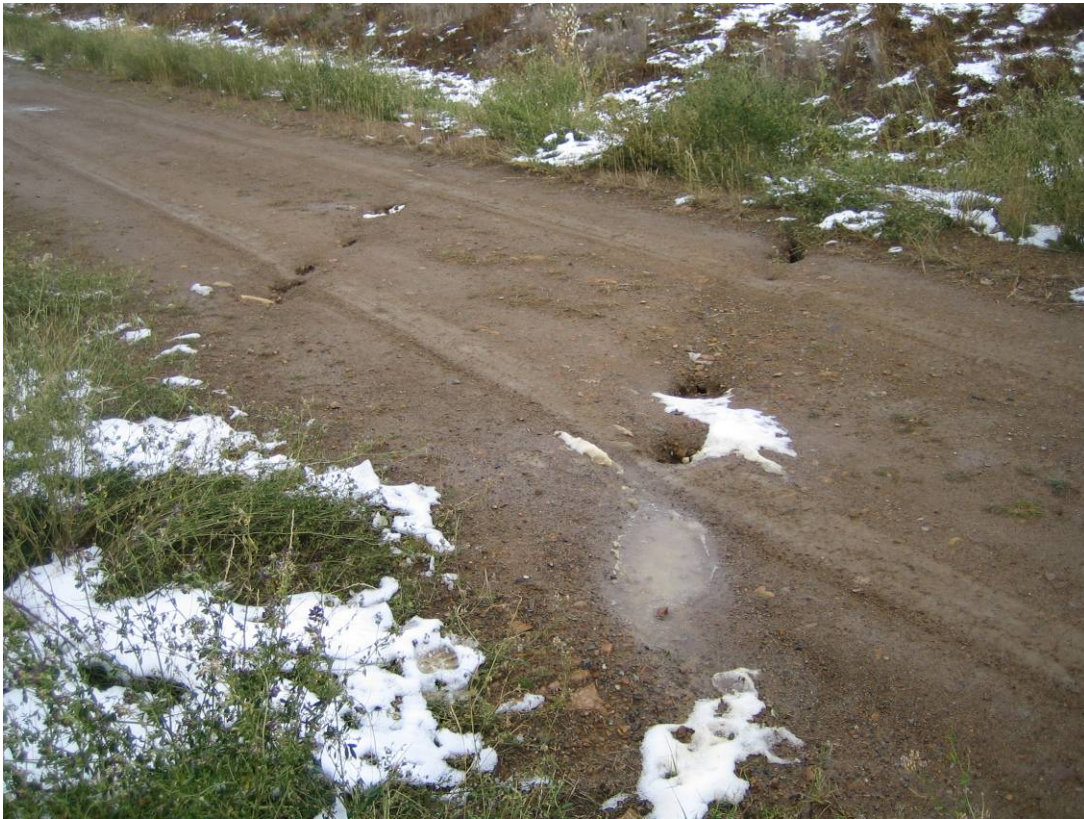
Possible sinkhole cracking was observed across the main haul road just west of the Pacific Pit overflow (Photos 22-23) north of the Blue Dump. The holes were first observed onsite about 1 year ago. At this location, two cracks approximately 2m apart are orientated across the haul road. At the widest, a hole in the east crack measures approximately 15cm. It is possible that this movement may be caused groundwater flow from the Pacific Pit washing away fines. A risk of a slope failure this location is low there would be no significant consequences. It is recommended that this are should be monitored after each freshet (after water levels in the Pacific Pit have fallen).

Photo 22: View of the Main Haul Road looking west towards the Pacific Pit overflow location.
