ALEXCO RESOURCE CORP.
Brewery Creek Mine

2011 ANNUAL WATER LICENSE REPORT
SUBMITTED TO THE YUKON WATER BOARD
WATER USE LICENSE QZ96-007

2011 ANNUAL QUARTZ MINING LICENSE REPORT
SUBMITTED TO YUKON GOVERNMENT, ENERGY MINES AND RESOURCES
YUKON QUARTZ MINING LICENSE A99-001

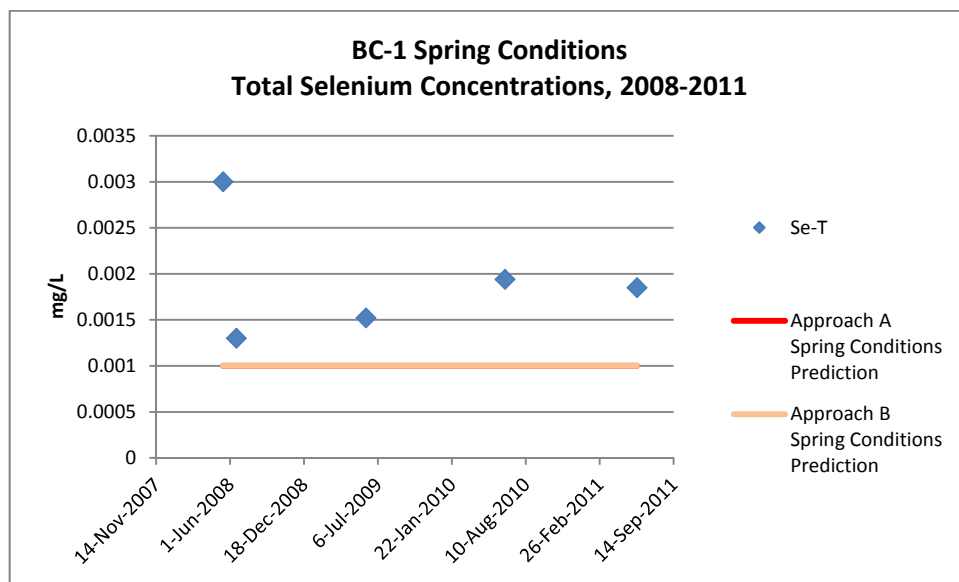
Selenium was higher than predicted in all five results at BC-1, and in three of four at BC-6. The results are consistently only marginally higher than the predicted concentration of 0.001 mg/L (results range from 0.0013 – 0.003 mg/L). The water quality results for selenium under spring conditions are shown in the following graphs.

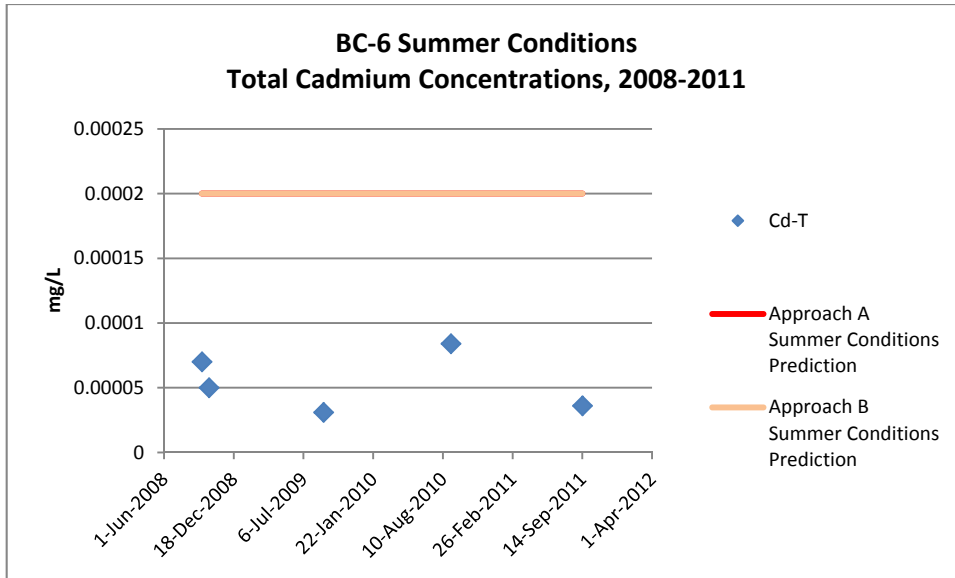
Cadmium

Like the prediction for arsenic, the cadmium prediction was only reported to 3 significant digits and showed a value of 0.000mg/L under Approach A. Thus, all seven sampling events at BC-1 returned results that were higher than this figure. None of the results returned exceeded the predictions made under Approach B. The water quality results for cadmium under summer conditions are shown in the following graphs.

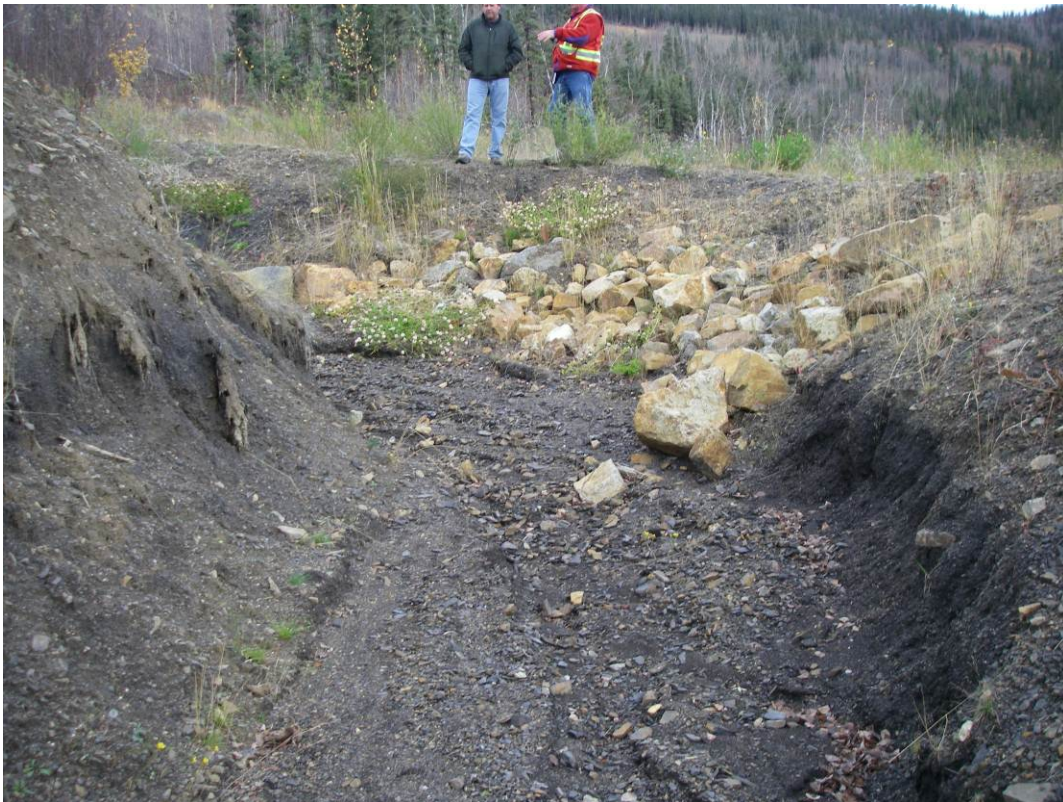
Photo 4: Rip-rap placed in 2009 near the outlet of the surface runoff collection ditch at the toe of the Blue Dump (1 of 2 locations). Compared to 2010 inspection photos, no further erosion observed.

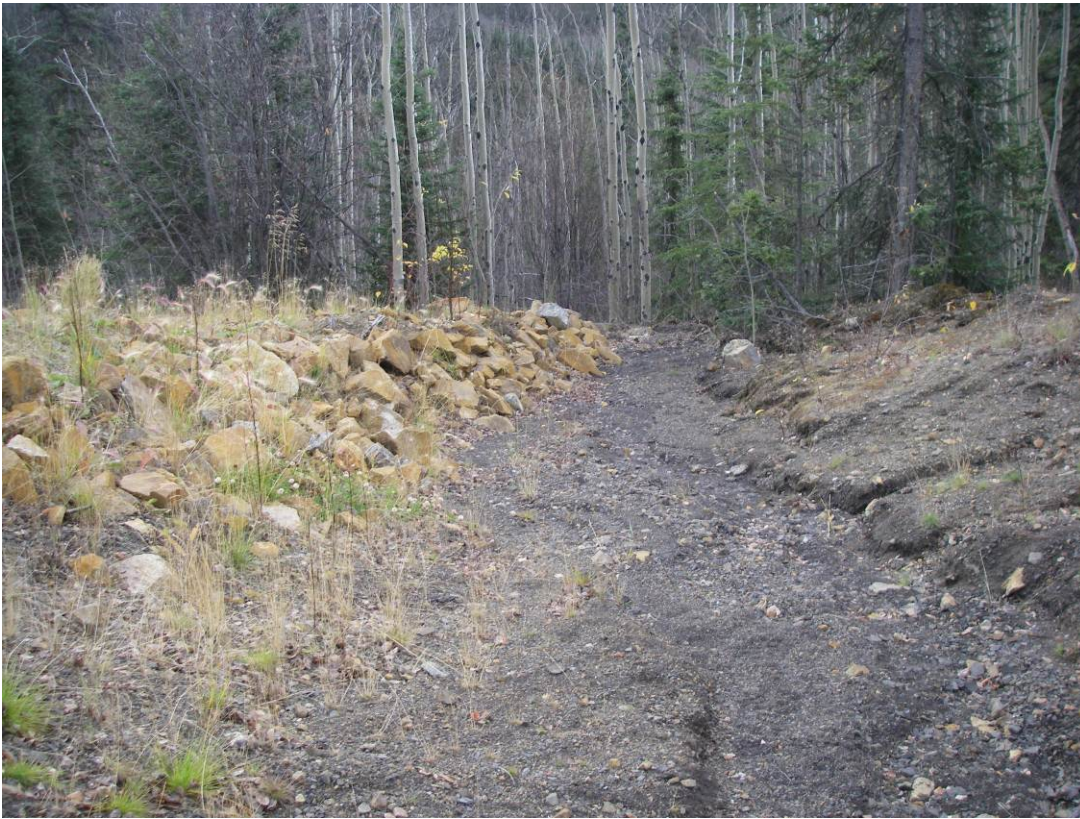
Photo 5: View of outfall looking downstream (south). Runoff is directed into the trees.

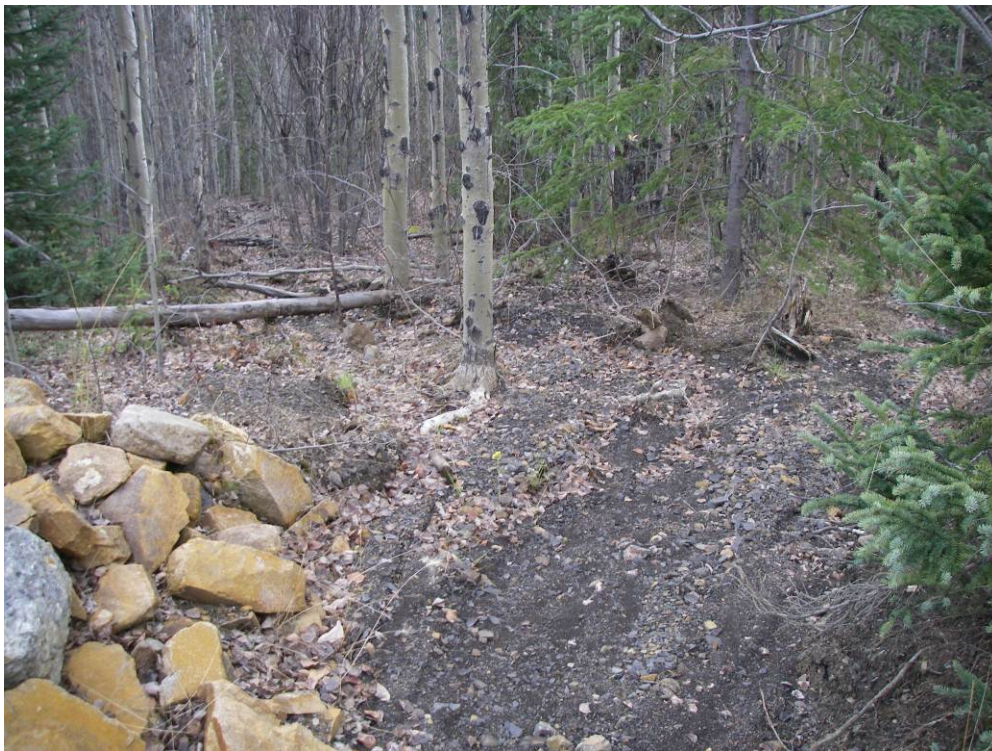
Photo 6: View of outfall looking into the trees. The deposition of eroded materials was followed for ~25m downstream of outfall. The end of the deposition zone was not found, the ground slope increased at that point from a gentle to moderate slope.

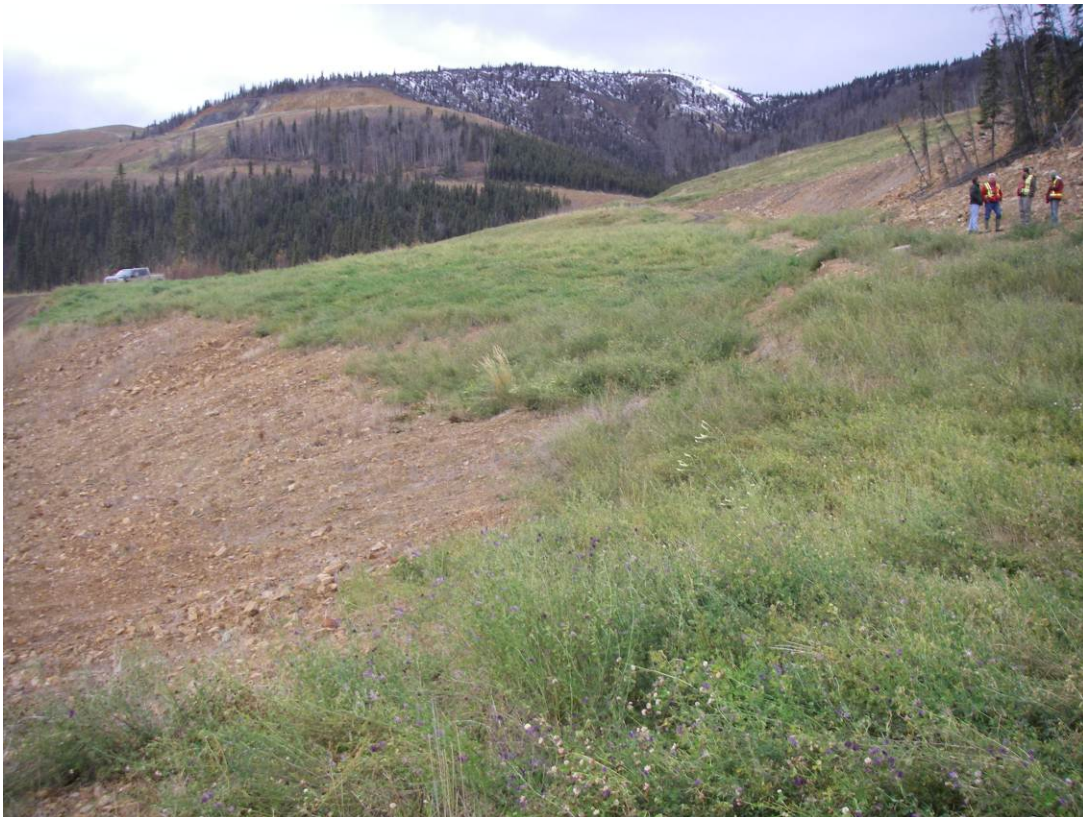
Photo 10: View of the second failure location by the Lucky Dump haul road above the Bohemian Access Trail, taken from "Photo Hub #4".

Consideration should be given to the establishment of settlement pins at the slope failure locations near the Lucky Haul Road, as well as the 'saddle area' scarp. Expanding on the monitoring program consisting of a collection of a photographic record, field measurements may then be taken to track the distance between the pins versus time, observing for any change in movement. Monitoring should be completed over a period of two years. Three pins are recommended at each location, placed in a triangular shape to be able to measure movement in multiple directions.

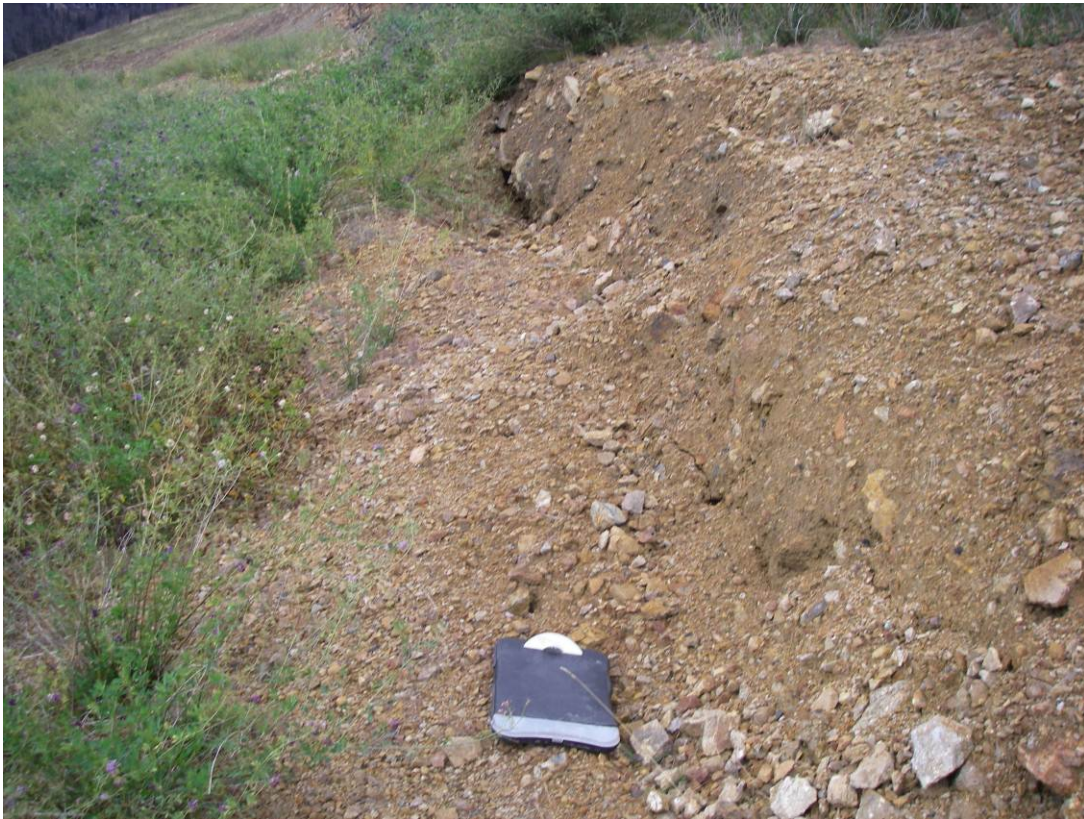
Photo 11: View of the scarp at the second failure location. The scarps are up to 1 m in height.

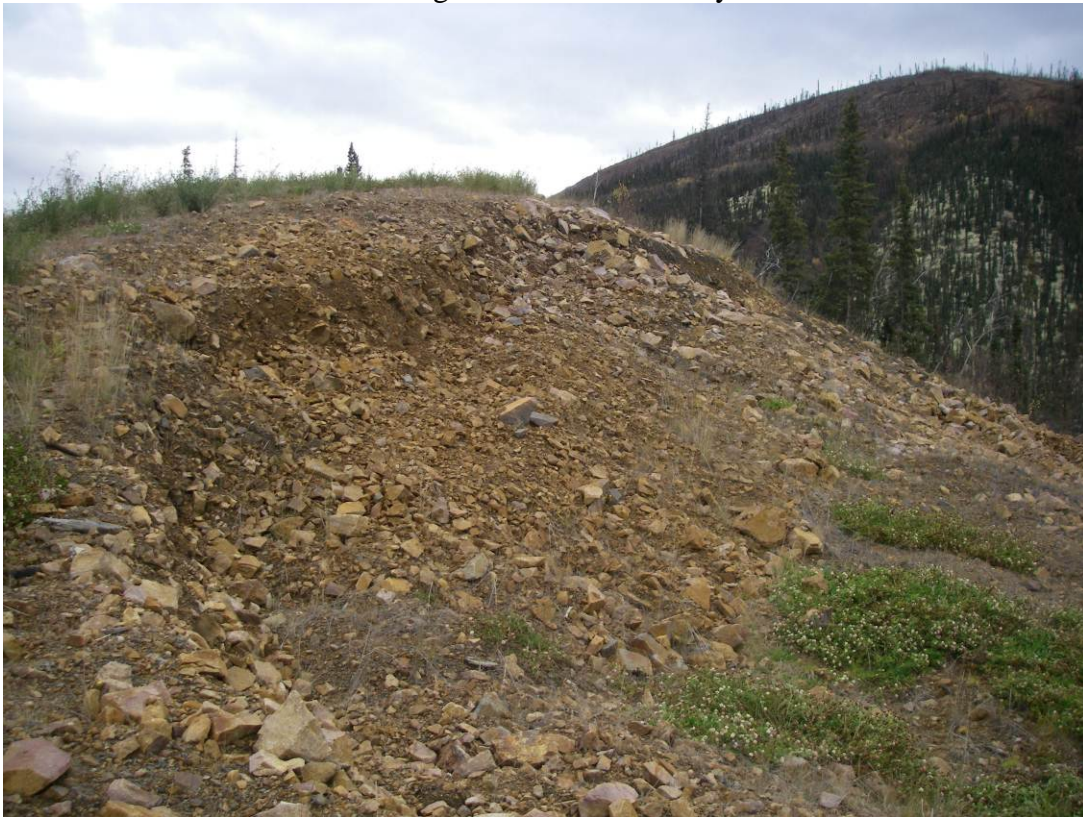
Photo 14: View of scarp in the ‘saddle area’. Looking east, settlement is orientated towards the north towards the 2nd failure location in photos 10 to 12.

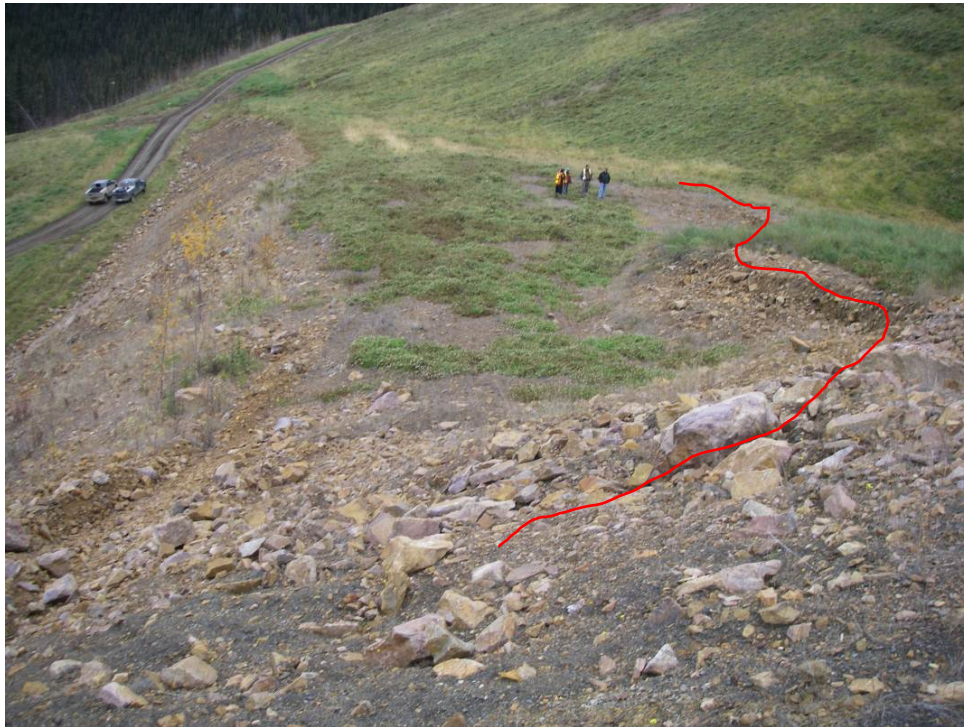
Photo 15: View looking towards the west. The Lucky Pit is located to the right of the photo, main access road to the left, and 2nd failure (photo 10-12) further to the left. Approx. locations of scarps/cracks are noted in red. These features were not noted in the 2010 inspection, possibly due to snow cover.

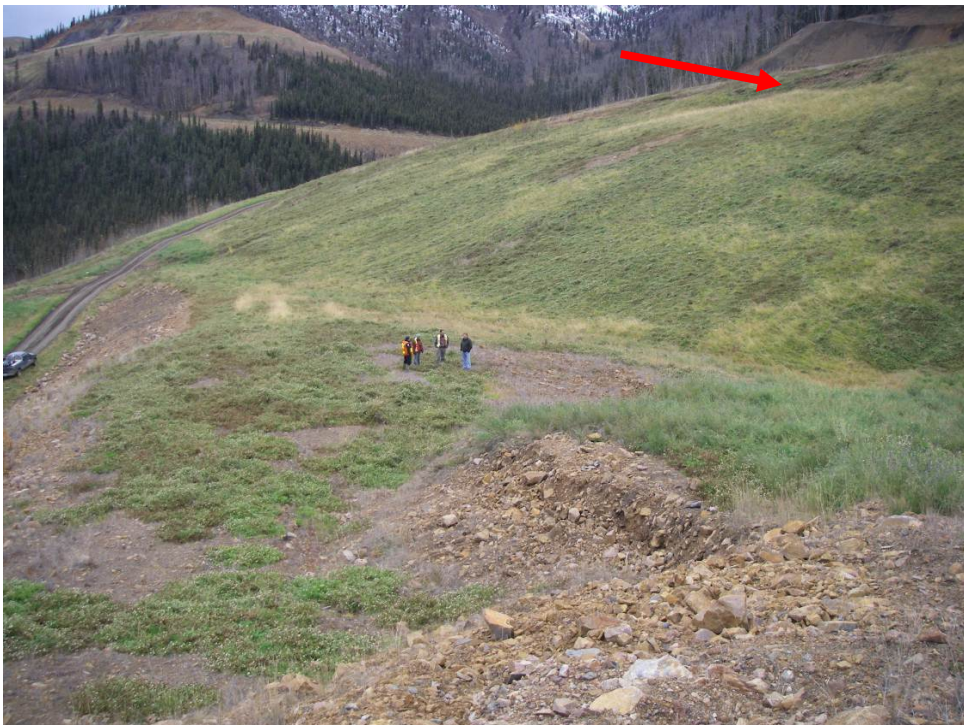
Photo 16: View from same location as Photo 15. Possible slope movement on the waste rock dump further to the west, noted by the arrow. Area was covered in snow during the 2010 inspection.

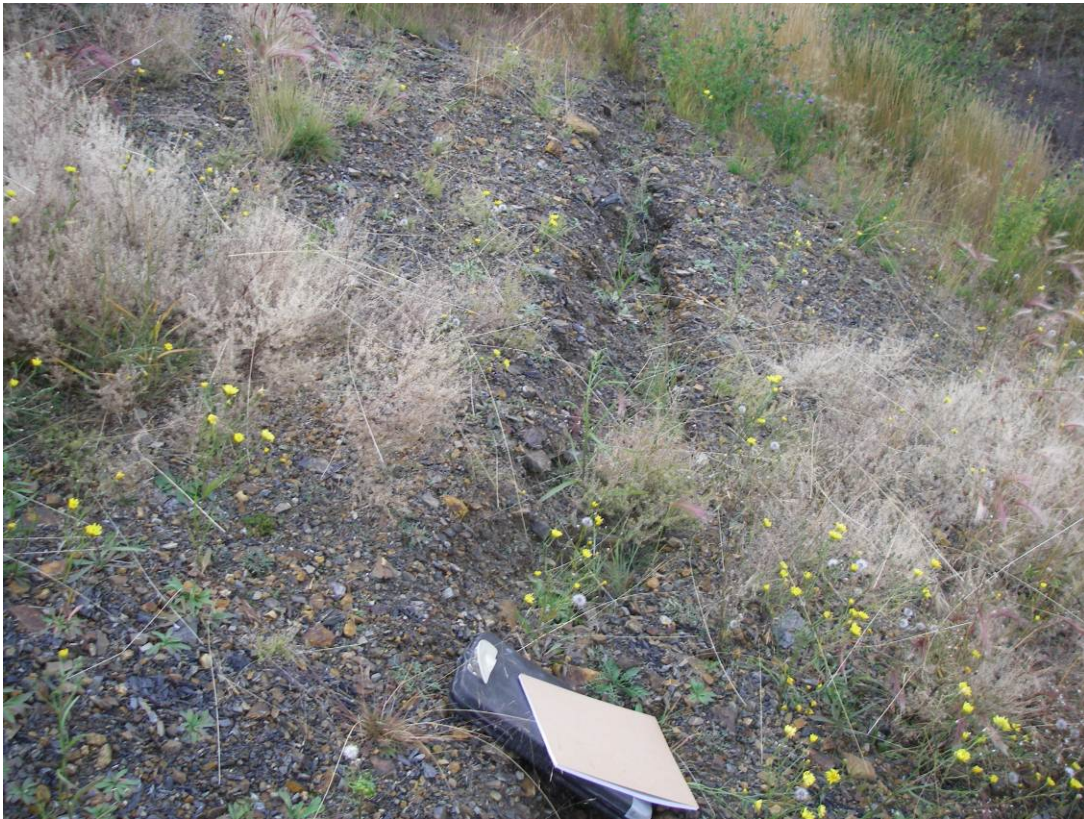
Photo 19: View of Tension cracks by the heap leach dyke near the breach location noted in the 2010 inspection. Vegetation is establishing within the crack indicating no further movement.
