**CARMACKS COPPER PROJECT**

**ADDENDUM TO  
VOLUME 1**

**BIOPHYSICAL ASSESSMENT OF THE  
CARMACKS COPPER MINE SITE**

**WESTERN COPPER HOLDINGS LIMITED**

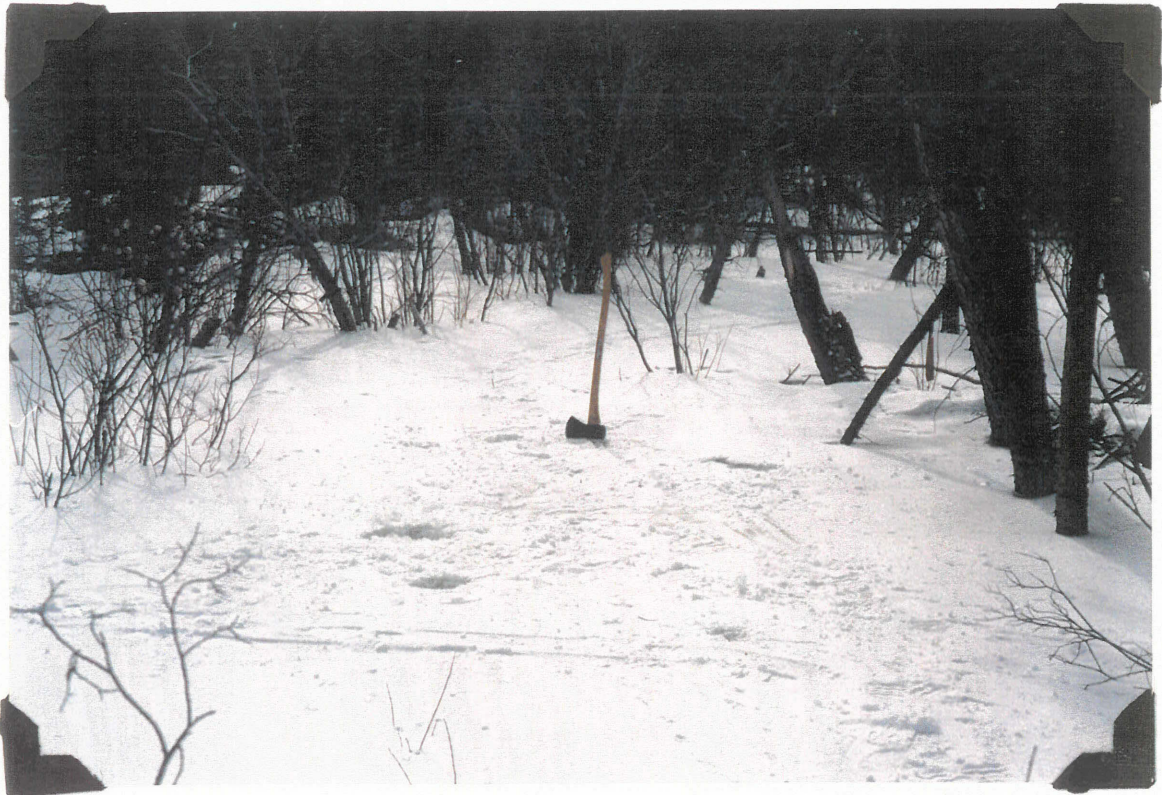
April 15, 1994. Williams Creek Data Logger Stations.  
Instrument housing under glacial ice cover.

1. **Water level data logger.** The logger site established in May of 1993 was under glacial ice cover to a depth greater than 1.91 meters. This is the difference between survey benchmark # 2 (under ice) and gauge zero on the staff gauge (creek bottom). The instrument culvert and housing were completely ice covered. No attempt was made to remove the ice cover as there would be no where for melt water to run and it would just re-freeze and ruin the instrument. The glacial ice cover was continuous from downstream of the logger site to upstream of the access road crossing. There was no melt water running on the ice surface as the temperature range of -10 to +5 Celsius over the past 10 days had halted the melt. Temperatures are forecast to increase starting April 20/21 and the glacial ice should start to melt. At least half the ice must melt before we think about putting the instrument in. I have scheduled another attempt for May 4 and 5, Merrice Creek should still be at lower water for crossing. The snow has melted off the south facing road surfaces and will hopefully be mostly gone from the north facing slopes - especially on the south side of Merrice Creek to allow ATV access.

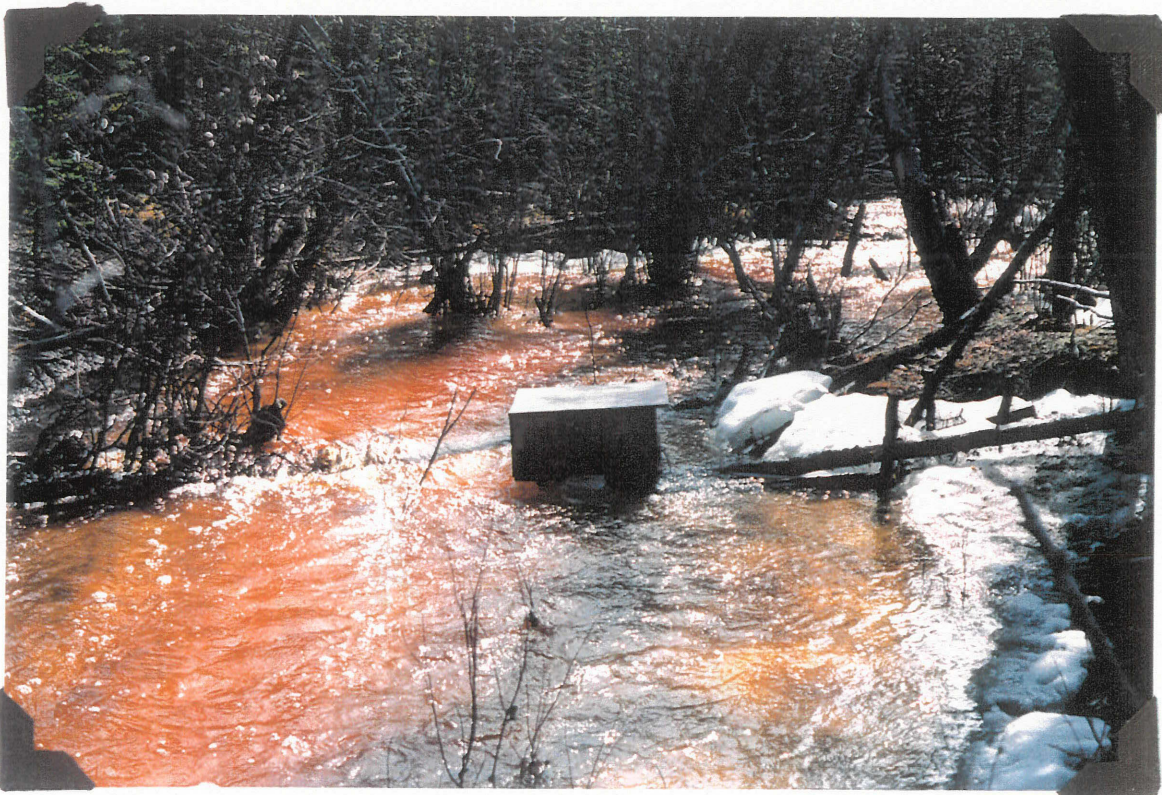
May 2, 1994. Williams Creek Data Logger station. Freshet  
flows on top of ice. Instrument shelter  
visible.

On the May 2, 1994 trip ice at the logger site had melted down to the top of the instrument culvert. The instrument shelter was built up 16 inches (for safety) and the logger installed. The logger was programmed from the benchmarks as the staff gauge was still under ice. Flows remained on top of channel ice 1.20 meters thick. Creek volume was measured at 0.235 cubic meters per second - a 38% increase over the previous high measured on May 28, 1993. Unfortunately with the ice situation the flow does not plot against a gauge height. It is still good data however. The staff gauge at the road crossing was also under ice cover so no flow measurement was done there.

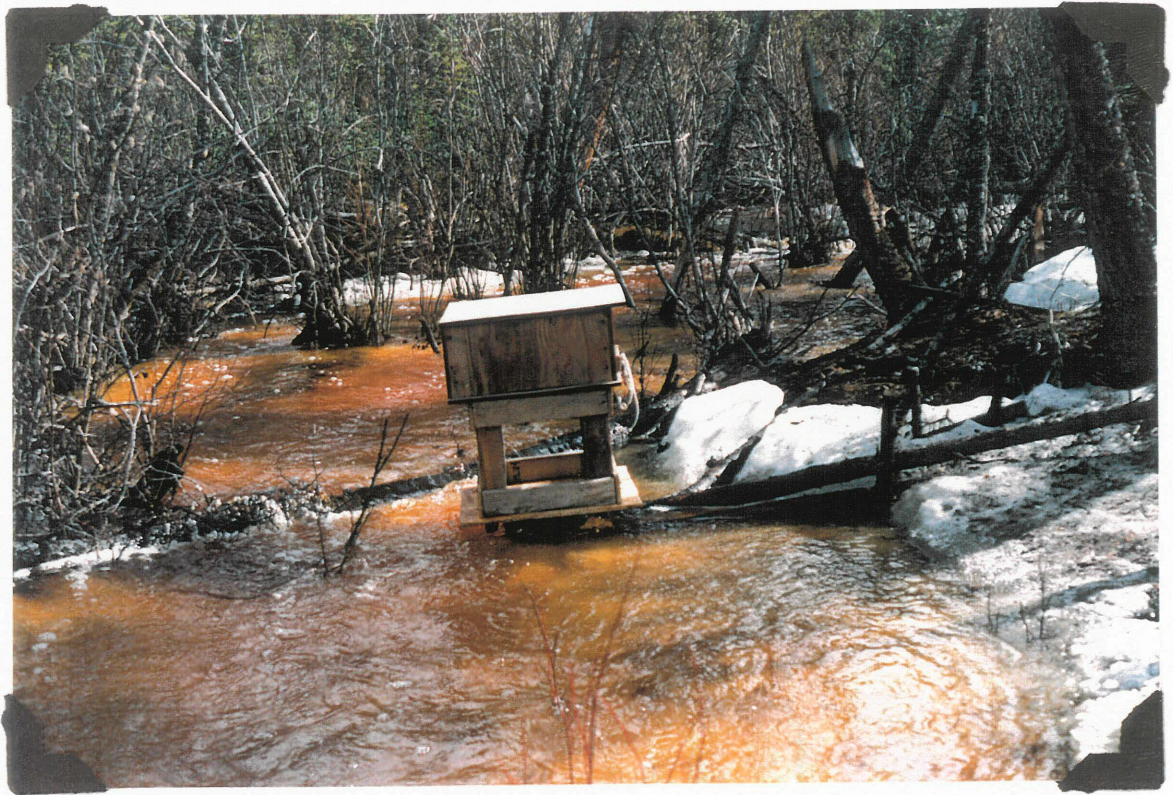
May 2, 1994. Williams Creek Data Logger Station.  
Extension to instrument housing to permit logger  
installation. Flow remain on top of channel ice.  
Ice decreased by 0.4 meters.

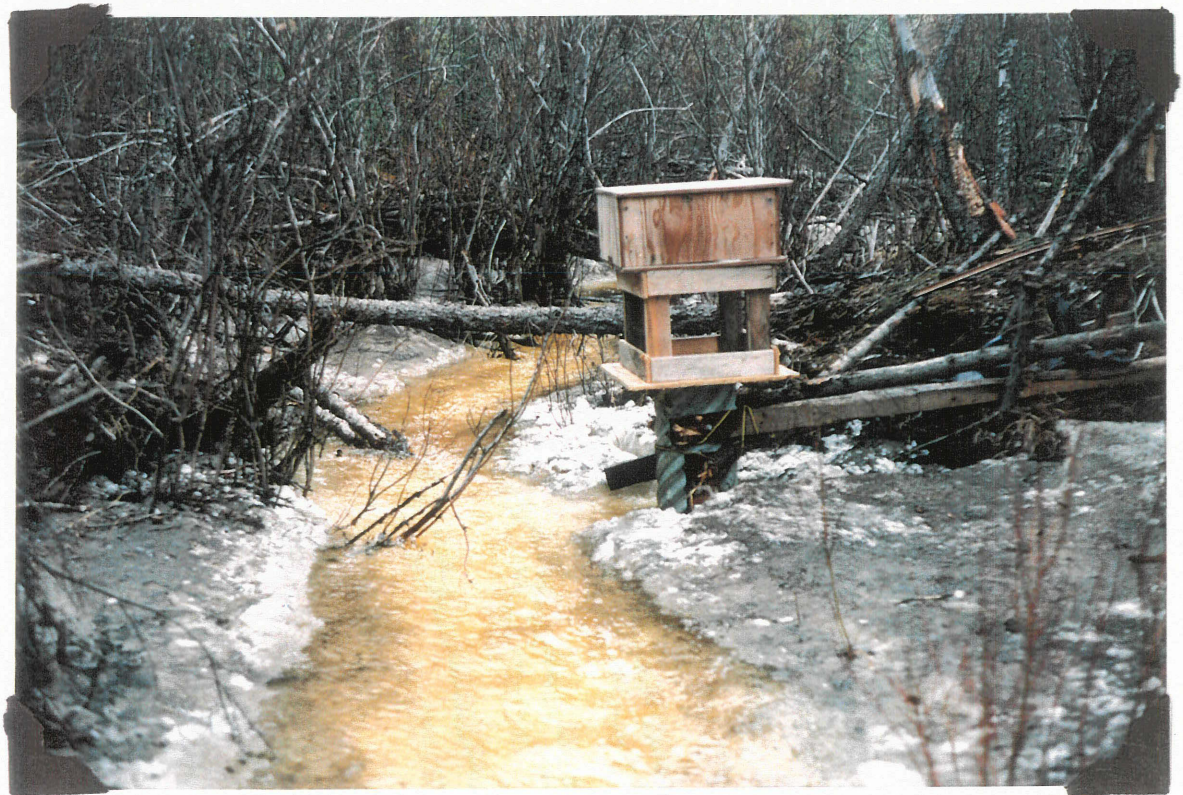
May 13, 1994. Williams Creek Data Logger station.  
Flows remain on top of ice. Ice decreased a  
further 0.4 meters.

On the May 13 survey, ice levels had decreased approximately 0.30 meters, enough to allow staff gauge readings. Total flow still remained on top of the channel ice however and volumes had decreased substantially to 0.047 cms. The logger was left operating after recalibrating against the staff gauge reading. Flows were also measured at the road crossing staff gauge (0.038 cms) in an ice free channel. This measurement plotted perfectly on the stage discharge curve.

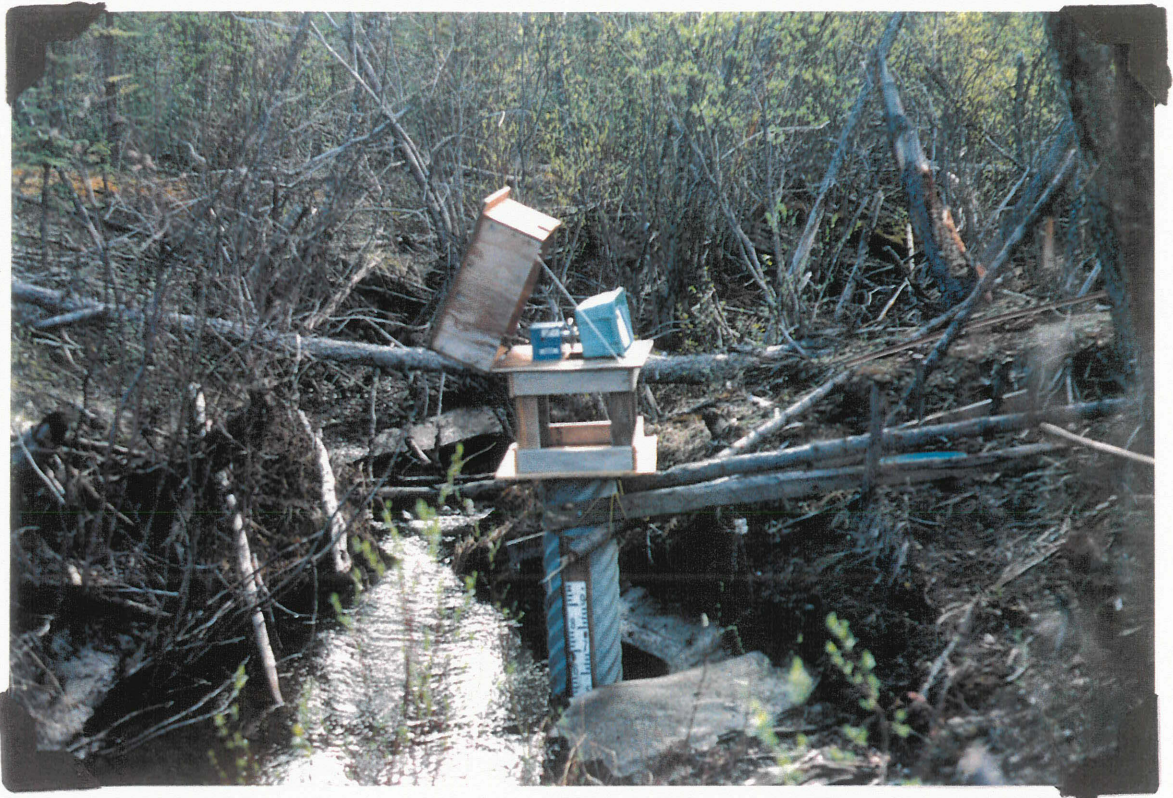
May 30, 1994. Williams Creek Data Logger Station.  
No further ice on channel invert.

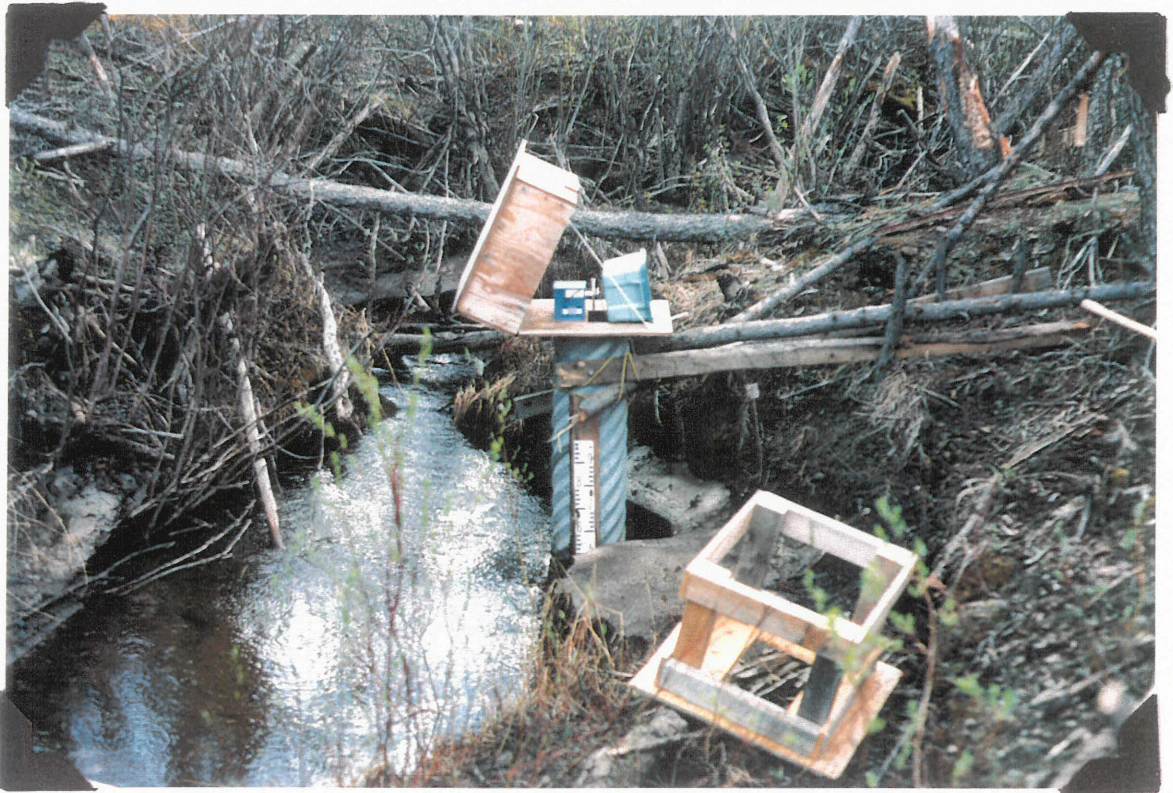
May 30, 1994. Williams Creek Data Logger station.  
Instrument extension removed - normal  
operation.

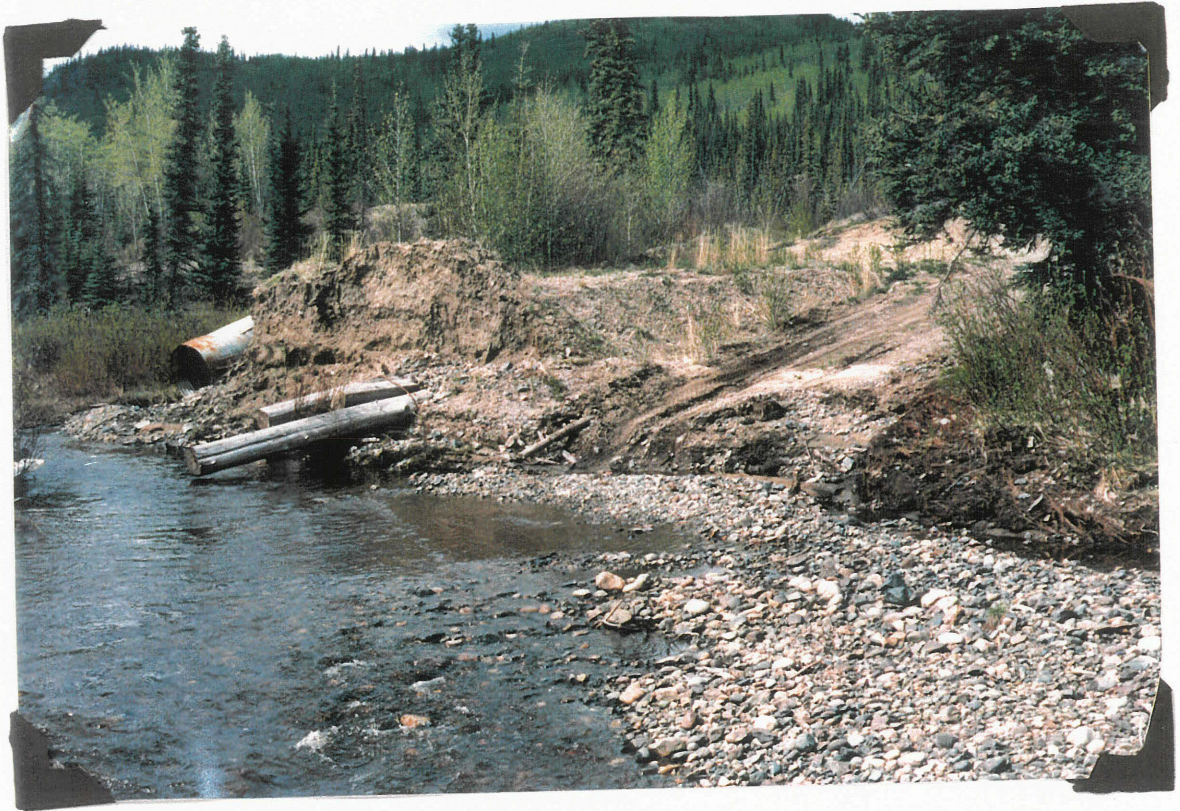
May 30, 1994. Merrice Creek road crossing - minor erosion to north bank

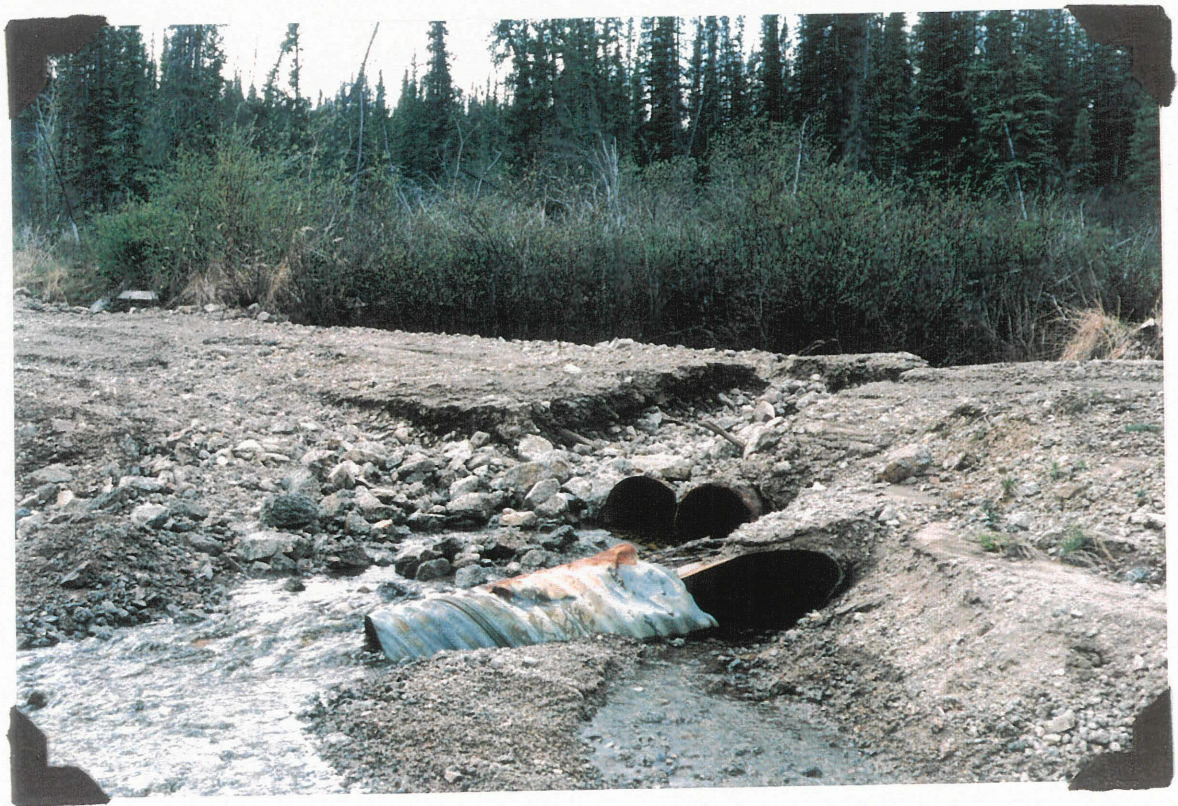
May 30, 1994. Williams Creek road crossing - minor erosion to road bed during freshet.

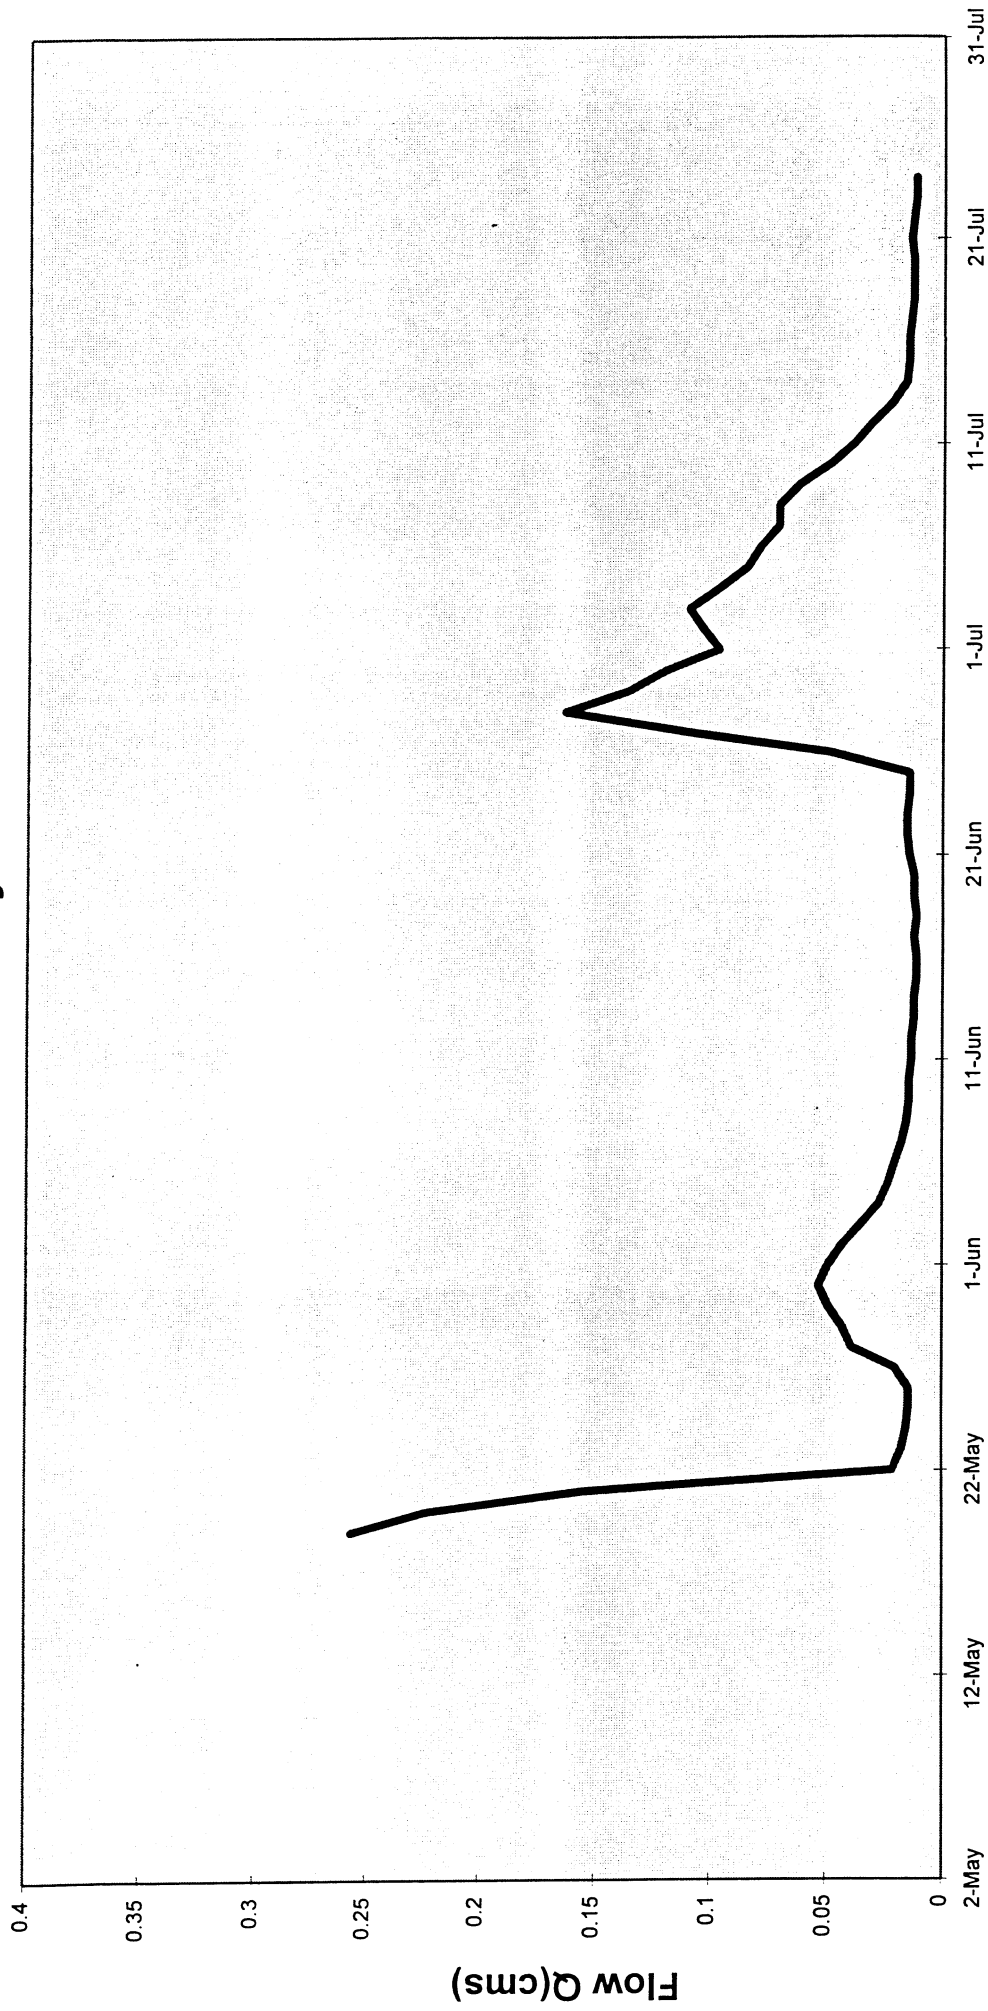
STAFF GAUGE - DISCHARGE CALIBRATION

Dates: May 2 to July 24, 1994
