## CASINO MINING CORPORATION CASINO PROJECT

## 2013 GEOTECHNICAL SITE INVESTIGATION DATA REPORT MINE SITE

VA101-325/16-1  
Rev 0  
January 24, 2014

### **2013 GEOTECHNICAL SITE INVESTIGATION DATA REPORT MINE SITE VA101-325/16-1**

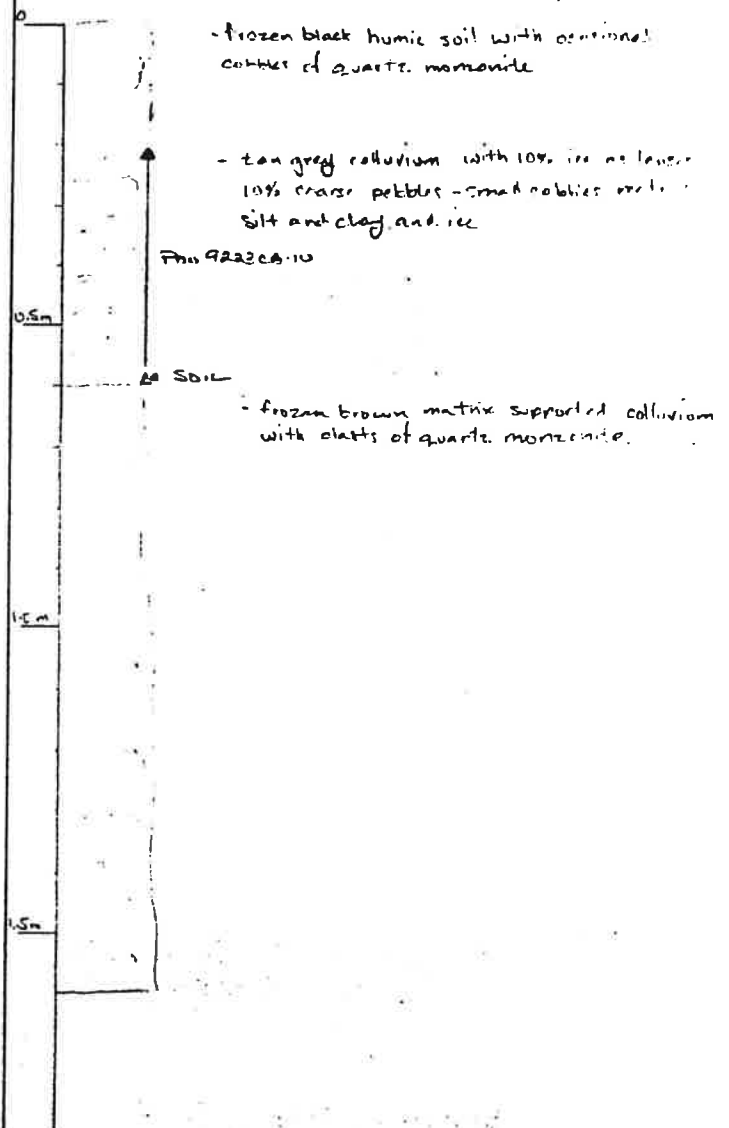
**SOIL PROFILE @ 5m**

COMMENTS: Frozen trench. No fluvial or glacial material discovered. Bedrock not reached.

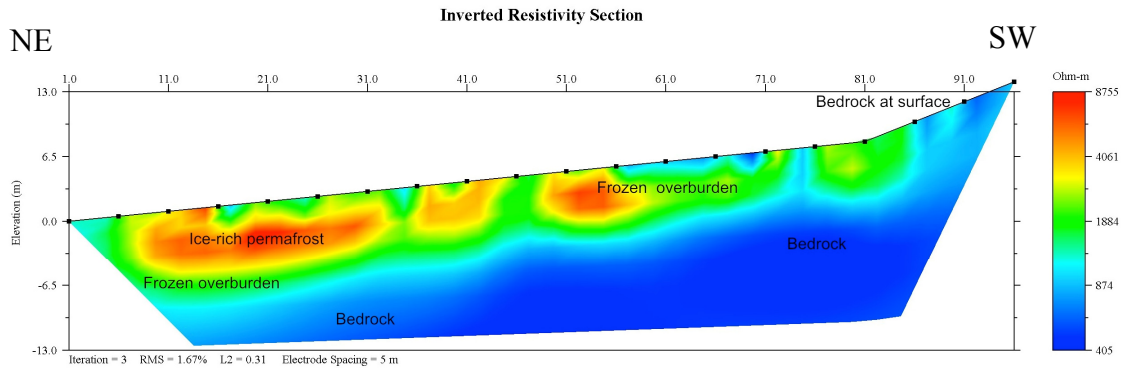
#### Line 1

This geophysics line was conducted in search of potential borrow material.

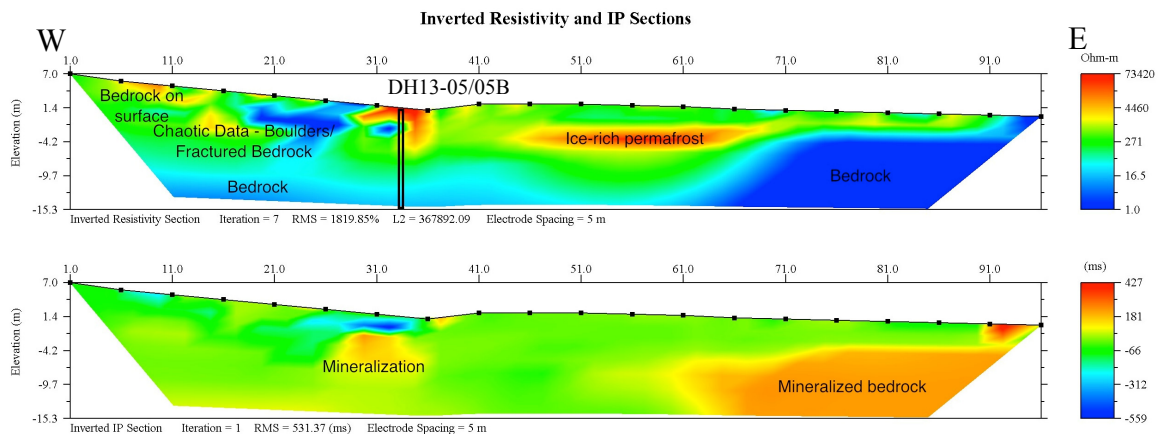
## Line 13

This line runs west to east near the proposed crusher site and across DH 13-05 and 13-05B.

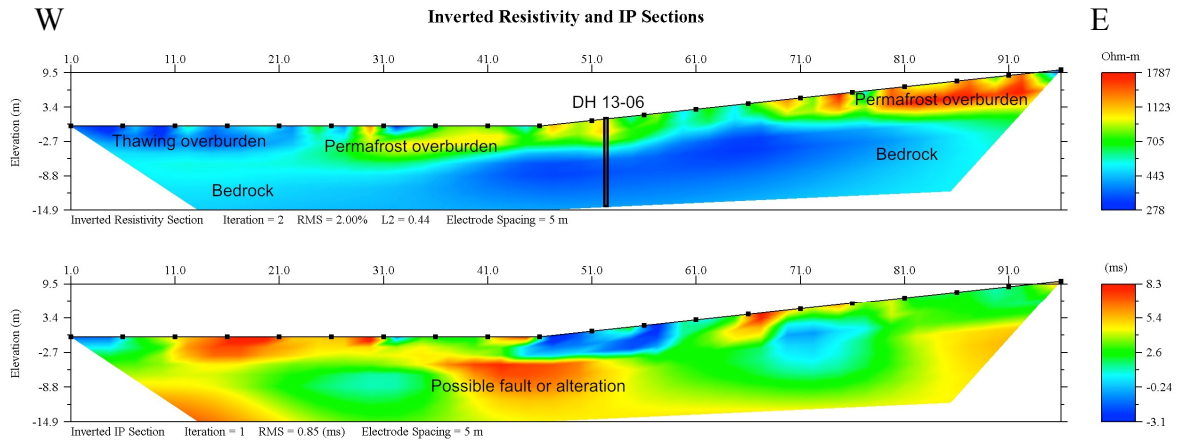
## Line 14

This line runs west to east across the proposed crusher site.

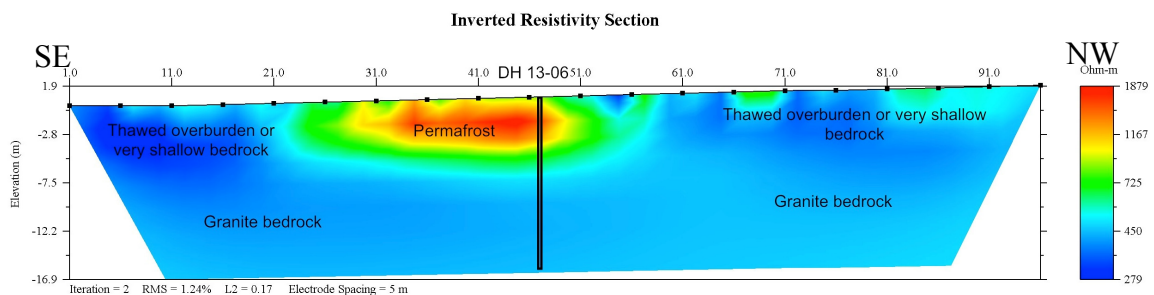
## Line 15

This image shows granite bedrock at 6-7.5 m depth in the centre of the image, and possibly higher near the edges. Overburden is generally thawed with frozen sections. An area of possible ice-rich permafrost is located between 30 and 50 m on the horizontal scale. This image runs southeast to northwest near the proposed crusher site.

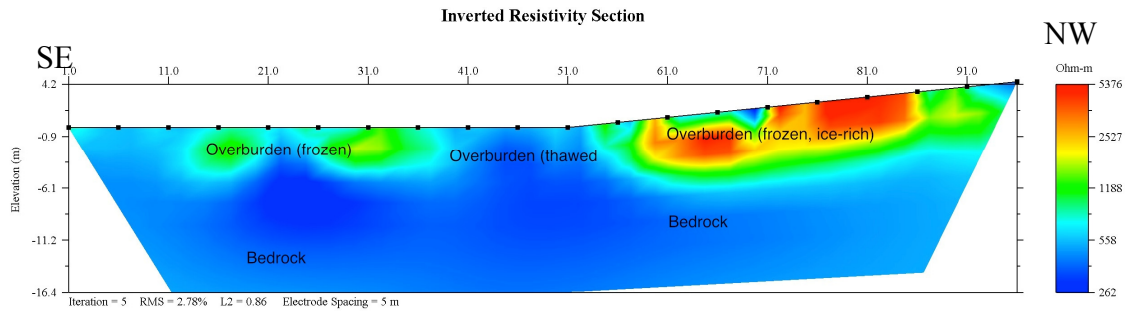
## Line 16

This line runs southeast to northwest near the crusher site.

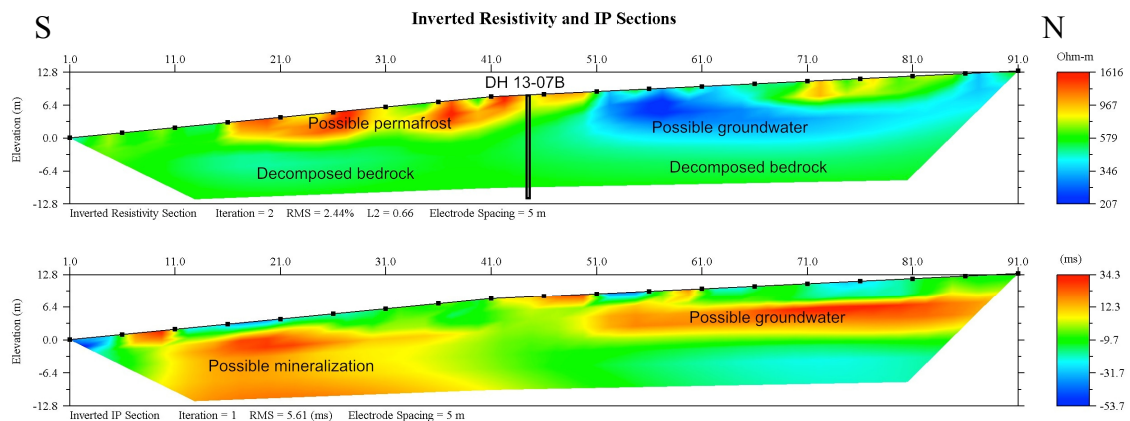
## Line 22

This image runs south to north at the proposed ADR/SART site.

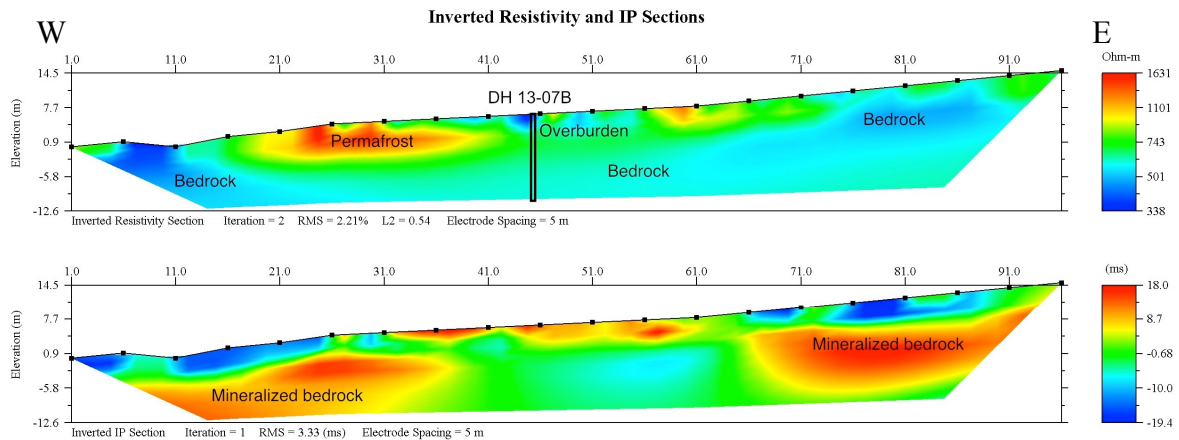
## Line 23

This image runs west to east through DH 13-07B at the proposed ADR/SART site, perpendicular to Line 22.
