VICTORIA GOLD CORPORATION

**EAGLE GOLD PROJECT
DUBLIN GULCH, YUKON**

**2011 GEOTECHNICAL INVESTIGATION
FOR MINE SITE INFRASTRUCTURE
FACTUAL DATA REPORT**

PROJECT NO: 0792-006
DATE: October 19, 2011
DOCUMENT NO:

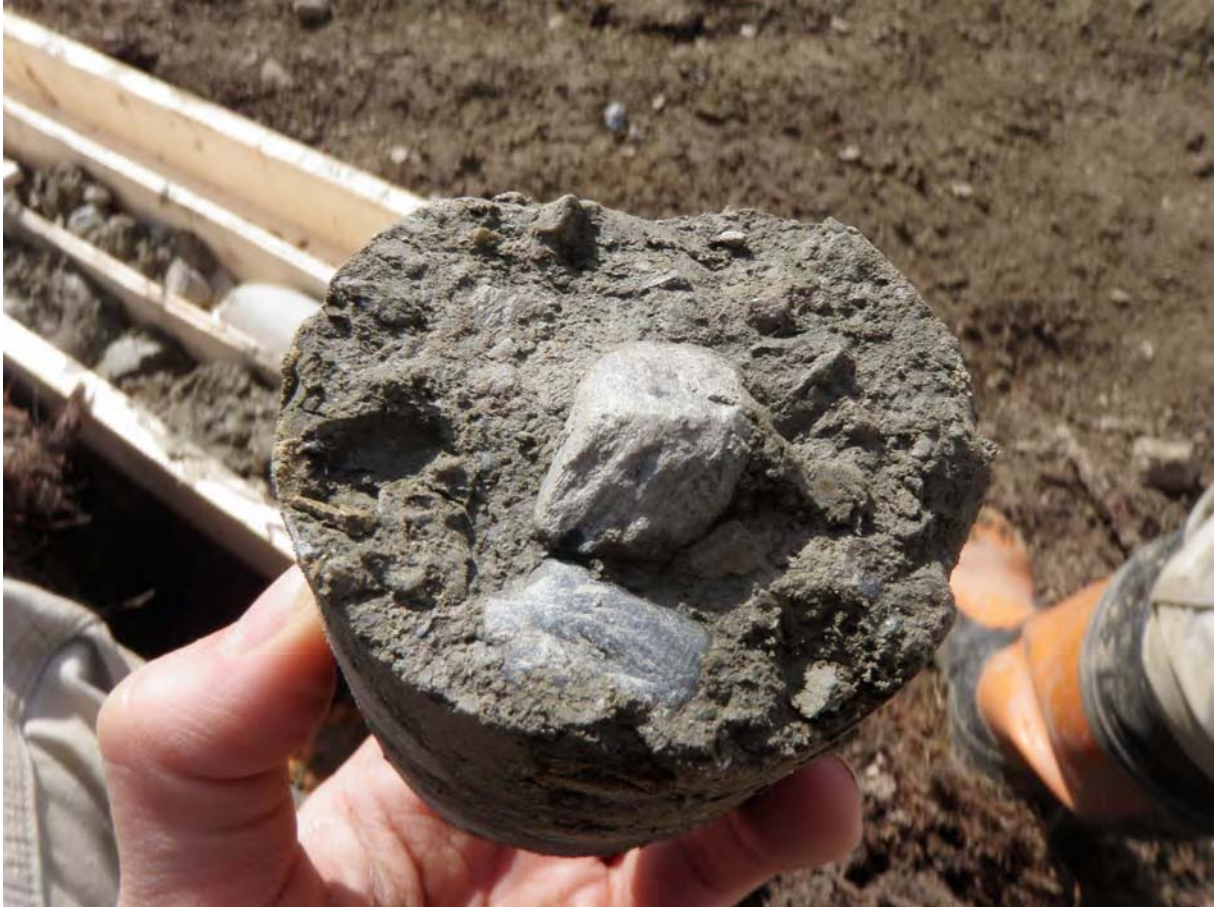
Photograph 2. Till core from 25 m depth at DH-BGC09-STU-3.

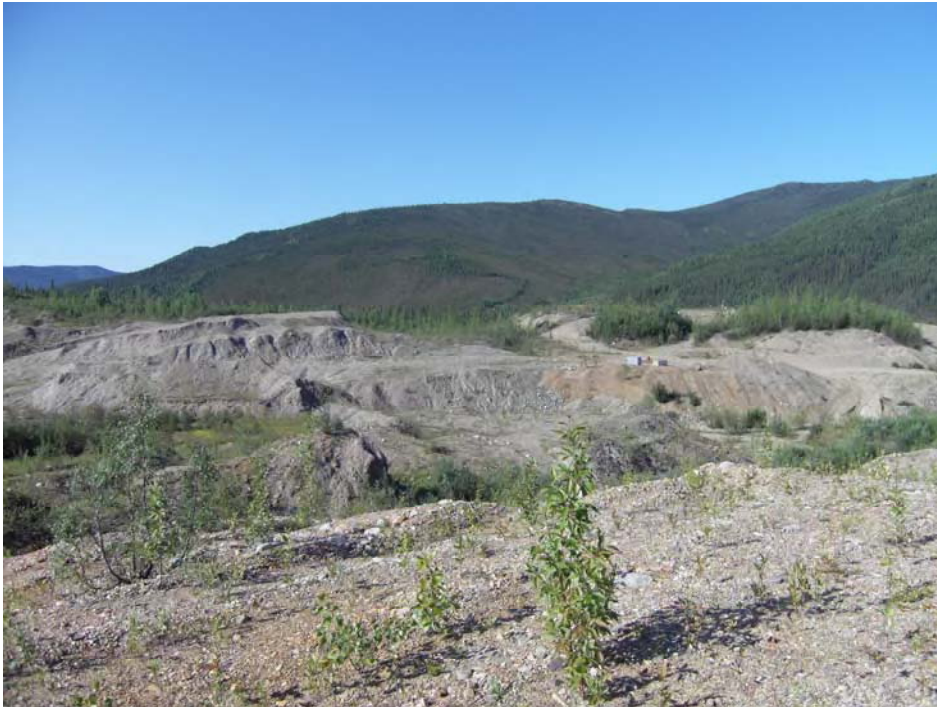
Photograph 4. Placer tailings in Dublin Gulch valley bottom.
