RE: Quartz Mining Licence QML-0011 Annual Report

**REVEGETATION AND BIOREMEDIATION TRIALS
ON THE DUBLIN GULCH PROPERTY
2012 to 2014**

Re: **Revegetation and Bioremediation Trials on the Dublin Gulch Property, 2012 to 2014**

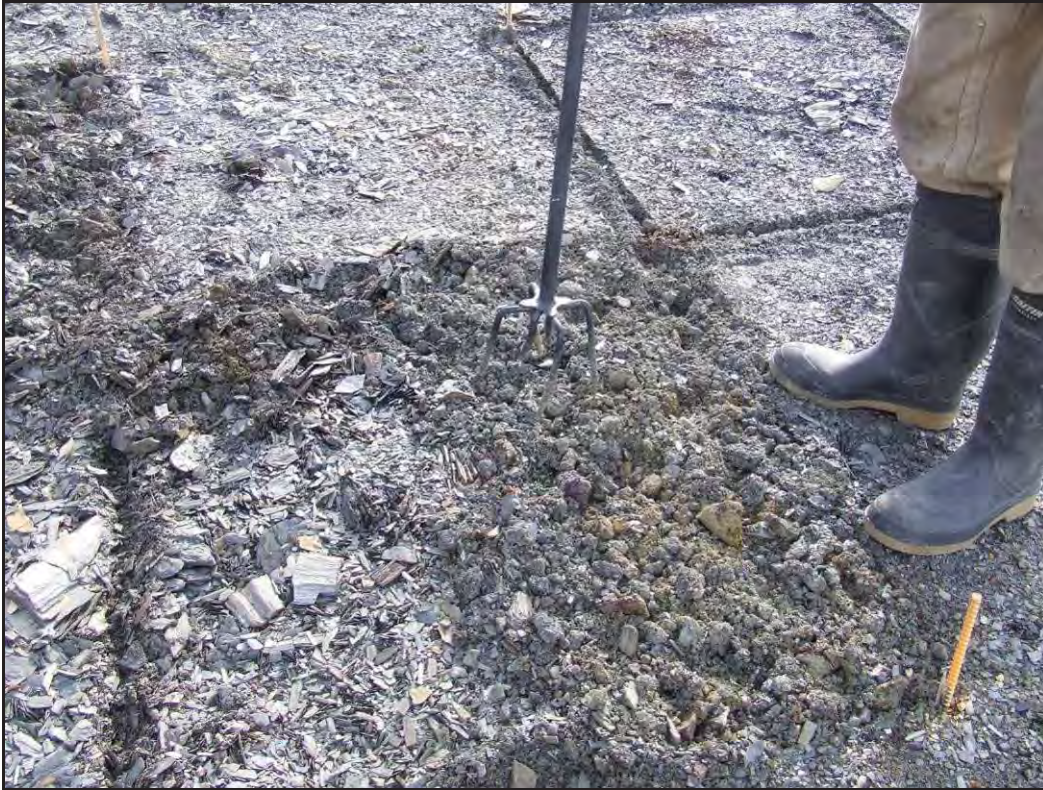
Photo #1: Each plot was first decompacted using a 5-pronged hand cultivator. Sept 2012.

The plots were prepared and seeded from September 18th to 20th, 2012. Each plot to be seeded was scarified first with a hand-cultivator (tine length 15 cm), and then raked with a fine-toothed rake (see Photo #1, Appendix B). Soil amendments were well mixed into the prepared plot and then the seeds were hand broadcast throughout the plot. Each plot was tamped gently but firmly with the back of a rake to create micro-sites and achieve good seed placement.

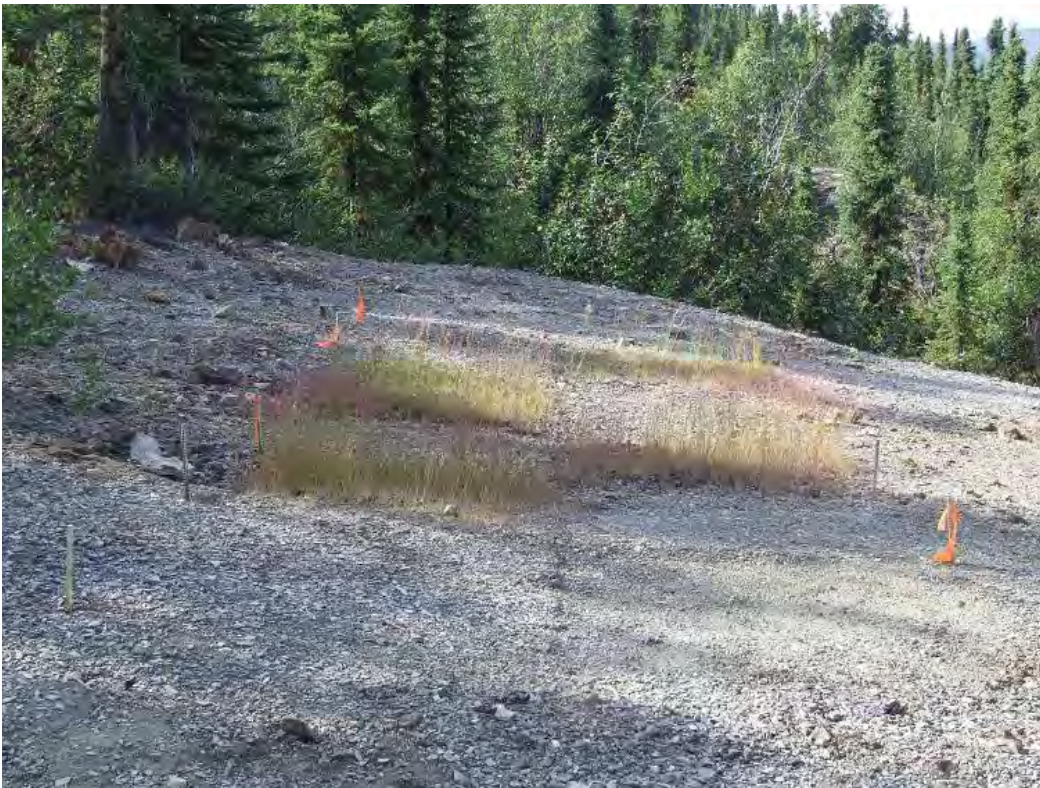
Photo #12: Waste Rock Block #2, Plot # 2-1 in lower right corner. August 5th, 2014 The pinkish colour are the mature seed heads of Ticklegrass.

Many plants had reached maturity in several of the waste rock plots. For each of the Waste Rock plots where enough mature plants existed to determine species, Ticklegrass (*Agrostis scabra*) was the dominant species. Although Ticklegrass was not one of the species planted at the Trench plots it was a common mature plant in several of the plots. Ticklegrass is a common native plant throughout the site, growing along the edges of the cleared areas and was prolific along the access road at the higher elevations near the Peso site.

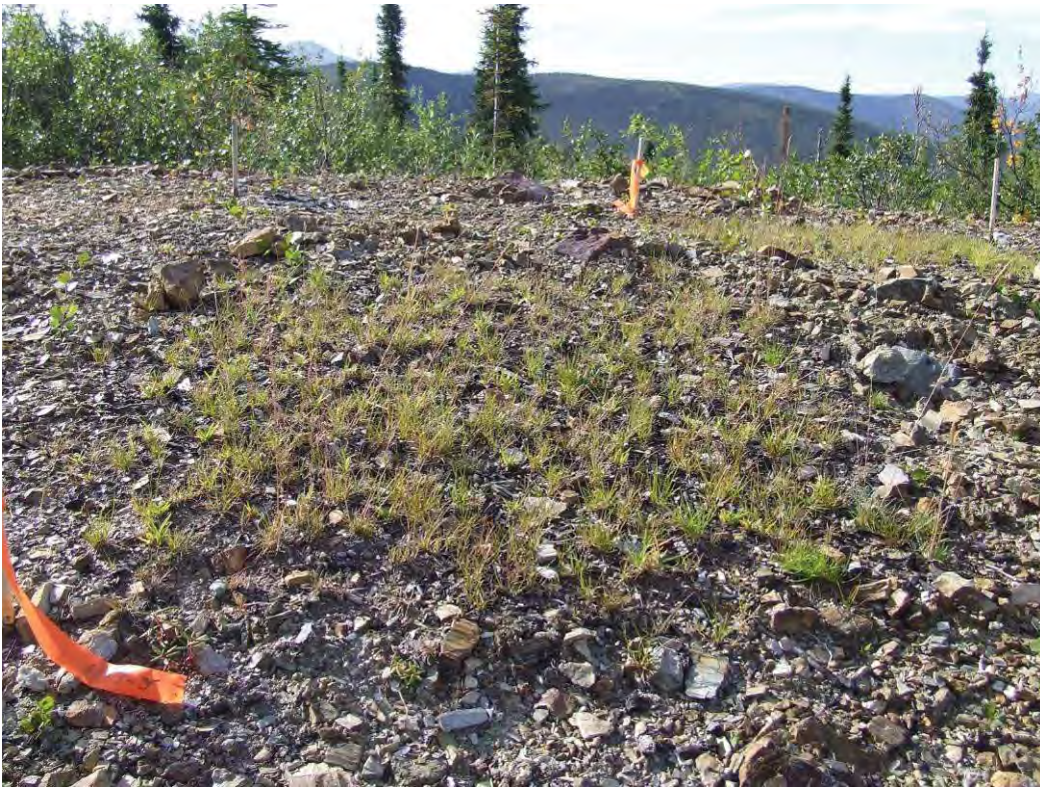
Photo #16: Healthy growth at Plot # 2-2 at the Trench site, August 5th, 2014.

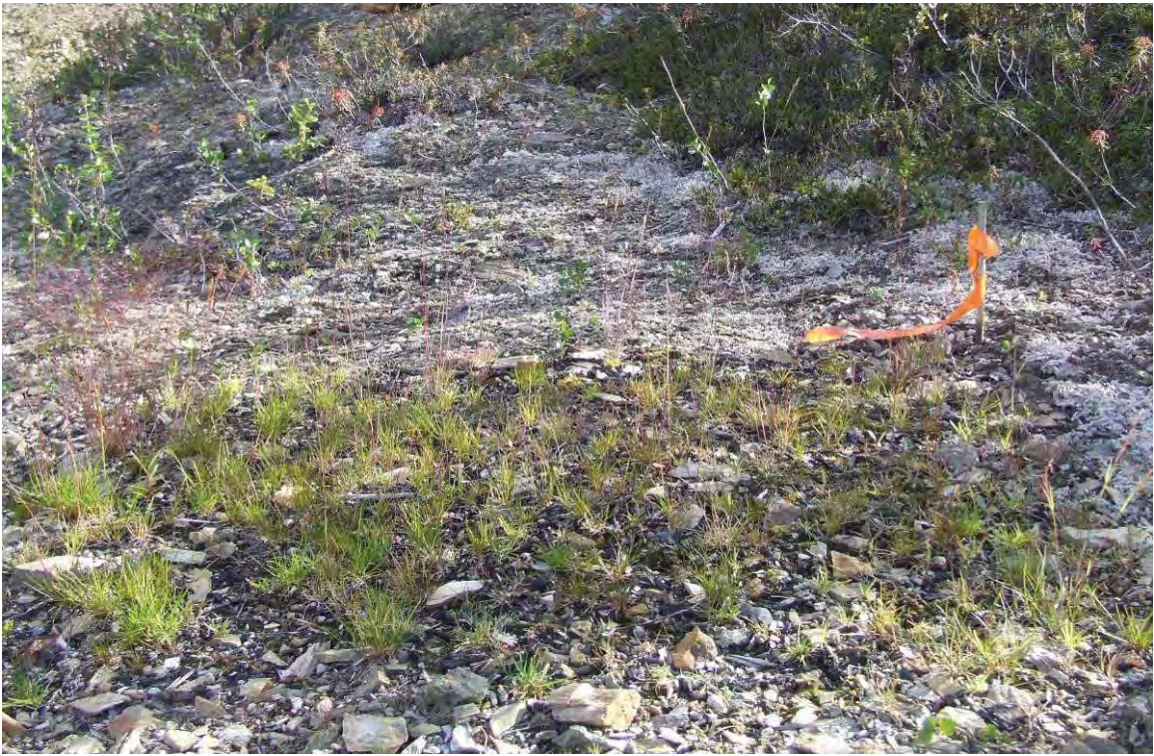
Photo #17: Plot # 3-2A was diverse and had the most mature plants of any plots at the Trench site, August 5th, 2014.

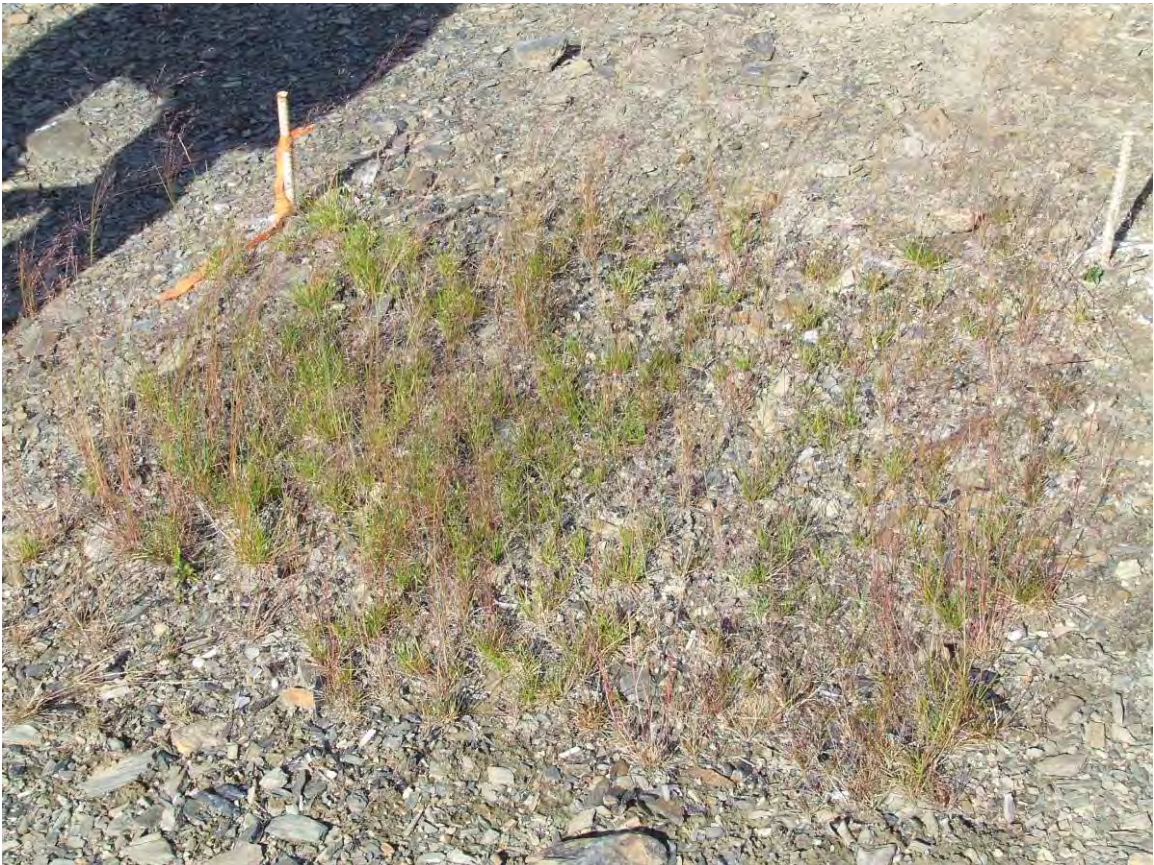
Photo # 18: Plot # 1-2 at the Waste Rock site had many mature ticklegrass plants, Aug 5th, 2014.

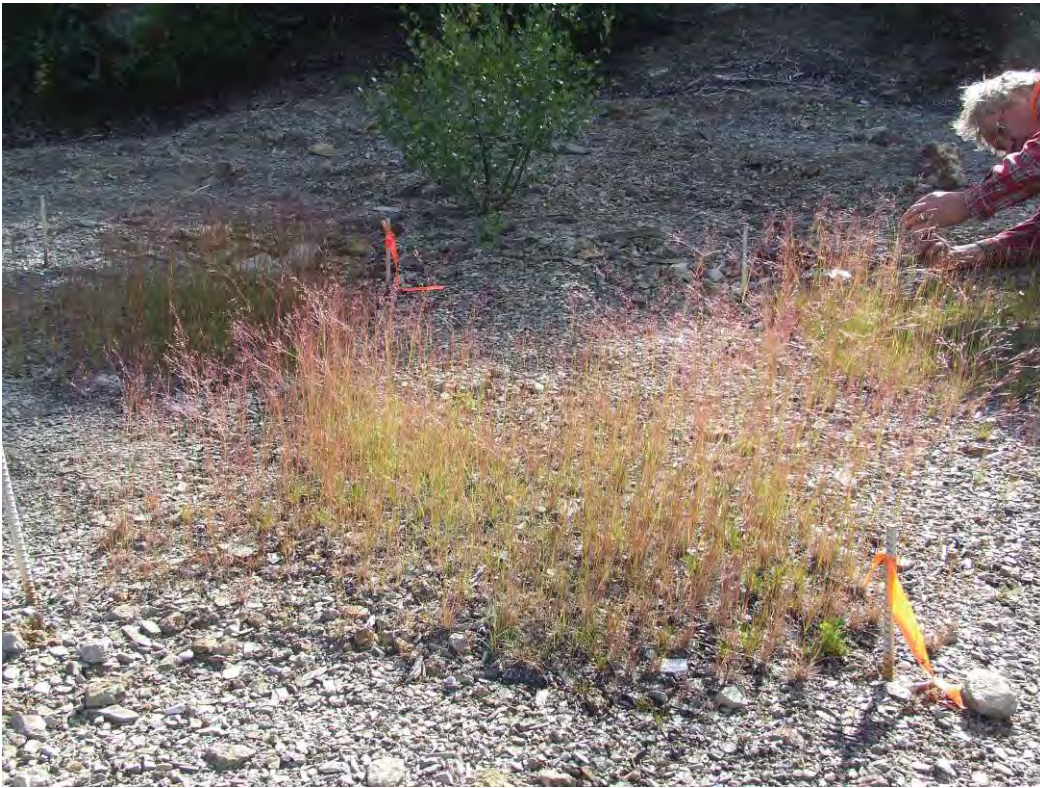
Photo #19: There were also many mature Ticklegrass plants at Block 2 at the Waste Rock Site, August 5th, 2014. Plot # 2-3 is in the centre of the photo.

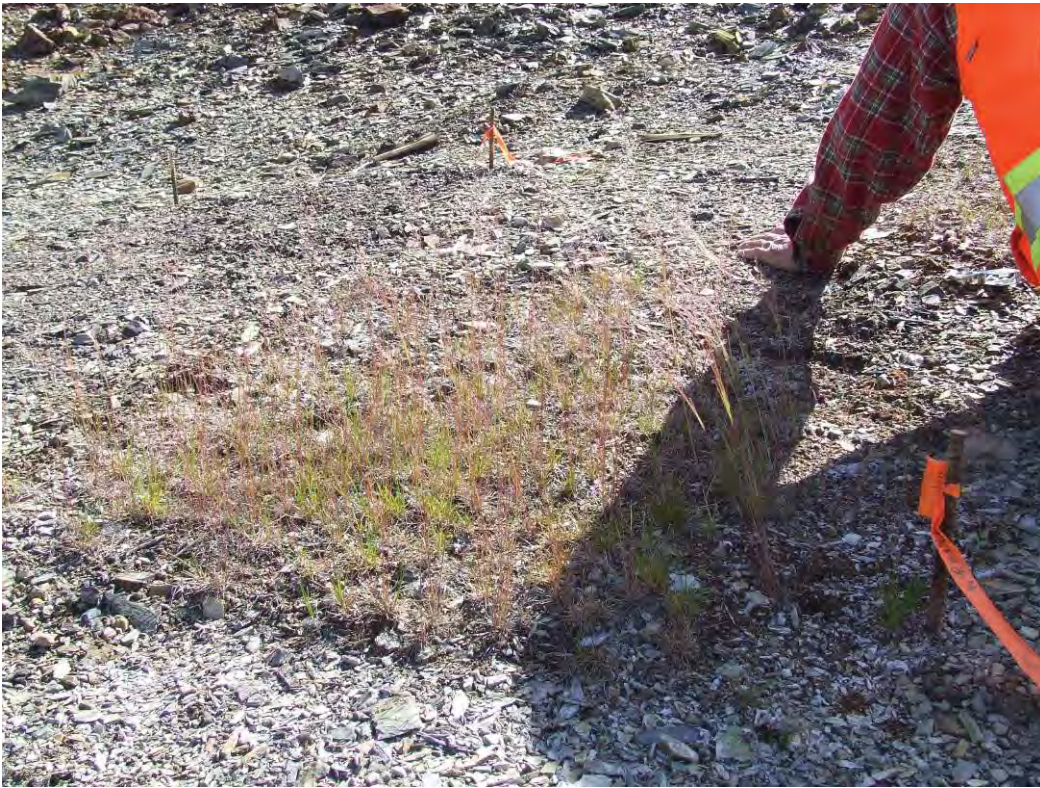
Photo #20: Plot # 3-4 was the healthiest plot in Block 3 of the Waste Rock Site, August 5th, 2014.
