EAGLE GOLD PROJECT FISH AND FISH HABITAT MONITORING REPORT 2019

Eagle Gold Project Fish and Fish Habitat Monitoring Report 2019

Nicholas de Graff, Can-nic-a-nick Environmental Sciences
P.O. Box 10106, Whitehorse, YT Y1A 7A1

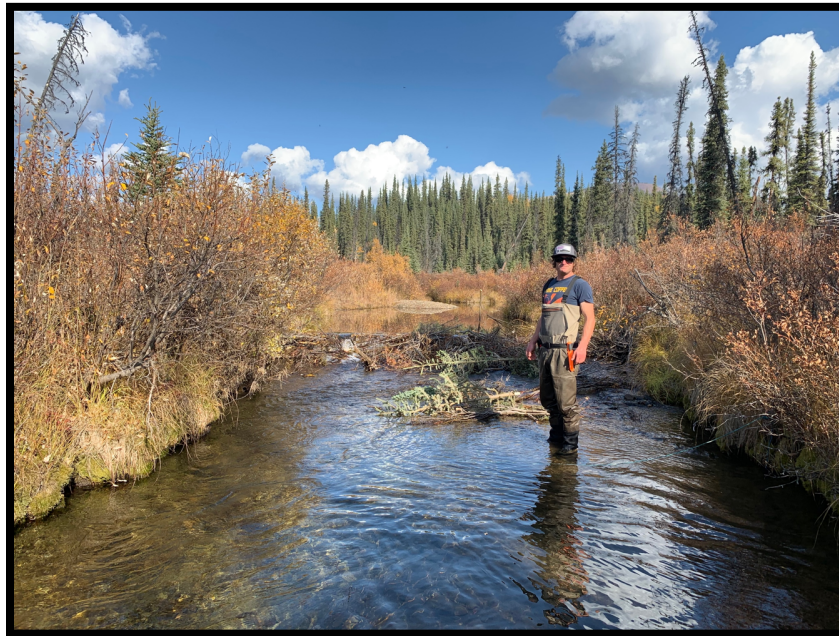
Cover Photo: Beaver dam located at Lynx Creek monitoring site L1, September 2019.
Photo Credit: N. de Graff

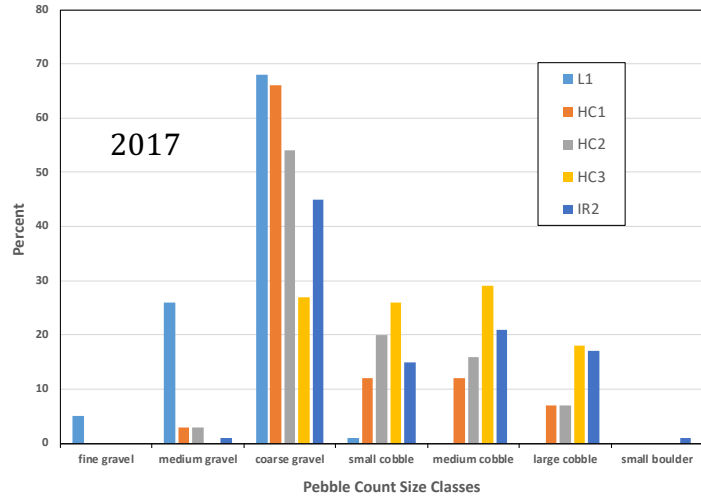
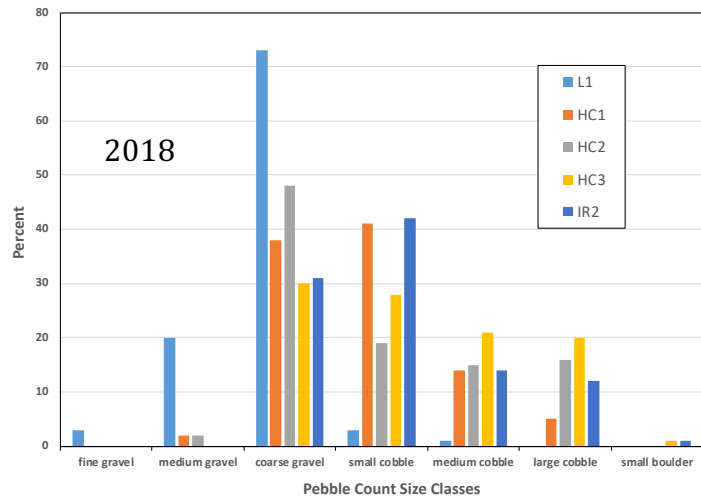
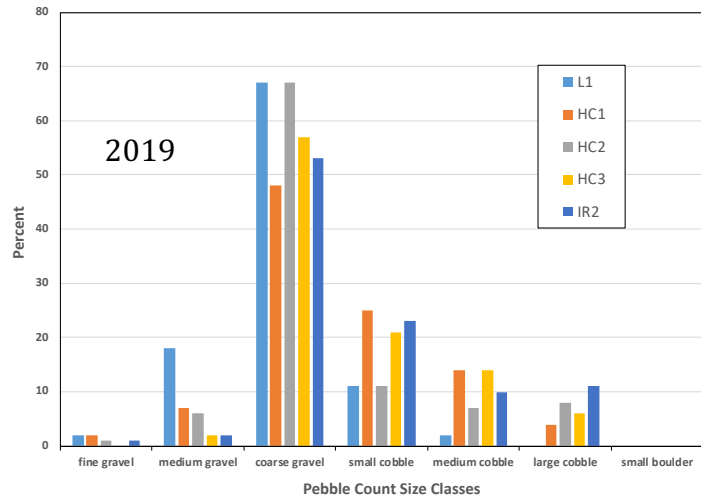
Figure 2 Comparison of 2017, 2018 and 2019 substrate size classes based on pebble counts at monitoring sites associated with the Eagle Gold Project.

A comparison between 2017, 2018 and 2019 substrate size classes as determined by pebble counts is presented in Figure 2. With the exception of some of the class proportions, mainly between small cobble and coarse gravel, little change is apparent between years. The slight differences at each of the sites are thought to be mainly due to the natural variability of the substrate that was chosen to complete the survey. In particular, the dry conditions and low stream stage in 2019 allowed the surveying of substrates that were not as accessible in previous monitoring years.

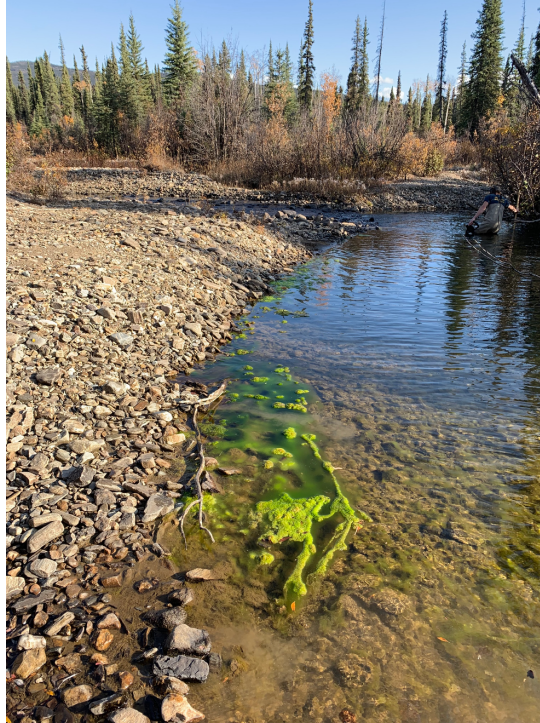
and the embeddedness of individual rocks averaged 50 percent. Course sand (0.1-0.2 cm) was the predominant type of interstitial material. Periphyton coverage was moderate with a noticeable slippery feel on the rocks. There were also patches of thicker green algae that were observed (Figure 3). The irregular meandering channel contained some disturbance indicators from changes in sediment supply and/or discharge variability that included elevated bars, eroding banks, abandoned and multiple channels that appear to reflect past upstream activities related to historic placer mining.

Figure 3 Picture of green algae (*Chlorophytes*) that was attached to the substrate at monitoring site HC1, September 2019.

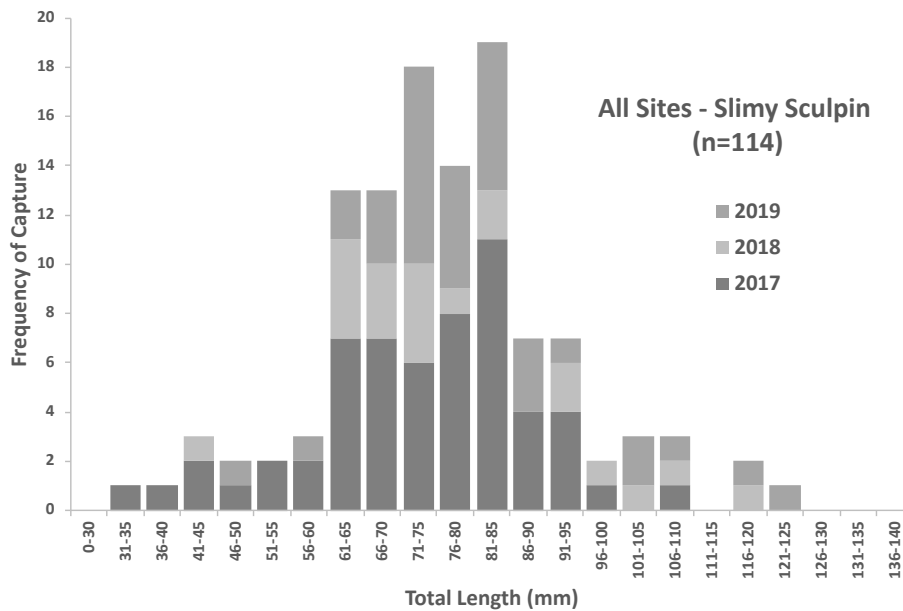
Slimy sculpin dominated the overall catch in 2019 and were found at all five monitoring sites. Sites HC1 and HC3 in Haggart Creek were locations that had the highest frequency of capture. Only modest numbers (5 or less) were encountered at sites HC2, IR2 and L1. Sculpin total lengths ranged from 50 to 125 mm indicating the presence of both juvenile and adult life history stages. This size range was similar to those reported by Stantec (2010) in their baseline study. A length frequency histogram that includes all captured sculpin from each yearly monitoring program is presented in Figure 4. Based on captures, the implied densities of sculpin encountered at the Haggart Creek sites were generally greater than in 2018 and similar to 2017 (Table 4). It is believed that the cold-water temperatures and ice conditions during the 2018 assessment negatively influenced catch.

Figure 4 Length frequency of captured slimy sculpin associated with monitoring sites at the Eagle Gold Project 2017 to 2019.

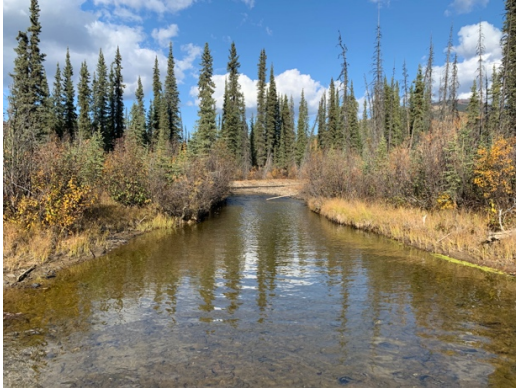
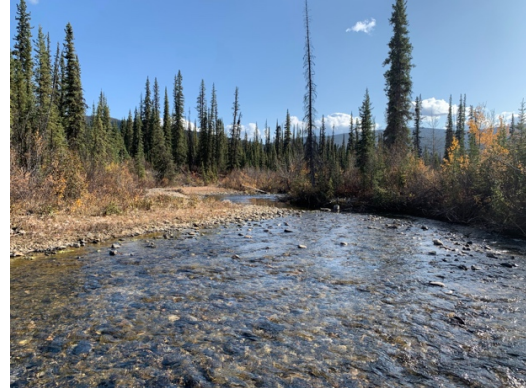
SITE – HAGGART CREEK (HC1)

Site HC1 is situated on the mainstem of Haggart Creek upstream of the Lynx Creek confluence. The mean channel width at this location was 9.8 meters with a wetted width of 7.4 meters at the time of the survey. The gradient of the site was estimated to be about 1 percent. The aquatic habitat at this site continued to provide ample fish cover primarily in the form of deep pools and undercut banks. When combined with other cover types that included small woody debris and overhanging vegetation, it was estimated that total cover occupied about 15 percent of the entire channel. The average residual pool depth of 0.6 m was greater than the other Haggart Creek sites. Pools were also more frequently encountered and generally larger in area. Based on the pebble counts, coarse gravel dominated the substrates

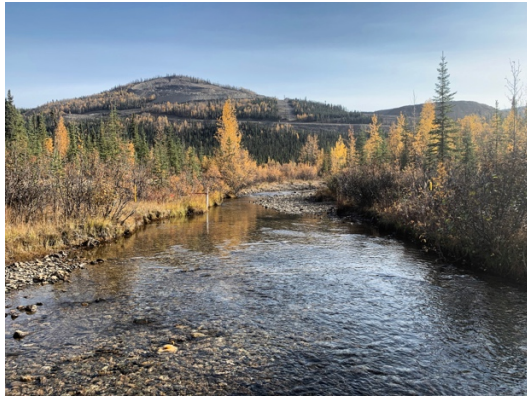
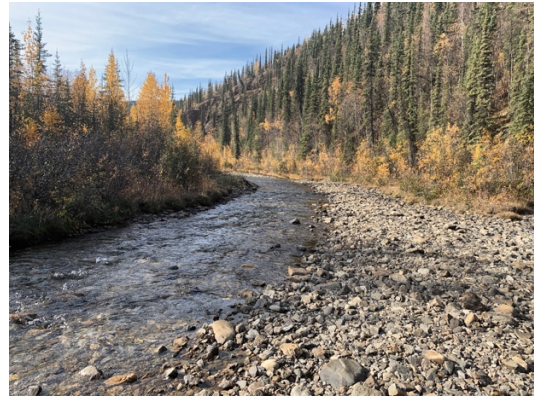
SITE – HAGGART CREEK (HC2)

Monitoring site HC2 is situated between sites HC1 and HC3 at the Dublin Gulch confluence, the principle drainage associated with the Eagle Gold Project. The landscape at this location has been previously disturbed from historic placer mining. Access roads and construction activities associated with the current mine development were in close proximity. The mean channel width at this location was similar to site HC1 and of slightly higher gradient. Total fish cover was low and estimated to be only 5 percent of the available aquatic habitat. Fish cover was mainly in the form of deep pools and undercut banks however other cover types included boulders, overhanging vegetation and clumps of small woody debris. The pools that were present were the result of water scour and erosion with the average residual depth of about 0.4 meters. Course gravels dominated the substrate and the embeddedness of individual rocks averaged 63 percent. The interstitial material was largely composed of gravel (0.2 to 1.6 cm). Periphyton coverage was noticeable with rocks having a definite slippery feel with a yellow brown to light green coloration on the surface. The channel pattern was sinuous with several disturbance indicators including elevated bars, eroding banks, multiple and abandoned channels, and areas of extensive bed scour that appeared to be all linked to historical placer mining.

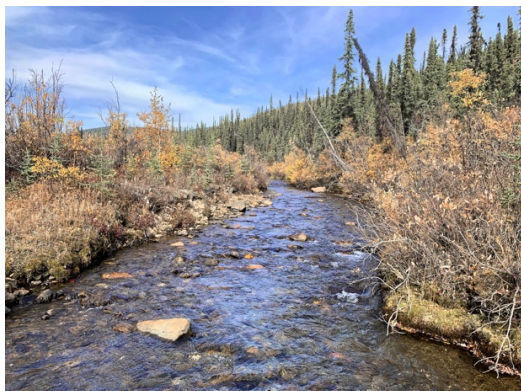
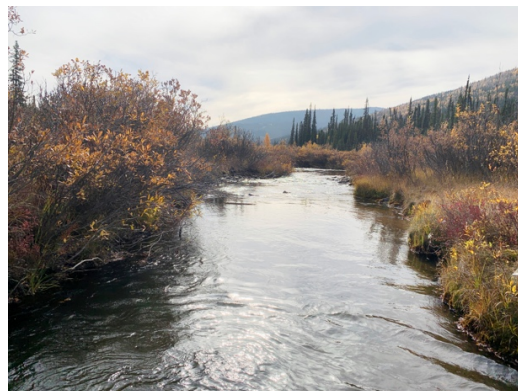
SITE – HAGGART CREEK (HC3)

Monitoring site HC3 is situated less than a kilometer upstream of site HC2 and upstream of all project influence. Higher stream velocities associated with the more confined channel (5.7 meters) resulted in the predominance of riffles, rapids and straight runs at this site. Boulders and undercut banks were the dominant forms of fish cover. The only other cover type present was overhanging vegetation along the channel margins. Total cover was estimated to be only 10 percent of the available habitat in the channel. Course gravel dominated the substrate. The embeddedness of individual rocks averaged 63 percent and the interstitial material was predominantly gravel (0.2 to 1.6 cm). Similar to site HC2 further downstream, periphyton coverage was again noticeable with rocks having a definite slippery feel with a yellow brown to light green coloration on the surface. The channel was sinuous in pattern and occasionally confined by the valley wall. No disturbance indicators were observed in the channel.

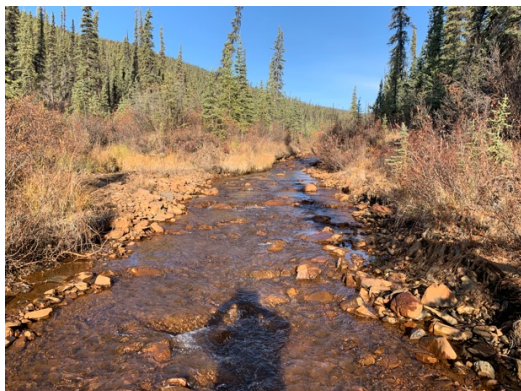
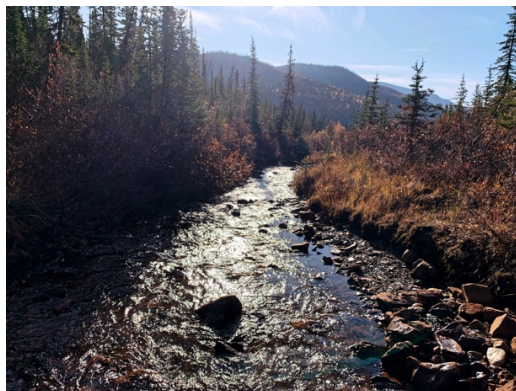
SITE – IRONRUST CREEK (IR2)

The stream morphology at monitoring site IR2 in Ironrust Creek, a water course upstream of project activities, was dominated by riffles, rapids and the occasional shallow scour pool. The channel width of approximately 3.5 meters was the narrowest of the sites surveyed. Fish cover was low and represented only 5 percent

of the aquatic habitat that was present. Boulders and overhanging vegetation were the primary fish cover types. Scour pools, when present, had low residual depths (<0.2 meters). While coarse gravel dominated the substrate, there were good quantities of small cobble throughout the width of the channel. The slope of the site was estimated to be 2.9 percent and the higher gradient was reflected by the substantial cobble armoring that characterized the stream bed. The embeddedness of individual rocks averaged 50 percent and the interstitial material was composed of gravel (0.2 to 1.6 cm). Periphyton thickness on substrates was noticeable with a definite slippery feel and a yellow brown to light green coloration on the surface. The sinuous channel was frequently confined in the valley and the disturbance indicators were limited to a few small areas where the stream bank was sloughing.

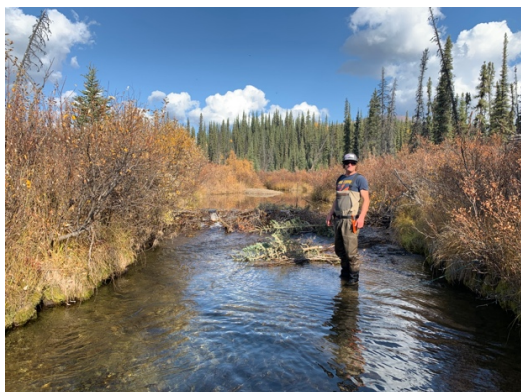
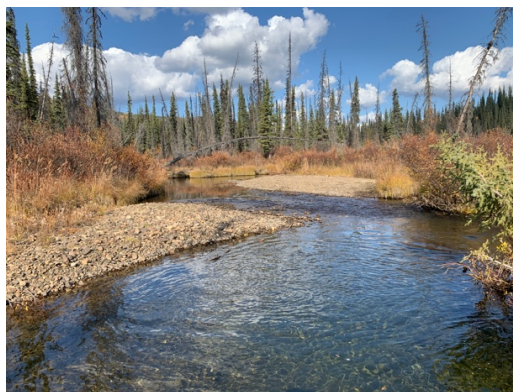
SITE – LYNX CREEK (L1)

The stream channel at site L1 of Lynx Creek, a proximal water course that joins Haggart Creek south of the Project, is within a drainage basin that has no current or planned Project facilities or activities, and has previously been characterized as a classic riffle-pool-glide sequence. Recently constructed beaver dams near L1, however, have reduced stream velocities and created more standing water throughout the reach. Total fish cover, nevertheless, remained relatively high and thought to represent about 20 percent of the aquatic habitat that was present. Deep pools and undercut banks were the dominant fish cover types with small woody debris and overhanging vegetation also contributing where present. The average residual pool depth of 0.7 meters provided excellent cover and refuge for fish. Course gravel dominated the bed material making for some of the best substrates observed in the project area. The interstitial material was mostly composed of fines (<0.1 cm) and the embeddedness of the rocks was 44 percent, which had increased from the previous year. It is believed there is more sediment deposition at this site which can be attributed to an increase in area of standing water associated with the beaver dams. Periphyton on the rock surfaces was thin with only a slightly slippery feel apparent. The channel pattern was characterized with irregular meanders, well-defined streambanks which were unconfined by the valley walls. The site is situated near the center of the Lynx Creek valley and beaver dams were the only disturbance that were observed.
