## TECHNICAL MEMO

Re: **EROSION CONTROL INSTALLATIONS AT SPECIFIC SITES, EAGLE GOLD PROJECT**

Bonnie Burns and Krystal Isbister of Laberge Environmental Services assessed five main areas of erosion concern at the Eagle Gold Project site from June 5<sup>th</sup> to 7<sup>th</sup>, 2019. These areas were examined and prescriptions for treatment devised. Donor sites for willow staking and bioengineering were also identified at this time. (See Technical Memo submitted on June 20<sup>th</sup>, 2019 for details.)

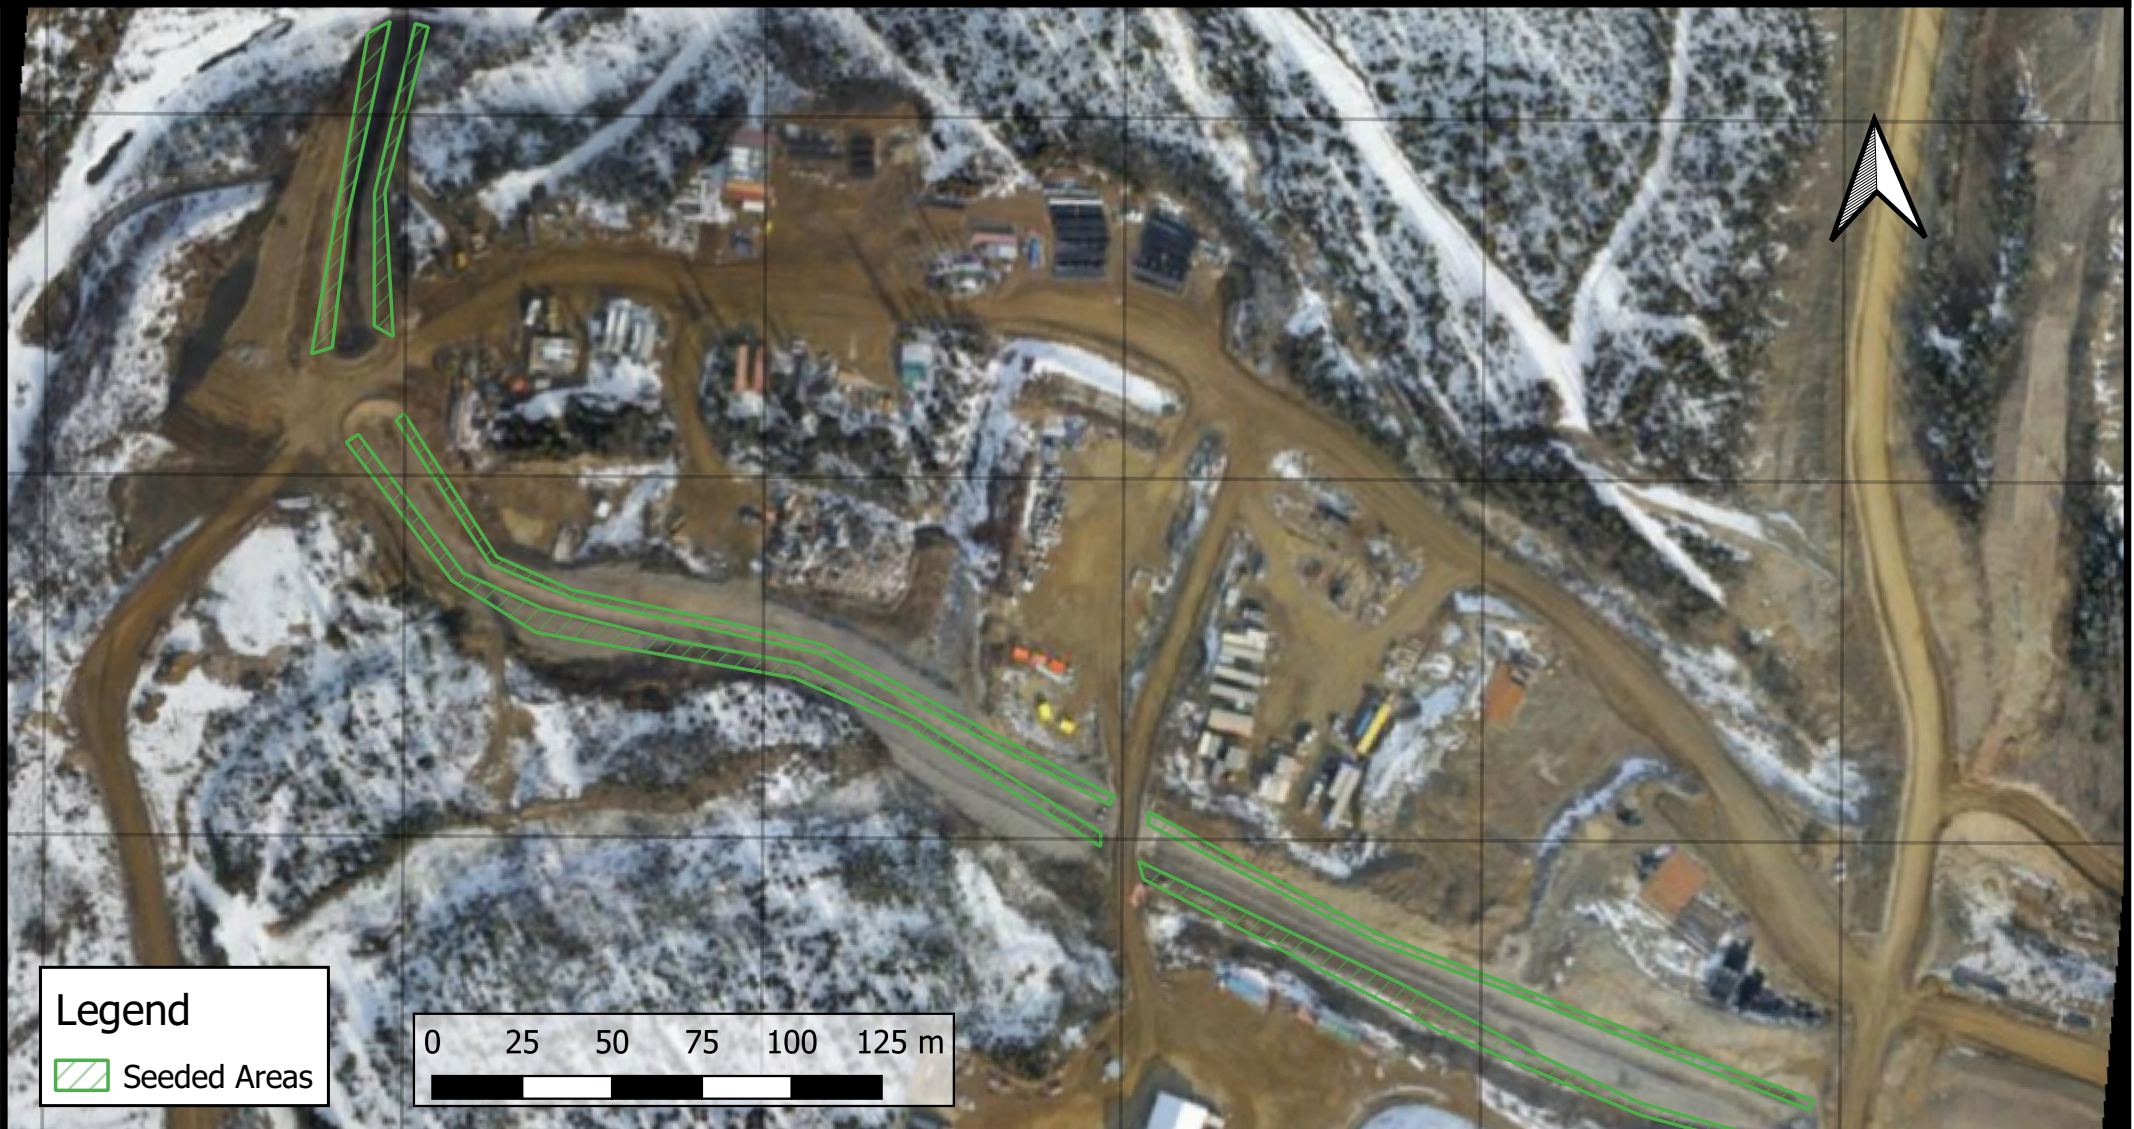
**Figure 2: Site 2 - Ditch C Revegetation Areas October 2019**

Notes:  
 Seed mix: Slender wheatgrass, fowl bluegrass,  
 ticklegrass and tufted hairgrass  
 Application rate: 18.5 kg/ha

Ditch C was seeded by Katie Babin and Jessica Wilkinson of Victoria Gold on October 2<sup>nd</sup> at a rate of 18.5 kg/ha (Figure 2).

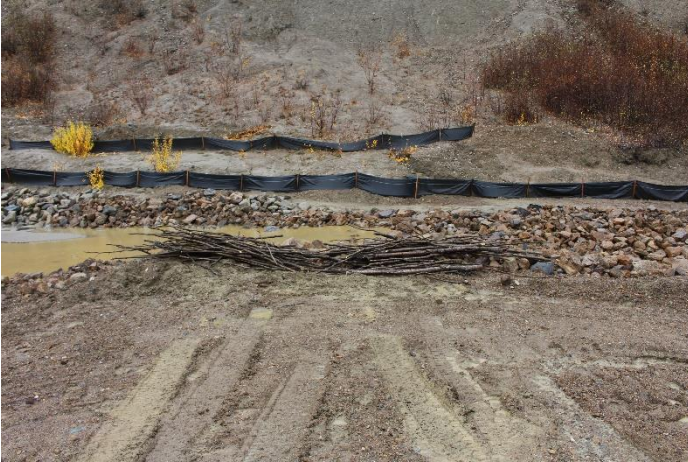
Photo #1: willows staged near Site #1.

On September 20<sup>th</sup> and 21<sup>st</sup>, Katie Babin, Helaina Moses and Bryan Moses of Victoria Gold, and Bonnie Burns, Krystal Isbister and Patrick Soprovich of Laberge Environmental Services commenced the erosion control program. Willows were harvested from the donor site at W29 and staged at Site 1, Lower Dublin South Pond and Weir (LDSP).

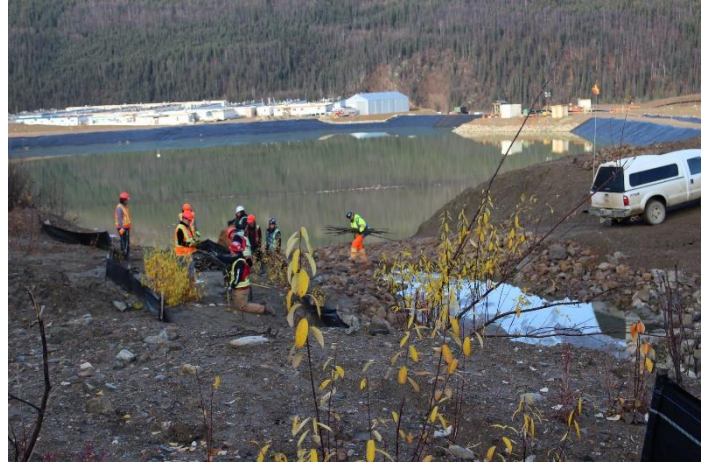
Photo #2: willow staking, Site #1.

All crew members worked on willow staking, mostly along the stream between the silt fences which have captured significant soil and provide an excellent growth medium. Once the willows are established the silt fences can gradually be removed. In addition, two pole drains were constructed and installed in erosion channels. One wattle fence was established upslope of the other bioengineering works where significant erosion had occurred in the past. Coco-matting geotextile material was laid on the upslope side of the wattle fence to help control any undercutting.

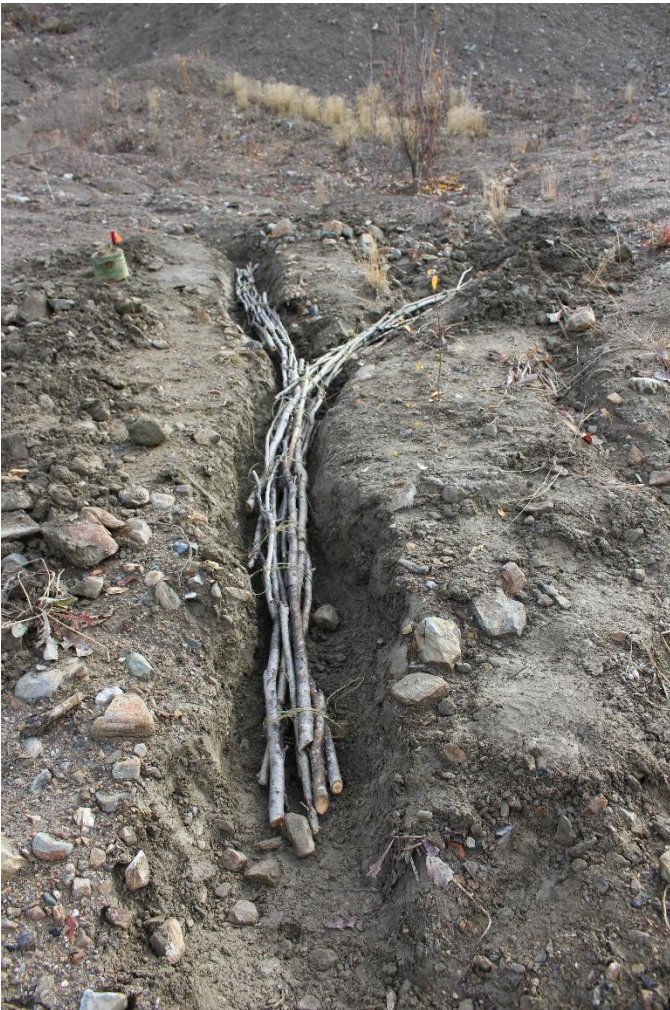
Photo #3: Y pole drain prior to burial.

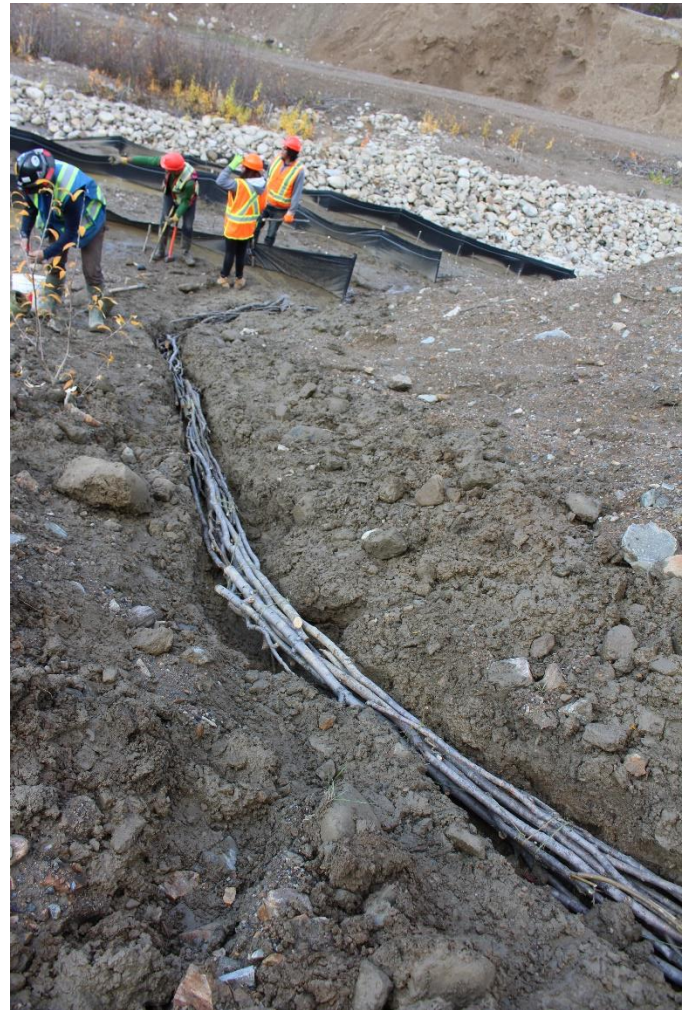
Photo #4: long pole drain prior to burial.

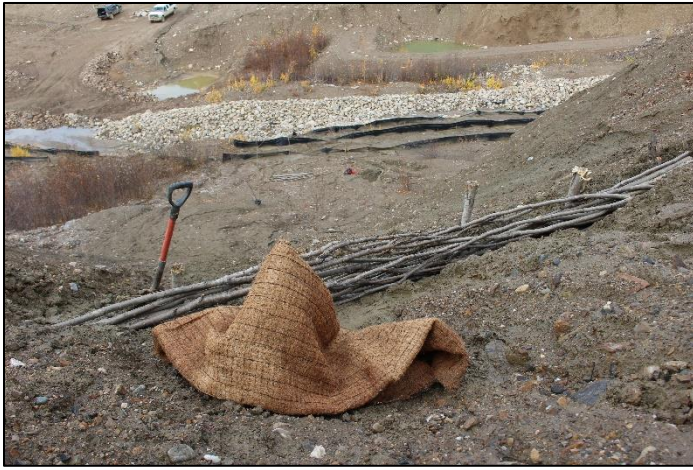
Photo #5: wattle fence prior to coco mat installation

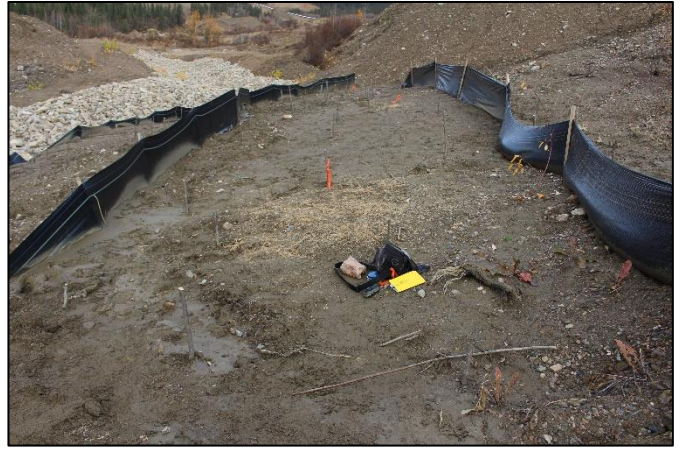
Photo #6: Seed plots and staked willows, Site #1.

Several plots of locally collected seed were set up at Site #1 on September 23<sup>rd</sup>. A crew with Yukon Seed and Restoration Inc (YSR) collected wheatgrass (*Elymus alaskanus*, 28 g), fescue (*Festuca saximontana*, 2 g) and bluejoint (*Calamagrostis canadensis*, <0.5 g) from the Elsa and Keno areas. YSR is a local company jointly owned by Na-Cho Nyäk Dun Development Corporation (NNDDC; 51%), Core Geosciences Services Inc. (Coregeo; 34%), and Maureen Huggard (15%).

On September 22<sup>nd</sup> Bonnie Burns (Laberge) and Helaina Moses (Victoria Gold) made some seed collections near W29. Plots were set up on September 23<sup>rd</sup>. The seed was not cleaned but spread along with the vegetative material which will add carbon and texture etc to the soil. Species collected were bluejoint and yarrow (*Achillea millefolium*).

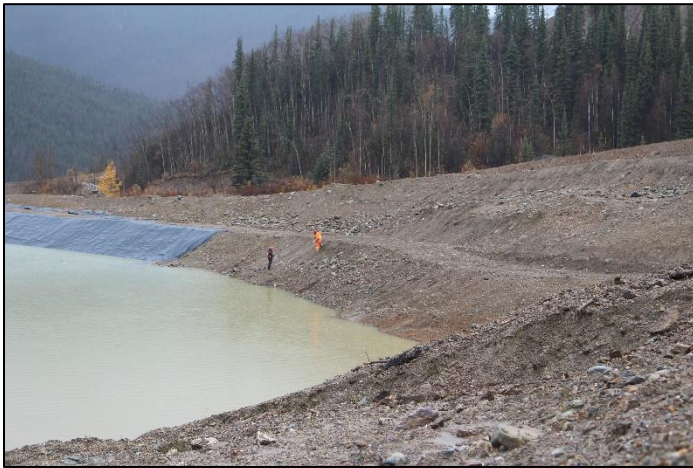
Photo #7: Seeding around the LDSP.

Seeds were weighed and hand spread at the weir area and the surrounding slopes of the LDSP at a rate of 18.5 kg/ha. The small seed mix was spread by one person followed by a second person spreading the wheatgrass. This will ensure a much more even coverage rather than having them mixed together, due to the great variation in size. Willow staking was completed along the east shore of the pond.

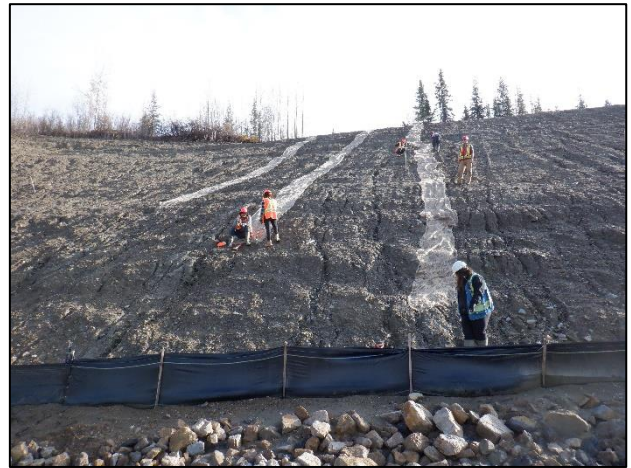
Photo #8: laying down the jute mats on the cutbank

The cutbank above the LDSP was seeded at a rate of 30.5 kg/ha due to the steepness of the slope. In addition, jute mats were overlain down the slope in 3 different areas and represents a trial for this technique.

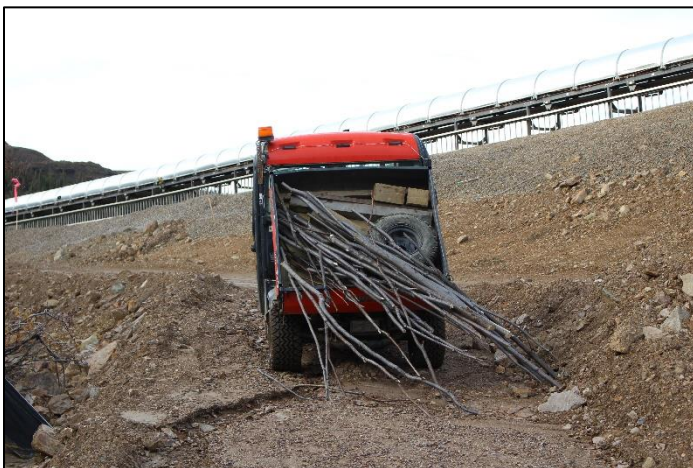
Photo #9: Staging willows at Site #5.

On September 22<sup>nd</sup>, willows were harvested from the donor site near surface water station, W26, Stewart Gulch. The collected willows were staged at the first creek crossing along the conveyor belt area. Staking was to commence that day but the ground was too frozen to allow for successful installation. It was hoped that warmer weather would occur within the next few days, however this was not the case and Site 5 did not receive any treatment in 2019.

- If the stored harvested willows are still viable in the spring, stake along the banks of the creeks along the conveyor belt area. Apply the mixed seed and the wheatgrass seed at the 18.5 kg/ha rate. If the stakes have not survived winter storage, harvest fresh willow early in the spring prior to any bud development and install stakes and any bioengineering structures.

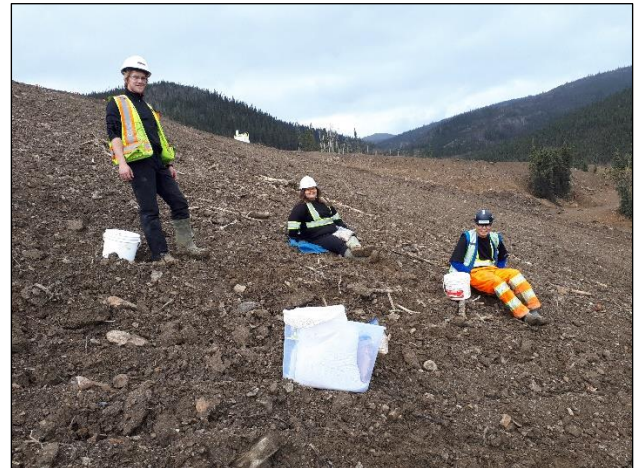
Photo #10: Seeding the heap leach embankment

As this area encompasses a total of 5 ha, it was divided into zones for ease of planning and seeding. Over the course of two days the heap leach embankment was hand seeded at a rate of 30.5 kg/ha (Figure 3). The application rate was increased here due to the steepness of the slope. The increased grass growth will provide more rapid erosion control.
