EAGLE GOLD PROJECT
HERITAGE RESOURCE PROTECTION PLAN

Version 2014-01

MARCH 2014

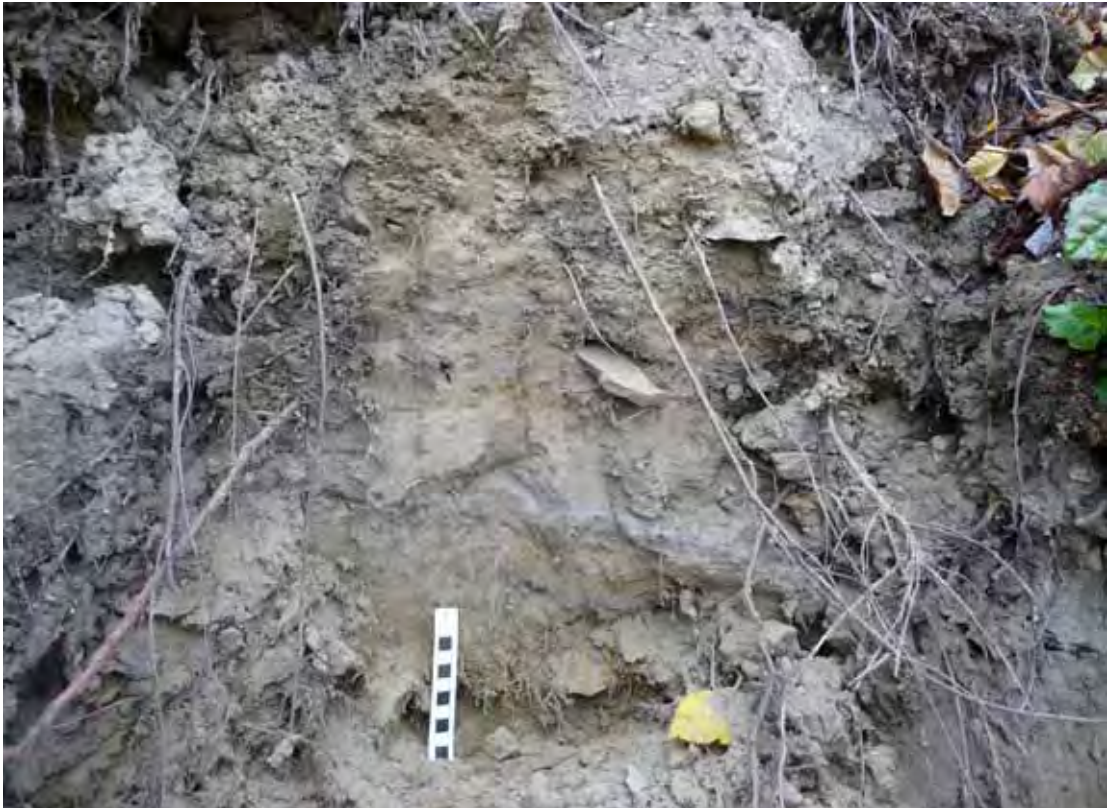
Plate 7 Fine-Grained Deposits, Waypoint DG1

Note: Deposits at top of slope.

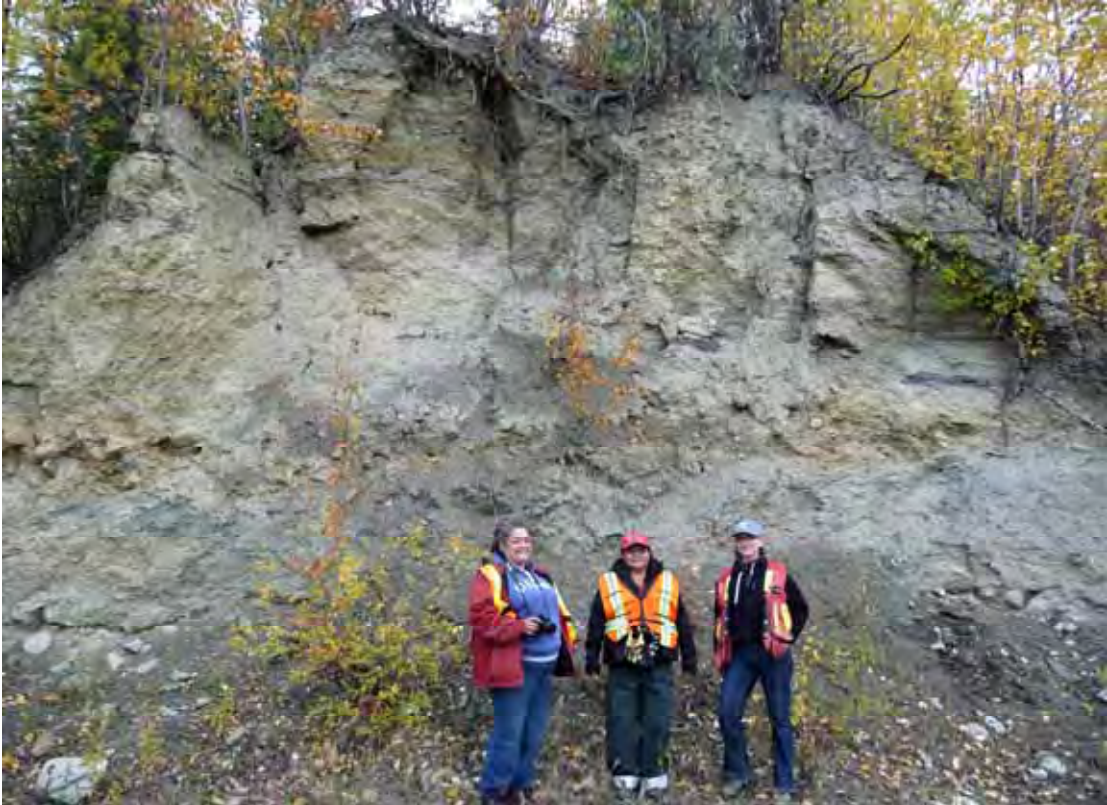
Plate 14 Dublin Gulch North Slope Exposure, Waypoint DG11

Note: View to the north at roadcut.

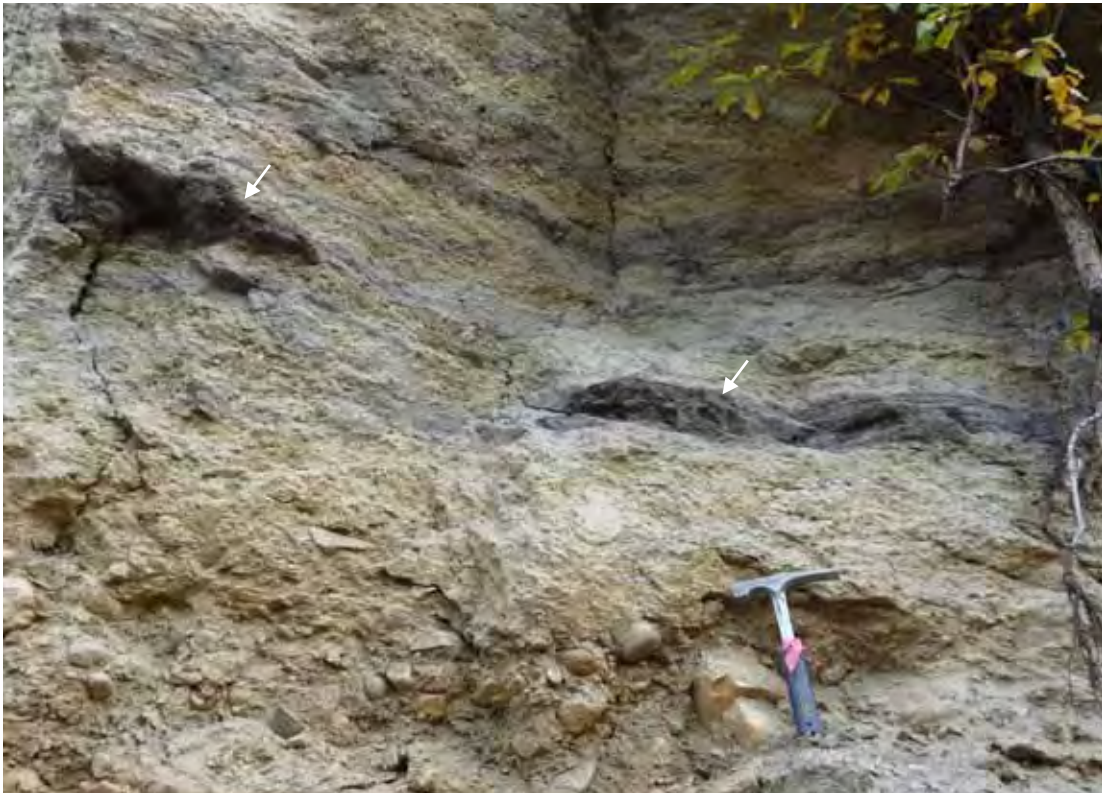
Plate 15 Fine-Grained Upper Sequence, Waypoint DG11

Note: Cobble layer overlain by bedded sand and silt with organic lenses (arrows).

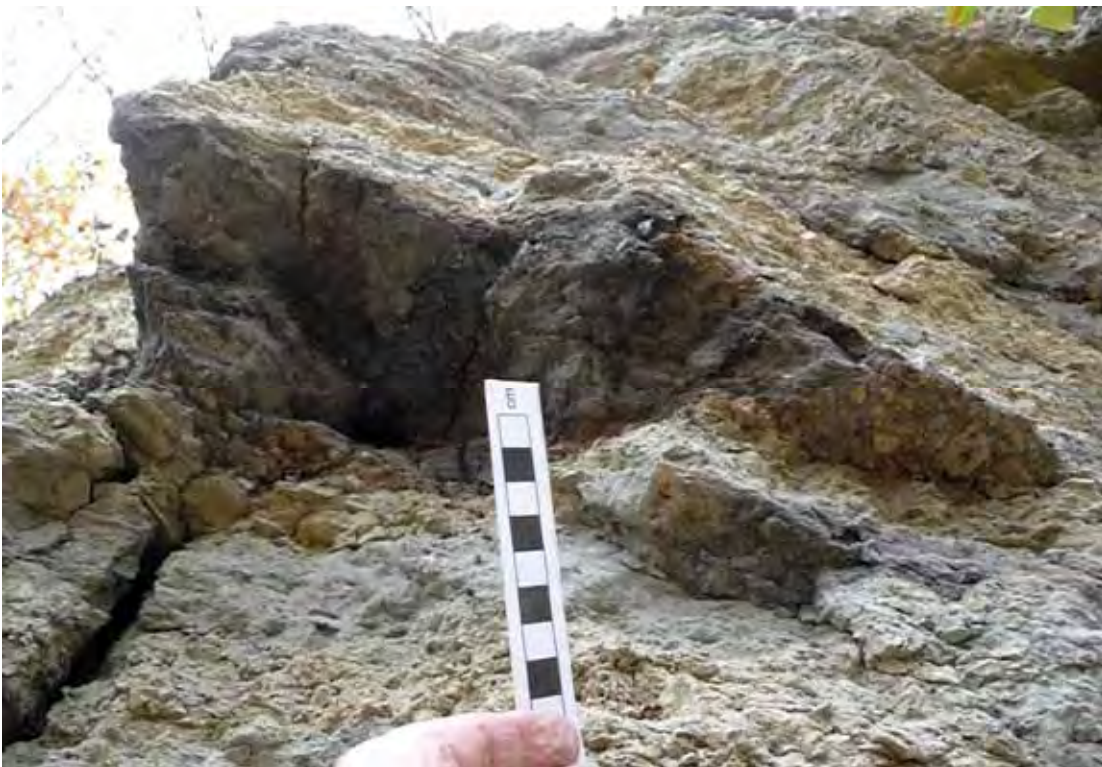
Plate 16 Organic Layer and Sheet of Flat Clasts, Waypoint DG11

Note: Closeup of organic lens (left side of Plate 15) radiocarbon dated at 10,330 +/- 90 years (calibrated, conventional).

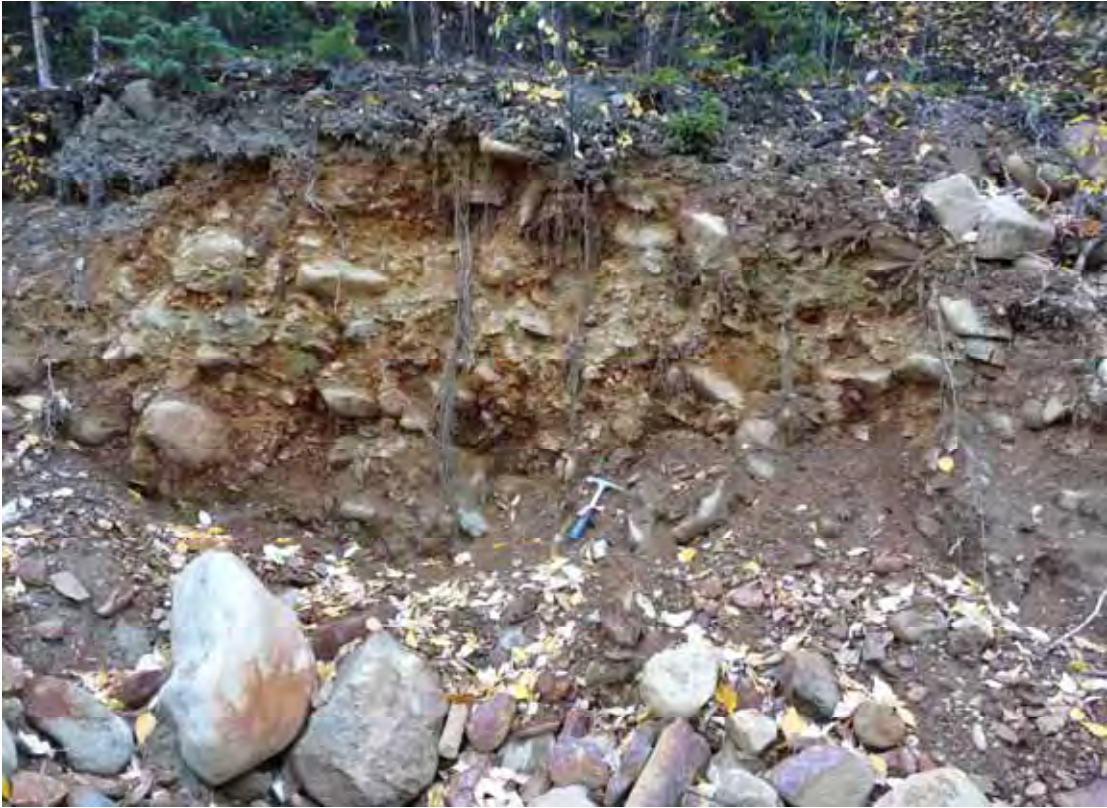
Plate 19 Reid Till, Waypoint DG8

Note: View to the north along access road, north side of Dublin Gulch.

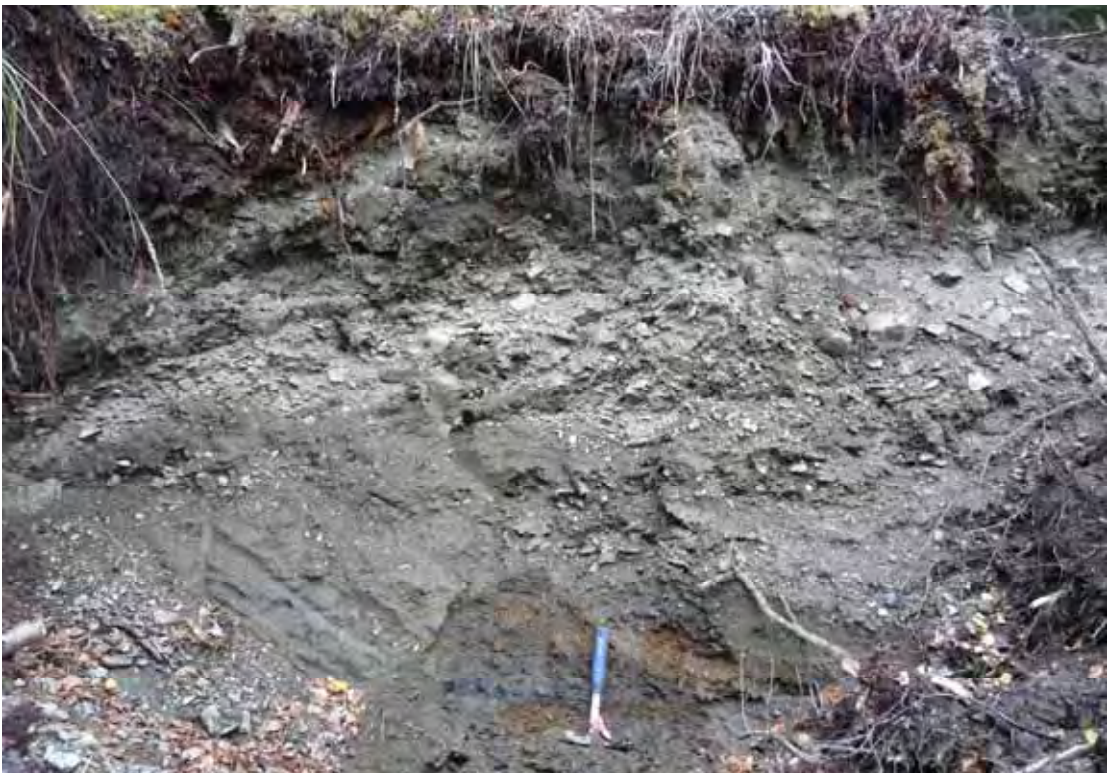
Plate 20 Test Pit Exposure along Ann Gulch, Waypoint DG12

Note: View to the northeast of colluvium overlying bedded sand and silt.

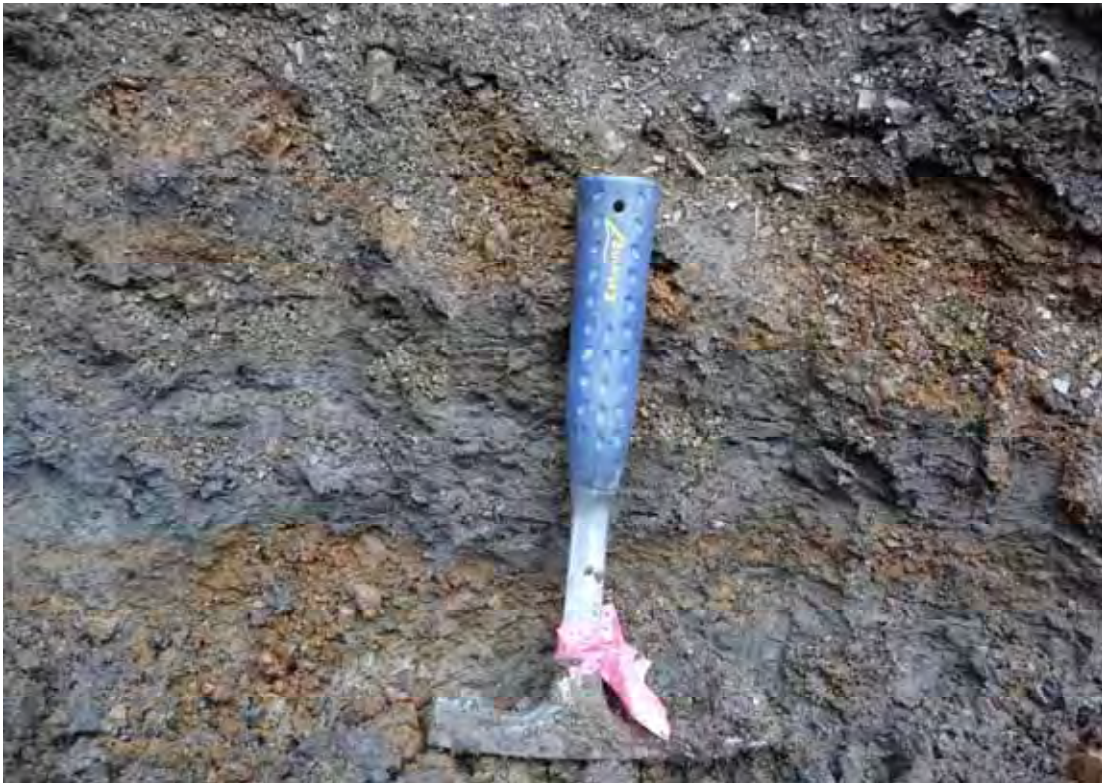
Plate 21 Bedded Sand and Silt, Waypoint DG12

Note: Closeup of lower sediments in Plate 20.

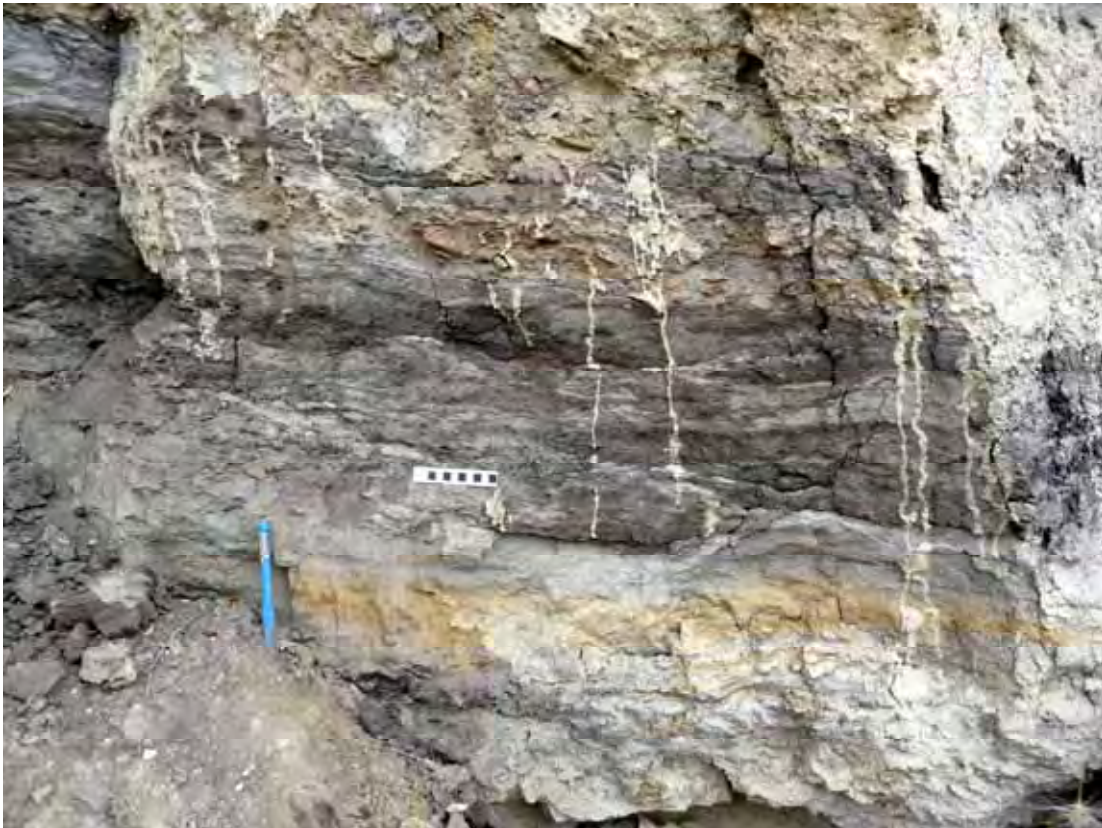
Plate 28 Sand and Silt Deposits, Waypoint DG19

Note: Closeup of Plate 27 interbedded sand and silt deposits with pockets of organic material.

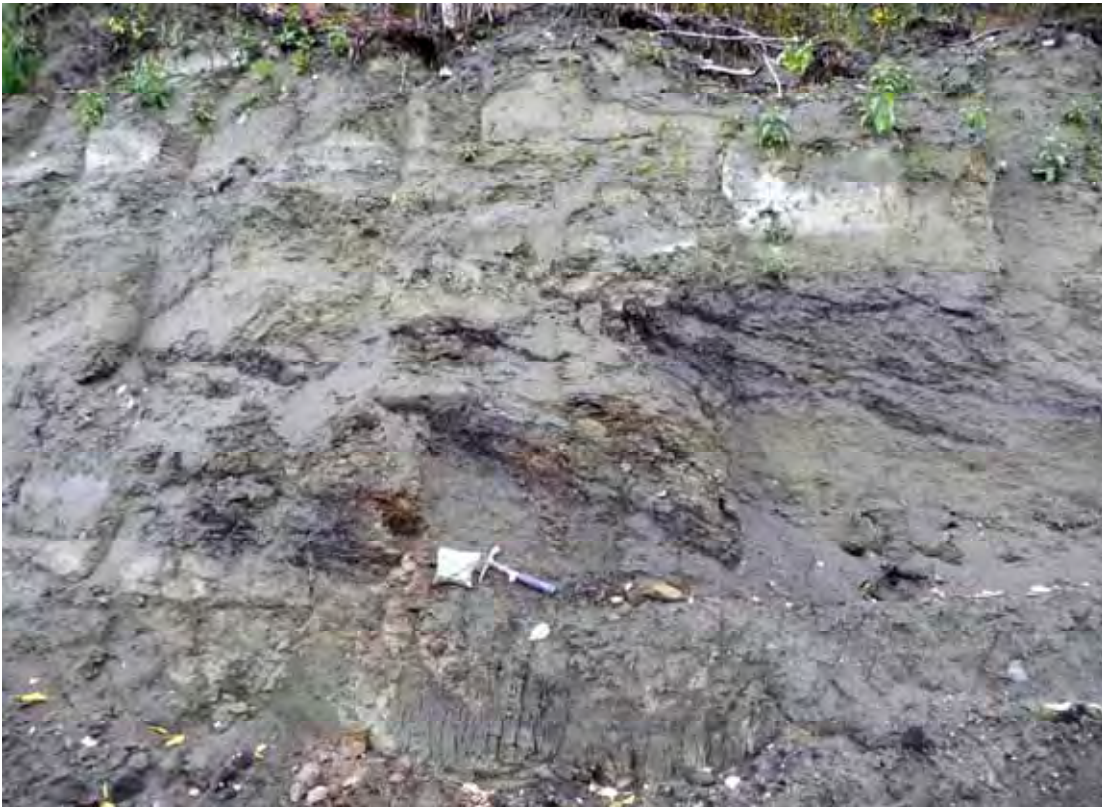
Plate 38 Intact Deposits, Waypoint DG26

Note: View to the west of roadcut (see Plate 36). Hammer and bag mark collecting site for wood.

At the unnamed creek crossing at DG26 (Figure 9), access road improvements could disturb intact surficial strata of early Holocene age. A palaeontological education program for the equipment operators and adherence to the Fossil Discovery Protocol (Appendix D) is recommended during the construction stage in the event that vertebrate material is encountered.

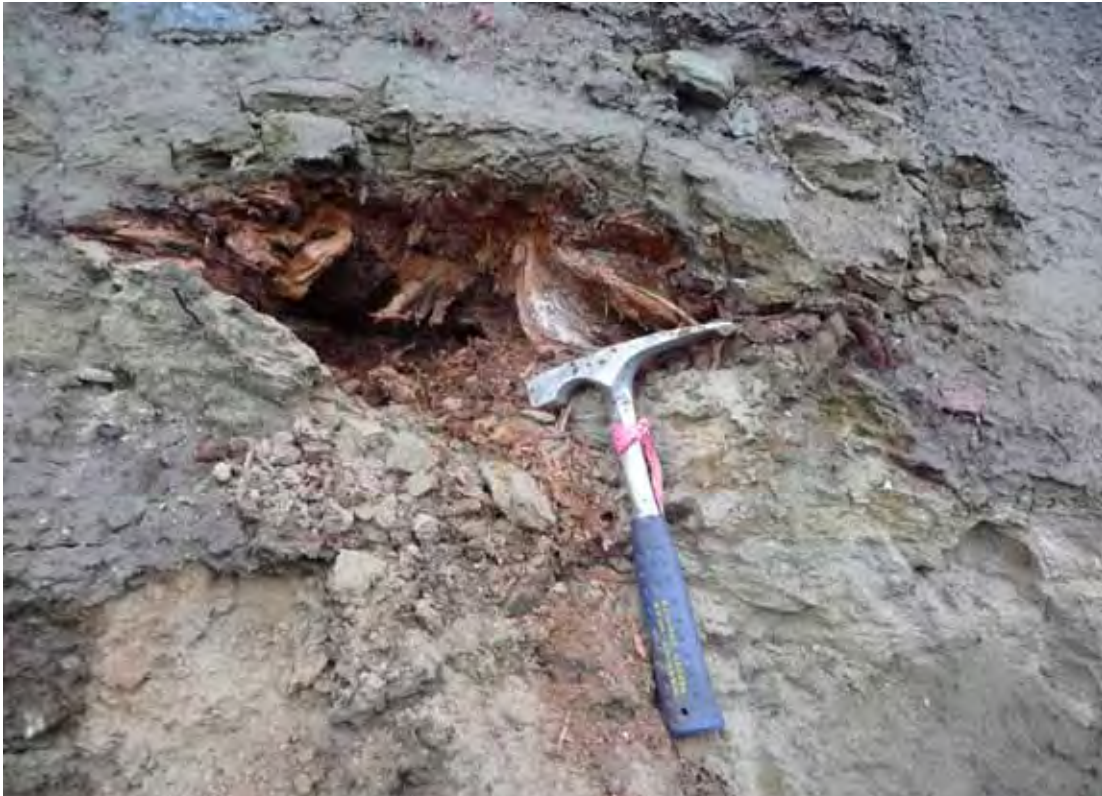
Plate 39 Preserved Wood, Waypoint DG21

Note: Wood sample radiocarbon dated at 2,730 +/- 50 years (calibrated, conventional).

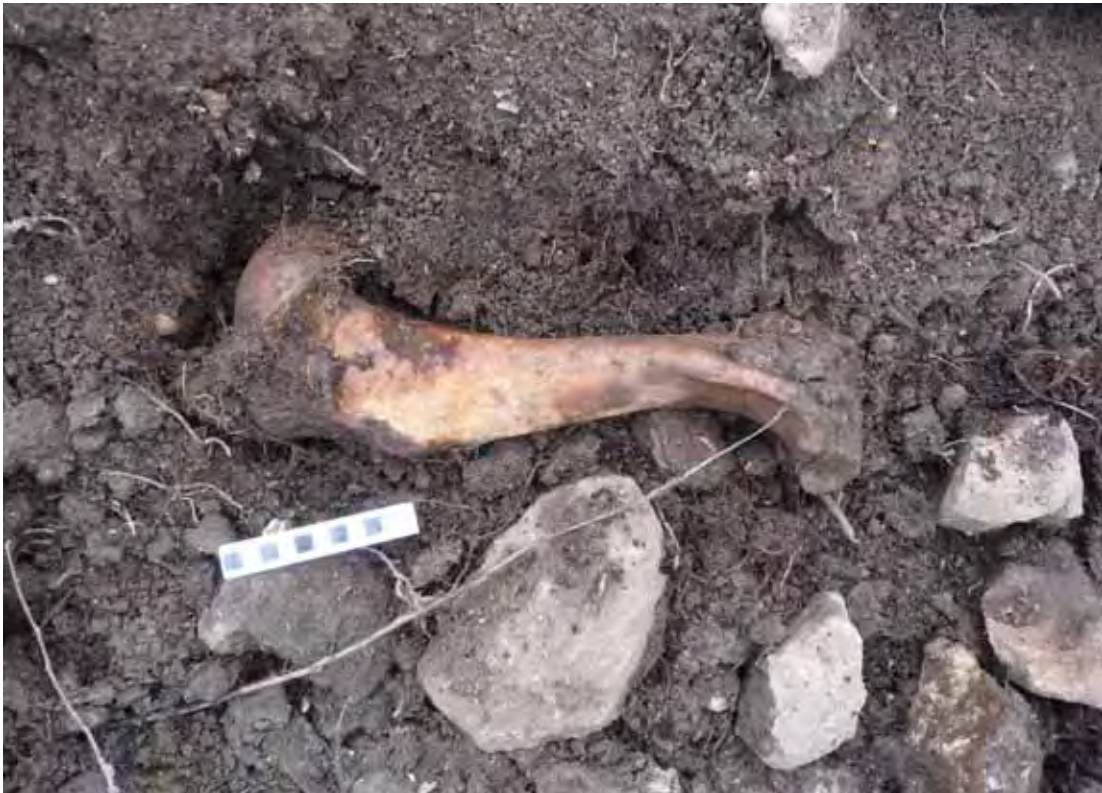
Plate 41 Moose Humerus, Waypoint DG15

Note: Found in disturbed surface layer (see Plate 42).
