**Eagle Gold Project**

Appendix 5: Environmental Baseline Report: Fish and Fish Habitat

## Environmental Baseline Report: Fish and Fish Habitat

### *FINAL REPORT*

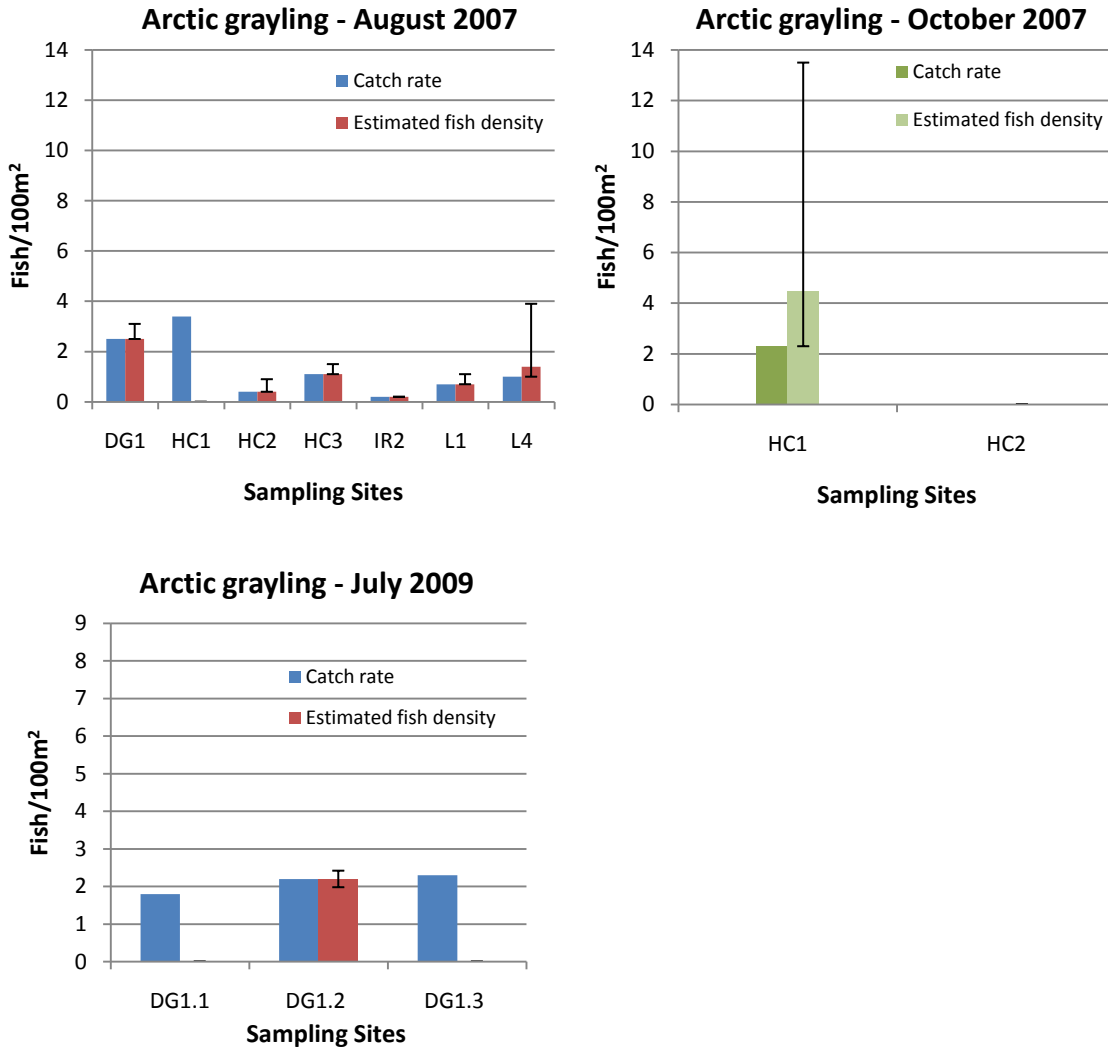
Figure 3-1: Catch rates and estimated densities ( $\pm$  95% confidence intervals) per unit area for Arctic grayling sampled at sites in four creeks during August 2007, October 2007, and July 2009

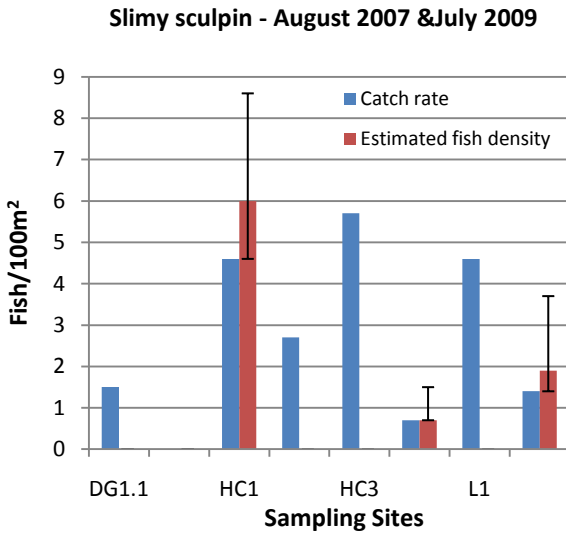
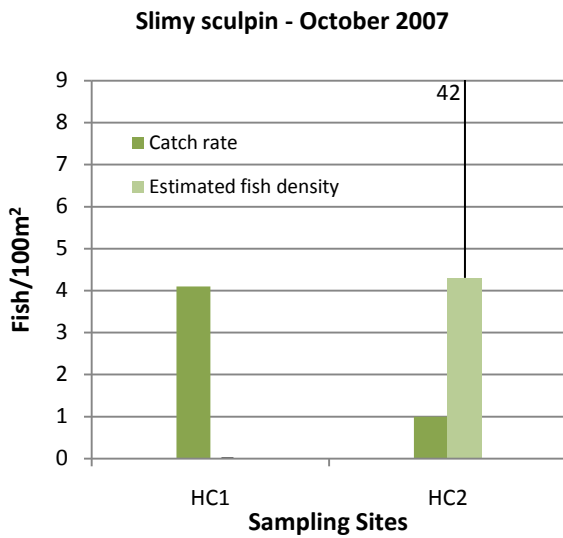
**Figure 3-2: Observed catch rates and estimated densities ( $\pm$  95% confidence intervals) per unit area for slimy sculpin sampled at sites in 4 creeks during August 2007, October 2007, and July 2009.**

Mean catch rate for slimy sculpin for all sites was 2.9 fish/100 m<sup>2</sup>, and the mean population density estimate was 2.9 fish/100 m<sup>2</sup>. Haggart Creek (HC3) had the highest observed catch rate (5.7 fish/100 m<sup>2</sup>) and highest population density estimates of slimy sculpin (6.0 fish/100 m<sup>2</sup>). Ironrust Creek (IR2) had the lowest observed catch rate (0.7 fish/100 m<sup>2</sup>), and lowest population density estimate (0.7 fish/100 m<sup>2</sup>) of slimy sculpin. Slimy sculpin were not captured in Dublin Gulch (DG1) during the August 2007 survey, but four fish were captured at a nearby site in Dublin Gulch (DG1.1) during the July 2009 survey.

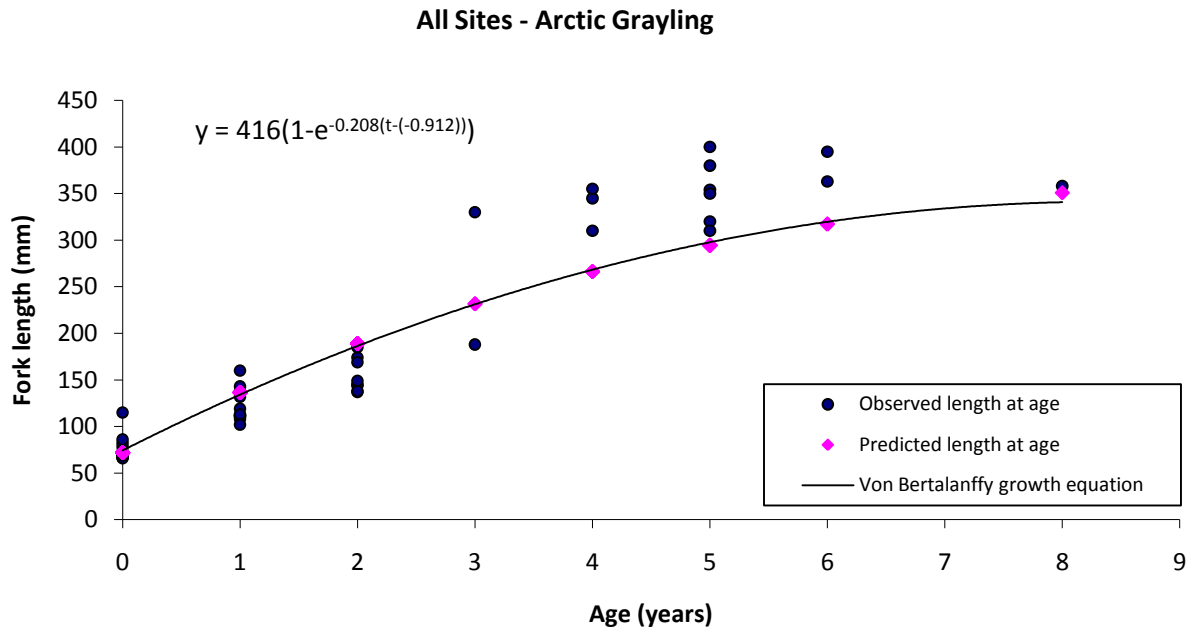
Figure 3-3: Population growth pattern for Arctic grayling

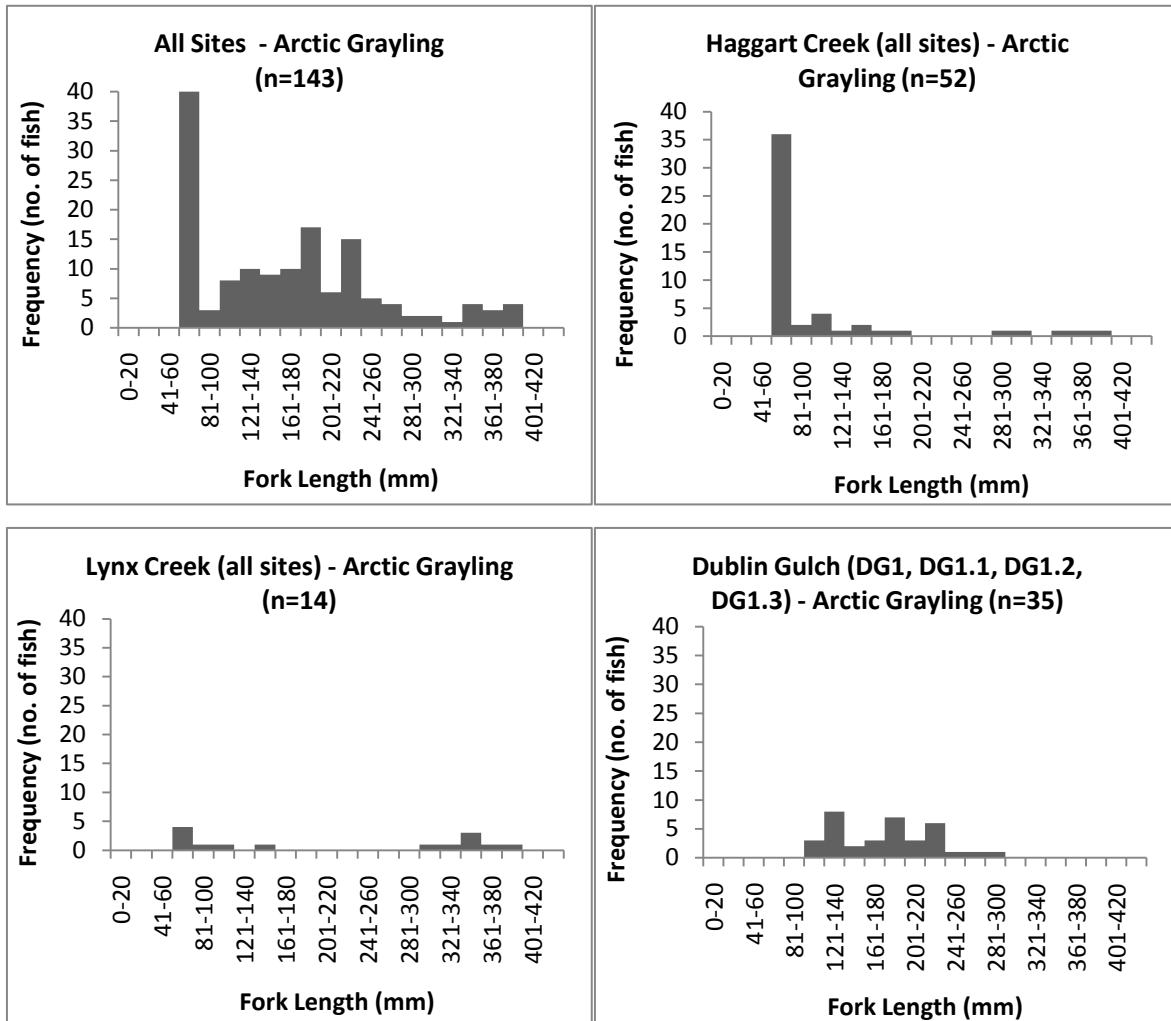
**Figure 3-4: Length frequency histograms for Arctic grayling**

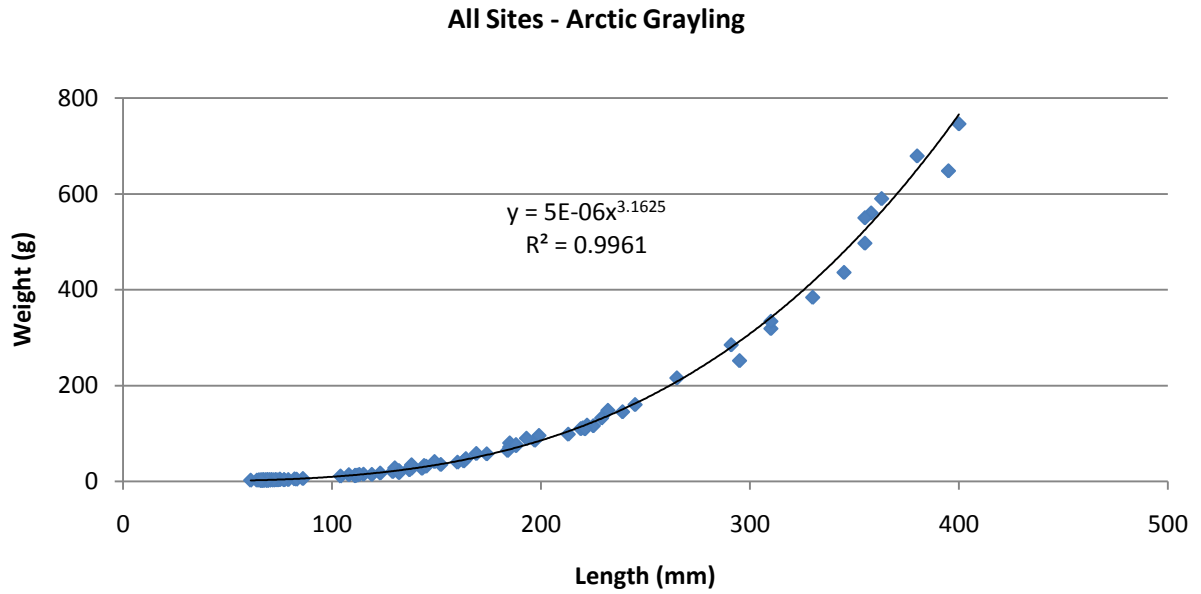
Figure 3-5: Weight versus length relationship for Arctic grayling

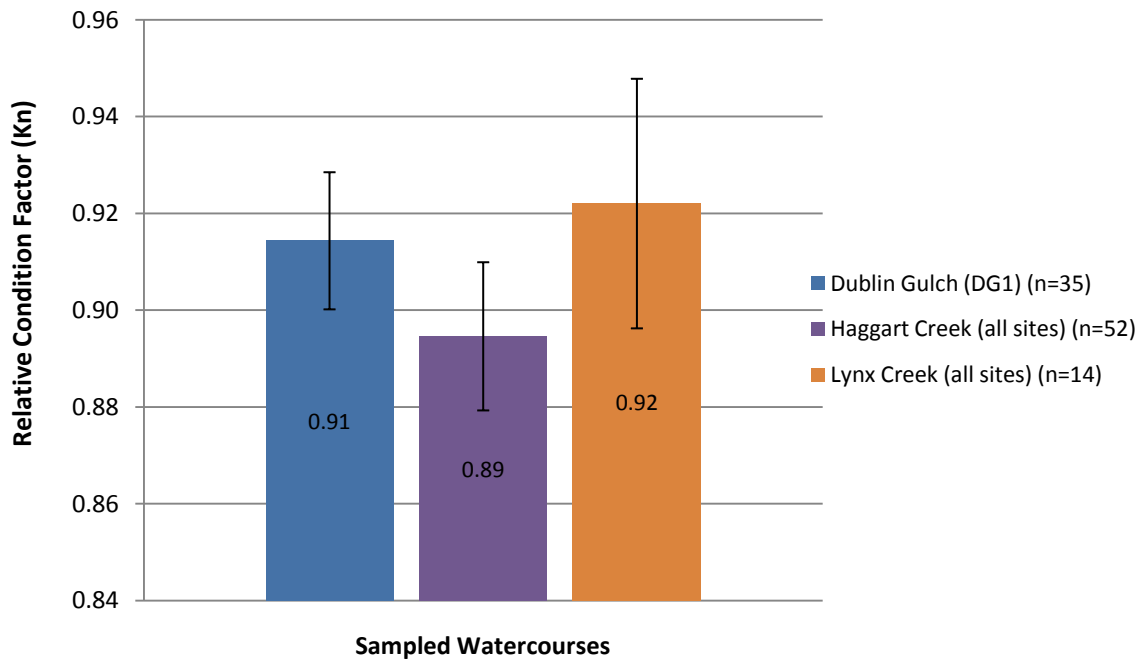
Figure 3-6: Mean relative condition factor ( $K_n$ ) ( $\pm$  SE) of Arctic grayling for individual watercourses

Arctic grayling relative condition factor values were similar (ANOVA;  $P<0.05$ , Appendix D) between Dublin Gulch, Haggart Creek, and Lynx Creek with average values ranging from  $K_n = 0.90$  at Haggart Creek to  $K_n = 0.93$  for Lynx Creek (Figure 3-6). Data for Ironrust Creek (IR2) are not

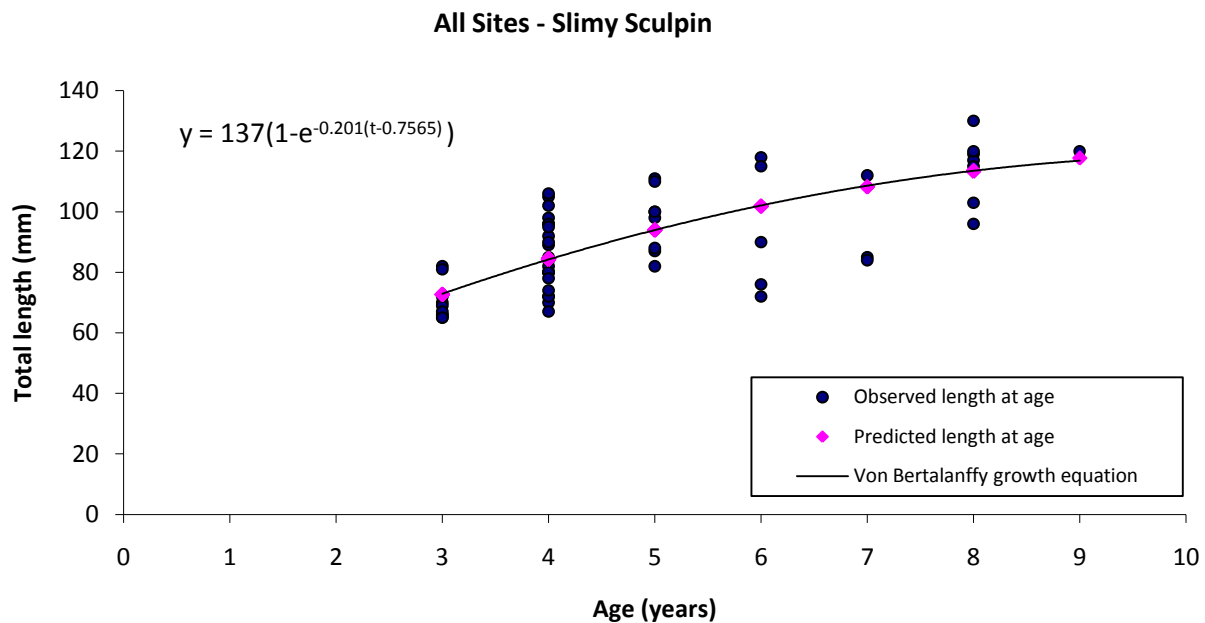
Figure 3-7: Population growth pattern for all slimy sculpin

Otoliths were collected from 58 slimy sculpin from Haggart Creek, Lynx Creek, and Ironrust Creek. One sample from Ironrust Creek (IR2) was not included in the data, as the otolith could not be confidently aged. Slimy sculpin ages at all sites ranged from 3 to 9 years (Table 3-3; Appendix F); Lynx Creek (all sites) had the largest number of age classes (7), while Ironrust Creek (IR2) exhibited the fewest (3 age classes) (Table 3-3; Appendix F). It is unknown why there were fewer age classes of slimy sculpin at Ironrust Creek, as habitat conditions were similar to other watercourses. Mean fork length increased from 70 mm for three year old fish to 120 mm at age 9 (Table 3-3), with a predicted asymptotic length of 137 mm (Figure 3-7).

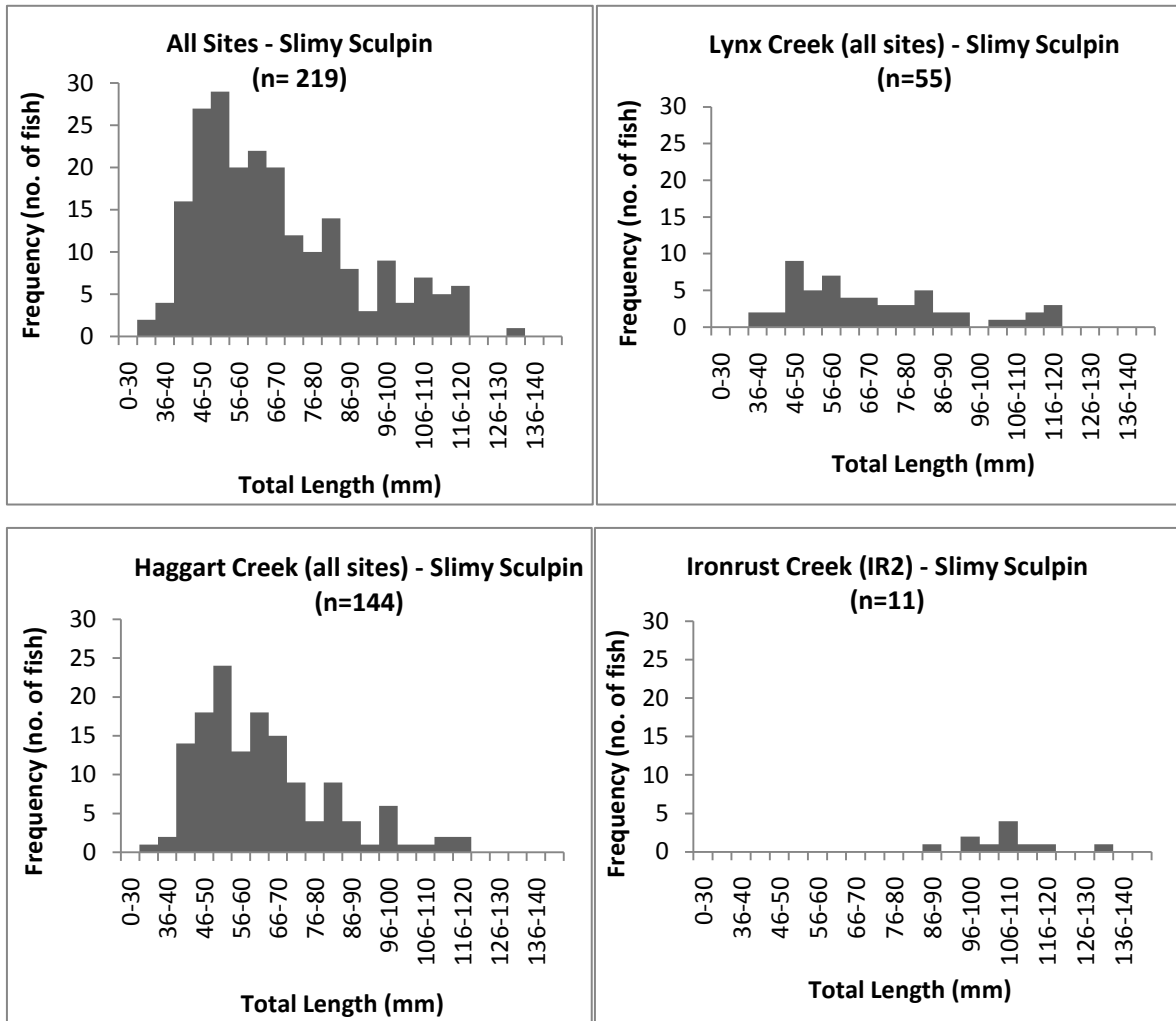
Figure 3-8: Length frequency histograms for slimy sculpin. The histogram for all sites combined includes five fish captured in Eagle Pup Placer Ponds and four fish in Dublin Gulch

The overall length frequency distribution for slimy sculpin is heavily weighted by the distribution of slimy sculpin in Haggart Creek, where all size ranges are represented with majority of the population consisting of small fish ( $\leq 70$ mm). Lynx Creek and Haggart Creek distributions are similar; however, Haggart Creek had a higher concentration of smaller sized fish (41 to 70 mm). Smaller sized slimy sculpin ( $< 86$  mm) were absent from the length frequency distribution for Ironrust Creek (IR2). The predominance of smaller size fish in Haggart Creek may be due to poor habitat conditions at the site (e.g., shallow pool depth, limited food availability).

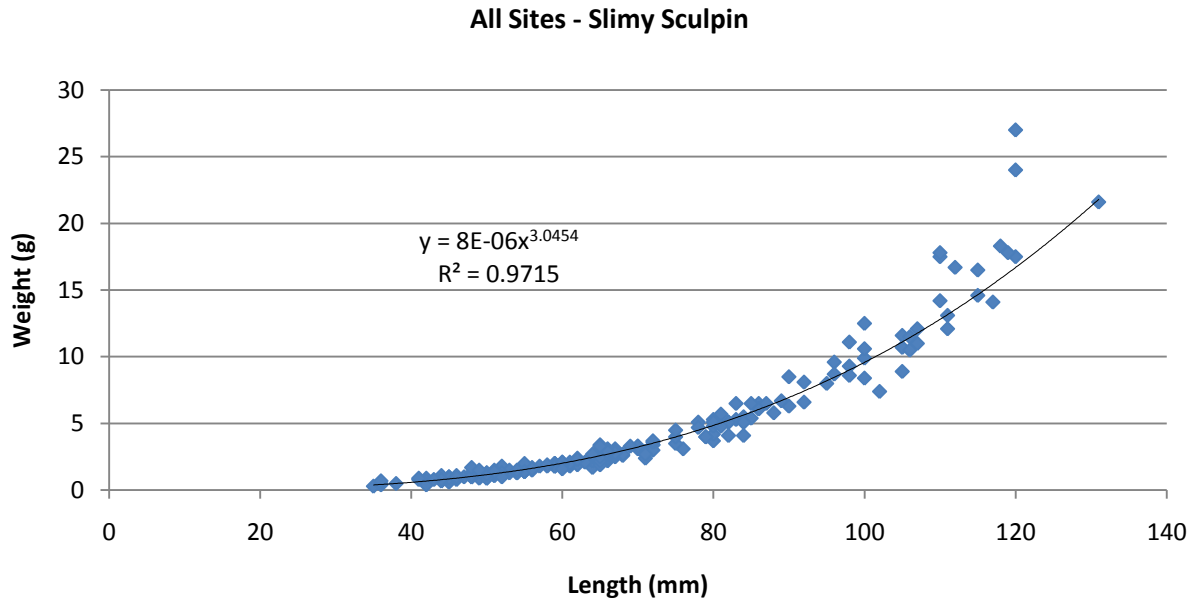
Figure 3-9: Weight versus length relationship for slimy sculpin

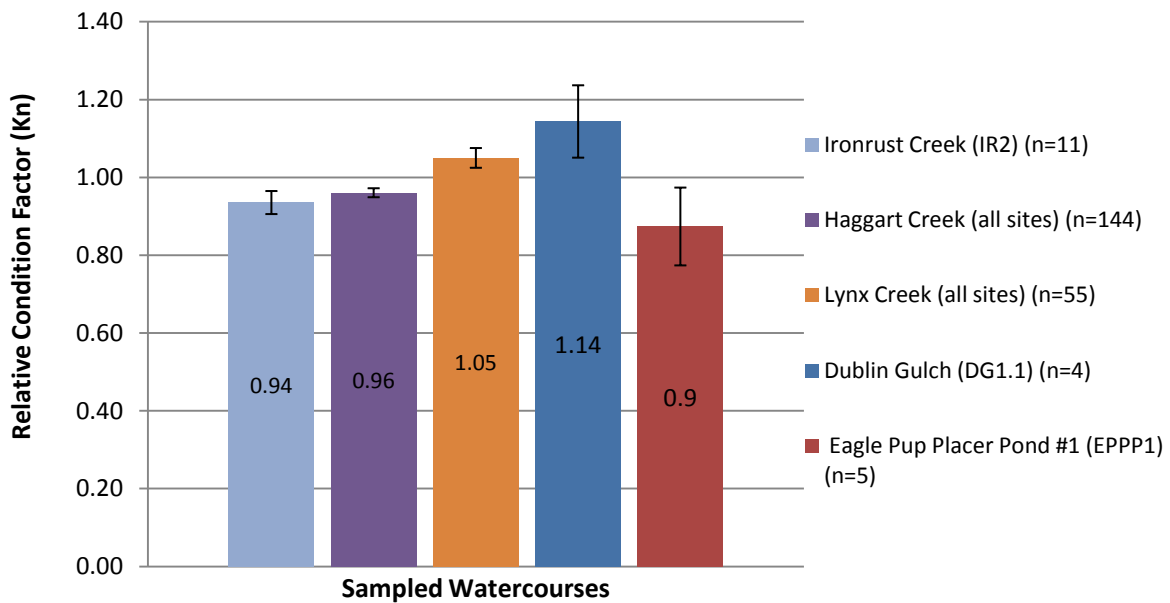
Figure 3-10: Mean ( $\pm$  SE) relative condition factor ( $K_n$ ) of slimy sculpin for individual watercourses.

Relative condition factor ( $K_n$ ) values varied between sites, ranging from 0.9 (Eagle Pup Placer Pond #1) to 1.14 (Dublin Gulch) (Anderson and Neumann 1996). The only statistically significant difference in mean condition of slimy sculpin was between Lynx Creek ( $K_n = 1.05$ ) and Haggart Creek ( $K_n = 0.96$ ) (ANOVA and Tukey tests;  $P < 0.05$ ). The lack of statistically significant differences between the remaining watercourses could be due to lower sample sizes (i.e., at least 55 replicates for Haggart and Lynx creeks versus no more than 11 replicates for the other streams) which lowers the precision of their mean condition estimates. Higher condition of fish at Lynx Creek compared to Haggart creek may be due to better sculpin habitat conditions (e.g., deeper pool habitat) (Figure 3-10).

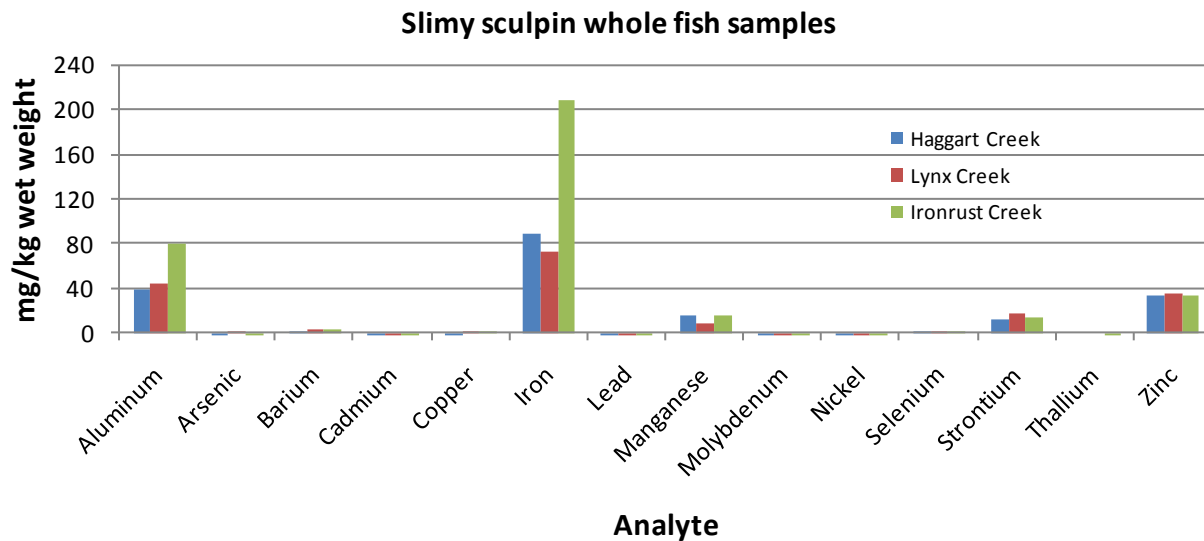
Figure 3-13: Select total metal concentrations in slimy sculpin (whole fish)

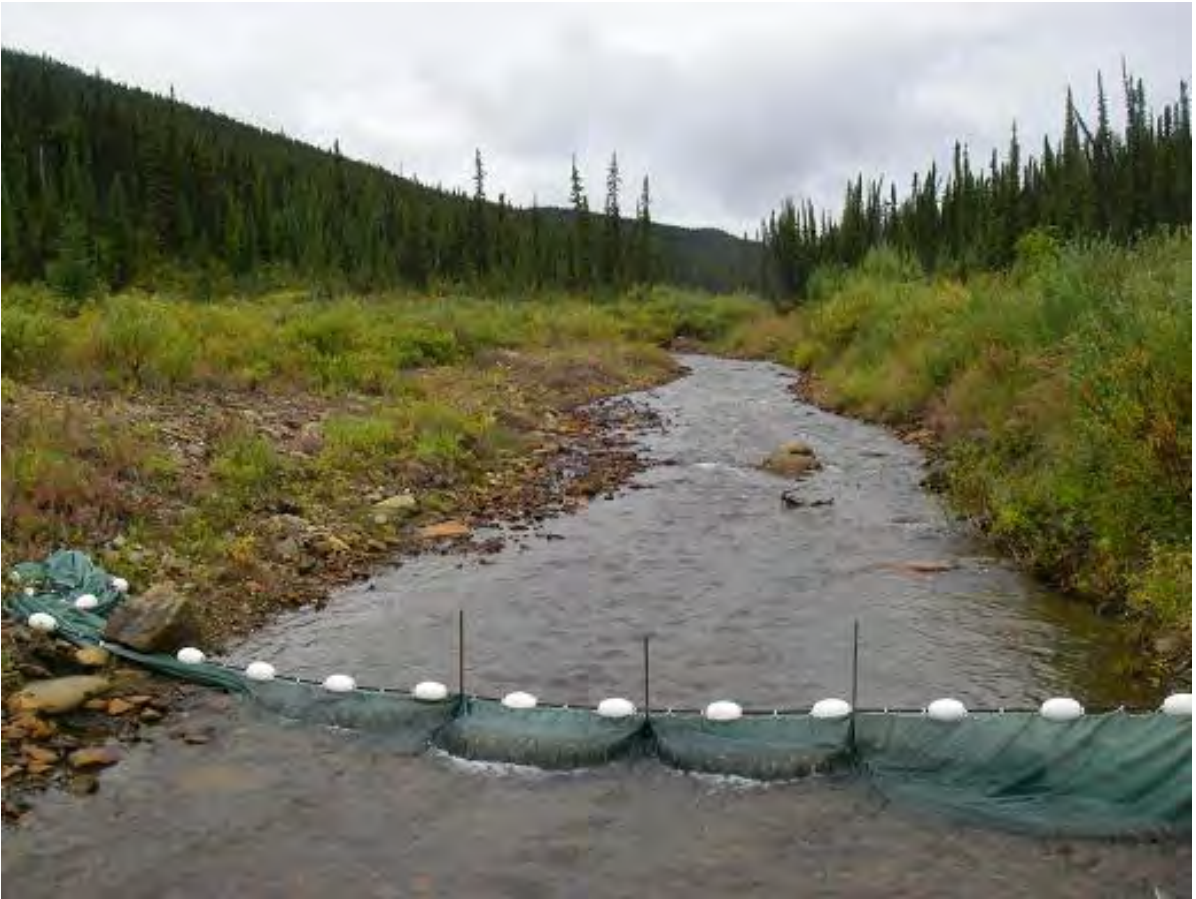
**Photo 3-1: Photo of Ironrust Creek (IR2) indicating a lack of residual pool depth, photo taken facing upstream on August 21, 2007**

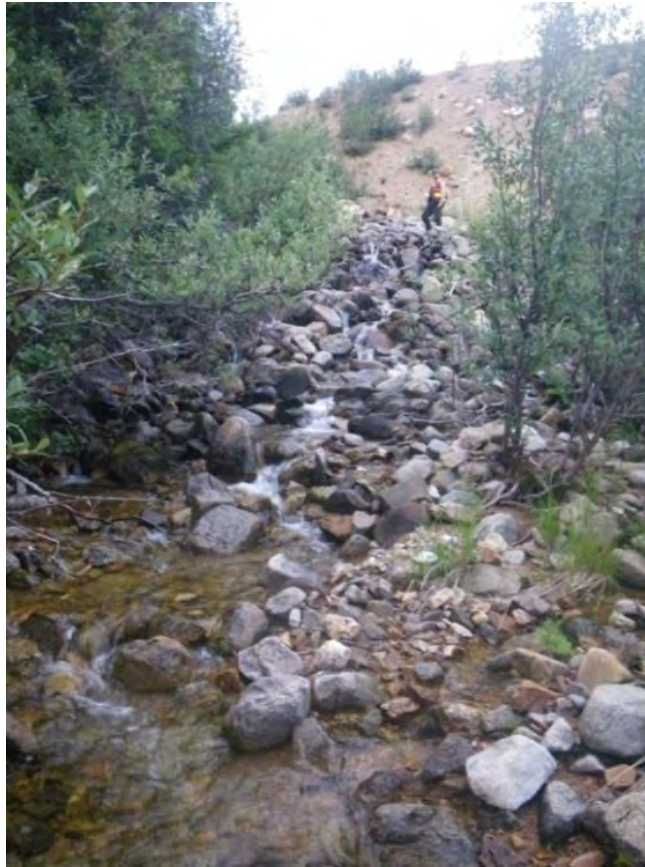
**Photo 3-2: 20 m high cascade barrier on Dublin Gulch, photo taken facing upstream on July 22, 2009**

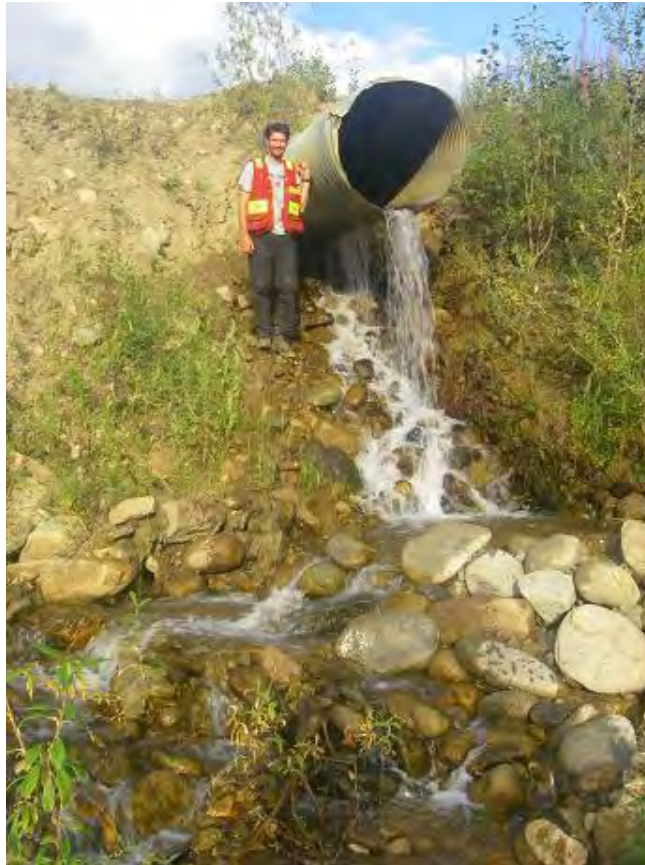
**Photo 3-3: Culvert barrier on lower Eagle Pup, photo taken facing upstream on August 15, 2008**

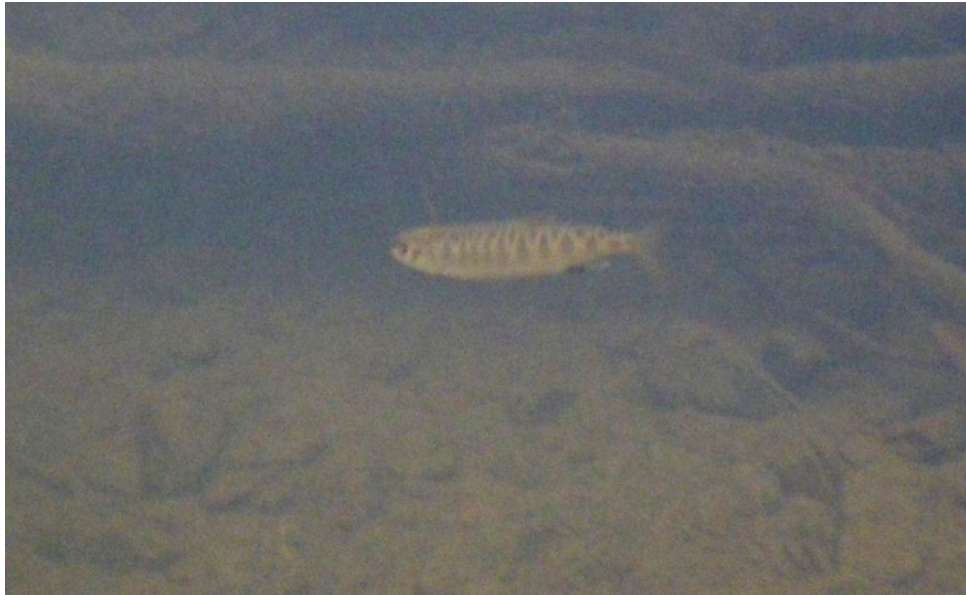
**Photo 3-5: Chinook salmon parr observed during snorkel survey of the South McQuesten River on July 23, 2009**

Those studies also reported the presence of Chinook salmon in the South McQuesten River, which was confirmed by the sighting of juvenile Chinook (est. age 1+) during a snorkel survey of the South McQuesten River at the access road crossing on July 23, 2009 (Photo 3-5). During the snorkel survey, no adult spawning Chinook or Chinook redds were observed which may be attributed to the timing of the survey, or low to nil returns.

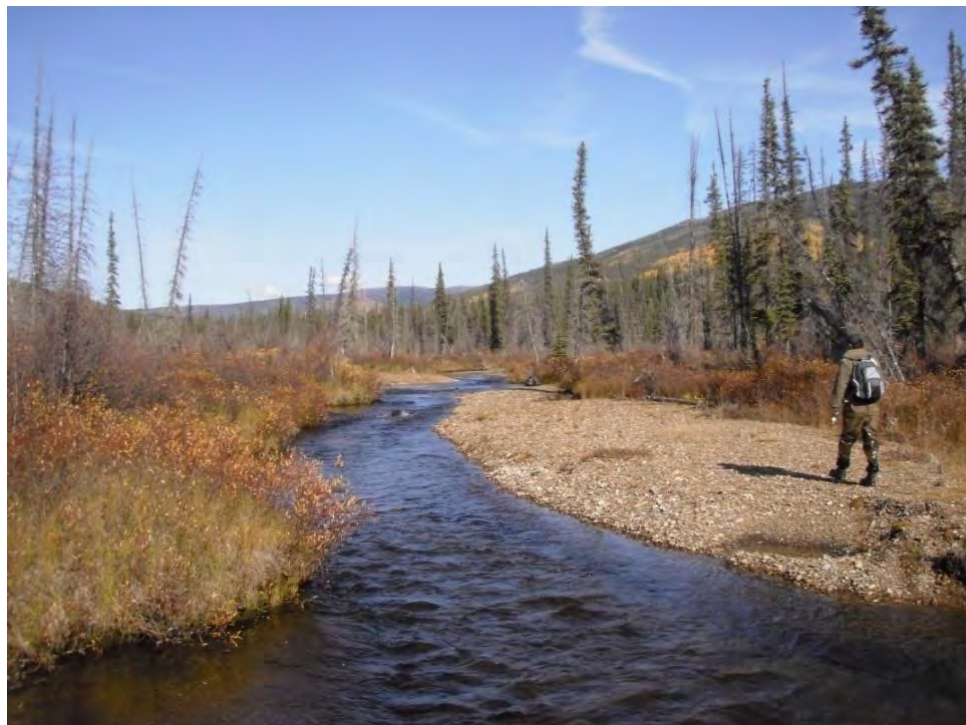
**Photo 3-6: Excellent quality rearing habitat on Lynx Creek (L1), photo taken facing upstream on September 15, 2009**

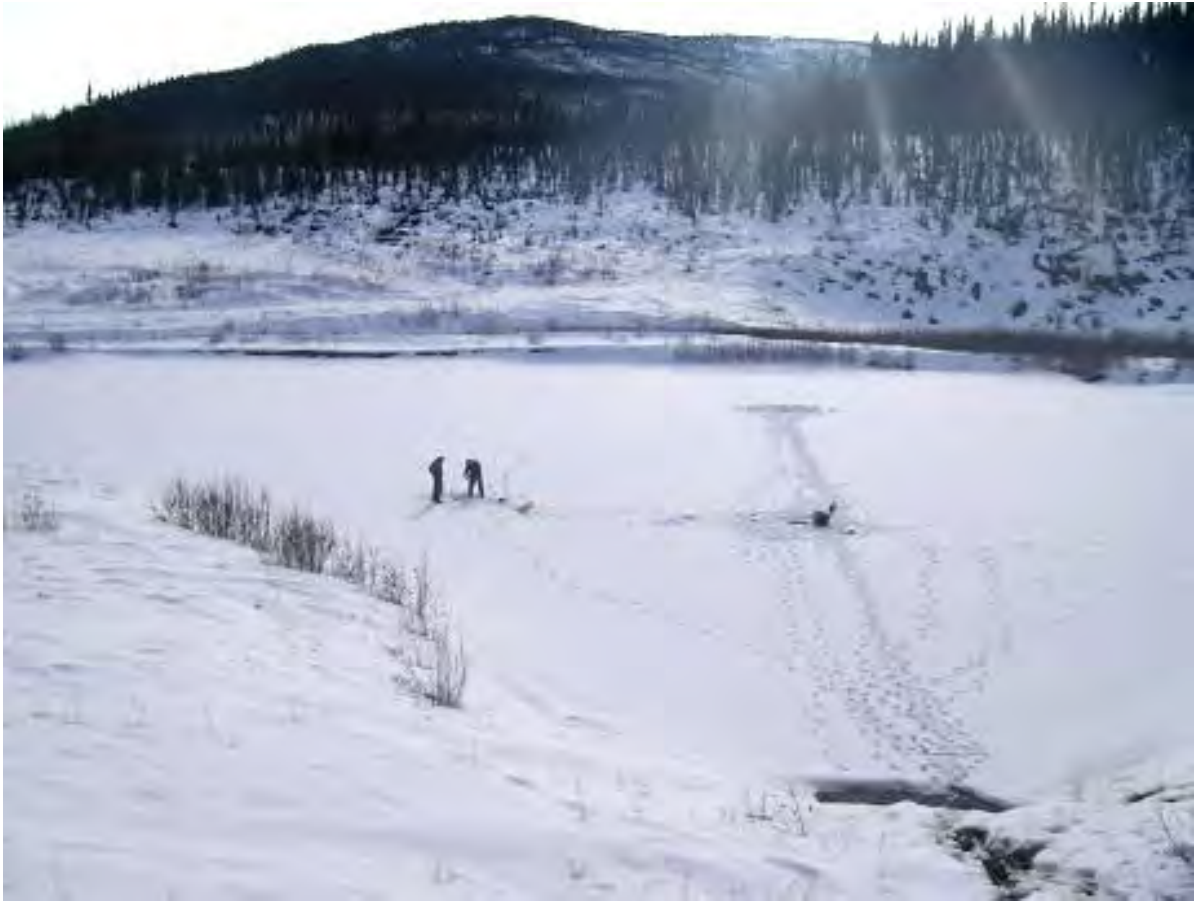
**Photo 3-7: Overwintering habitat use sampling at a large, deep pool on Haggart Creek, approximately halfway between sites HC1 and HC2. Photo taken April 25, 2008**
