2011 ANNUAL REPORT

QUARTZ MINING LICENCE QML-0009

March 2012

YUKON GOVERNMENT ENERGY, MINES AND RESOURCES

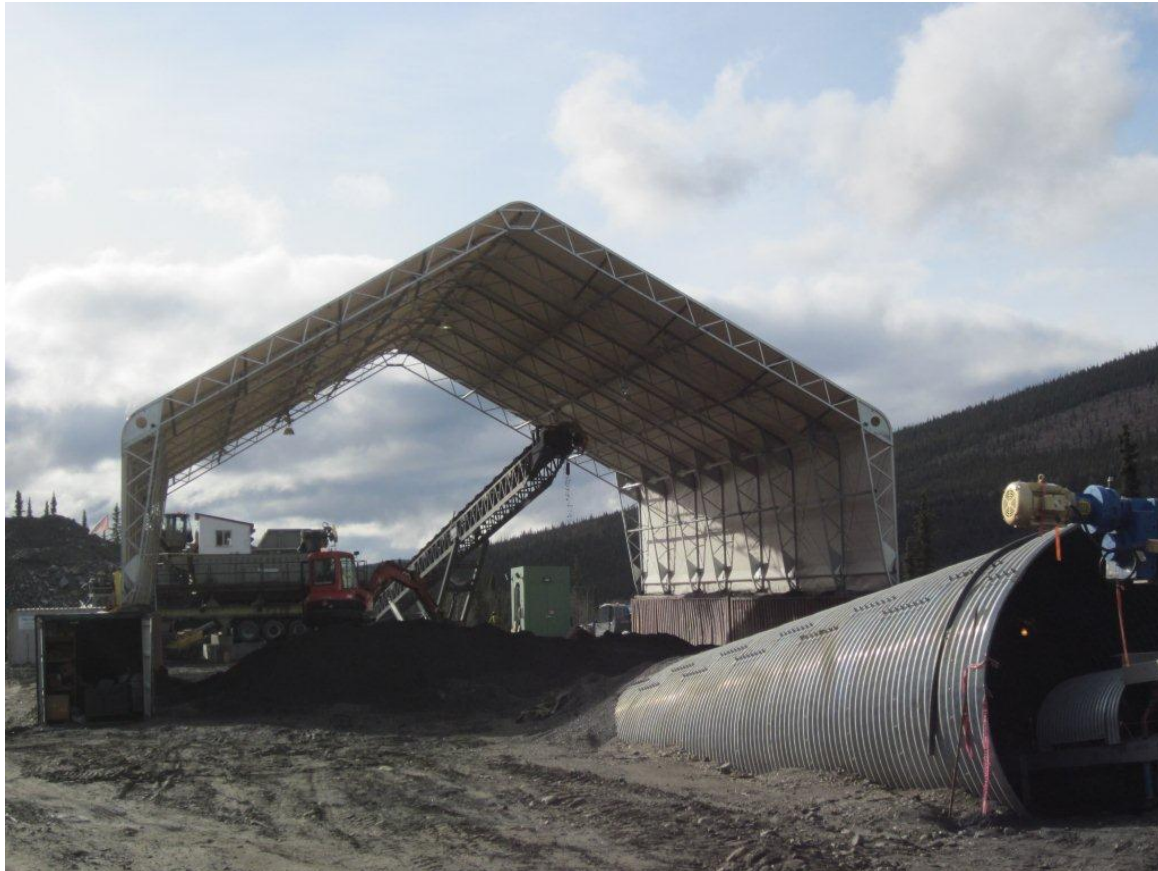
Figure 3-18 Fine Ore Stockpile

Fine ore produced from the crushing plant is stored on a fine ore stockpile covered by a fabric membrane structure to isolate the ore from snow, rain and windy conditions. The fabric membrane structure is 11.35 meters tall, 18.3 x 24.5 meters in dimension and is supported by an aluminium support structure sitting on four (ea) 40' steel containers that provide containment of the fine ore as well as storage units for the crushing plant and mill spare parts inventory. The fine ore stockpile structure is shown in Figure 3-18.

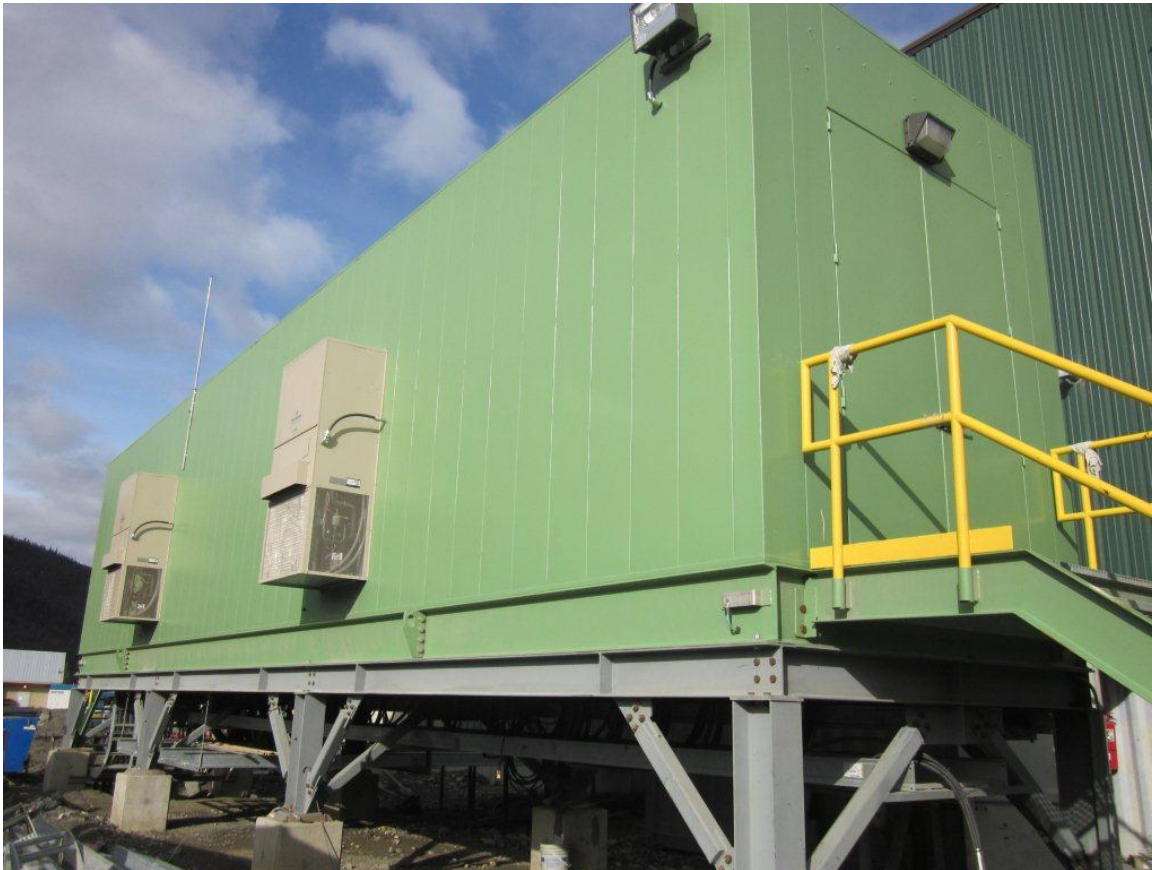
Figure 3-26 Mill MCC

A Motor Control Centre (MCC) for the mill building is located immediately adjacent to the mill and contains the motor control starters and distribution for the mill equipment. The main electrical substation distributes 600 V electrical power to the mill MCC. The mill MCC is a skid mounted unit mounted a steel support structure and has a dimension of 15.24 x 3.04 meters. The mill MCC is shown in Figure 3-26.

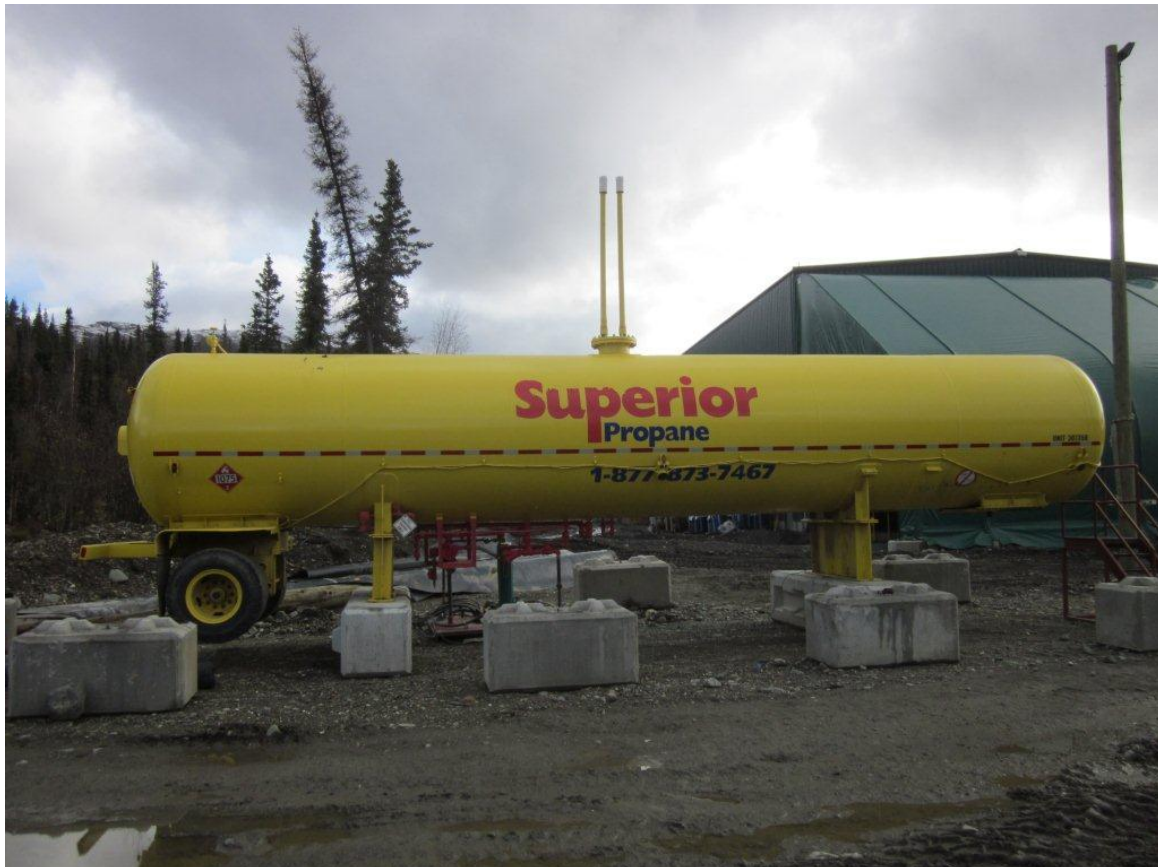
Figure 3-32 Propane Storage Tank

A tire mounted portable propane storage tank sits near the mill building with a capacity of 45,425 litres of propane. Propane is used at the mill for heating the mill building during winter conditions. The propane tank is shown in Figure 3-32.

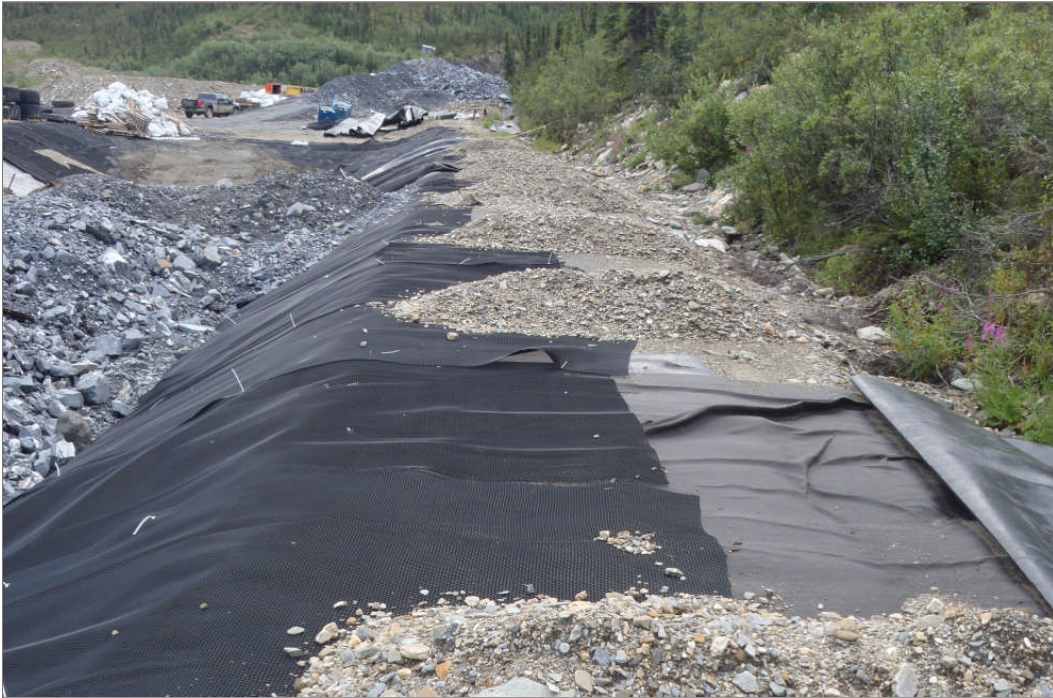
Photo 5: Loose material piled on top of west berm to hold liner in place
(Facing south – July 28, 2011)

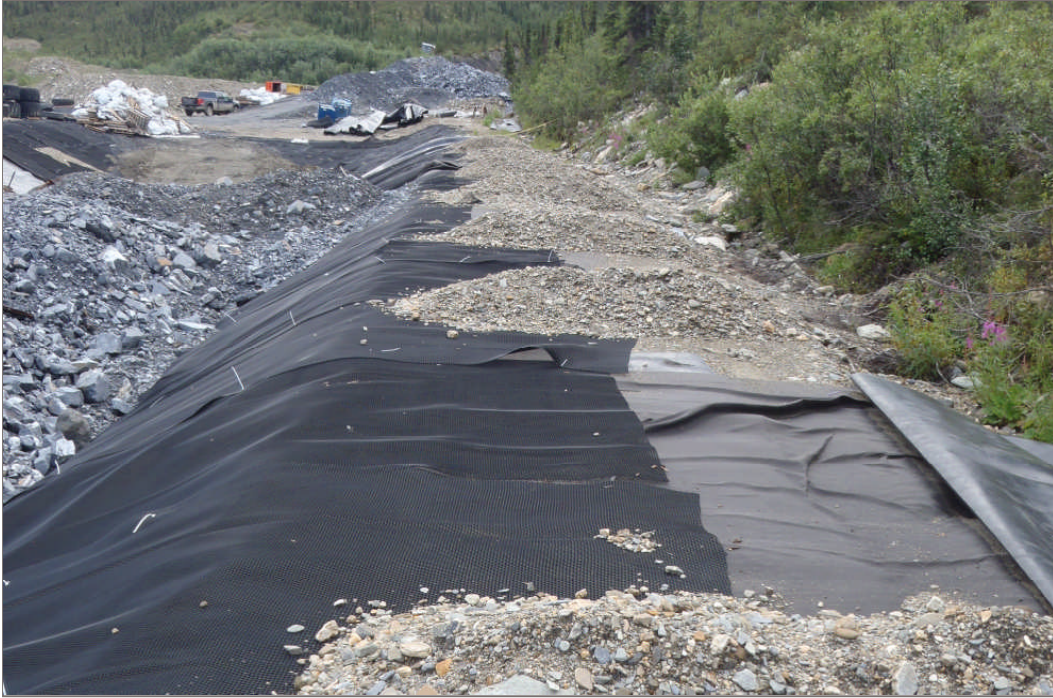
Photo 5: Loose material piled on top of west berm to hold liner in place
(Facing south – July 28, 2011)

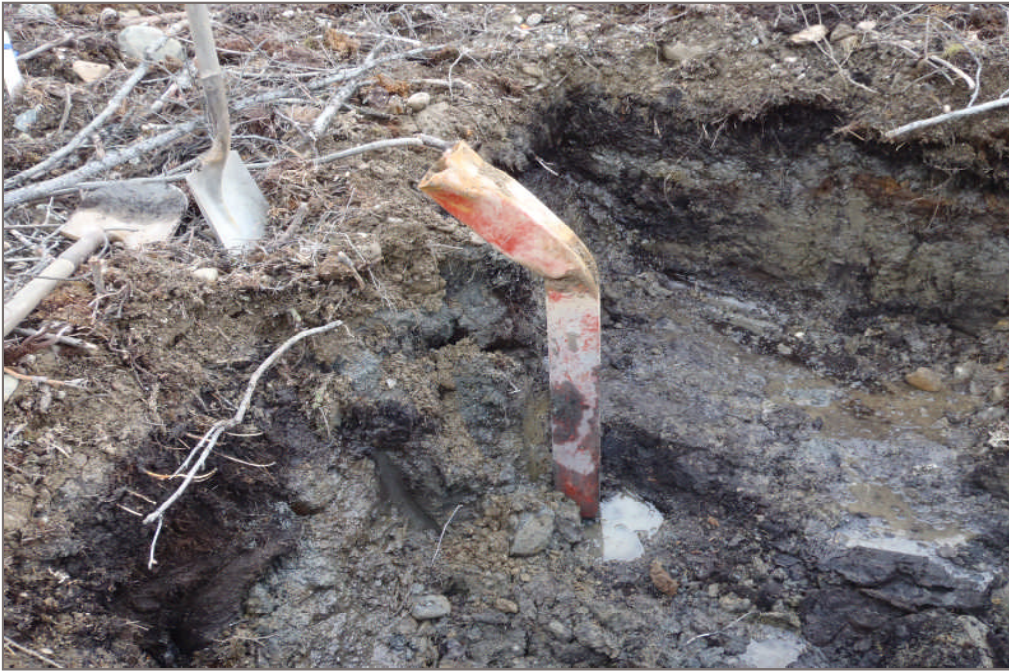
Photo 1: Borehole BH28 – Damaged slope indicator kinked at ground surface. September 28, 2011.

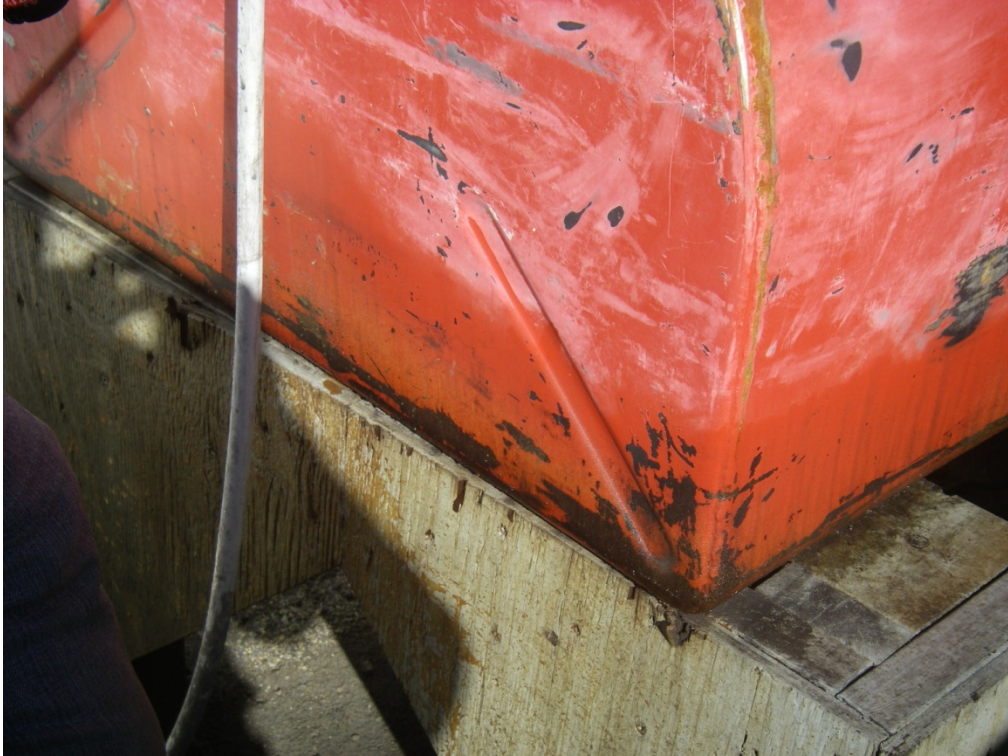
Photo 1: Source of leak

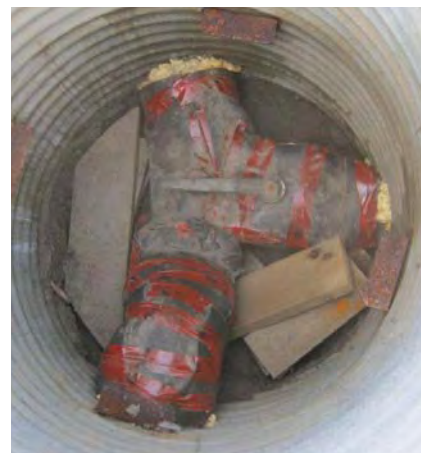
FIGURE 2 – INLET VALVE

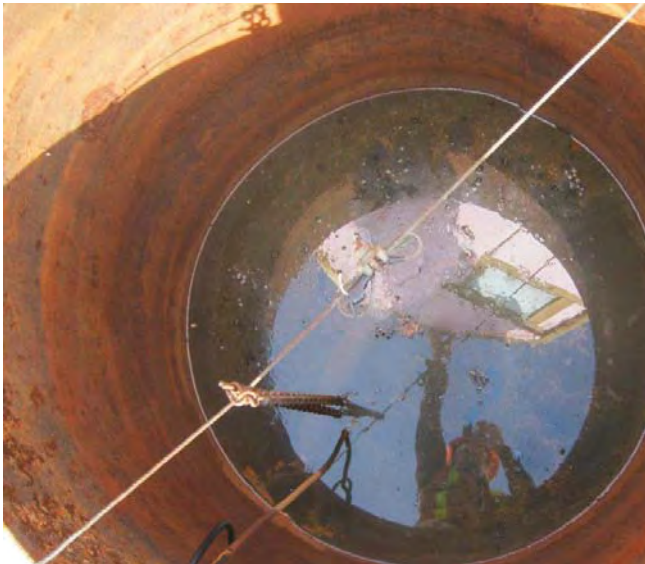
FIGURE 3 – BIOREACTOR INFLUENT SUMP

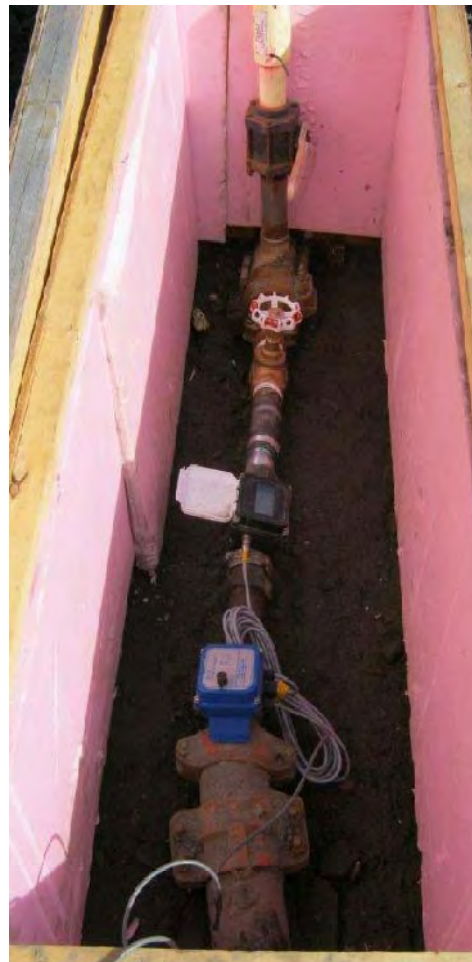
FIGURE 4 – BIOREACTOR INLET
