2013 ANNUAL REPORT

QUARTZ MINING LICENSE QML-0009

March 2014

YUKON GOVERNMENT - ENERGY, MINES AND RESOURCES

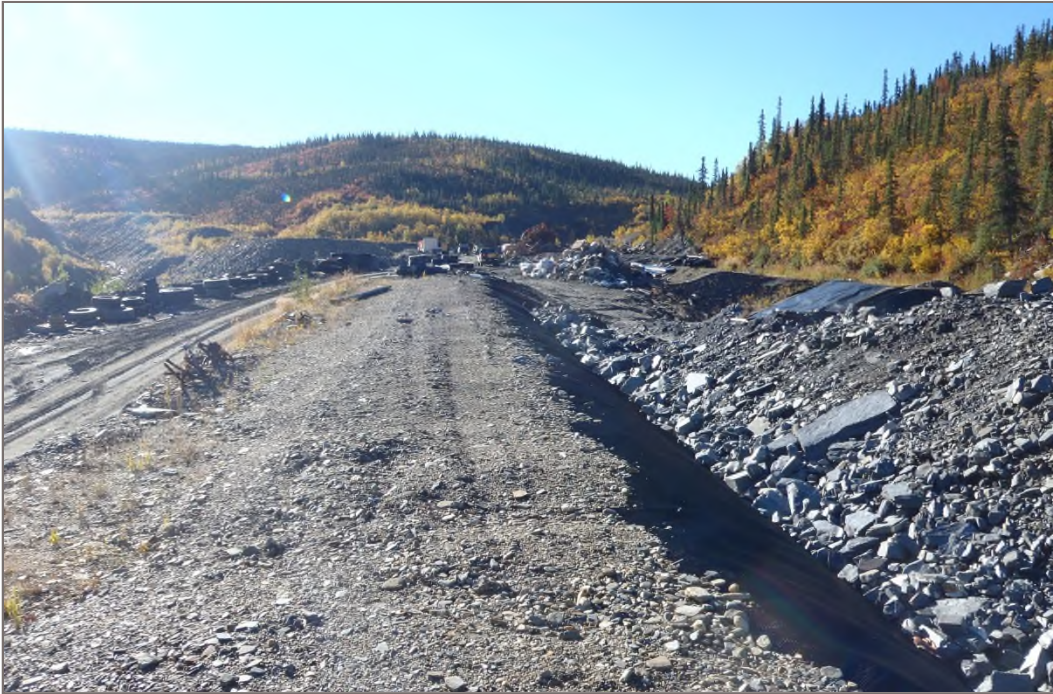
Photo 1: PAG Waste Storage Facility
Perimeter berm
Facing south – September 10, 2013

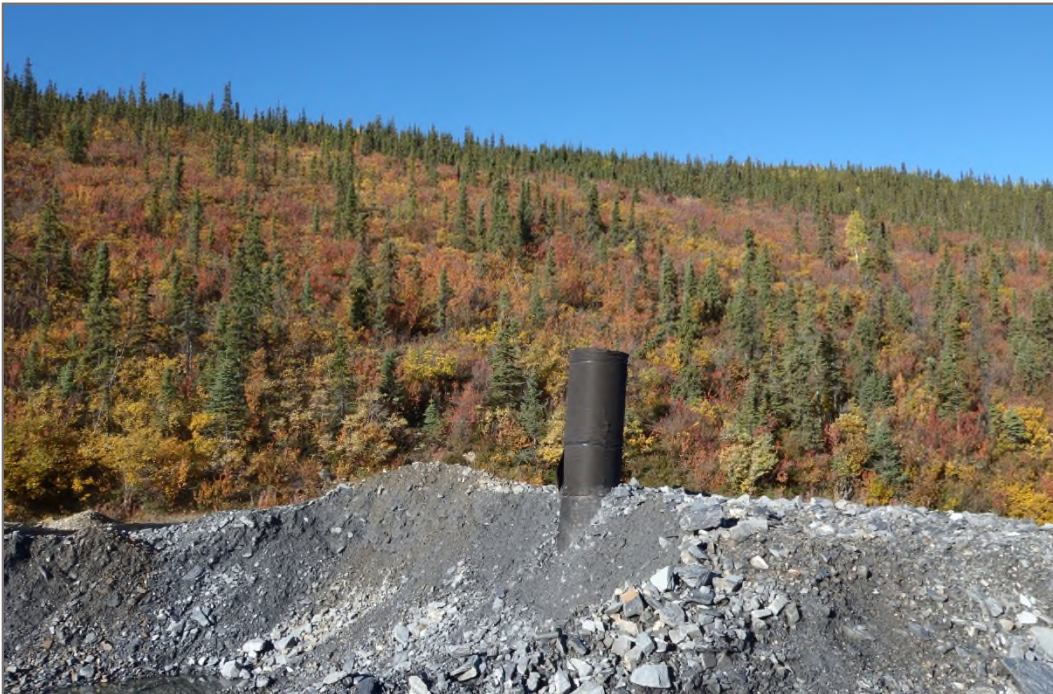
Photo 2: PAG Waste Storage Facility
Material stored in facility
Facing north – September 10, 2013

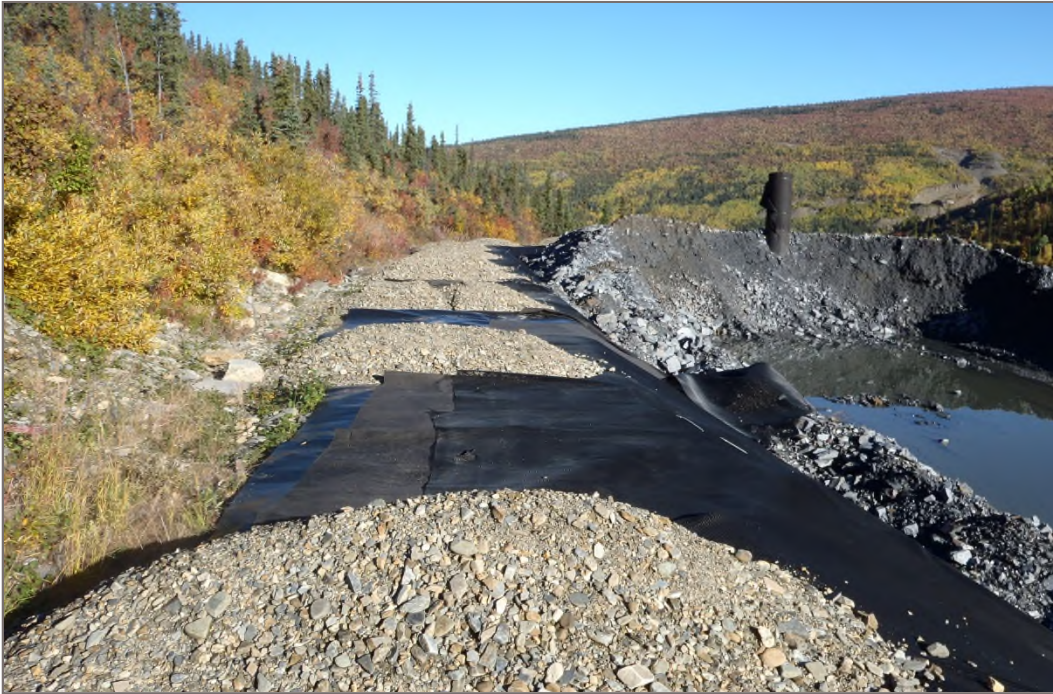
Photo 3: PAG Waste Storage Facility
Liner not properly anchored around north and west perimeter
Facing north – September 10, 2013

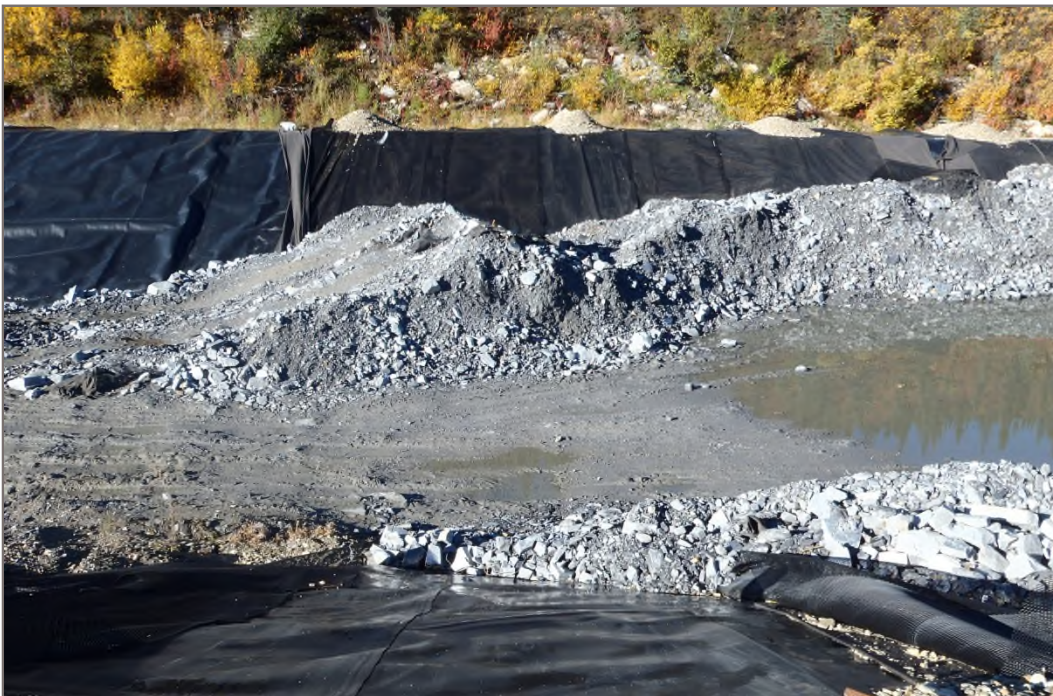
Photo 4: PAG Waste Storage Facility
Angular waste material in direct contact with liner
Facing west – September 10, 2013

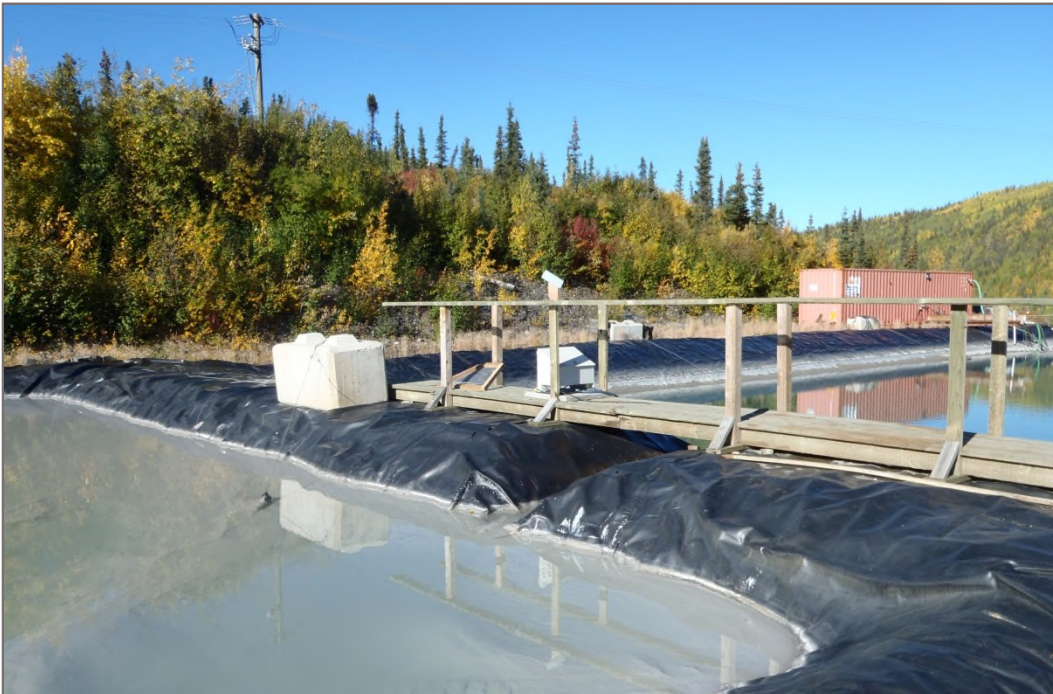
Photo 5: Bellekeno 625 Water Treatment Ponds
Photograph showing condition of facility
Facing north – September 10, 2013

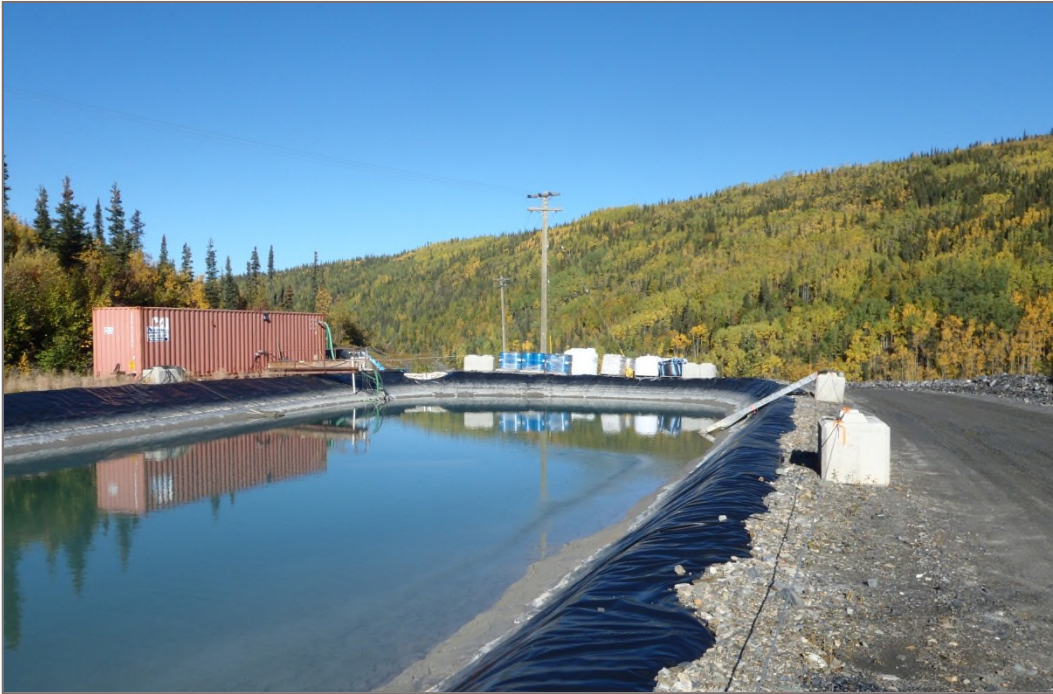
The Bellekeno 625 water treatment ponds are located northeast of the Bellekeno portal, as shown on Figure 1. The ponds and surrounding structures (vehicle barriers, walkways, and piping) appeared stable at the time of inspection (Photo 5). The facility consists of two water treatment ponds and was operating at the time of the inspection. The water level in the primary pond was at the spillway invert with a freeboard of approximately 0.5 m below the crest of the perimeter berm (Photo 6). The water level in the secondary pond was approximately 1.5 m below the crest of the perimeter berm and 1.0 m below the emergency spillway invert (Photo 7).

Photo 7: Bellekeno 625 Water Treatment Ponds
Approximately 1.5 m freeboard in pond two
Facing north – September 10, 2013

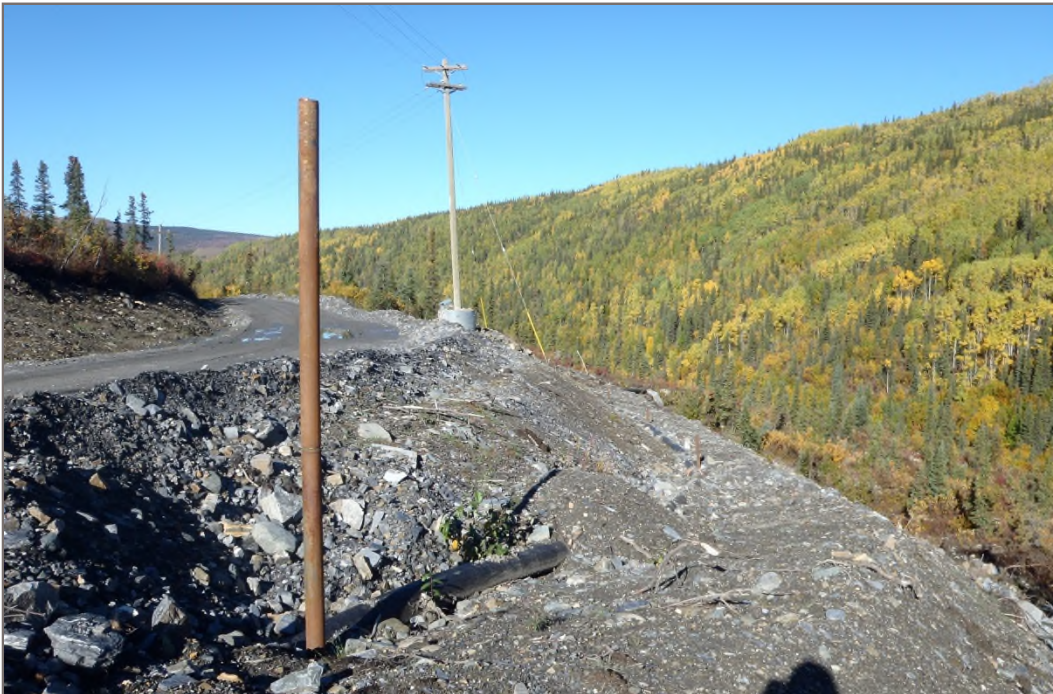
At the time of the inspection water was being discharged from the secondary pond downslope of the facility. The partially buried discharge line appeared stable and intact (Photo 8). Erosion protection in the form of rip-rap should be placed immediately below the discharge point to protect the natural slope (Photo 9).

Photo 8: Bellekeno 625 Water Treatment Ponds
Partially buried discharge line
Facing west – September 10, 2013

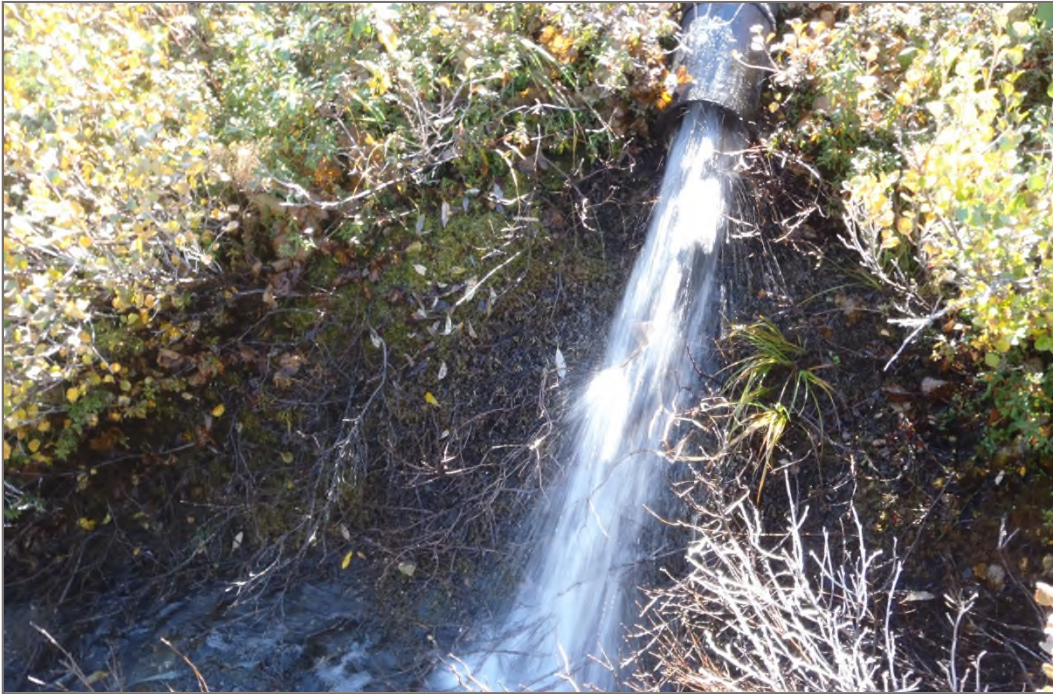
Photo 9: Bellekeno 625 Water Treatment Ponds
Discharge point requiring rip-rap armouring for erosion protection
Facing south – September 10, 2013

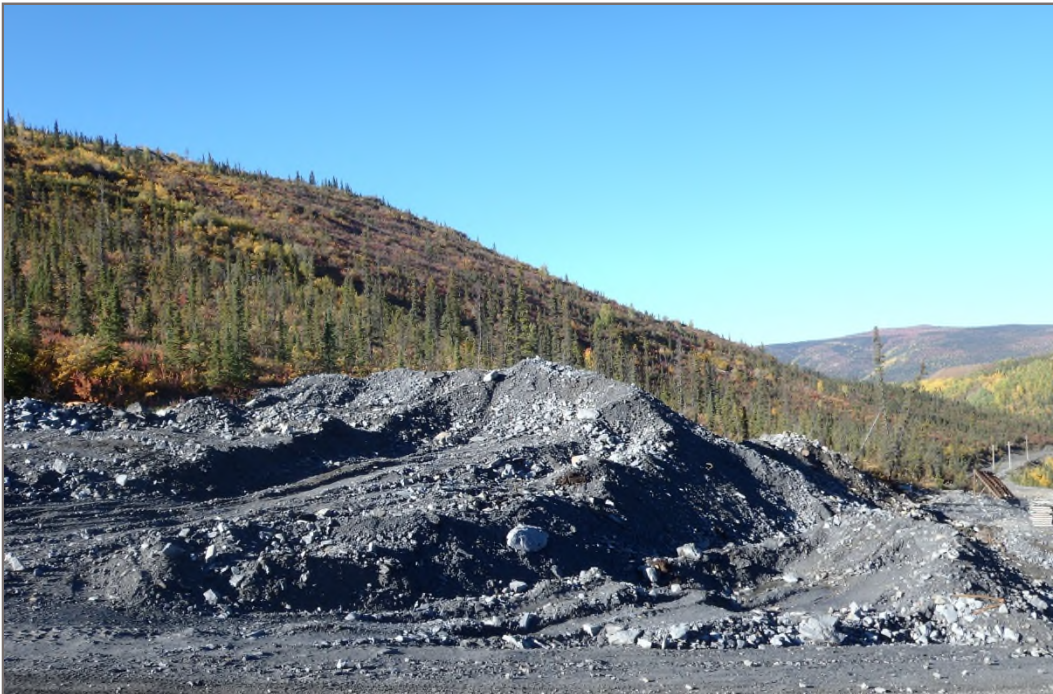
The Bellekeno waste rock pile is located beside the Bellekeno Road north of the Bellekeno portal, as shown on Figure 1. The waste rock pile has decreased in overall size from previous inspections because of ongoing construction activities around the property (Photos 10 and 11). The pile and side slopes appeared stable at the time of the inspection (Photo 12). No remedial action is recommended for the Bellekeno waste rock pile.

Photo 10: Bellekeno Waste Rock Pile
Overview of waste rock pile
Facing west – September 10, 2013

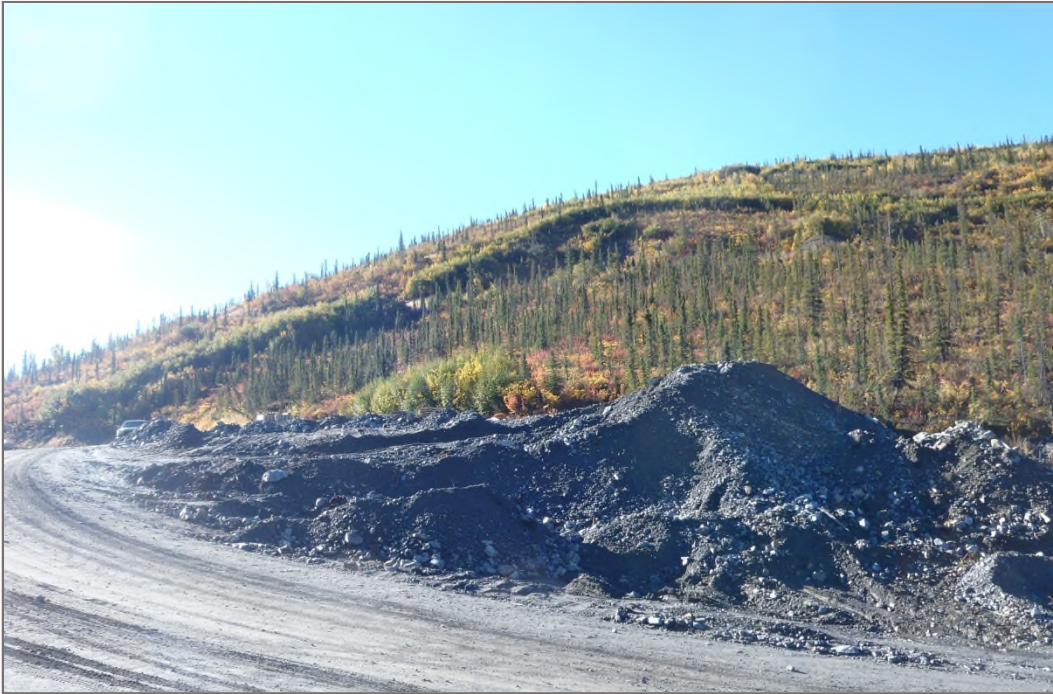
Photo 11: Bellekeno Waste Rock Pile
Overview of waste rock pile
Facing south – September 10, 2013

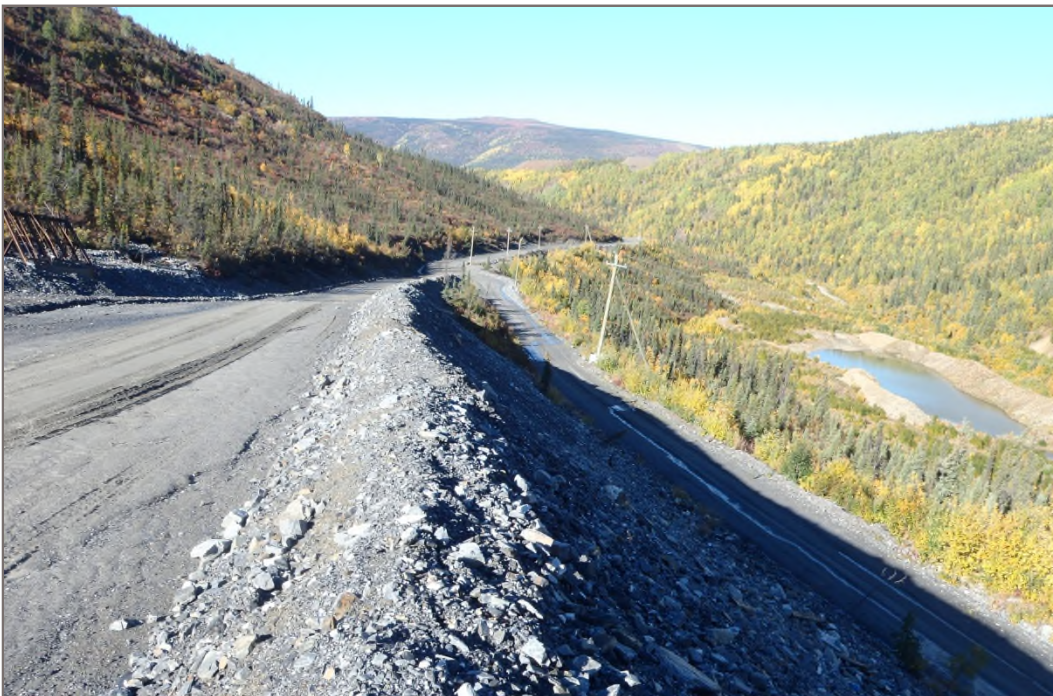
Photo 12: Bellekeno Waste Rock Pile
Stable pile sideslopes
Facing west – September 10, 2013

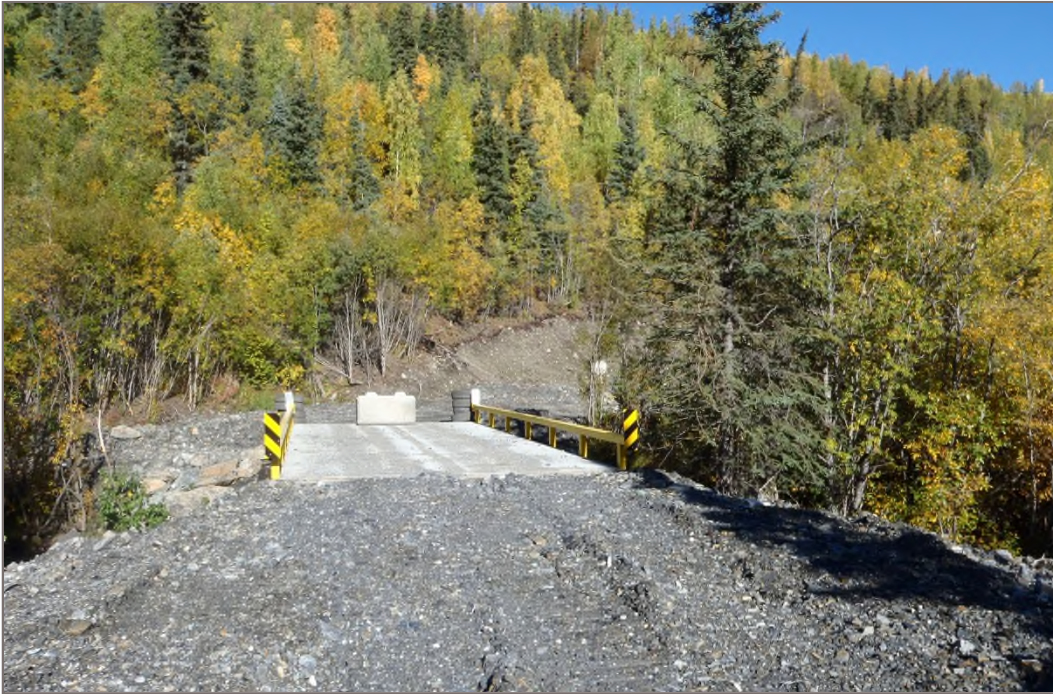
The Onek Road Lightning Creek Bridge is located east of Keno City, as shown on Figure 1. The bridge was recently constructed and was not in service at the time of the inspection. It is a single span steel structure approximately 6 m in length (Photo 13) founded on compacted earth fill and adjustable wooden timber abutments (Photo 14). The abutments appeared stable at the time of the inspection.

Photo 13: Lightning Creek Bridge Abutments (Onek Road)
Lightning Creek Bridge on the Onek Road
Facing north – September 10, 2013

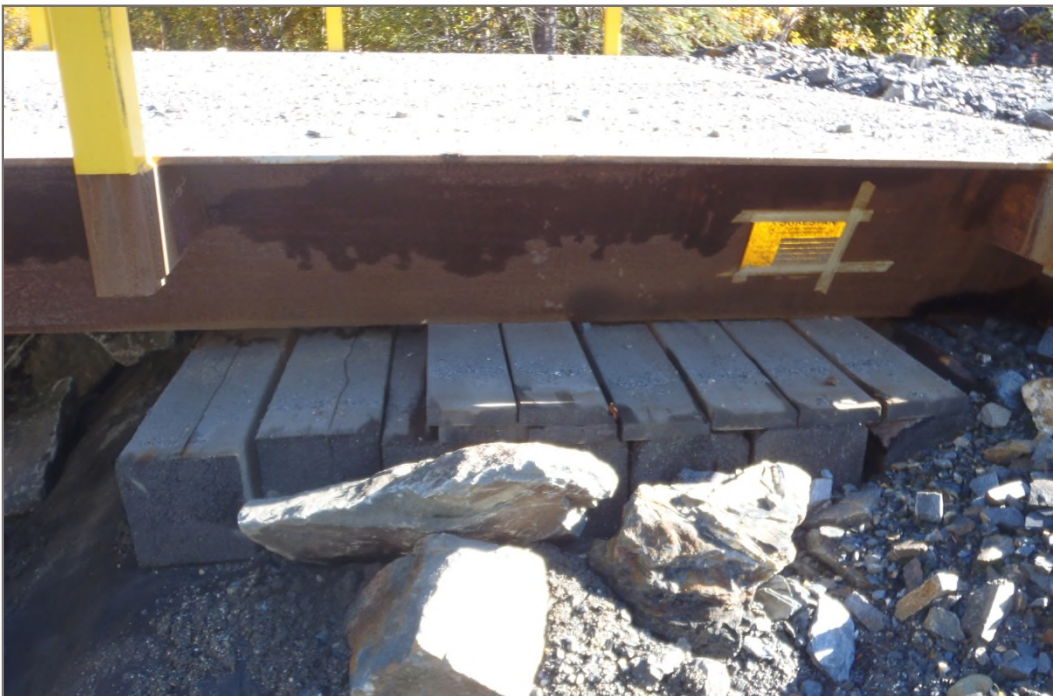
Photo 14: Lightning Creek Bridge Abutments (Onek Road)
Compacted earth fill and wooden timber bridge abutments
Facing east – September 10, 2013

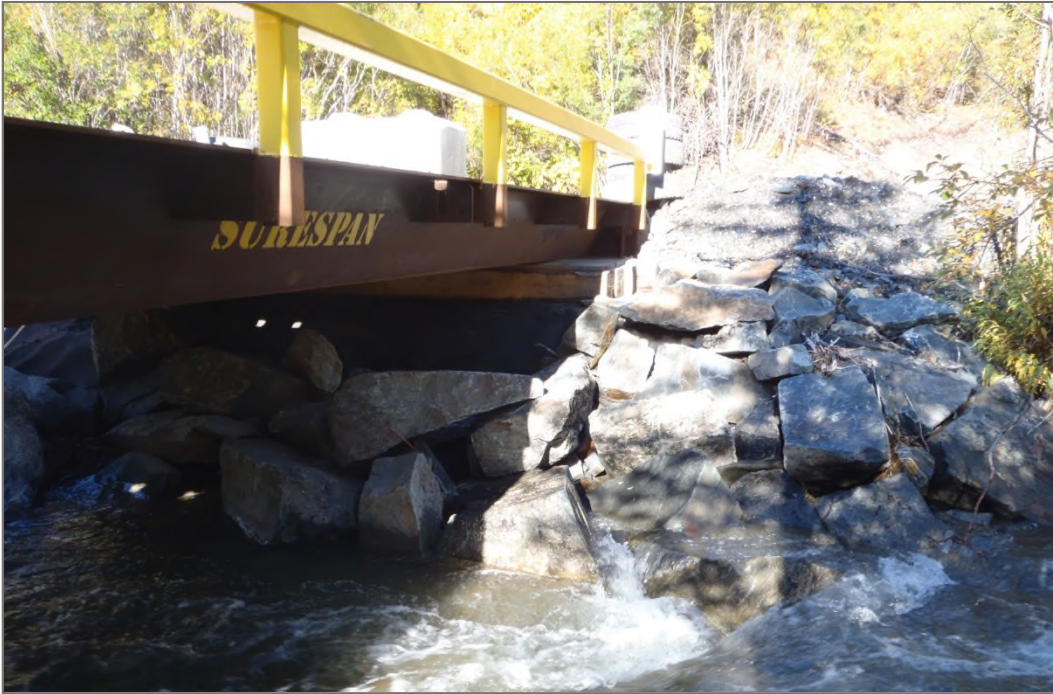
The earth fill abutments are guarded from erosion by rip-rap placed after construction. The rip-rap placed protecting both bridge abutments appears satisfactory (Photo 15). No remedial action is recommended for the Lightning Creek Bridge on the Onek Road.

Photo 15: Lightning Creek Bridge Abutments (Onek Road)
Rip-rap armouring providing erosion protection for bridge abutments
Facing north – September 10, 2013

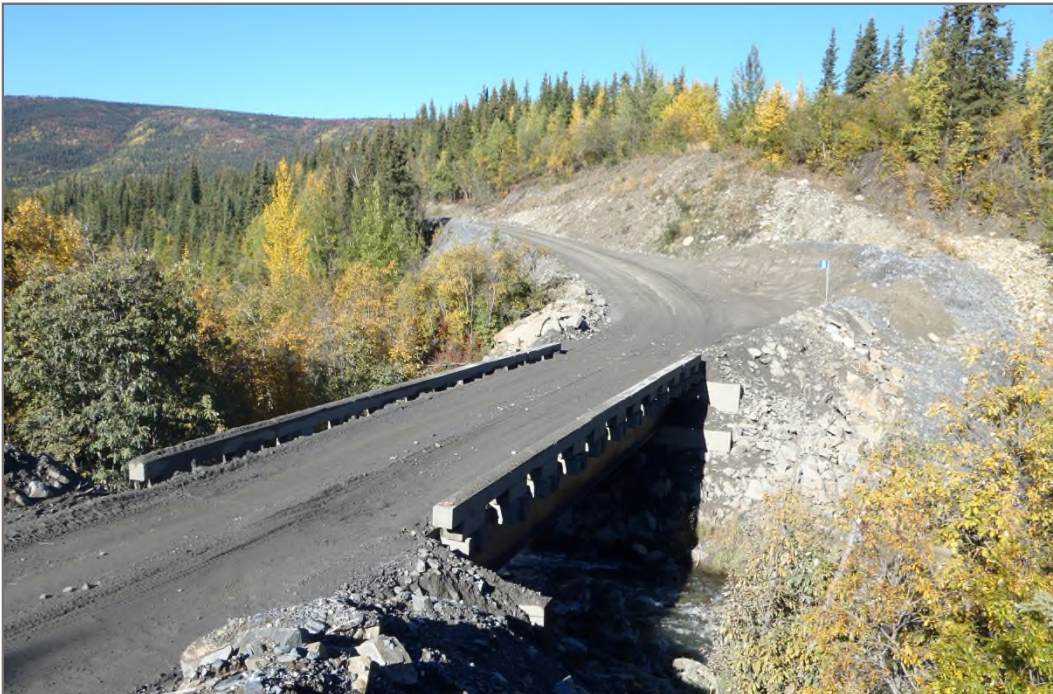
The Bellekeno Road Lightning Creek Bridge is located southwest of Keno City, as shown on Figure 1. The bridge was in service at the time of the inspection. It is a single span steel structure approximately 9 m in length (Photo 16) founded on earth filled timber cribbing abutments (Photo 17). The abutments appeared stable at the time of inspection.

Photo 16: Lightning Creek Bridge Abutments (Bellekeno Road)
Lightning Creek Bridge on the Bellekeno Road
Facing west – September 10, 2013

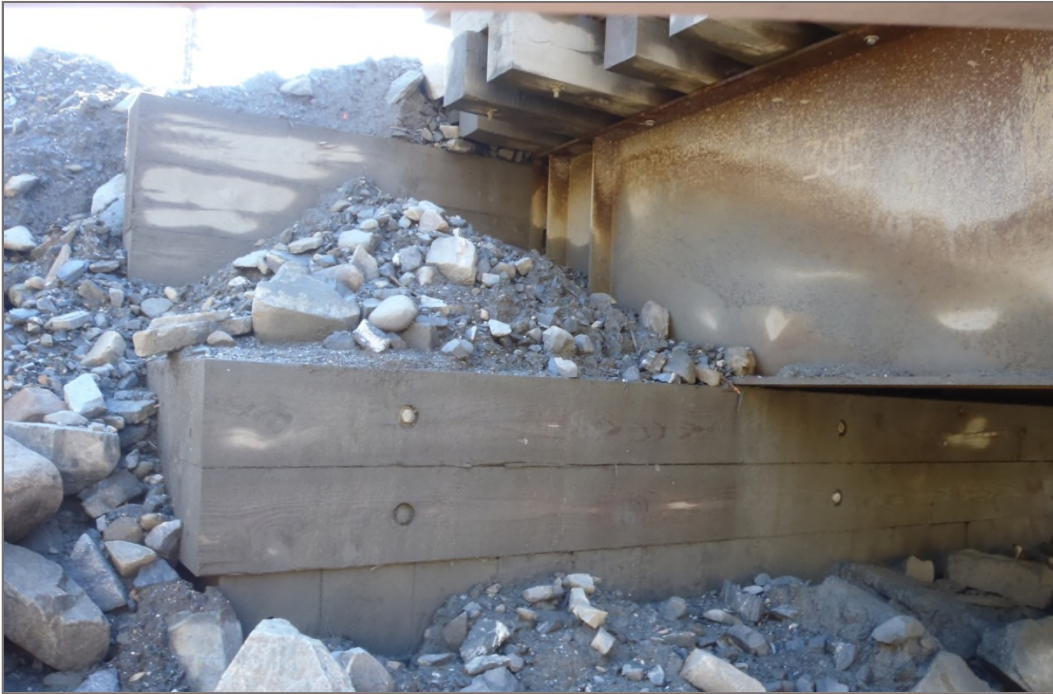
Photo 17: Lightning Creek Bridge Abutments (Bellekeno Road)
Earth filled timber cribbing bridge abutments
Facing east – September 10, 2013

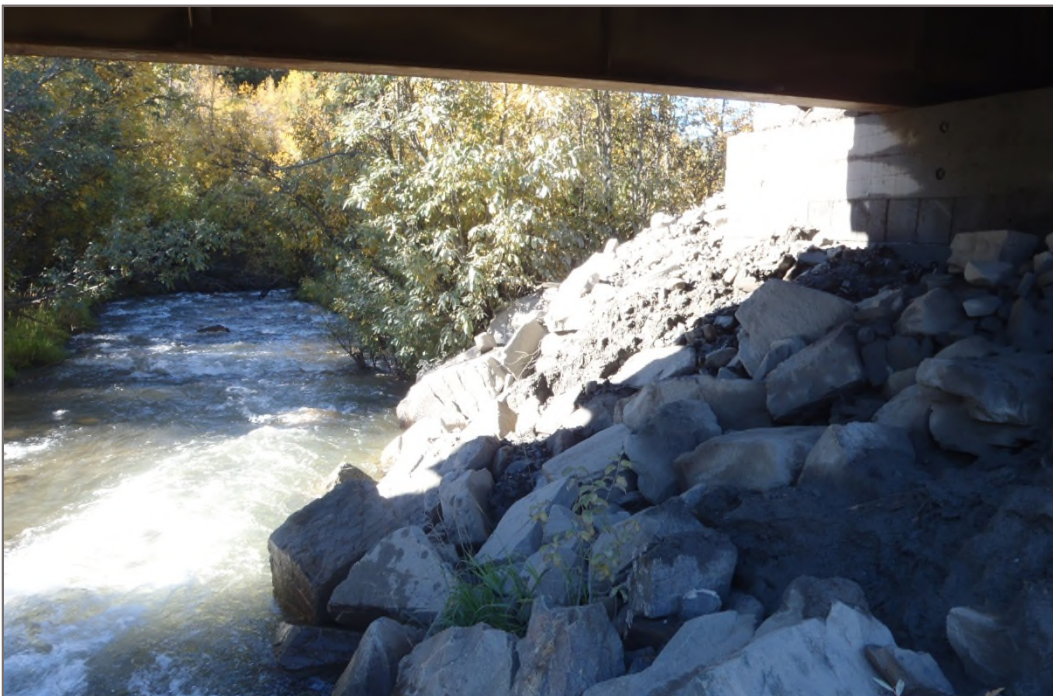
The earth fill abutments are guarded from erosion by rip-rap placed after construction. The rip-rap protection for both abutments appears satisfactory (Photo 18). No remedial action is recommended for the Lightning Creek Bridge on the Bellekeno Road.

Photo 18: Lightning Creek Bridge Abutments (Bellekeno Road)
Rip-rap armouring providing erosion protection for bridge abutments
Facing south – September 10, 2013

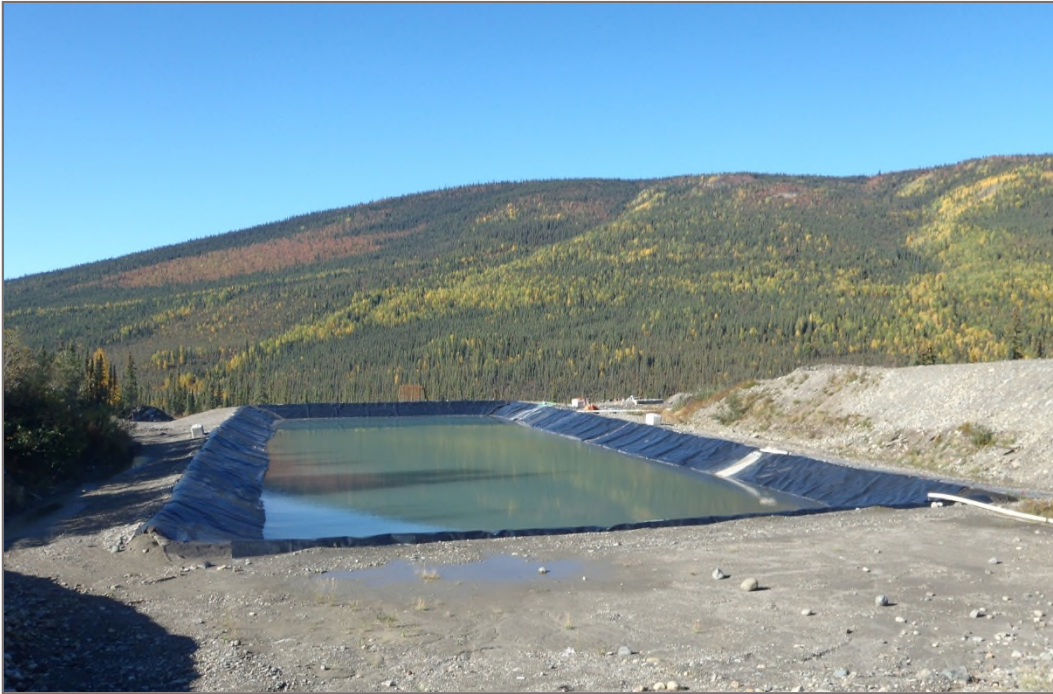
The mill water storage pond is located at the Keno Hill District Mill Site approximately 1 km west of Keno City, as shown on Figure 1. The pond was operating at the time of the inspection with a water level approximately 2 m below the perimeter berm crest (Photo 19). The perimeter berm appeared stable at the time of inspection and no loose seems, excessive tension or bulging was observed in the liner (Photo 20).

Photo 19: Mill Water Storage Pond
Approximately 2.0 m of freeboard in mill water storage pond
Facing west – September 10, 2013

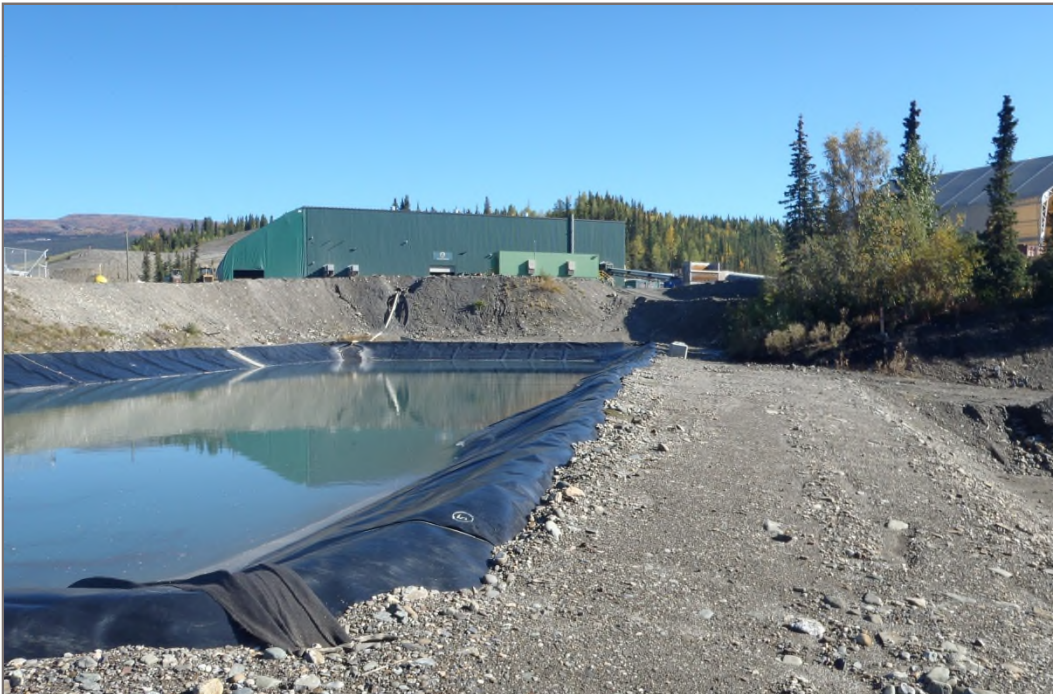
Photo 20: Mill Water Storage Pond
Stable perimeter berm
Facing east – September 10, 2013

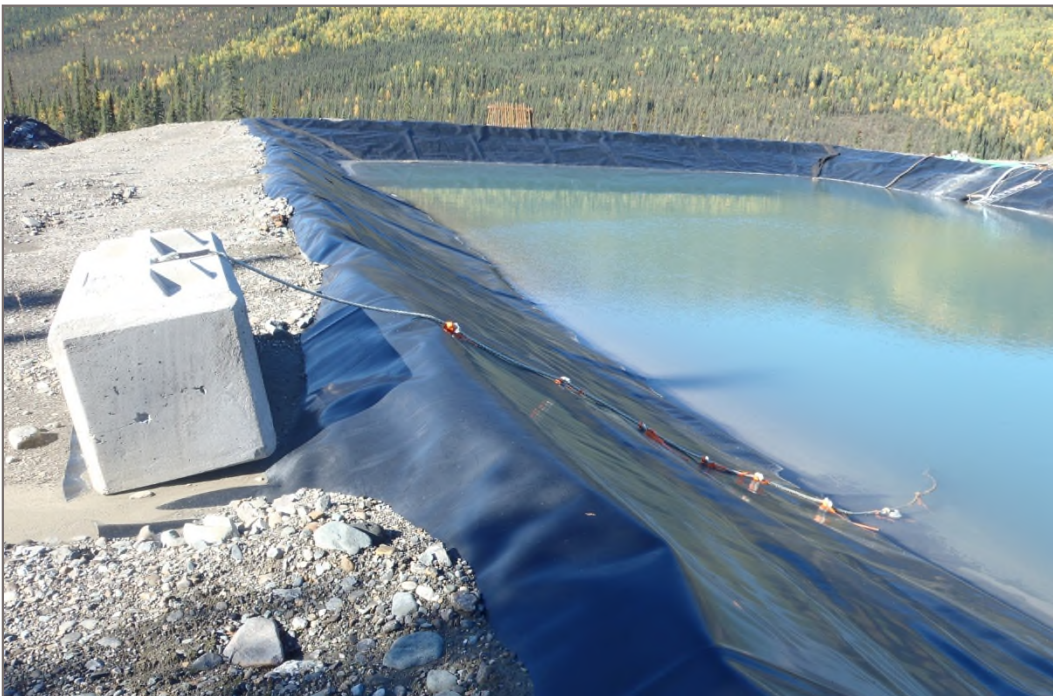
Photo 21: Mill Water Storage Pond
Minor erosion observed on exterior of perimeter berm on south and west sides
Facing west – September 10, 2013

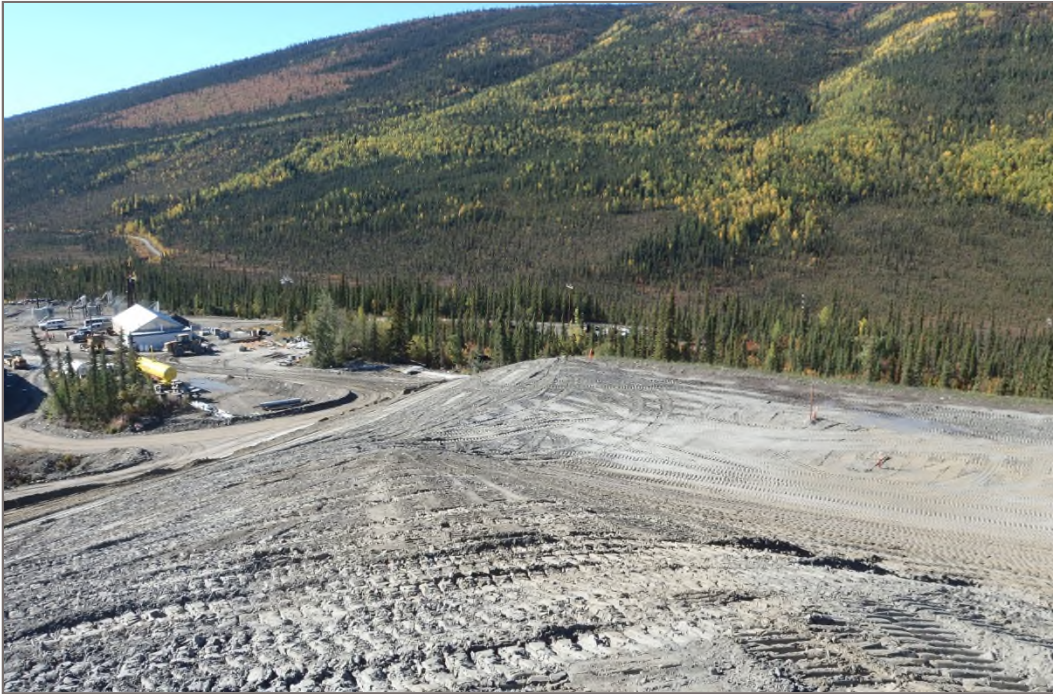
The dry stacked tailings facility (DSTF) is located at the Keno Hill District Mill Site approximately 1 km west of Keno City, as shown on Figure 1. Construction and operation of the DSTF was ongoing at the time of the inspection with work being focussed on contouring the sideslopes (Photo 23).

Photo 23: Dry Stacked Tailings Facility
Contouring of facility to design grades
Facing west – September 10, 2013

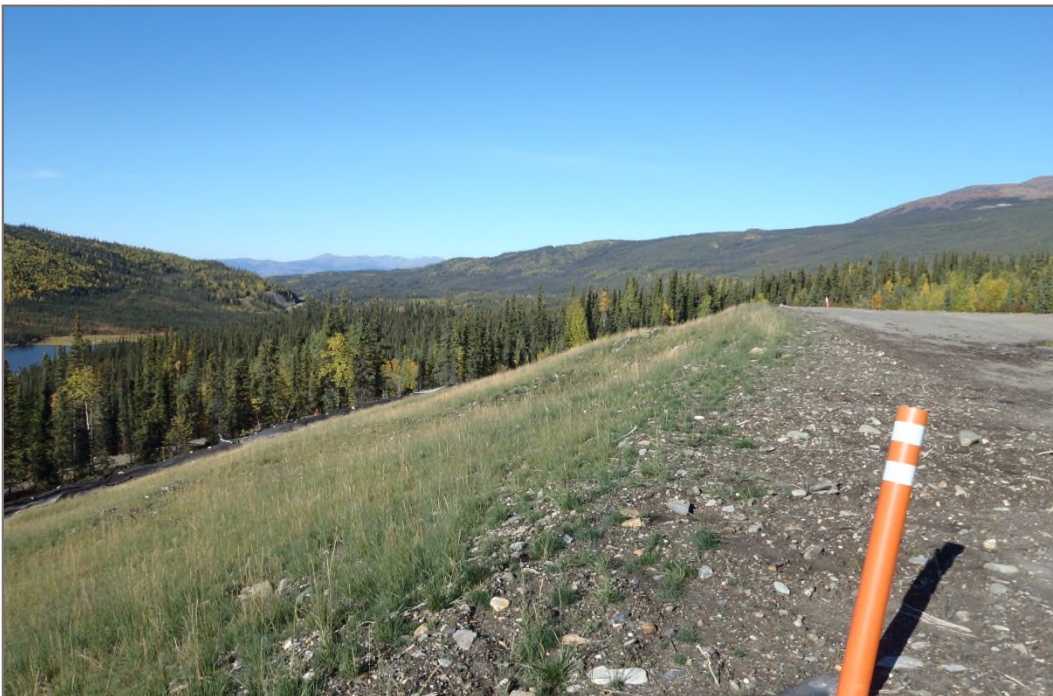
Construction of the lower tailings bench is complete to the design dimensions and elevations. Progressive reclamation of the facility is underway with revegetation of the western face of the lower bench (Photo 24).

Photo 24: Dry Stacked Tailings Facility
Vegetation on western slope of lower tailings bench
Facing north – September 10, 2013

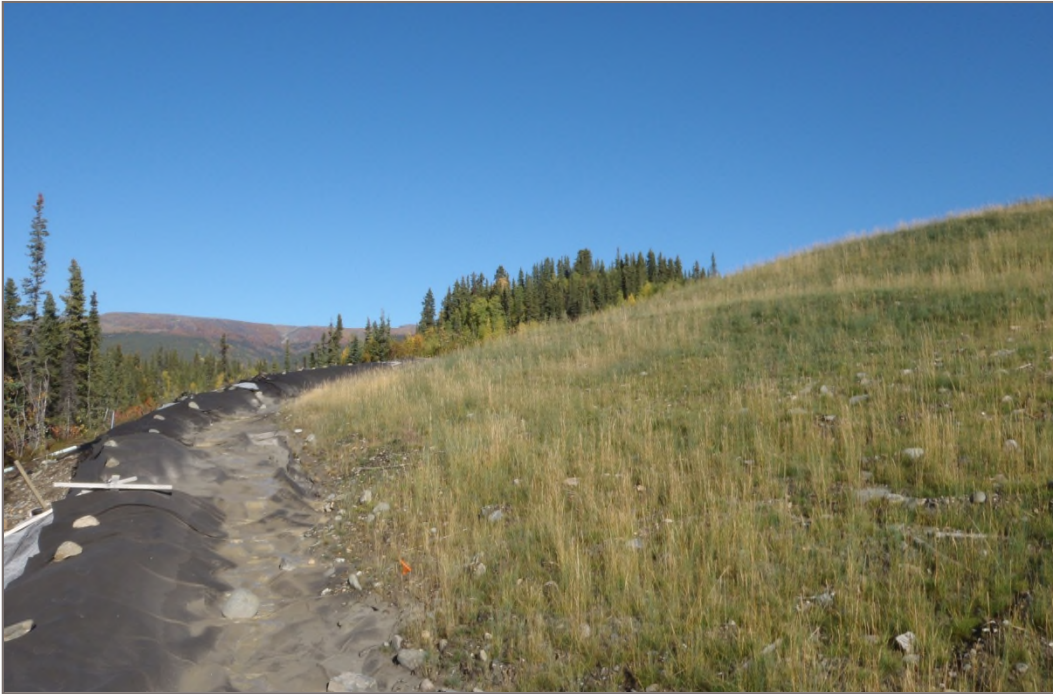
The foundation elements of the DSTF (gravel drainage blanket, geosynthetic clay liner, geonet, and geotextile) placed to date appeared properly installed and intact at the time of the inspection. The perimeter berms and surface water collection structures appeared stable and functional (Photo 25).

Photo 25: Dry Stacked Tailings Facility
Perimeter berm and surface water collection system
Facing north – September 10, 2013

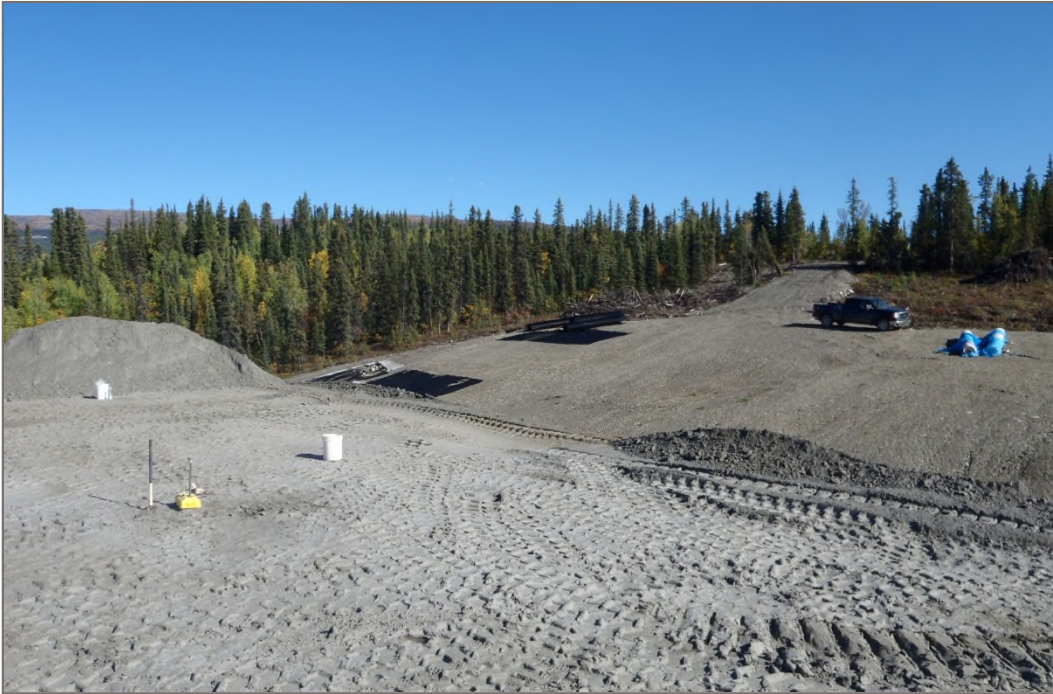
Photo 26: Dry Stacked Tailings Facility
Minor tension cracking on north side of facility
Facing east – September 10, 2013

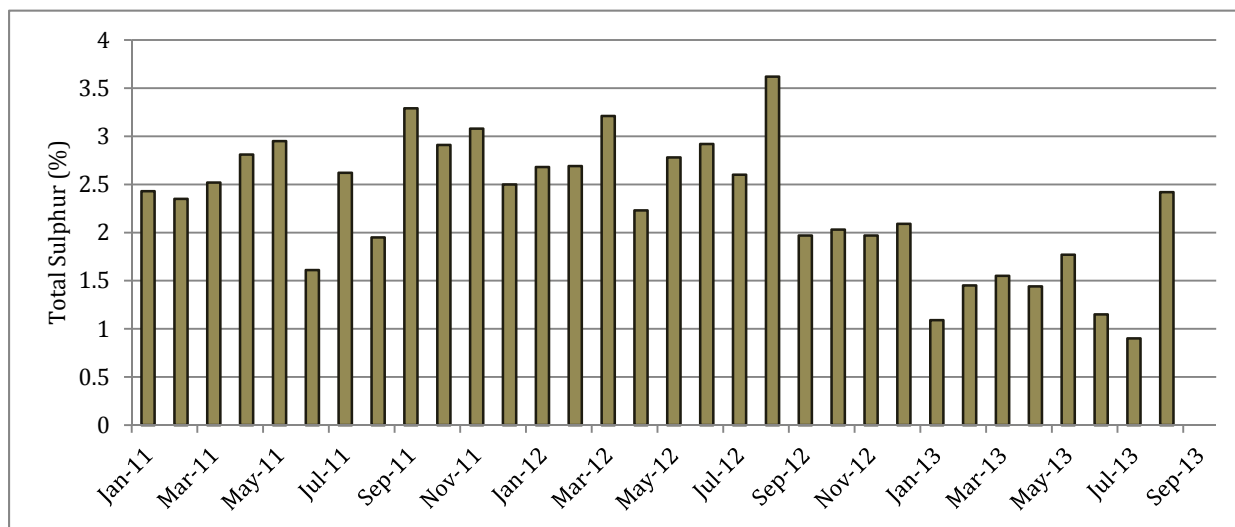
The total sulphur concentration ranged between 0.90 and 2.42%, with an average of 1.47% in 2013. The maximum sulphur content was observed in the August 2013 composite, which was the final sample produced before the mill operations were suspended. Total sulphur concentrations in the 2013 composite samples were generally lower than those measured in previous years (Figure 3-1). Sulphide sulphur was the dominant form of sulphur in the tailings, accounting for 95 – 100% of the total sulphur. The maximum potential acidity (MPA) of the tailings composites ranged from 28.1 to 75.6 kg CaCO₃/tonne.

Figure 3-1 Total sulphur content of Mill tailings composites.

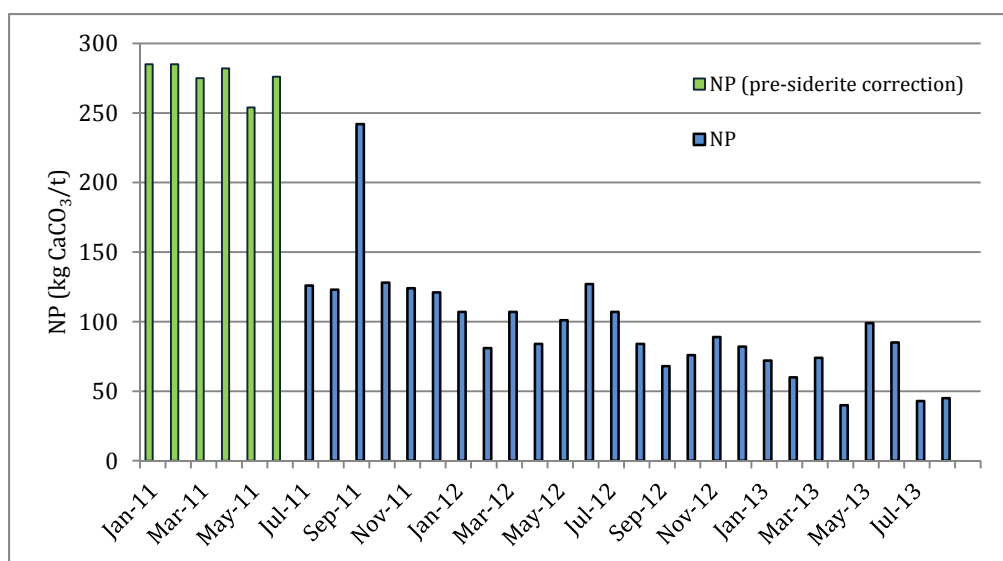
The results of mineralogical testing of the tailings composite using X-Ray Diffraction (XRD) has shown that Bellekeno tailings contain significant siderite (26 to 35 wt. %). As a result of this determination, the ABA package was switched in July 2011 from standard ABA to a siderite-corrected ABA analytical package to remove any potential neutralization potential (NP) contributions from the siderite. All 2013 NP was calculated using the siderite correction. The NP in 2013 ranged from 40 to 99 kg CaCO₃/tonne. Overall, lower NP values were observed for the 2013 tailings composites than in 2012 (Figure 3-2). A decreasing overall trend in NP values is observed, with annual median siderite-corrected NP values for the tailings composites in 2011, 2012, and 2013 of 125, 87, and 65 kg CaCO₃/tonne, respectively.

Figure 3-2 Neutralization potential (NP) of Mill tailings composites

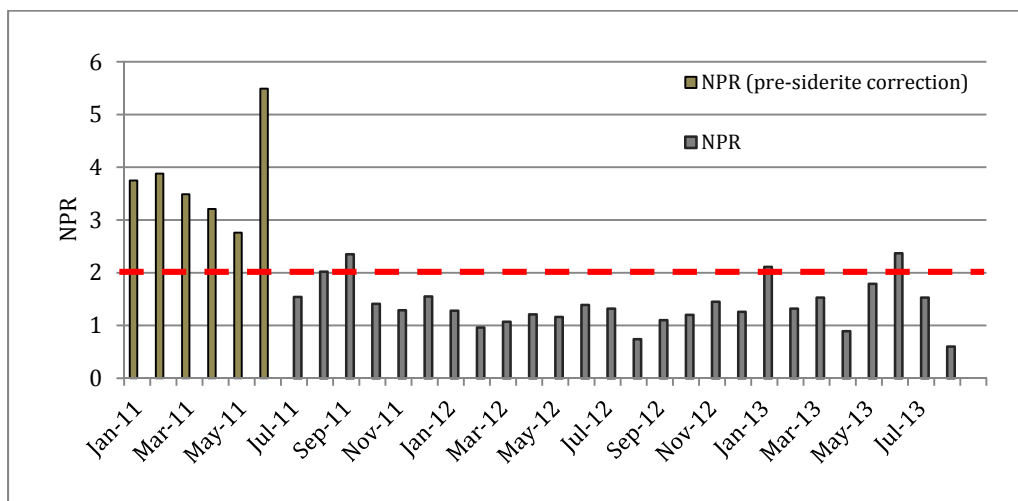
The neutralization potential ratio (NPR = NP:MPA ratio) of the tailings composites in 2013 ranged from 0.60 to 2.37, with an average of 1.52. The 2013 NPR values are broadly higher than those from 2012, likely due to the lower sulphide content of the 2013 tailings composite samples. Net neutralization potential (NNP), the difference between NP and MPA, of the tailings composites ranged between -31 and 49 kg CaCO₃/tonne, with two values below zero in 2013 (Figure 3-4). The median NNP in 2013 was 19 kg CaCO₃/tonne, which is slightly higher than that observed in 2012 (14 kg CaCO₃/tonne), but lower than in 2011 (44 kg CaCO₃/tonne siderite-corrected).

Figure 3-3 Neutralization potential ratio (NPR = NP/MPA) of Mill tailings composites. Red dashed line indicates NPR = 2, above which MEND (2009) indicate the sample is unlikely to be acid generating.

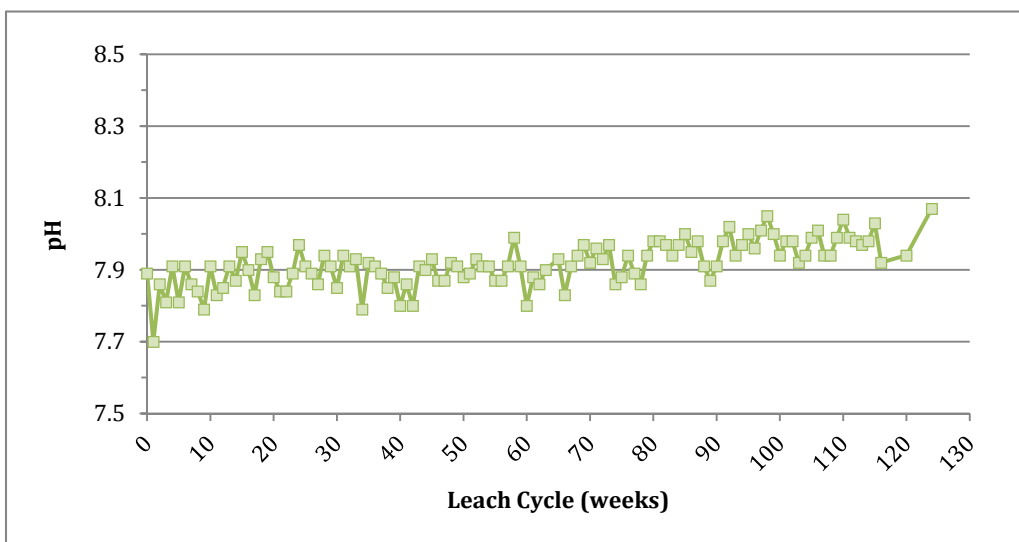
Figure 6-1 Change in humidity cell pH as a function of leach cycle

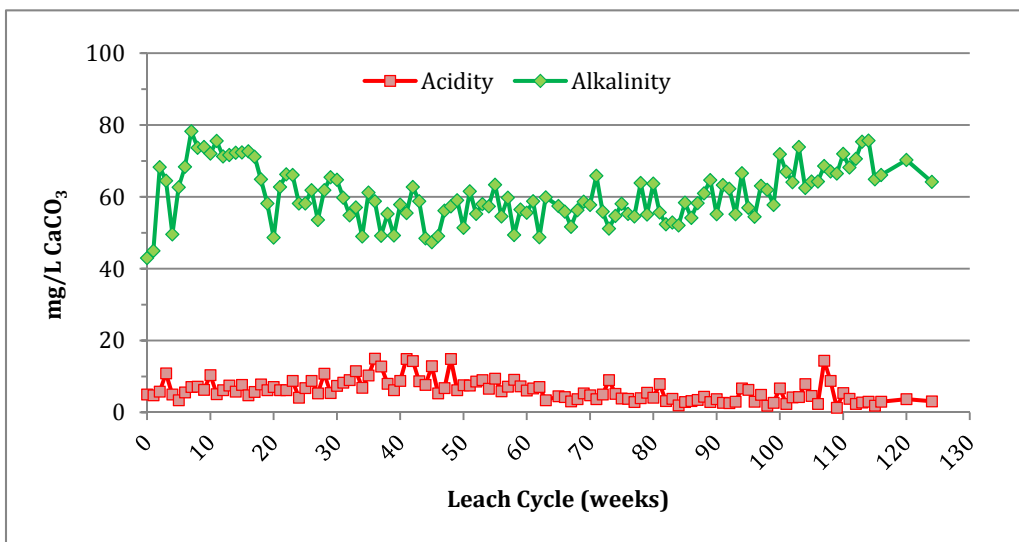
peaks were observed between Week 33 and Week 48 reaching a maximum of 15 mg CaCO₃/L in Week 36 (Figure 6-2). However, outside those weeks, acidity has been fairly consistent ranging between 1.3 and 11 mg CaCO₃/L, with the exception of a spike at Week 107 of 14.4 mg CaCO₃/L.

Figure 6-2 Change in humidity cell acidity and alkalinity levels as a function of leach cycle
