2013 ANNUAL REPORT

QUARTZ MINING LICENSE QML-0009

March 2014

YUKON GOVERNMENT - ENERGY, MINES AND RESOURCES

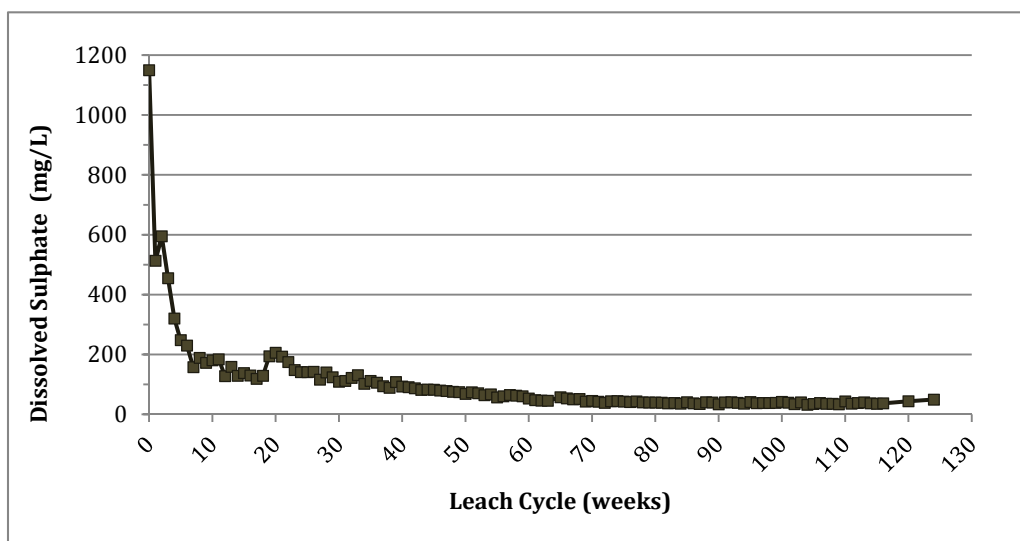
Sulphate was highest at the beginning of the humidity cell testing with a maximum concentration of 1150 mg/L at Week 0 as soluble secondary sulphate salts that likely accumulated during storage of the sample were washed out. The dissolved sulphate concentration then decreased rapidly to 158 mg/L by Week 7 (Figure 6-3). Sulphate increased slightly to 206 mg/L in Week 20 and since then has gradually trended downwards and remained below 50 mg/L since Week 69.

Figure 6-3 Change in humidity cell dissolved sulphate concentration as a function of leach cycle

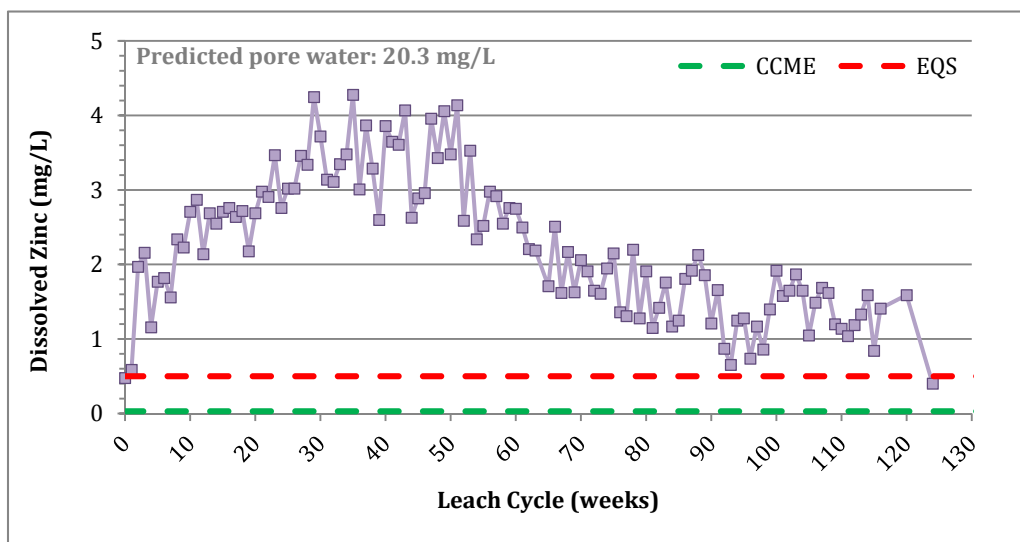
Figure 6-4 Change in humidity cell dissolved zinc concentration as a function of leach cycle

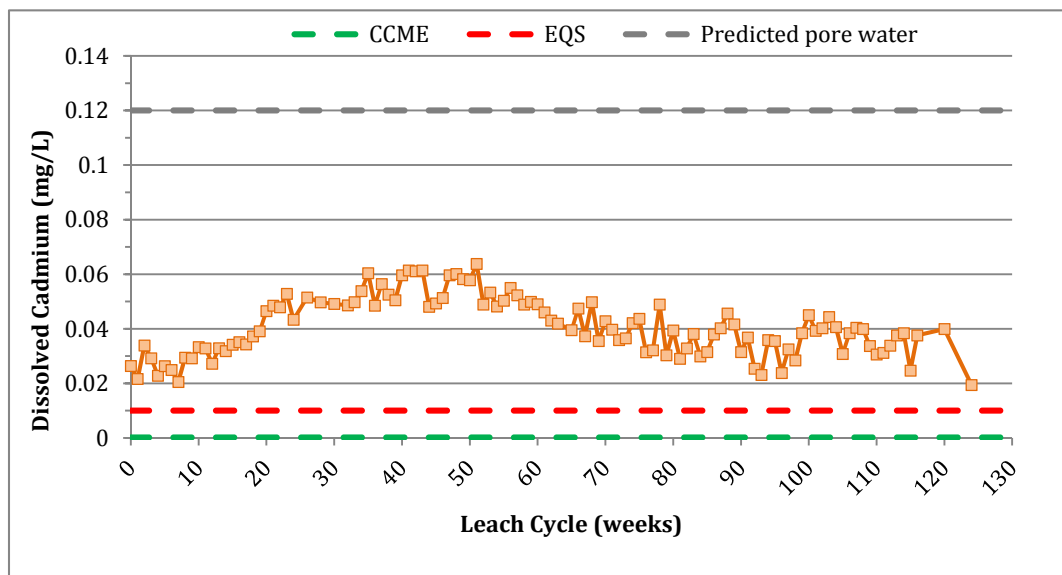
has been consistently above the CCME guideline (0.00015 mg/L for 90 mg/L hardness) and the EQS (0.01 mg/L), but well below the pore water cadmium concentration predicted from the initial metallurgical testing program (0.12 mg/L).

Figure 6-5 Change in humidity cell dissolved cadmium concentration as a function of leach cycle

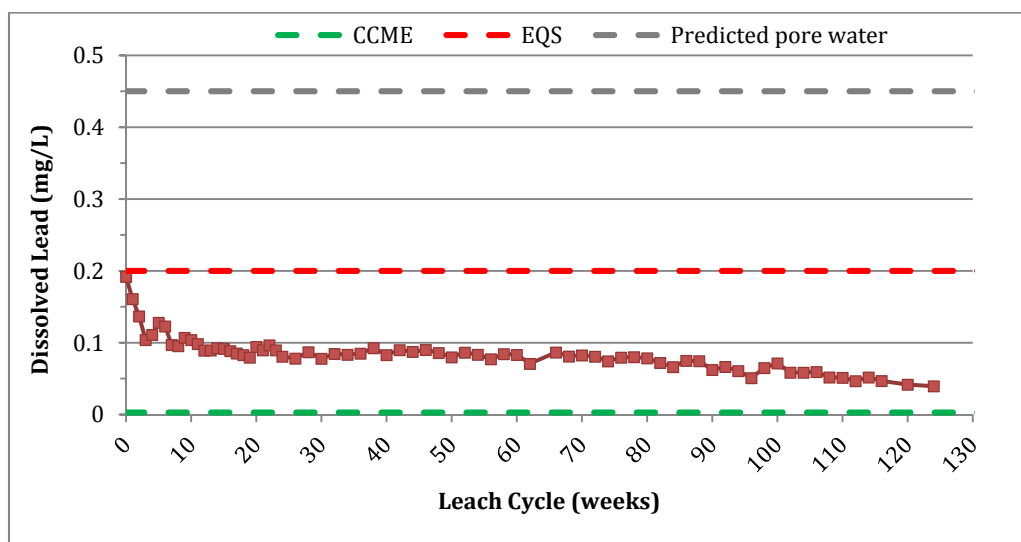
Dissolved lead concentrations in the humidity cell leachate were highest at the beginning of testing with a maximum of 0.2 mg/L in Week 0, but decreased quickly to remain below 0.1 mg/L from Week 10 onwards (Figure 6-6). The dissolved lead has continued to decline slowly, reaching the lowest concentration recorded (0.04 mg/L) at the latest sampling in Week 124. All dissolved lead values were higher than the CCME guideline (0.0028 mg/L for 90 mg/L hardness), but lower than the EQS (0.2 mg/L) and the pore water concentration predicted by metallurgical testing (0.45 mg/L).

Figure 6-6 Change in humidity cell dissolved lead concentration as a function of leach cycle

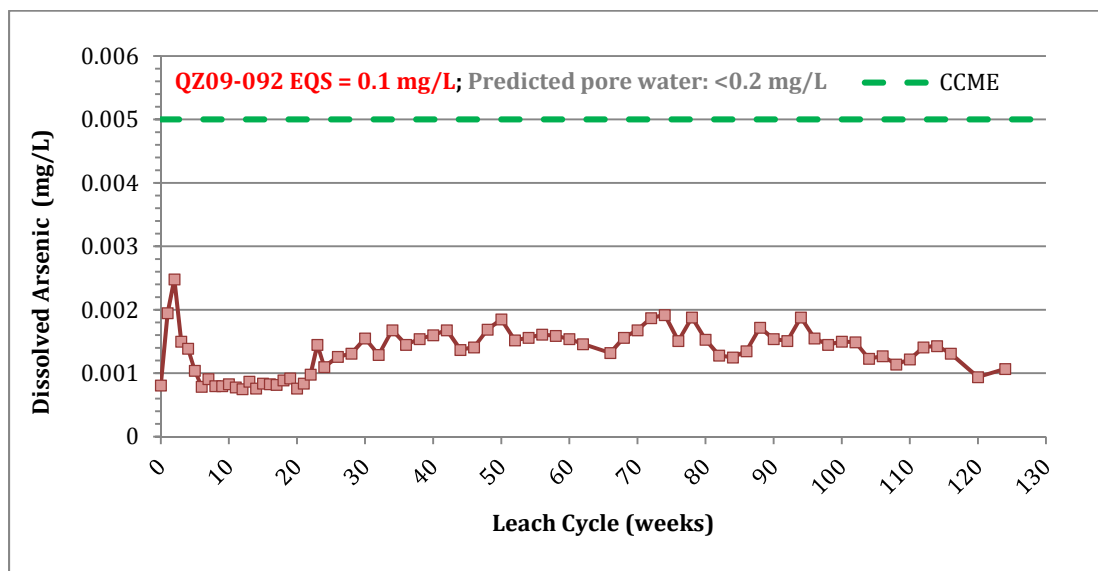
The maximum dissolved arsenic concentration was observed in Week 2 (0.0025 mg/L), which was followed by consistently low arsenic concentrations averaging 0.0008 mg/L between Weeks 5 and 22 (Figure 6-7). Since then, the dissolved arsenic concentration has fluctuated between 0.0009 and 0.0020 mg/L for the remainder of the humidity cell testing conducted to date. All dissolved arsenic concentrations were well below the CCME guideline of 0.005 mg/L and the EQS of 0.1 mg/L. Metallurgical testing predicted pore water arsenic concentrations <0.2 mg/L. Dissolved arsenic concentrations in the humidity cell leachate have been two orders of magnitude below this predicted upper bound.

Figure 6-7 Change in humidity cell dissolved arsenic concentration as a function of leach cycle

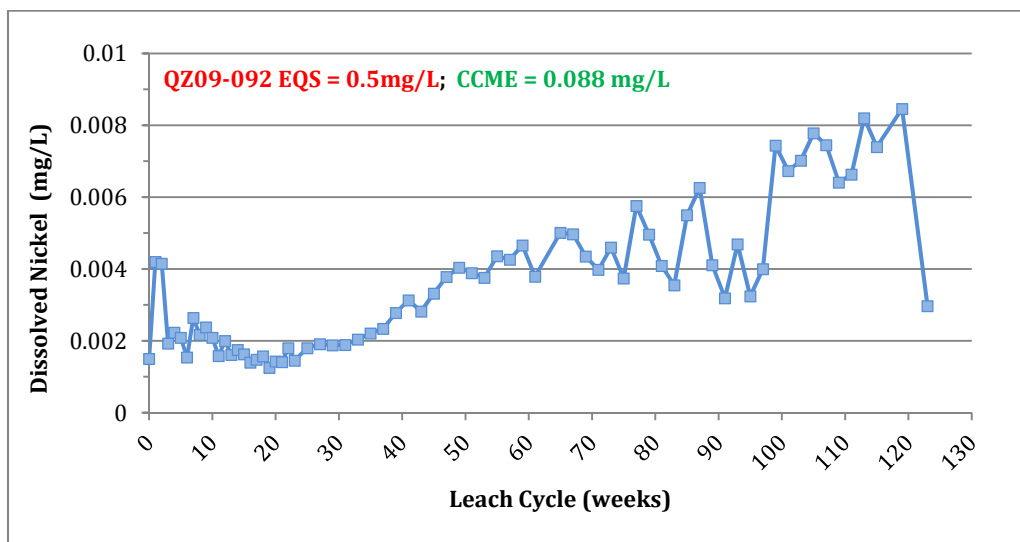
Figure 6-8 Change in humidity cell dissolved nickel concentration as a function of leach cycle

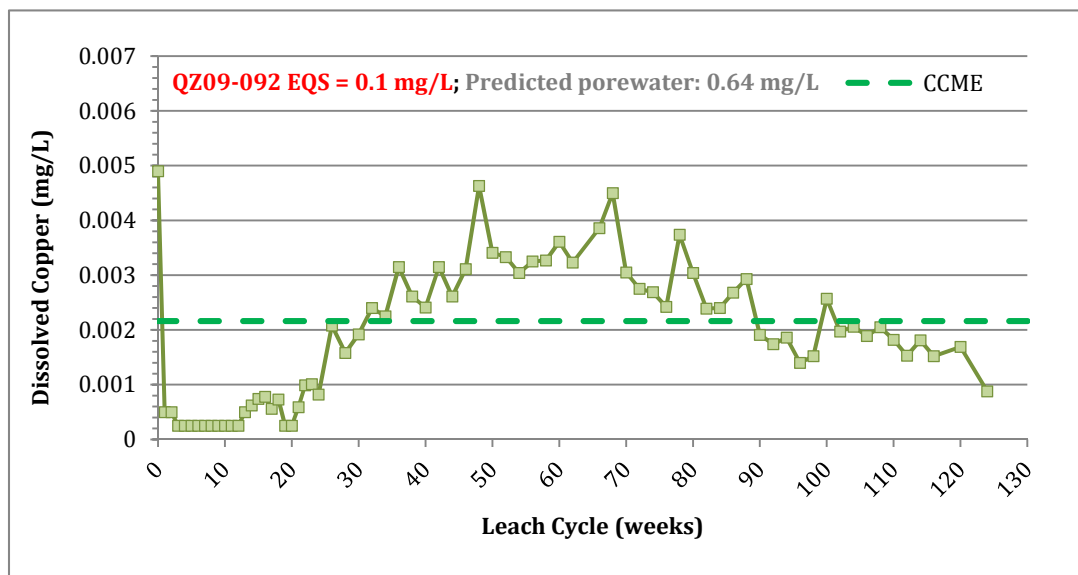
Figure 6-9 Change in humidity cell dissolved copper concentration as a function of leach cycle

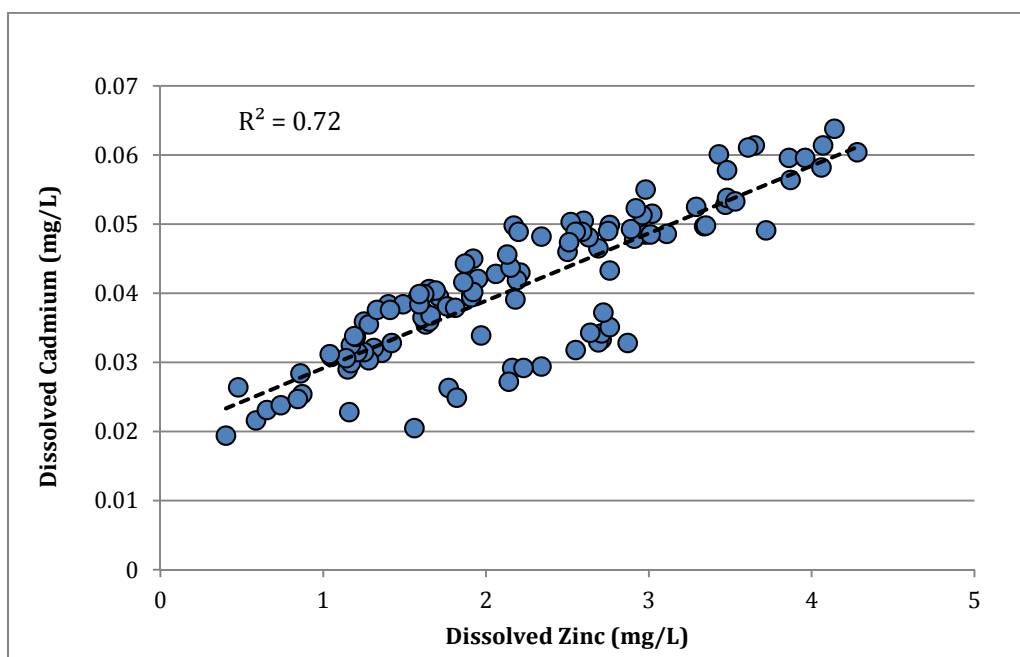
Figure 6-10 Relationship between dissolved cadmium and zinc in humidity cell leachate

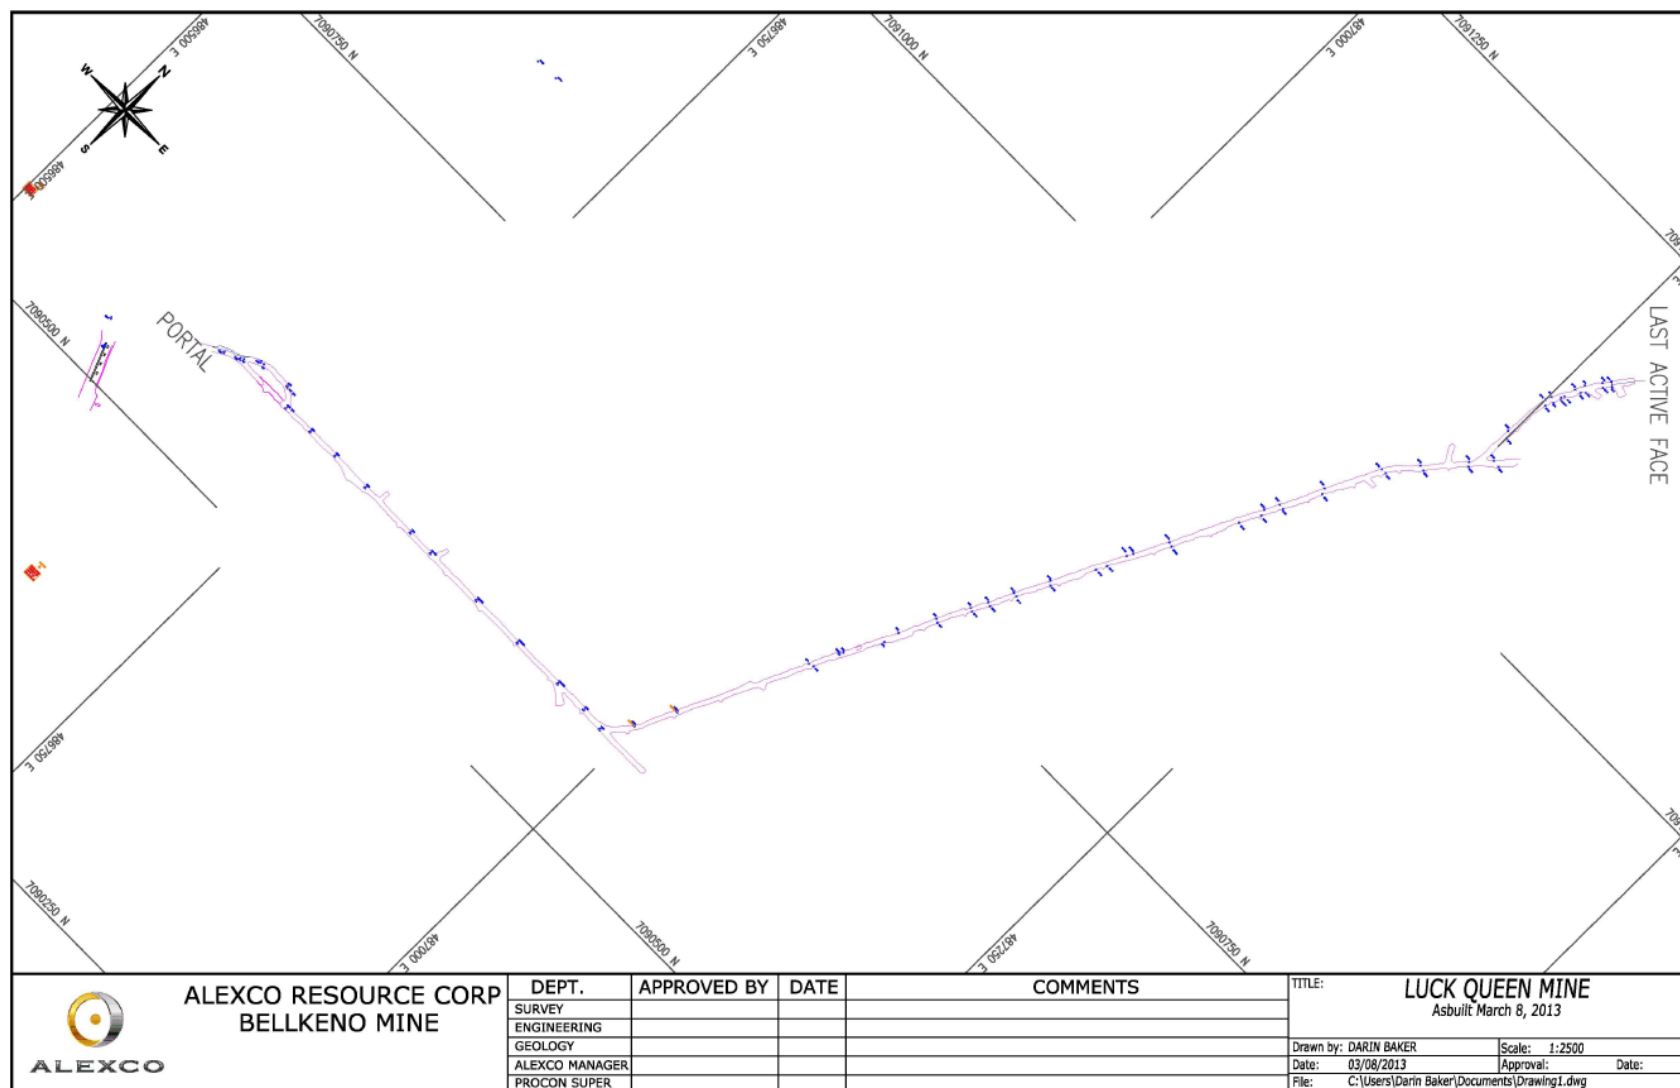
Figure 3. Plan View of Lucky Queen 500 Underground Development As-Built

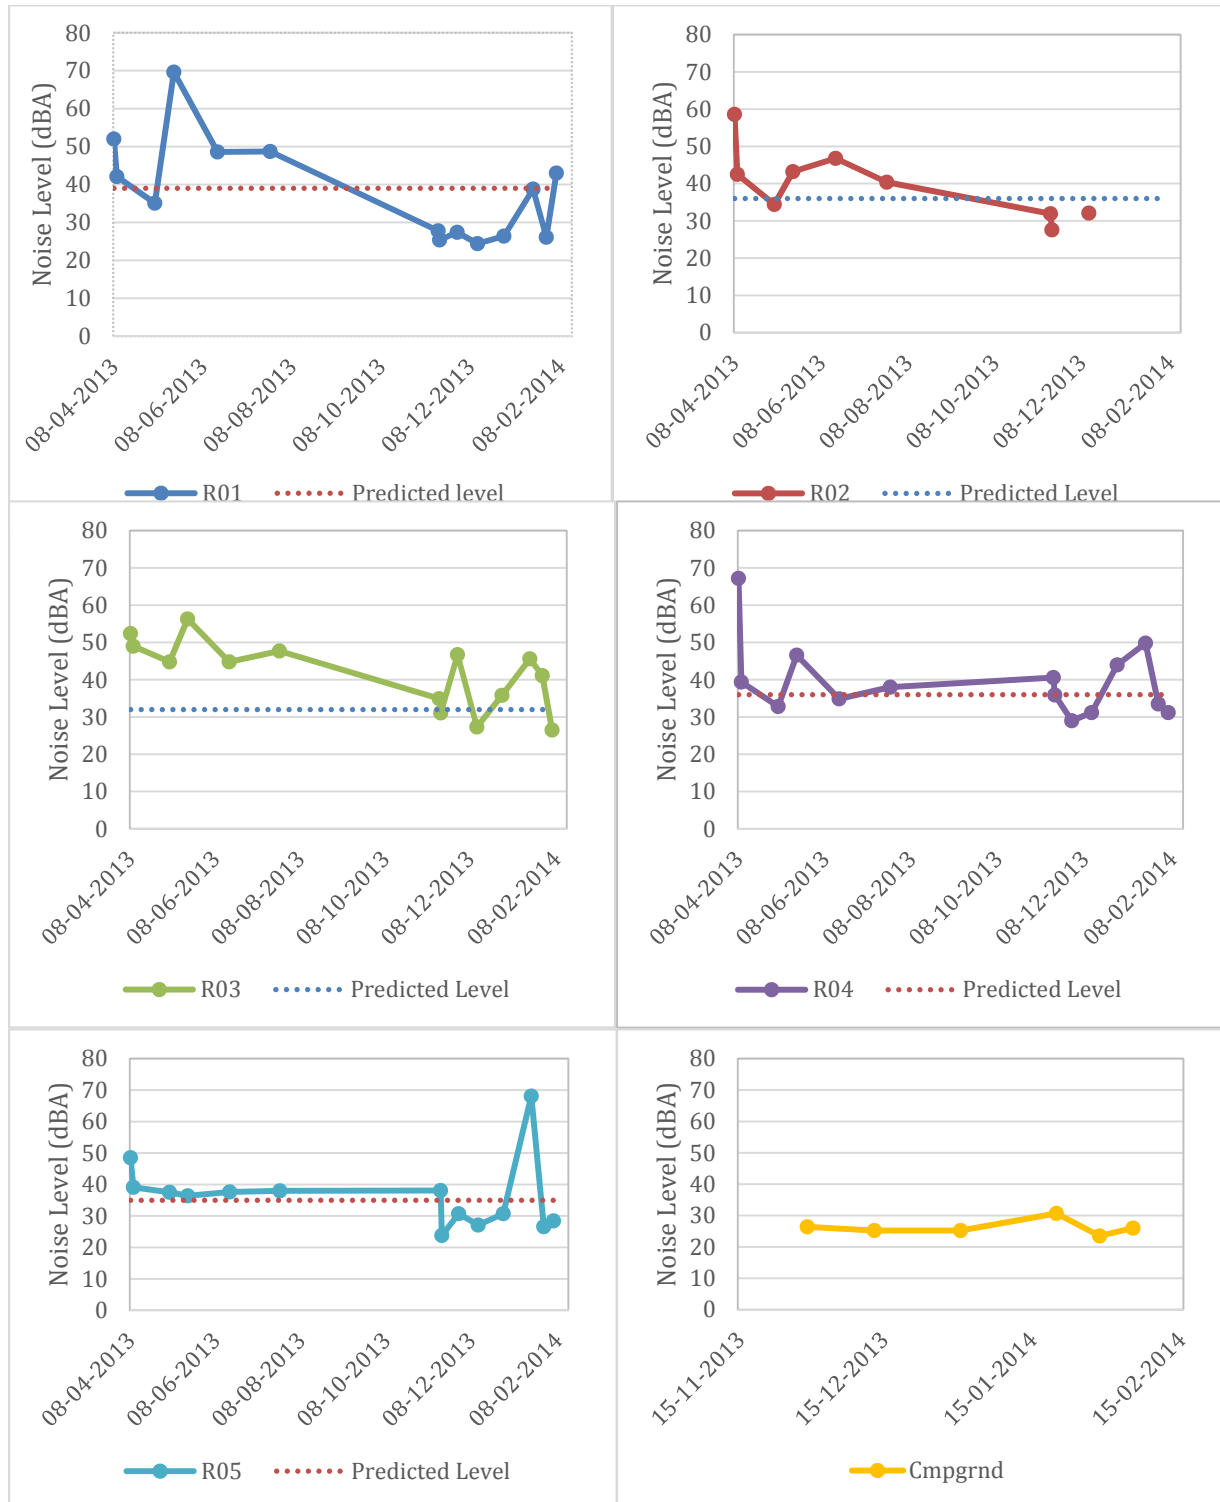
Figure 2 Keno Noise Monitoring Data

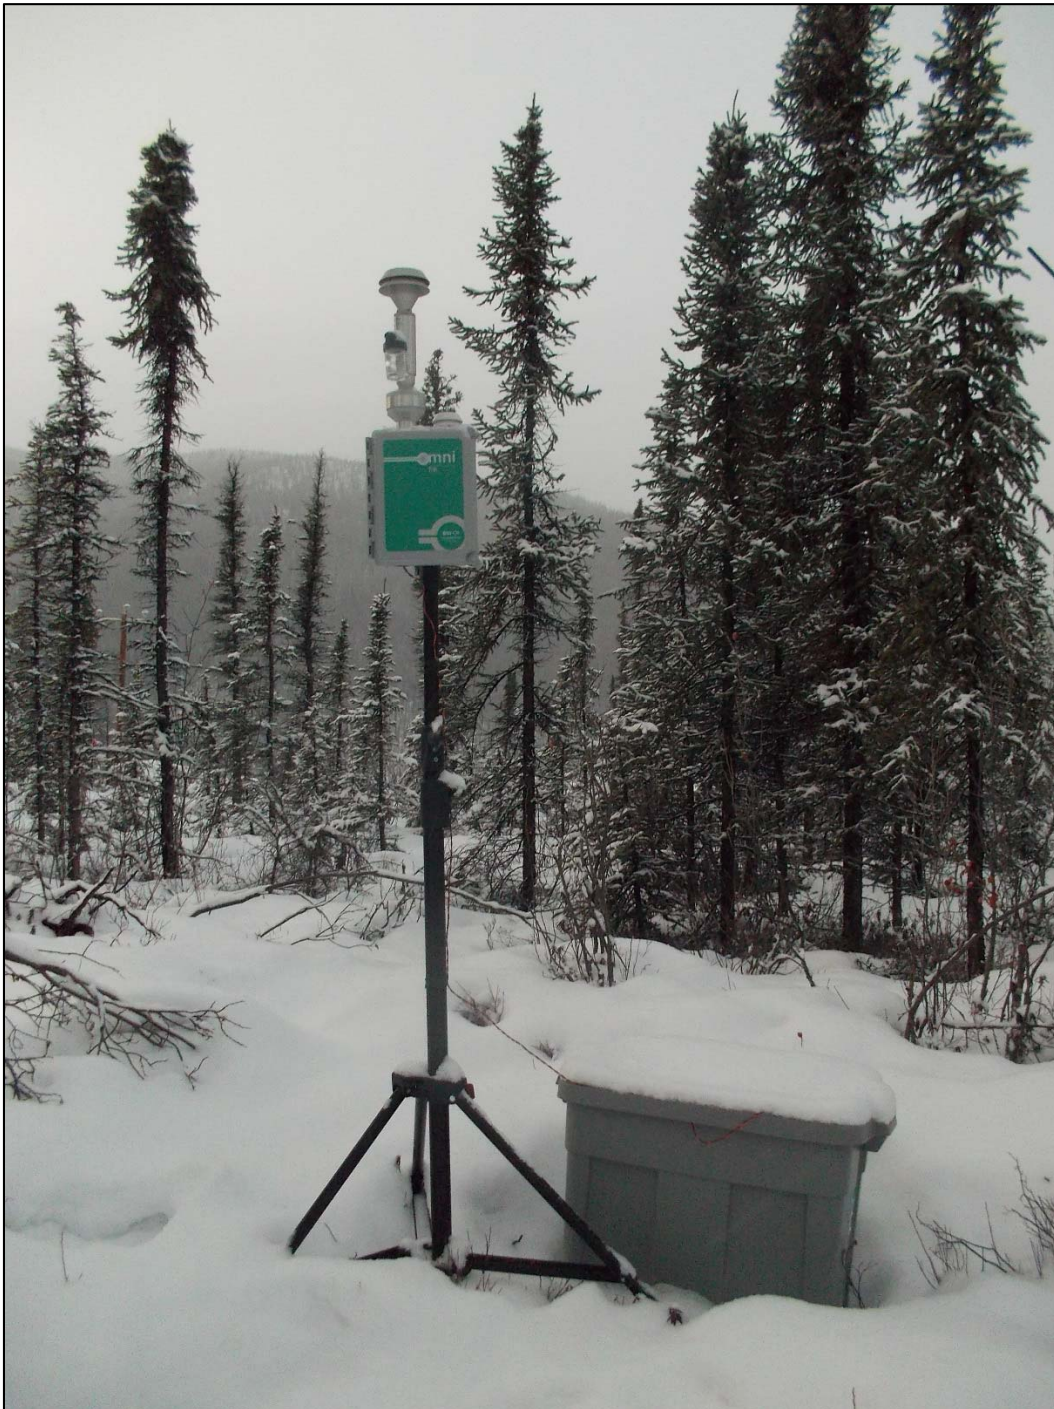
Two BGI Omni Ambient Air Quality Samplers (see Figure 1) were commissioned in August 2012, one to the East of the mill and crusher (TSP-1) and one at the toe of the dry stack tailings facility (TSP-2). The locations are shown on Figure 2. The BGI Omni samplers are set up with Total Suspended Particulates (TSP) inlets, and use the filter reference method. Samples are collected over 24-hour periods and sent to Maxxam Analytics laboratory for gravimetric analysis and ICP metals mass spectrometry. Four samples per location are collected every month, in order to capture the different weather conditions that may affect dust sources and transport. The BGI Omni Ambient Air Quality Samplers cannot collect samples below -20°C and therefore some winter months will have reduced data collected.

Figure 1 BGI Omni Ambient Air Quality Sampler

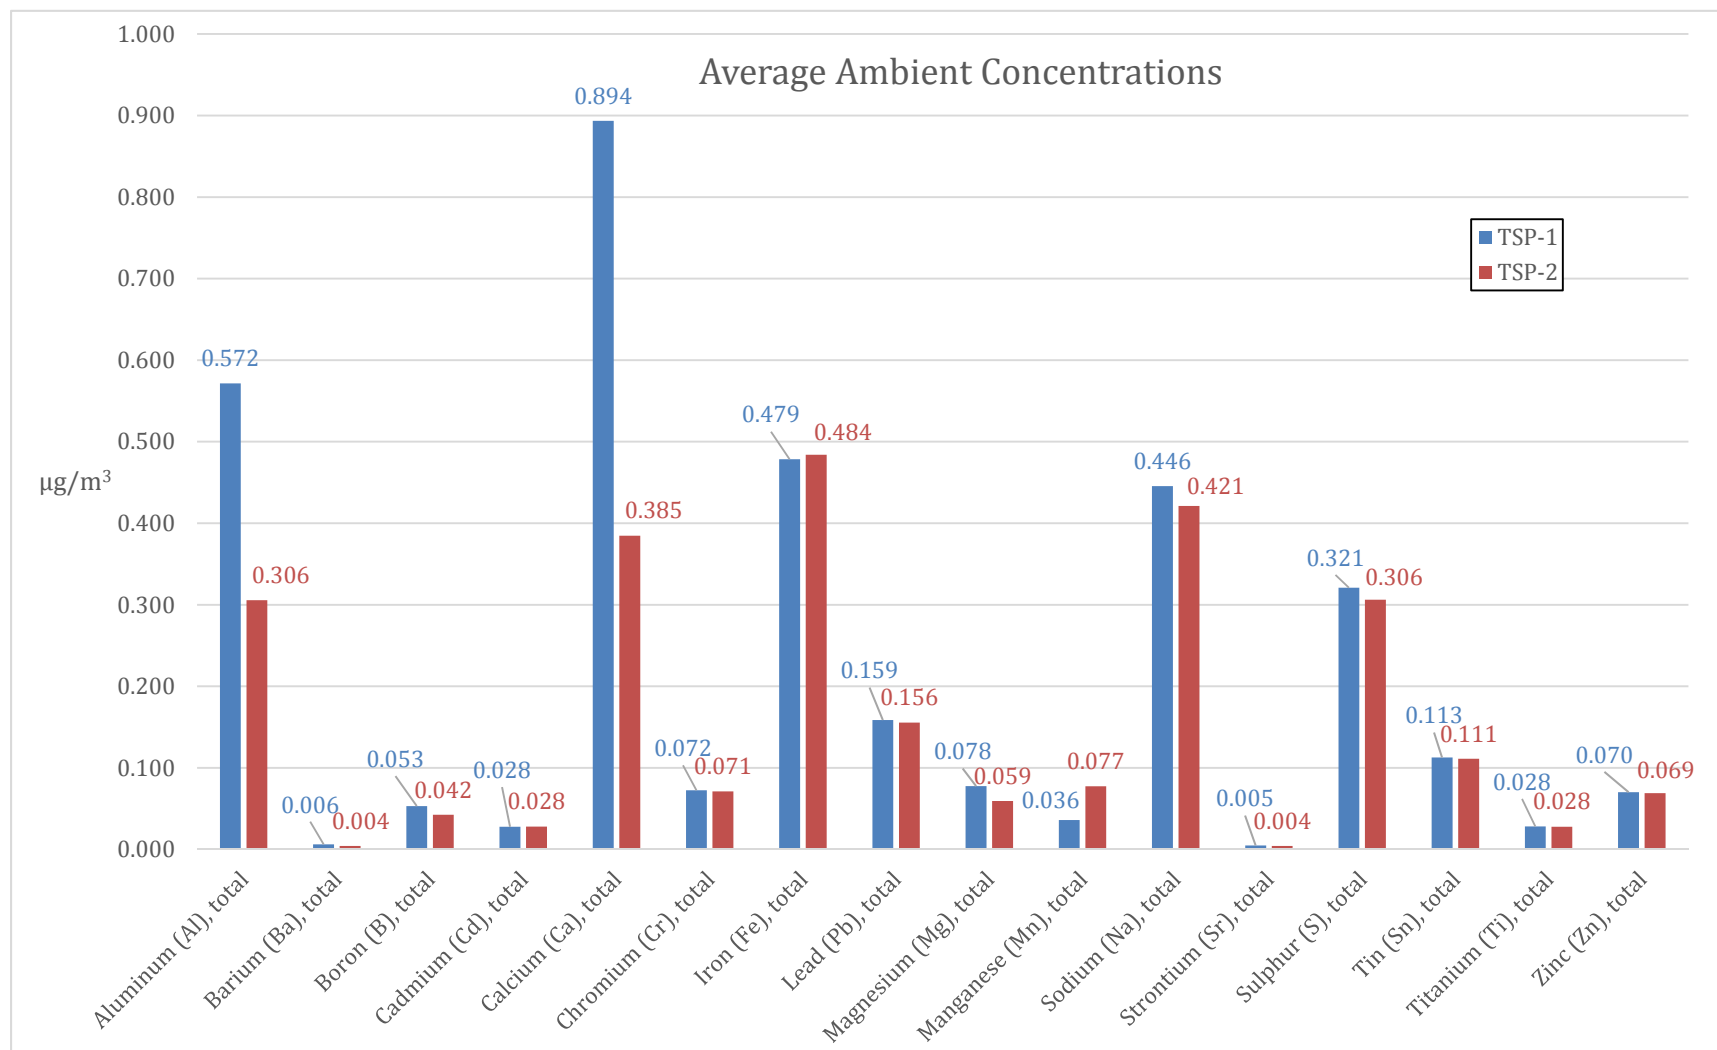
Figure 4 Average Ambient Metal Concentrations
