## **2015-2016 VEGETATION BASELINE REPORT**

### **KUDZ ZE KAYAH MINE PROJECT**

BMC-16-01-345\_002\_Vegetation Baseline Report\_RevB\_161205

December 2016

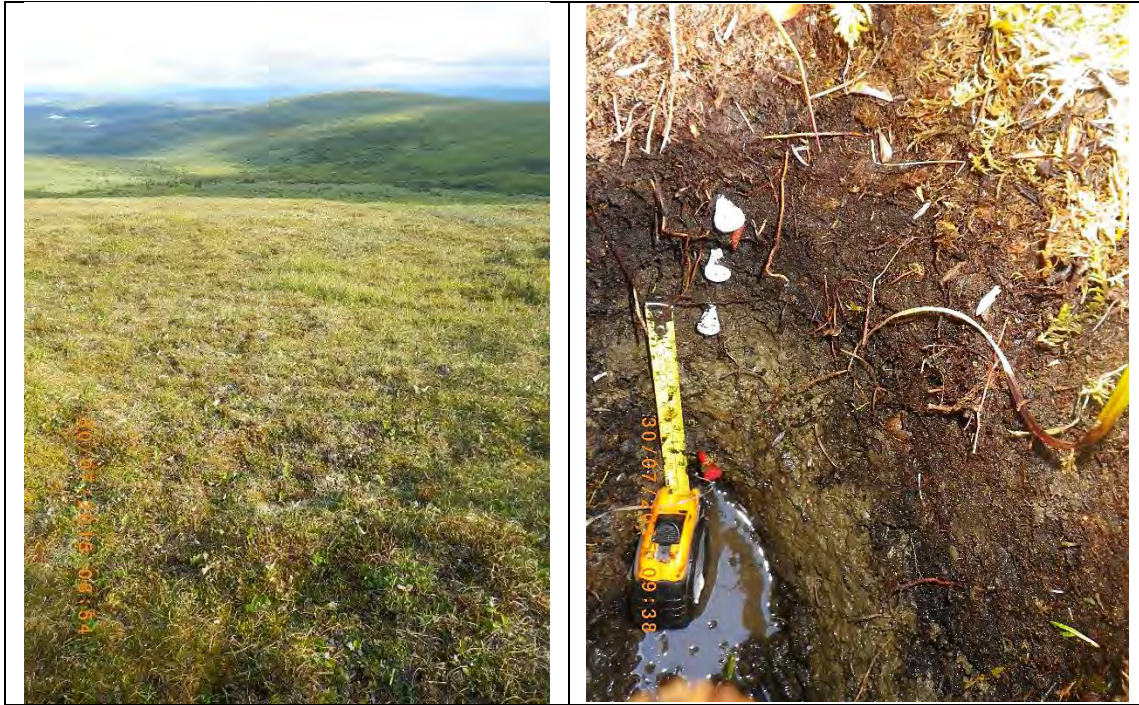
Plot PA04

Vegetation cover	20 Dwarf shrubs, 30 Graminoid, 25 bryophytes
Age in years (dominant species)	N/A
Polygon Number	73
Site Code	(10) 31SZ-SireCxMo-3b
Soil moisture and nutrient values (SNR/SMR)	C/5
Soil Classification	OD.TC
Soil Texture	SL
Surficial material	Colluvium veneer over bedrock (R.dsCv)
Crown cover for polygon in %	N/A
Structural Stage	2b/2d
Aspect (°)	340
Elevation (m)	1664
Slope %	13
Meso slope position	Upper
Drainage	I
Samples	Soil

**Site description:** Gentle rolling alpine tundra, N aspect,

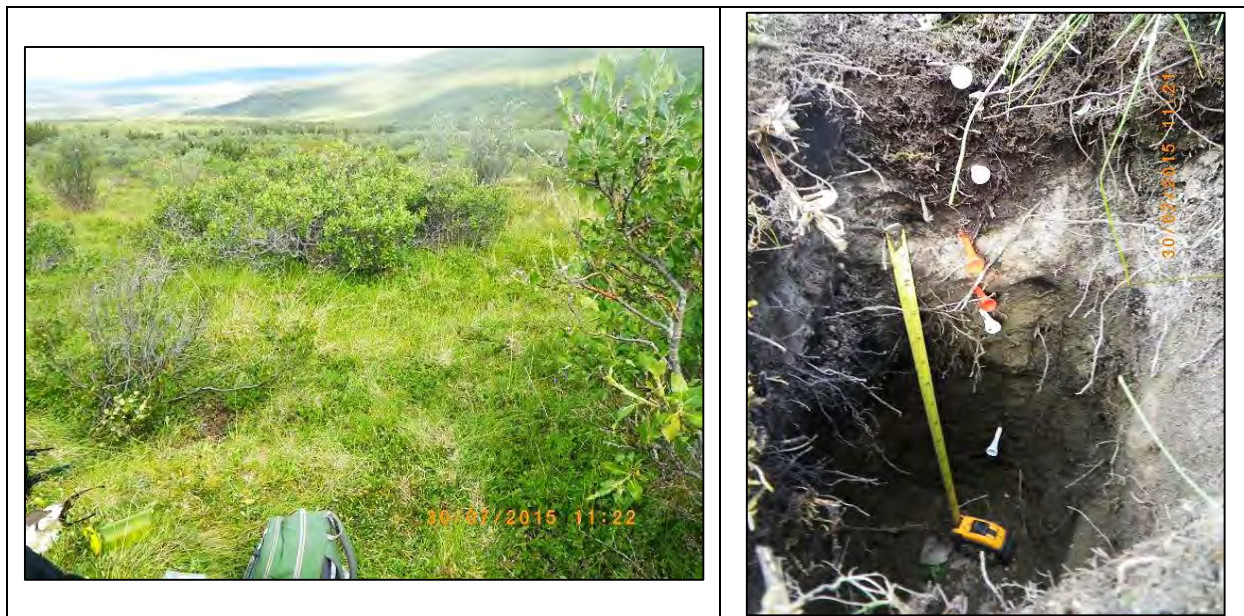
Plot PA05

Vegetation cover	50% low willows, 40 Graminoid, 40 Herb, 20 Dwarf shrubs
Age in years (dominant species)	N/A
Polygon Number	74
Site Code	(8) 33-WiFbCx-3b / (2) 31SZ-SireCxMo-2b-C/R
Soil moisture and nutrient values (SNR/SMR)	D/4
Soil Classification	BRD.TC
Soil Texture	SL
Surficial material	Colluvium veneer over bedrock (R.dsCv)
Crown cover for polygon in %	N/A
Structural Stage	2a/b, 3
Aspect (°)	350
Elevation (m)	1576
Slope %	10
Meso slope position	Upper
Drainage	MW
Samples	Soil, grass, willow

**Site description:** Gentle sloped sub-alpine shrub/meadow mosaic, frost generated hummocks present, N aspect.

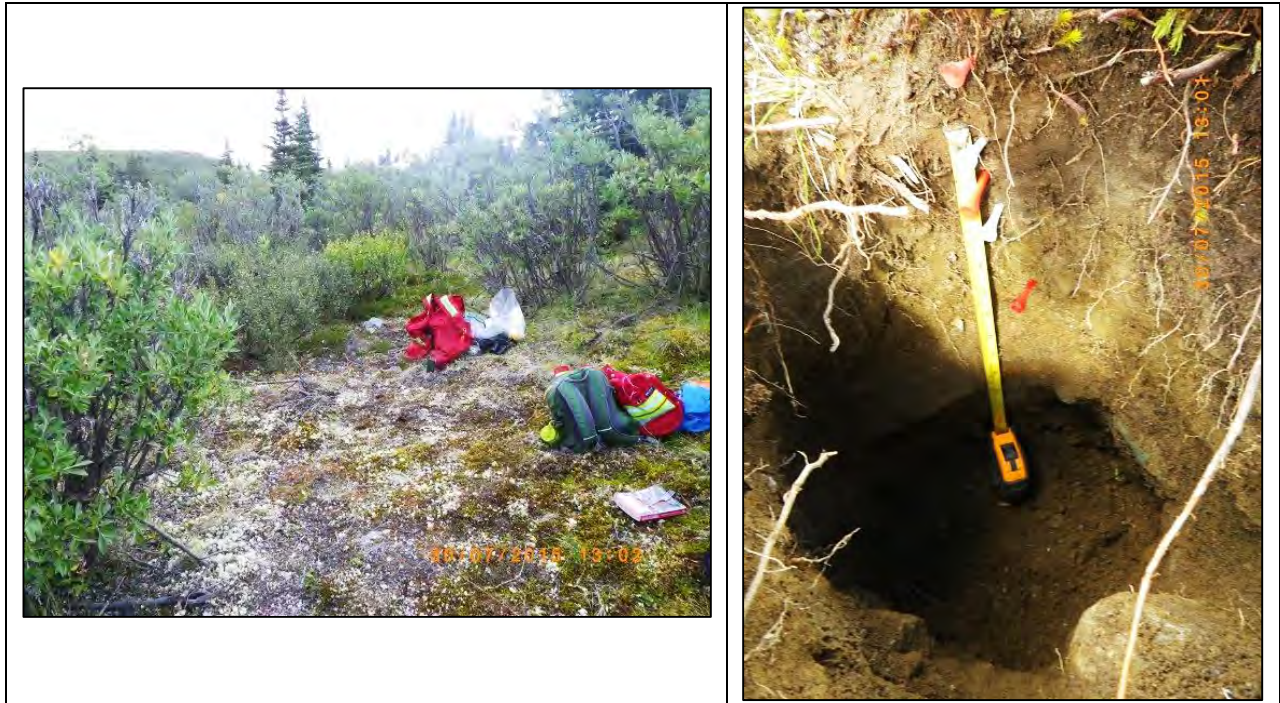
Plot PA06

Vegetation cover	15 Fir, 30 shrub birch, 15 willow, 50 moss, 15 lichen
Age in years (dominant species)	Approx. 120 SF
Polygon Number	75
Site Code	(6) 01-EsWiFm-3b / (2) 01SZ-FEsWiFm-6-C/M / (2) 48OZ-CxGrFbMo-2b
Soil moisture and nutrient values (SNR/SMR)	B/3
Soil Classification	OD.SC
Soil Texture	SL
Surficial material	Colluvium veneer over morainal (xCv/dsMb)
Crown cover for polygon in %	15
Structural Stage	3/6
Aspect (°)	352
Elevation (m)	1497
Slope %	8
Meso slope position	Mid
Drainage	W
Samples	Soil, grass, willow

**Site description:** Gentle sloped subalpine parkland, below treeline.

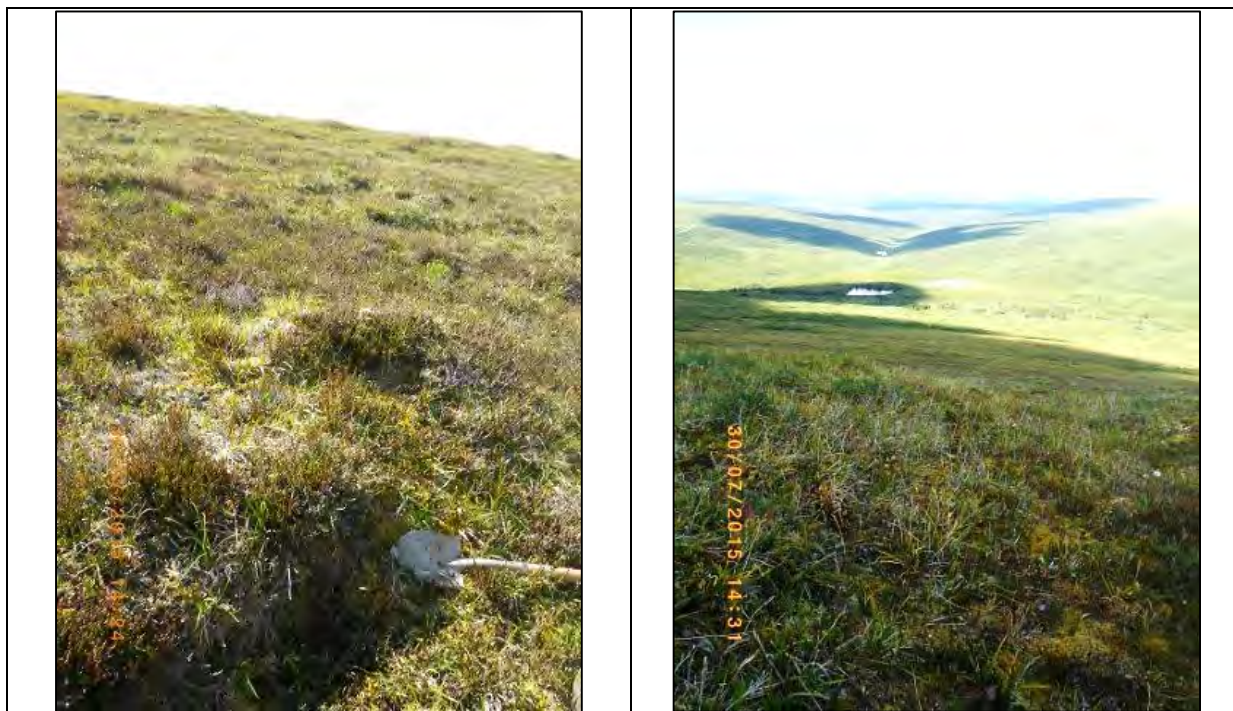
Plot PA07

Vegetation cover	30 Graminoid, 35 Dwarf shrub, 15 moss
Age in years (dominant species)	N/A
Polygon Number	50
Site Code	(8) 21SZ-EsDsGr-w-2d / (2) 01-WiEsDsLu-3a-C
Soil moisture and nutrient values (SNR/SMR)	B/5(4)
Soil Classification	BRE.TC
Soil Texture	SL
Surficial material	Colluvium veneer over bedrock (gsxCv/R)
Crown cover for polygon in %	N/A
Structural Stage	2b/d
Aspect (°)	8
Elevation (m)	1667
Slope %	18
Meso slope position	Upper
Drainage	MW
Samples	Soil, willow

**Site description:** Gentle sloped alpine tundra, solifluction present

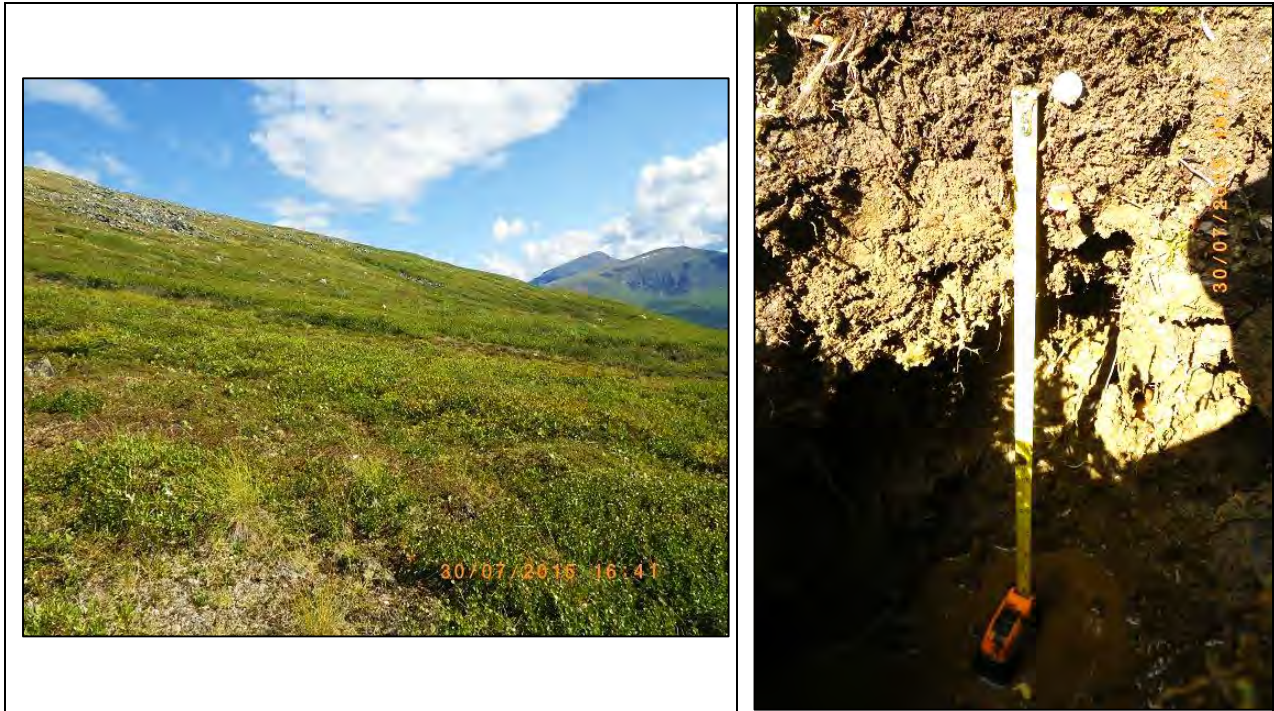
Plot PA08

Vegetation cover	35 Shrub birch, 35 Dwarf shrub, 20 Graminoid
Age in years (dominant species)	N/A
Polygon Number	25
Site Code	(7) 13G-EsGrLi-3a / (3) 33-WiFbCx-3b-C
Soil moisture and nutrient values (SNR/SMR)	B/3
Soil Classification	BRD.TC
Soil Texture	SL
Surficial material	Colluvium veneer over bedrock (gsxCv/R)
Crown cover for polygon in %	N/A
Structural Stage	2d/3a
Aspect (°)	242
Elevation (m)	1690
Slope %	28
Meso slope position	Upper
Drainage	I
Samples	Soil, willow

**Site description:** Moderate sloped alpine tundra, solifluction present, SWW aspect, exposed rock and gravel ~10%. Soil pit located in small drainage hidden by overlying rocks, not representative of plot moisture regime.

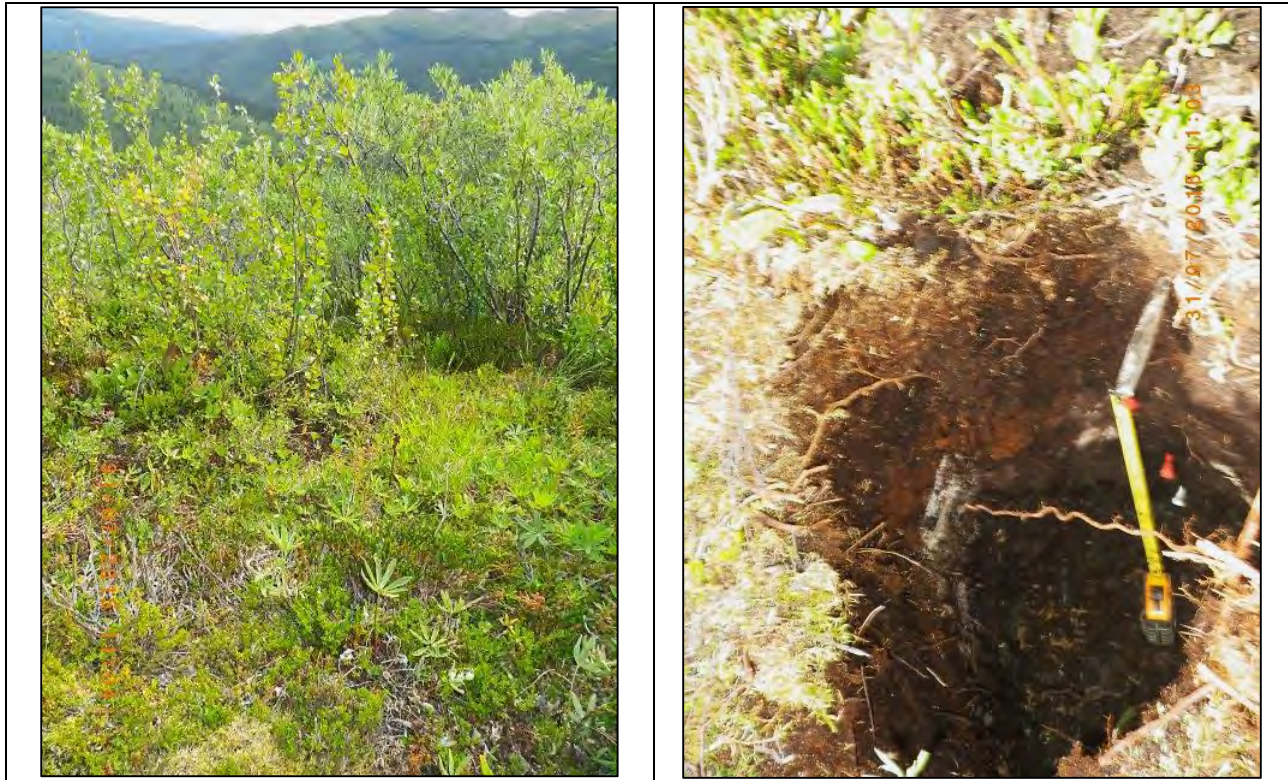
Plot PA10

Vegetation cover	60 shrub- 20 herb
Age in years (dominant species)	N/A
Polygon Number	243
Site Code	(7) 01-EsWiFm-3b / (3) 01-FSwEsWiFm-F
Soil moisture and nutrient values (SNR/SMR)	C/4
Soil Classification	BRE.TC
Soil Texture	SL
Surficial material	Colluvium veneer over Morainal (gsxCv/M)
Crown cover for polygon in %	N/A
Structural Stage	3
Aspect (°)	65
Elevation (m)	1440
Slope %	22
Meso slope position	Mid
Drainage	W
Samples	Soil, Willow, Blueberries

**Site description:** Gentle sloped sub-alpine near treeline, solifluction present, NEE aspect.

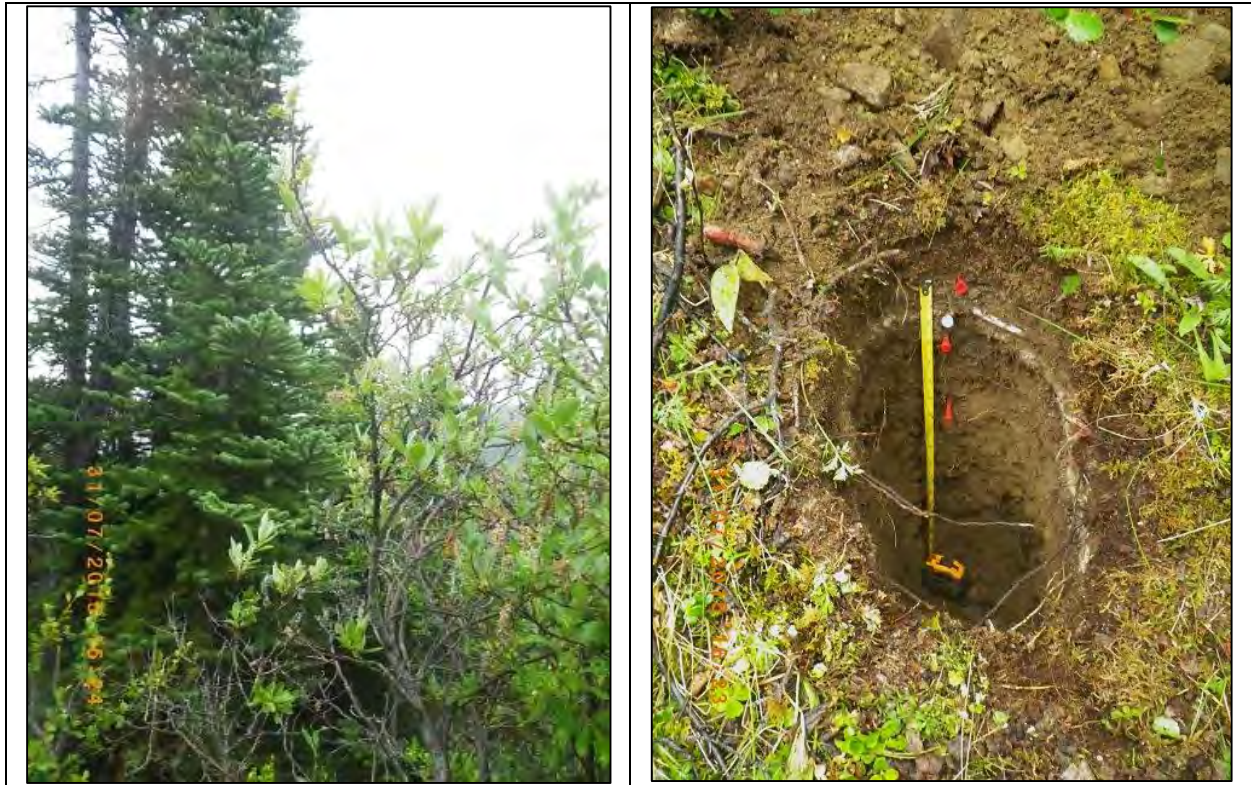
Plot PA12

Vegetation cover	85 Tall shrub- 90 herb (10 tree)
Age in years (dominant species)	Approximate 100
Polygon / Site Code	*outside mapped area
Soil moisture and nutrient values (SNR/SMR)	C/4
Soil Classification	BRD.TC
Soil Texture	SL
Surficial material	Morainal (szMv/R)
Crown cover for polygon in %	10
Structural Stage	3b (Sub-alpine fir=6)
Aspect (°)	235
Elevation (m)	1477
Slope %	26
Meso slope position	Upper
Drainage	MW
Samples	Soil (duplicate collected), willow, grass

**Site description:** West facing moderate sloped sub-alpine parkland. Control plot.

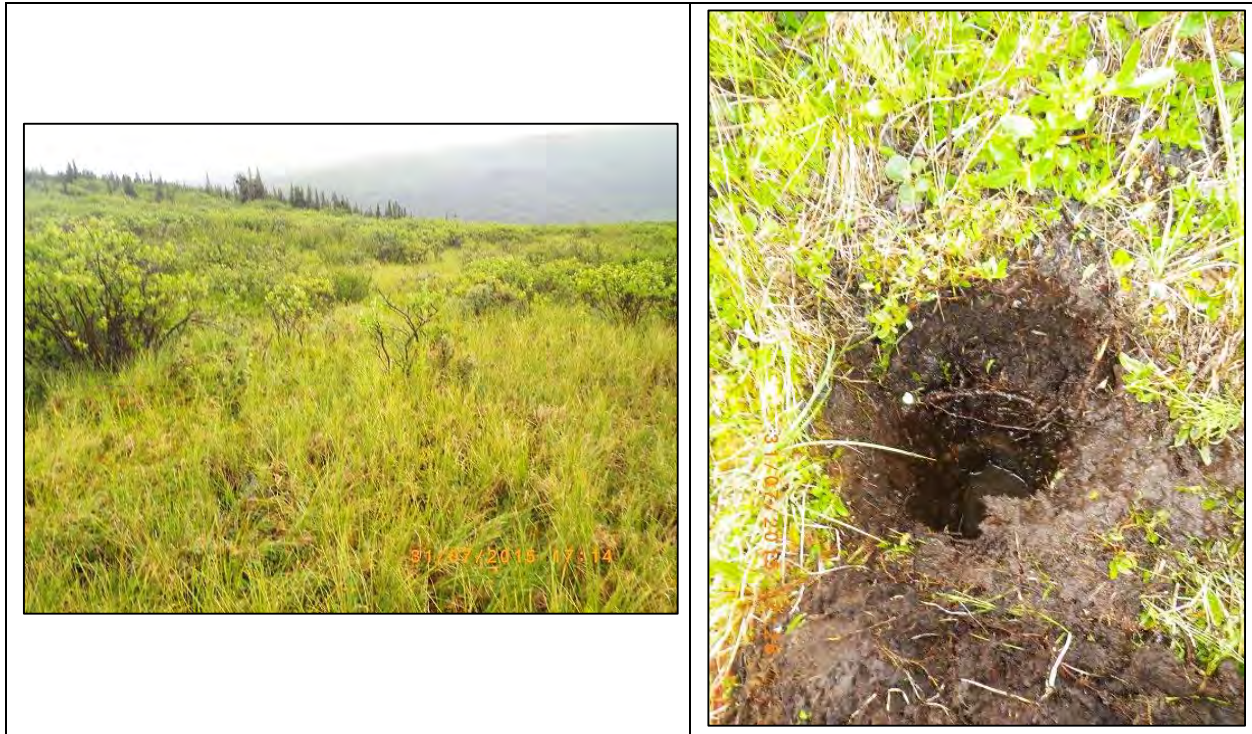
Plot PA13

Vegetation cover	70 Sedge 35 willow 60 moss
Age in years (dominant species)	N/A
Polygon Number	234
Site Code	(7) 01-EsWiFm-3b / (3) 01-FSwEsWiFm-F
Soil moisture and nutrient values (SNR/SMR)	B/7
Soil Classification	HU.MC
Soil Texture	organic
Surficial material	(hObd/F <sup>6</sup> )
Crown cover for polygon in %	N/A
Structural Stage	2b/3
Aspect (°)	112
Elevation (m)	1421
Slope %	5
Meso slope position	Depression
Drainage	P
Samples	No soil – organics, Horsetail

**Site description:** Wet meadow dominated by water sedge and low willows. Control plot.

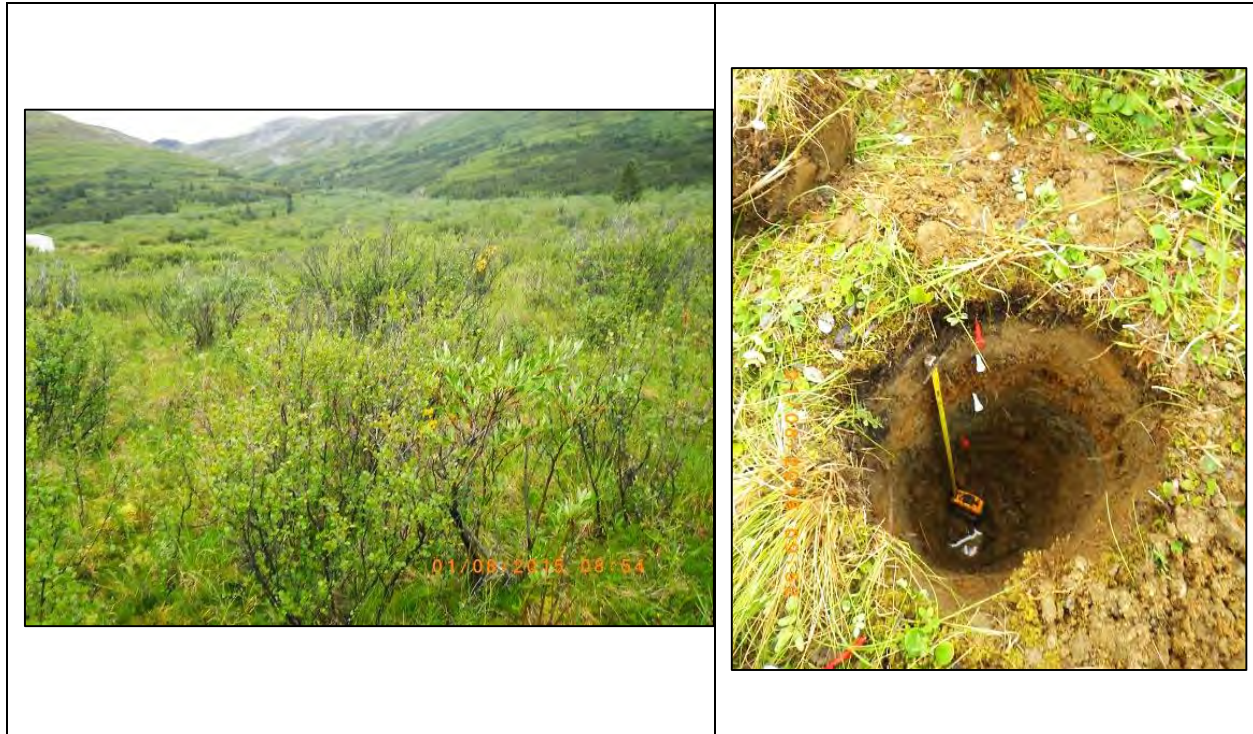
Plot PA14

Vegetation cover	70 willow/birch 40 Graminoids 30 Herb
Age in years (dominant species)	N/A
Polygon Number	33
Site Code	(10) 01-EsWiFm-3a-C/Gf
Soil moisture and nutrient values (SNR/SMR)	C/6
Soil Classification	GL.EB
Soil Texture	LS
Surficial material	sgmFGf
Crown cover for polygon in %	N/A
Structural Stage	2b,c/3b
Aspect (°)	88
Elevation (m)	1377
Slope %	6
Meso slope position	Depression
Drainage	Imperfect
Samples	Soil, grass roots, horsetail, willow

**Site description:** Moist shrub/meadow mosaic at pass, within mine pit footprint. Alluvial fan from Fault Creek.

**Soils:** Not effected by permafrost. Gleyed Eutric Brunisol (GL.EB) on F<sup>G</sup> alluvial fan.

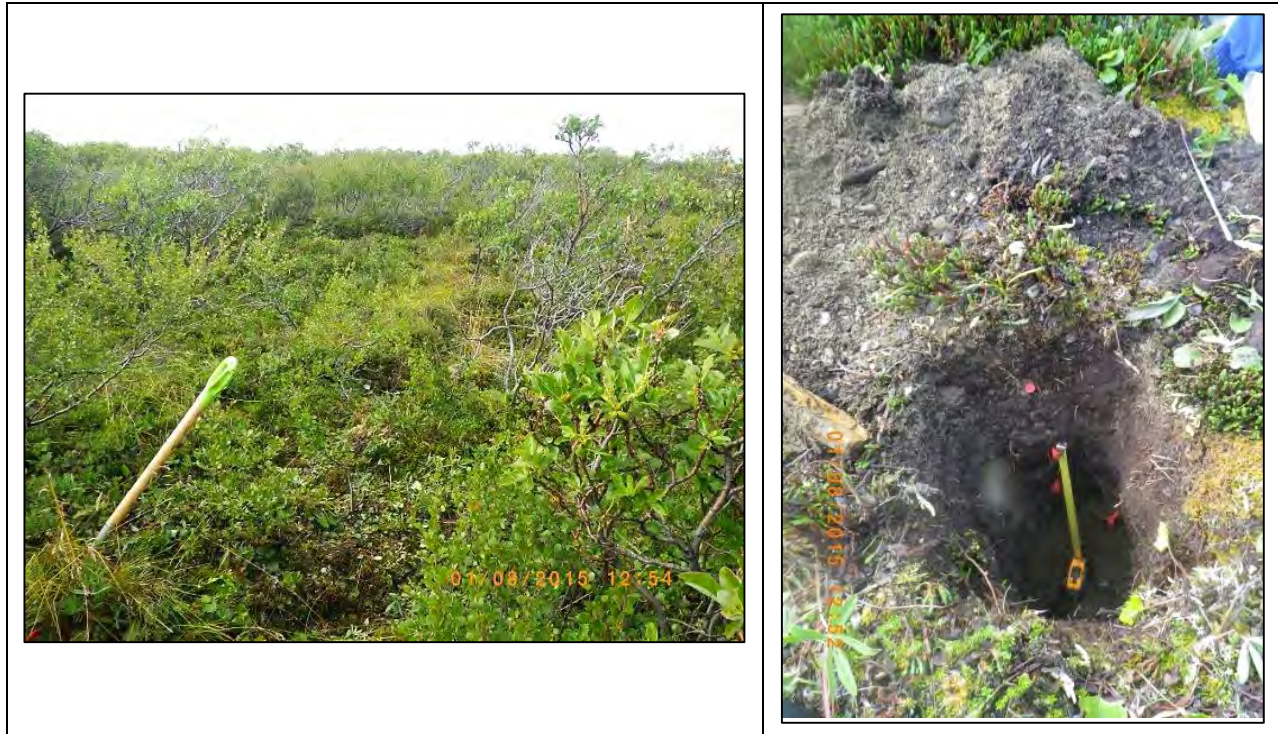
Plot PA15

Vegetation cover	70 willow/birch 40 Graminoids 30 Herb
Age in years (dominant species)	N/A
Polygon Number	80
Site Code	(8) 11S-EsLi-3b/2a-M / (2) TA
Soil moisture and nutrient values (SNR/SMR)	B/4(3)
Soil Classification	O.EB
Soil Texture	LS
Surficial material	dszCv-Mb
Crown cover for polygon in %	N/A
Structural Stage	3b, 2c/d
Aspect (°)	54
Elevation (m)	1454
Slope %	20
Meso slope position	Upper
Drainage	Well
Samples	Soil, willow, blueberries, grass roots

**Site description:** Gentle NEE facing slope at 100m above road.

**Soils:** Not effected by permafrost. Orthic Eutric Brunisol (O.EB) on colluvium veneer over morainal till, 35% c.f..

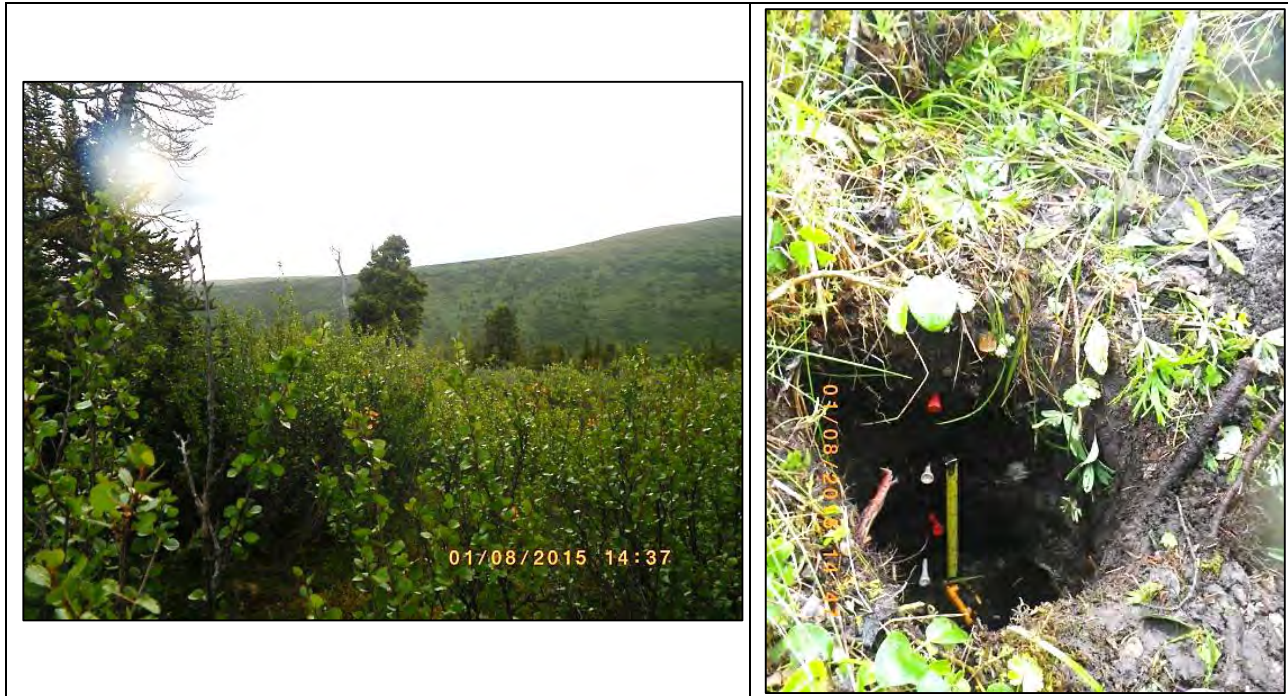
Plot PA16

Vegetation cover	15 Fir 70 willow/birch 70 Herb
Age in years (dominant species)	N/A
Polygon Number	78
Site Code	(9) 01SZ-FEsWiFm-3a / (1) 11S-EsLi-3a-C/Gf
Soil moisture and nutrient values (SNR/SMR)	B/4(3)
Soil Classification	OE.TC
Soil Texture	SL
Surficial material	dszCv-Mb
Crown cover for polygon in %	15
Structural Stage	6 /3a
Aspect (°)	103
Elevation (m)	1442
Slope %	20
Meso slope position	Mid
Drainage	Moderately Well
Samples	Soil, willow, grass

**Site description:** Gentle E facing slope at 100m below road where mill site is proposed. Strongly mounded, frost boils likely.

**Plant community:** Mature Sub-alpine fir at site, old growth white spruce at lower elevation ~1400m. Low shrub- birch/willow dominant cover. Rich moist site, high diversity of herbs.

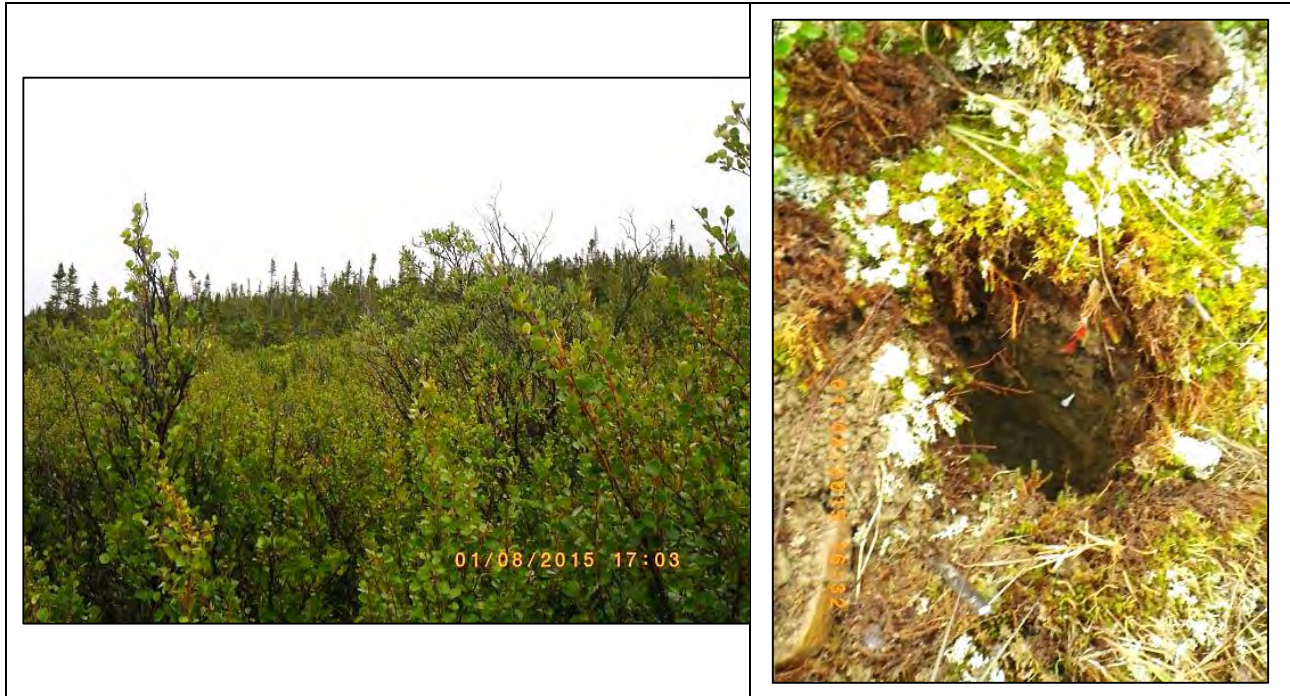
**Plot PA17a (Sample Site)**

Vegetation cover	Low shrub birch-moss-lichen
Age in years (dominant species)	N/A
Polygon Number	68
Site Code	(10) Wi-3b-F/M
Soil moisture and nutrient values (SNR/SMR)	B/3
Soil Classification	O.EB
Soil Texture	SL
Surficial material	szmF <sup>ch</sup>
Crown cover for polygon in %	N/A
Structural Stage	3a
Aspect (°)	100
Elevation (m)	1370
Slope %	20
Meso slope position	Lower
Drainage	Well
Samples	Soil, grass leaves, willow

**Site description:** Large mound or hummock, drier relative to lower contiguous mountain slope.

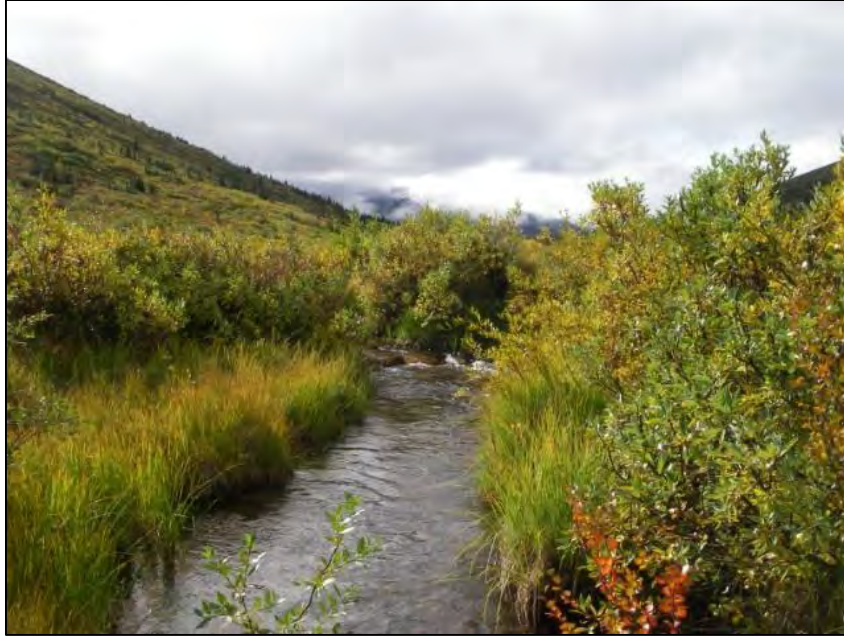
Plot PA17

Vegetation cover	Willow(birch)-Water sedge-Sphagnum
Age in years (dominant species)	N/A
Polygon Number	68
Site Code	(10) Wi-3b-F/M
Soil moisture and nutrient values (SNR/SMR)	D/7
Soil Classification	Of
Soil Texture	Organic
Surficial material	sgmF-active
Crown cover for polygon in %	3a
Structural Stage	3B
Aspect (°)	N/A
Elevation (m)	1359
Slope %	2
Meso slope position	Depression
Drainage	Poorly
Samples	None

**Site description:** Along west side of Genoa Creek, strongly mounded. Site of proposed tailings pond.

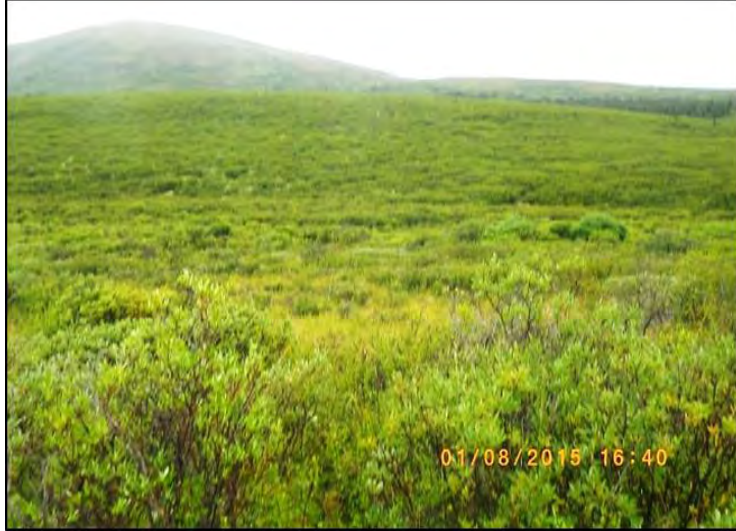
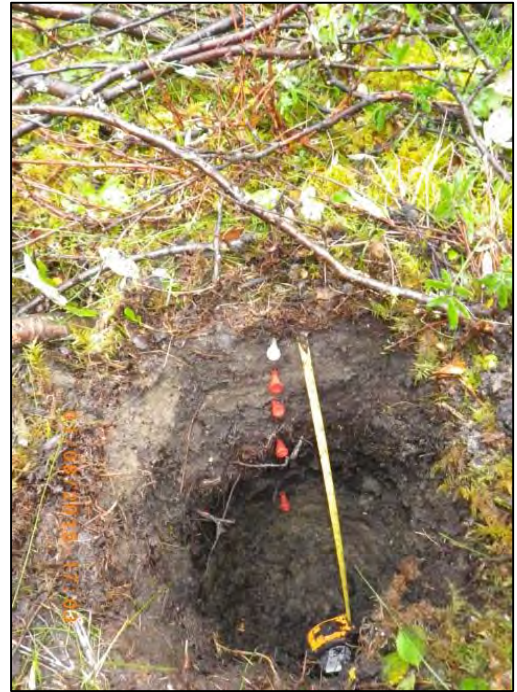
Plot PA18

Vegetation cover	Shrub birch-feathermoss
Age in years (dominant species)	N/A
Polygon Code	69
Site Code	(6) 23SZ-EsWiEmni-3b / (4) 01SZ-FEsWiFm-6-C/M
Soil moisture and nutrient values (SNR/SMR)	C/5
Soil Classification	BRE.TC
Soil Texture	SL
Surficial material	Glaciofluvial
Crown cover for polygon in %	N/A
Structural Stage	3b
Aspect ( <sup>0</sup> )	270
Elevation (m)	1365
Slope %	18
Meso slope position	Lower
Drainage	Imperfectly
Samples	Soil, willow

**Site description:** West facing slope

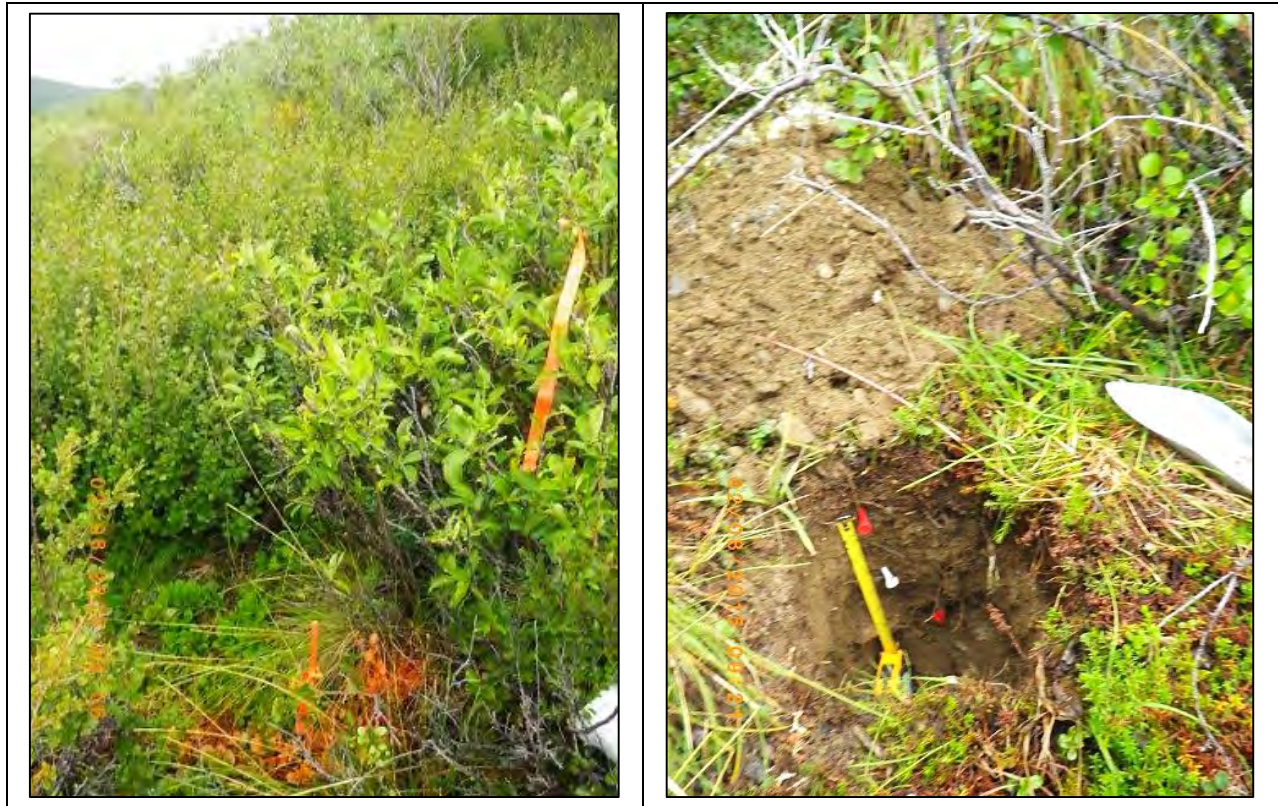
Plot PA19

Vegetation cover	Shrub birch/Willow-Dwarf shrub-feathermoss
Age in years (dominant species)	N/A
Polygon / Site Code	Outside Mapped area
Soil moisture and nutrient values (SNR/SMR)	B/4 (3)
Soil Classification	BRD.TC
Soil Texture	L
Surficial material	Glaciofluvial
Crown cover for polygon in %	1
Structural Stage	3a
Aspect (°)	222
Elevation (m)	1448
Slope %	24
Meso slope position	Mid
Drainage	Moderately well
Samples	Soil, willow, grass roots

**Site description:** Control plot, same elevation, exposure as east side of proposed mine pit.

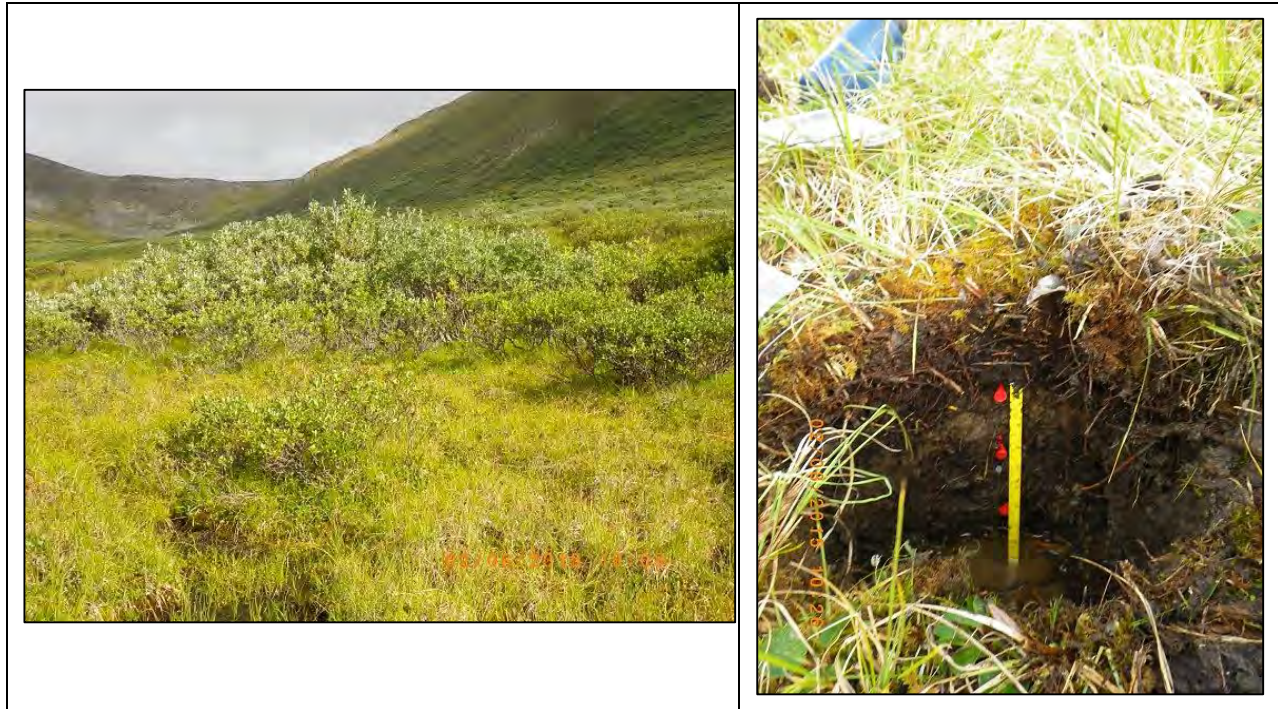
Plot PA20

Vegetation cover	Sedge-Herb-Sphagnum
Age in years (dominant species)	N/A
Polygon / Site Code	Outside mapped area
Soil moisture and nutrient values (SNR/SMR)	C /7
Soil Classification	GL.TC
Soil Texture	SiL
Surficial material	zdCv/F
Crown cover for polygon in %	N/A
Structural Stage	2b/3
Aspect (°)	148
Elevation (m)	1517
Slope %	5
Meso slope position	Lower
Drainage	Poorly
Samples	Soil, willow, grass, horsetail

**Site description:** Control plot, same elevation and exposure as South Lakes south of proposed mine site.

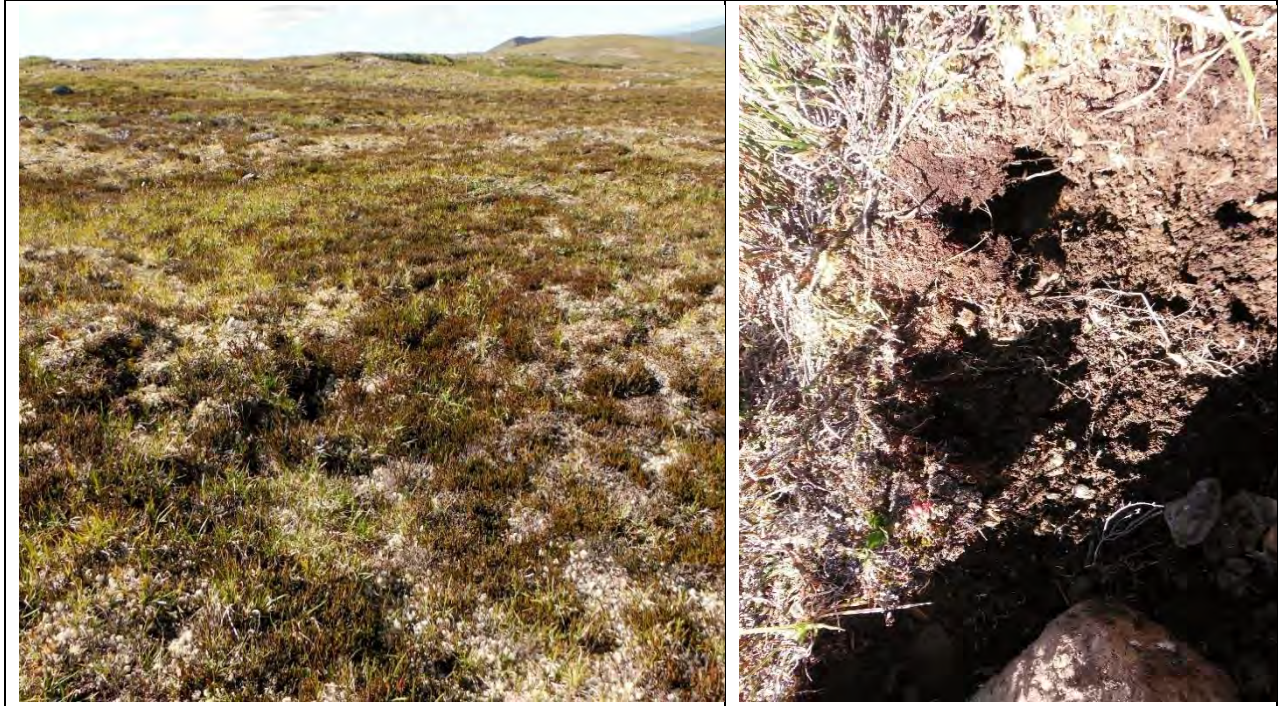
Plot PA35w

Vegetation cover	Heather-Carex-Lichen
Polygon Number	39
Site Code	(7) 21SZ-HeCxLi-2d / (3) TA- C/R
Soil moisture and nutrient values (SNR/SMR)	B/2
Soil Classification	BRD.TC (young development)
Soil Texture	SiL
Terrain/Surficial material	zskCv/M
Structural Stage	2d/2b
Aspect (°)	34
Elevation (m)	1728
Slope %	12
Meso slope position	Mid
Drainage	Rapidly
Samples	None

**Site description:** Gentle dry alpine slope, diverse moss and lichen species.

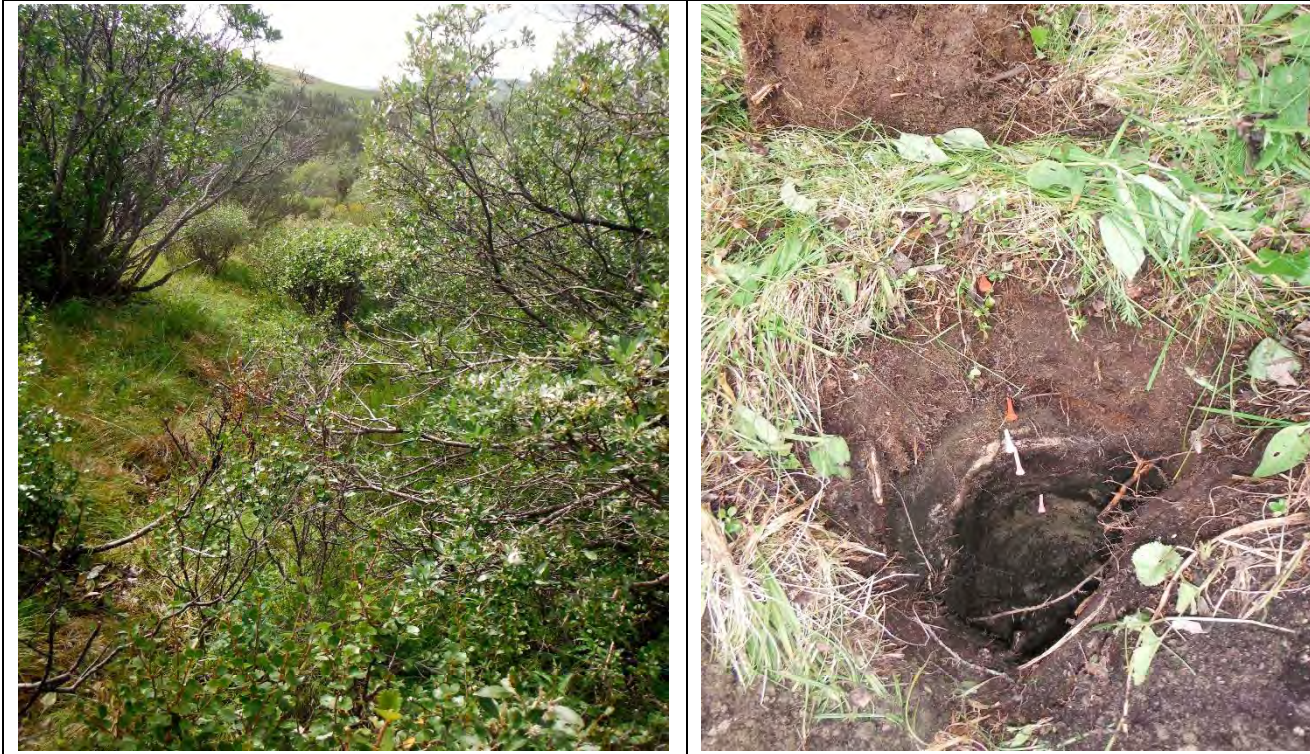
Plot PA41

Vegetation cover	Willow-Horsetail-Forb
Polygon Number	81
Site Code	(10) 48OZ-CxGrFbMo-3a/2a-C/R
Soil moisture and nutrient values (SNR/SMR)	E/5
Soil Classification	GL.HR
Soil Texture	SiL
Terrain/Surficial material	sgkCv/R
Structural Stage	3b/2a
Aspect (°)	258
Elevation (m)	1462
Slope %	12
Meso slope position	Depression
Drainage	Moderately well
Samples	Willow, horsetail

**Site description:** Riparian corridor, ephemeral stream, dry at time of visit, high plant species diversity, rich-moist soils.

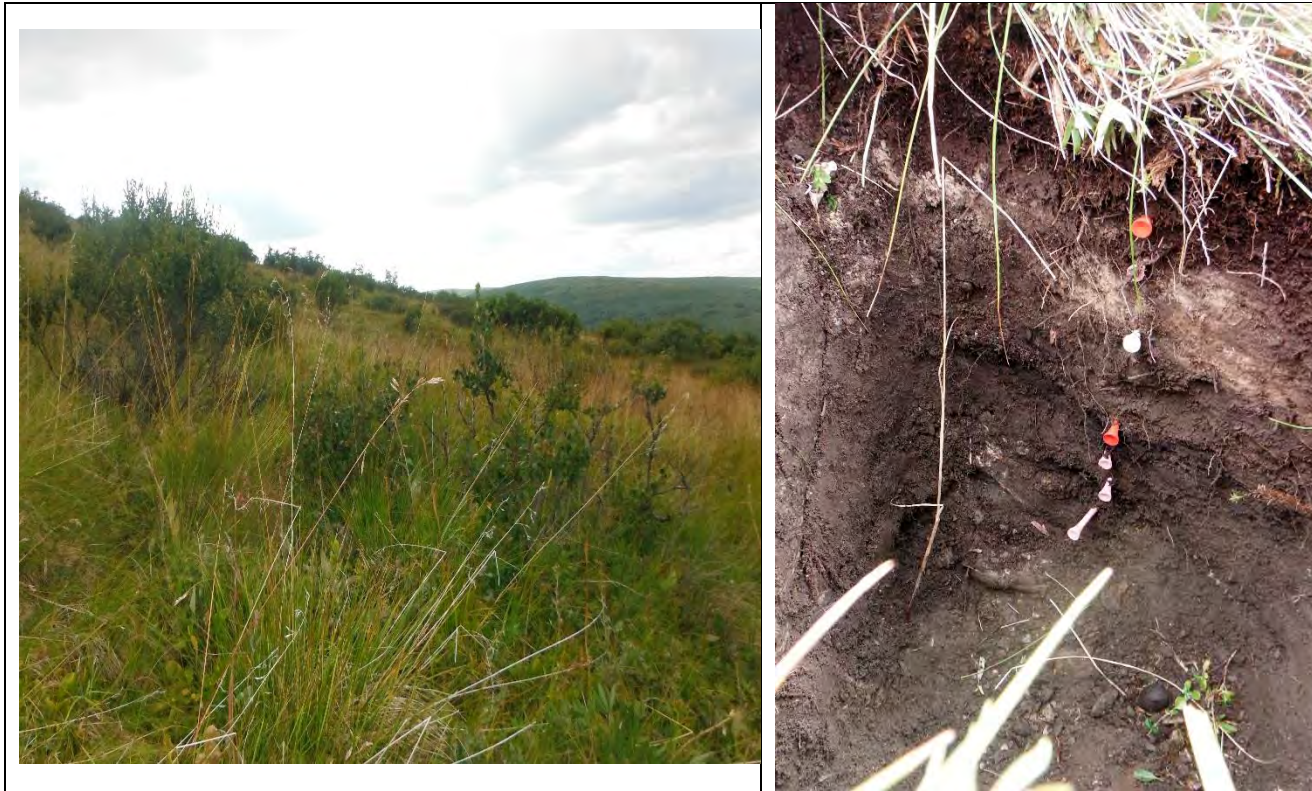
Plot PA42

Vegetation cover	Willow-Grass-Forb
Polygon Number	#82
Site Code	(10) 01-EsWiFm-6-F/M
Soil moisture and nutrient values (SNR/SMR)	D/5
Soil Classification	R.TC
Soil Texture	LS
Terrain/Surficial material	zskCv/F
Structural Stage	3a/2
Aspect (°)	002
Elevation (m)	1481
Slope %	15
Meso slope position	Mid
Drainage	Moderately well
Samples	Soil, willow, horsetail

**Site description:** Dry meadow on gentle slope with small streams, a few fir in polygon.

**Wildlife habitat:** Moose browsed willows, moose scat, wildlife trails. Mice observed and vole tunnels.

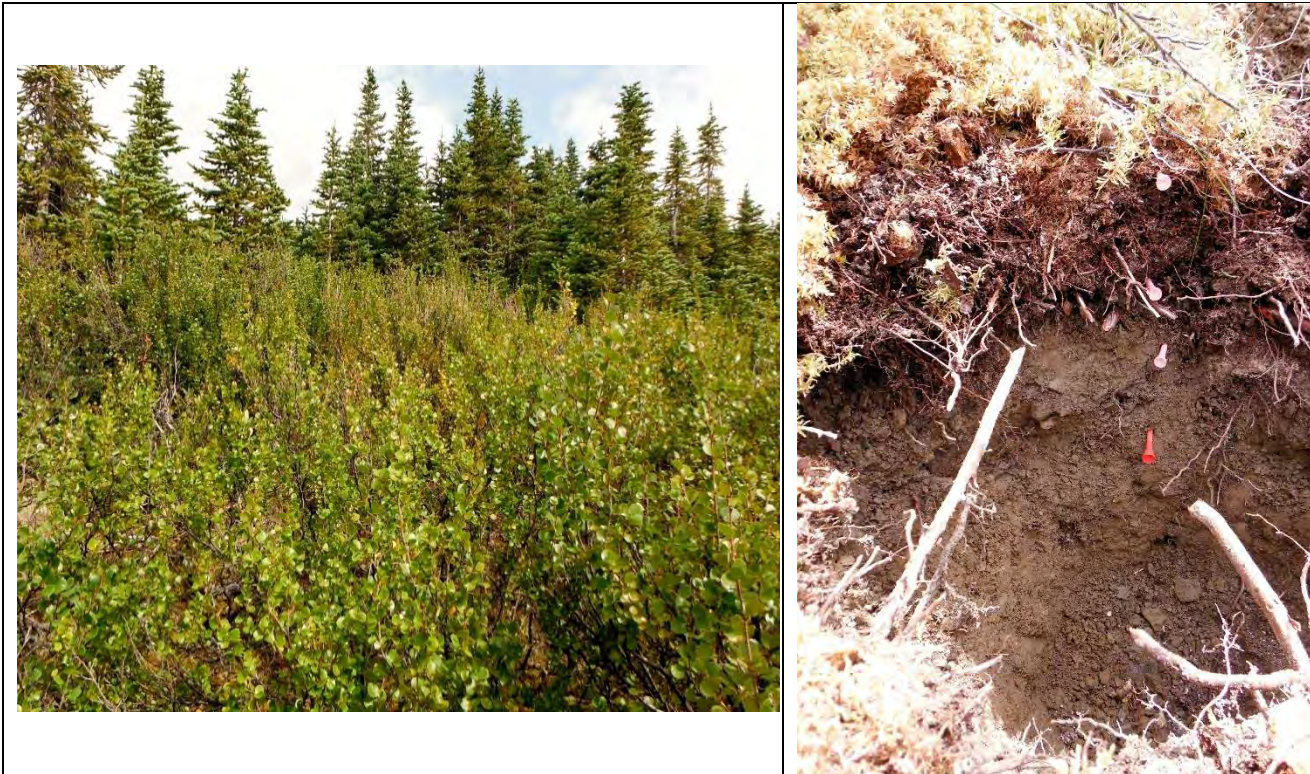
Plot PA45

Vegetation cover	Scrub birch-grass, Sub-alpine fir-feathermoss,
Polygon Number	69
Site Code	(6) 23SZ-EsWiEmni-3b/ (4) 01SZ-FEsWiFm-6-C/M
Soil nutrient and moisture values (SNR/SMR)	B/4
Soil Classification	O.DYB
Soil Texture	SL
Terrain/Surficial material	sdCv
Structural Stage	3a
Aspect (°)	232
Elevation (m)	1540
Slope %	20
Meso slope position	Mid
Drainage	Well
Samples	willow, lichen

**Site description:** Gentle to moderate slope, sparse to open sub alpine forest in shrub matrix.

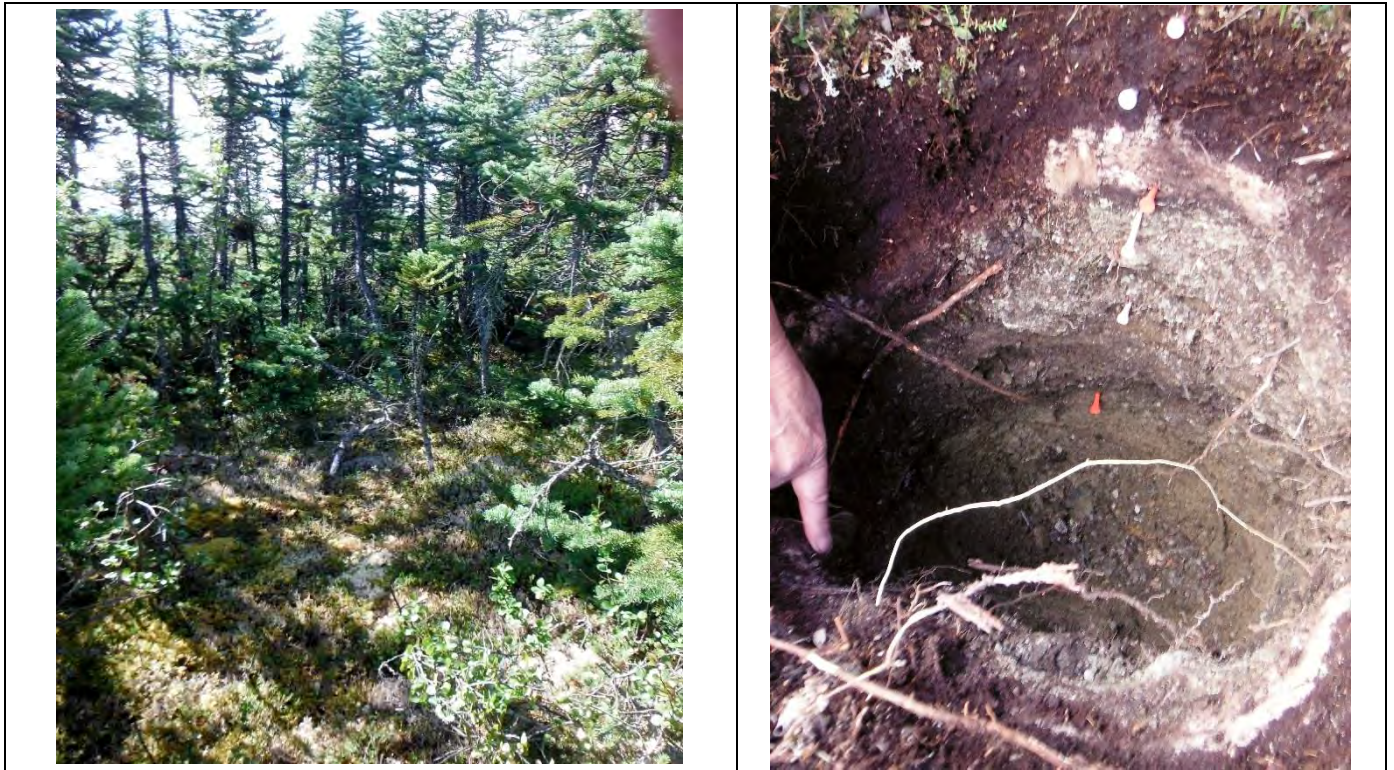
Plot PA52

Vegetation cover	Sub-alpine forest-scrub birch-feathermoss
Polygon Number	78
Site Code	(9) 01SZ-FEsWiFm-3a / (1) 11S-EsLi-3a-C/Gf
Soil nutrient and moisture values (SNR/SMR)	B/4
Soil Classification	O.DYB
Soil Texture	LS
Terrain/Surficial material	sxCv/M
Structural Stage	5 Young forest (F) and 7 Old growth (Sw)
Aspect (°)	60
Elevation (m)	1426
Slope %	17
Meso slope position	Mid
Drainage	Well
Samples	Soil, willow, lichen

**Site description:** Sparse to open forest of young sub-alpine fir intermixed with larger, older white spruce at lower elevations in polygon, forb poor.
