## **2015-2016 VEGETATION BASELINE REPORT**

### **KUDZ ZE KAYAH MINE PROJECT**

BMC-16-01-345\_002\_Vegetation Baseline Report\_RevB\_161205

December 2016

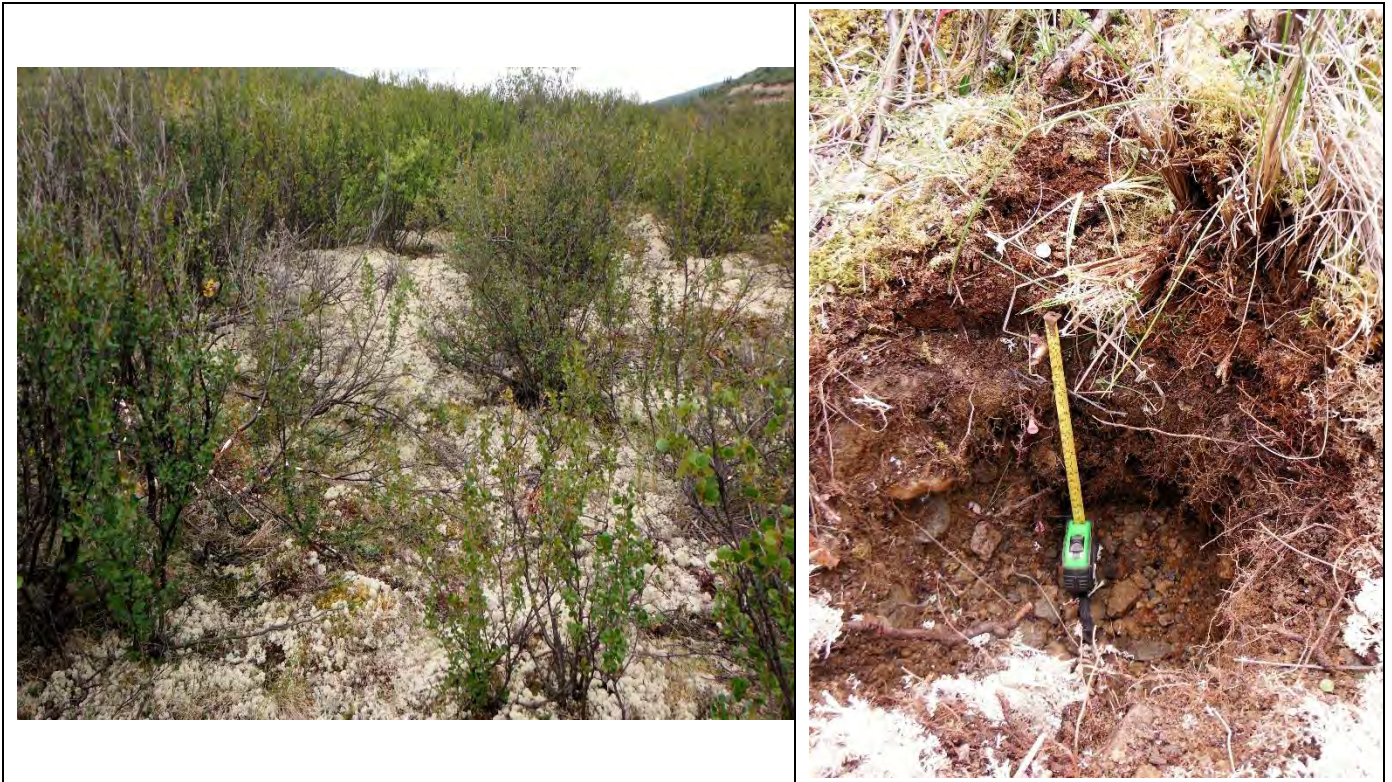
Plot PA53

Vegetation cover	Scrub birch(Willow)-feathermoss-lichen
Polygon Number	33
Site Code	(10) 01-EsWiFm-3a-C/Gf
Soil nutrient and moisture values (SNR/SMR)	B/3 (2)
Soil Classification	O.DYB
Soil Texture	Sand, gravel
Terrain/Surficial material	rx/Cc rapid mass failure
Structural Stage	3a
Aspect (°)	75
Elevation (m)	1392
Slope %	6
Meso slope position	Lower
Drainage	Rapid
Samples	willow, lichen

**Site description:** Colluvial cone from mass failure along Fault Creek. Unconsolidated angular gravels and cobbles high %CF through soil pit. Disturbance from equipment moving through polygon.

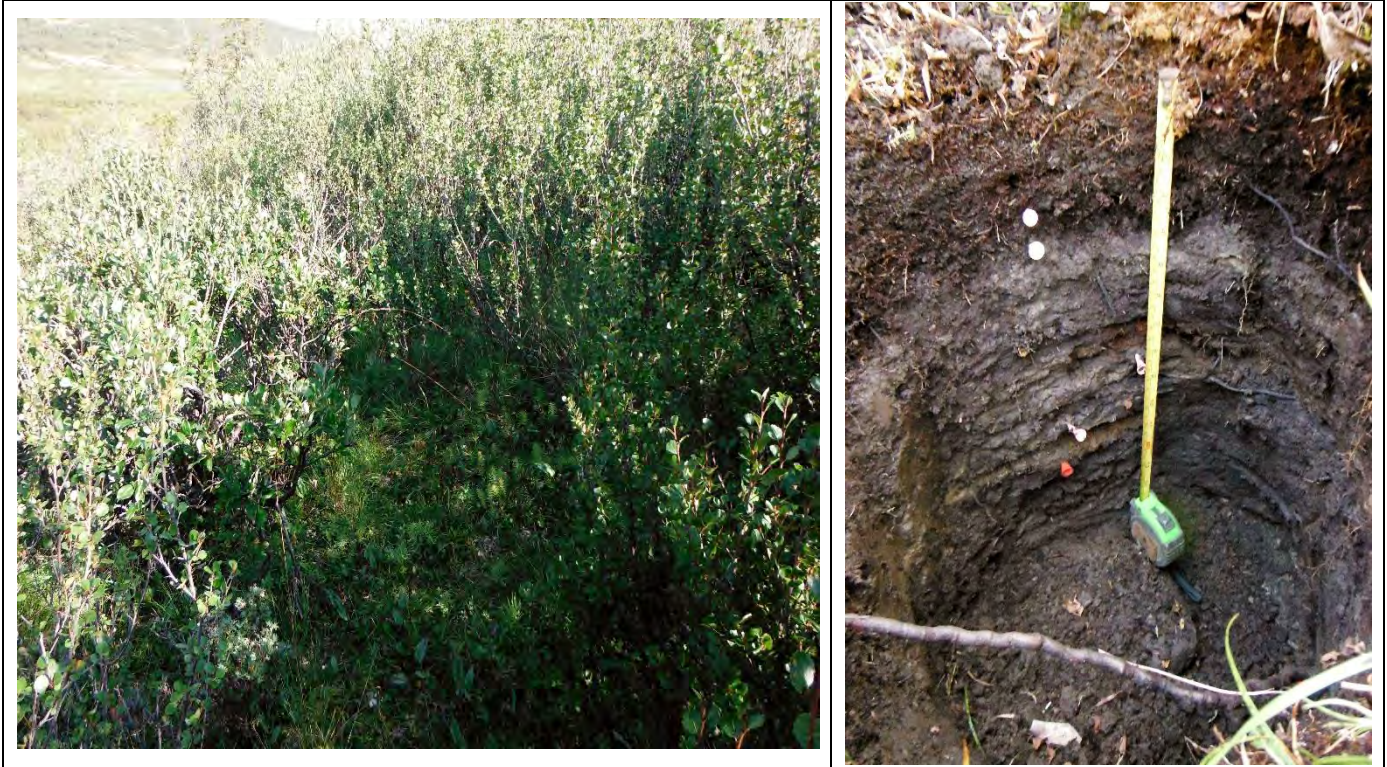
Plot PA54

Vegetation cover	Scrub birch(Willow)-feathermoss-Forb
Polygon Number	32
Site Code	(10) 01-WiEsDsLu-3b-C/Gf
Soil nutrient and moisture values (SNR/SMR)	D/5
Soil Classification	GL.TC
Soil Texture	SiL
Terrain/Surficial material	Cv
Structural Stage	3a
Aspect (°)	265
Elevation (m)	1393
Slope %	16
Meso slope position	Toe
Drainage	Imperfectly
Samples	Soil, willow, horsetail

**Site description:** Repeated buried humus horizons, angular colluvial CF in B horizons. Gleysolic chromas and signs of soil creep from solifluction. Lower portion of plot is moister with grasses and sedges present.

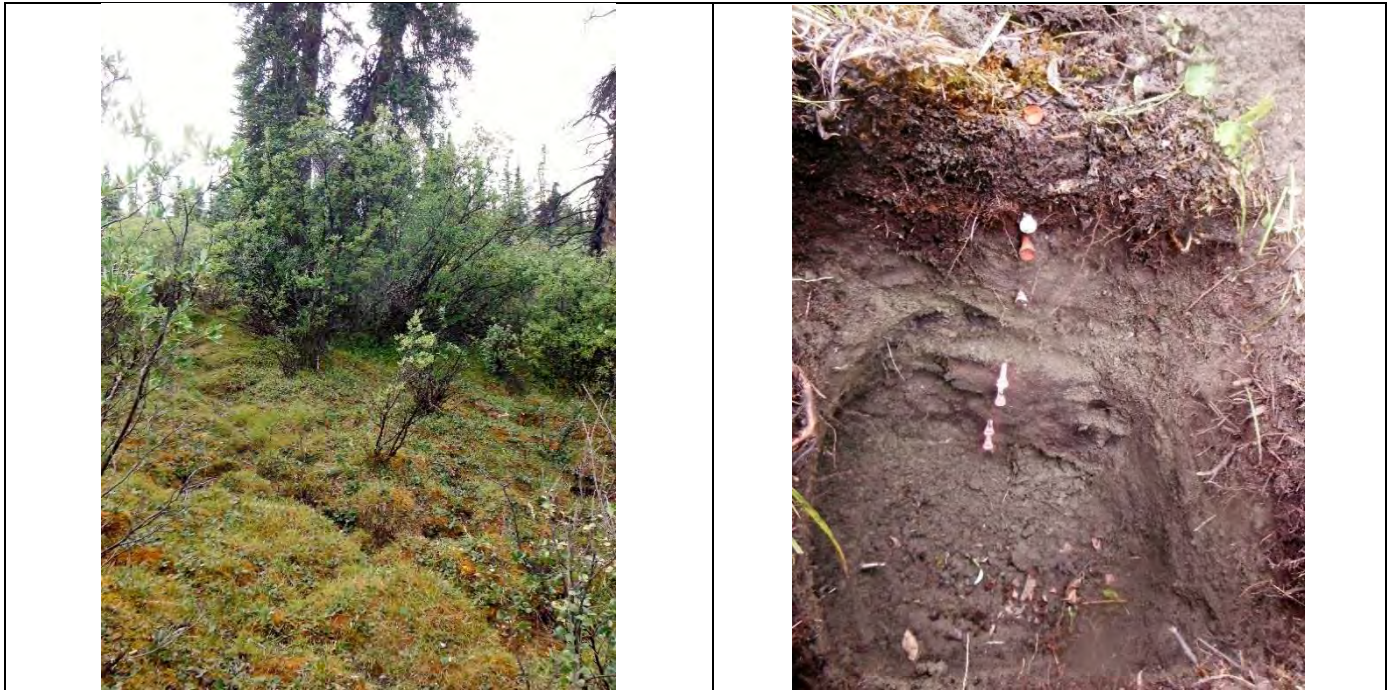
Plot PA55

Vegetation cover	White spruce-Sub-alpine fir-Feathermoss-Forbs
Polygon number	86
Site Code	(5) 31-RhEsFmLi-3a / (4) 01-EsWiFm-3b-F / (1) 11S-EsLi-3a
Soil nutrient and moisture values (SNR/SMR)	C/4
Soil Classification	O.DYB
Soil Texture	LS (SiL below 32 cm)
Terrain/Surficial material	F
Structural Stage	3b/7 (Fir is younger <80 yrs)
Aspect (°)	NEE
Elevation (m)	1356
Slope %	10
Meso slope position	Lower
Drainage	Well
Samples	Soil, salix, lichen

**Site description:** Repeated buried humus horizons, sorted sands and gravels. Small ephemeral streams in plot and polygon.

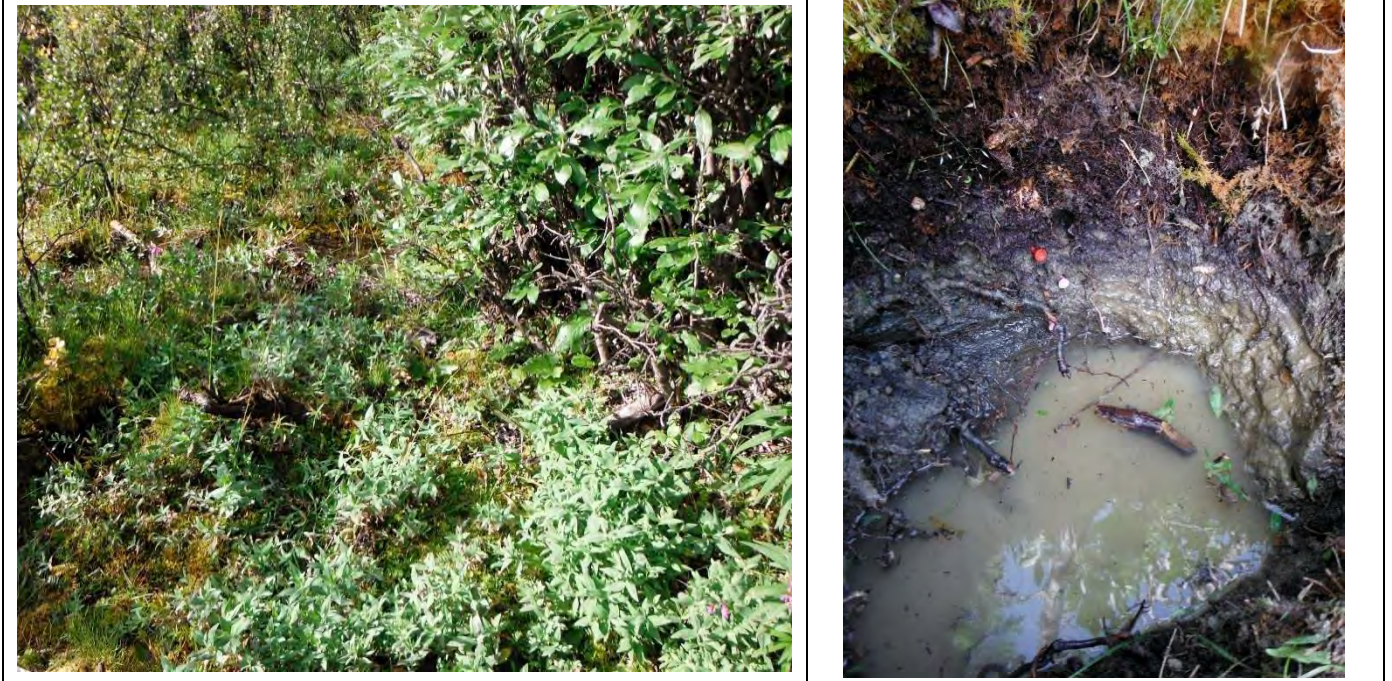
Plot PA56

Vegetation cover	Willow Forb- Feathermoss-Horsetail
Polygon Number	6
Site Code	(7) 01-EsWiFm-3a / (3) 48OZ-CxGrFbMo-2b-C/F
Soil nutrient and moisture values (SNR/SMR)	D/6
Soil Classification	GL.TC
Soil Texture	L
Terrain/Surficial material	zsF
Structural Stage	3b
Aspect (°)	97
Elevation (m)	1370
Slope %	10
Meso slope position	Depression
Drainage	Poor
Samples	Soil, willow, horsetail, lichen

**Site description:** Site in floodplain on west side of Genoa Creek Buried humus horizons interspersed with sorted mineral horizons slightly mixed. Soil deposition from flooding regime of Genoa Creek.

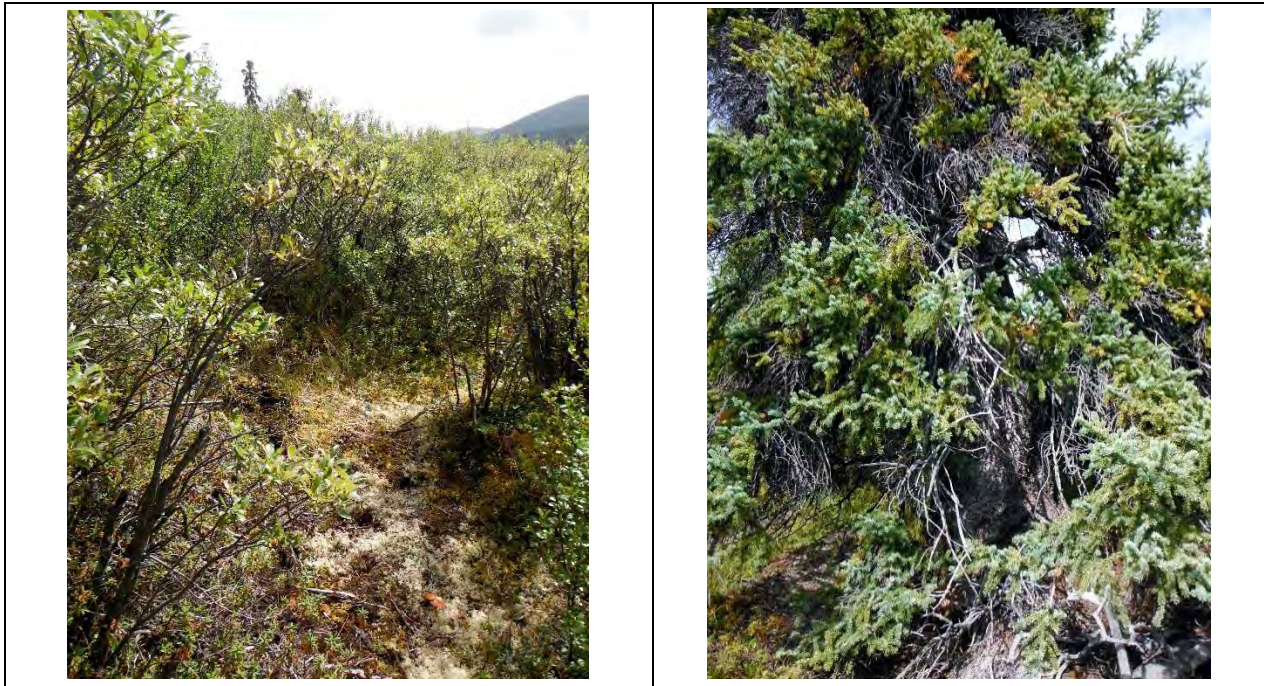
Plot PA59

Vegetation cover	Scrub birch- willow Feathermoss-Lichen/ White spruce-Fir-Feathermoss
Polygon Number	93
Site Code	(6) 31-RhEsFmLi-3a / (4) 23SZ-EsWiEmni-3b-C/R / (1) 11S-EsLi-B3
Soil nutrient and moisture values (SNR/SMR)	C/3 (4)
Soil Classification	O.DYB
Soil Texture	LS
Terrain/Surficial material	sdCv/R
Structural Stage	3b/7
Aspect (°)	260
Elevation (m)	1313
Slope %	6
Meso slope position	Mid
Drainage	Moderately well
Samples	Soil, willow, horsetail, blueberries (Vacc mem)

**Site description:** On bench, exposed rock just south of plot. Old growth spruce (>200yrs.) open forest within shrub matrix, a few younger Fir in polygon. Large boulders in plot.

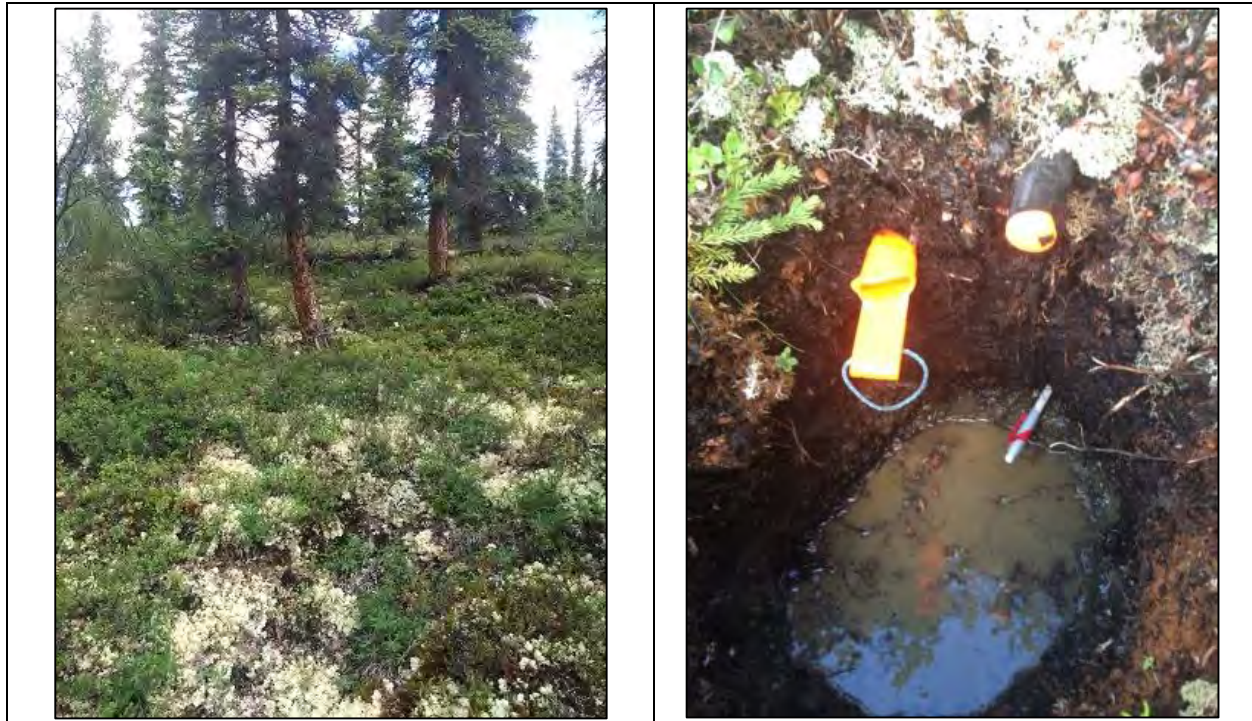
Plot KZK1

Vegetation cover	Sw-blueberry-lichen
Age in years (dominant species)	Sw >200
Polygon Number	148
Site Code	(5) 25-SwEsDsFm-3 / (3) 520-EsCaaqSp-2b / (2) 35-SwRhFm-3a
Soil moisture and nutrient values (SNR/SMR)	B/6(7)
Soil Classification	BRD.TC
Soil Texture	SiL
Surficial material	M
Crown cover for polygon in %	20
Structural Stage	6/7(veteran Sw)
Aspect (°)	200
Elevation (m)	1122
Slope %	16
Meso slope position	Lower
Drainage	Imperfectly

**Site description:** Boreal High. Gentle slope on warm aspect above East Creek.

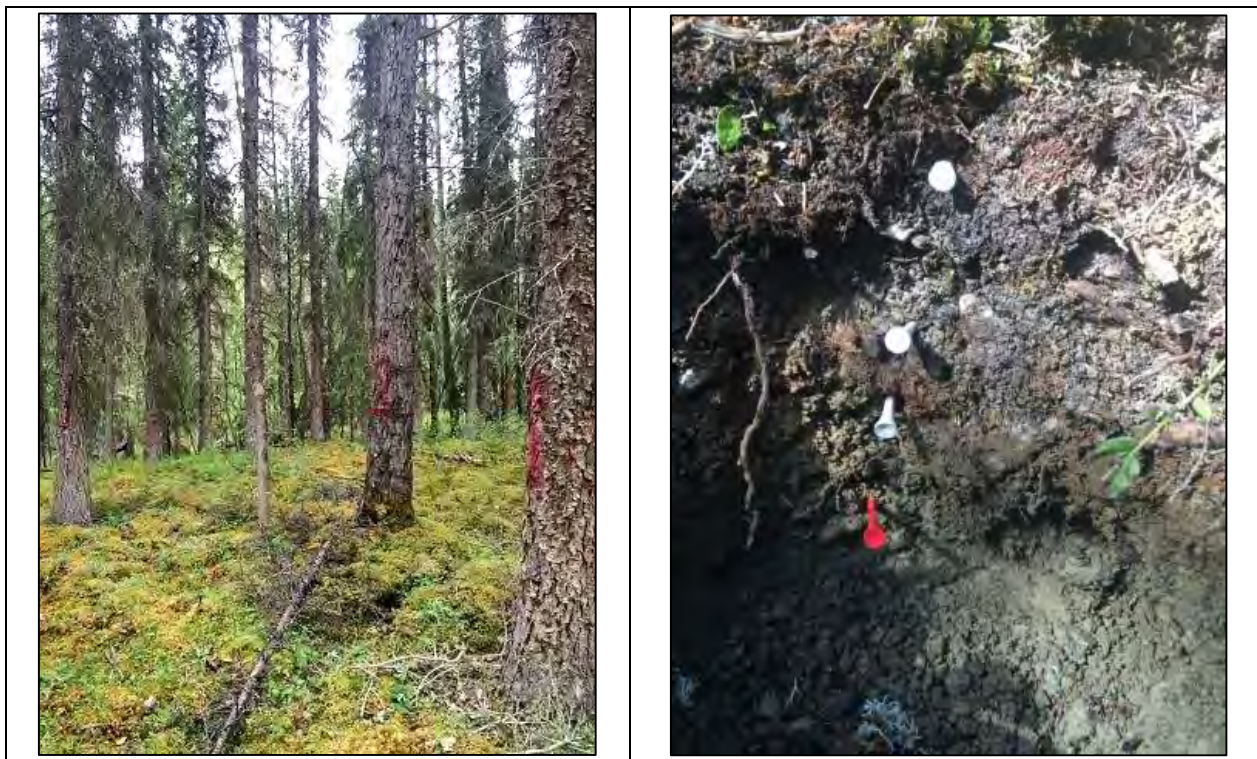
Plot KZK2

Vegetation cover	Sw-birch/willow -Feathermoss
Age in years (dominant species)	Sw >200
Polygon Number	199
Site Code	(8) 25-SwEsDsFm-5 / (2) 35SZ--SbSwRhFm-3
Soil moisture and nutrient values (SNR/SMR)	C/4 (reference site?)
Soil Classification	GL.TC
Soil Texture	SiL
Surficial material	zdCv/Mb
Crown cover for polygon in %	30-40
Structural Stage	7
Aspect (°)	190
Elevation (m)	1097
Slope %	18
Meso slope position	Mid
Drainage	Moderately Well

**Site description:** Boreal High. Old growth open Sw forest on gentle southern exposure.

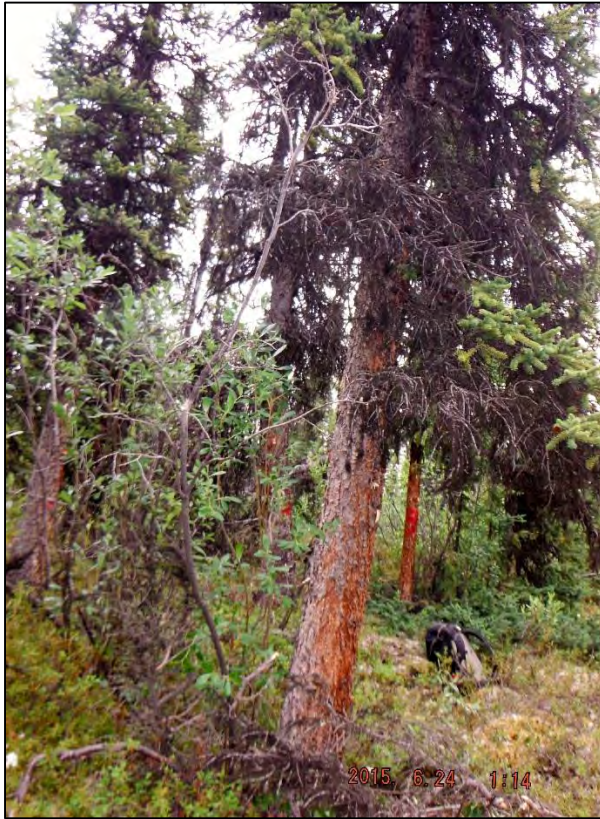
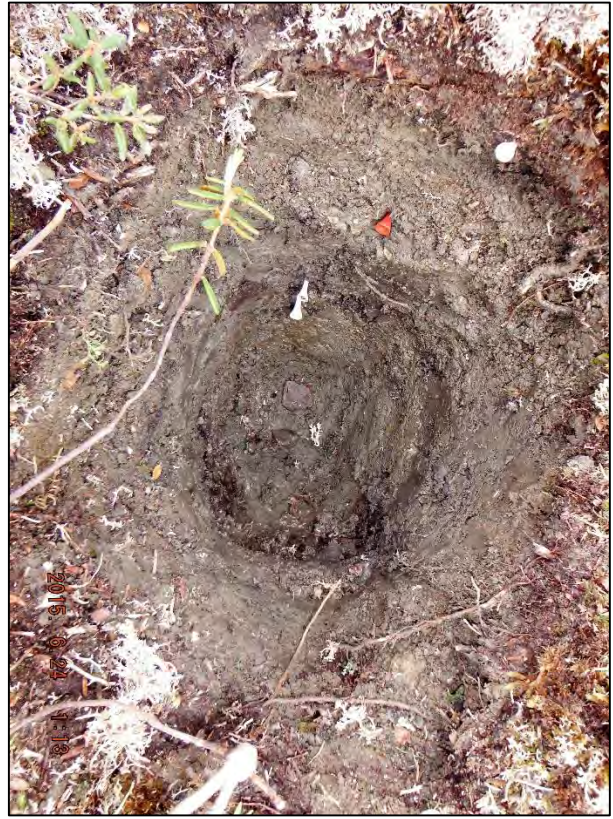
KZK4

Vegetation cover	SwSb-willow(Rhodo)-Feathermoss
Age in years (dominant species)	Sw > 100
Polygon Number	151
Site Code	(7) 25-EsDsFmCl-3 / (3) 35-SbSwRhFm-6-M
Soil moisture and nutrient values (SNR/SMR)	B/6 (5)
Soil Classification	GL.TC
Soil Texture	SiL
Surficial material	Mb
Crown cover for polygon in %	25
Structural Stage	6
Aspect (°)	236
Elevation (m)	1270
Slope %	12
Meso slope position	Upper
Drainage	Imperfectly

**Site description:** Boreal High, mature white /black (7%) spruce open forest, in low shrub matrix.

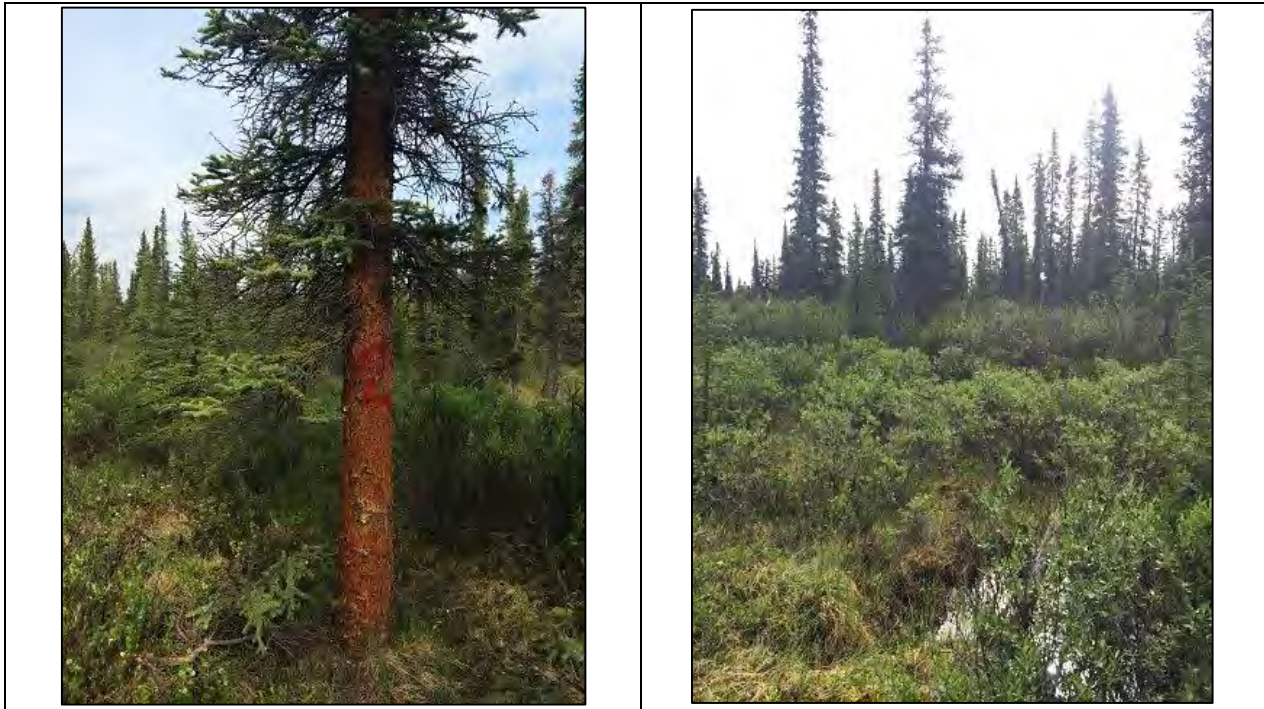
TE9

Vegetation cover	Willow-Sedge/Sw(Sb)-Shrub birch-feathermoss
Age in years (dominant species)	> 150 years
Polygon Number	152
Site Code	(4) 25-SwEsDsFmCl-6 / (4) 35-SbSwRhFm-6-M / (2) 52O-EsCaaqSp-2b
Soil moisture and nutrient values (SNR/SMR)	C/8
Soil Classification	HY.F
Soil Texture	N/A
Surficial material	Organic/Fluvial
Crown cover for polygon in %	10-20
Structural Stage	6/3a
Aspect (°)	N/A
Elevation (m)	1133
Slope %	0
Meso slope position	Depression
Drainage	Very poorly

**Site Description:** Relatively flat area with fens and

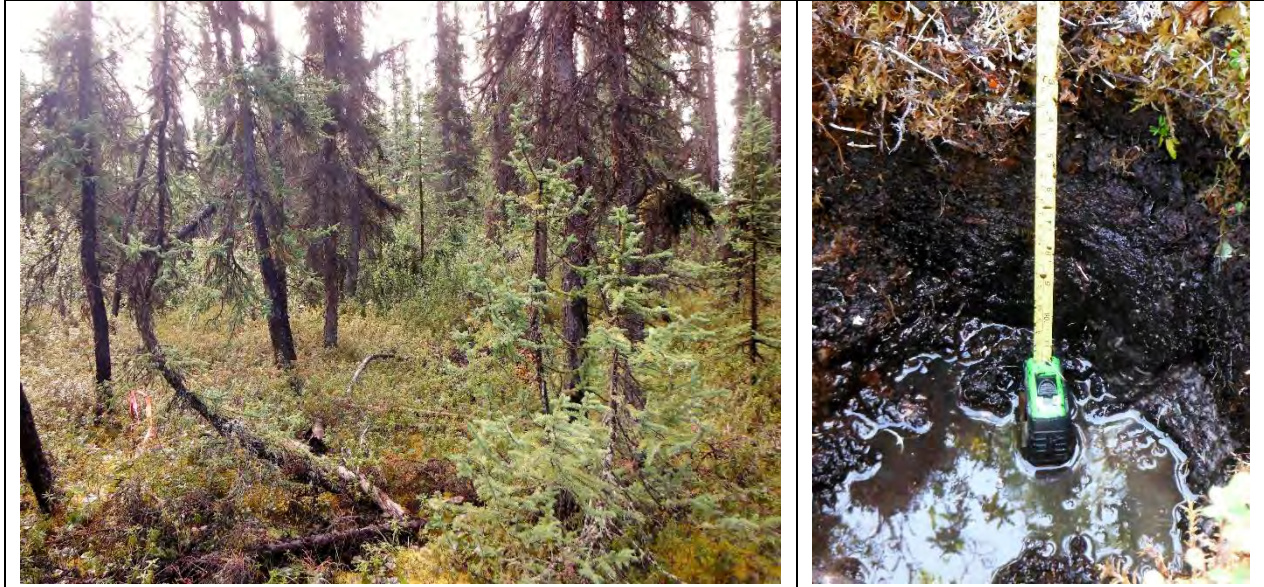
Plot TE20

Vegetation cover	Black Spruce-Rhododendron-Feathermoss, White spruce-Feathermoss-Lichen, Sedge-Sphagnum
Polygon Number	211
Site Code	(6) 35-SbSwRhFm-3a / (4) 15S-SwEsCl-7-F
Soil nutrient and moisture values (SNR/SMR)	B/6 (7)
Soil Classification	GL.TC
Soil Texture	Organic mesic
Terrain/Surficial material	O/M
Structural Stage	3a/7
Aspect (°)	---
Elevation (m)	1036
Slope %	<2
Meso slope position	Level
Drainage	Poor

**Site description:** Mix Sb and Sw forest. Thick organic layer > 40 cm, strongly mounded. Three ecosystems depending on variations in moisture regime. Depressions have sedges and sphagnum with open water, higher ground is Sw, feathermoss and lichen, Mid level is Sb, rhododendron and feather moss with 60% cloud berry BOH Old growth black and white spruce (125yrs.). Kettle/esker topography.

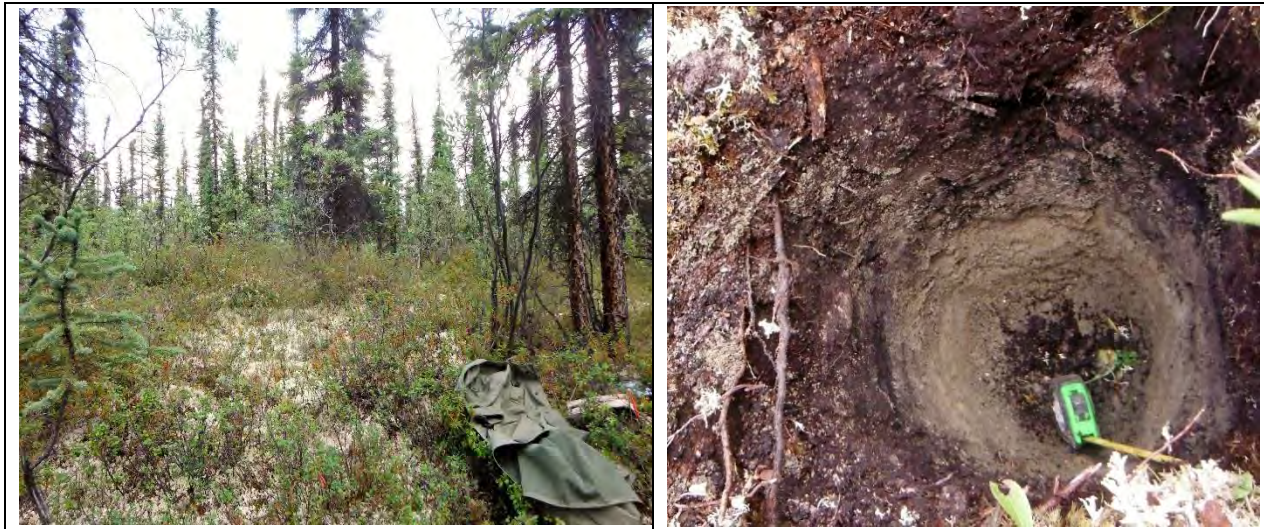
Plot TE21

Vegetation cover	White spruce-willow-Feathermoss-Lichen/ Black spruce-Rhododendron-Feathermoss
Polygon Number	196
Site Code	(8) 01-SwWiFbFm-3 / (2)35-SbSwRhFm-7-M
Soil nutrient and moisture values (SNR/SMR)	B/4, B/5
Soil Classification	O.DYB
Soil Texture	SL
Terrain/Surficial material	dCv/szFg
Structural Stage	6/3a
Aspect (°)	73
Elevation (m)	1042
Slope %	8
Meso slope position	Mid
Drainage	Well

**Site description:** Sw (Sb) forest, 20-15% cover. Sb in lower wetter microsites. Mature to old growth (Sw 120yrs). Rh 70%, Wi 20% and Scrub birch 10% as minor component of shrub layer.

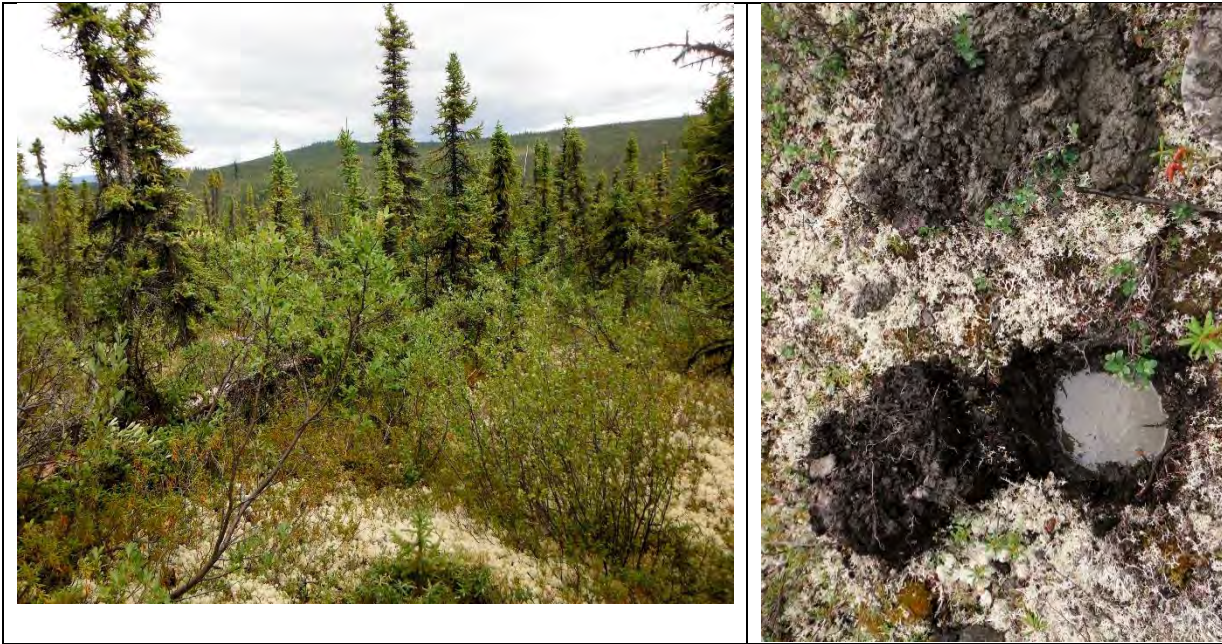
Plot TE22

Vegetation cover	White spruce-willow- Lichen-Feathermoss/ Black spruce-Rhododendron-Feathermoss
Polygon Number	170
Site Code	(8)40-SbRhFmCl-6 / (2)01-SwWiFbFm-6-M
Soil nutrient and moisture values (SNR/SMR)	B/7
Soil Classification	GL.TC
Soil Texture	SiL
Terrain/Surficial material	dCv/M
Structural Stage	7/3a
Aspect (°)	82
Elevation (m)	1092
Slope %	15
Meso slope position	Mid
Drainage	Poor

**Site description:** Sb forest, 20-25% cover. Mature to old growth (Sb 135yrs). Rh 50%, Wi 25% and Scrub birch 10% as minor component of shrub layer. FM 30%, Lichen (Cladina) 50% with 3% horsetail. Vac uli and vit 30%.

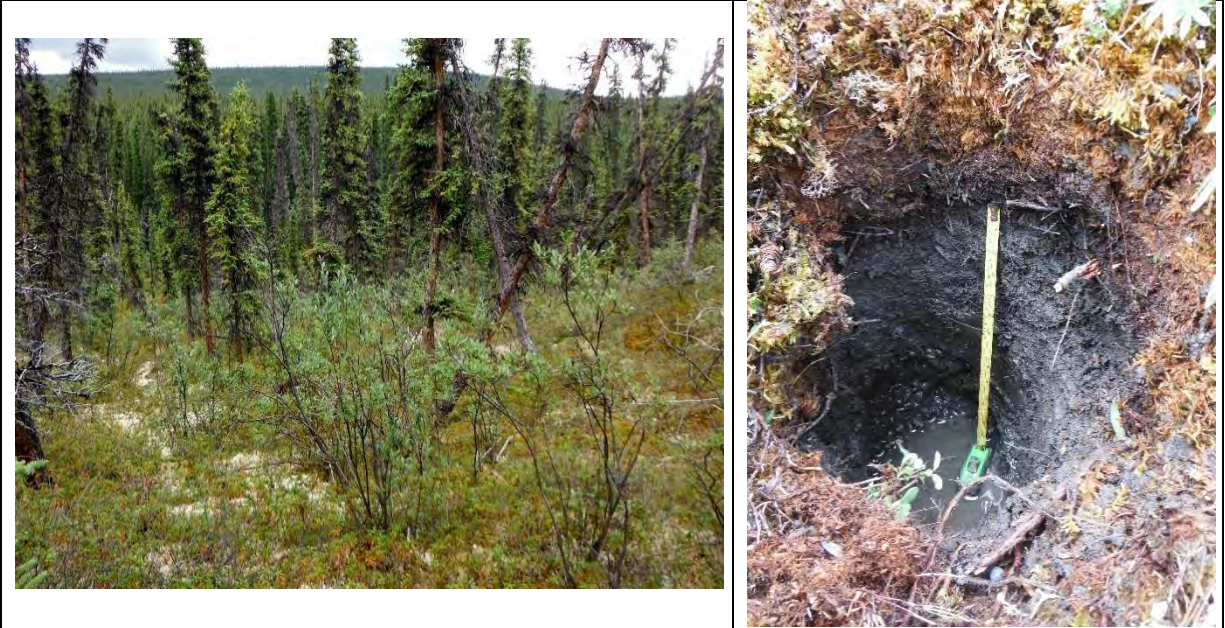
Plot TE23

Vegetation cover	White spruce-Rhododendron-Willow-Lichen-Feathermoss/ Black spruce-Rhododendron-Feathermoss
Polygon Number	168
Site Code	(7)01-SwWiFbFm-3 / (3)35-SbSwRhFm-6-F
Soil nutrient and moisture values (SNR/SMR)	C/6
Soil Classification	GL.TC
Soil Texture	SiL
Terrain/Surficial material	dCv/M
Structural Stage	7/3a
Aspect (°)	90
Elevation (m)	1062
Slope %	26
Meso slope position	Mid
Drainage	Poor

**Site description:** Sw forest, 20% (Sb 5%) cover. Old growth (Sw 168 yrs). Rh 65%, Wi 35% (Scrub birch is in polygon 10%, not plot). FM (with glowmoss) 70%, Lichen (Cladina) 35%, Vac uli 25%.

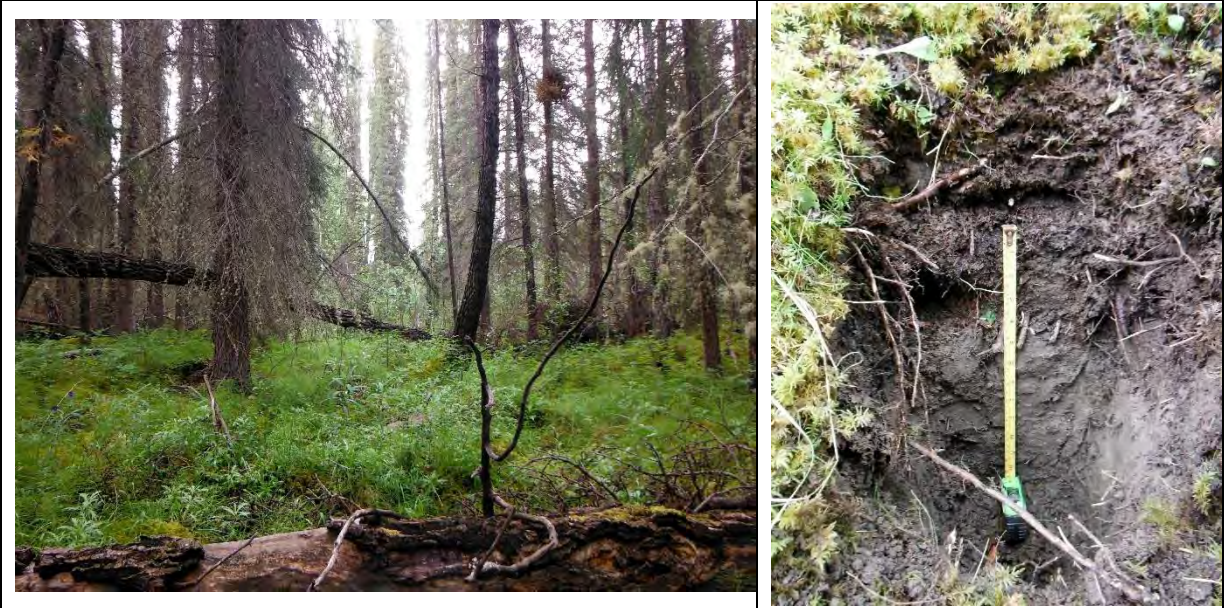
Plot TE24

Vegetation cover	White spruce-Balsam poplar-Equisetum-Feathermoss
Polygon Number	278
Site Code	(10) 28SK-SwBEqFm-F
Soil nutrient and moisture values (SNR/SMR)	D/4 (5)
Soil Classification	O.R
Soil Texture	FSL
Terrain/Surficial material	skFg
Structural Stage	7/2c
Aspect (°)	---
Elevation (m)	1050
Slope %	none
Meso slope position	Level
Drainage	Moderately well

**Site description:** Sw and Balsam poplar forest, 45% cover. Upper terrace of Finlayson Cr floodplain. Sw over 20 m high. Old growth (Sw 140 yrs). Eq 35%, FM 70%. High diversity of forbs; willows, rose and soapberry in gaps.

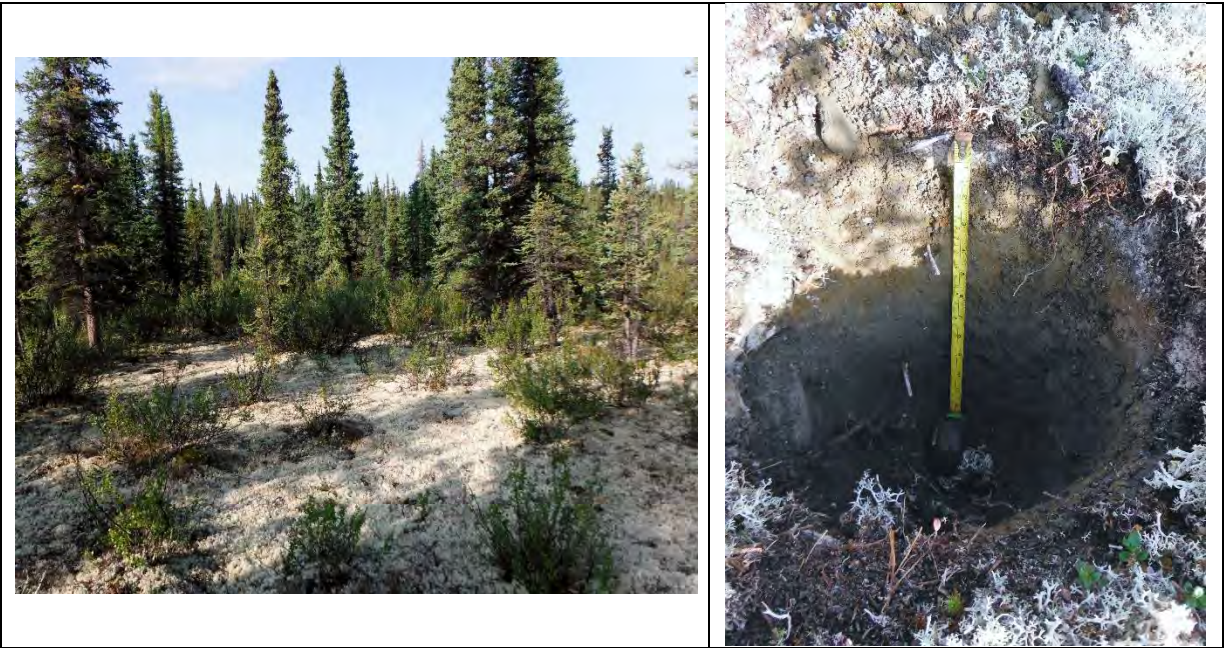
Plot TE26

Vegetation cover	White spruce-Scrub birch-Lichen/ Sedge-Scrub birch-Mosses
Polygon Number	139
Site Code	(7)15S-SwEsCl-3b / (3)52O-EsCaaqSp-2b-O/Gf
Soil nutrient and moisture values (SNR/SMR)	B/2, B/7
Soil Classification	O.DYB
Soil Texture	FSL
Terrain/Surficial material	szE/skFg
Structural Stage	6/1b
Aspect (°)	---
Elevation (m)	1129
Slope %	none
Meso slope position	Level
Drainage	Rapid

**Site description:** Sparse to open Sw forest with *C. stellaris* and *Stereocaulon* spp. main lichen types. Raised ground and small basin wetlands typical topography for polygon. Glacio-fluvial genesis of landform, eolian deposits recent.

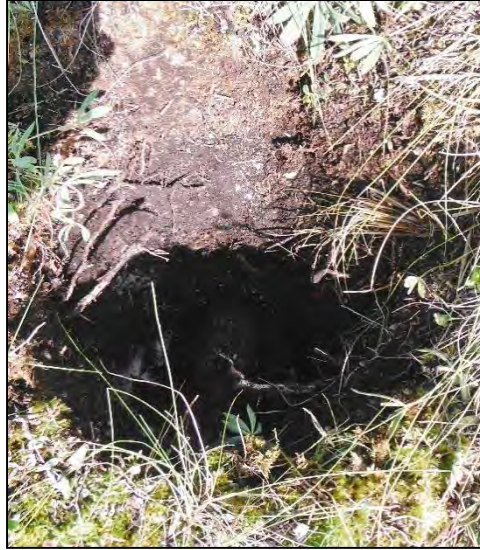
Plot TE29

Vegetation cover	White spruce-Sub-alpine fir-Scrub birch-Feathermoss
Polygon Number	121
Site Code	(9)22-EsFmCl-6 / (1)31-RhEsFmLi-6-M
Soil nutrient and moisture values (SNR/SMR)	B/4
Soil Classification	O.DYB
Soil Texture	SiL
Terrain/Surficial material	szxM/F
Structural Stage	5(6)/3b
Aspect (°)	---
Elevation (m)	1376
Slope %	2%
Meso slope position	Upper, mountain top plateau
Drainage	Well

**Site description:** Sparse young sub-alpine fir and white spruce crown cover <10%. Mostly a mix of matrix of tall scrub birch and willows, scrub birch 65%, willow 15% and Labrador tea is 40%.

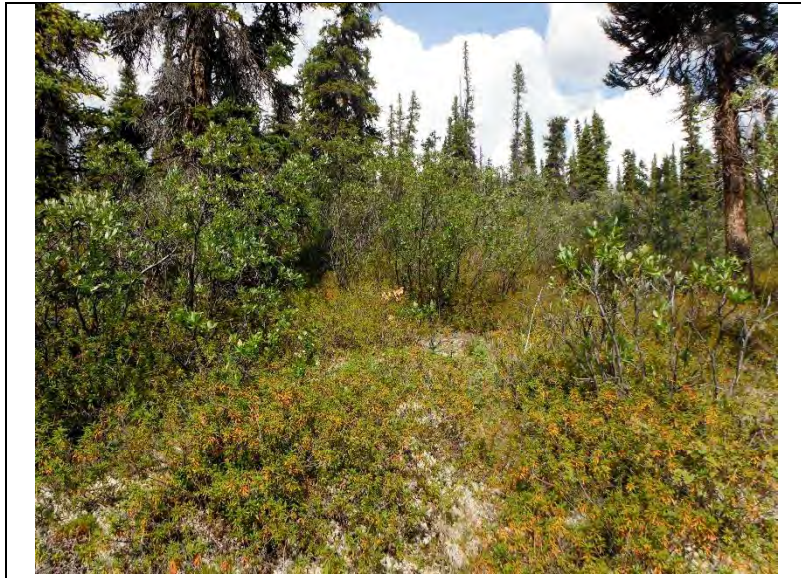
Plot TE30

Vegetation cover	White spruce-Labrador tea-Willow-Scrub birch-Feathermoss
Polygon Number	116
Site Code	(10)01-SwWiFbFm-3a-M/F
Soil nutrient and moisture values (SNR/SMR)	C/4 (5)
Soil Classification	BRD.TC
Soil Texture	SiL
Terrain/Surficial material	szxcv/Fg
Structural Stage	7/3a
Aspect (°)	140
Elevation (m)	1305
Slope %	13%
Meso slope position	Mid
Drainage	Moderately well

**Site description:** White spruce crown cover 15%. Mix of low shrubs Labrador tea 70%, willows 35%, scrub birch 20%. Some forbs present, 9 species 30% cover and lichen (*Cladina* spp.) 25%. Solifluction evident; sinuous tree growth, linear hummocks and ice in soil pit.

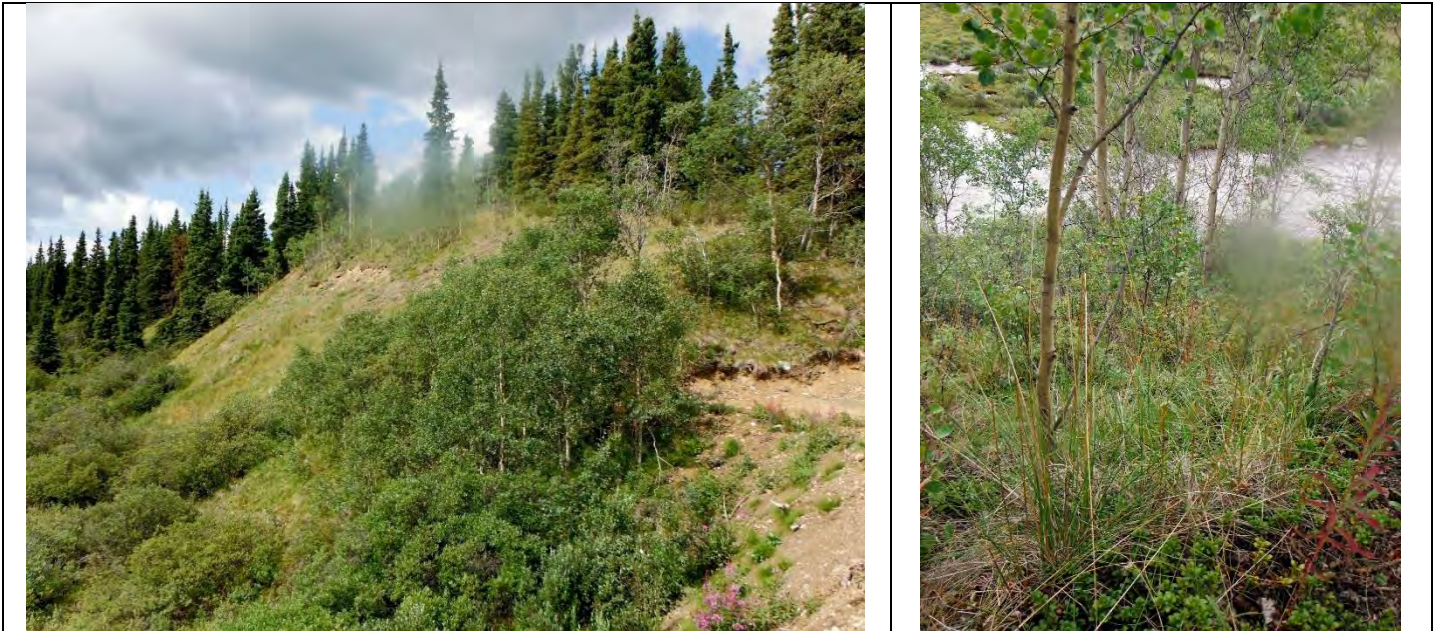
Plot TE31

Vegetation cover	White spruce-Scrub birch- -Feathermoss-Lichen/ Aspen-Kinnickinnick-Grass
Polygon Number	102
Site Code	(5)15S-SwEsCl-3 / (4)01-SwWiFbFm-3-F/M / (1)11Z-AKnGr-5
Soil nutrient and moisture values (SNR/SMR)	B/3, B/2
Soil Classification	O.DYB
Soil Texture	LS
Terrain/Surficial material	szCv/F
Structural Stage	6/5
Aspect (°)	172 (For Aspen ecotype)
Elevation (m)	1268
Slope %	5% (Aspen 40%)
Meso slope position	Level/Steep upper slope
Drainage	Well/ Rapid

**Site description:** White spruce crown cover 10-25%. Mix of low shrubs willows 35%, scrub birch 20%. Some forbs present, 9 species 30% cover and lichen (*Cladina* spp.) 25%. Solifluction evident; sinuous tree growth, linear hummocks and ice in soil pit.

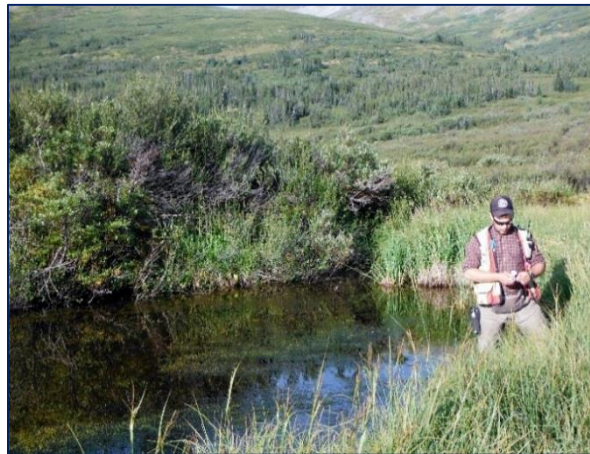
**Wetland C1** vegetation around shoreline: *C. aquatilis*, *L. parviflora*, *P. palustris*, *C. canadensis*, *Galium trifidum* and *Petasites frigidum*. The one aquatic found, in abundance, is the brown moss *Calligeron spp.*

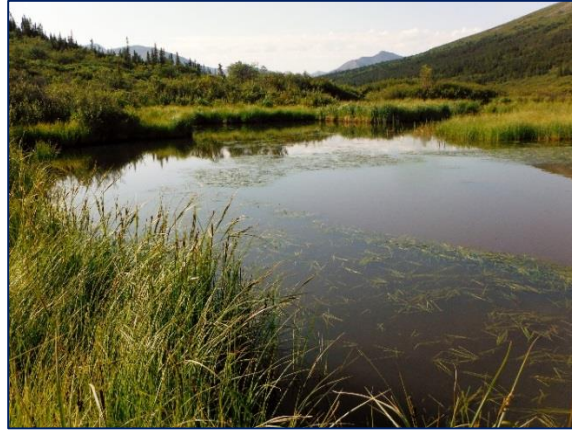
**Wetland C2** is the largest of wetland of the group. The dominant shore plant is *C. aquatilis*, other plants as observed at C1, plus *Glyceria pulchella*. Aquatic plants include: *Potamogeton alpinus*, *Sparganium hyperboreum*, *Ranunculus hyperboreus* and *Myriophyllum. sibiricum*.

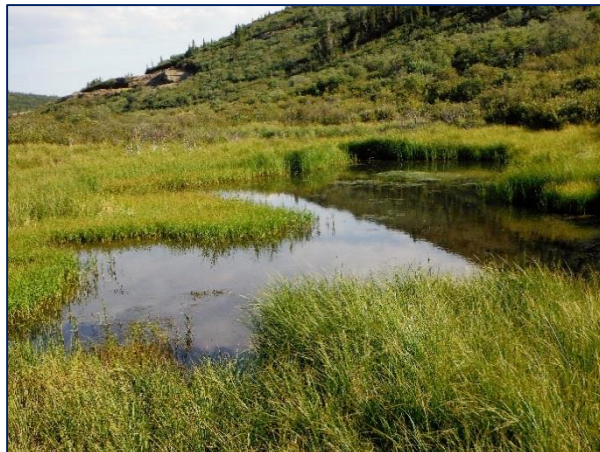
**Wetland C3** shoreline is dominated by *Glyceria pulchella* and *C. aquatilis* shore vegetation similar to C1

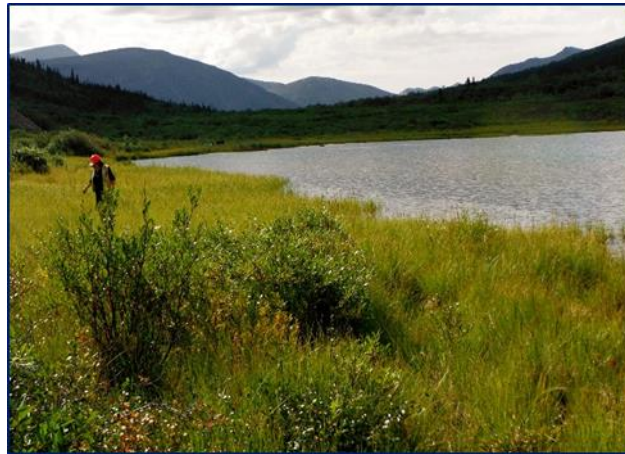
Shoreline vegetation: *Carex aquatilis*, *Juncus castaneus*, *Glyceria pulchella*, *Luzulu parviflora*, *Poa palustris*, *Calamagrostis canadensis* and *Eriophorum angustifolium*.

Aquatics: *Calligeron* spp. and *Scouleria aquatilis*, both are mosses.

Wetland D view to the south

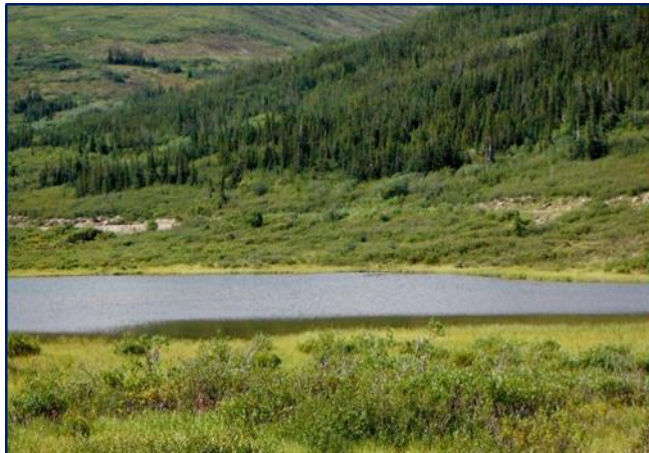
Wetland E

Shoreline vegetation: *Carex aquatilis*, *Juncus castaneus*, *Glyceria pulchella*, *Luzulu parviflora*, *Poa palustris*, *Calamagrostis canadensis*, *Aulacomnium palustre* and a few patches of *sphagnum spp.*

Aquatic plants: *Sparganium hyperboreum*, *Hippuris vulgaris*, *Calligeron spp.*

Wildlife: Skull and pelt remains of two beaver found on east side. Moose sign tracks, scat and browsed willows.

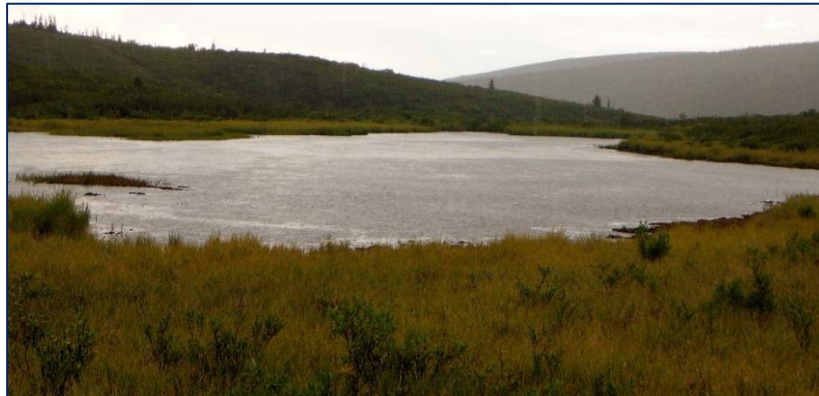
Shoreline vegetation: *Carex aquatilis*, *Carex saxatilis*, *Juncus castaneus*, *Glyceria pulchella*, *Luzulu parviflora*, *Poa palustris*, *Calamagrostis canadensis*, *Aulacomnium palustre* and *sphagnum spp.* Few scattered willows and scrub birch, 2 to 5 m back from shoreline.

Aquatic plants: *Sparganium hyperboreum*, *Ranunculus hyperboreus*, *Calligeron spp.*

Wildlife: Several wildlife trails, recent moose and wolf sign. Two mallards and one Yellow legs.

Wetland F view to the northwest

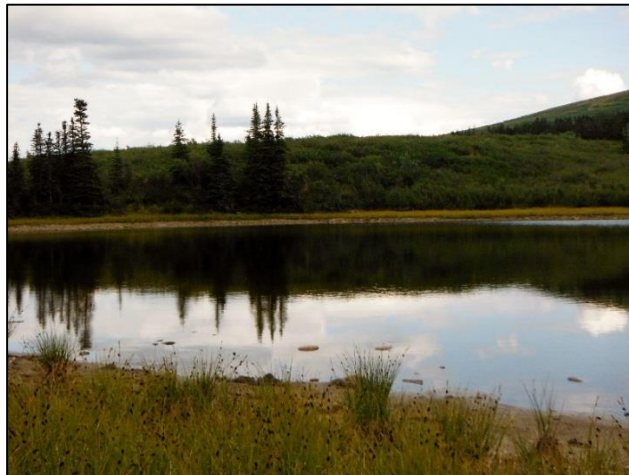
Wetland G

Aquatic plants: *Sparganium hyperboreum*, only a few plants, 10% cover.

Wildlife: Moose tracks and scat. Many shorebird tracks. Old wolf and caribou scat.

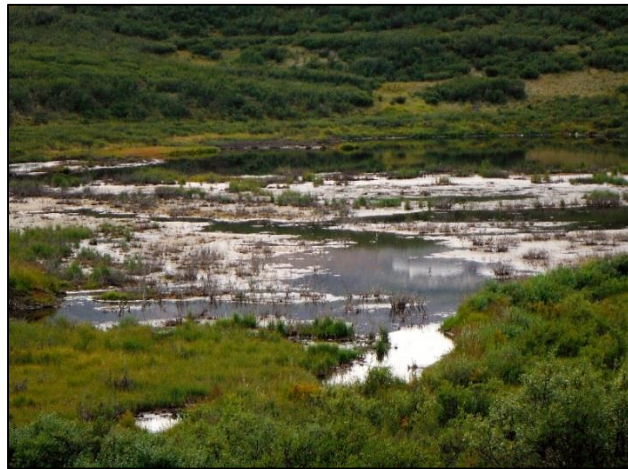
Wetland H

Wildlife: Area has many signs of moose usage: trails, tracks, scat and willow browse. Several warbler species in shrubs near wetland. Old beaver sign, no sign of recent beaver activity.

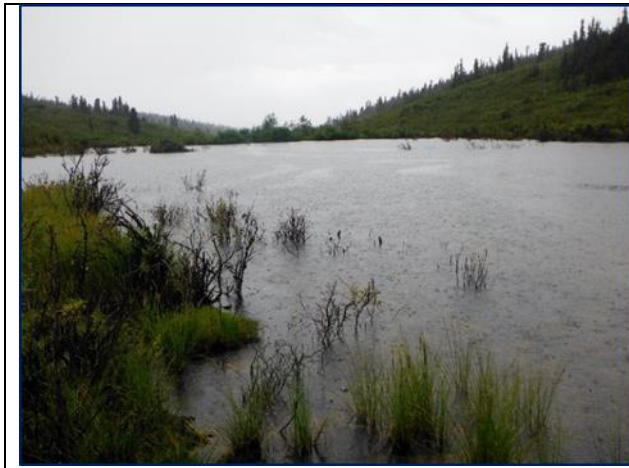
Wetland I beaver created (old lodge upper left)

Wildlife: Many trails, moose tracks (cow and calf), scat and willow browse. Old beaver sign evident, no signs of recent activity.

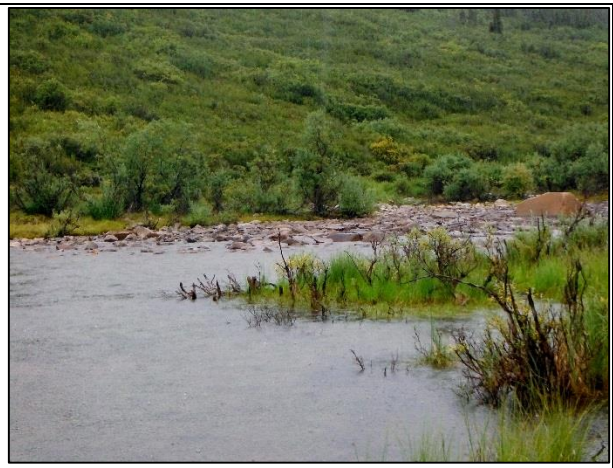
Inflow to Wetland I, note rocky channel substrate

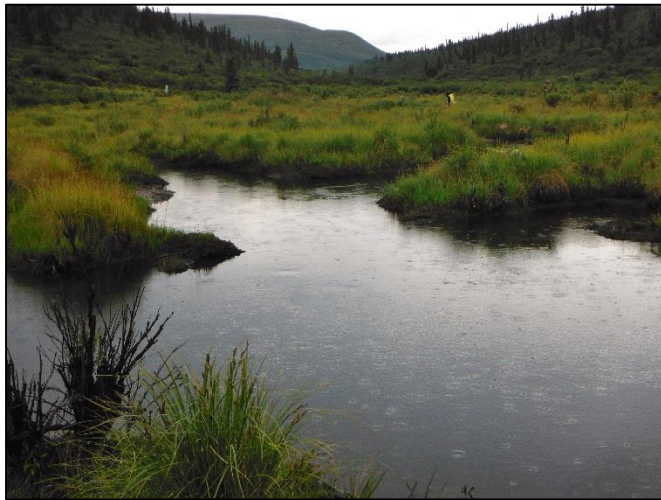
Wetland J view to the south

Shoreline vegetation: *Carex aquatilis* is the dominate shore cover, other plants include *Luzulu parviflora*, *Calamagrostis canadensis*, *Juncus castaneus*, and *Equisetum arvense*.
