## **2015-2016 VEGETATION BASELINE REPORT**

### **KUDZ ZE KAYAH MINE PROJECT**

BMC-16-01-345\_002\_Vegetation Baseline Report\_RevB\_161205

December 2016

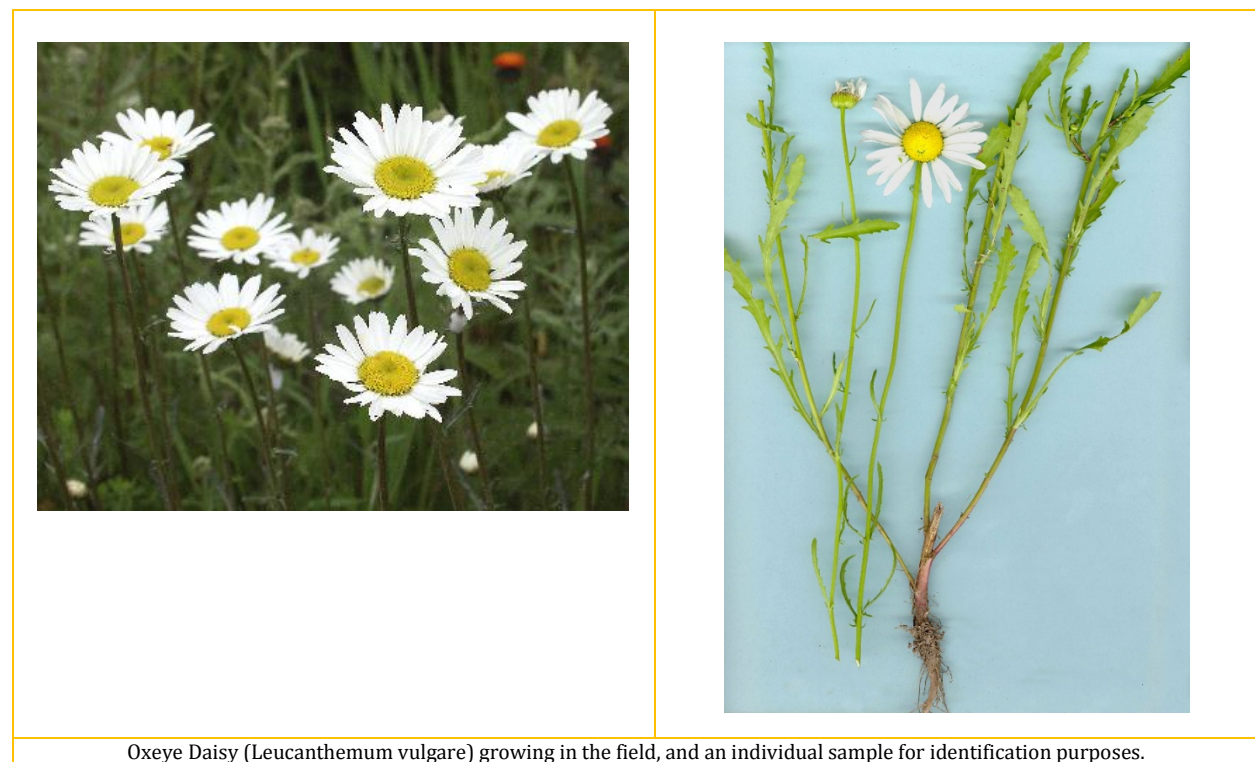
**Figure 4 Oxeye daisy**

Often cultivated in gardens as a “wildflower”, this non-native is an aggressive invader. Oxeye daisy (Figure 4) is a perennial that spreads primarily by seed, but also by shallow, creeping roots (rhizomes). Individual plants can produce over 500 seeds that are viable in the soil for two to three years or more. The greatest impact of oxeye daisy is on forage production in pastures and meadows. Dense stands of oxeye daisy can decrease plant diversity and increase the amount of bare soil in an area.

Repeated mowing prevents seed production, but also can stimulate re-sprouting of stems. Hand-pulling or digging before seed production is effective, but it is important to remove as much of the fibrous roots and rhizomes as possible. Ground disturbance while digging should be kept to a minimum. Hand removal will have to be continued for several years because seeds may remain viable in the soil for some time. Because of its shallow root system, oxeye daisy is easily killed by intensive cultivation.

The chemical control method is to apply Aminopyralid alone or in a product mix with Metsulfuron-methyl, registered for use on oxeye daisy. Always check product labels to ensure the herbicide is registered for use on the target plant in Canada by the Pest Management Regulatory Agency. Always read and follow label directions (AISC, 2014).

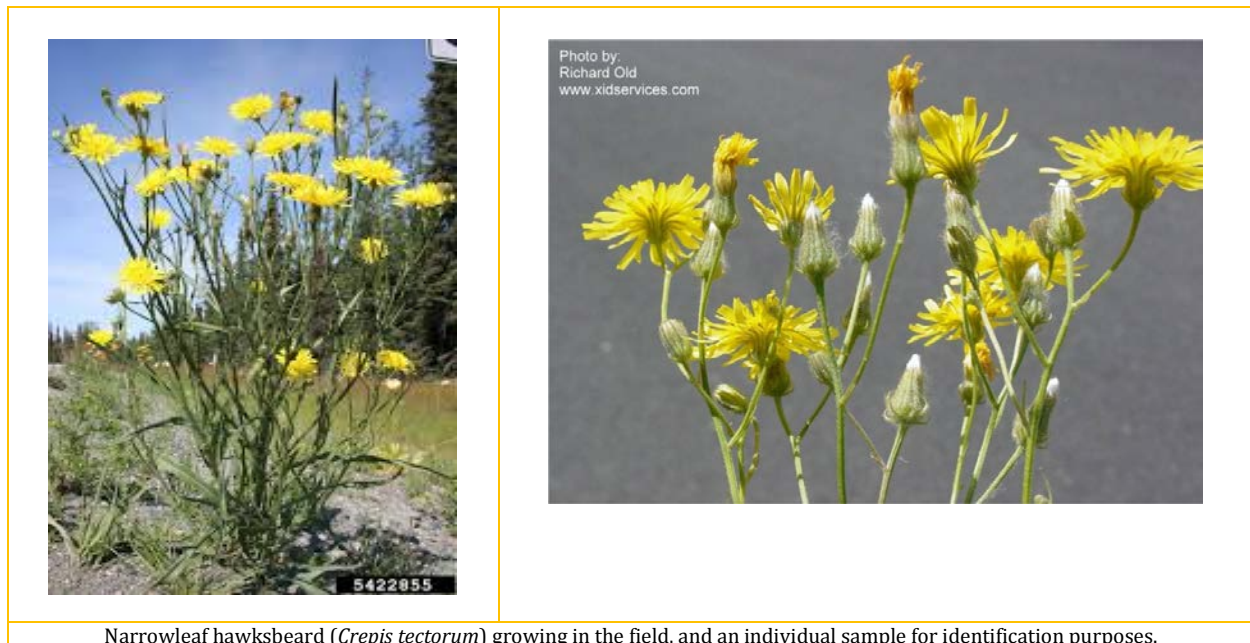
**Figure 5** Narrowleaf hawksbeard

Narrowleaf hawksbeard (Figure 5) occurs throughout Yukon along all the major highways (YISC, 2010). Hawksbeard only reproduces by seed, but each plant is capable of producing up to 50,000 seeds. The plant will therefore displace native colonizers and competes with hay crops and, once established, is hard to remove.

Small infestations of plants are easily controlled by hand pulling. Further monitoring after eradication is important as this plant is likely to be introduced again because it is a prolific seed producer. Annual plants require prevention of seed production and prevention of dispersal. Caution is necessary when using hay from road ditches or known infested areas. The plants will continue to mature after pulling so all plant parts should be placed in a clear plastic bag, left in the sun to decompose and brought to the landfill where the bag should be buried (YISC, 2010).

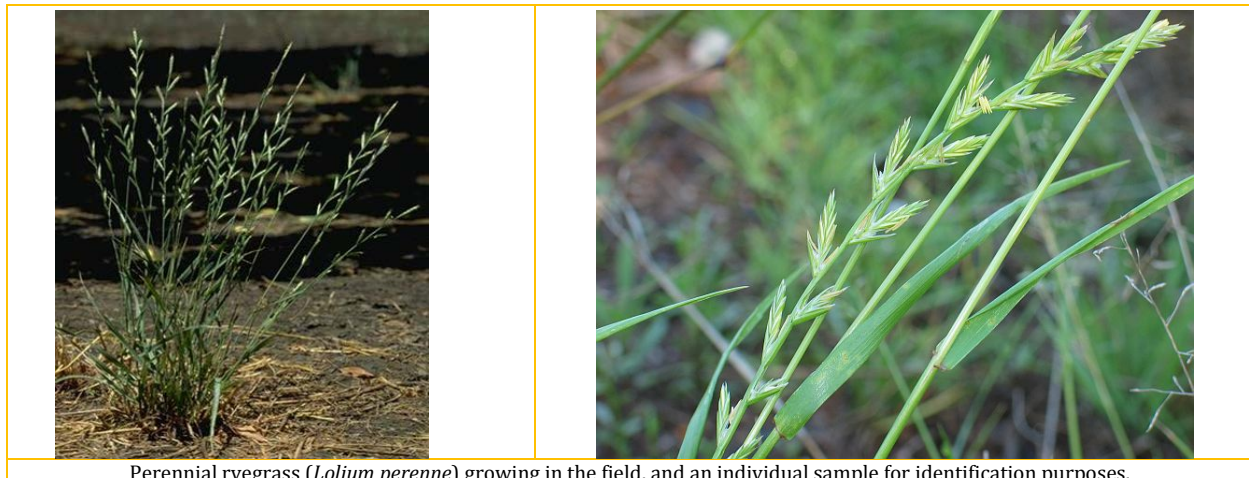
Perennial ryegrass (*Lolium perenne*) growing in the field, and an individual sample for identification purposes.

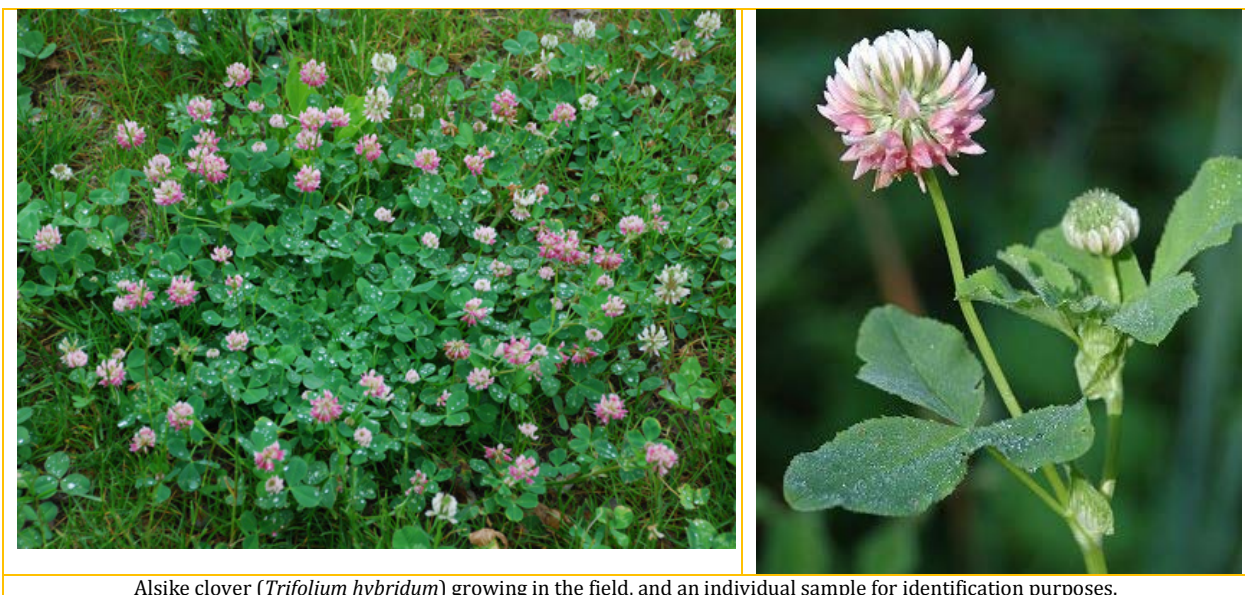
**Figure 7** Alsike clover

Alsike clover (Figure 7) was introduced from Europe and is used agriculturally as a pasture, hay or silage crop, and is also planted to prevent erosion (NatureServe 2015; USDA NRCS 2008). It grows in wet or acidic conditions, is well adapted to a range of soil types and grows well in northern latitudes at high elevations (NatureServe 2015). The plant spreads by seed and under ideal conditions, seeds last up to six years in the soil (NatureServe 2015).

Alsike clover (*Trifolium hybridum*) growing in the field, and an individual sample for identification purposes.

Small populations can be controlled by hand-pulling. Given the plant's taproot, digging may be required where the infestation is well established (UAA 2011a.). The herbicides Banvel/Banvell II (dicamba) or Lontrel 360 (clopyralid) can be used in spring or fall against alsike clover (BCMoA n.d.).

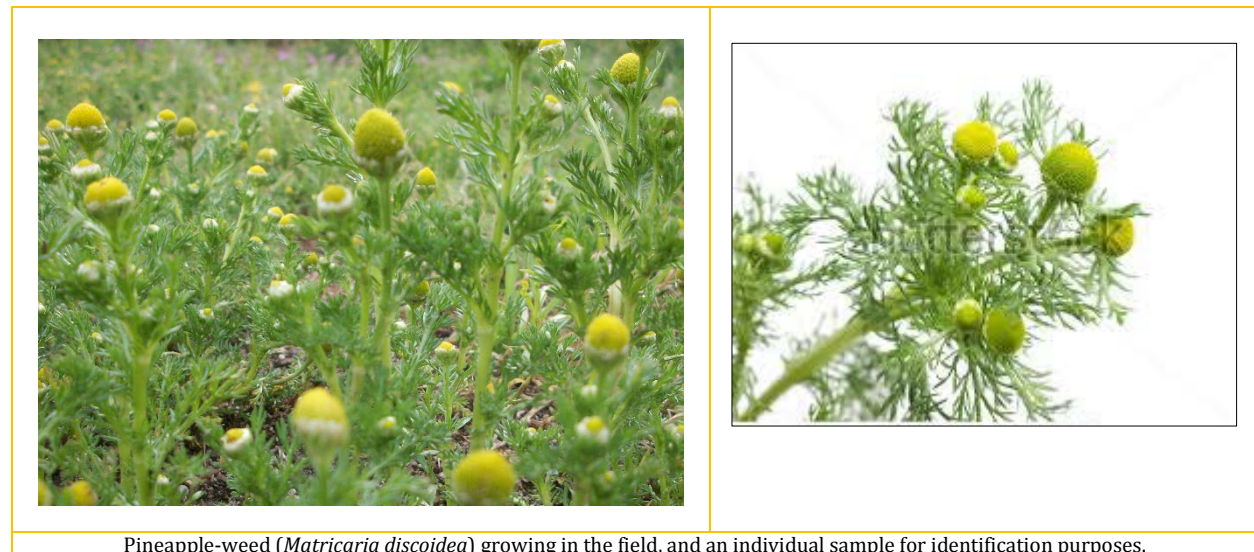
**Figure 8 Pineapple-weed**

This weed (Figure 8) is native to the Pacific coast and is now widely distributed in North America. Pineapple-weed is a summer or winter annual that reproduces by seed and seeds germinate from early spring to early fall. This species tolerates compact soil and mowing (Berry and Coop, 2000).

Pineapple-weed (*Matricaria discoidea*) growing in the field, and an individual sample for identification purposes.

Pineapple-weed is hard to control by manual methods and in most cases chemical control is required. The herbicide Gramoxone plus Goal is effective in late fall. Gramoxone is a non-residual herbicide for the control of many grasses and broadleaf weeds (Berry and Coop, 2000).

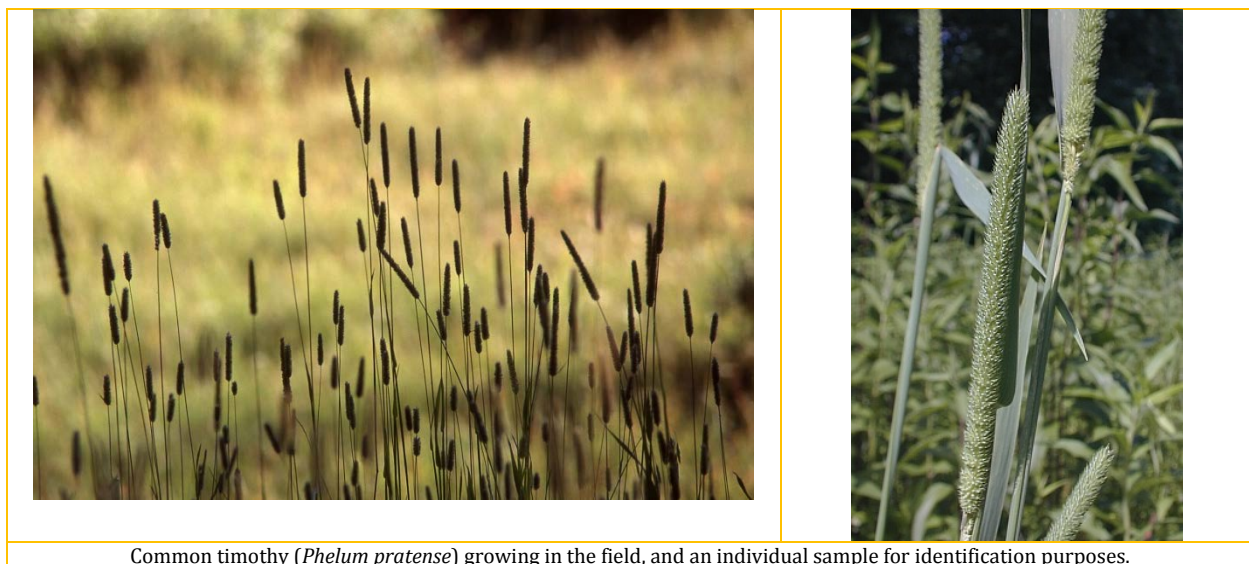
**Figure 9 Common timothy**

Common timothy (Figure 9) is an agricultural species of perennial bunchgrass introduced from Eurasia and inhabits mesic fields, roadsides, waste areas and disturbed sites (Klinkenberg, 2015b). It is well adapted to cool areas and high elevations (USDA NRCS, 2011). Timothy spreads via seed distribution and seeds can remain viable in the soil for up to five years (USDA NRCS, 2011).

Timothy is a shallow-rooted grass so hand-pulling before the grass sets seed (July) can be effective at eliminating small infestations (UAA, 2011c). Cutting or mowing repeatedly, and continuous grazing will also weaken the plant (UAA, 2011c).

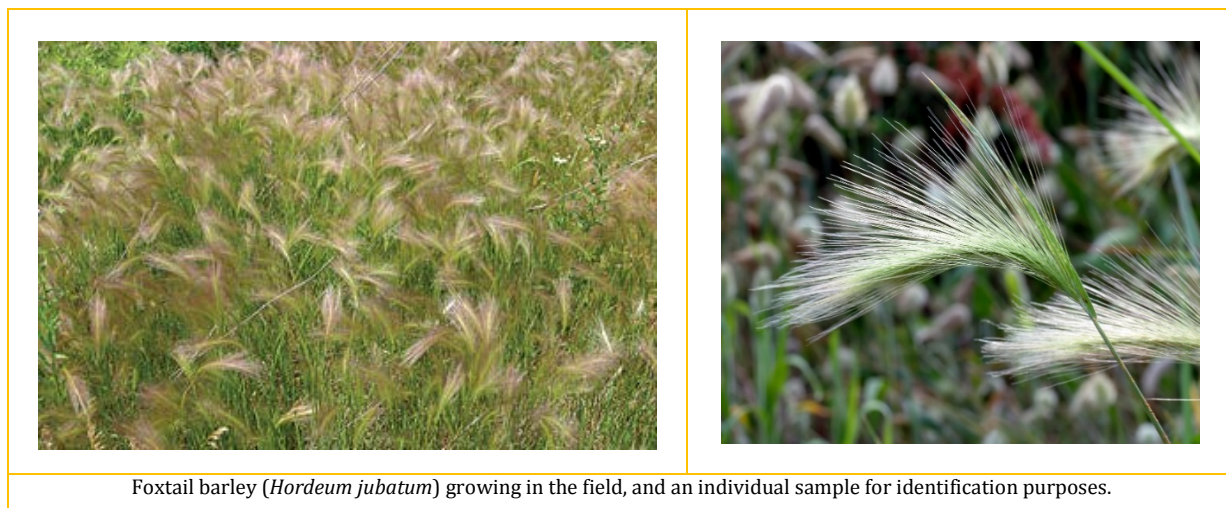
**Figure 10 Foxtail barley**

Foxtail barley (Figure 10) is an annual or perennial grass that is considered a native species in Yukon. It is, however, opportunistic and spreading rapidly across Yukon landscape, both along roads and in agricultural situations. The Yukon public has voiced concern about this plant due to its socio-economic impacts: it is harmful to livestock and horses due to its sharp awns, it reduces crop yields and it forms monocultures in once-diverse native ecosystems. Each plant can produce over 150 seeds, which may remain viable in the soil for over a year (UAA, 2011b). A strategy for managing this species is in demand in Yukon and thus it should be part of an invasive species monitoring program (Line et al., 2008).

Foxtail barley can be removed by hand-pulling, digging or tillage as it is shallow-rooted (Dunn and Blackshaw, 2007). Care should be taken to do so before the seed heads form in summer. As foxtail barley is also very tolerant of standing water so reducing anthropogenic wet areas during construction or road works can be helpful (UAA, 2011b). In areas where foxtail barley needs to be eradicated and no desirable grass species are present, a clethodim product (Select) or Assure II applied especially before plants mature will be successful. If the areas contain desirable grass species then Plateau is labeled for control. It is important to follow label direction to apply at the proper timing, to use recommended adjuvants, and follow other label information (NDSU, 2015).

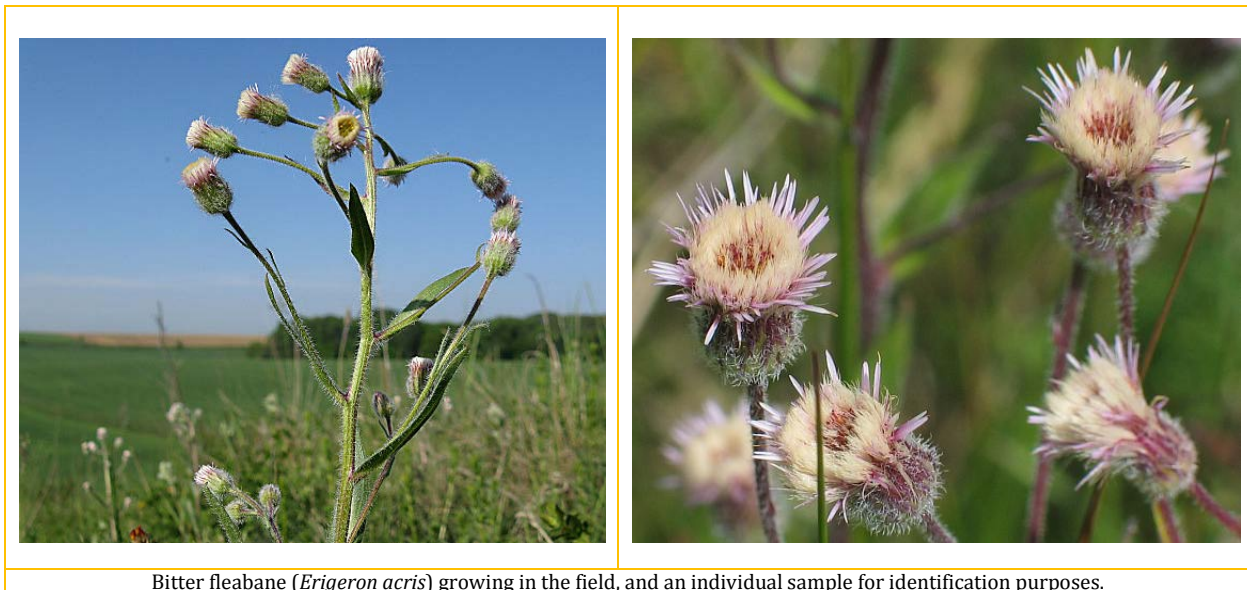
**Figure 11 Bitter fleabane**

Bitter fleabane (Figure 11) is a native pioneer species that often colonizes disturbed areas such as pastures, abandoned fields, vacant lots, roadsides, railways, and waste areas. In these habitats it competes, often successfully, with introduced invasive weeds. This plant was seen at many of the same sites where IP were found during the survey. It does not need to be controlled, where possible should be left alone.

Bitter fleabane is biennial or perennial herb; stems erect, solitary to several, branched above, often spreading stiff and hairy, 20-80 cm tall. The basal leaves are oblanceolate or spoon-shaped, stalked, usually entire, 1-15 cm long, 1-14 mm wide; stem leaves ample or strongly reduced, linear-oblong, becoming unstalked.

The heads have ray and disk flowers, several to numerous on stalks in a flat or round-topped inflorescence; involucre bracts lanceolate, finely glandular and/or stiff-hairy, green or more or less purplish; ray flowers numerous, although sometimes inconspicuous, in several series, of two types, the outer with a long threadlike tube and narrow pink to purplish or white erect ray flowers, these about 2.5-4.5 mm long, the inner female flowers rayless or nearly so (Klinkenberg, 2015a).

Bitter fleabane (*Erigeron acris*) growing in the field, and an individual sample for identification purposes.

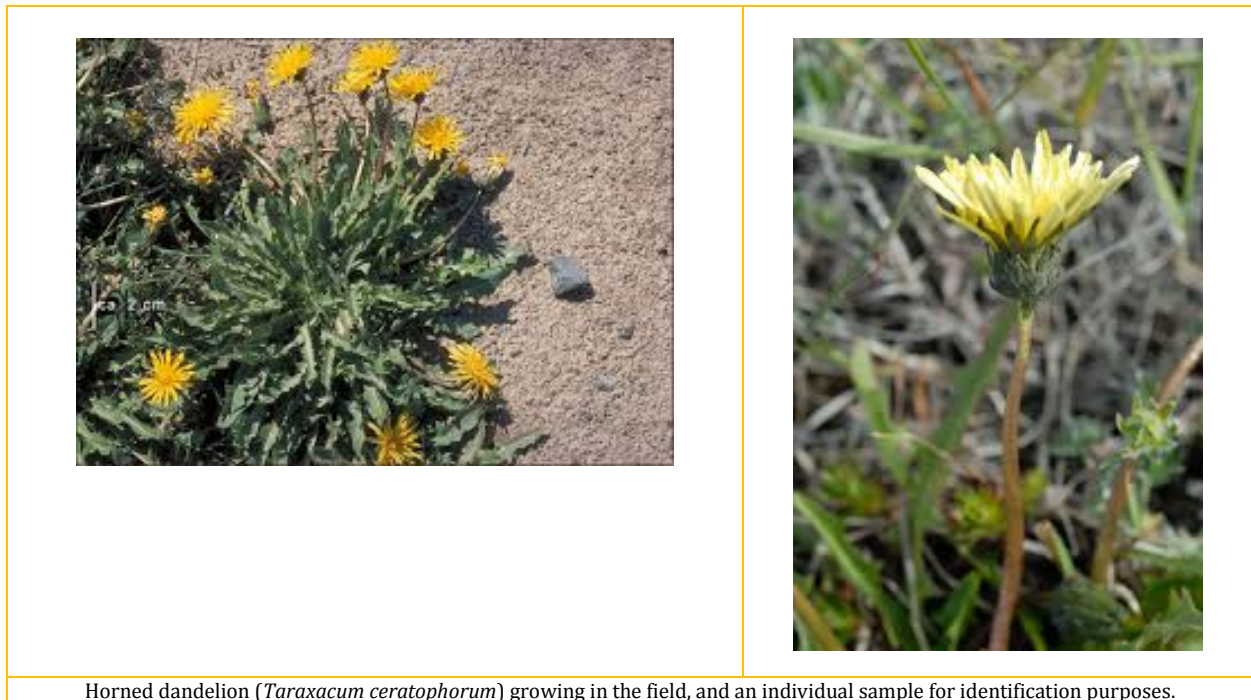
**Figure 12** Horned dandelion

The horned dandelion (Figure 12) is native to North America and often found in alpine environments. It is a perennial herb and grows from a simple or branched stem-base and a thick, often black, taproot; stems ascending to erect, solitary to several, simple, hollow, glabrous or sparsely long-hairy, exuding milky juice when broken, 3-60 cm tall. Basal leaves lanceolate to oblanceolate, 1-35 cm long, 0.3-6 cm wide, tapering basally to a more or less winged stalk, nearly entire to toothed or more often pinnately lobed to pinnately cut, the terminal lobe often wider than the others, Heads with yellow strap-shaped flowers, solitary; involucre 7-22 mm tall; involucre bracts in 2 series, the outer ones egg-shaped to lanceolate, appressed to ascending, glabrous or long-hairy, the inner ones lance-oblong, long-pointed, usually horned at the tips, rarely only slightly so; ray flowers yellow, sometimes purple-veined; disk flowers lacking (Klinkenberg, 2015c).

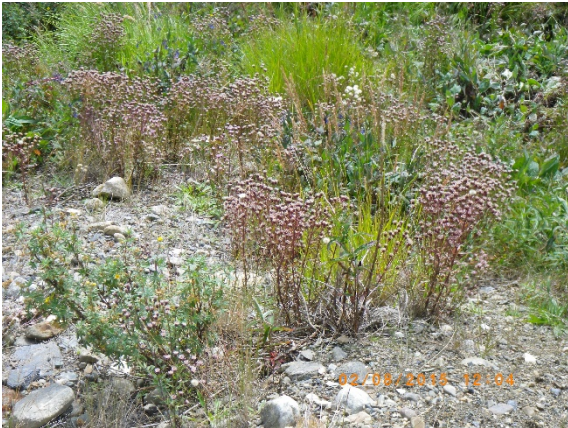
Photo 1: Native bitter fleabane found along access road

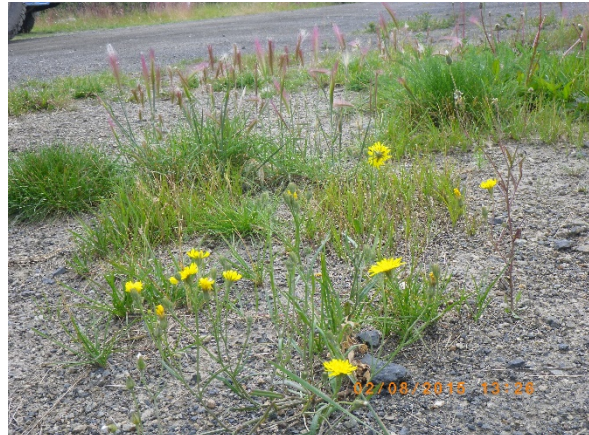
Photo 2: Native horned dandelion found along access road

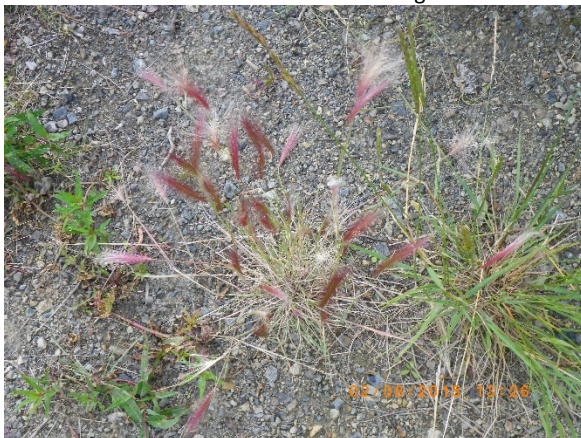
Photo 3: Foxtail barley found along access road

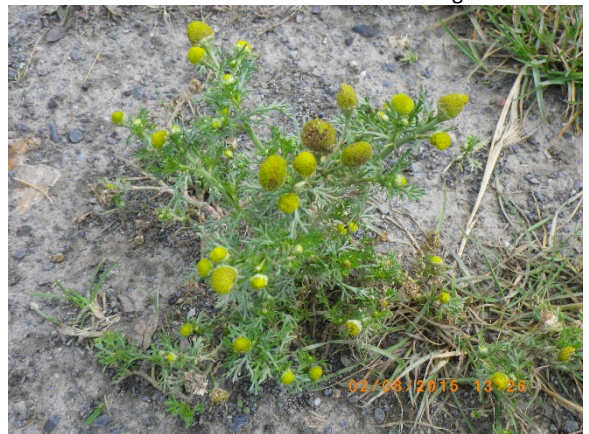
Photo 4: Invasive pineapple weed found at gatehouse

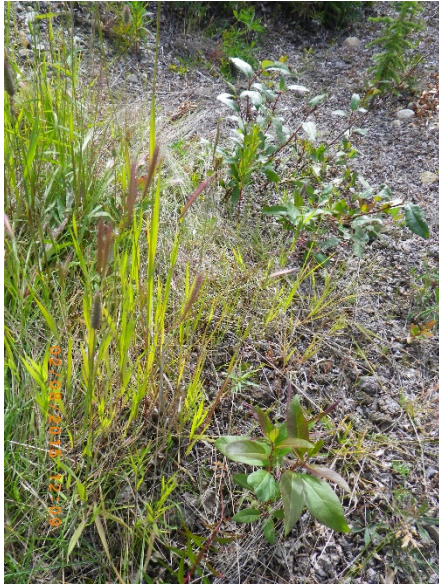
Photo 5: Common timothy found along access road

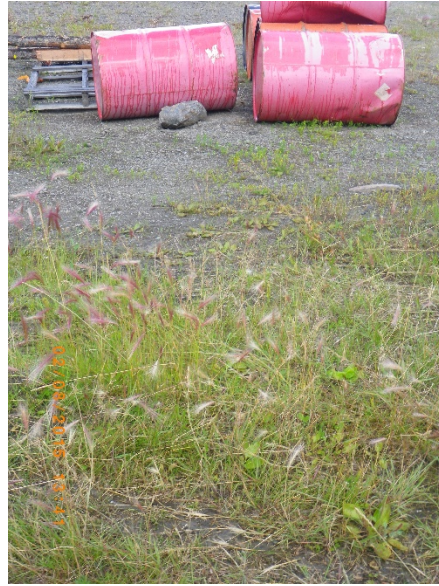
Photo 6: Foxtail barley at layby area near intersection of access road and Robert Campbell Hwy

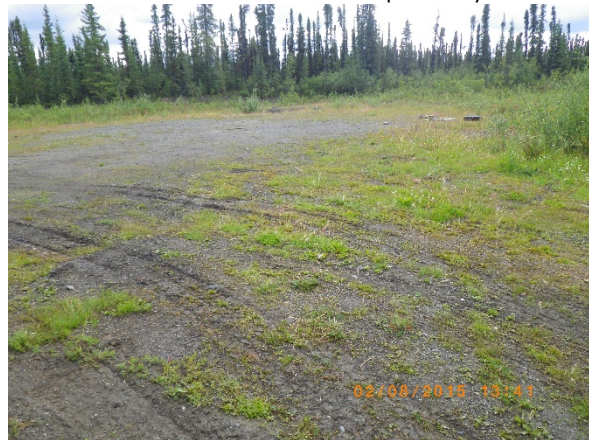
Photo 8: Invasive alsike clover found at layby area
