July 8, 2008

EBA File: W23101021.016

**Re: Avalanche Assessment for Mactung Access Road Alignment
May 9TH, 2008. MacMillan Pass, Yukon**

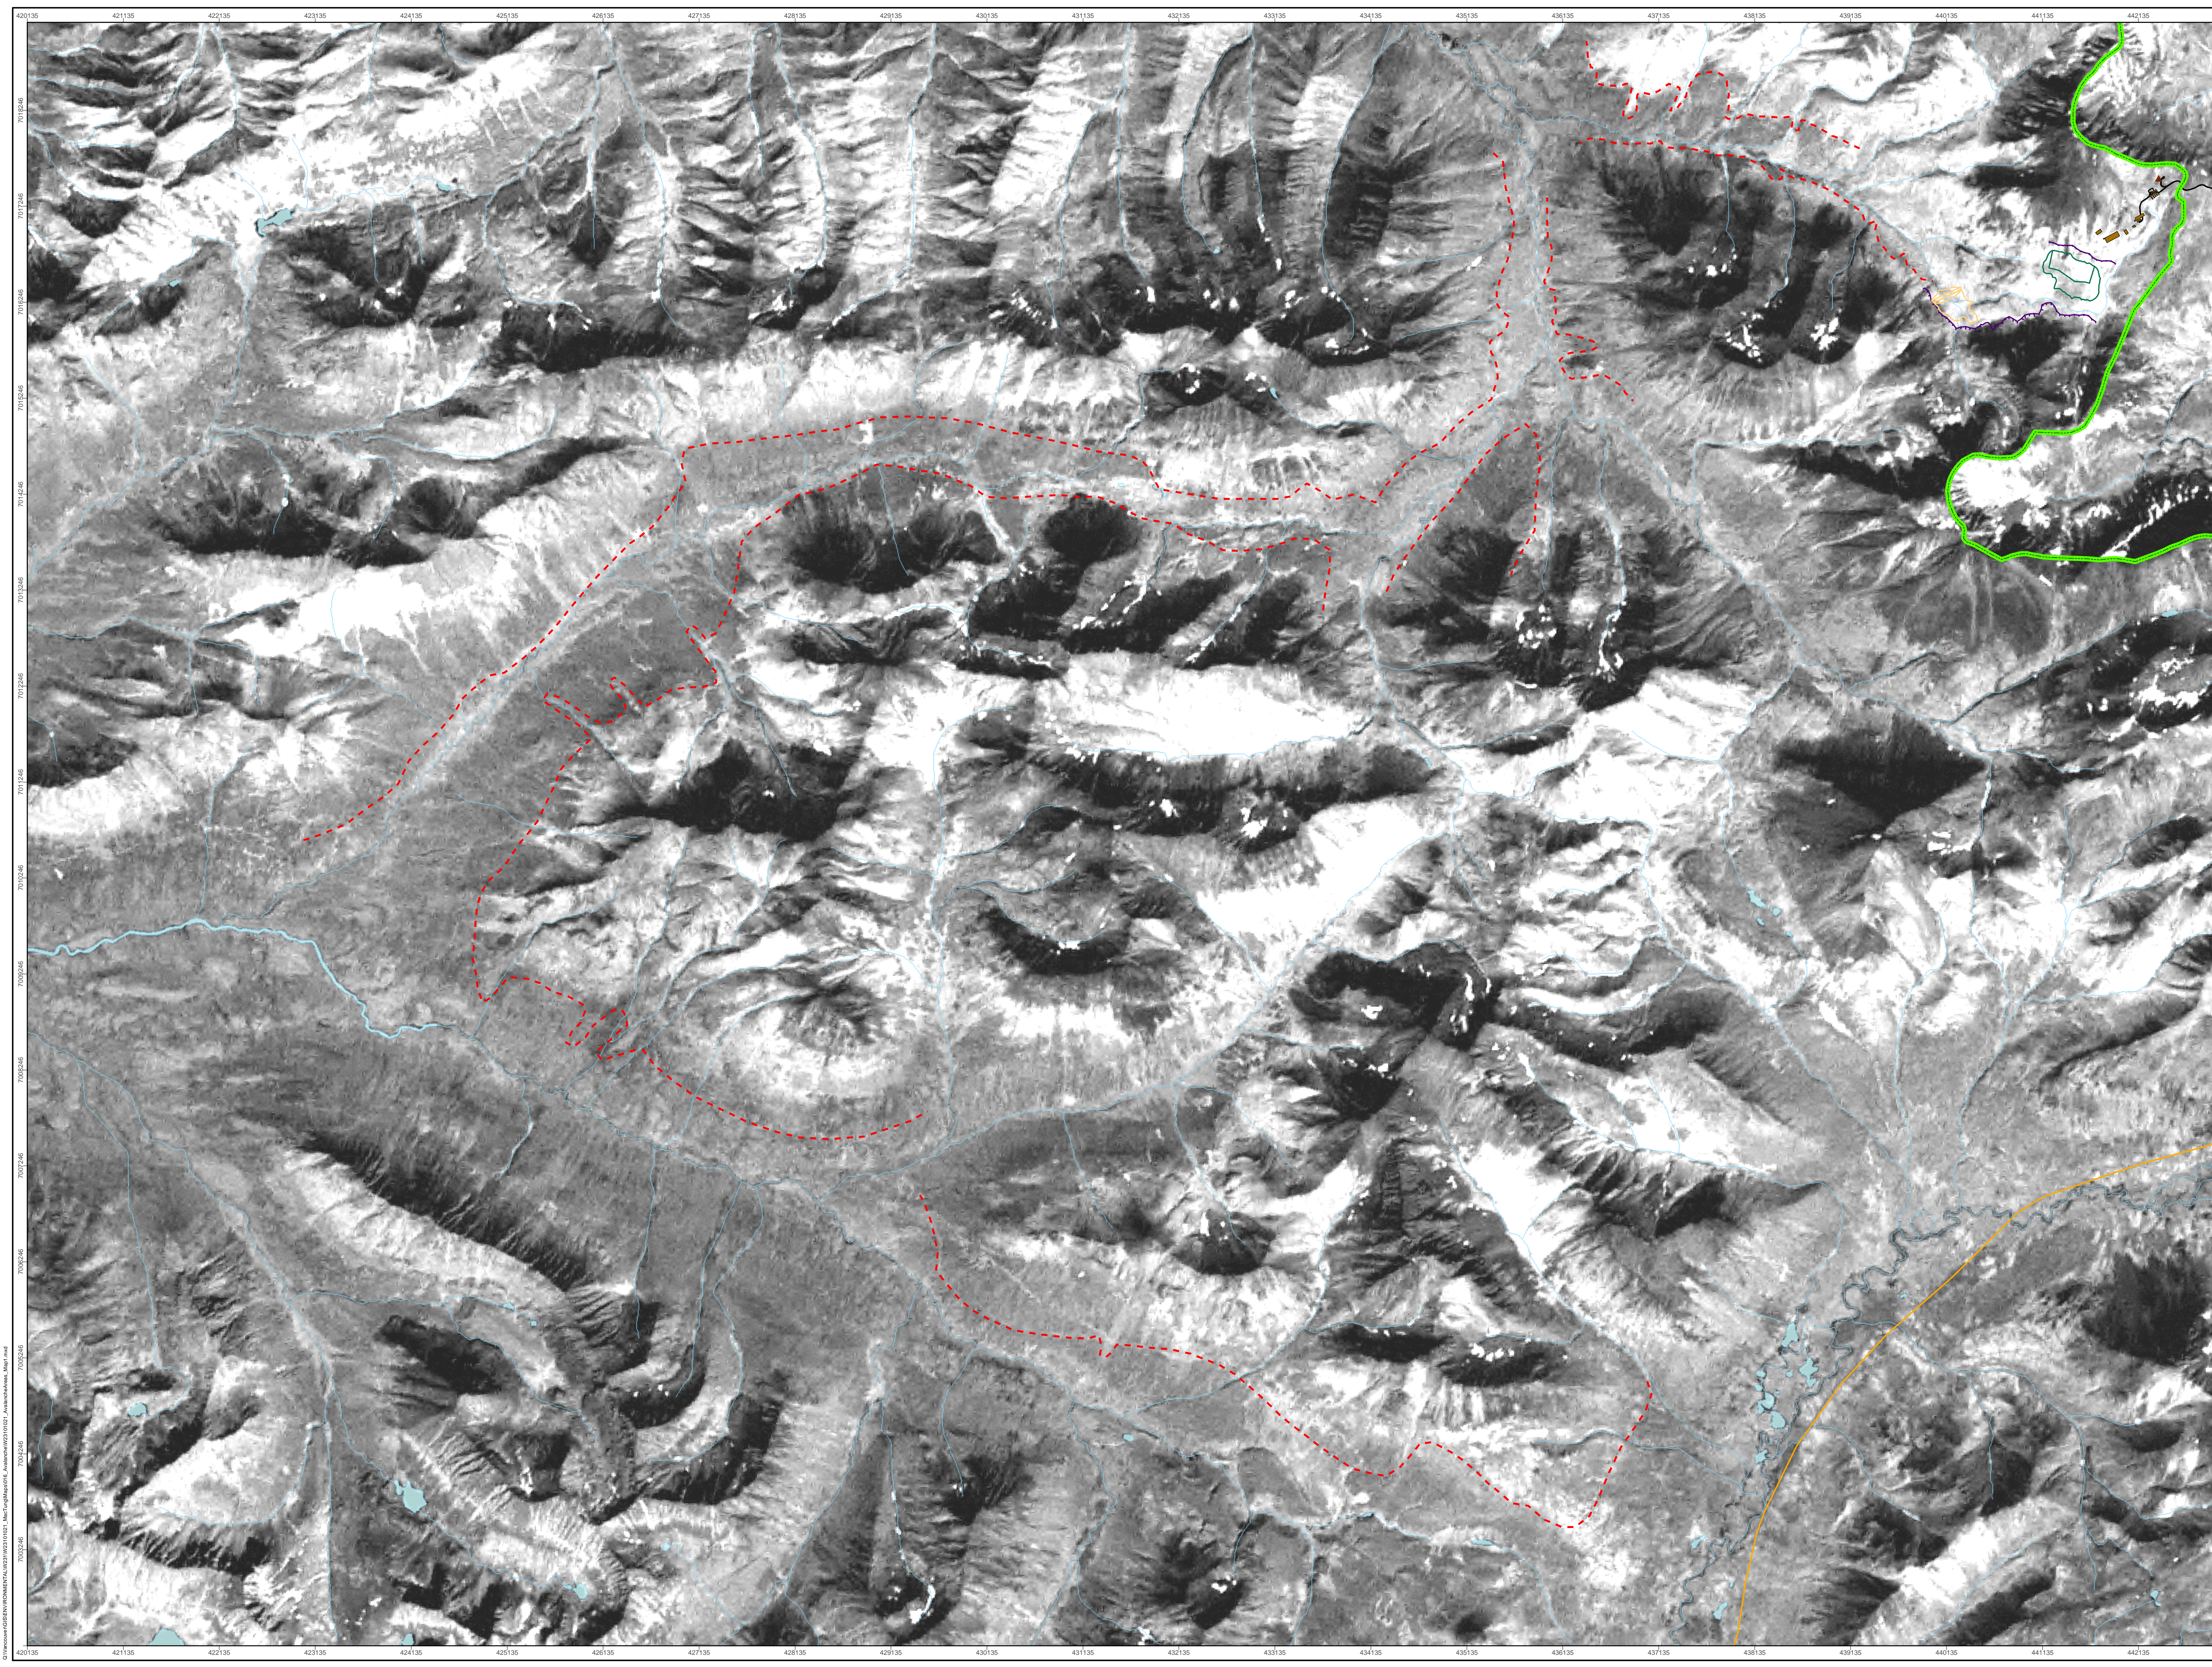
MACTUNG			
MacTung Proposed Access Road Preliminary Delineation of the Extent of High Hazard Avalanche Terrain			
PROJECTION UTM Zone 9	SCALE 1:30,000	DATUM NAD83	
FILE NO. W23101021_AvalancheAreas_Map1.mxd	DRAWN MEZ	CHKD SD	REV 0
PROJECT NO. W23101021.016	DATE June 11, 2008	EBA Engineering Consultants Ltd.	
OFFICE EBA-VANC	Map 1

Map 1 and Map 2 delineate the potential extent of avalanche activity observed during the May 9, 2008 aerial reconnaissance. The mapping is based on reconnaissance level investigation only, as there is insufficient information at this time to ascertain the extent of the avalanche paths and hazard along the route. More detailed avalanche path mapping,

frequency studies and snow texturing (previously recommended) are required to advance the avalanche hazard map.

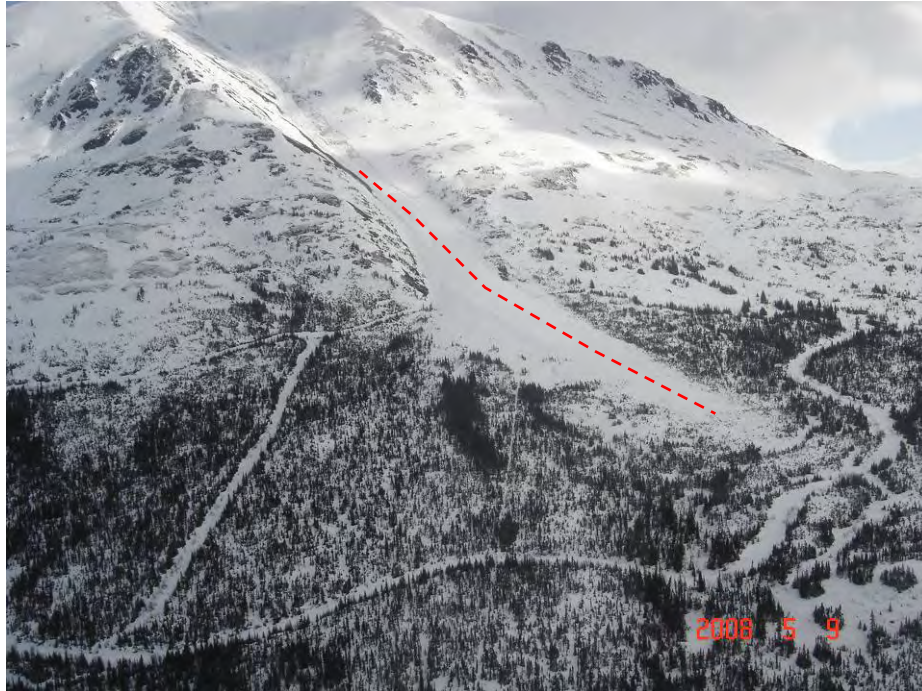
Section 1 of the proposed road traverses along southwest aspect slopes. Avalanche activity along this entire section was predominantly from the smaller gullied terrain features. Only one of the larger gully features in this section of the route had experienced any substantial avalanche activity. Runout from this recent avalanche activity travelled to the elevation of the existing exploration access road. Photo 1 through Photo 3 show typical of avalanche activity along Section 1.

Photo 1. May 9, 2008 Recent avalanche activity along Section 1

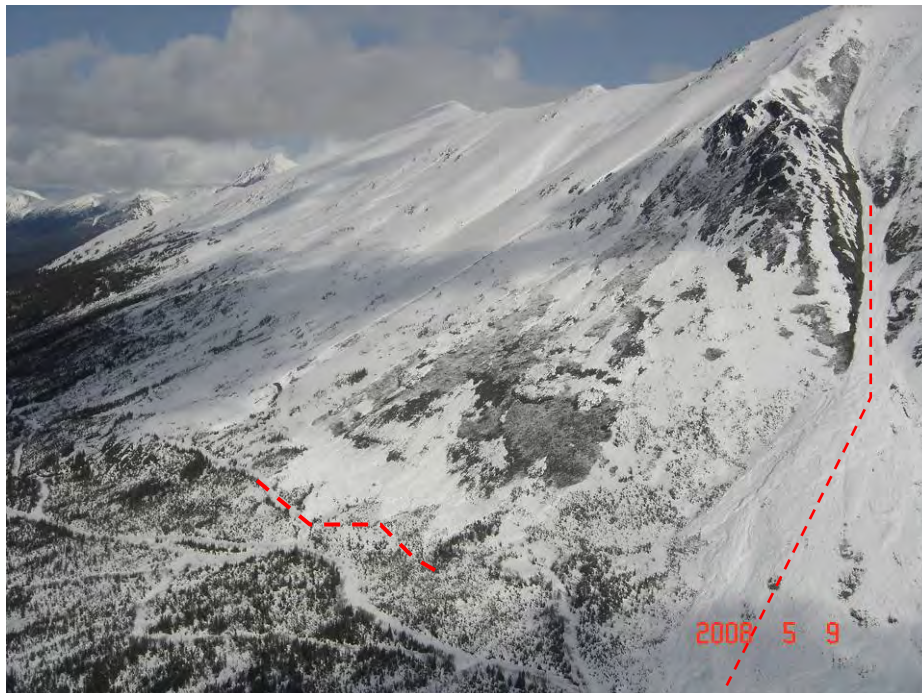
Photo 2. May 9, 2008 Recent avalanche activity along Section 1
(red dashed lines shows approximate toe of recent runout and path of large gully avalanche)

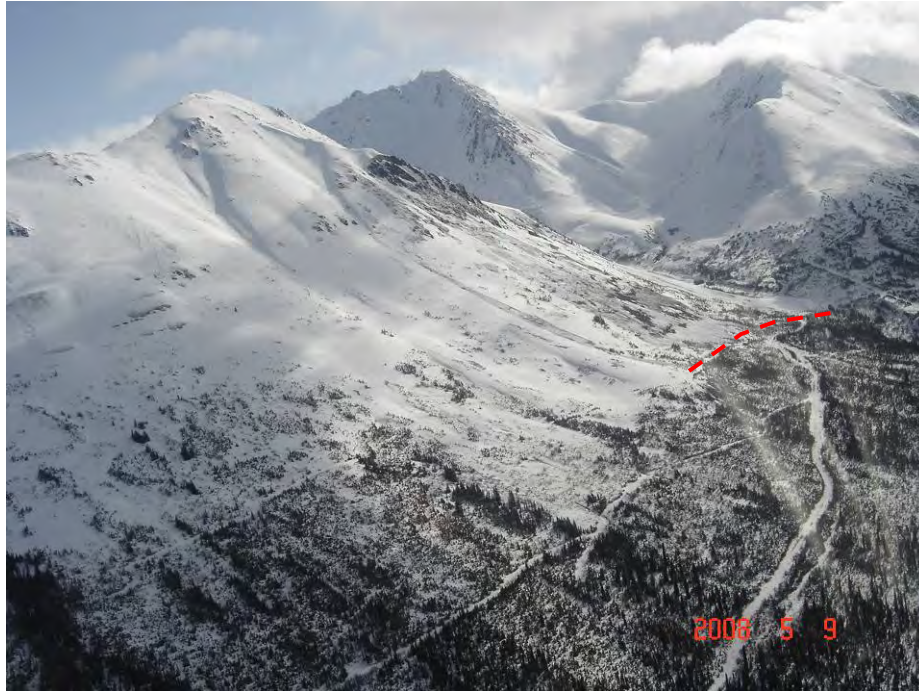
Photo 3. May 9, 2008 Recent avalanche activity along Section 1

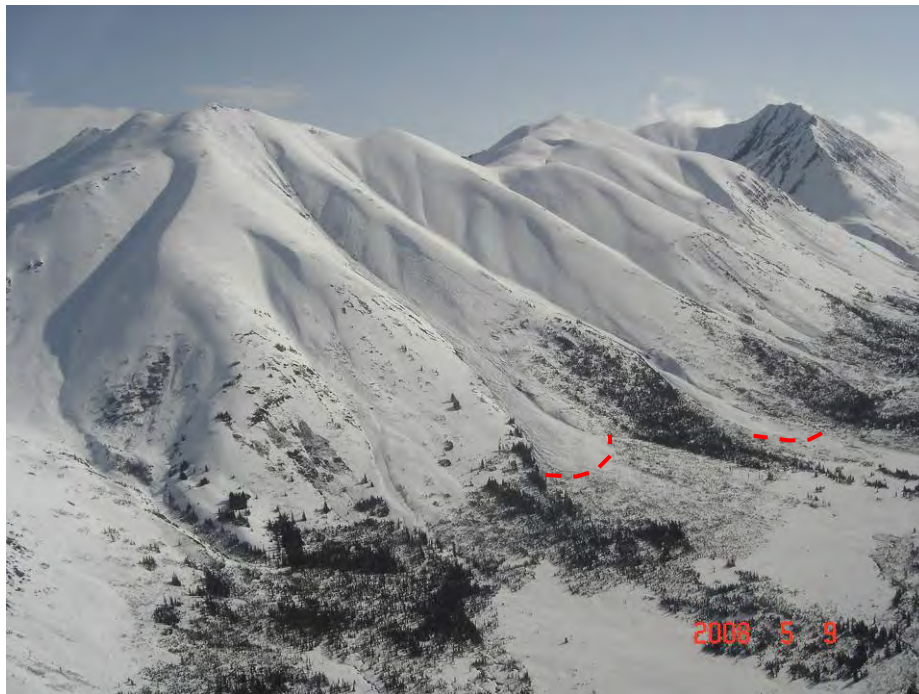
Section 2 of the proposed road traverses northeast then east along a small tributary to the drainage divide. Recent avalanche activity in small gullies and on smooth straight slopes on the northern side of the valley (south to southeastern aspect) was observed. Current runout on these slopes was typically to the upper to middle elevations of colluvial fans with evidence of historical runouts extending onto the valley flats based on vegetation patterns in these areas. The southern side of the valley (northwest to northern aspect) had less avalanche activity, which is probably due to lower solar radiation inputs to these slopes. Runouts on these slopes were typically limited to midslope elevations. These southern valley (northwestern aspect) slopes had substantial snowpack remaining and the potential for large avalanches cannot be discounted. Photo 4 and Photo 5 are typical of avalanche activity along Section 2.

Photo 4. May 9, 2008 Typical avalanche activity along Section 2 with runout onto upper to mid fan.

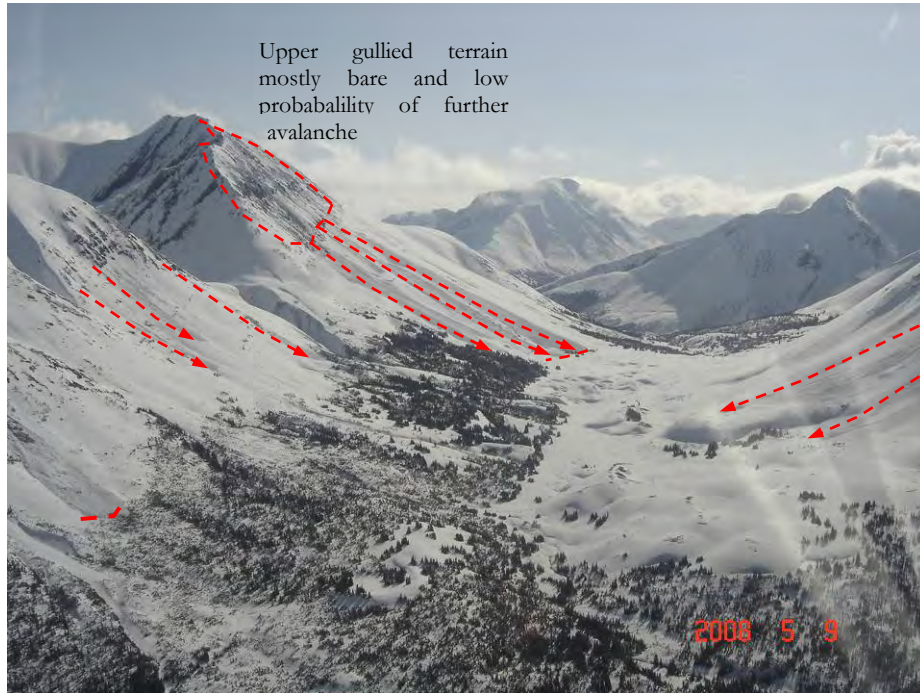
Photo 5. May 9, 2008 Recent avalanche activity near drainage divide in Section 2. Historical avalanche runout extends to valley bottom on photo left .

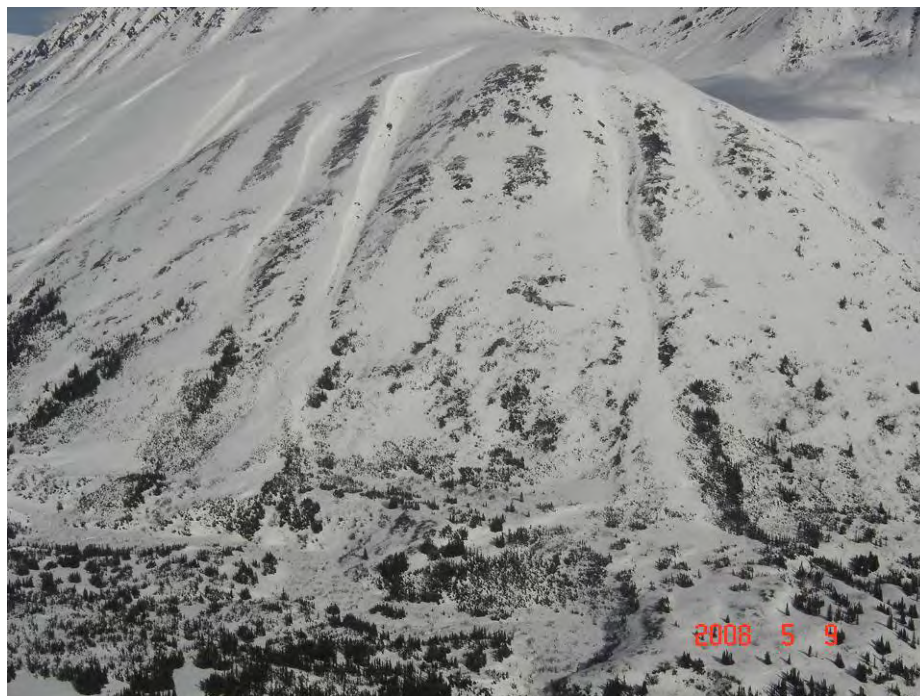
Section 3 of the proposed road traverses north along Tributary A (Figure 1). The slopes on both sides of the valley in this section showed evidence of recent avalanche activity (see Photo 6 to Photo 8). The extent of runouts on both sides of the valley was limited to the upper sections of colluvial fans. There is considerable snowpack accumulation at high elevation and the potential for large avalanches on the western side of the valley cannot be discounted. The avalanche terrain on the eastern side of the valley has smaller catchment areas and recent avalanche activity appears to have removed much of the snow mass.

Photo 6. May 9, 2008 View of small avalanche paths at start of Section 3.

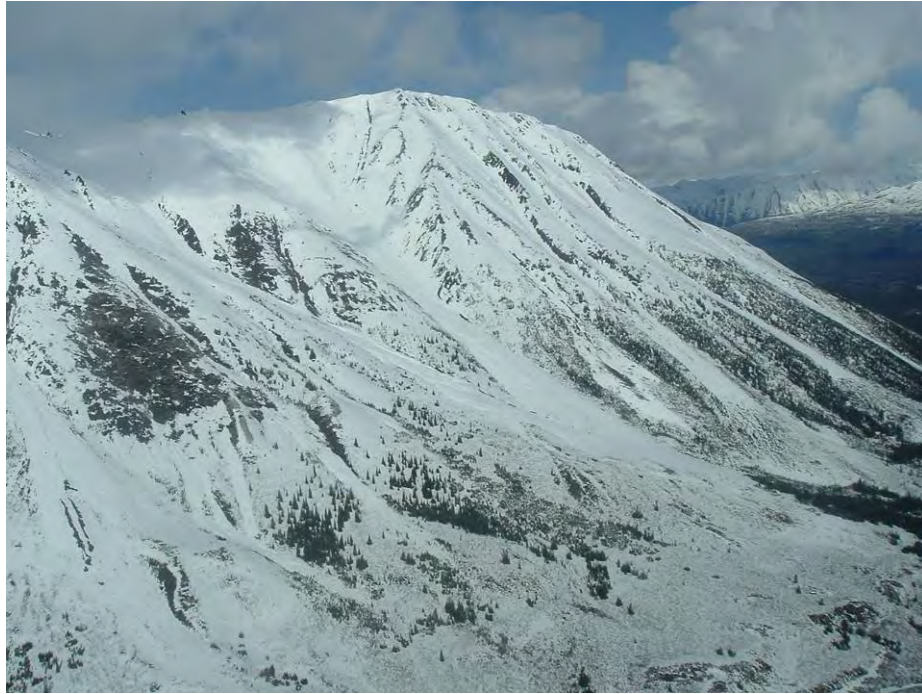
Photo 7. May 9, 2008 View to western valley slopes in Section 3 with avalanche runouts to upper area of colluvial fan

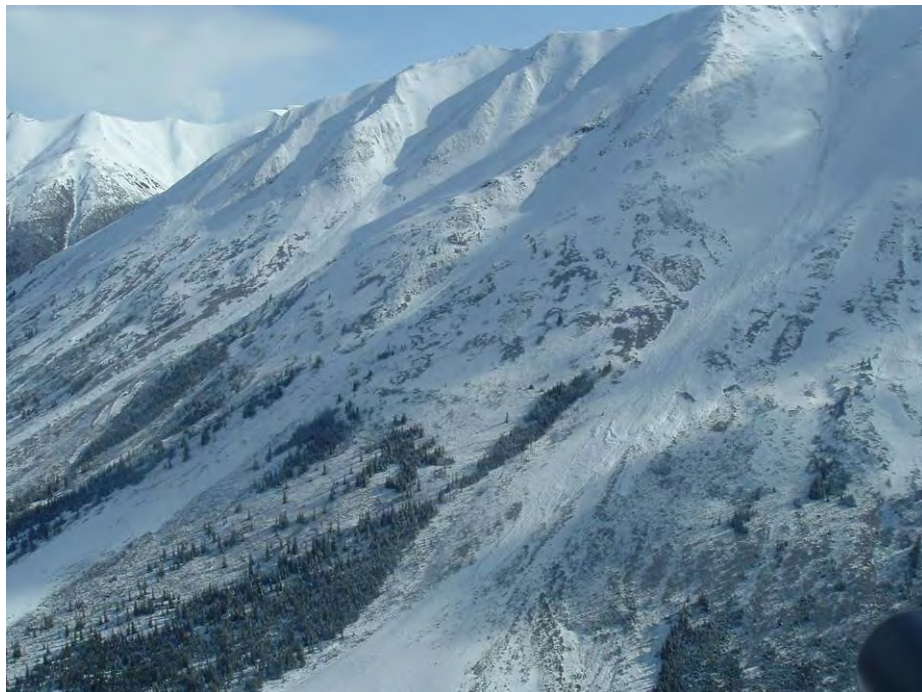
Photo 8. May 9 2008 Section 3 eastern valley slope with typical runout to upper area of colluvial fan.

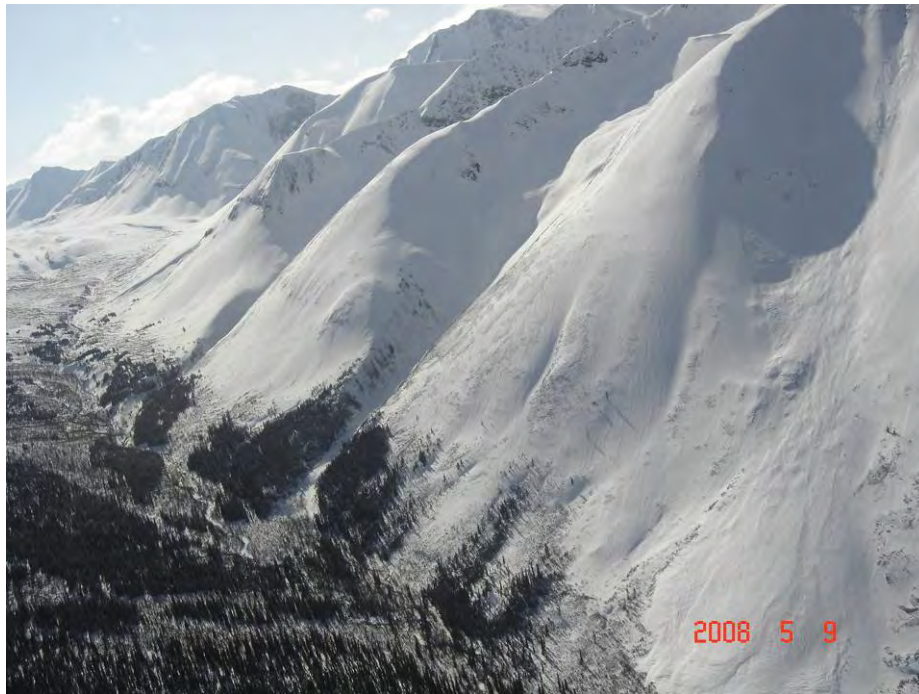
Section 4 of the proposed road traverses the northern slopes of Tributary C up to the minesite. Avalanche activity was evident along the south side of the valley (north aspect) with runouts of lower elevation gullies reaching close to the valley bottom. The northern slopes had avalanche runout to upper sections of colluvial fans. Relic avalanche debris tracks indicate historical avalanche runouts extending down to Tributary C. Larger gullies on the northern side of the valley still had residual snowpack and there is potential for avalanche activity along these slopes. Photo 9 and Photo 10 show avalanche activity along Section 4.

Photo 9. May 9, 2008 southern valley slopes in Section 4
with avalanche runout close to valley bottom

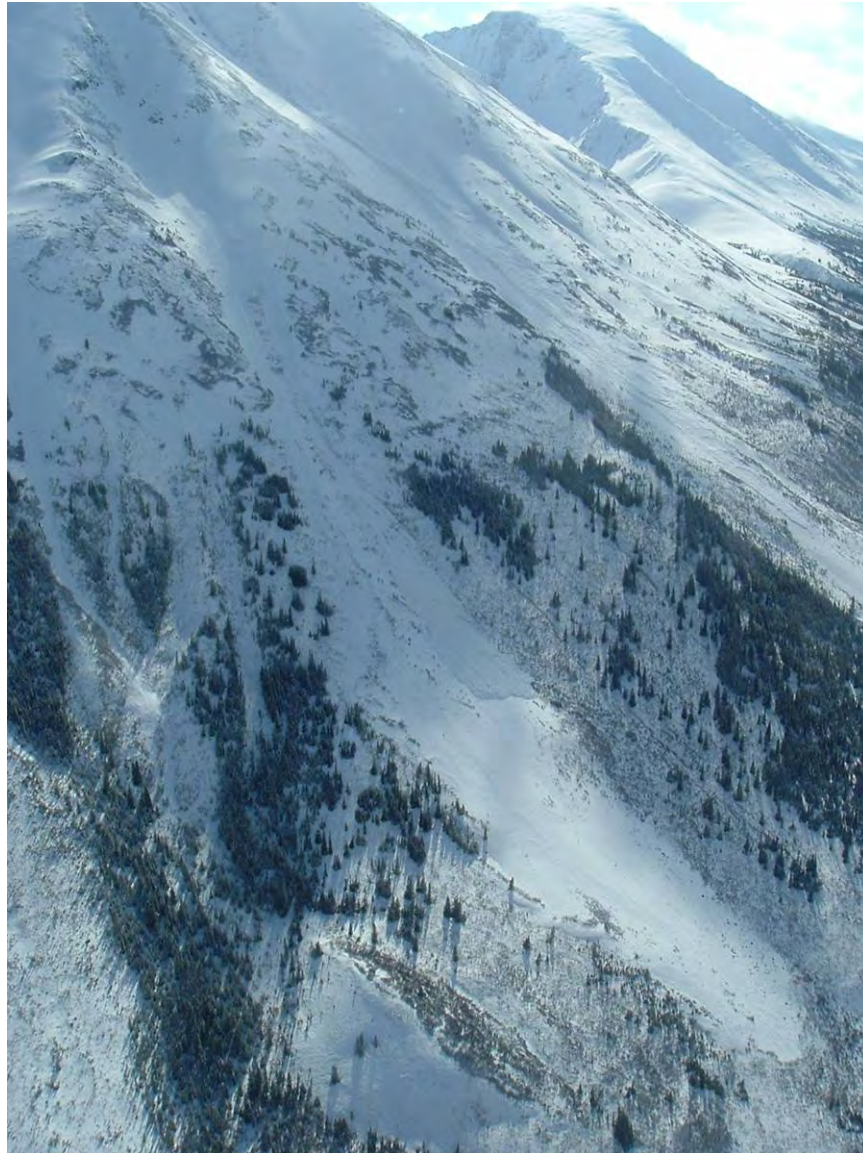
Photo 10. May 9, 2008 northern valley slopes in Section 4
with avalanche runout onto upper to mid fan elevations

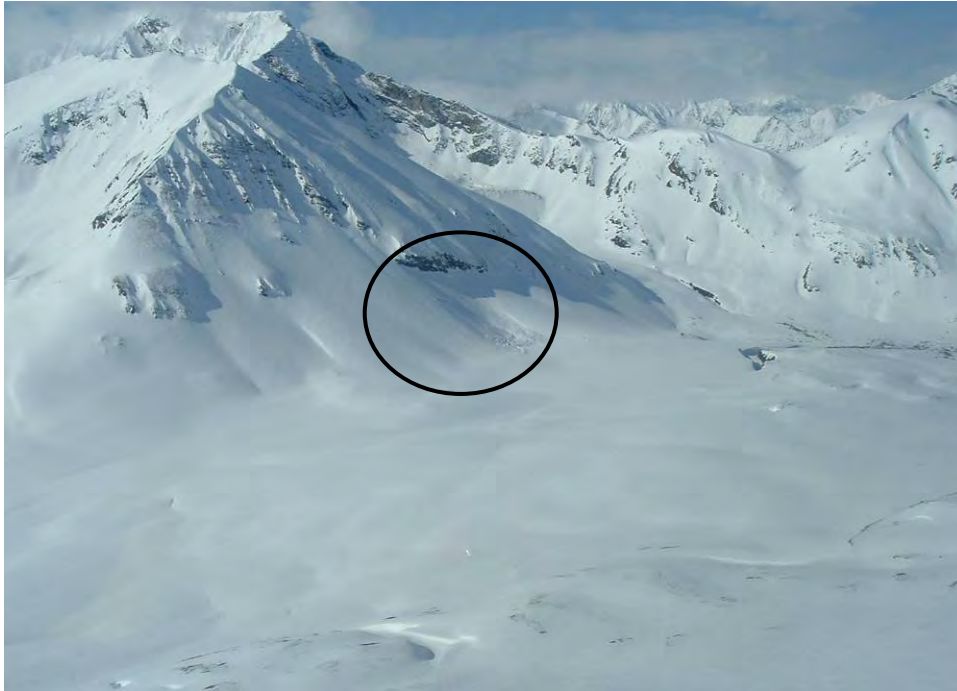
One avalanche was noted on the steep north aspect slopes adjacent to the Tailings Storage Facility (Photo 11). Several small avalanches were noted on a southwest aspect slope to the west of the proposed infrastructure at an elevation of approximately 1800 m. Several small avalanches were also noted to the east of the minesite just inside the Northwest Territories. These avalanches occurred below bedrock outcrops at an elevation of approximately 1800 m.

Photo 11 May 9, 2008 Recent avalanche activity by proposed Tailings Storage Area

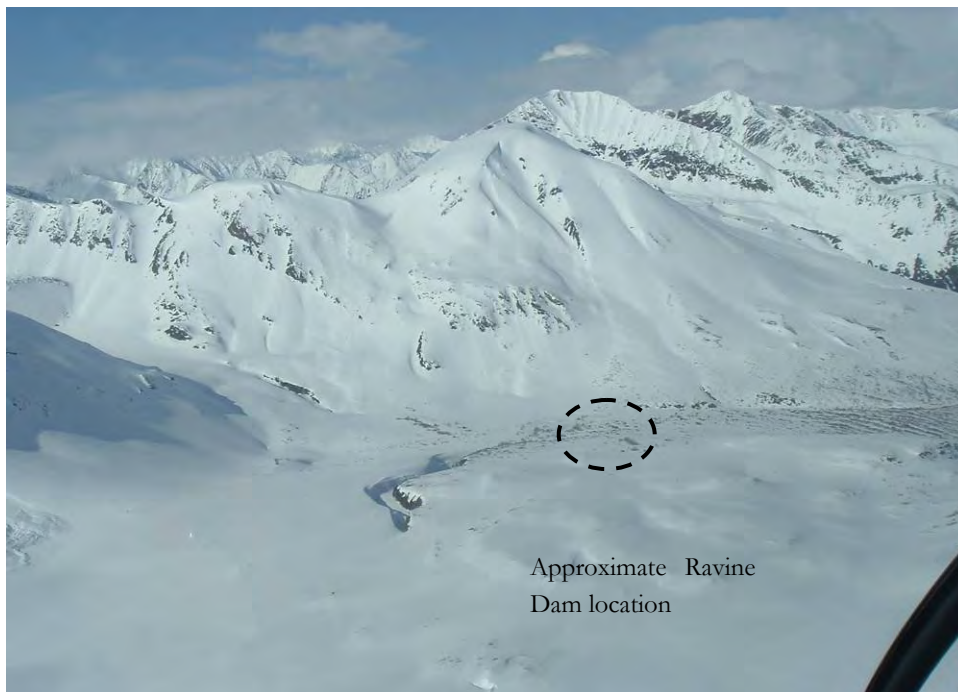
The slopes above the proposed Ravine Dam showed no evidence of recent avalanche activity (Photo 12). However, based on slope gradient, aspect, smooth slope configuration, thickness of remaining snowpack and evidence of activity on similar slopes in the area, there is judged to be potential for avalanche activity on these slopes as the season advances. No recent avalanche activity was noted on or above the slopes where mine infrastructure is proposed (Photo 13).

Photo 12. May 9, 2008 View to Ravine Dam location with no recent avalanche activity.

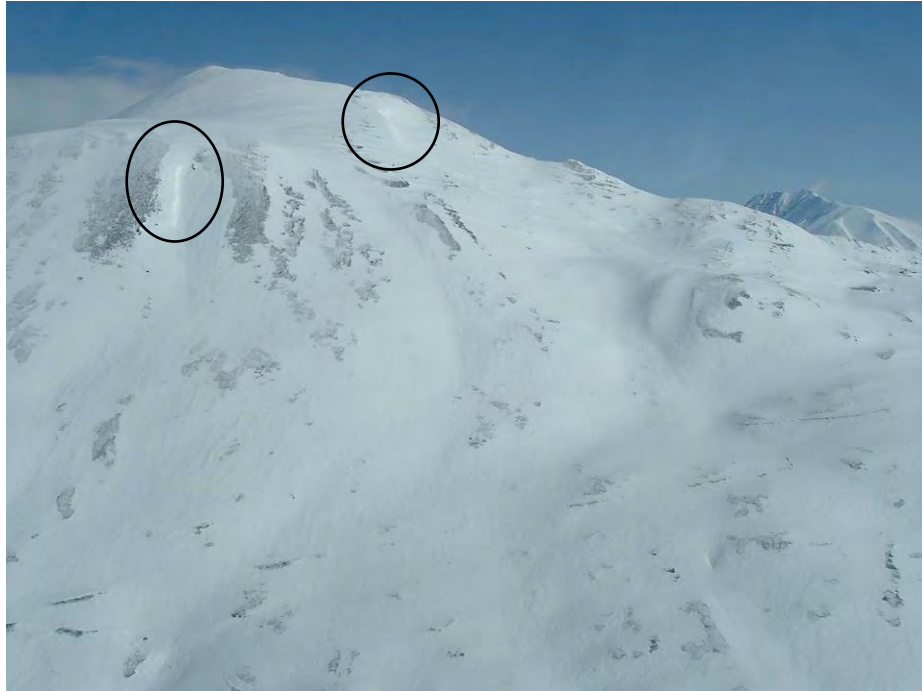
Photo 13. May 9, 2008 View to proposed minesite infrastructure with no evidence of recent avalanche activity. Cornices on ridge line indicate an easterly dominant wind.
