North American Tungsten Corporation Ltd.

MACTUNG PROJECT

2006 Environmental Baseline Studies FISHERIES AND AQUATIC RESOURCES

April 2007

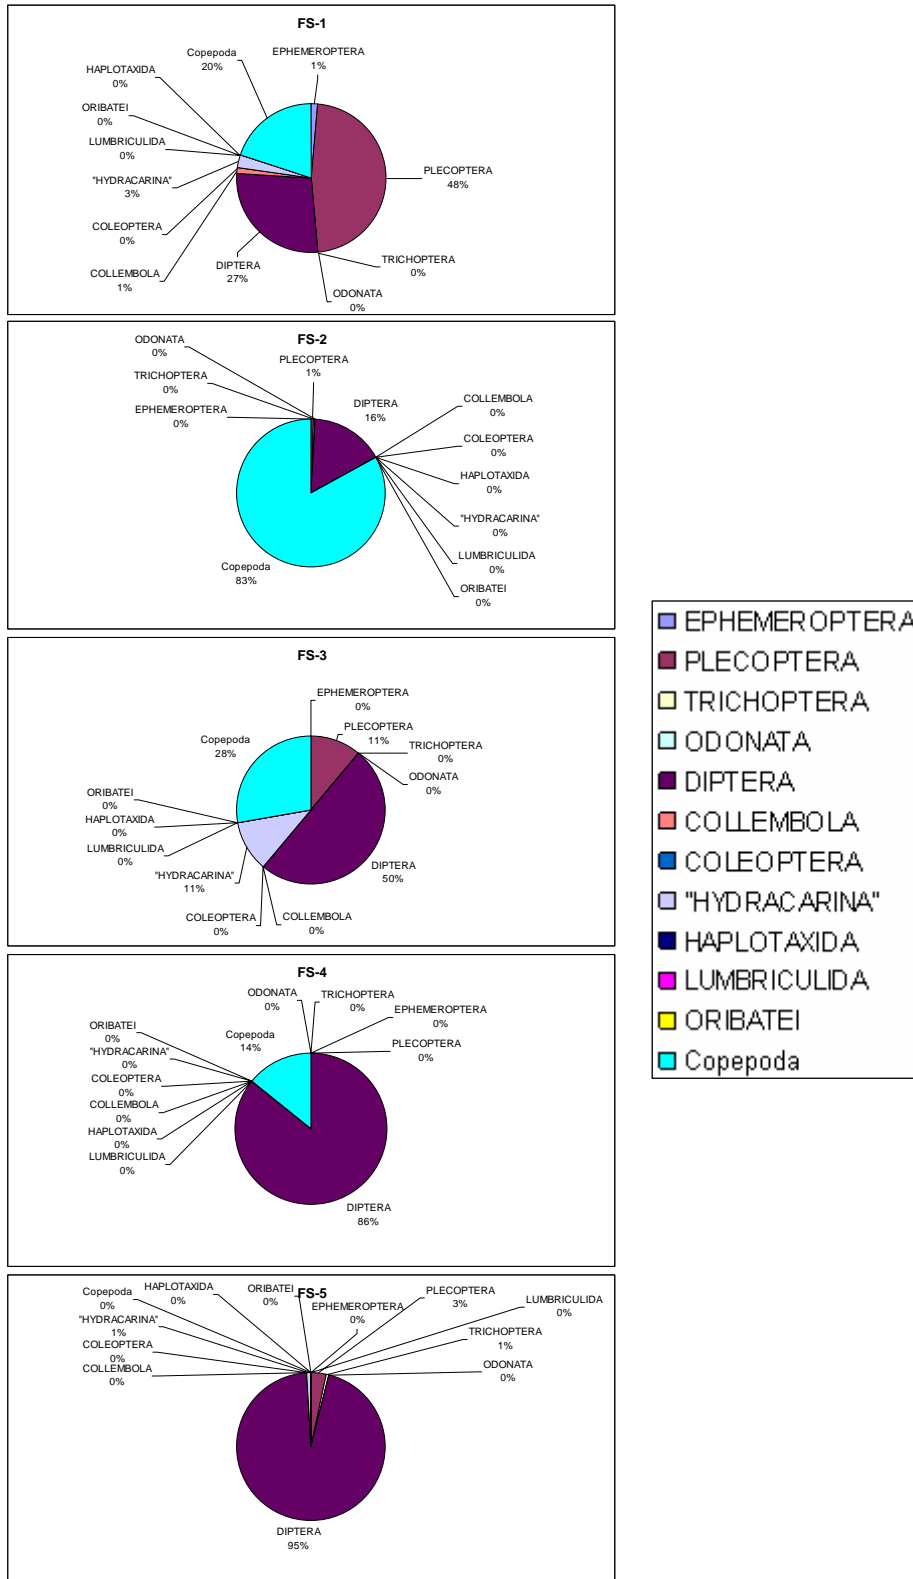
Figure 3a. Benthic invertebrate community composition for stations on the eastern slope of Macmillan Pass (FS1-FS5).

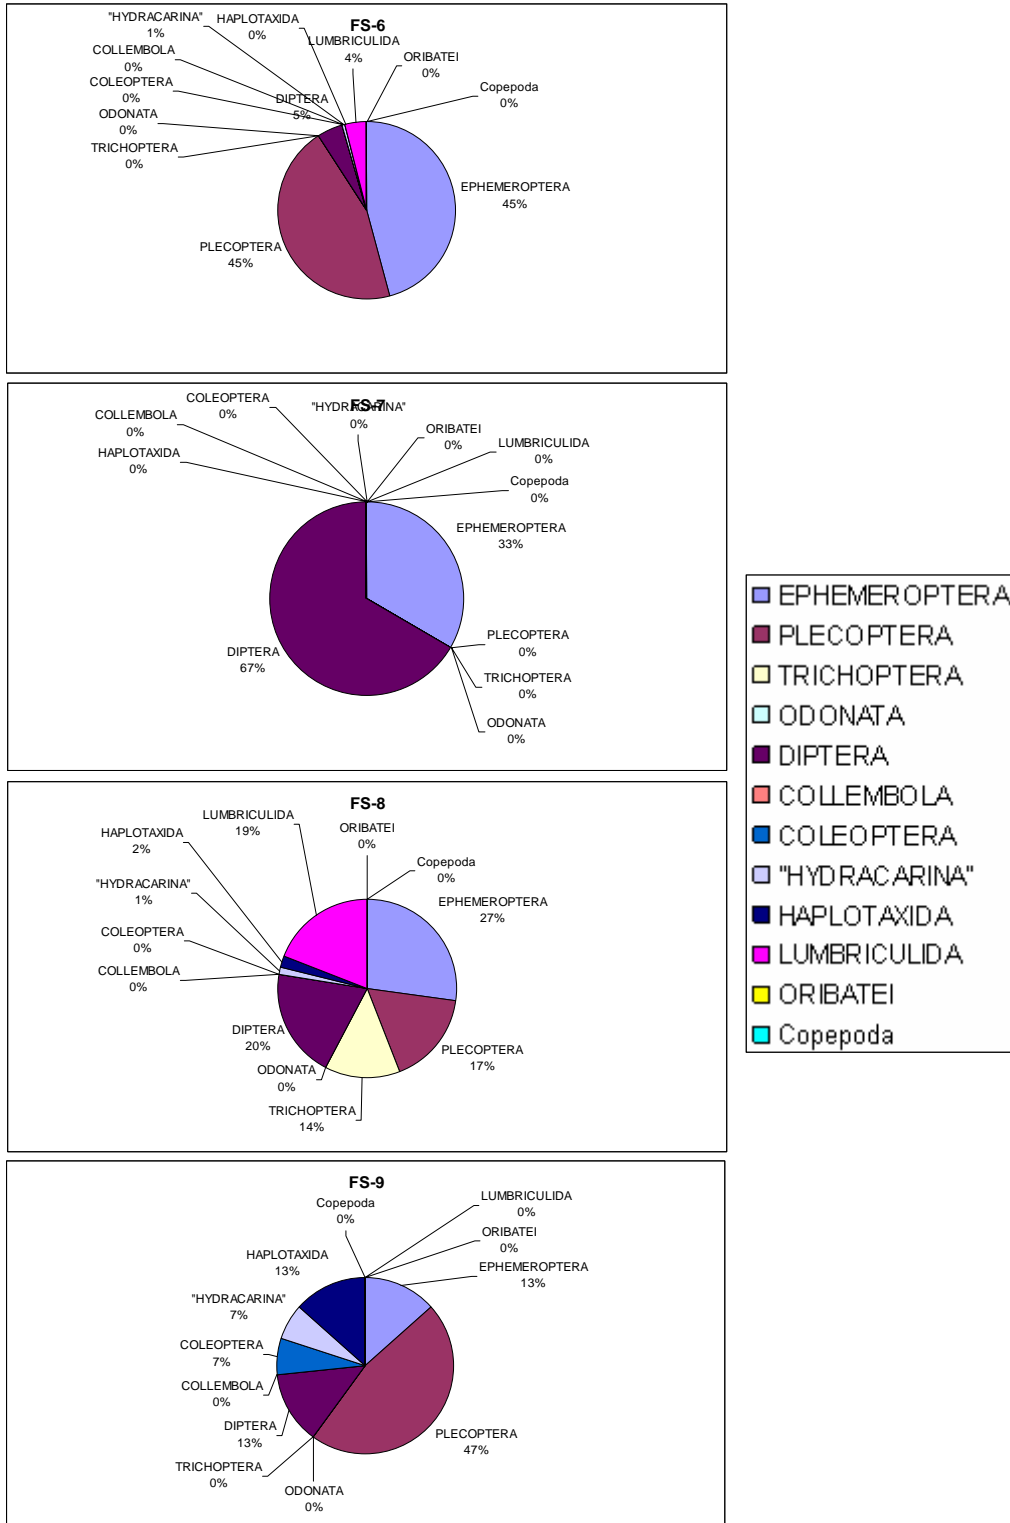
Figure 3b: Benthic invertebrate community composition for stations on the western slope of Macmillan Pass (FS6-FS9).

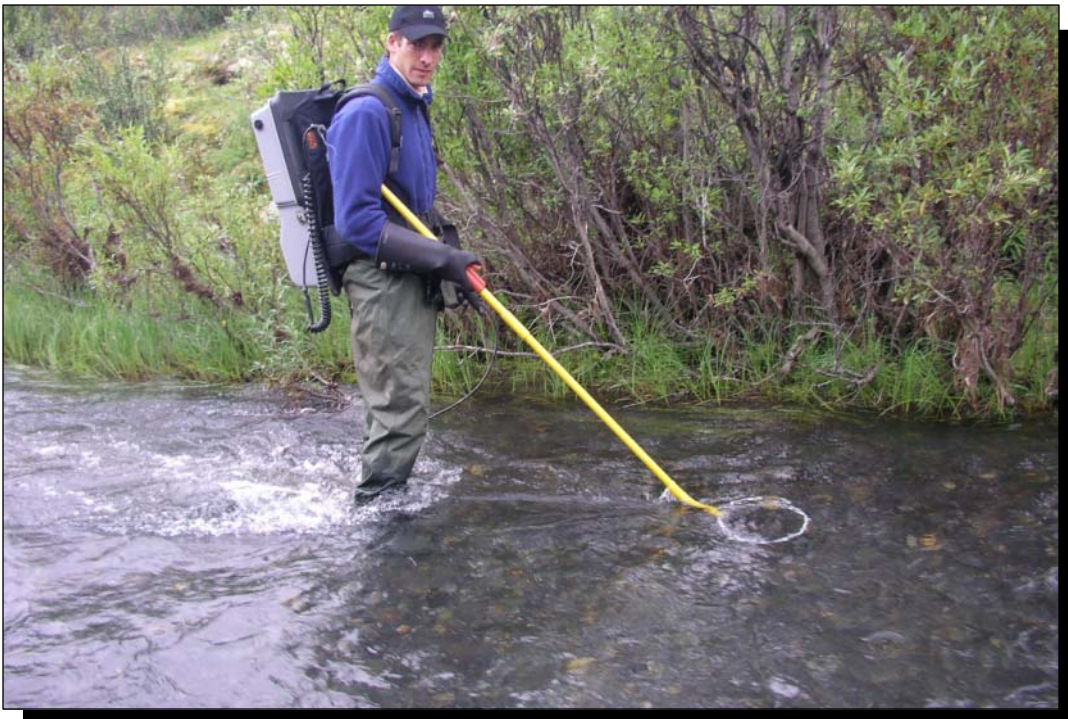
Photo 2
Fish sampling conducted by Electrofishing

Fish sampling was conducted by electrofishing using a Smith-Root LR-24 battery powered backpack electrofisher (see Photo 2). The number of seconds fished, voltage, and frequency and pulse width were recorded. The distance fished was recorded with hip-chain and the area was estimated. At stations FS8 and FS9, on the Hess River where water was too deep and fast at the sampling sites to cross safely, electrofishing was conducted from near the edges of the river channel.

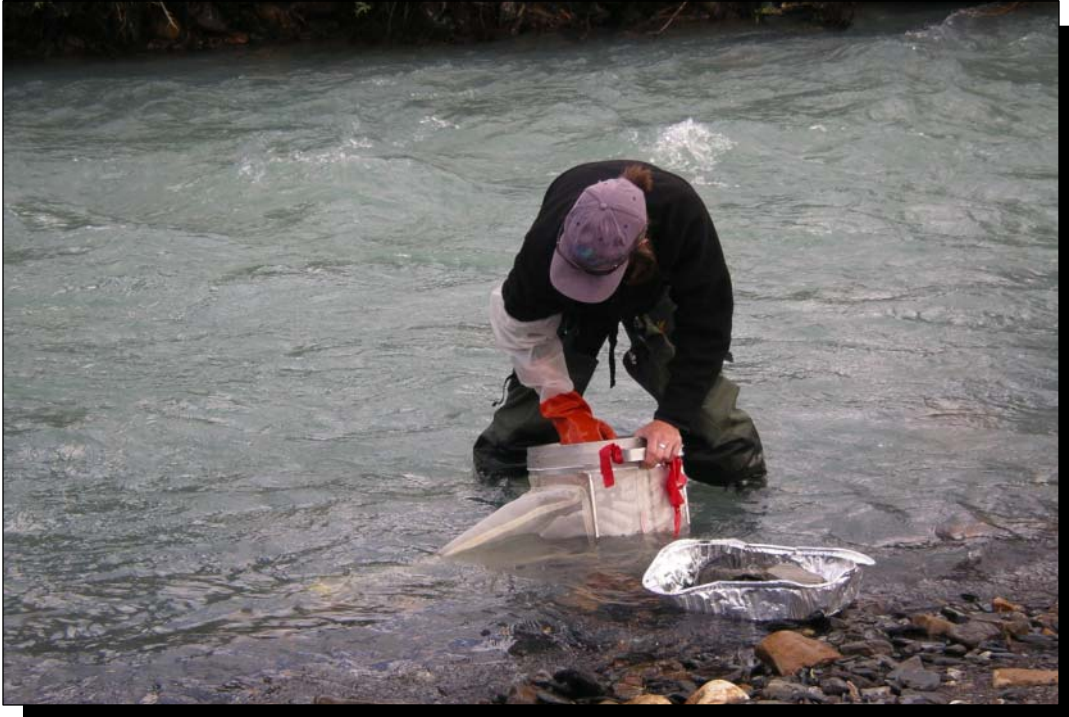
Photo 3
Benthic invertebrate sampling

Benthic sampling was conducted at all fisheries stations. A Hess invertebrate sampler with an area of 0.086 m² and a 363 µm mesh size was inserted into the shallow riffle sediments, and the sediment inside the sampler (to a depth of ~10 cm) was washed for 5 minutes (Resources Inventory Committee 1997) (see Photo 3). The contents were then transferred to a polyethylene jar and preserved with 10% phosphate buffered formalin. To eliminate

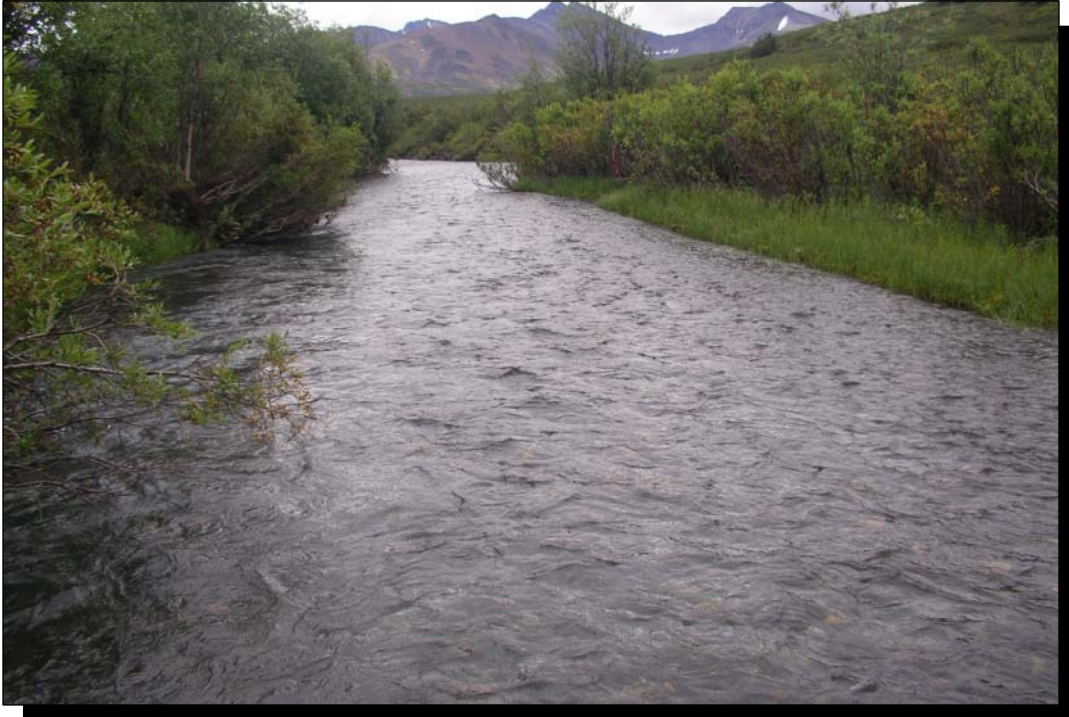
Photo 5
Station FS1 downstream

At Station FS1 in Dale Creek, no fish were observed and no fish were captured after an electrofishing effort of 1151 seconds over 209 m. The channel was narrow (8m), and water quickly flowing.

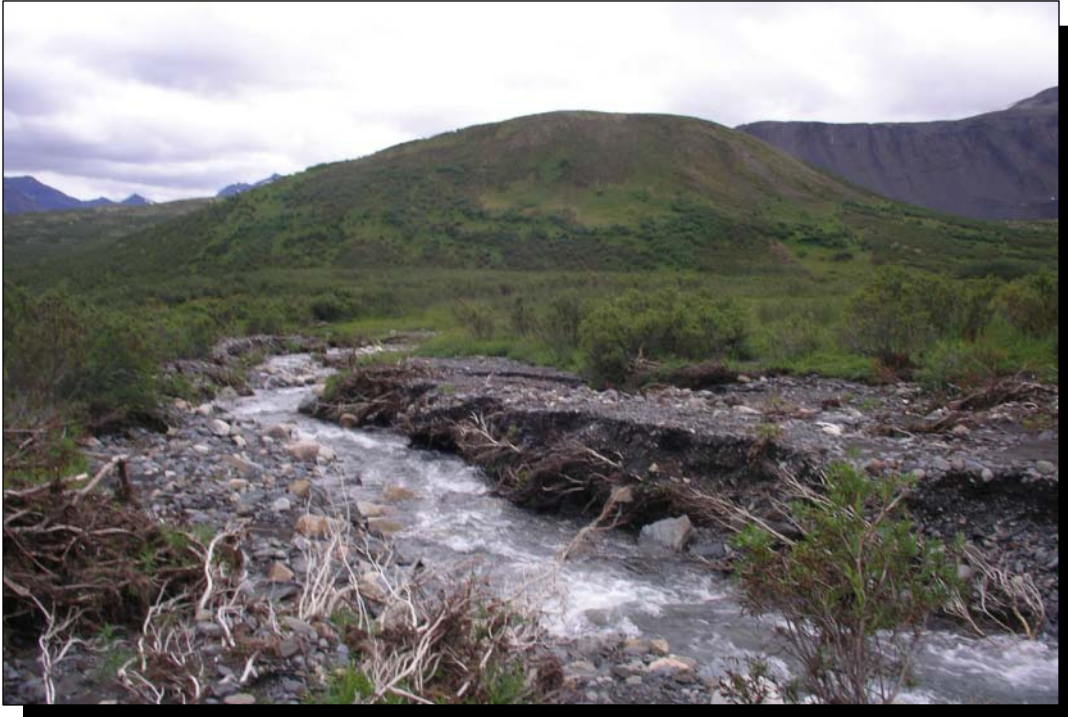
Photo 9
Station FS2 looking downstream

At Station FS2 in Cirque Creek, no fish were observed and no fish were captured after an electrofishing effort of 458 seconds over 100 m. Electrofishing was conducted between pools within the larger boulders on a moderate gradient.

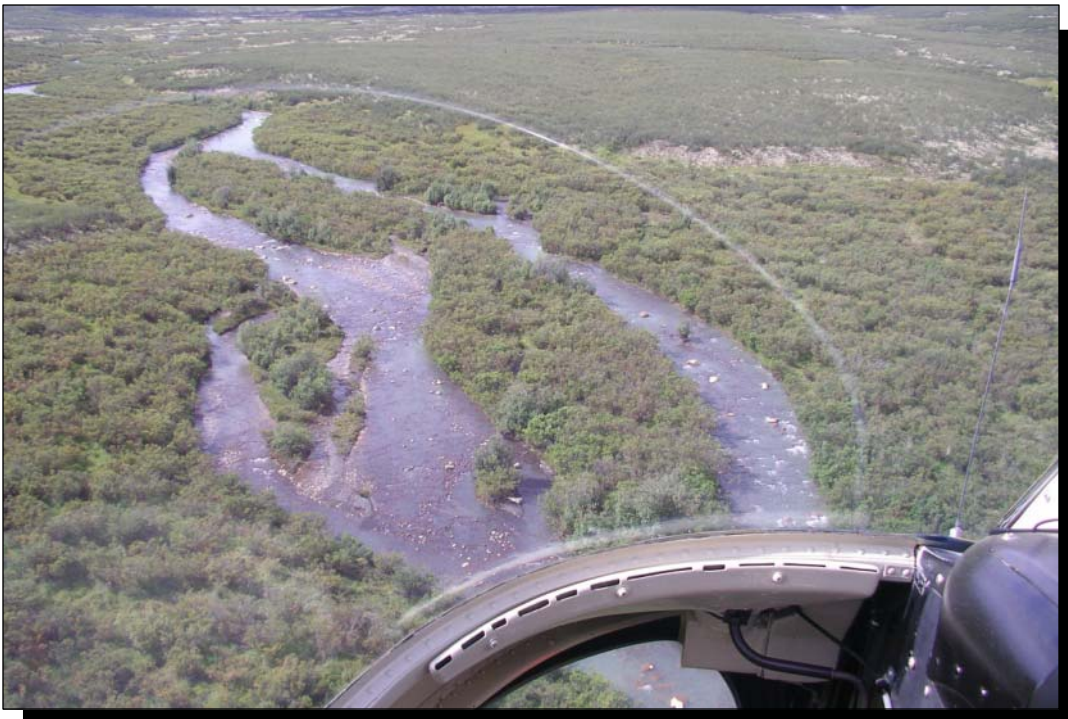
Photo 12
Aerial view of station FS3. Channel is braided and meandering

At Station FS3 in the lower Tsichu River, no fish were observed and no fish were captured after an electrofishing effort of 2021 seconds. Approximately 529 m of shallow braided habitat on the lower Tsichu River were electrofished.

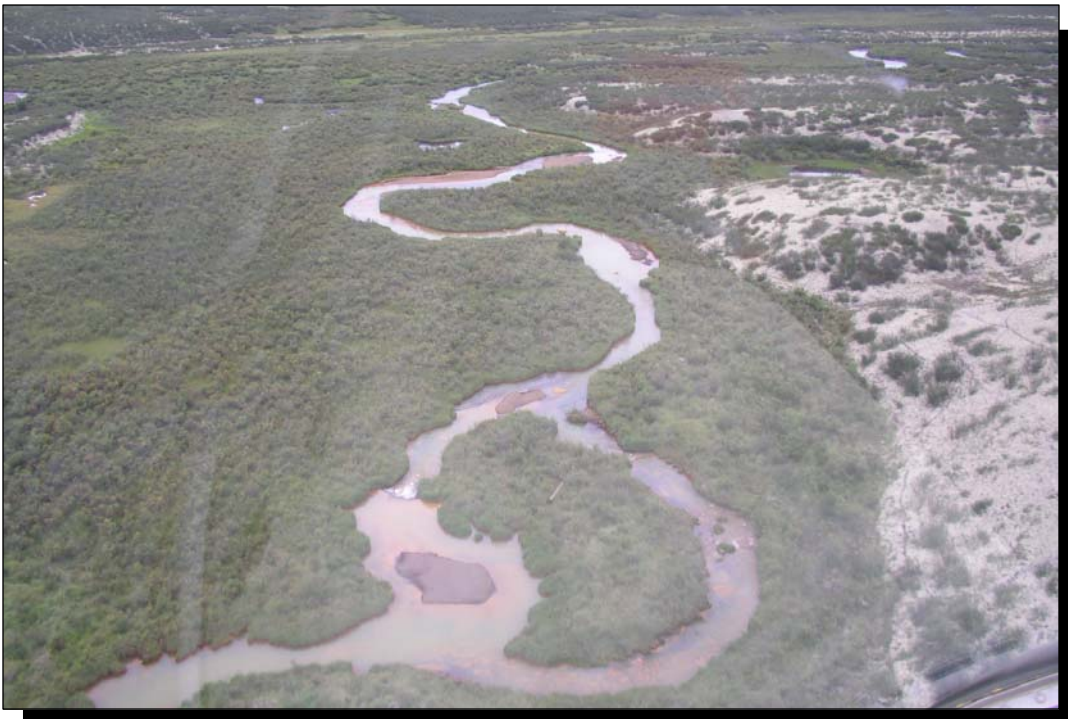
Photo 16
Aerial view of station FS4, upper Tschu River

At Station FS4 in the upper Tsichu River, no fish were observed and no fish were captured after an electrofishing effort of 1294 seconds. Approximately 250 m of shallow complexly braided habitat on the upper Tsichu River were electrofished.

Physically, the habitat characteristics of the Upper Tsichu River upstream of its confluence with Dale Creek were similar to that of lower Dale Creek. The channel is meandering and braided, however the degraded water quality (due to low pH and natural mineralization in the area) and resulting coloration and precipitates create unique habitat conditions.

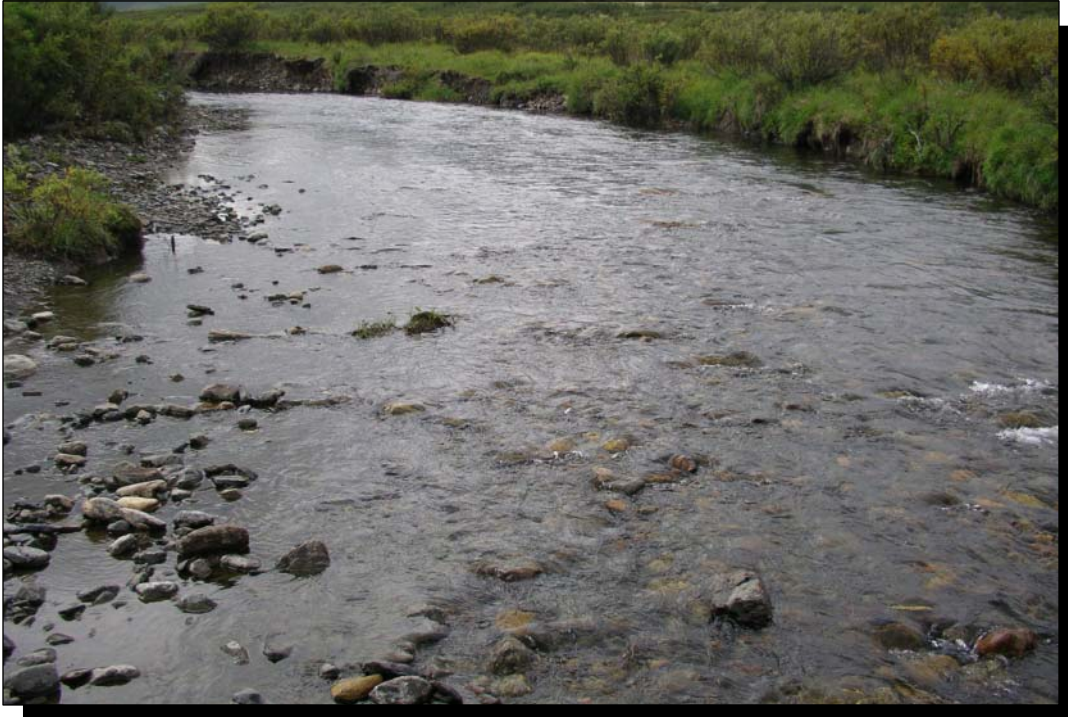
Photo 21
Station FS5 looking upstream

Station FS5 is located 300-400 m upstream of the confluence with the Tsichu River. At FS5, Dale Creek had a narrow wetted width of 7.4 m and a channel width of 42 m. The substrates of the channel were predominantly composed of large cobbles with some boulders, smaller cobbles and gravels. The water surface was 40% pool, 40% run and 20% riffle, with water depths approximately 20 cm in the riffles and 65 cm in the pools. Cover for fish habitat amounted to approximately 60% and consisted of deep pools, undercut banks, boulders and instream vegetation. Small falls observed downstream of Station FS5 could be an obstruction to fish passage.

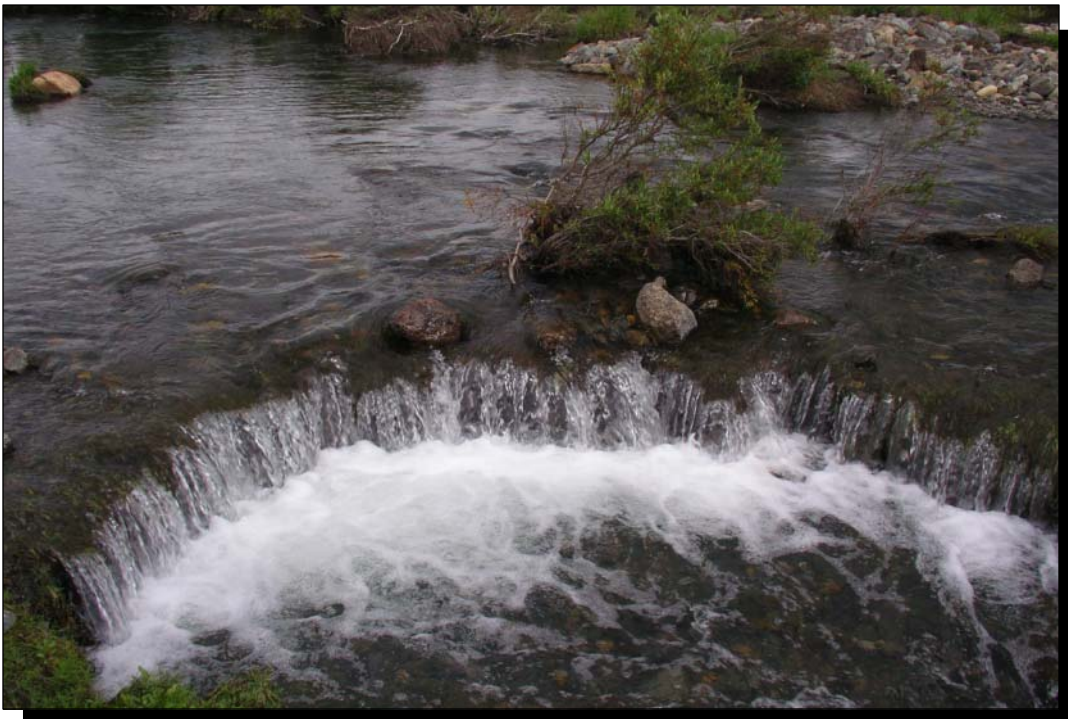
Photo 22
Small falls near station FS5

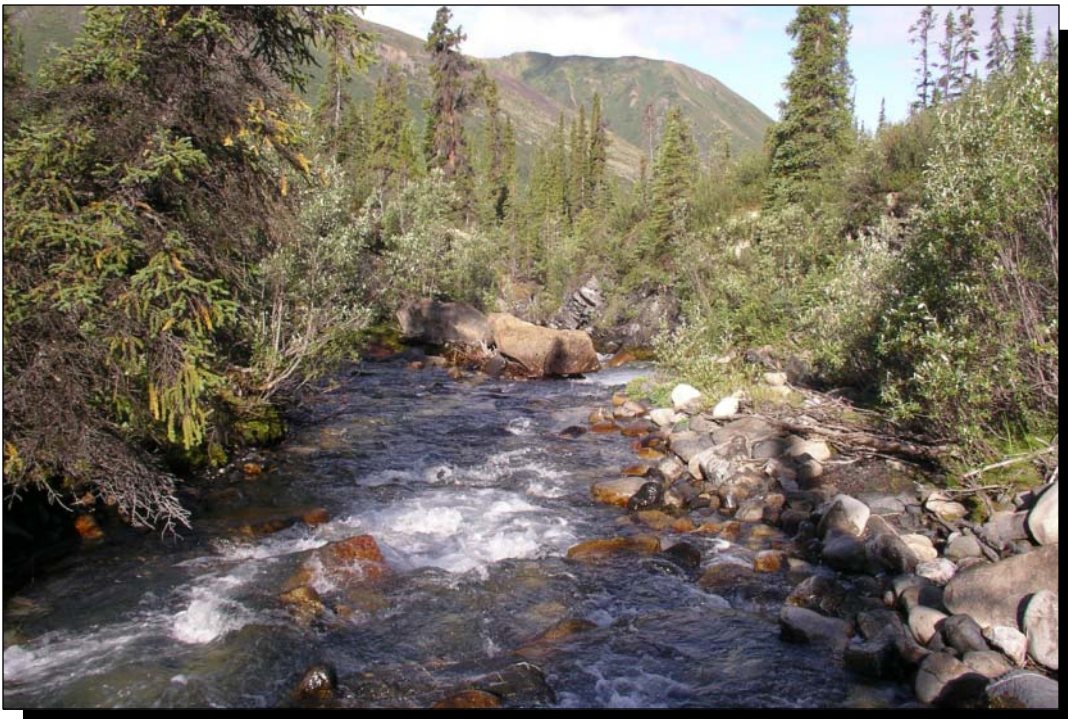
Photo 24
Station FS6 looking downstream

Station FS6 is located downstream of WQ1. At Station FS6, Tributary C had a narrow wetted width of 7.0 m and a channel width of 11.4 m. The channel substrates were predominantly composed of boulders with some cobbles and gravels. The water surface was 20% pool, 30% run and 50% riffle, with water depths about 20 cm in the riffles and 40 cm in the pools. Cover for fish habitat amounted to approximately 10% and consisted of deep pools, boulders, undercut banks, and overstream vegetation. At Station FS6, rapids, a steep gradient, and small falls observed downstream could be an obstruction to fish passage.

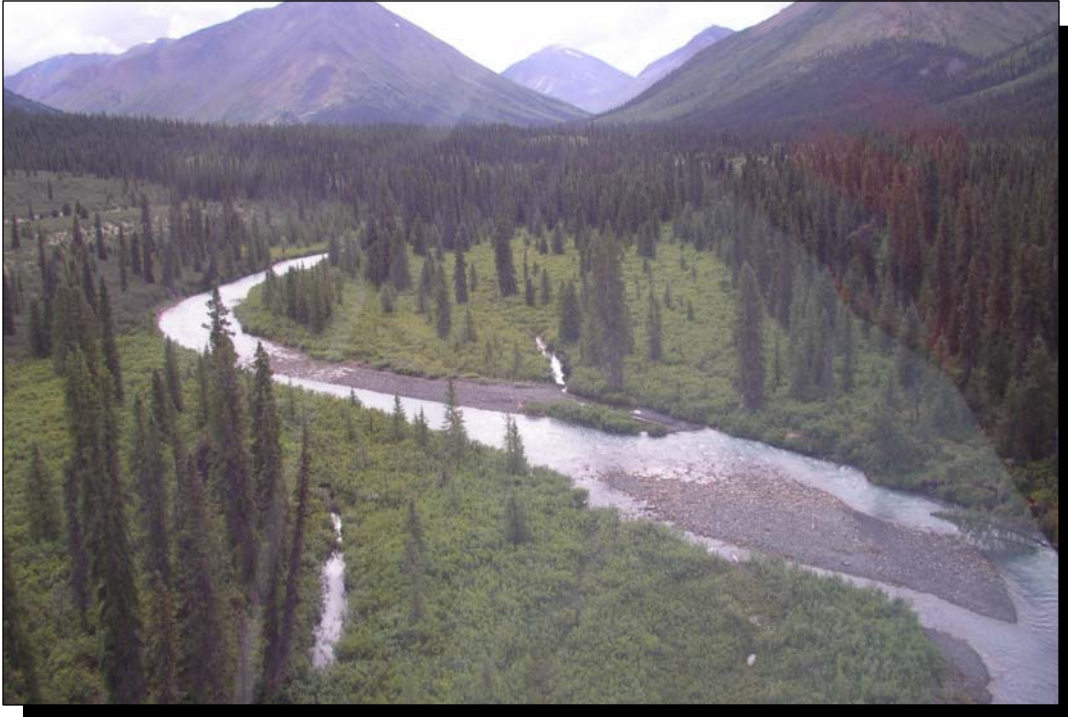
Photo 27
Aerial view of station FS7

Station FS7 on Tributary A is located upstream of its confluence with the Hess River. At FS7, Tributary A had a narrow wetted width of 7.2 m and a channel width of 14.8 m. The substrates of the channel consisted of small and large cobbles, gravels and fines. The water surface was 30% pool, 50% run and 20% riffle, with water depths about 35 cm in the riffles and 75 cm in the pools. Cover for fish habitat amounted to approximately 40% and consisted of deep pools, undercut banks, and large organic debris. Conditions at Station FS7 appeared to provide ideal fish habitat. Backwater areas around Station FS7 provide what appears to be good fish rearing habitat.

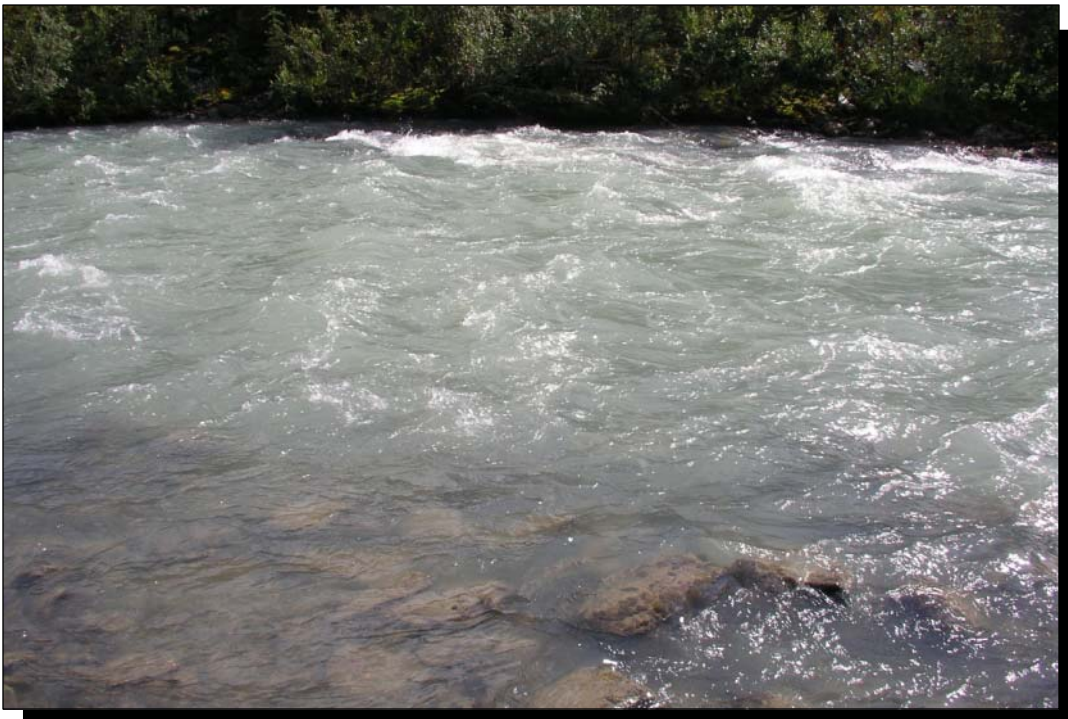
Photo 32
Fast deep flow at station FS8

At Station FS8 in the upper Hess River, approximately 8 slimy sculpins were observed, however none were captured. An electrofishing effort of 1347 seconds was conducted over 108 m along the south shoreline of the Hess River. In this area, the Hess River was fast flowing and electrofishing could only be conducted safely and effectively from the river's edge where the water was calm.

Station FS8 is located upstream of the confluence with Tributary A. At FS8, the Hess River had an estimated wetted width of 14 m and a channel width of 15 m (water was too deep and fast-flowing to wade across). The substrates of the channel consisted of small and large cobbles, boulders and gravels. The water surface was 40% run and 60% rapids. The water depths could not be determined. Cover for fish habitat amounted to approximately 10% and consisted of boulders and overstream vegetation. Conditions at FS8 appeared to provide good fish habitat. However, the wide stream and water flows provided little cover.

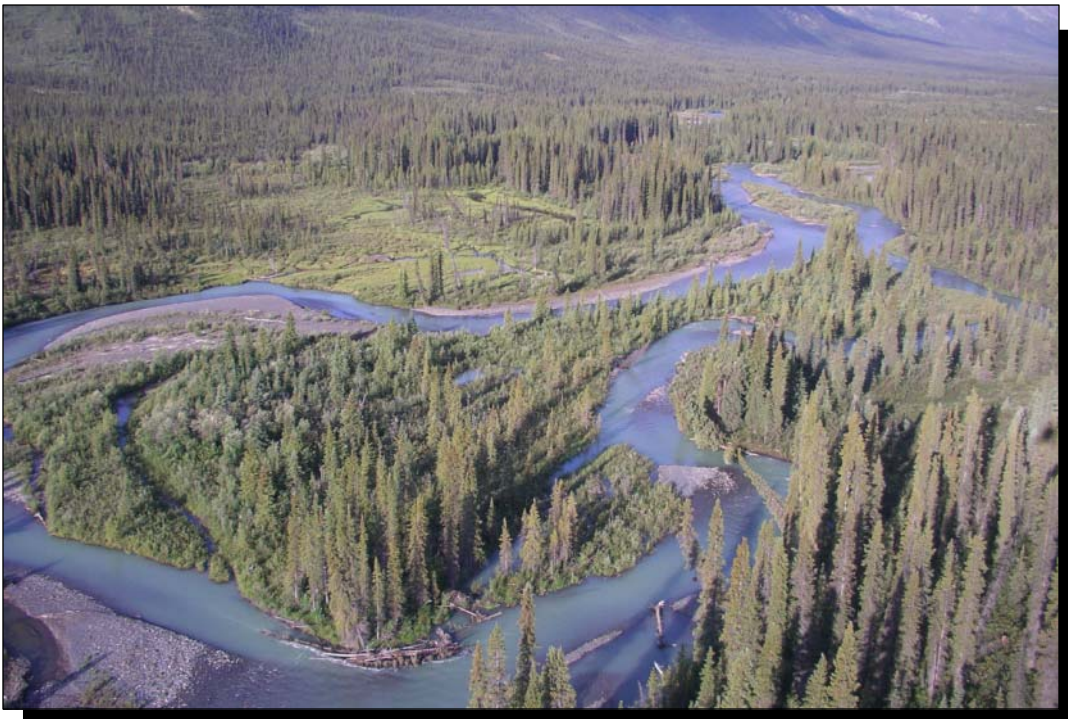
Photo 34
Braided channels at station FS9 on the Hess River

At Station FS9 in the lower Hess River, approximately 26 slimy sculpins and 9 Arctic grayling were observed, however, no fish were captured. An electrofishing effort of 2506 seconds was conducted over approximately 500 m of the braided section of the Hess downstream of the Tributary C. Of the observed slimy sculpins, 24 ranged from 4-6 cm, while 2 ranged from 8-10 cm in length. Of the Arctic grayling observed, 7 were juveniles ranging 2-5 cm in length and 2 adults ranging 12-15 cm in length.

At Station FS9, the Hess River had a wetted width of 9.4 m and a channel width of 19.8 m. The substrates of the channel consisted of small and large cobbles, boulders and gravels. The water surface was 30% pool, 20% run and 50% riffle. The water depths were 35 cm in the riffle area and 70 cm in the run area. Cover for fish habitat amounted to approximately 40%, and consisted of deep pools and undercut banks. Conditions at FS9 appeared to provide good fish habitat. Numerous side channels also provide good fish rearing habitat.

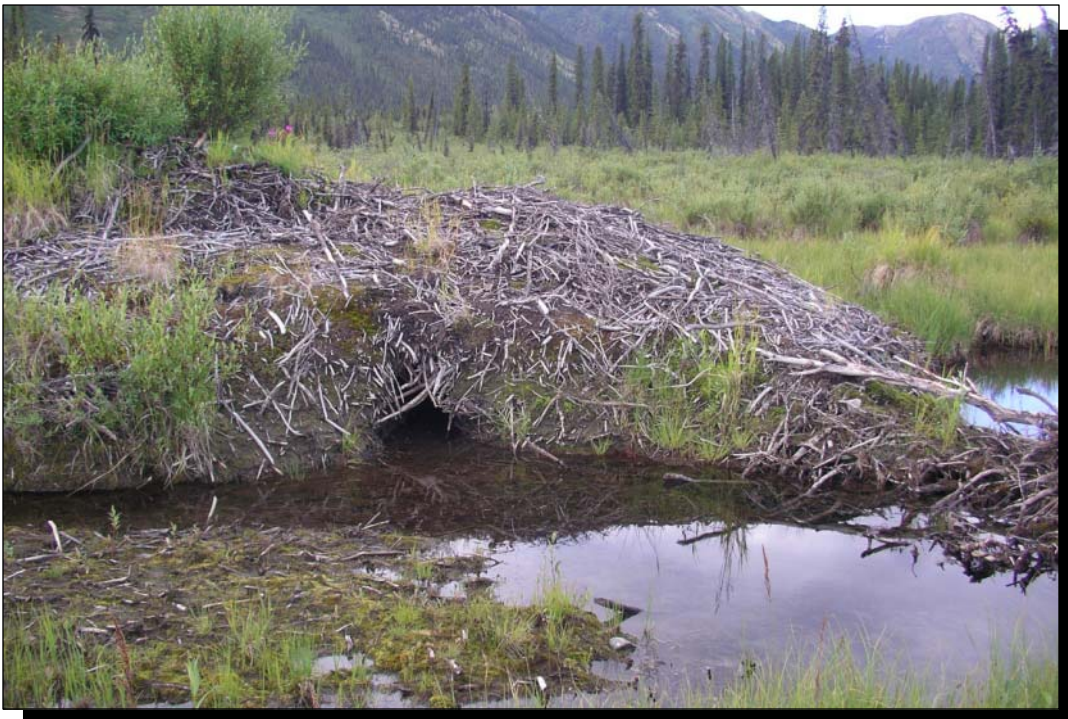
Photo 36
Beaver dam on side channel at station FS9
