North American Tungsten Corporation Ltd.

MACTUNG PROJECT

2007 ENVIRONMENTAL BASELINE STUDIES
FISHERIES AND AQUATIC RESOURCES

DECEMBER 2007

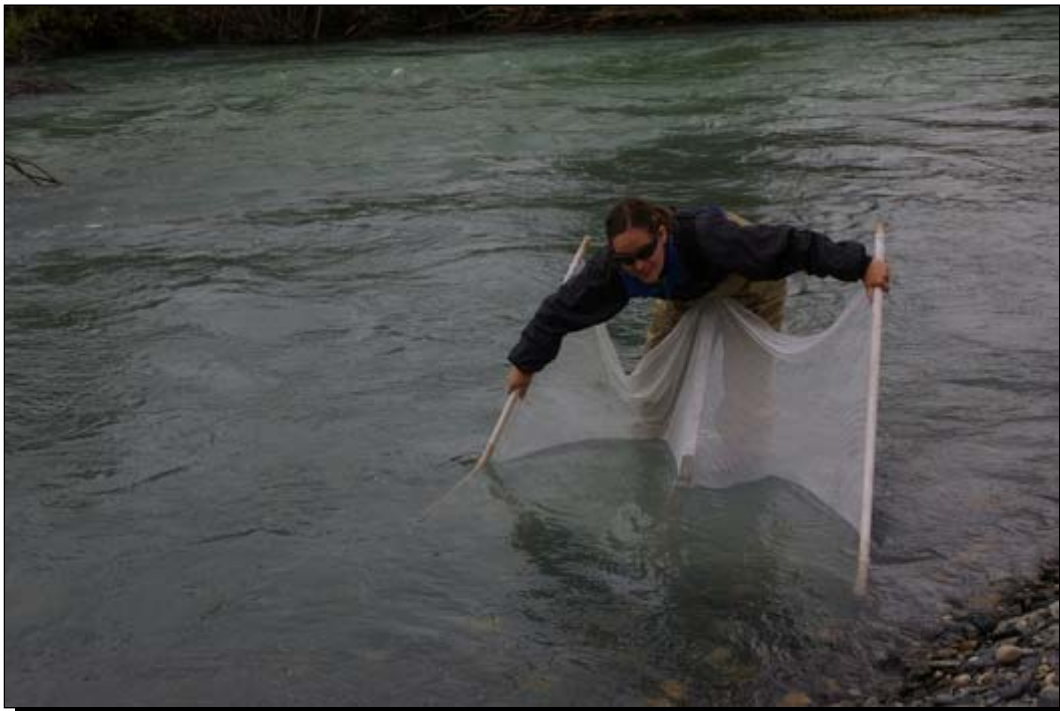
Photograph 2: A modified pole net with 3 mm mesh netting used to capture fish during electrofishing in fast currents. Photo taken August 14, 2007.

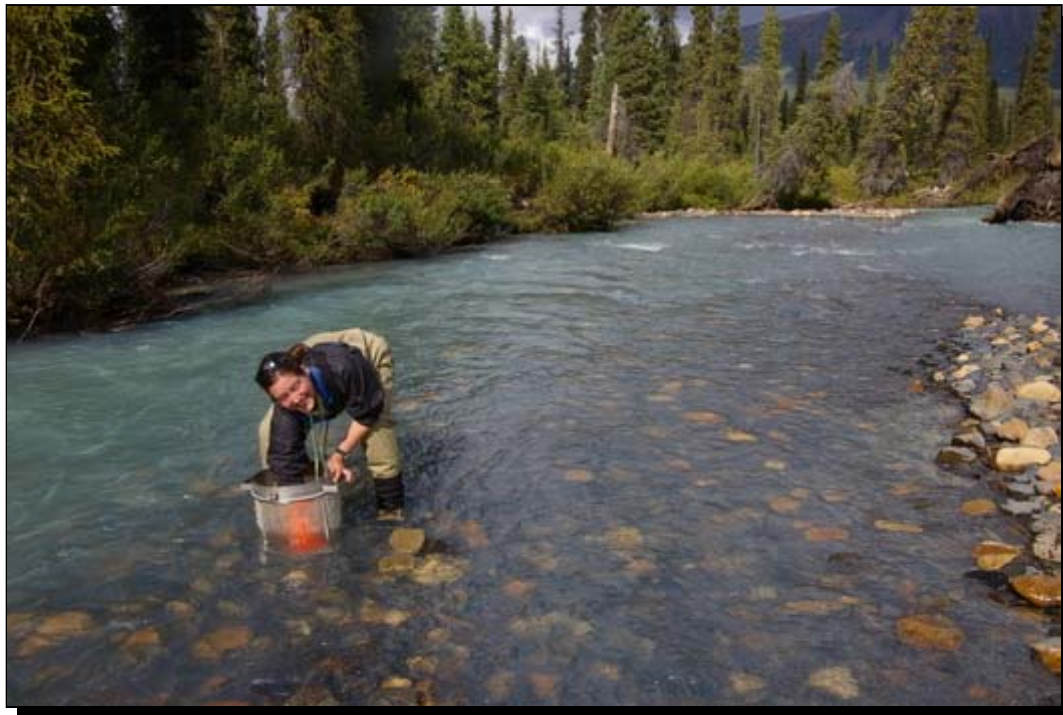
Photograph 3: Sampling of benthic macroinvertebrates using a Hess sampler at FS7.

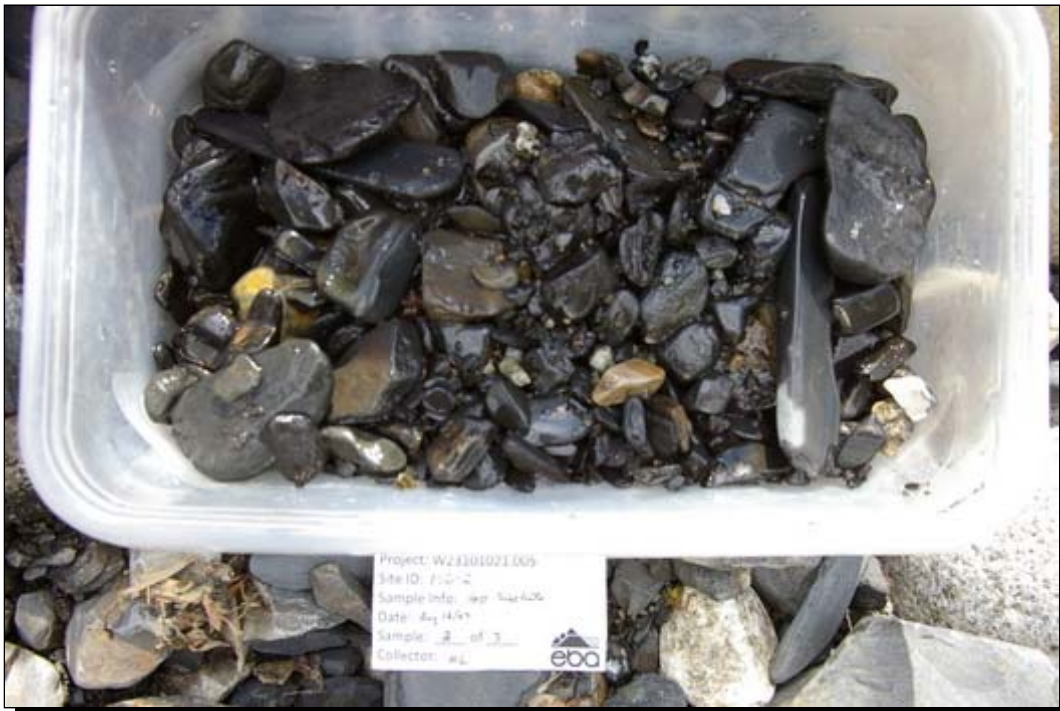
Photograph 6: Typical channel substrate at FS6. Photograph taken August 16, 2007.

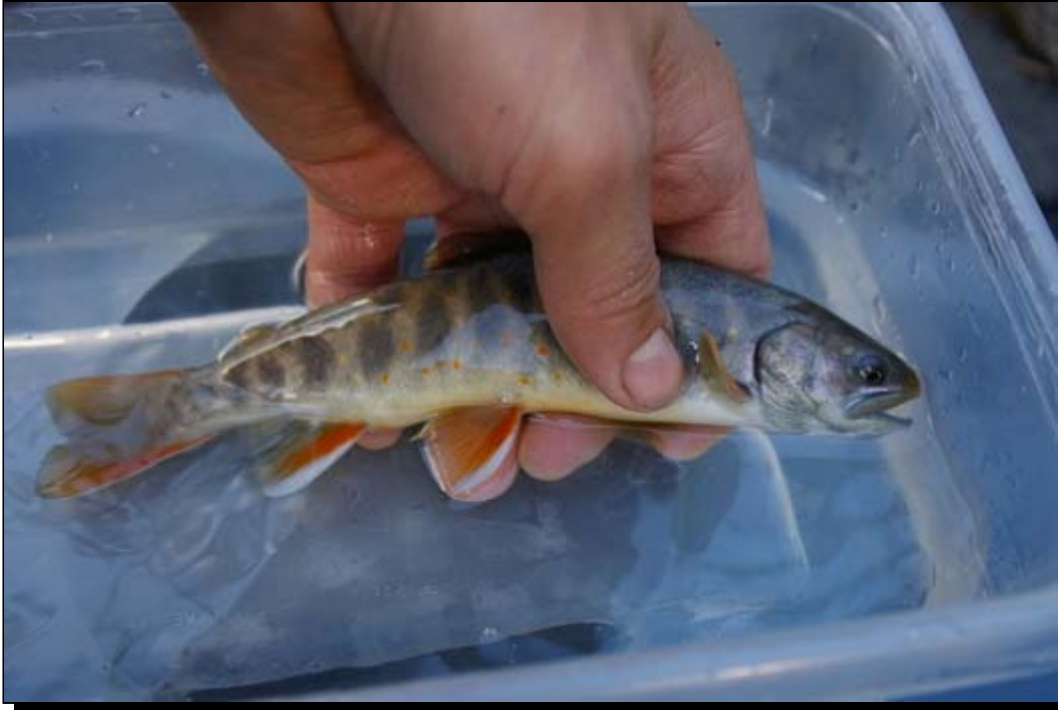
Photograph 7: A 213 mm dolly varden taken by electrofishing at FS6 (Note the reproductive coloration). Photograph taken August 16, 2007.

At FS6, approximately 500 m of channel were electrofished for 1342 seconds of effort (Table 2). Three dolly varden¹ (164 mm – 213 mm) were captured during this effort, with four additional dolly varden being observed during this time (Photograph 28). These fish were primarily found within plunge pools associated with large woody debris, or beneath extensive undercut bank areas, which were measured to extend for greater than one metre beneath the willow/moss root mat in some areas. In addition to these individuals, an assistant angled two larger dolly varden from a deep pool at the habitat sampling location. One fish was retained (272 mm), and was provided to EBA for internal sampling following removal of flesh for consumption. This individual was a mature male, entering reproductive condition at the time of capture (Photograph 29). The other individuals electrofished also demonstrated reproductive coloration at the time of sampling (Photograph 28). Full maturation at such a small size suggests that these individuals are part of a local resident dwarf dolly varden population.

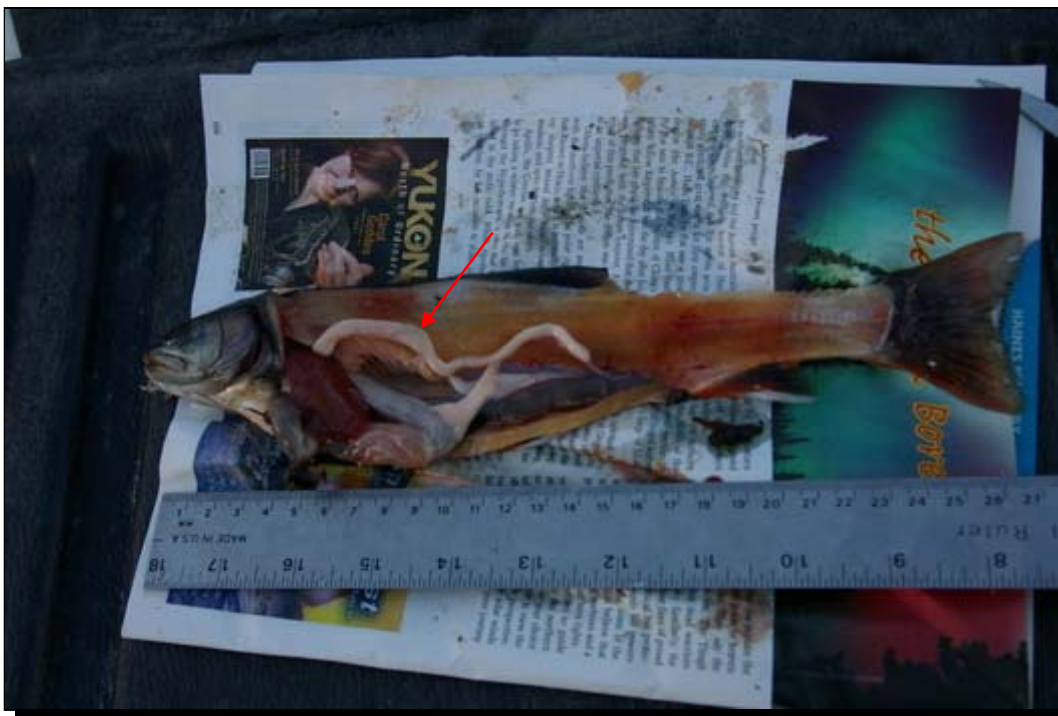
Photograph 8: A 272 mm male dolly varden taken from near FS6 by angling (Note the mature, ripe state of testes, shown by the arrow). Photograph taken August 16, 2007.

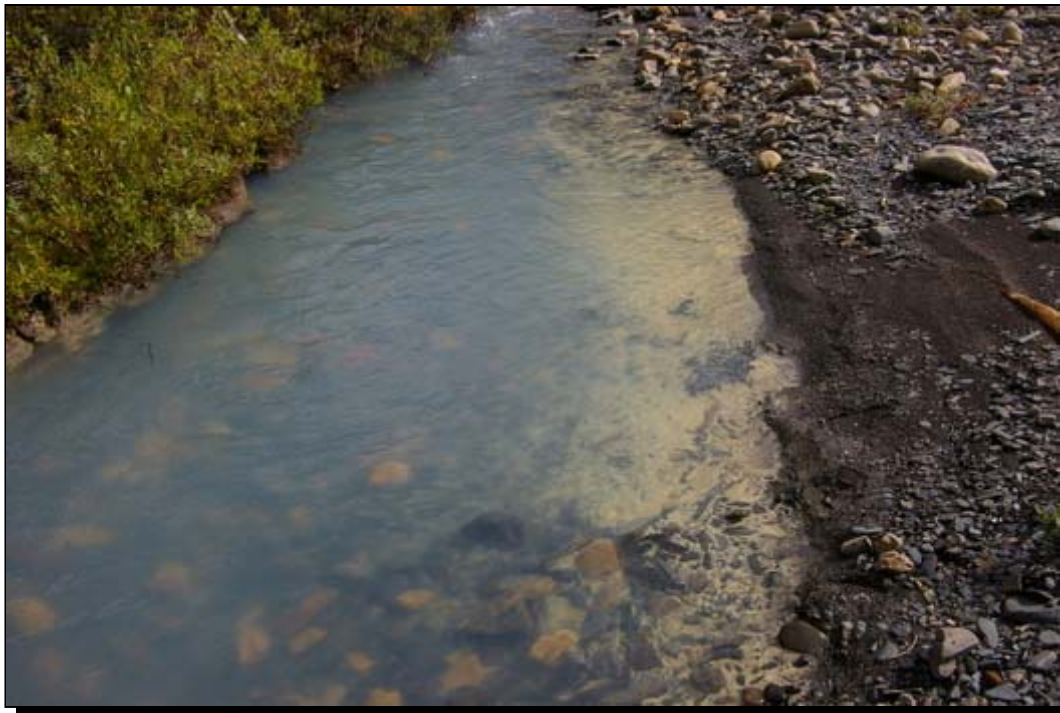
Photograph 11: View of the white growth accumulating along the channel at FS7. Photograph taken August 15, 2007.

Although physical habitat features appeared to be generally suitable to support fish and aquatic life, the channel at this location appeared to contain considerable iron precipitate, as in the Tsichu River. Additionally, a white substance was noted along the stream margins throughout this site. This substance appeared to be an algal growth, although it was not identified at the time of this report (Photograph 32).

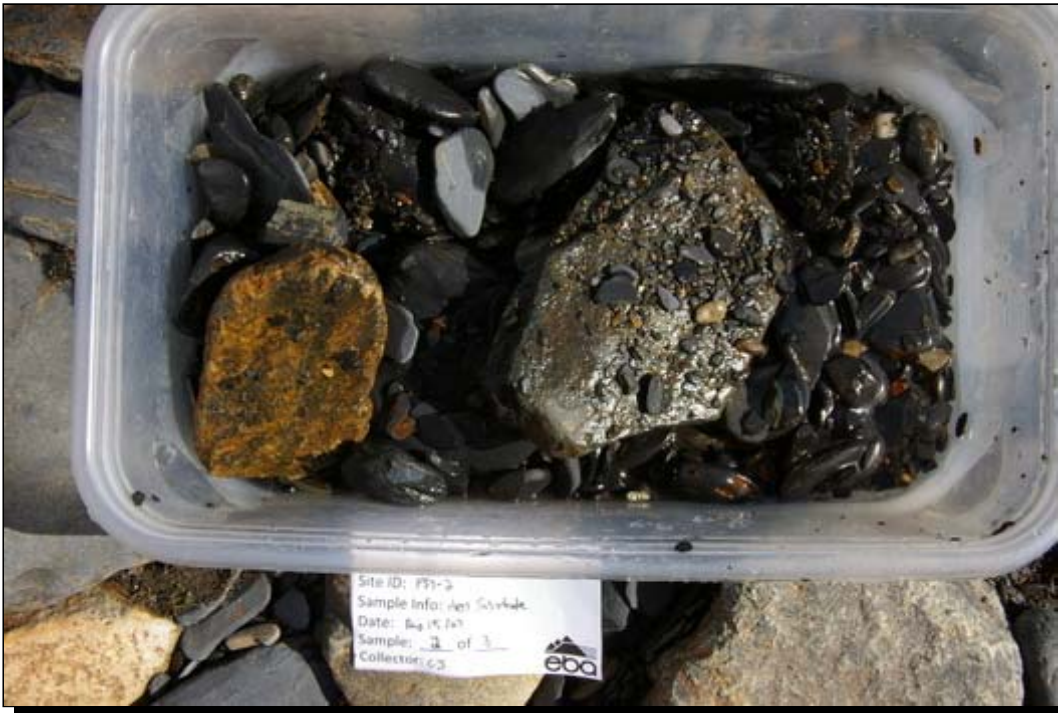
Photograph 13: Typical channel substrate at FS7. Photograph taken August 15, 2007.

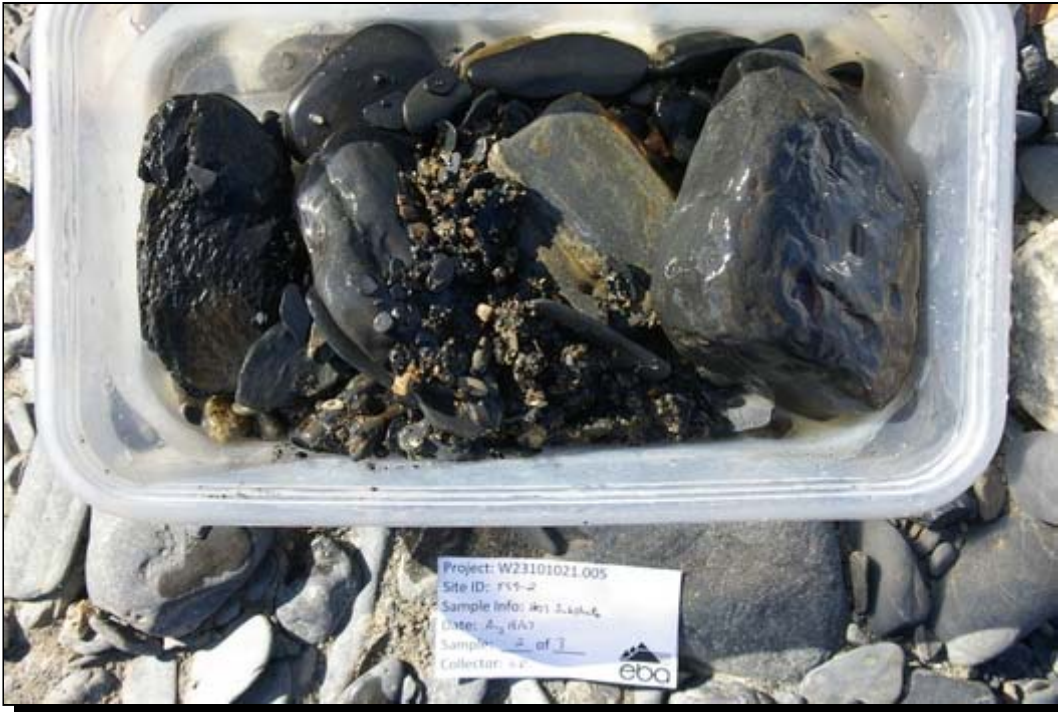
Photograph 21: Typical channel substrate at FS9. Photograph taken August 14, 2007

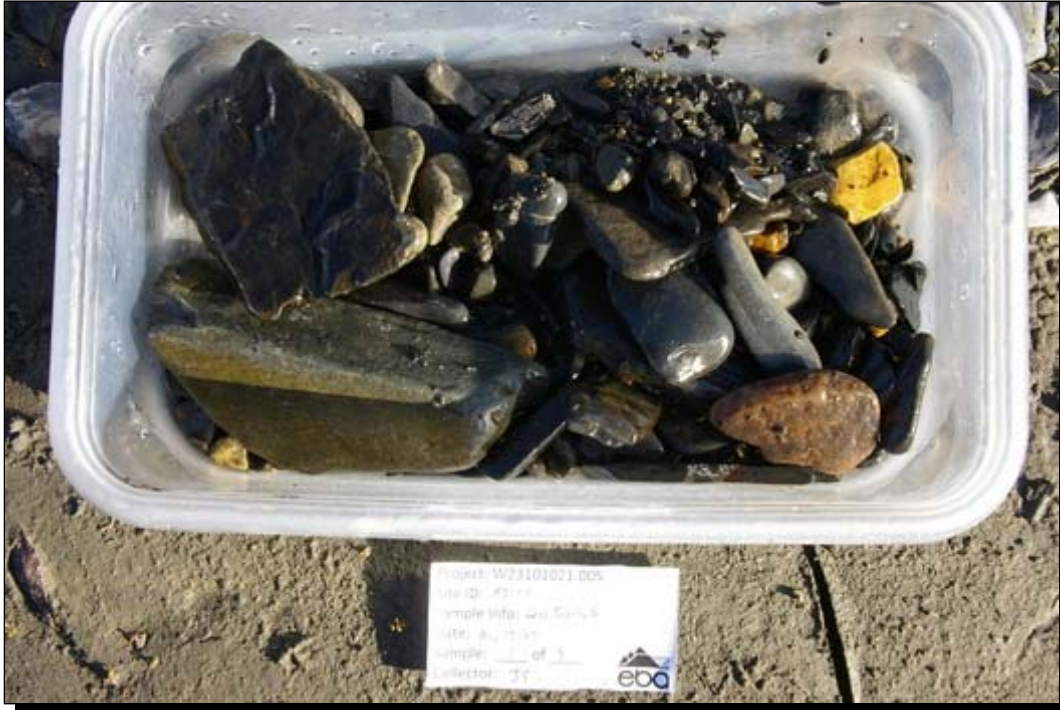
Photograph 29: Typical channel substrate at FS1. Photograph taken August 17, 2007.

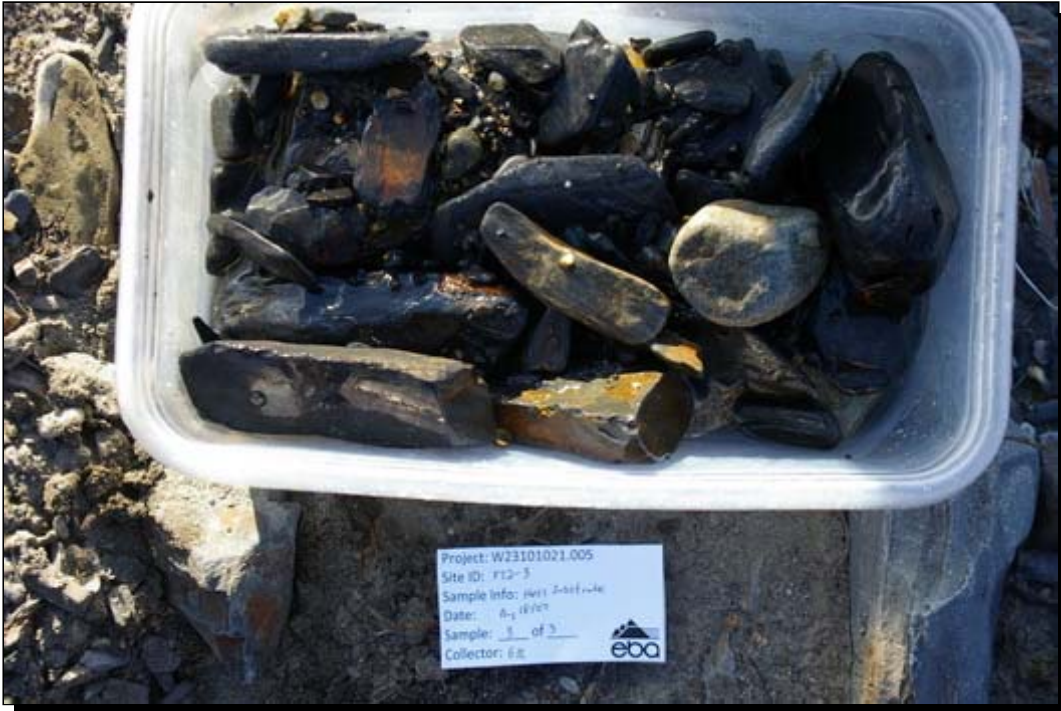
Photograph 33: Typical channel substrate at FS2. Photograph taken August 18, 2007.

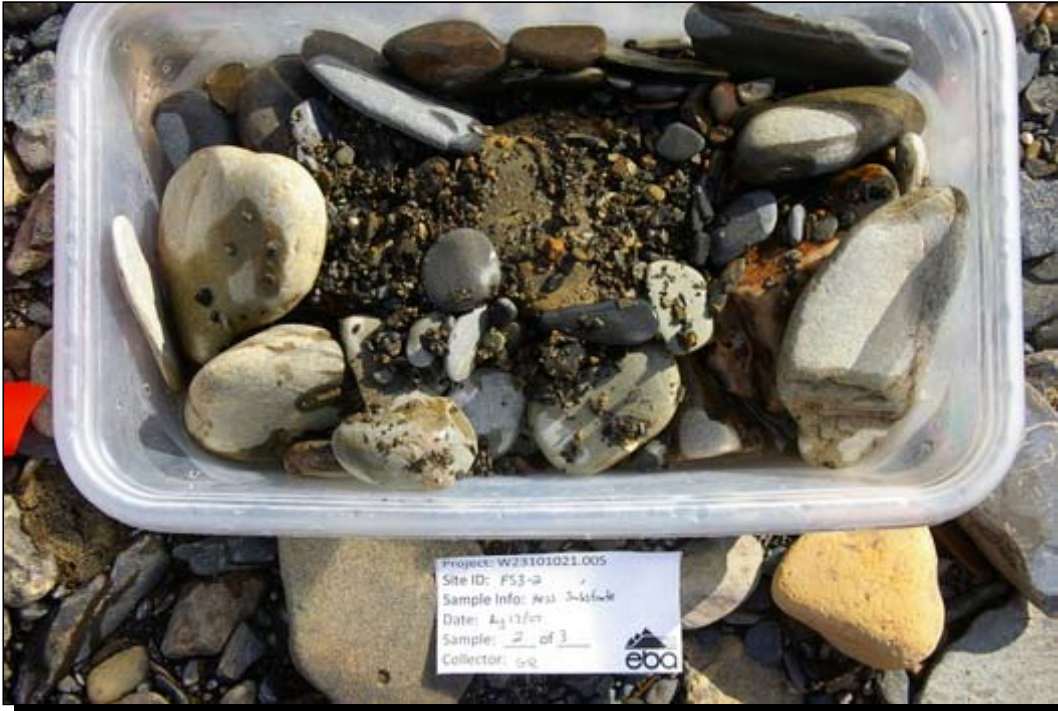
Photograph 37: Typical channel substrate at FS3. Photograph taken August 17, 2007.

In addition to these readings, the Tsichu River has reduced water quality in other aspects. As noted by EBA (2007b), the upper Tsichu River is characterized by elevated metals levels and iron precipitation as a downstream effect of acid rock drainage in headwater areas (EBA 2007a). This iron precipitate was readily apparent at FS3, as in all upper reaches of the Tsichu River.

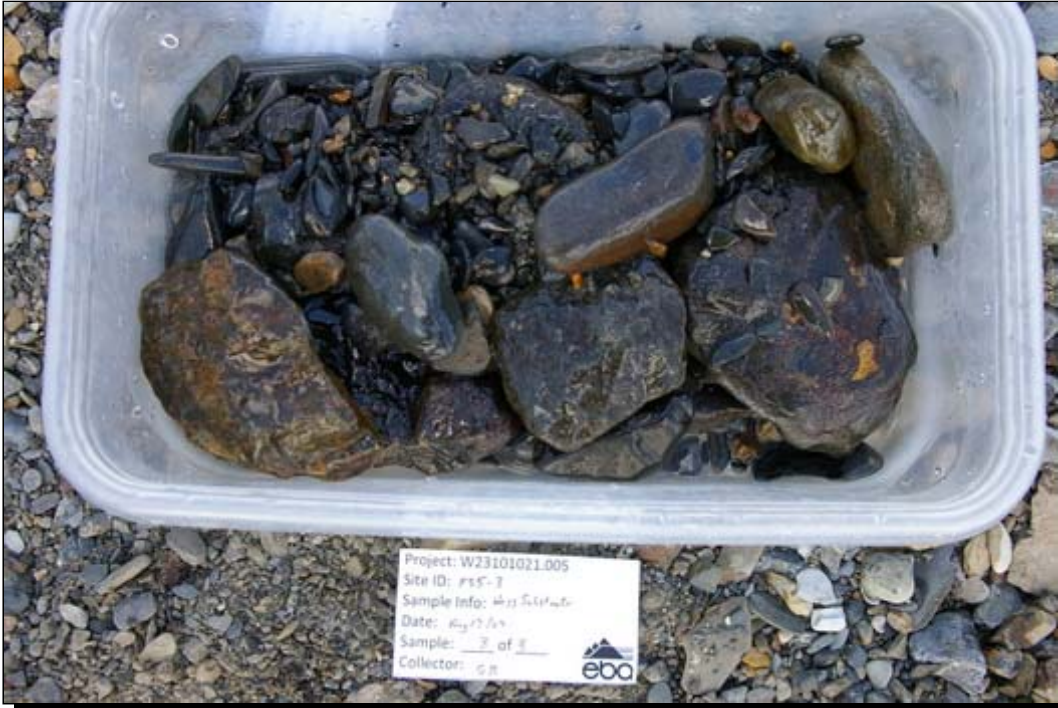
Photograph 41: Typical channel substrate at FS5. Photograph taken August 17, 2007.

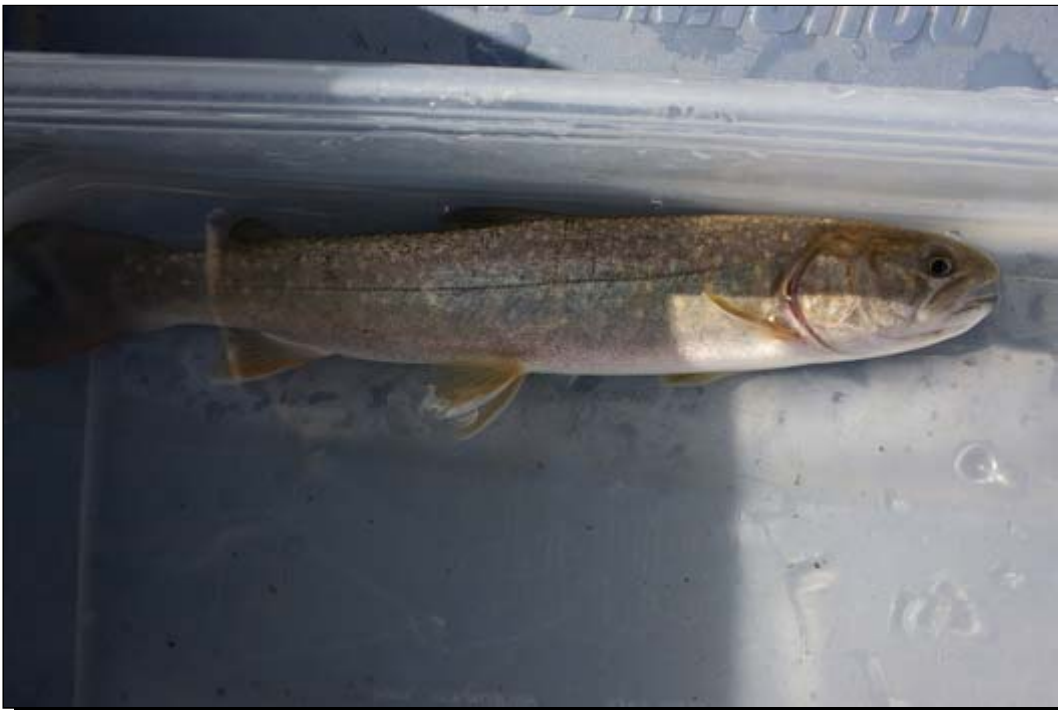
Photograph 42: 194 mm bull trout captured by electrofishing at FS5. Photograph taken August 17, 2007.

At FS5, approximately 430 m of channel were electrofished for 822 seconds of effort (Table 2). A total of 4 fish were captured, including 1 bull trout (194 mm) and 3 slimy sculpin. Fewer fish were observed than expected, however, a variety of habitats suitable for bull trout were observed. The single bull trout captured was electrofished from a small plunge pool formed by woody debris (Photograph 20).

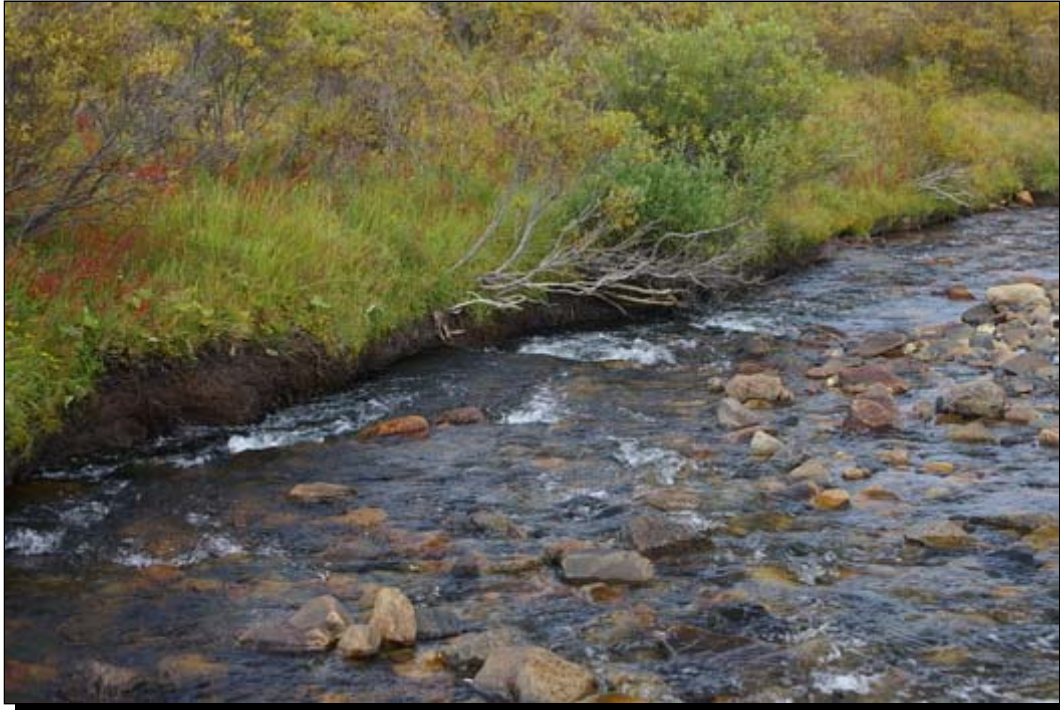
Photograph 45: Typical undercut bank habitat at FS11. Photograph taken August 18, 2007.

At FS11, approximately 410 m of channel were electrofished in 956 seconds of effort (Table 2). One bull trout (173 mm) was captured from beneath an area of undercut bank. No sculpins were observed or captured in this site, despite the apparent availability of suitable habitat for this species.
