North American Tungsten Corporation Ltd.

**MACTUNG PROJECT
2008 ENVIRONMENTAL BASELINE STUDIES
FISHERIES AND
AQUATIC RESOURCES PROGRAM**

W23101021.015

December 2008

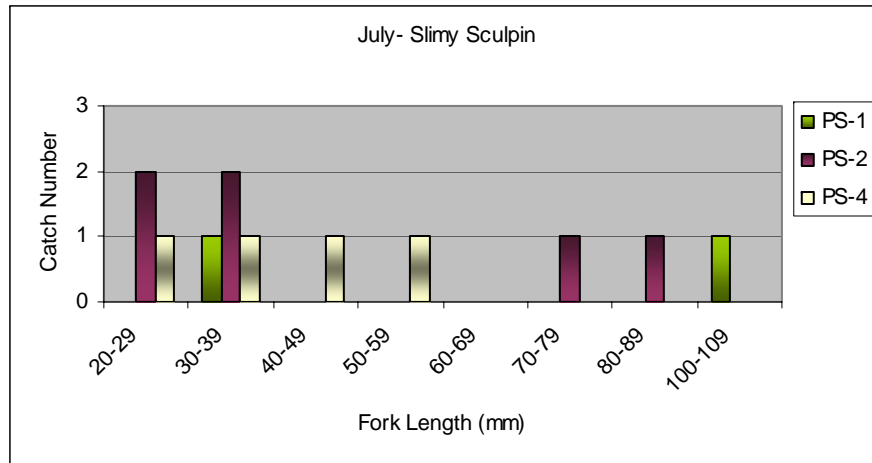
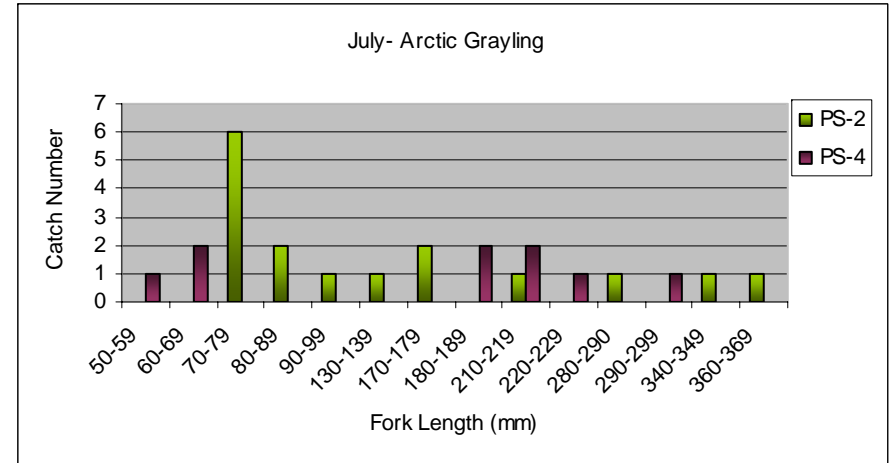
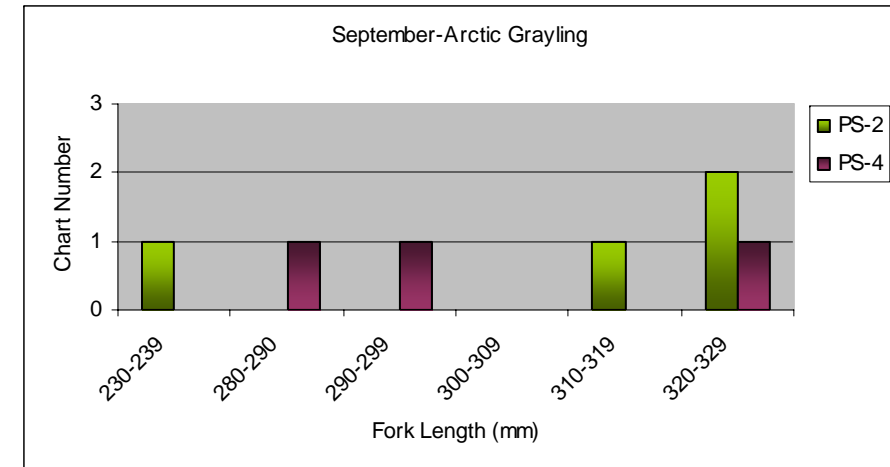
Figure 5

CLIENT North American Tungsten Corporation Ltd.	Mactung Project 2008 Fisheries and Aquatics Baseline Studies			
	2008 Hess River Tributary Arctic Grayling Size Distribution			
EBA Engineering Consultants Ltd.

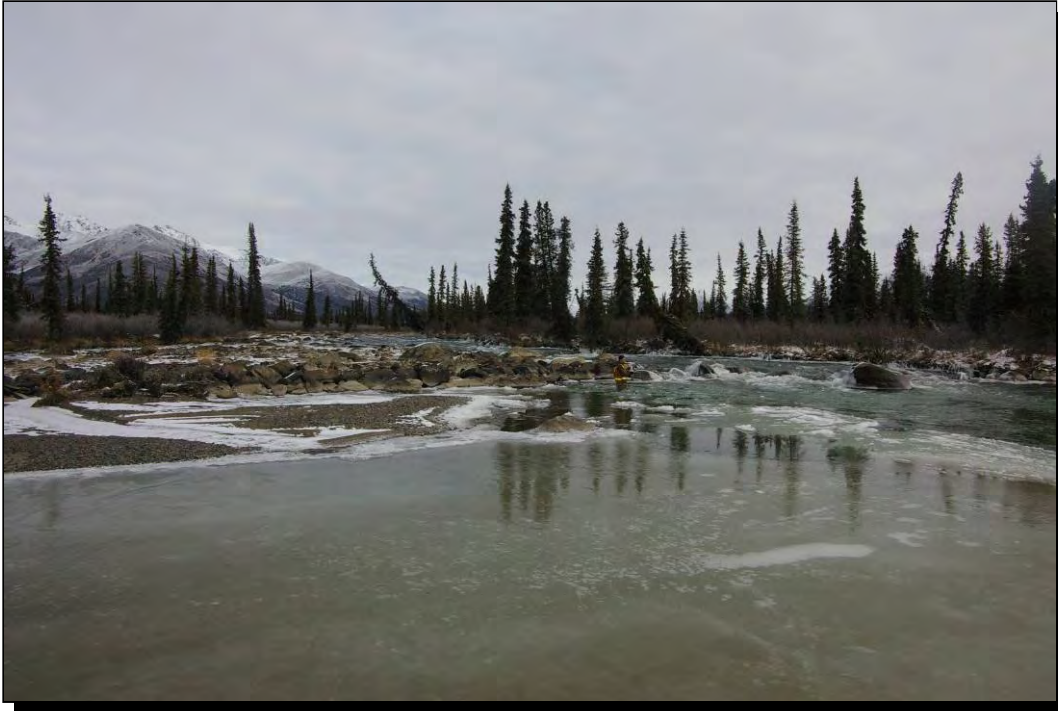
Photo 7

Looking upstream on the Upper Hess River Tributary on October 10, 2008. Ice is beginning to form.

On October 10th during the final sampling effort, much of the marginal areas of the HRT had frozen over, including many off-channel areas (Photo 7). Additionally, flows were substantially reduced and many side channel and other shallow habitats were dewatered. EBA attempted to use gill netting during this visit, however significant slush and ice floes on the river immediately built up behind the net, tearing nets and making unsafe conditions for working.

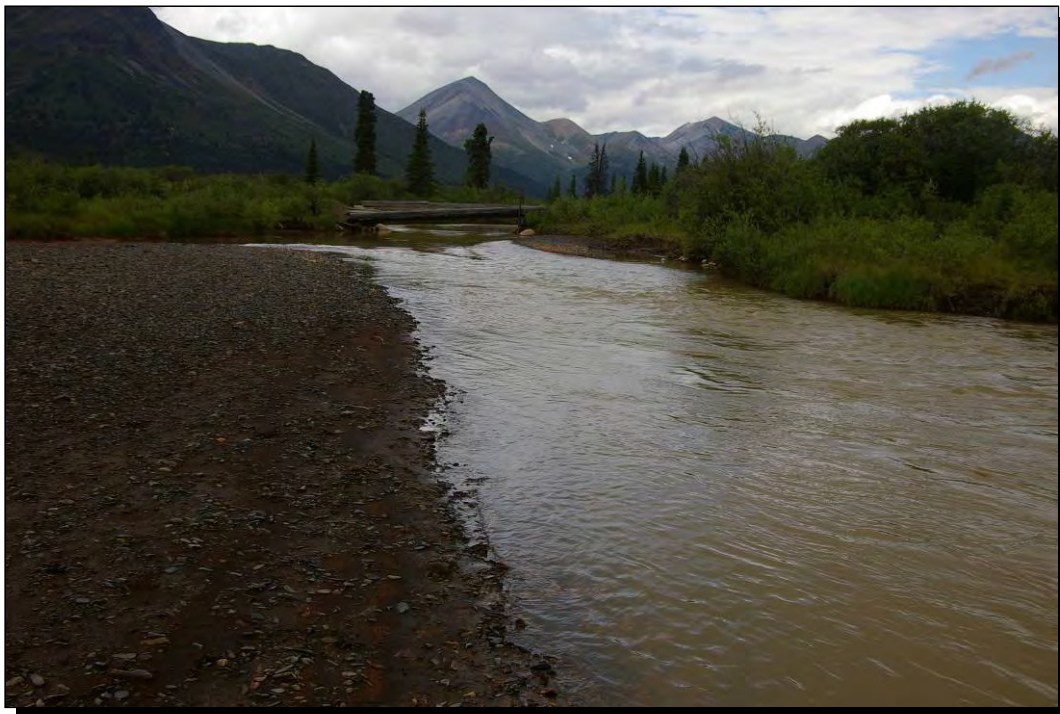
Photo 10
Existing bridge crossing on the South Macmillan River, west of the airstrip, August 2008.

The proposed access road crosses only the mainstem of the South Macmillan River (no tributaries) adjacent to the existing but deteriorated crossing (Figure 6) (Photos 10 and 11). At this location, the river consists of a wide and deep channel carved through gravels and fines, with minimal larger substrate composition. The channel in the greater crossing area is moderately mobile, showing signs of ongoing migration (eroding banks, depositional areas), and forms numerous point bars and deep pools/channel segments. Despite the presence of deep run and pool habitats, the upper reaches of this river are heavily impacted by local geological features and prior mining projects (e.g. Sekie Creek #2 from the Jason Project, pH = 2.9; MPERG 2007). Consequently, the area local to the crossing lacks suitable water quality to support fish, and shows visible signs of negatively impacted physical and water quality (e.g. visible siderite precipitate, local pH of 4.99, and turbidity of 30.2 NTU). Consequently, local areas of the South Macmillan River do not provide suitable fish habitat. Detailed information regarding this crossing is available in Tables 7 and 8. Based on the water quality, EBA did not conduct fishing effort and the watercourse is considered non fish bearing in this area (Table 9, Figure 7).

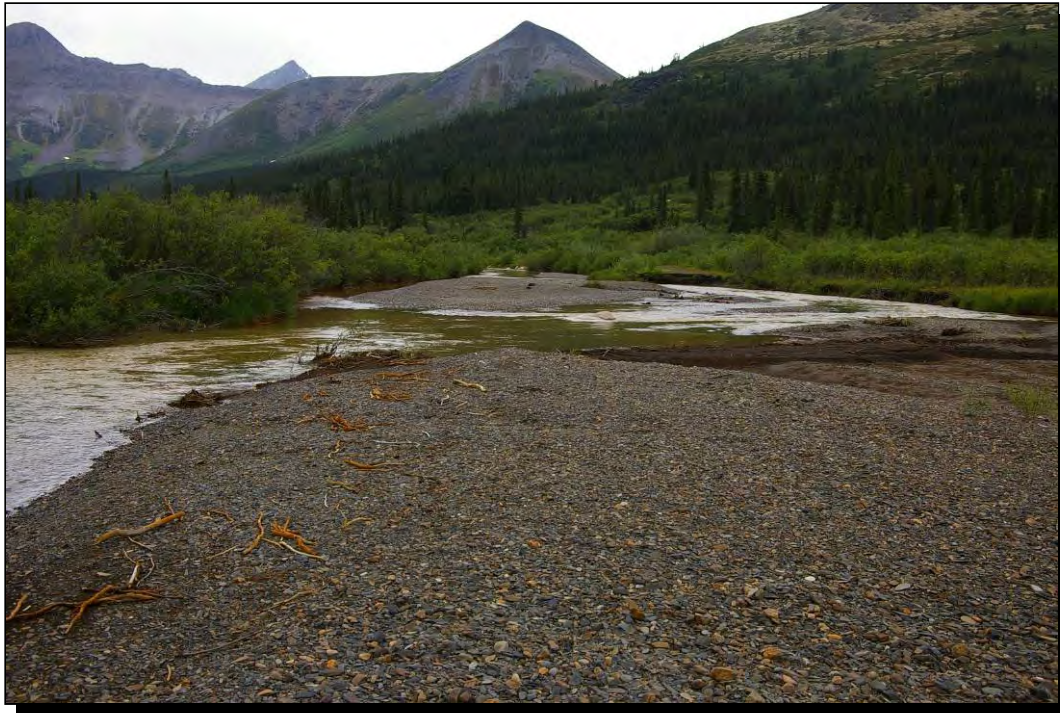
Photo 11
South Macmillan River, note the wide channel consisting mostly of fines and gravel, August 2008.

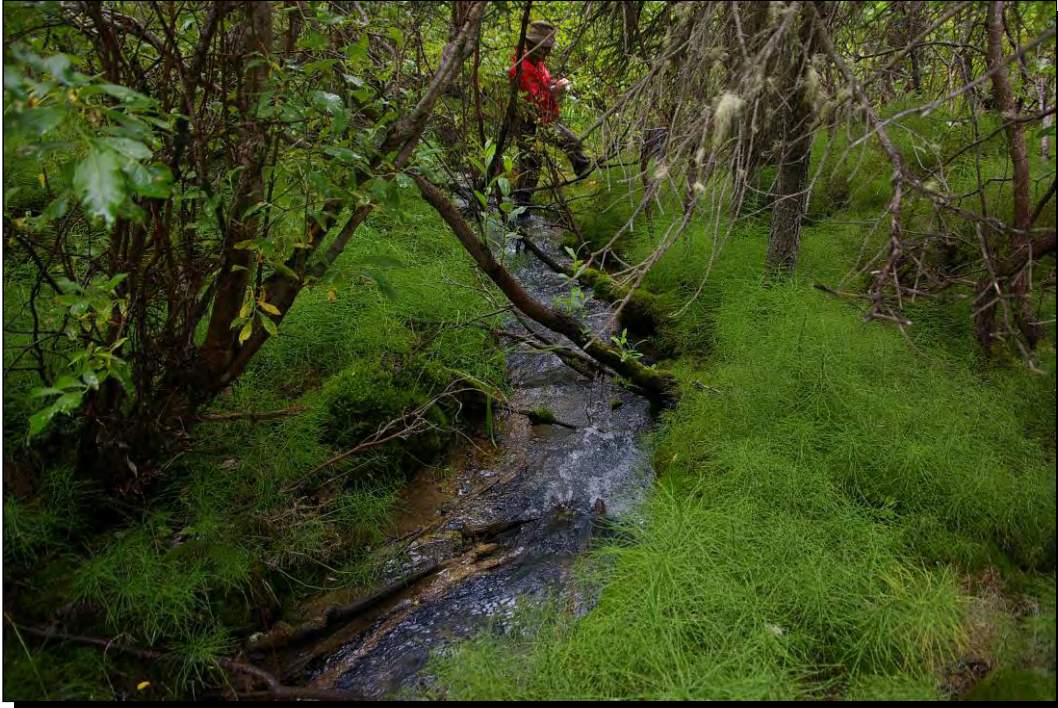
Photo 14

Tributary D3 is characterized by cascade pool pattern with gravel and boulder substrate, August 7, 2008.

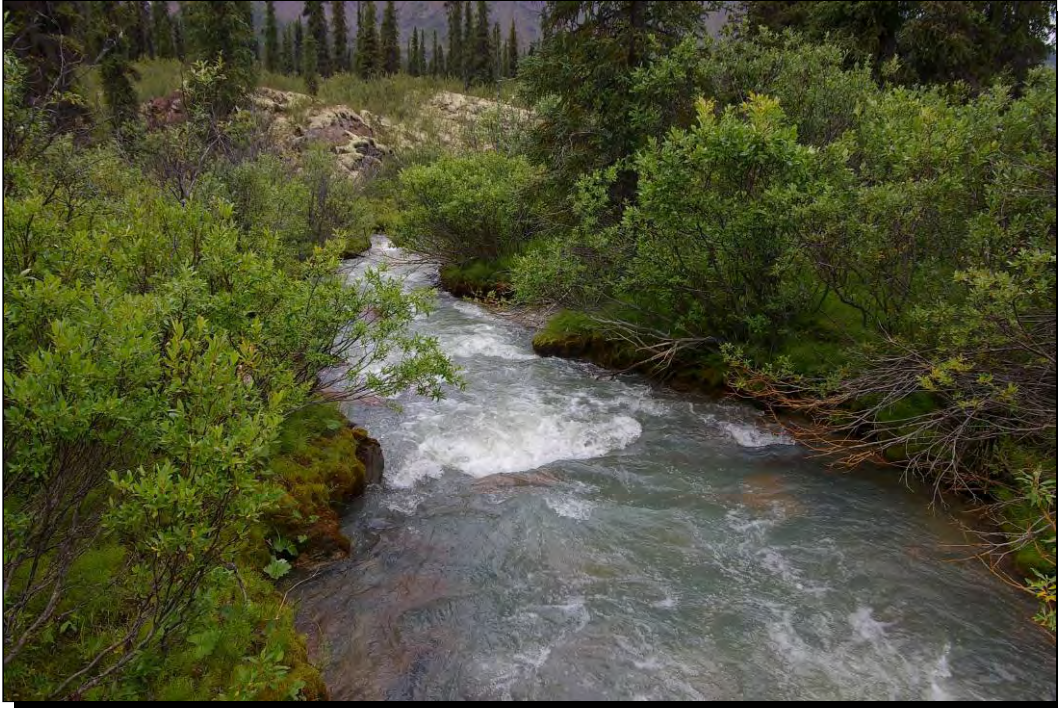
Photo 16

Tributary D9 is moderate in size, consists mainly of cascade pool pattern and often has high discharge.
Photo taken on August 5, 2008.

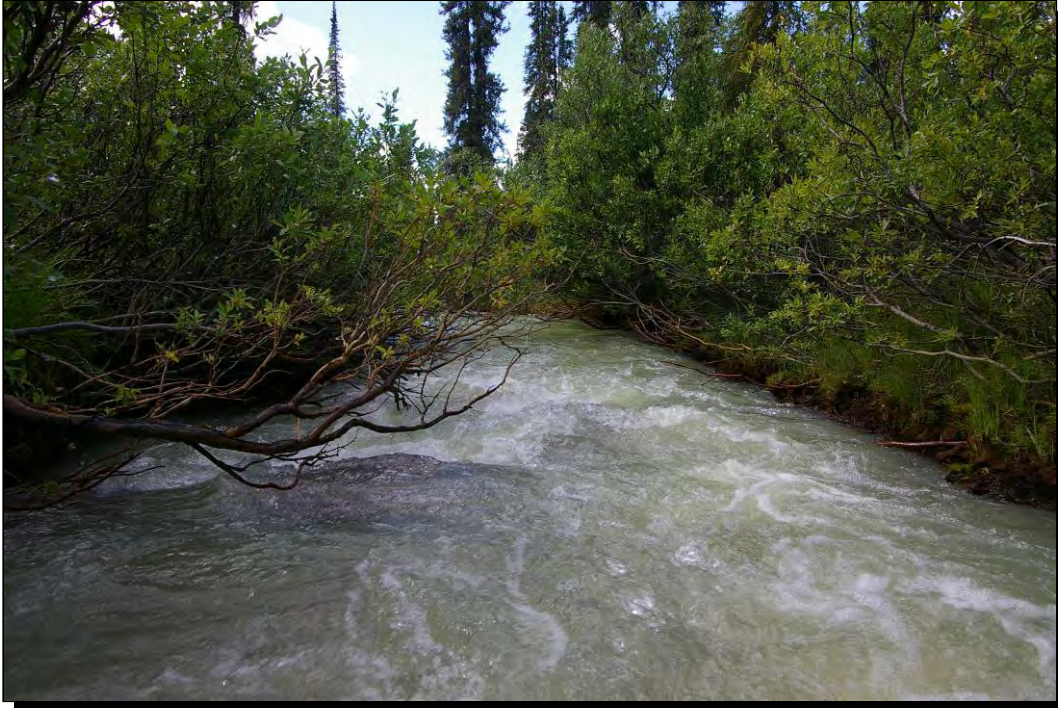
Photo 22
Overstorey cover is abundant on Tributary E. Photo taken August 6, 2008.

From a physical habitat perspective, Tributary E was found to be a high energy/high discharge watercourse with channel characteristics dominated by a boulder substrate (riffle-pool with some cascade). Cover in Tributary E was also not abundant or of high quality (little canopy closure or vegetation/wood), but characteristic of other area main tributaries in the form of pools and turbulent water (Table 8).

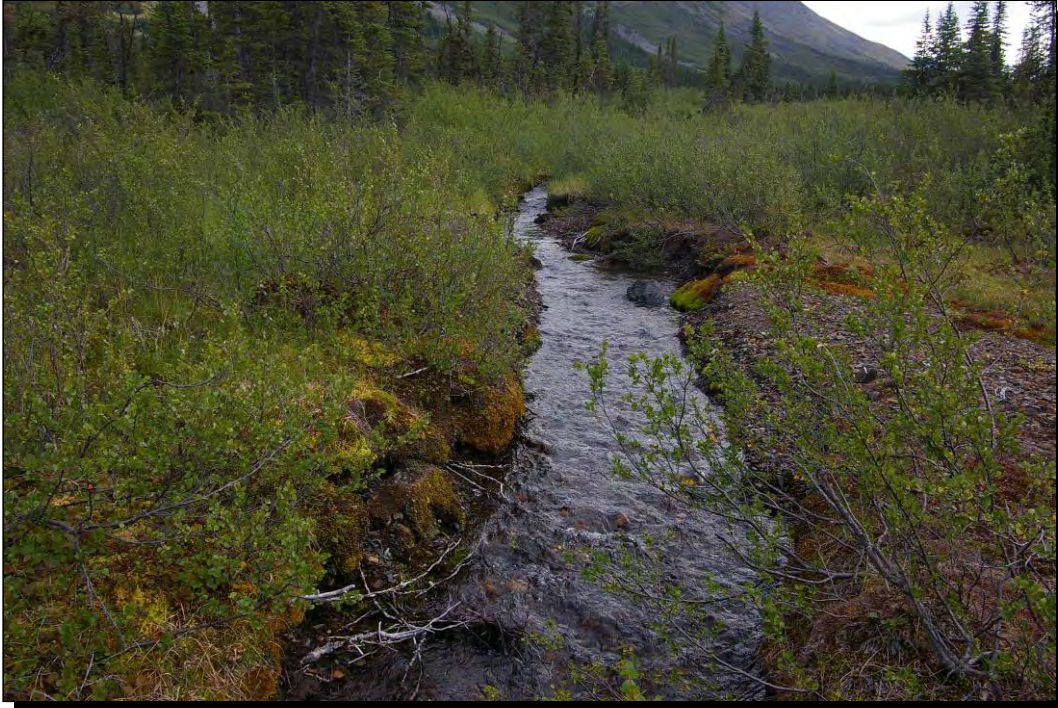
Photo 24
Tributary E7 is characterized as a low energy, riffle pool stream that is dominated by gravel and cobble, August 5, 2008.

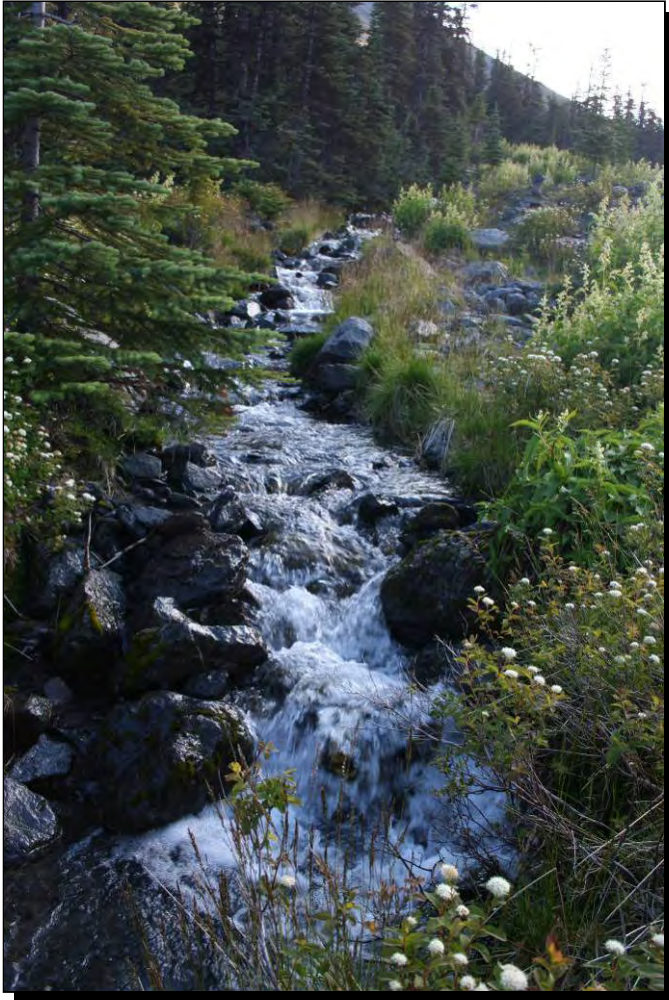
Photo 27

Upper Tributary E is characterized as a high gradient, cascade pool stream dominated by boulders and cobble.

Overall, this watercourse system was found to provide low fish habitat value, and was not found to support any fish. The uppermost reach of Tributary E, as well as site E1 that crossed the road route, were high energy streams with cobble or boulder dominated substrates and high gradients. E1 was the only site found to have suitable water quality and habitat distribution. In contrast, the suitability of Site E7 and Upper Tributary E (both of which cross the road route) were limited by acidic characteristics (pH of 3.36 and 4.5, respectively). This trend was also observed in other tributaries that feed the system from the south, which were found to have very poor water quality attributes (pH ranging from 5.94 to 7.93, and precipitate in E3 resulting in turbidity of 97 NTU), and overall habitat characteristics that did not appear to be suitable to support fish (Table 9).

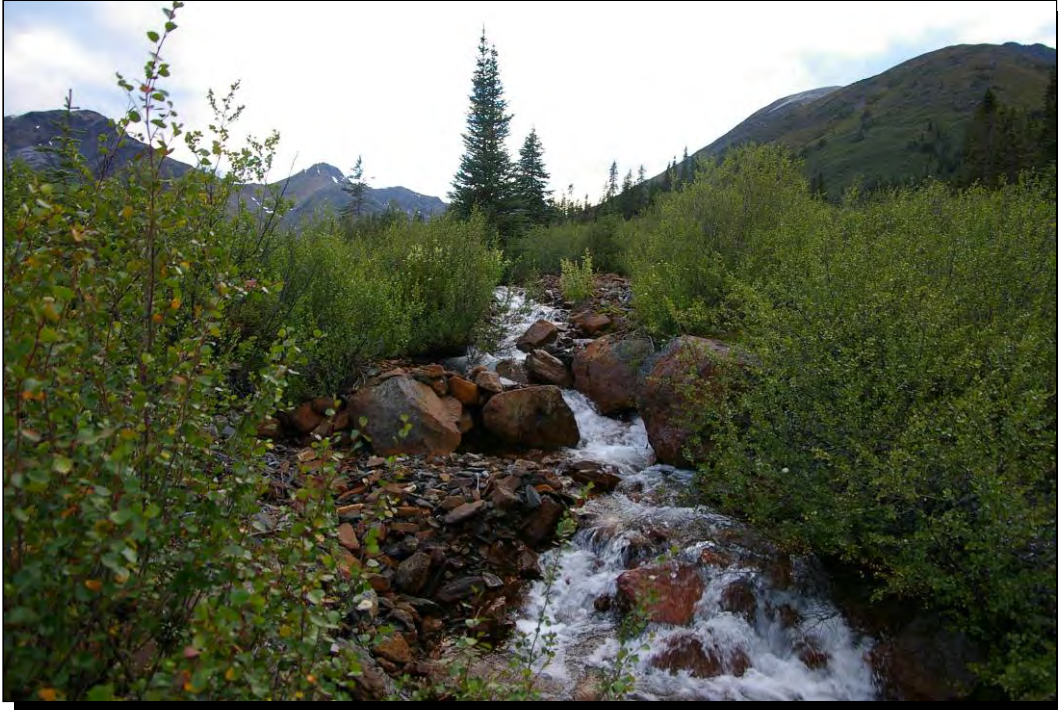
Photo 30

Tributary B1 is dominated by a cascade pool pattern with boulder/cobble substrate, August 4, 2008.

The crossing site B1 was not found to support fish, nor did it provide suitable fish habitat. Despite being a steep, disturbance channel dominated by cobble and boulder cascades (with little cover), the pH of this watercourse was measured at only 3.75 (Table 9). Because of the low fish habitat value and the unsuitable water quality, EBA assume that Tributary B1 is non fish bearing.

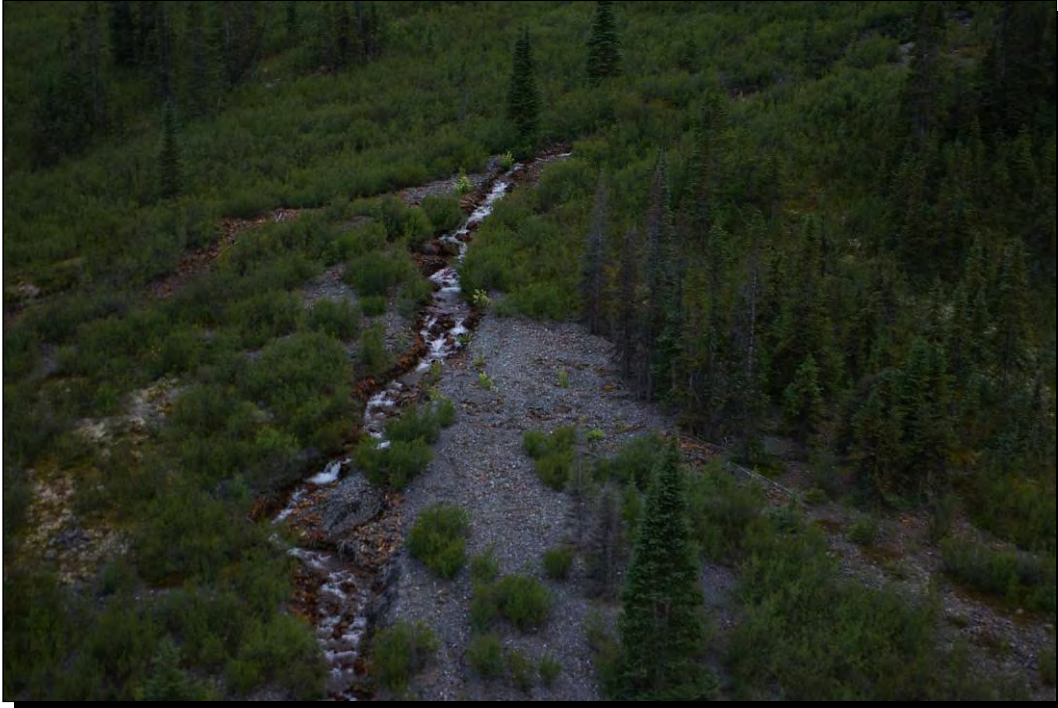
Photo 32

The upper reaches of Tributary B1 are steep with high energy and contained low quality fish habitat, August 4, 2008.

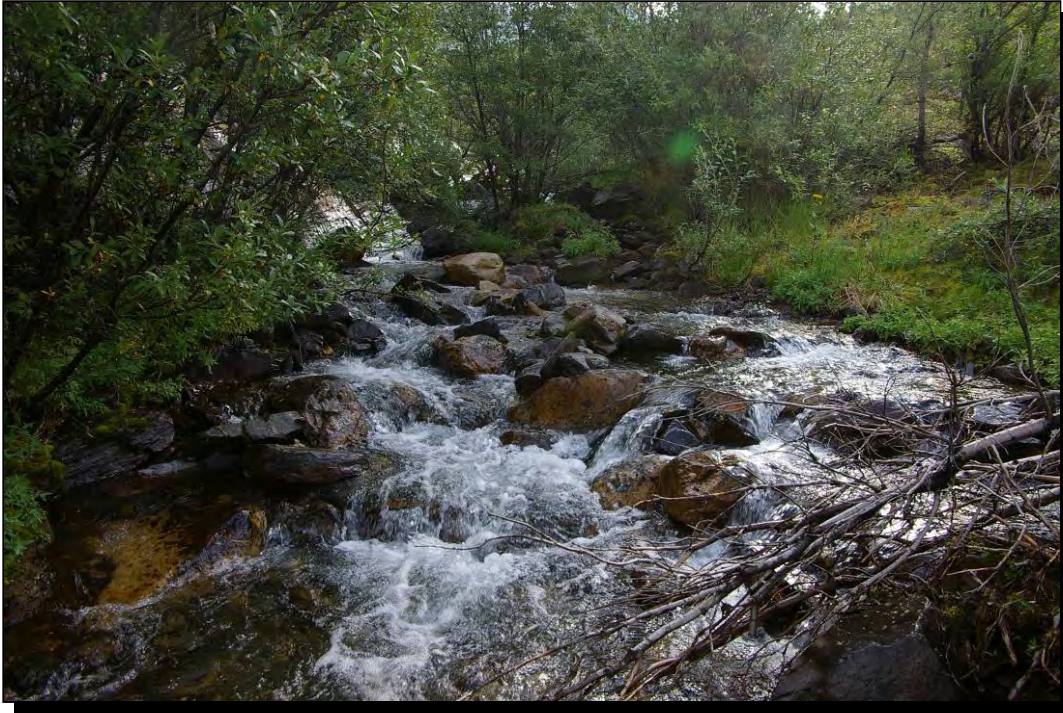
Photo 33

Tributary C6 is dominated by boulders and cobble in a cascade pool channel type. Overstorey vegetation is abundant, August 8, 2008.

Tributary C6 was a steep, high energy stream and the study area was moderately confined by bedrock and boulder. As a result, numerous large cascades presented possible to likely barriers to fish passage. Consequently, areas upstream from the sampling location are considered to be non-fish bearing. However, it is possible that areas closer to the mainstem of Tributary C support fish populations. Water quality characteristics, cover, and general habitat distributions were found to be suitable to support fish (with the exception of barriers).

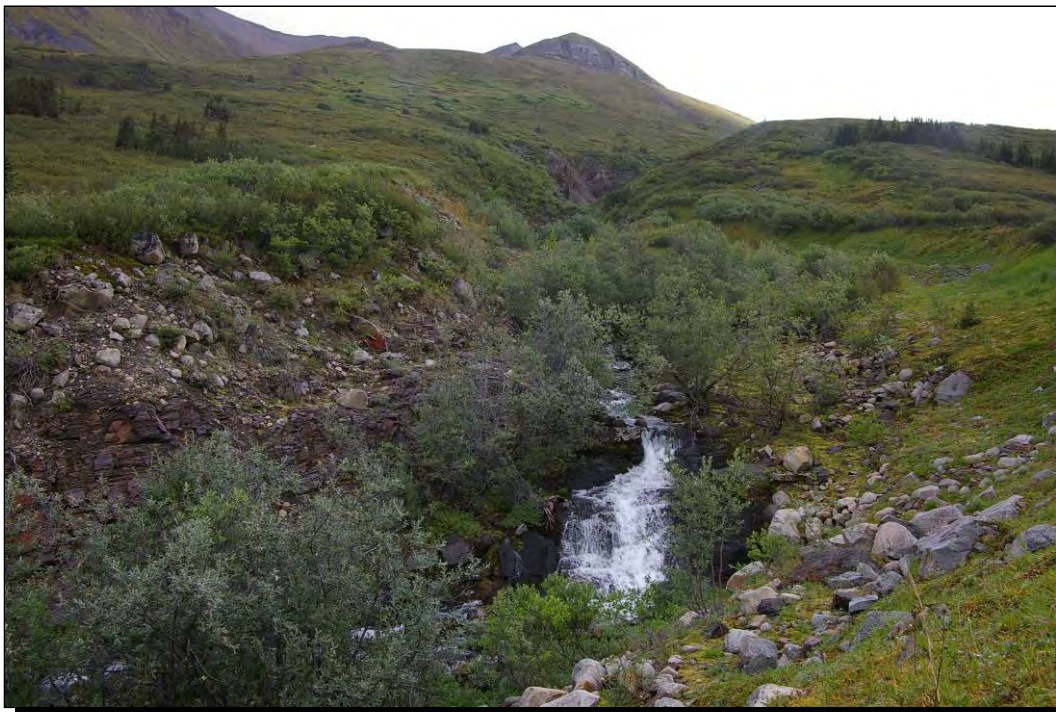
Photo 36

Tributary C6 - a barrier that is likely impassible to fish, located downstream of the sample site on Tributary C6, August 8, 2008.

EBA electrofished at Tributary C6 for a total of 403 seconds, during which time no fish were caught or observed (Table 10). Water quality and habitat were found to be suitable for fish. Several large potential barriers to fish passage were observed within 300 m downstream of the proposed crossing site, and EBA considered the areas upstream of those to be non-fish bearing (Photo 36). Areas below the barriers or closer to Tributary C may be fish bearing, although it has not been confirmed.

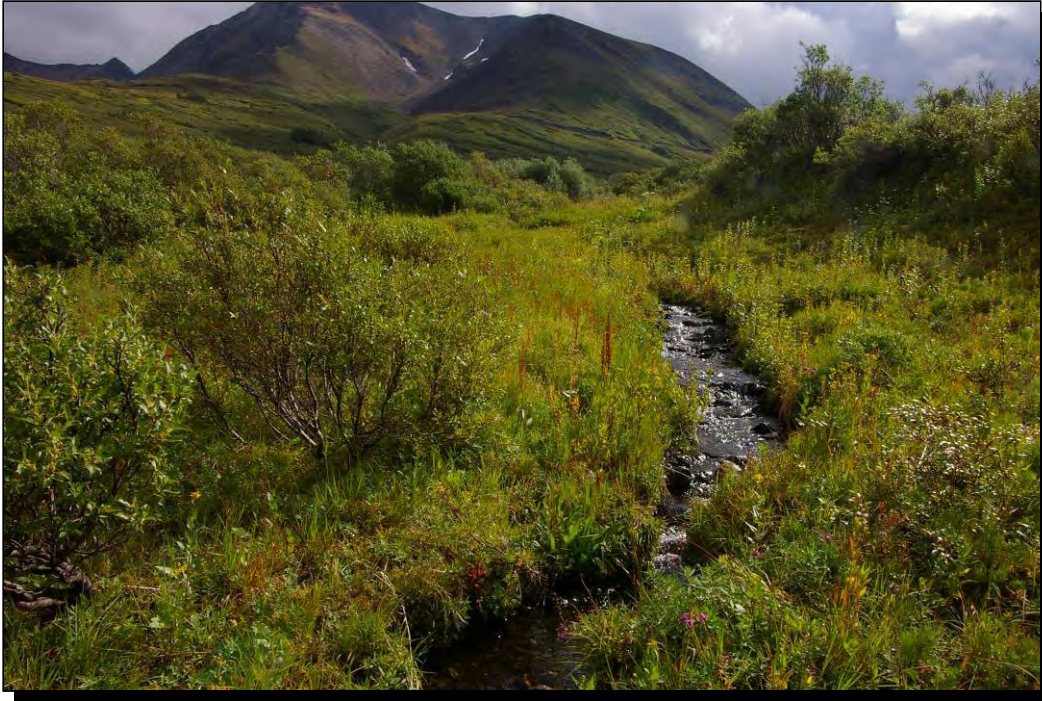
Photo 37
Tributary C7 is characterized by riffle pool channel type, August 8, 2008.

Tributary C7 was a much shallower watercourse with a predominantly cobble substrate channelized by tall vegetated banks. Despite being shallow and having little overhead cover, the water quality and availability of undercut bank cover in this tributary were conducive to supporting fish. However, as noted above, no fish were captured.

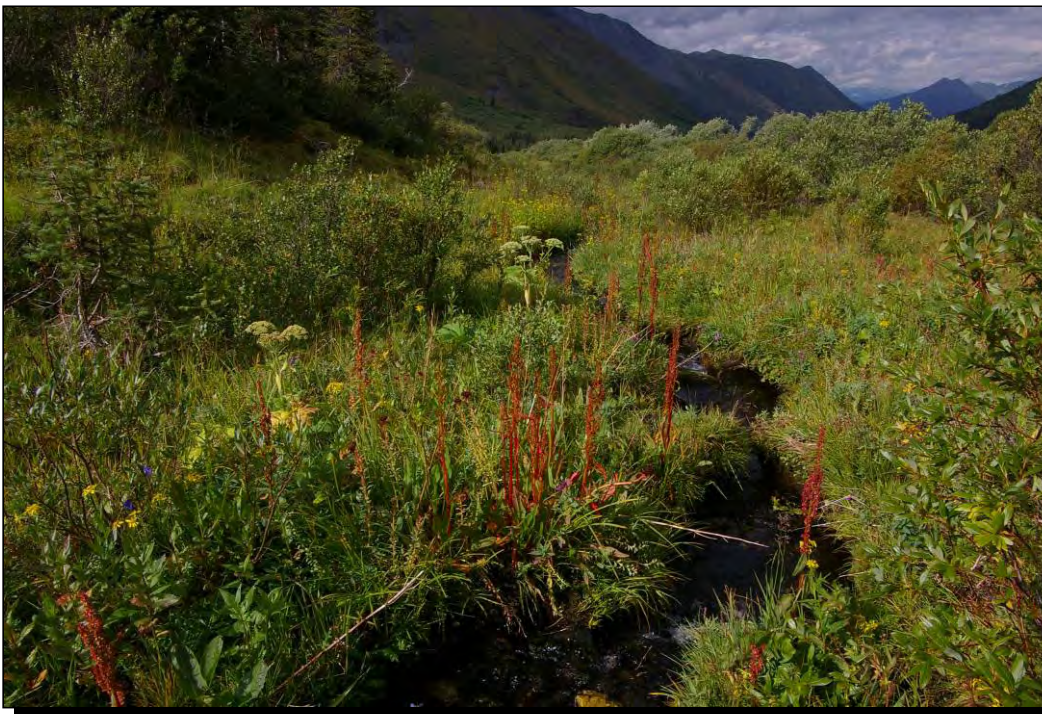
Photo 38
Tributary C7 a small meandering channel confined by vegetated banks. Photo taken on August 8, 2008.

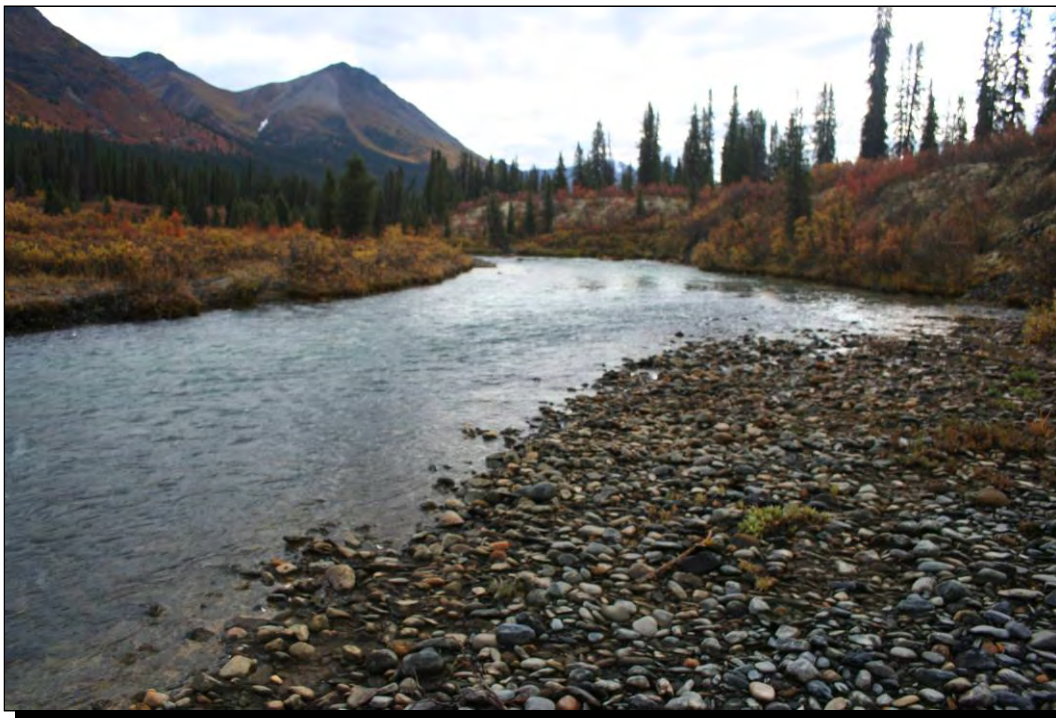
Photo 40
Looking upstream at aquatic sampling site AQ-D, located on lower Tributary D.
Photo taken on September 6, 2008.

Sampling for stream sediment particle size and metals was conducted as part of EBA's 2008 aquatics baseline study program. EBA collected sediment samples from seven sites across five streams within the ASA^P and ASA^R, representing the both the potential receiving environment and the proposed access road areas (Figure 4). At each station, samples were collected from three separate depositional areas within the active channel. Each sample was collected using an aluminium scoop, by a collector wearing latex gloves. Samples were directly placed into labelled 125 mL glass jars and kept refrigerated until being placed on ice in coolers for transport under chain of custody to Maxxam Analytics Ltd. in Burnaby (BC) for analysis. All samples were collected on September 6, 2008. All sites were located at previous fisheries sites with the exception of two new sties, AQ-D and AQ-E that are associated with the access road (Photos 21, 22, 40, 41).

The macroinvertebrate samples collected at AQ-D were dominated by Dipterans (including chironomids) in all three samples. The most abundant genera within this group were Rhabdomastix and genera within the family Diamesinae. Plecopterans are the second most abundant order present. Single individuals from the orders Ephemeroptera and Trichoptera were also noted. In terms of macroinvertebrate composition, this site is most similar to FS7 with Dipterans being the most abundant organisms.

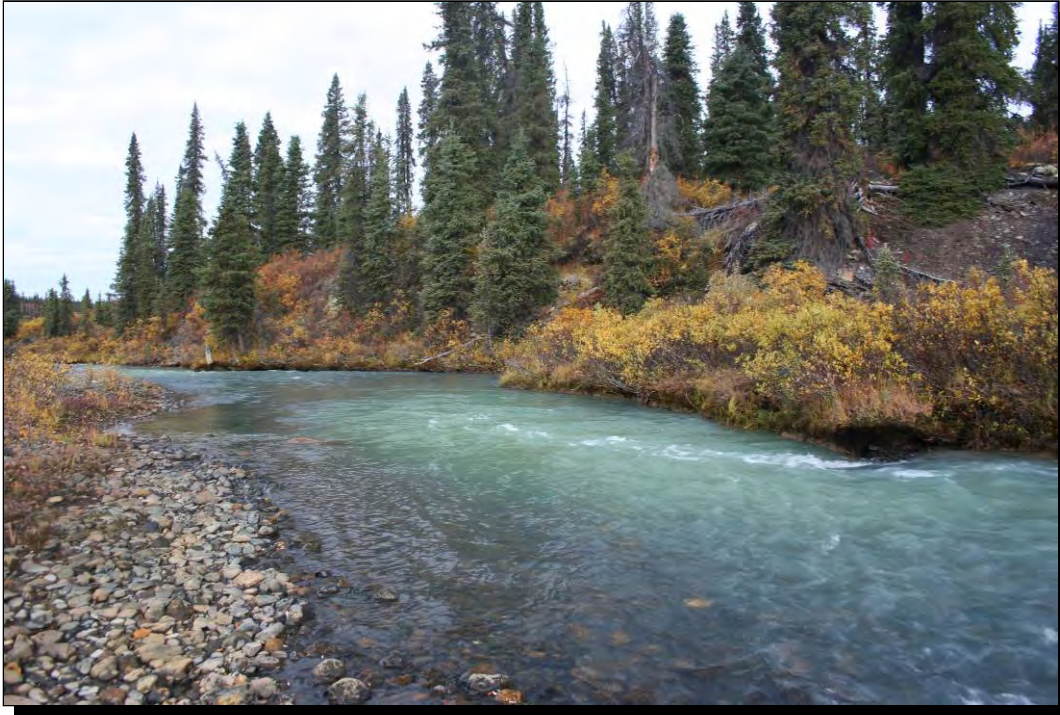
Photo 41

Down stream view at aquatic sampling site AQ-E. Photo taken on September 6, 2008.

As noted above, EBA was unable to collect samples at AQ-E due to environmental constraints.
