**CAPSTONE
MINING CORP.**

MINTO MINE

2012 ANNUAL WATER LICENCE REPORT

2012 ANNUAL QUARTZ MINING LICENCE REPORT

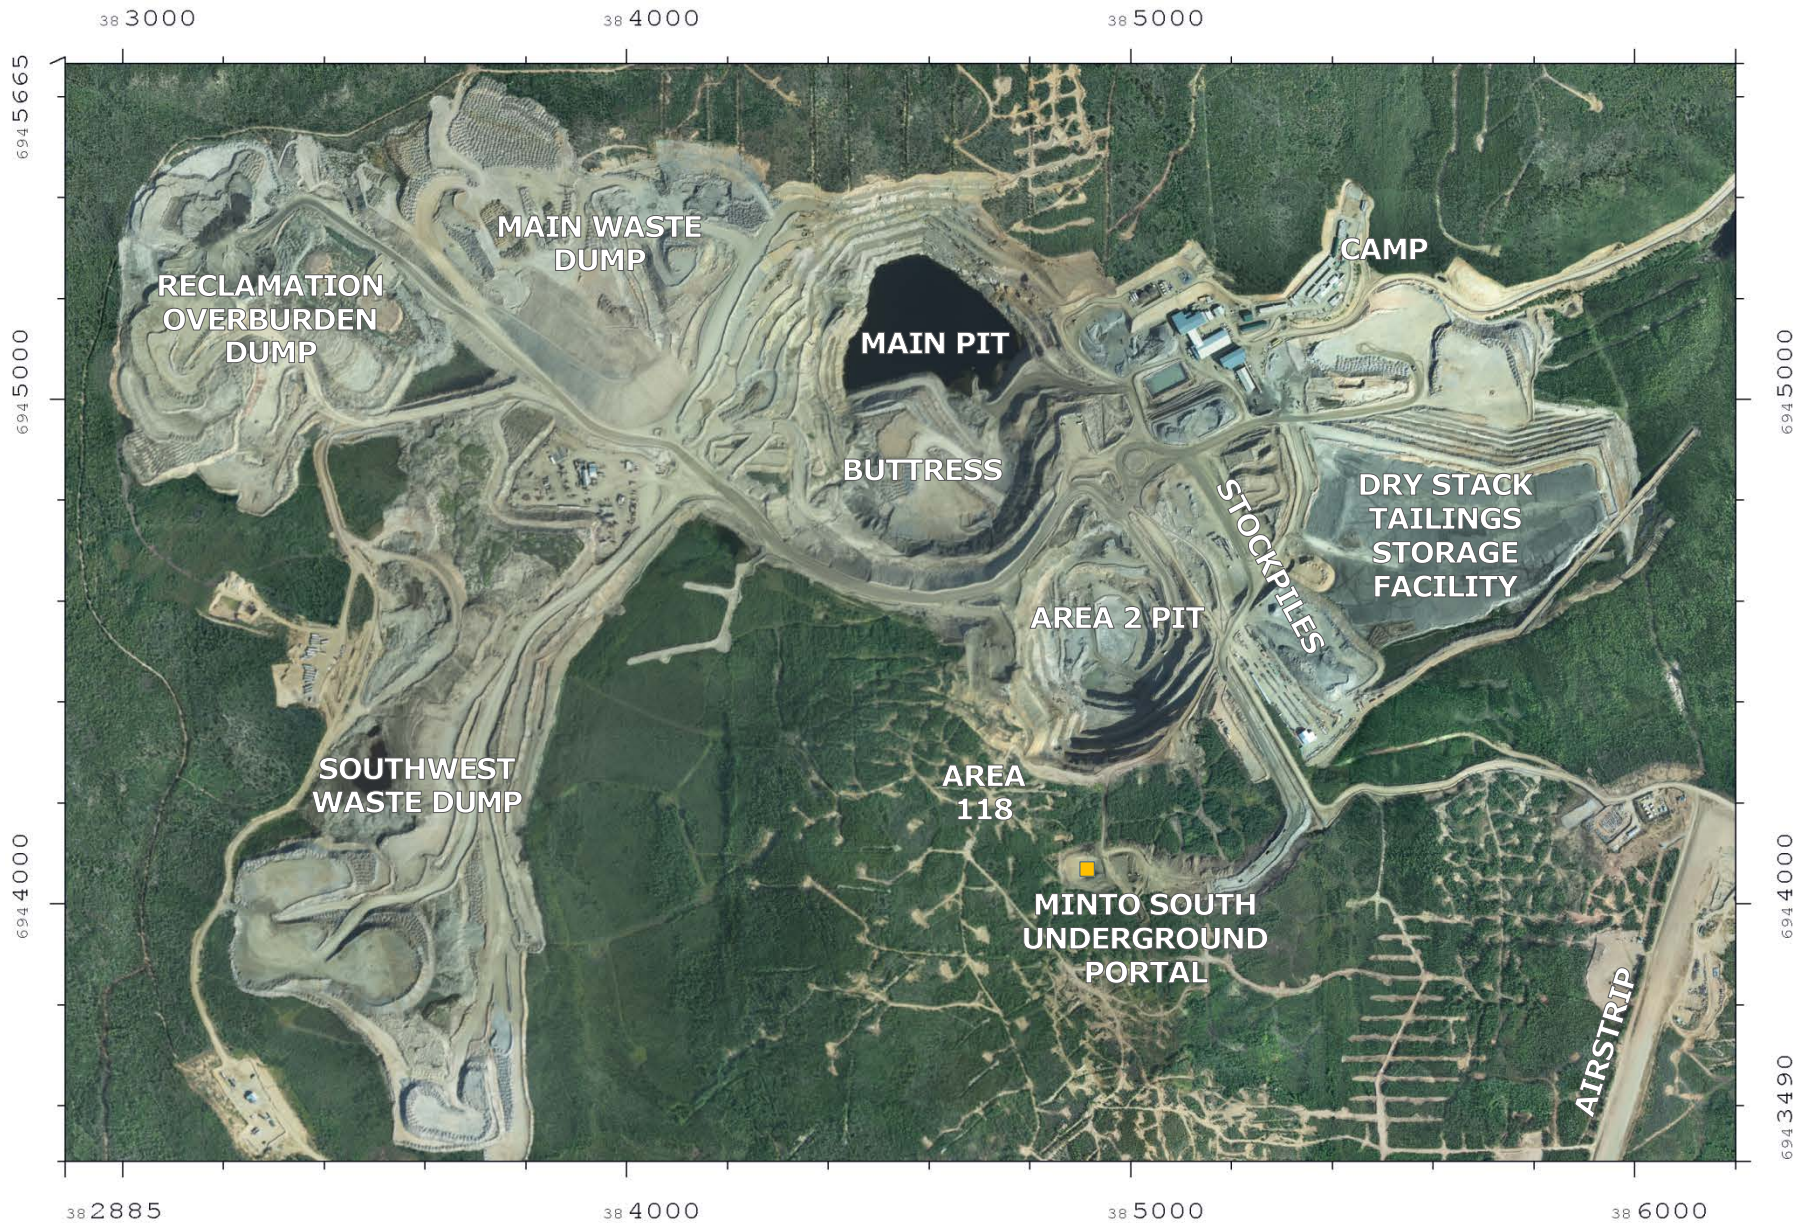
Figure 1-1: Site overview as of August 2012 (scale: 1:10000).

An aerial photo taken in August 2012 with site infrastructure labeled is presented in Figure 1-1, and site conditions at the end of the reporting period are presented in Figure 1-2,

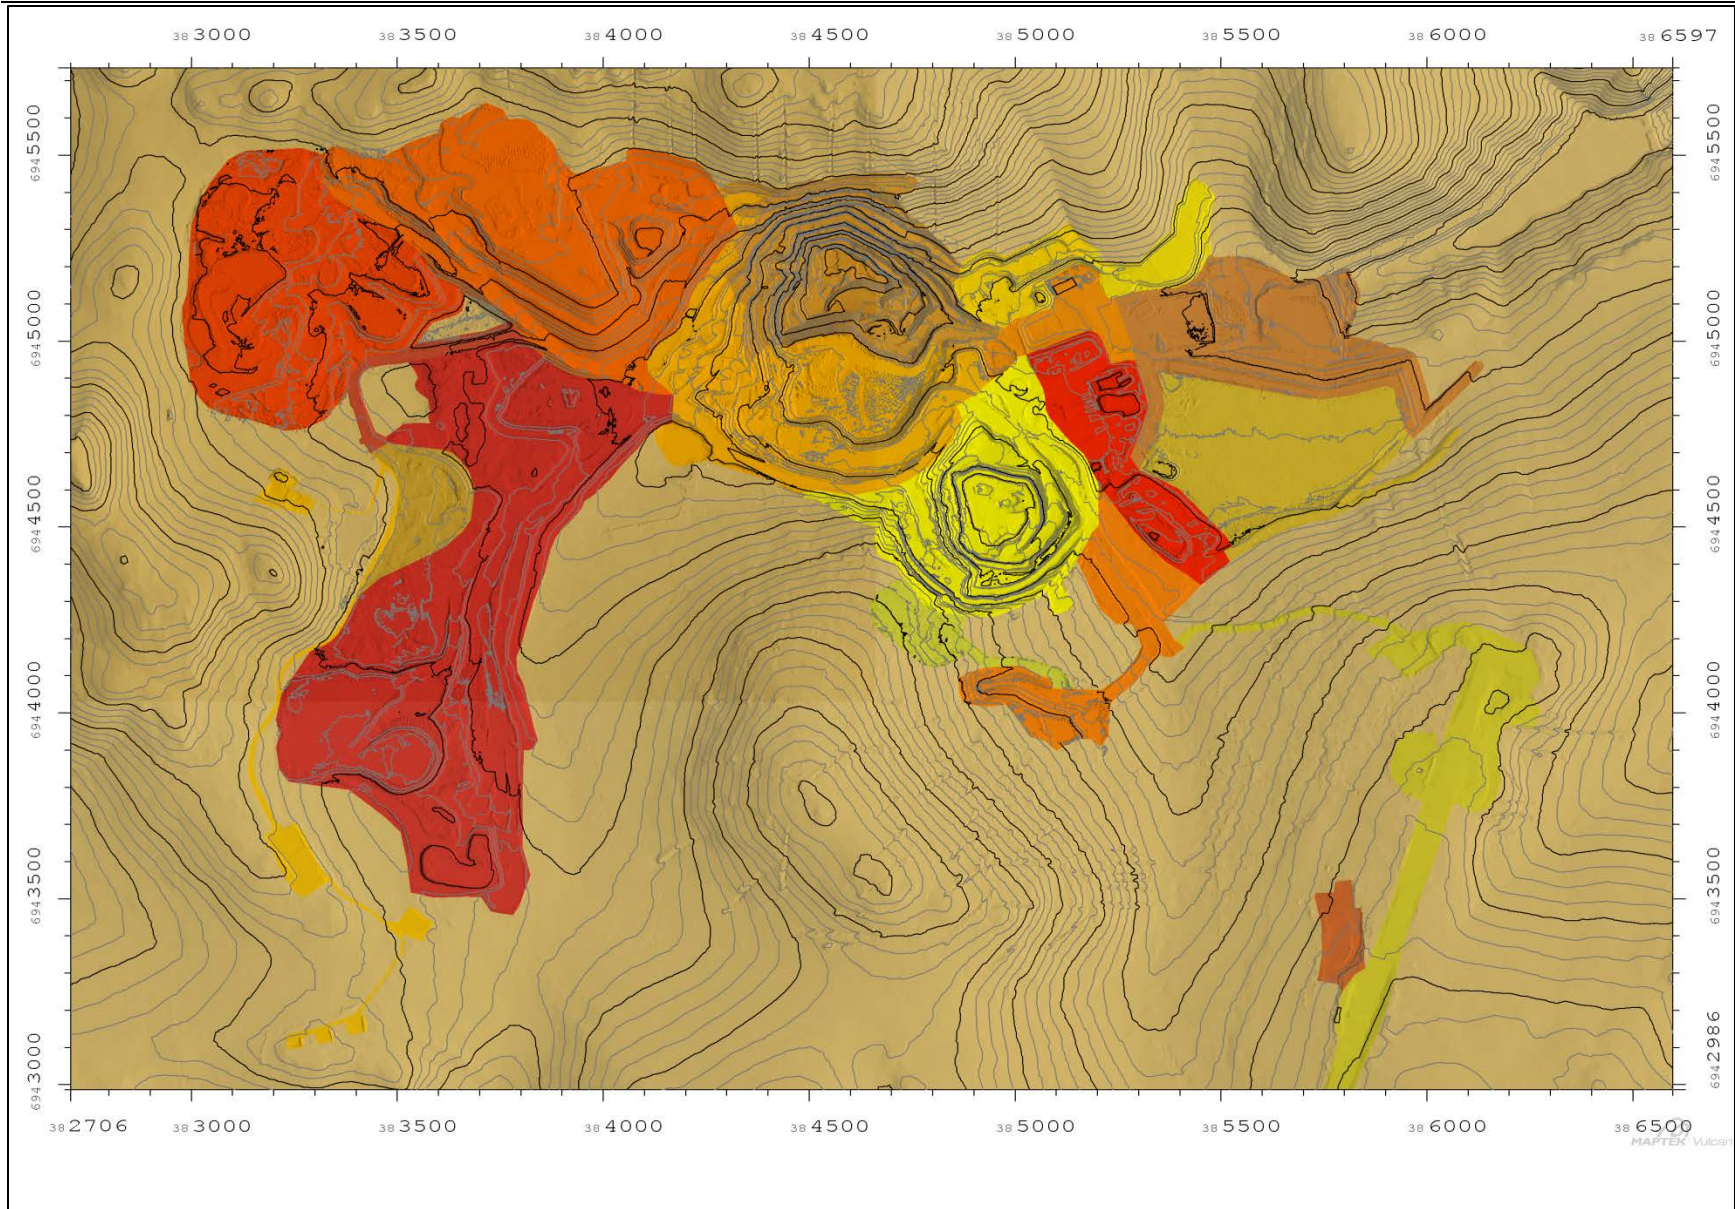
Figure 1-2: General site layout – December 31, 2012.

In 2012, the total volume of waste material excavated and placed was 3.91M BCM. The placement of the mined material is summarized in Table 2-1. "Other projects" includes construction projects, in-pit ramps, road work, stockpile pads, and rockfill roads on the DSTSF. A layout of various dumps on the project site can be found in Figure 1-2.

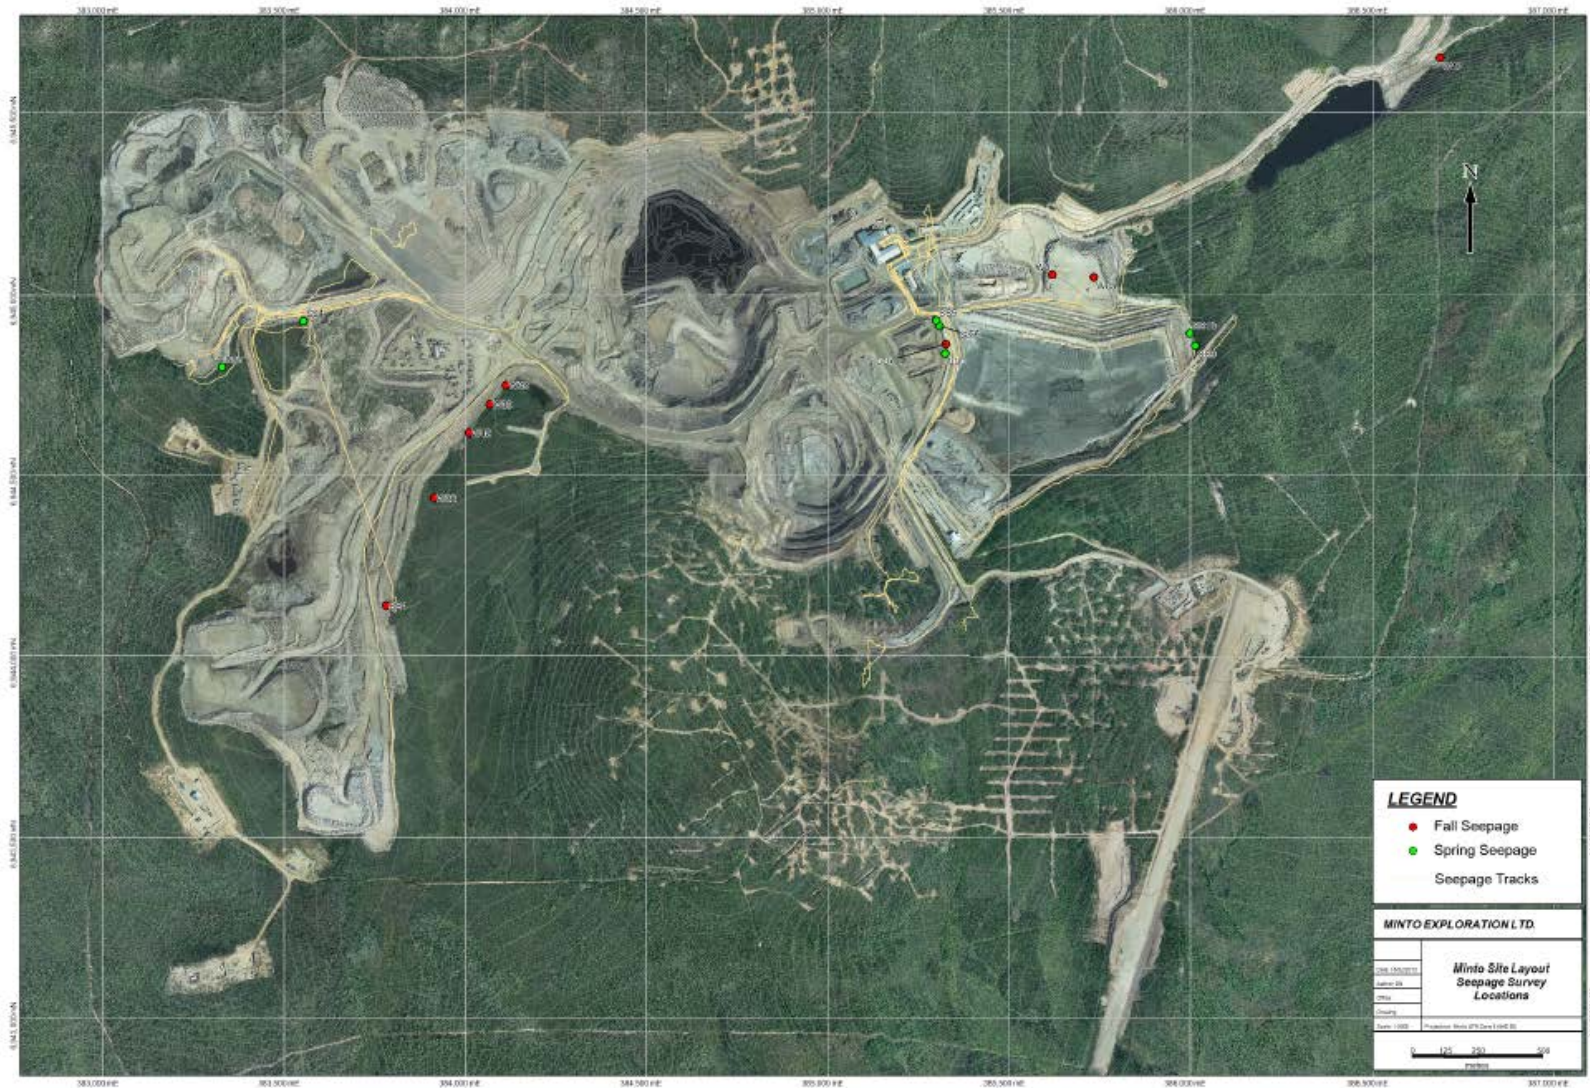
Figure 5-13: 2012 Minto Mine overview with seepage surveys (in yellow) and sample locations (fall samples in red and spring samples in green).

The *Seepage Monitoring Plan* states that seepage surveys will be conducted twice a year, during spring runoff and in early fall, by walking the toe of each waste dump, stockpile or other area of interest; for each seepage monitoring event survey routes will be recorded using the tracking function of a Global Positioning System (GPS). Figure 5-13 displays the 2012 survey routes and monitoring locations.

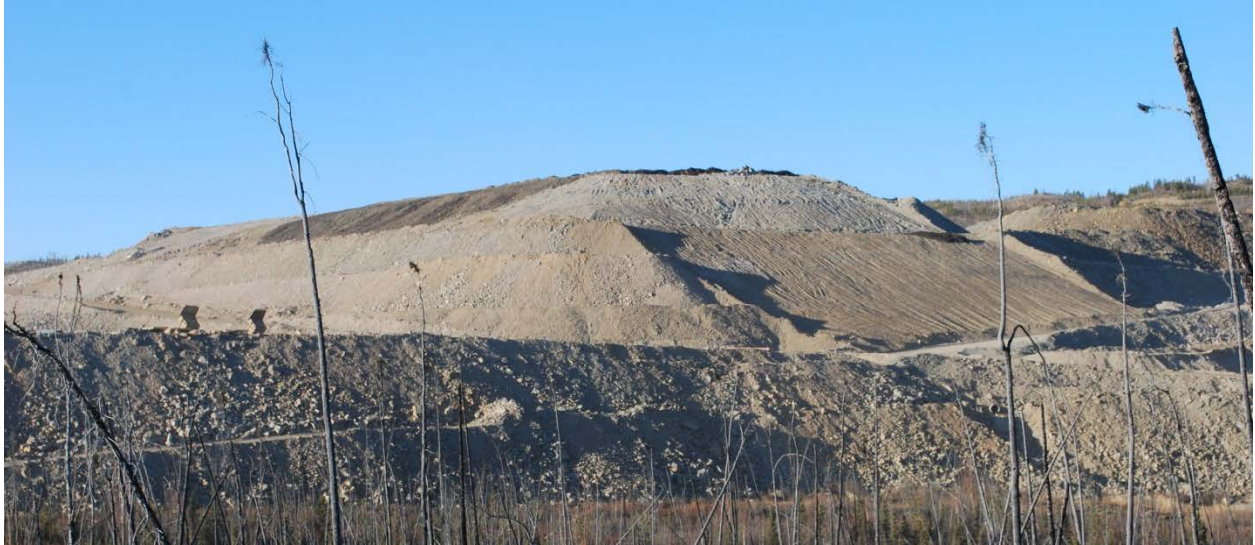
Figure 8-1: Main Waste Dump near the end of construction season 2011 (September).

Figure 8-1 shows the reclamation work that Minto Mine completed on the Main Waste Dump in 2011. At the beginning of the 2012 summer Minto completed the re-contouring of the slopes (Figure 8-2) and placed 1 m of overburden over the re-contoured slopes (Figure 8-3). As sections of the overburden were placed, they were hand seeded and fertilized (depending on plot amendment) (Figure 8-3).

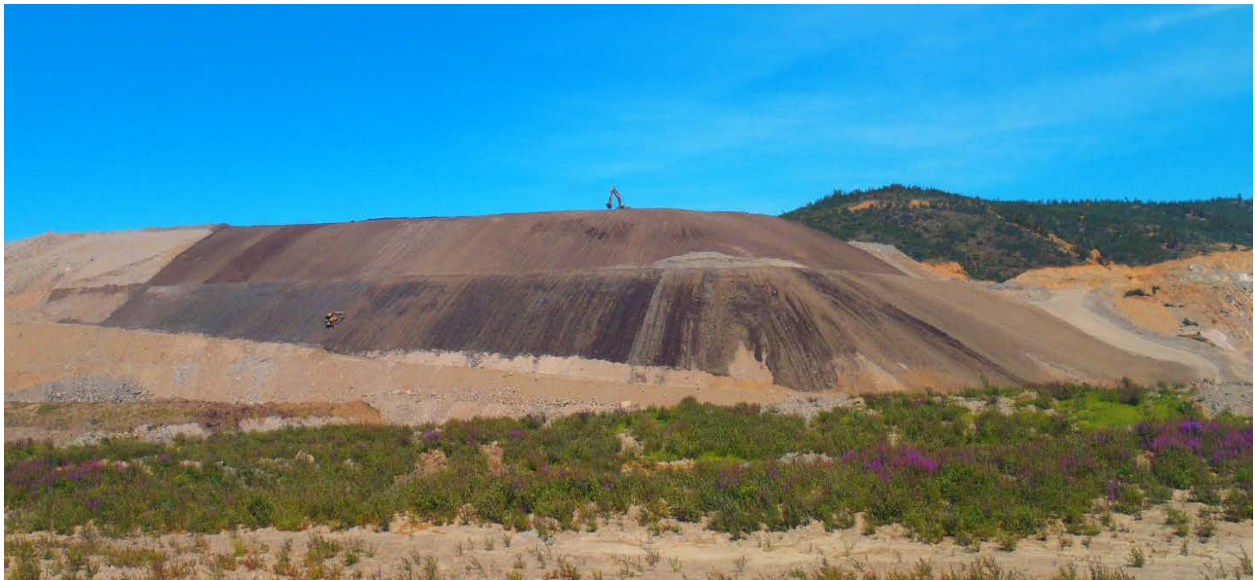
Figure 8-2: Main Waste Dump as it appeared in July 2012 with final placement of overburden into distinct plots.

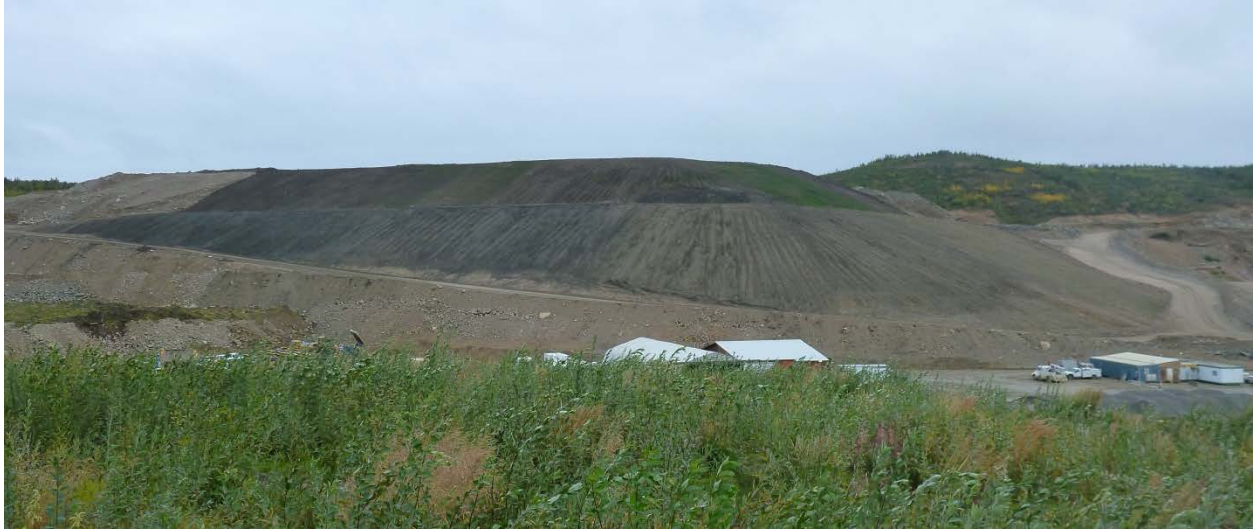
Figure 8-3: Final plot placement in August 2012. Note seedling emergence in upper right plots.

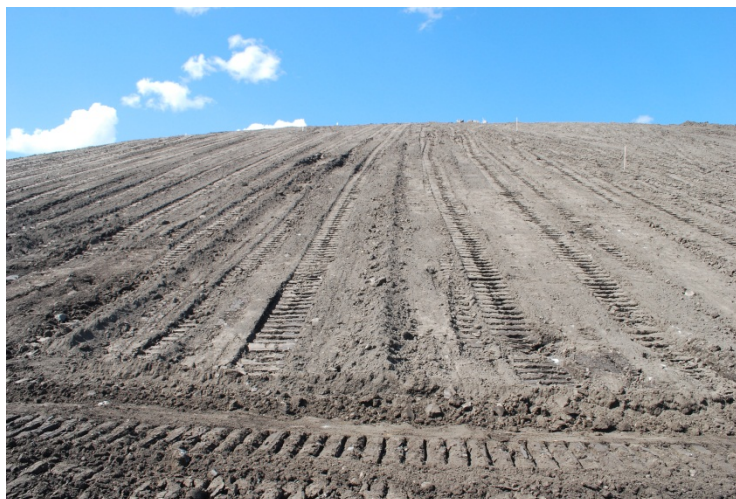
Figure 8-5: Plot surface after grading with the D6 Cat dozer.

The seeding surface was prepared by lightly grading the surface with the blade of a CAT D-6 dozer. The light grading was key for the slopes that had overburden placed on them in 2011, this grading brought moisture to the surface and broke up the hard surface created by heavy snow pack over the winter of 2011/2012 (Figure 8-5). The dozer tracks running up and down the plot's surface, perpendicular to the slope, created microsites. These microbenches are capable of capturing moisture, seeds and fertilizer pellets in depressions (Figure 8-6).

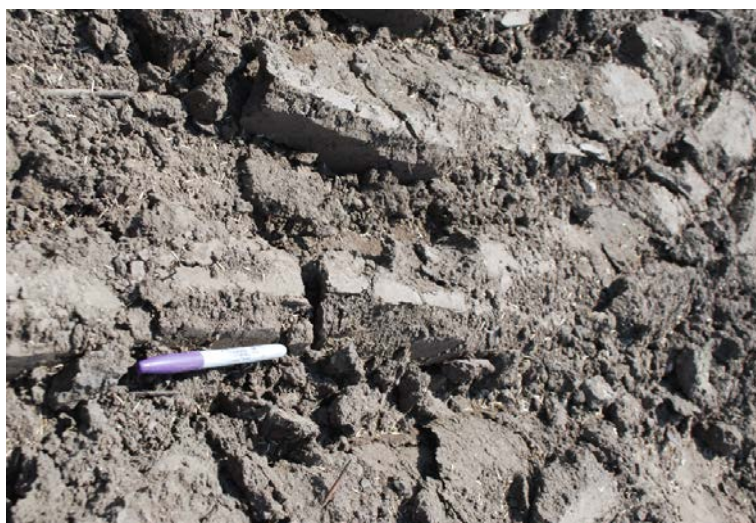
Figure 8-6: Close up of microbenches, depressions capture recent seeding.

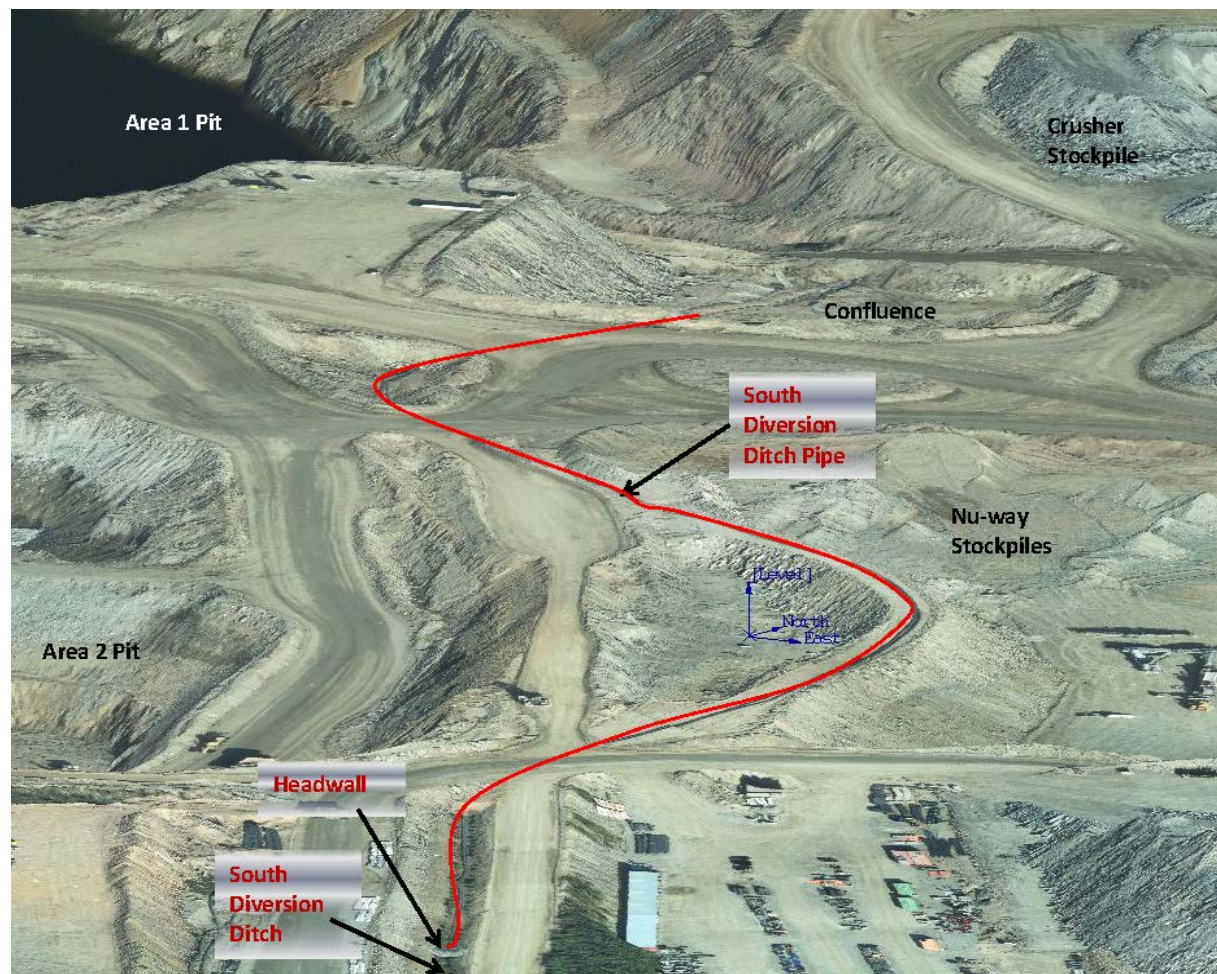
Figure 9-2: South Diversion Ditch (September, 2012).
