Minto Mine

Water Licence QZ14-031

Quartz Mining Licence QML-0001

2015 Annual Report

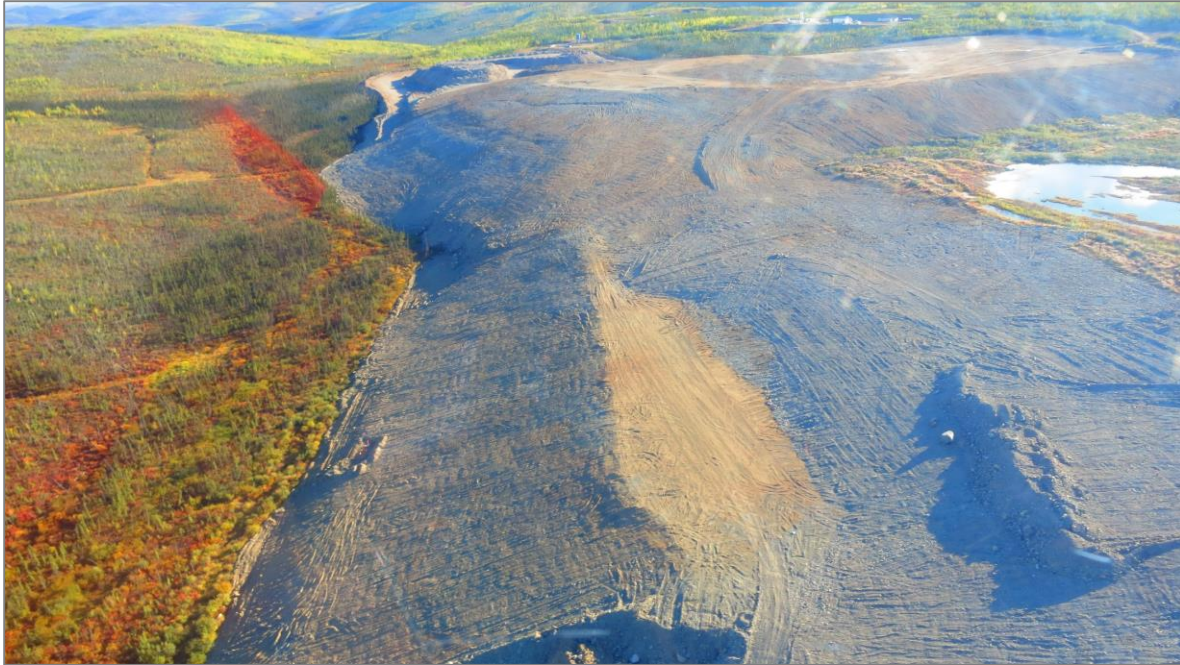
Photograph 6-1: Sloping of the Medium Grade Waste Area

In early 2015, Pelly Construction completed the recontouring on the low grade area of the SWD. After completion of the low grade area, the primary focus of the recontouring effort shifted to the medium grade waste area of the SWD starting at the south west corner. Over 1500 hrs of dozer time was put into the recontouring effort on the SWD in 2015. Slope angles ranging from 3:1 to 13:1 were achieved over the entire dump faces. The high grade waste area was the only area not worked on, as Minto has not decided the fate of that material in regards to closure. During 2015, recontouring work on the SWD carried out from January through July. Figure 6-1, below, shows as-built images for the SWD both before and after the recontouring was completed. Photograph 6-1, below, shows a detailed photo of the sloping of the medium grade waste area. Photograph 6-2, below, show the overall SWD after recontouring was completed in 2015.

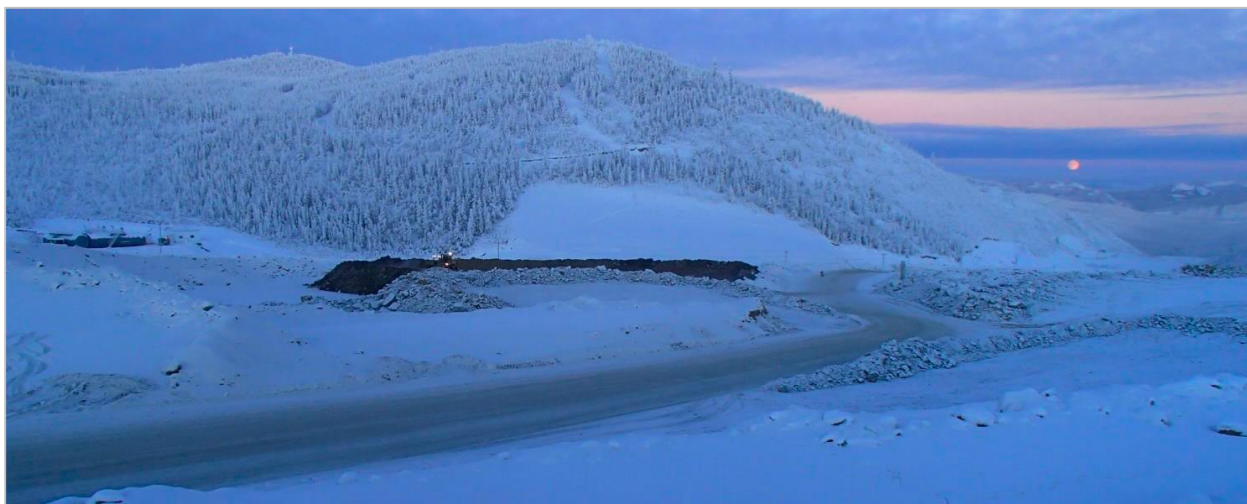
Photograph 6-3: Dumping of Material on Top of the Original Mill Valley Fill Extension (764 lift)

In late 2015, Minto began construction on the Mill Valley Fill Extension Stage 2 which is designed to arrest the movement of the Dry Stack Tailing Storage Facility. Minto submitted final design drawings on September 16, 2015 and notification of construction on November 7, 2015 to the YWB and EMR. Pelly Construction began construction by stripping the organic layer off of the foot print of the Mill Valley Fill Extension Stage 2. A total of 86,561 BCM was hauled to the Mill Valley Fill Extension Stage 2 by the end of 2015. Photograph 6-3 shows material being dumped on the 764 lift on top of the original Mill Valley Fill Extension.
