Minto Mine

Water Licence QZ14-031

2016 Annual Report

Prepared by:
Minto Explorations Ltd.
Minto Mine

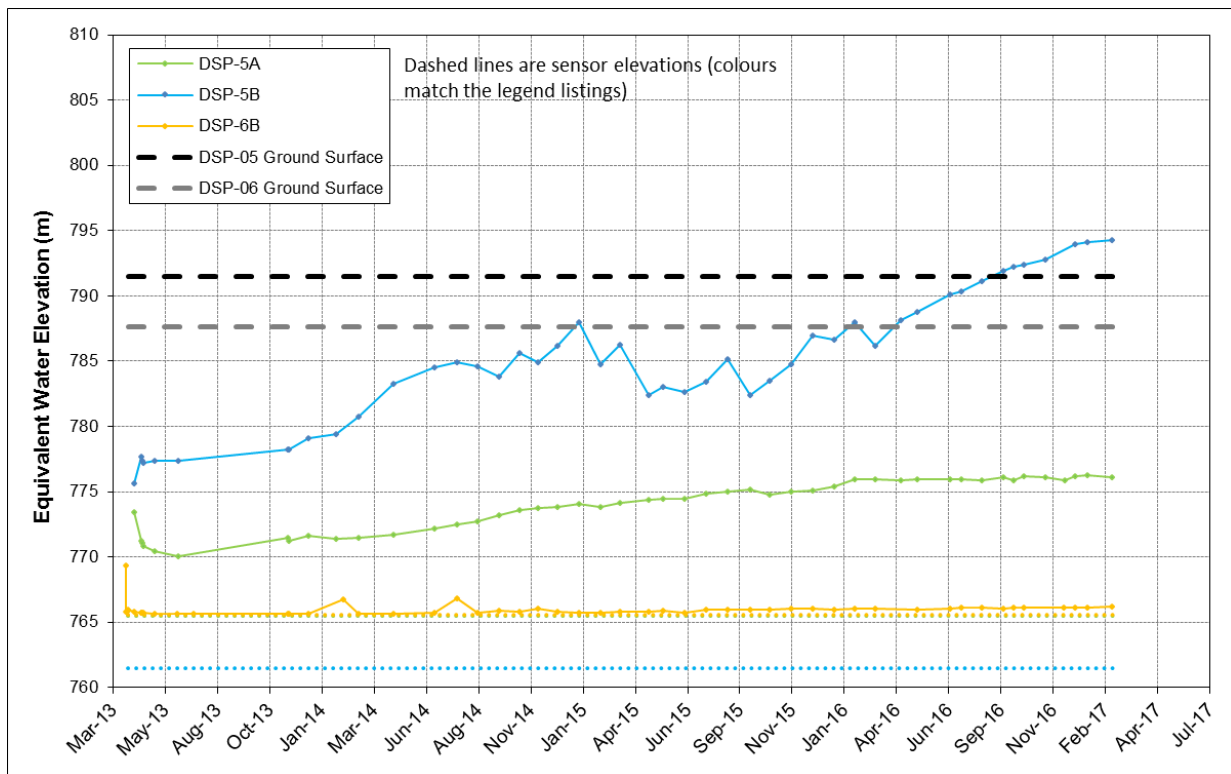
Figure 6-2: DSTSF Piezometer Data – DSP-05 and DSP-06 (2013-2016)

DSP-05 and DSP-06 data are collected monthly, DSP-07 and DSP-08 data are collected bi-monthly, and DSP-10 data are collected weekly.

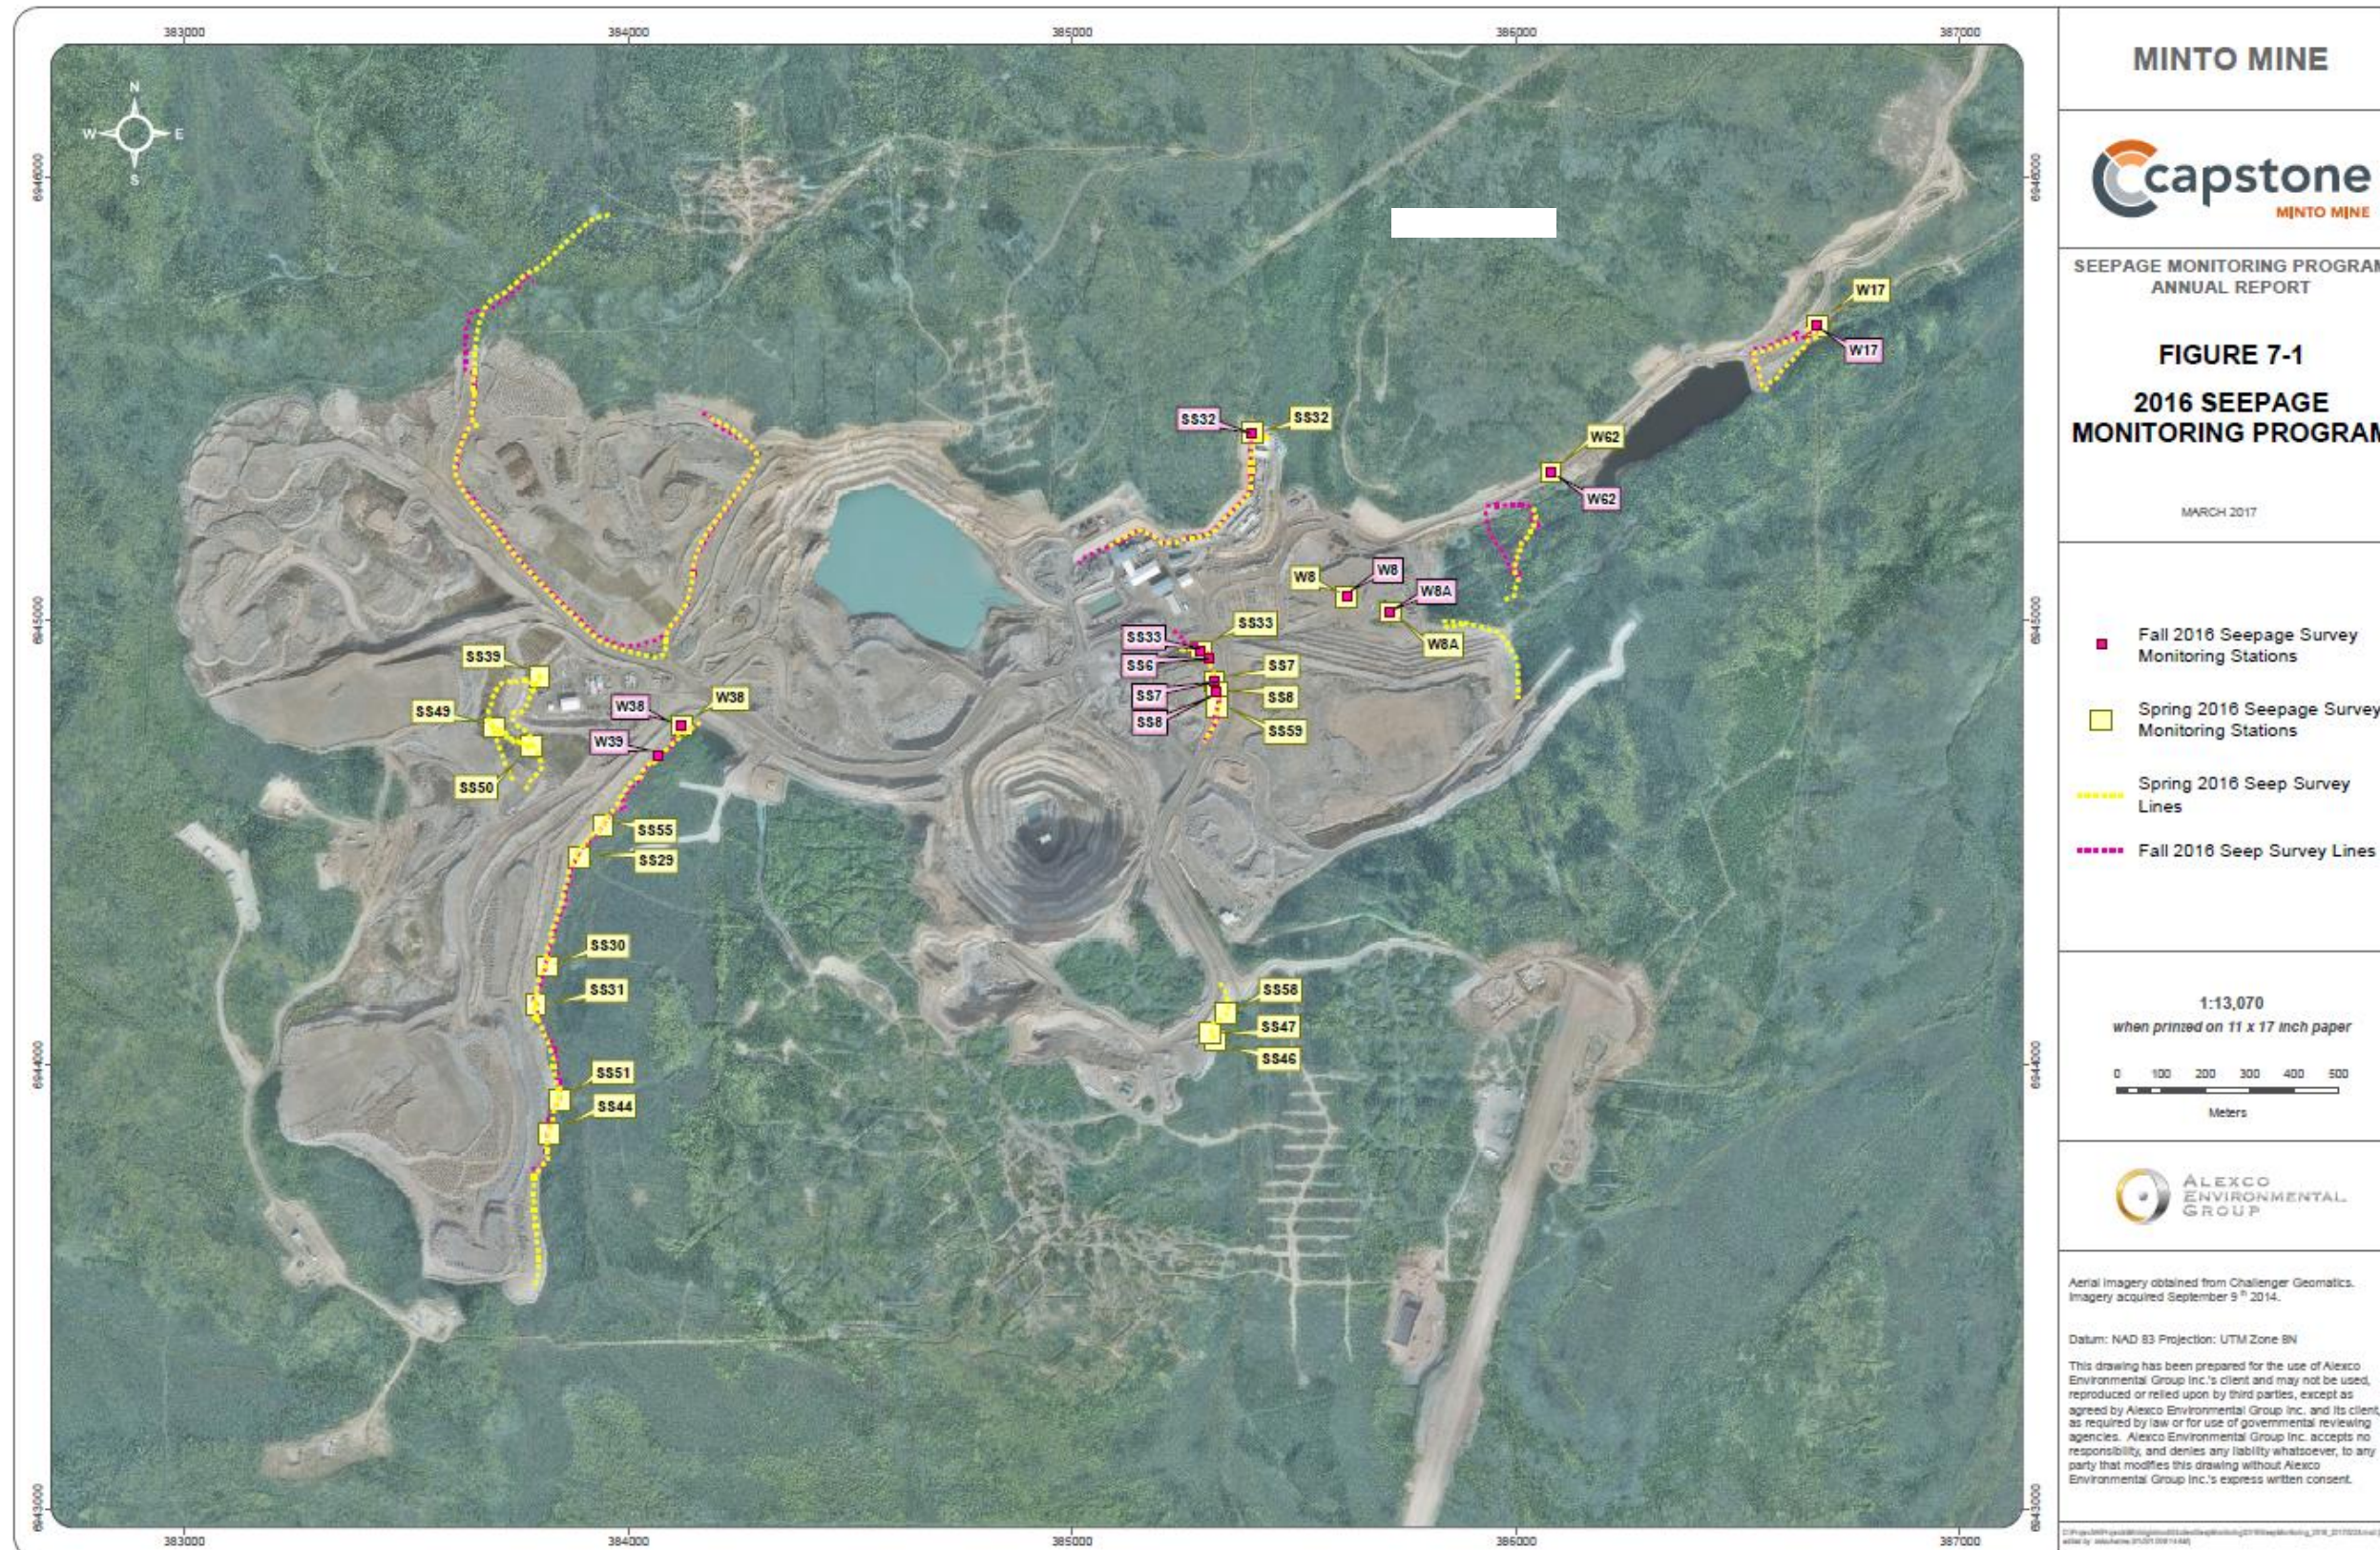
Figure 7-1: Seepage Monitoring Survey Routes and Monitoring Locations (2016)

Constituents of concern, namely dissolved copper, dissolved cadmium, dissolved iron, dissolved selenium, ammonia, nitrate, and nitrite have been graphed below for each site sampled. In cases where a graph's trend is skewed due to visual outliers (i.e. data points that are larger than the mean by an order of magnitude), a second graph with outliers removed is provided and labeled as "Reduced Concentration."

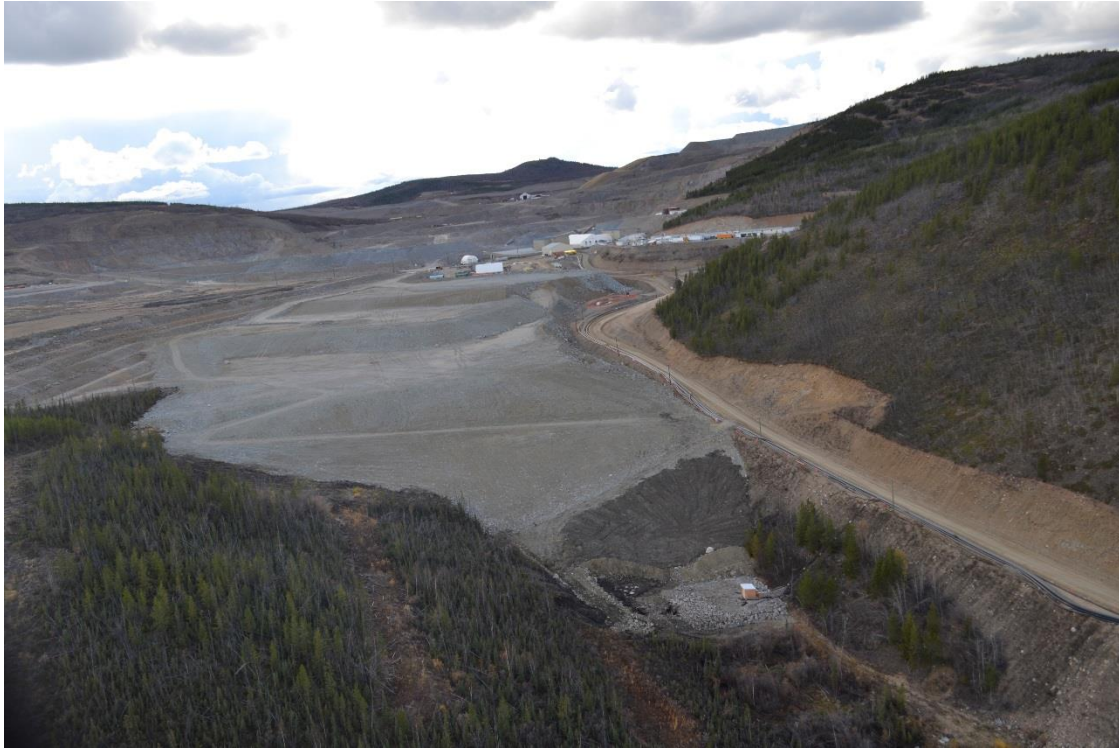
Figure 16-1: MVFES2 front face (looking west) recontoured at a maximum slope grade of 3:1.

After completion of the Minto North Pit in October 2016, Pelly Construction began to focus their resources to recontouring the MVFES2, DSTSF, SWD and Main Waste Dump Expansion (Figures 16-1 to 16-4). During 2016, recontouring continued from October 2016 to the end of the year and resulted in the completion of recontouring for the MVFES2 and DSTSF rock shell. The SWD recontouring was advanced significantly towards completion and recontouring of the upper bench of the Main Waste Dump Expansion was started.

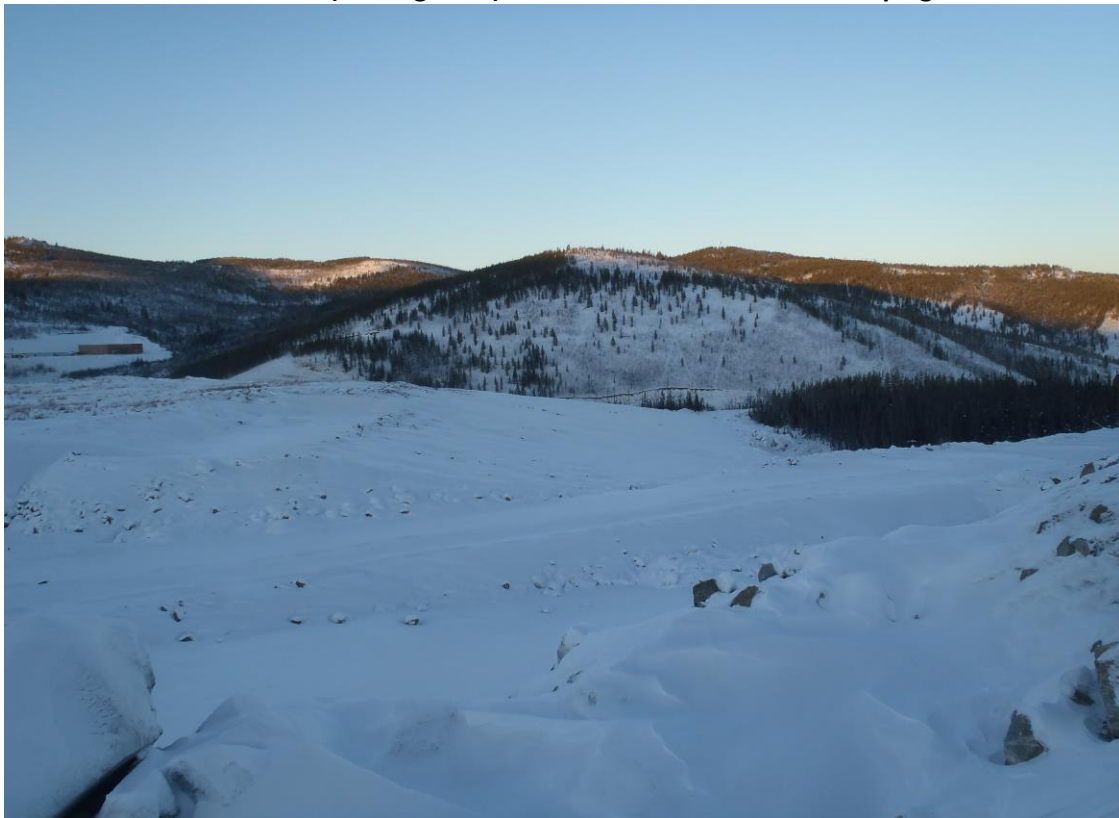
Figure 16-2: DSTSF east slope (looking north) recontoured at a maximum slope grade of 4:1.

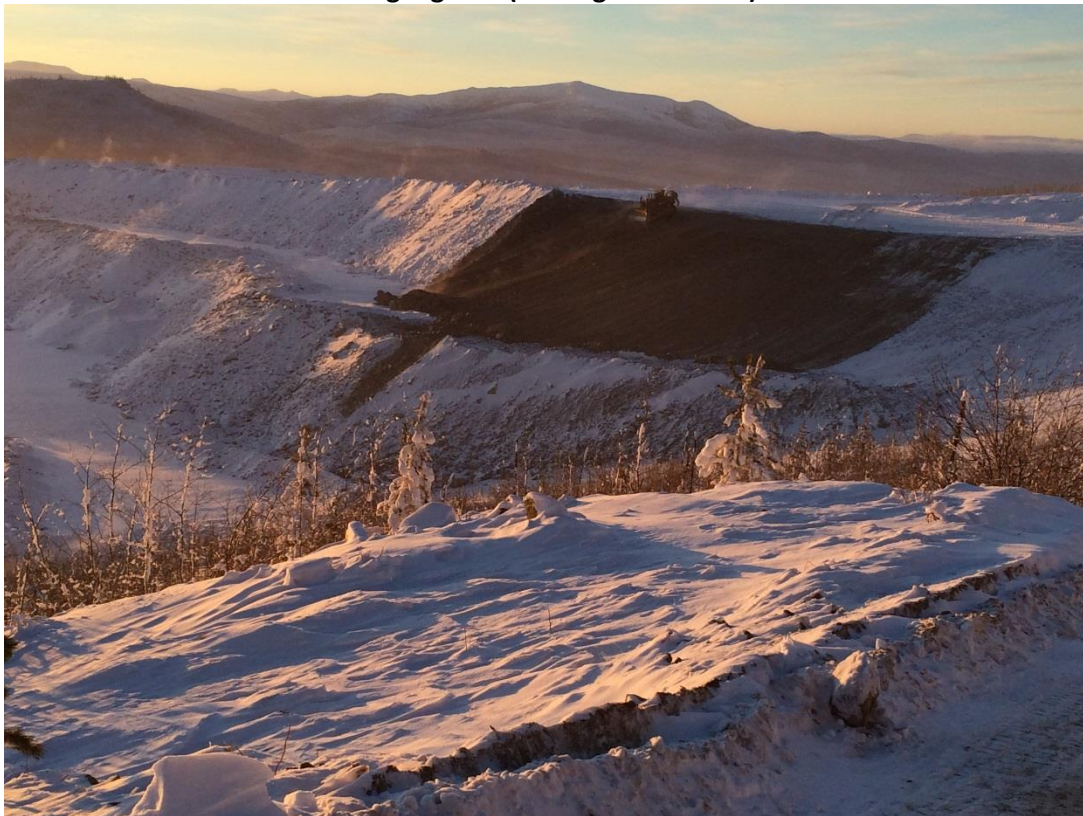
Figure 16-4: Main Waste Dump Expansion (looking west) top bench being recontoured in 2016.

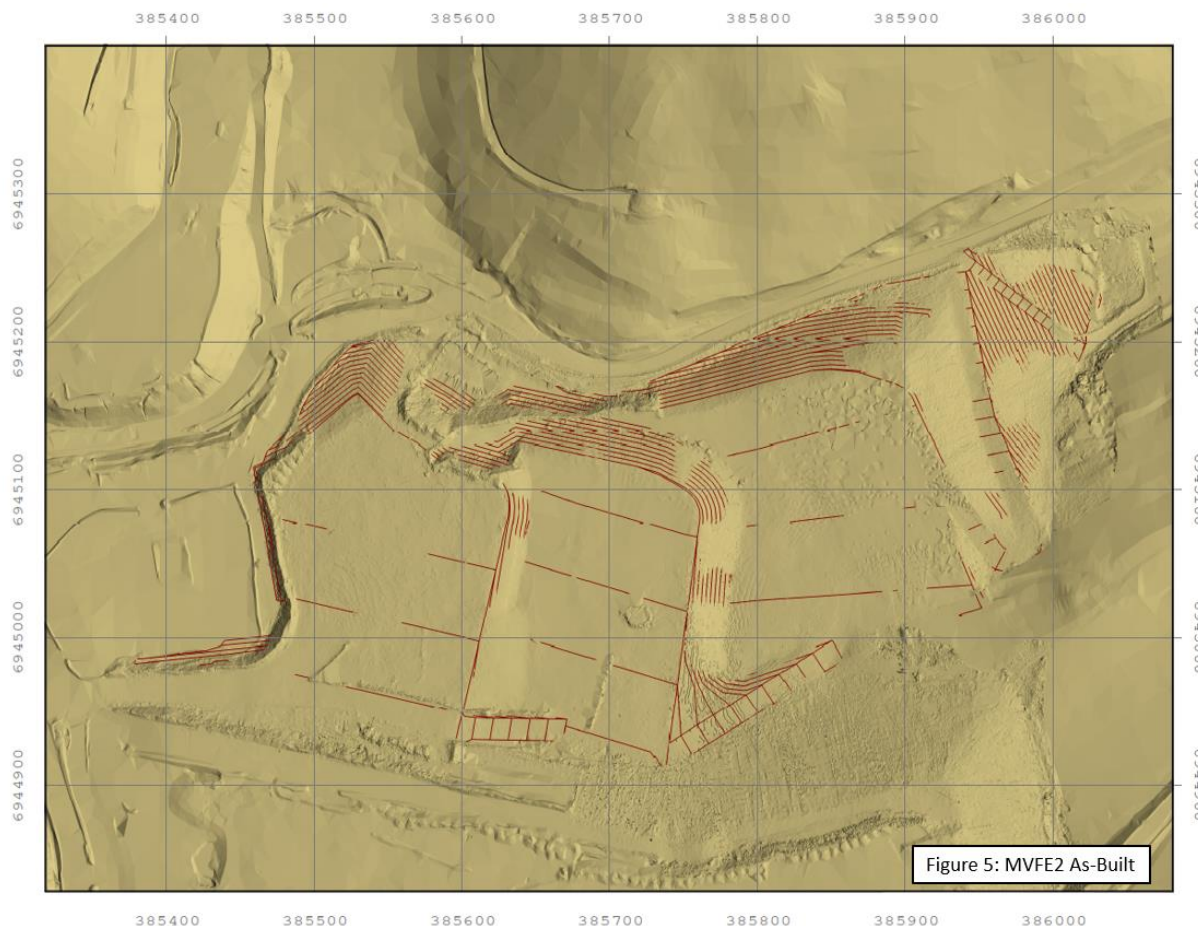
Figure 16-5: As-built surface of the Mill Valley Fill Stage 2 Extension.

Minto began construction on the Mill Valley Fill Extension Stage 2 which is designed to arrest the movement of the Dry Stack Tailing Storage Facility in late 2015. The drainage blanket of the Mill Valley Fill Stage 2 was completed in March 2016. The remaining material (bulk fill) was placed until the completion of the Mill Valley Fill Stage 2 in August 2016. The total as-built volume is 1.391 Mm³. The as-built report was submitted to EMR and the YWB in November 2016. Figure 16-5 below shows the final as-built surface.
