MINTO EXPLORATIONS LTD.

Minto Project Yukon

CARE AND MAINTENANCE & INTERIM CLOSURE PLAN

November 2003

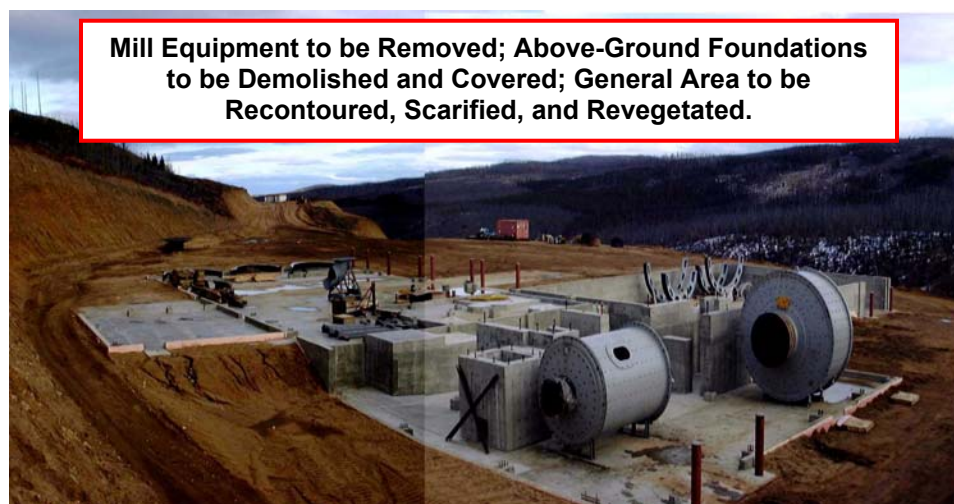
Plate 3 Mill Site (Looking south east towards camp and access road entry to mine site)

The mill footings and foundation were constructed in 1998 by Ketza Construction Corp. and have since seen limited placement of mill equipment. Portions of the concentrator equipment and ball/sag mill have been placed on the foundation/footings but are not yet fully assembled.

Closure measures for this site include removal of the salvageable mill components, such as the ball and SAG mill and milling related equipment stored here. The concrete mill foundations will then be demolished, covered with soil, and revegetated. The downhill slopes at both the mill and the campsite will then be recontoured to assume a more rounded slope, limiting erosion as much as possible.

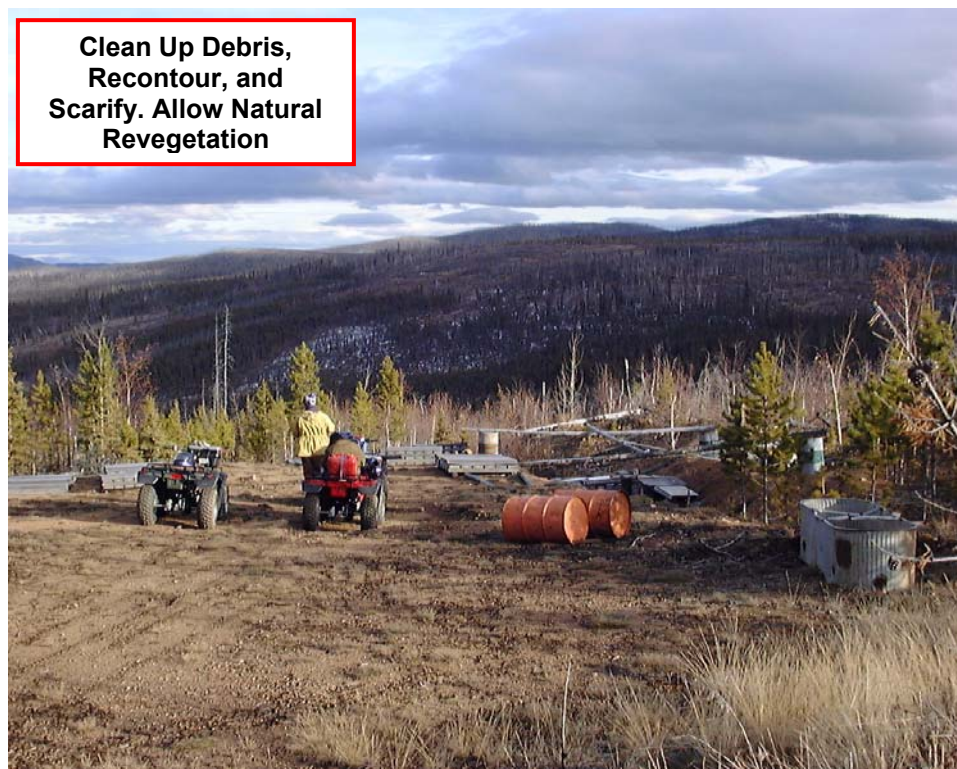
Plate 8 Old Drilling Area/Core Storage (Looking East)

Core racks remain from previous exploration at the property. They are located in an old drilling area 1 km southwest of the Mill/Camp site. The core will be removed from the property for secure storage (possibly at the H.S. Bottock Core Library in Whitehorse), and the racks will be demolished and burned and/or buried. Any scrap metal or other debris will be buried at the site as part of the reclamation of this location, which entails recontouring and scarification.

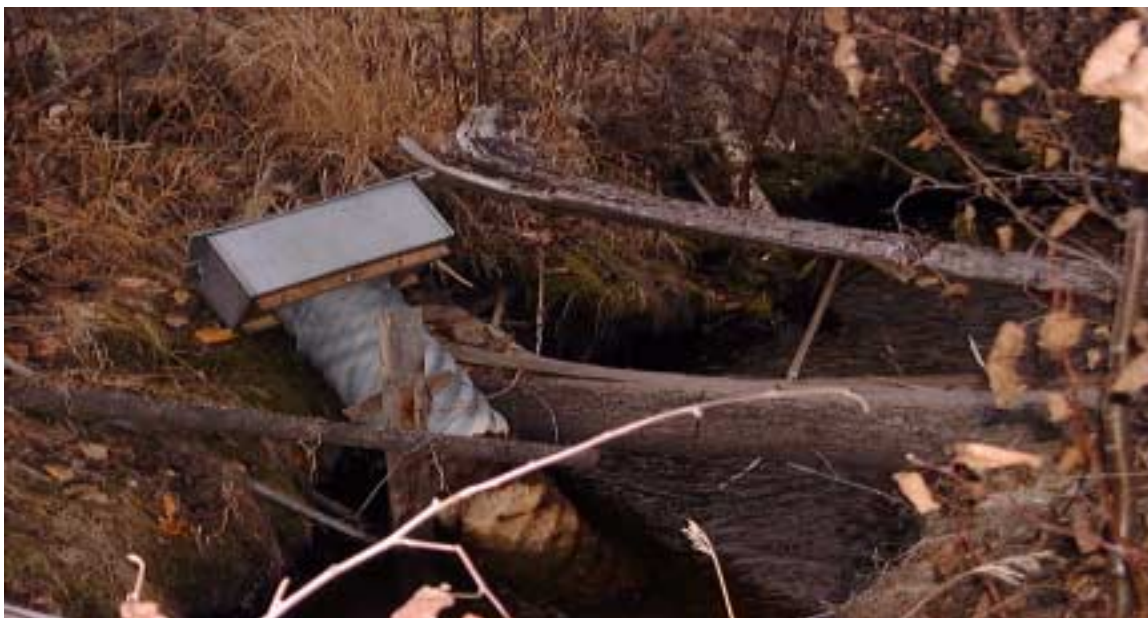
Environmental Monitoring Station W2 – Disturbed Housing for Hydrometric Datalogger
