MINTO PROJECT

DECOMMISSIONING & RECLAMATION PLAN

2001/April/27

MINTO EXPLORATIONS LTD.

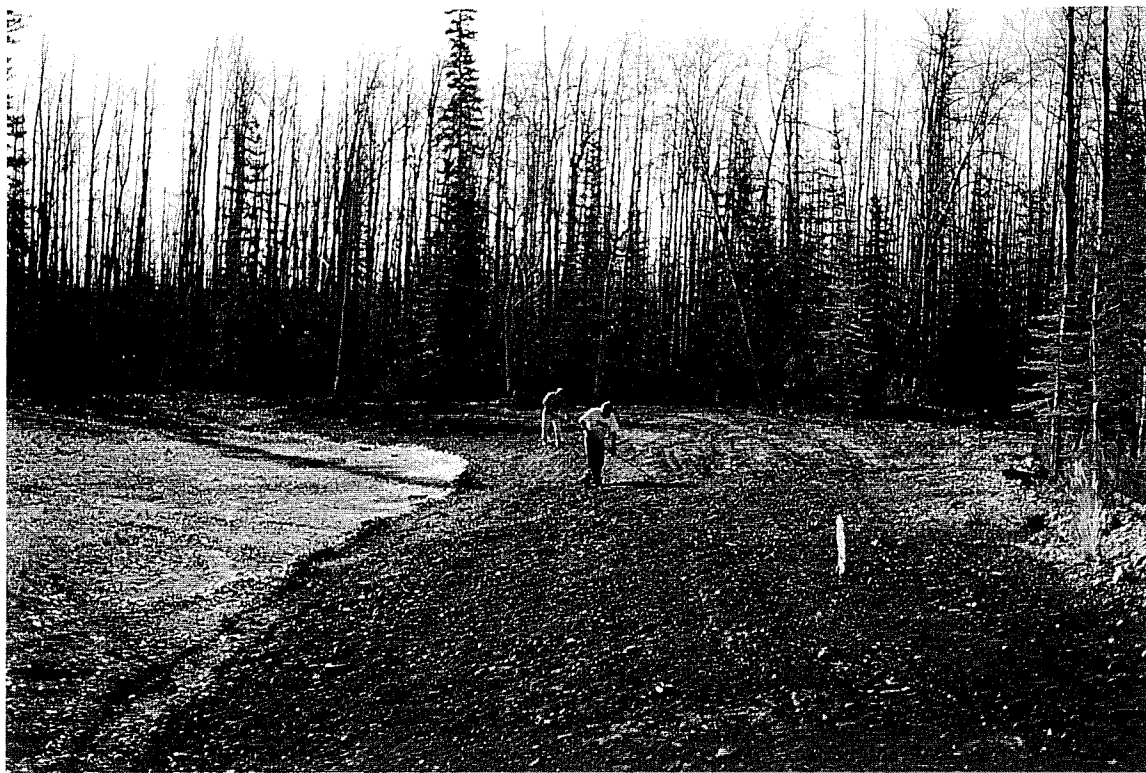
Photograph #4 - Selkirk First Nation workers raking planted ditch slopes - 09/May/2000

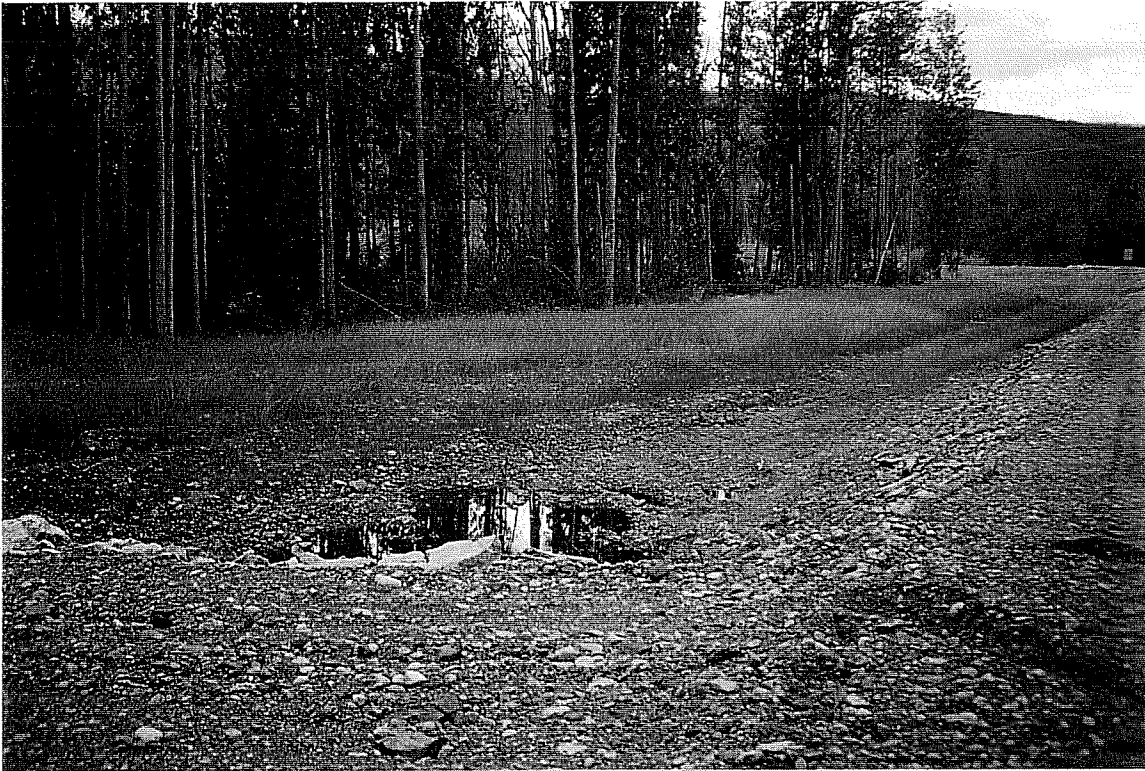
Photograph #6 – View of plant growth resulting from May 1999 seeding effort. South drainage ditch between ditch block #4 and #5. 05/September/1999

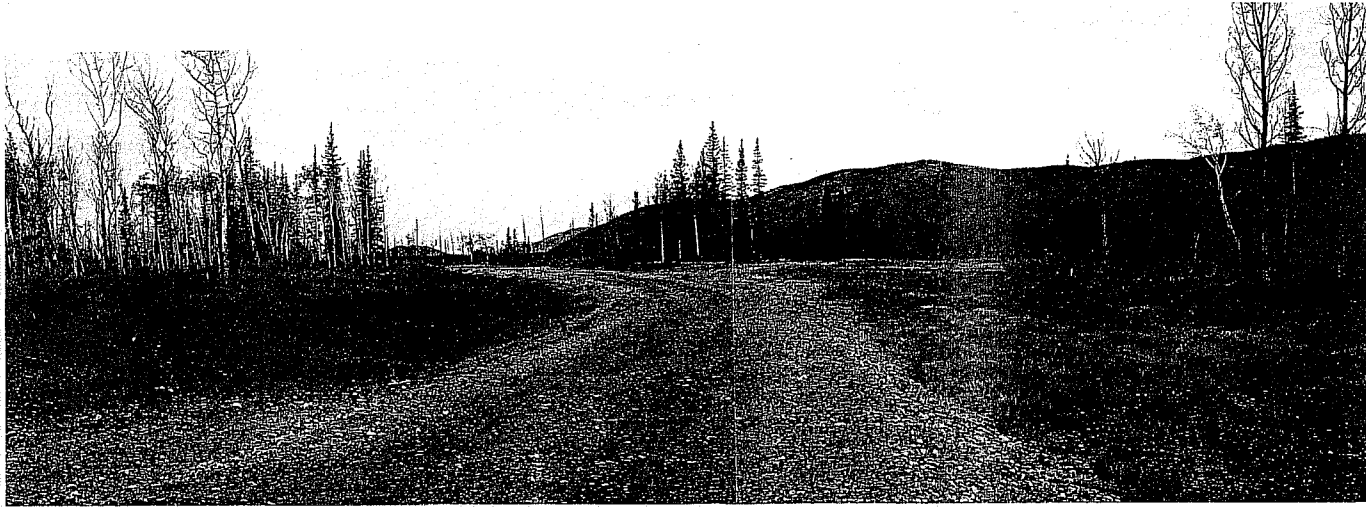
Photograph #8 – View of plant growth resulting from May 2000 reclamation work. Temporary construction camp at Yukon River lower barge landing ramp. 17/August/2000

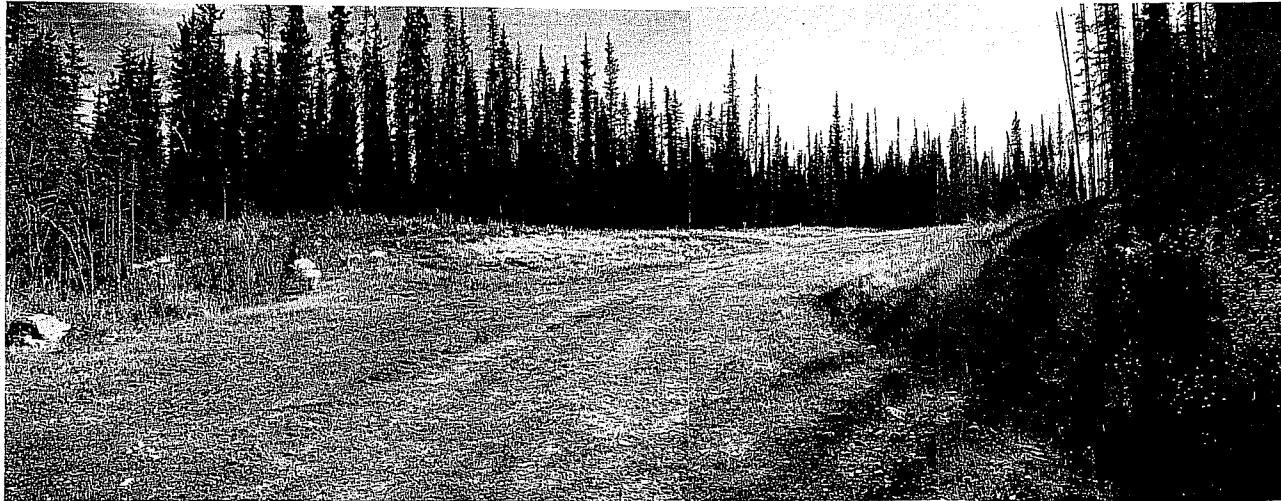
Photograph #9 – View of plant growth resulting from May 2000 reclamation work. Yukon River west side barge landing ramp at Minto. 17/August/2000

Reclamation work was successful and was completed at minimal cost. Photograph #5 shows grass and willow growth on the south side of the access road at Big Creek. Photographs #6 and #7 show ditches at Big Creek containing plant cover resulting from seeding efforts in May 1999. Photographs #8 and #9 show reclamation efforts at the temporary construction camp and at the west side barge landing ramp at Minto in August 2000.
