DETAILED DECOMMISSIONING AND RECLAMATION PLAN

Minto Project, Yukon Territory

Revision 1

June 2007

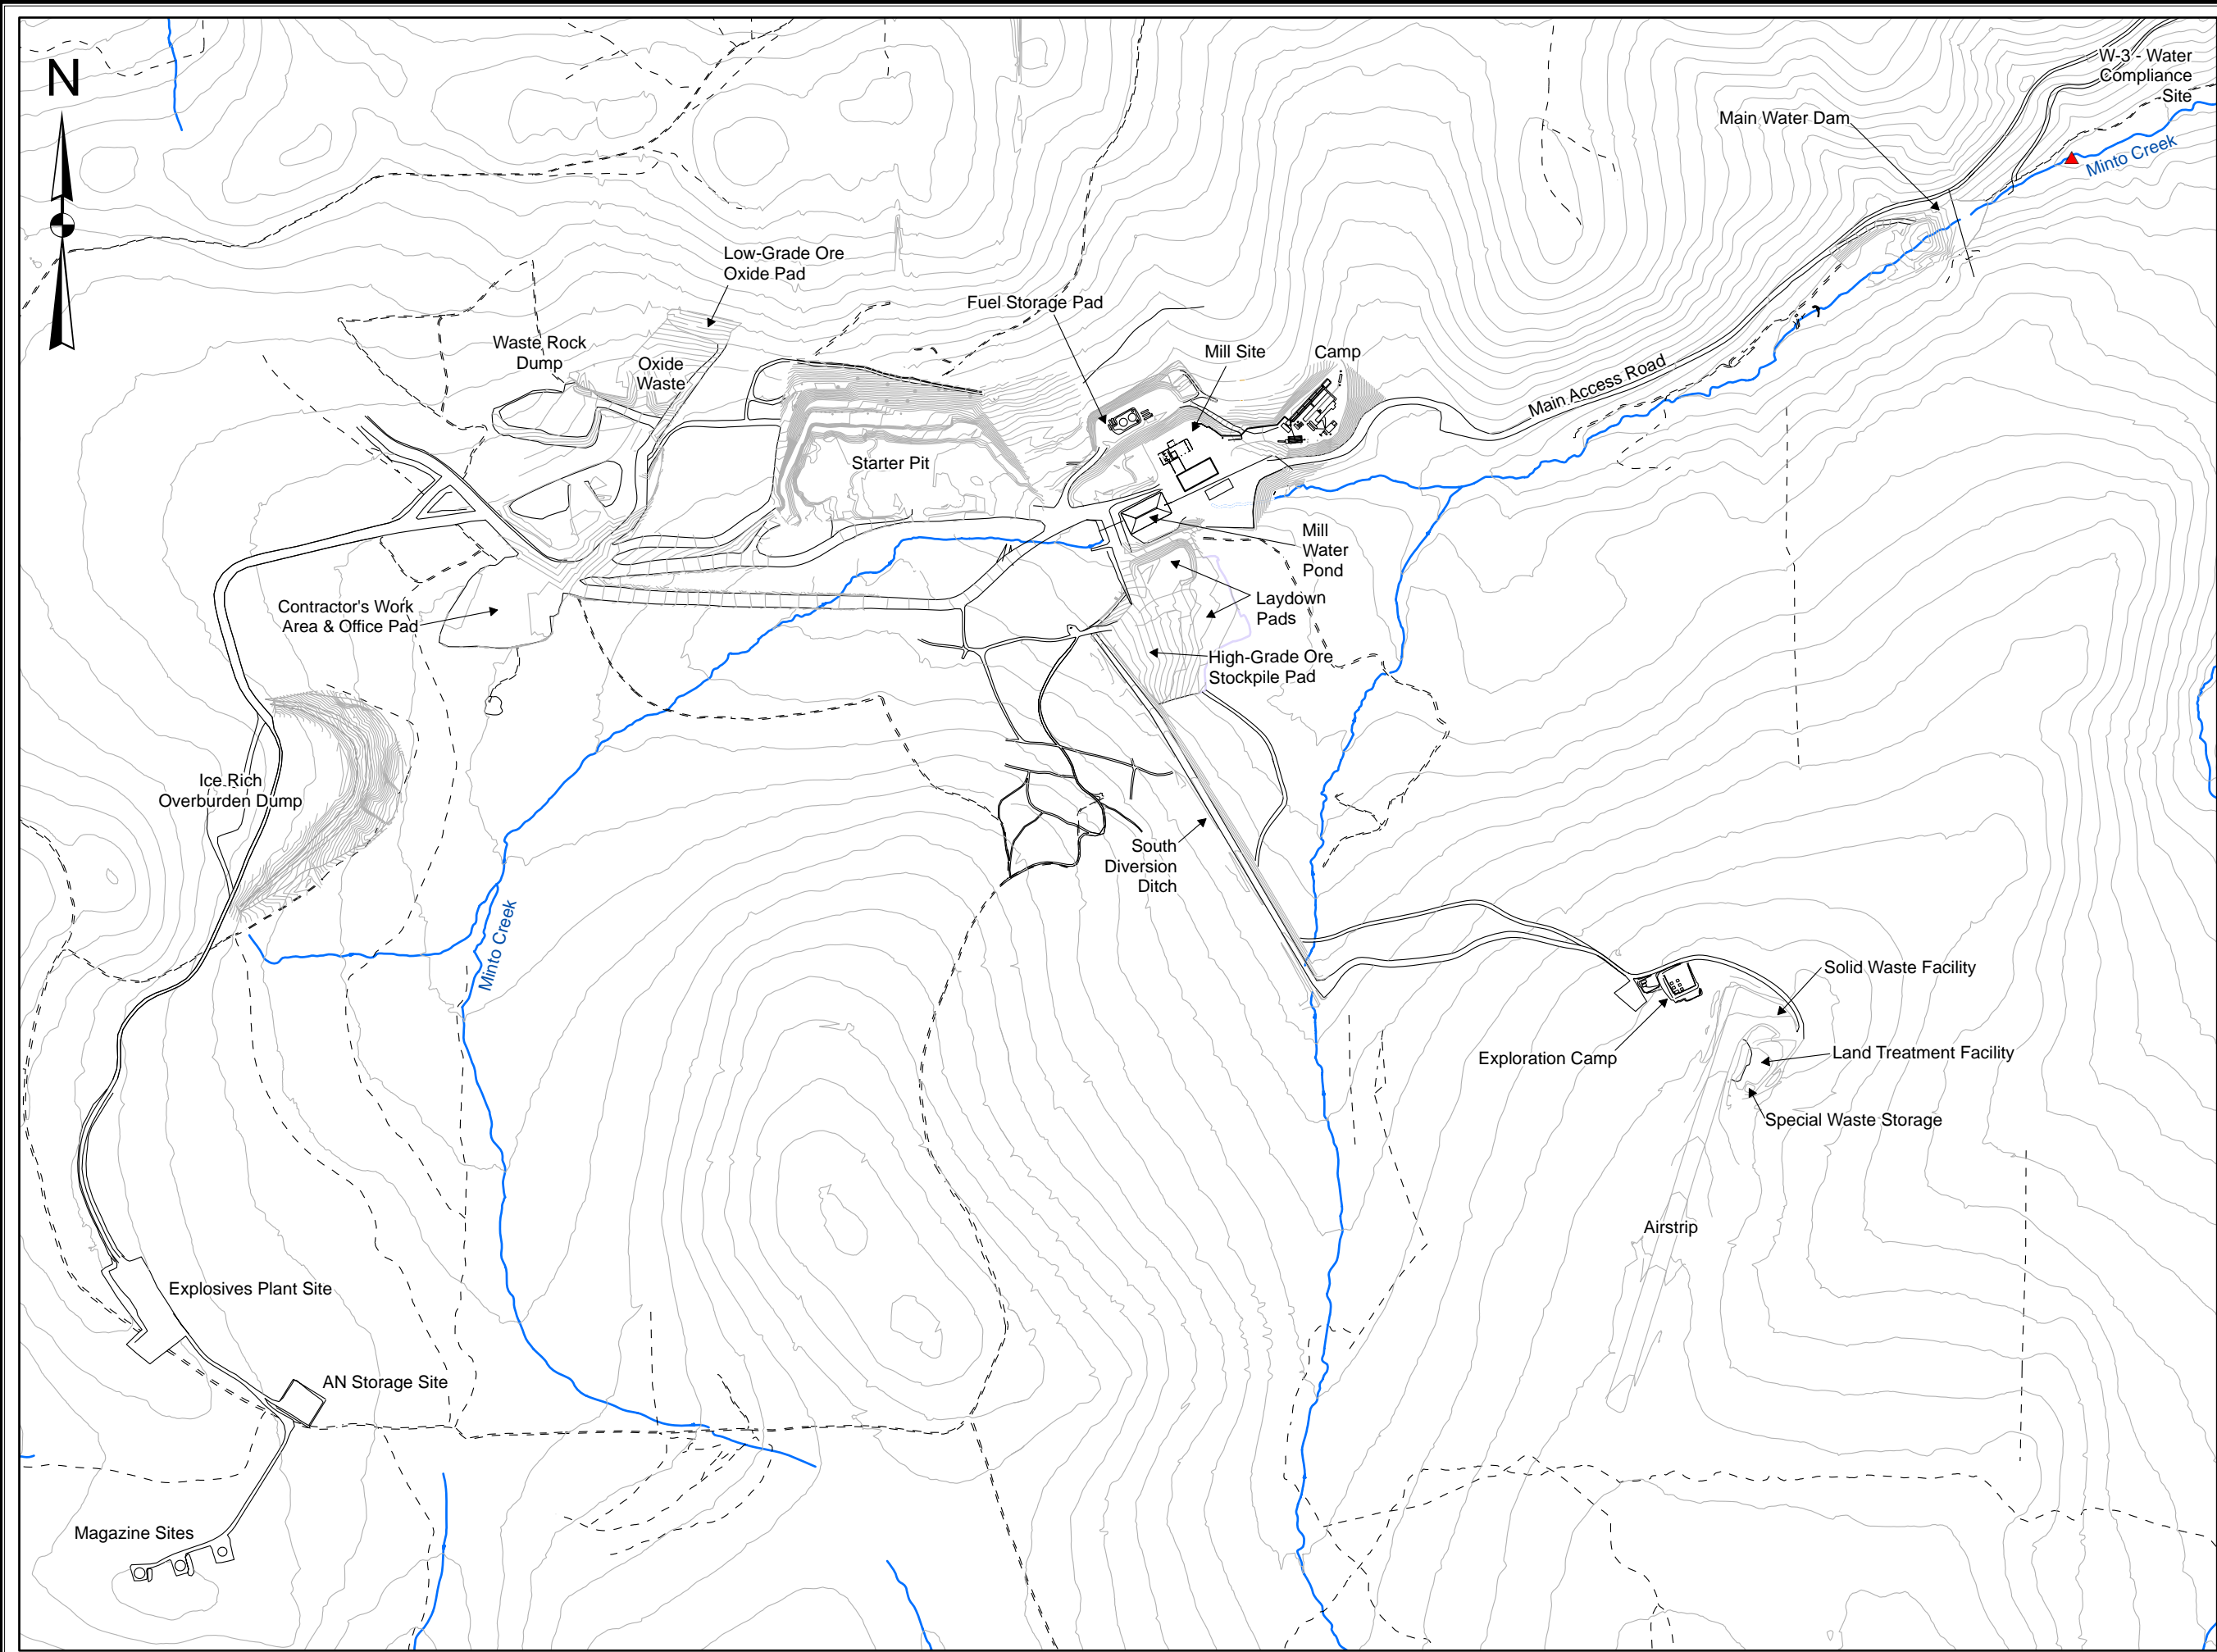
Current Site Conditions

Figure 2-3 presents an overview of current site conditions.

Figure 2-3 provides a general arrangement plan for current conditions at the site as of September 2006, and Figure 5-1 presents the ultimate overall site plan as proposed at the end of mine life. Figure 5-2 to Figure 5-9 provide summaries of the various closure measures for features or groups of features on the general arrangement plan.

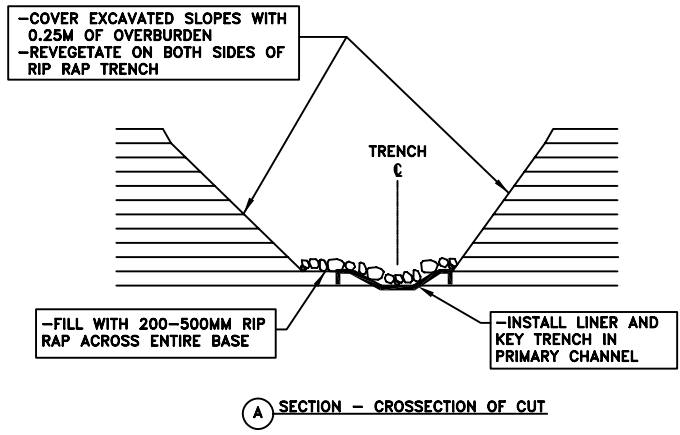
TITLE				FIGURE 5-4: RECLAMATION MEASURES FOR OPEN PIT AND HAUL ROADS			
PROJECT				MINTO MINE			
DATE:		October 2006		ACCESS JOB NO.		MIN-05-01	
DWN.		CSF		CHKD.		REVISION NO.: 1

MINTO CREEK ENTRANCE CHANNEL

Acid-base accounting indicates that the open pit wall rocks are slightly acid consuming or neutral and this will be confirmed by work done during the life of the mine through the Water License ABA Test Program. The open pit will act as a very large settling pond for all runoff from the overburden and waste rock dumps. Water quality will be monitored at the mill water pond channel as required, see section 7.4 for the monitoring locations and schedule.

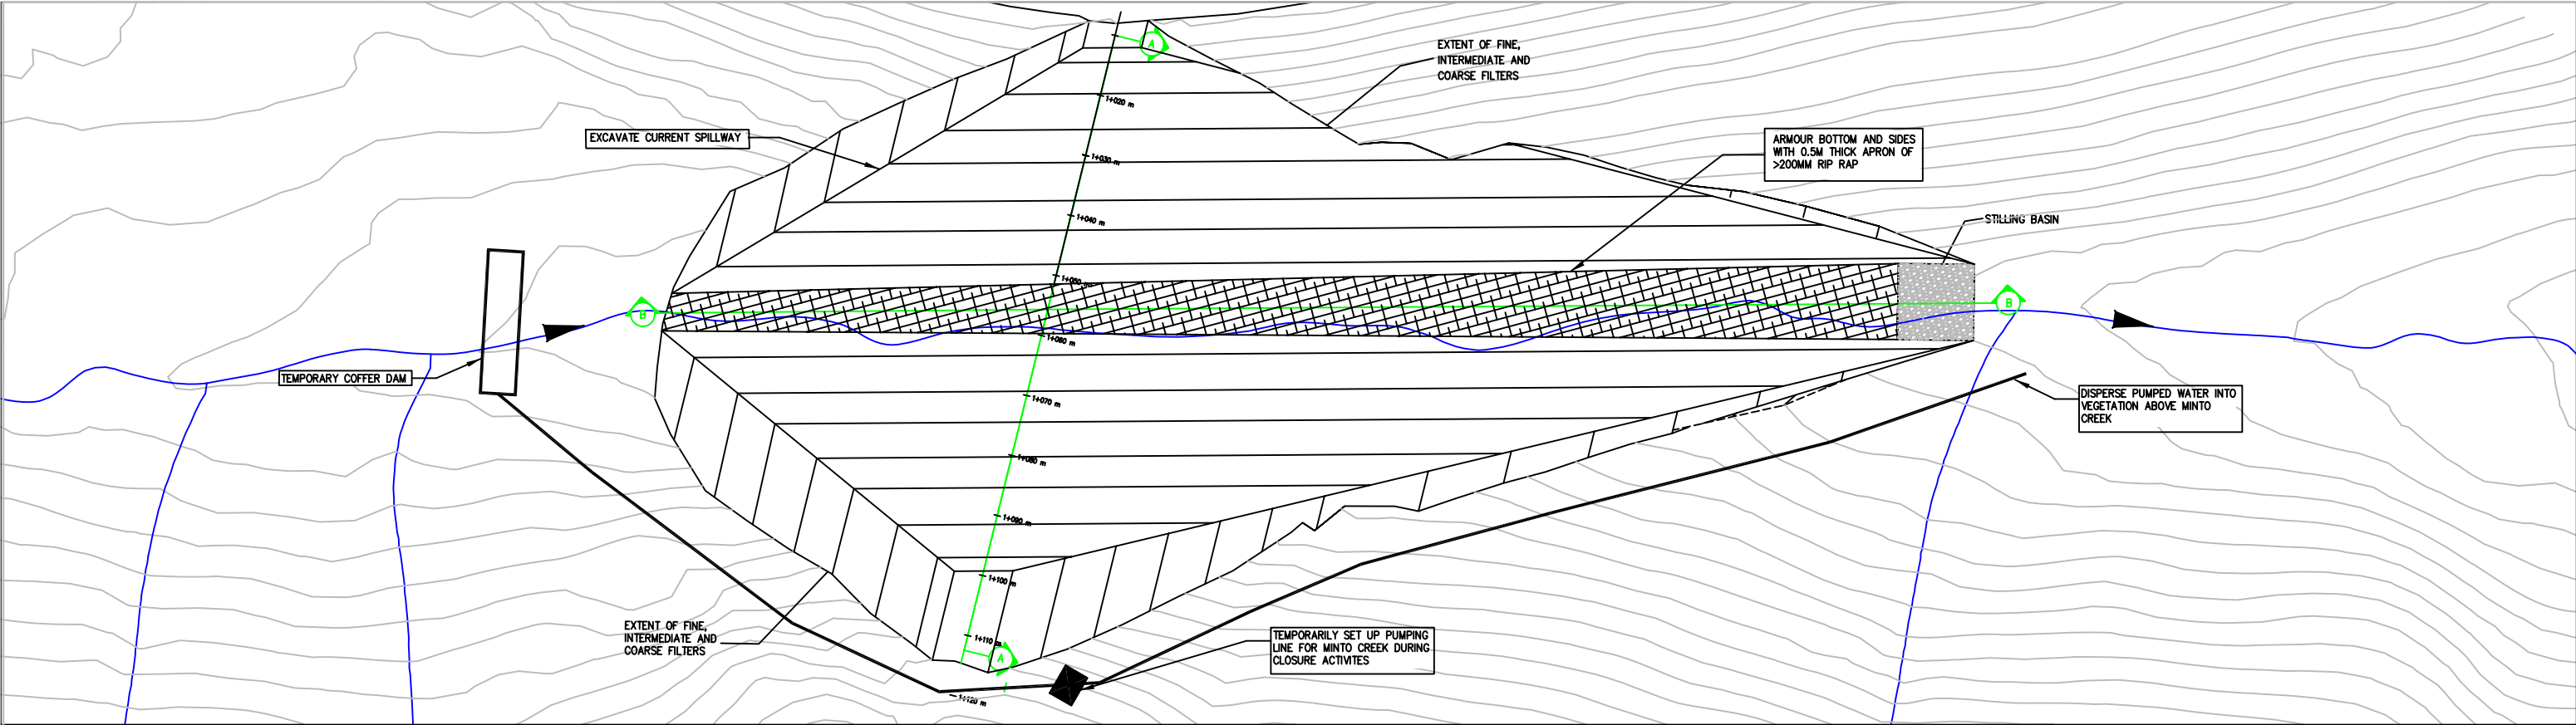
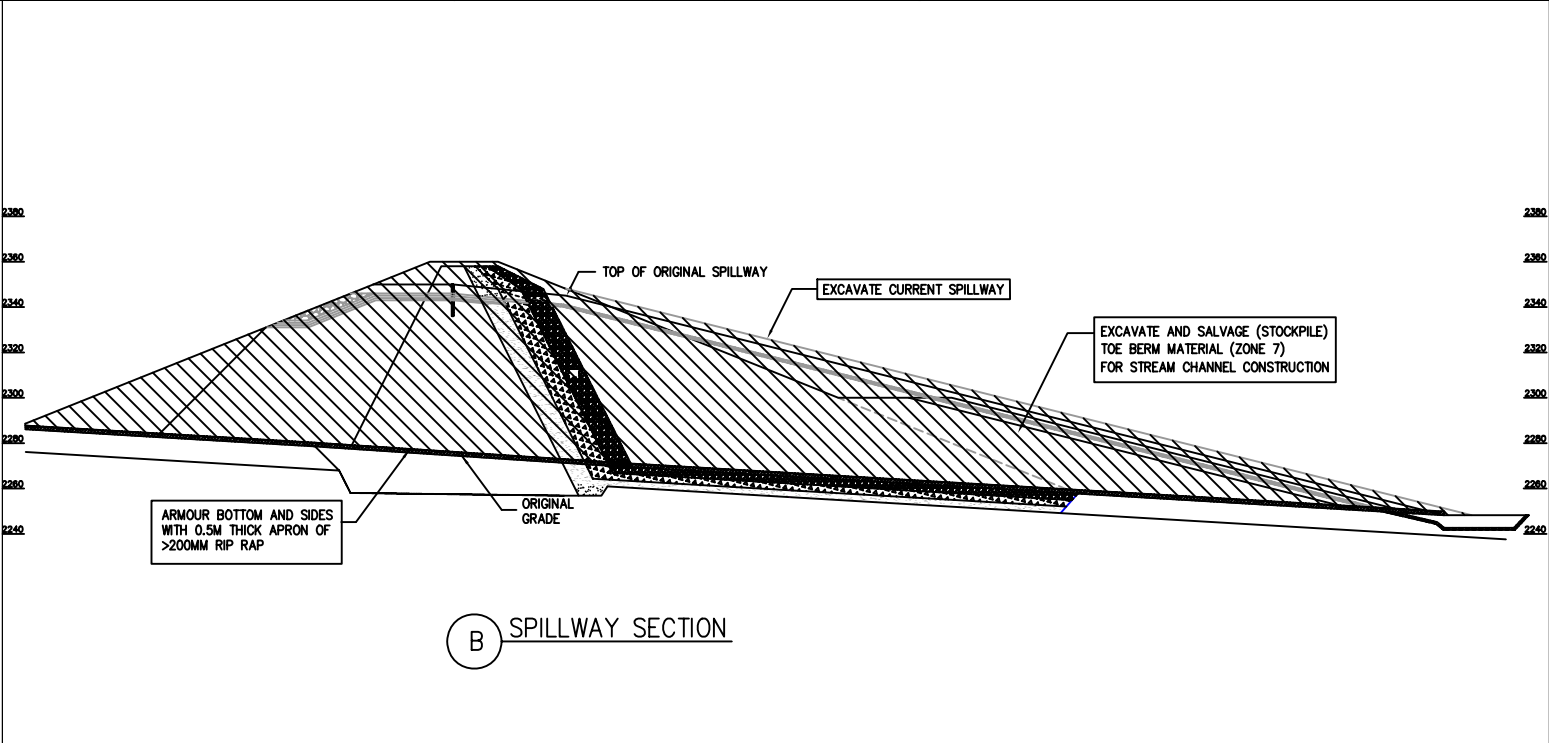
TITLE				FIGURE 5-7: RECLAMATION MEASURES FOR MAIN WATER DAM			
PROJECT				MINTO MINE			
DATE: October 2006		ACCESS JOB NO. MIN-05-01					
DWN. CSF		CHKD.		REVISION NO.: 1

Decommissioning of the main dam will begin with the drawdown of the reservoir by pumping into the Minto Creek channel. Once drained, a temporary coffer dam will be constructed upstream of the dam area to facilitate a 'pump around' system. This system will be in place for the duration of the dam decommissioning activities, and will mirror the dam/pump setup used for the dam construction.

The filling and operation of the dam will lead to the deposition of a layer of fine-grained sediment in the basin above the dam. At closure, this sediment will be tested and covered with fill material from the dam breaching by dozer pushing. Prior revegetation studies of exposed lakebeds created by dams suggest that natural revegetation, albeit slow because of albedo-related high soil temperatures and lower moisture content, would eventually establish on these fine grained soils (Grapel and Hebert, 2006). Bioengineering efforts, such as live willow plantings, may expedite the stabilization of these soils and assist with the establishment of pioneer species that would lower the albedo and retain more moisture. However, it is expected that covering with fill material and using revegetation and bioengineering efforts will return quicker stabilization of these materials.

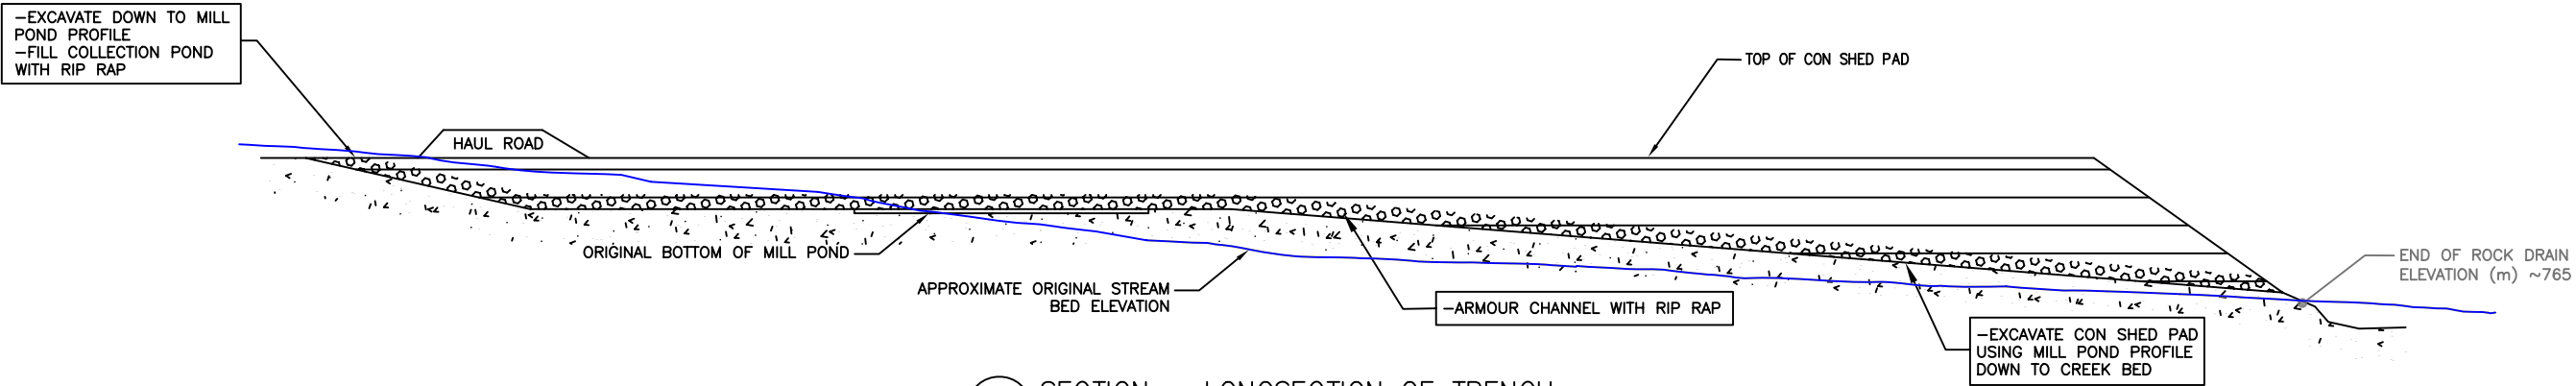
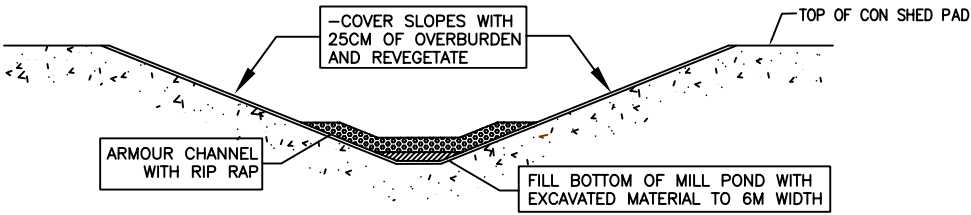
Minto Explorations Ltd.	
TITLE		FIGURE 5-9: RECLAMATION MEASURES FOR MILL WATER POND			
PROJECT		MINTO MINE			
DATE: October 2006		ACCESS JOB NO.		MIN-05-01	
DWN. CSF		CHKD.		REVISION NO.: 1

Figure 5-9 shows the planned reclamation activities for the section of Minto Creek presently entering and exiting the mill water pond. The existing culvert upstream of the mill water pond will be excavated and removed. In order to withstand the probable maximum flood flow, a conveyance channel will be constructed through the present alignment of the mill water pond, with the same dimensions as those utilized for the main dam spillway construction.

A SECTION – LONGSECTION OF TRENCH

MILL POND SECTION B
