# **MINTO EXPLORATIONS LTD.**

## **DETAILED DECOMMISSIONING & RECLAMATION PLAN**

Revision 2  
**September 2009**

## Minto Project, Yukon Territory

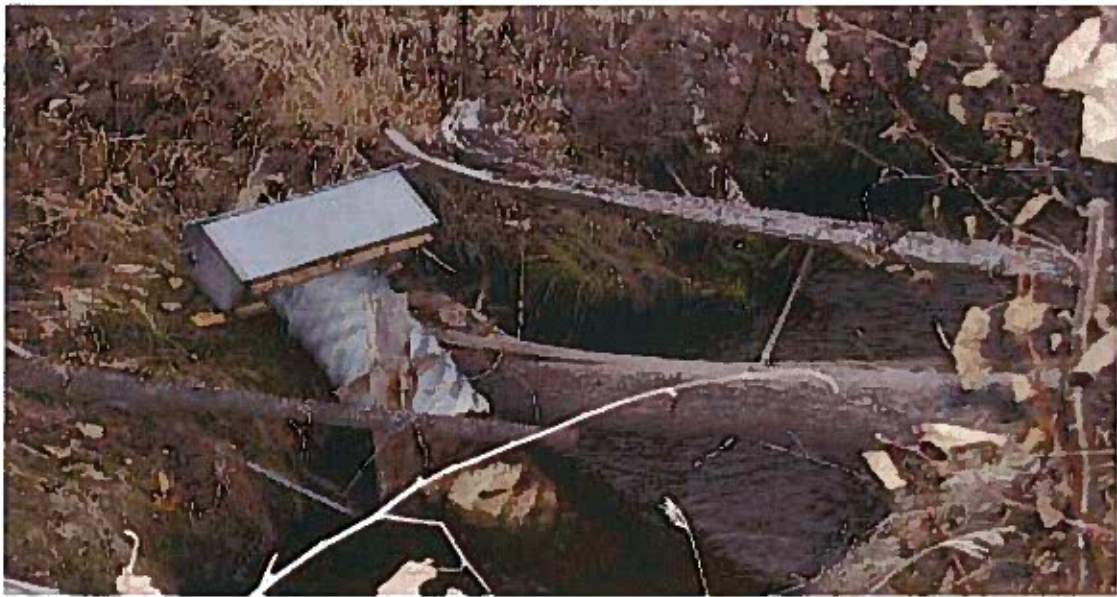
**Environmental Monitoring Station W2 – Disturbed Housing for Hydrometric Datalogger**

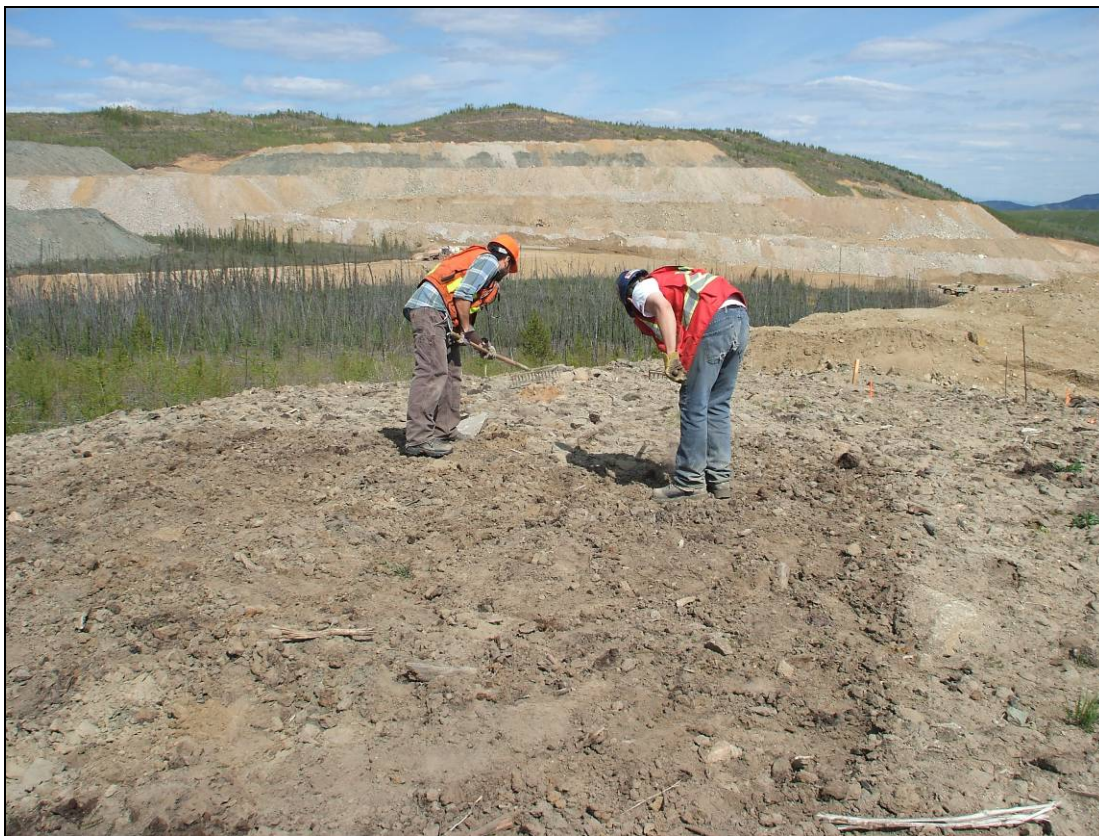
**Plate 1. Establishing new test plots and seeding at trial site R1 (IROD – Upper)**

Trial sites were selected and prepared at four locations including three on-site locations and one off-site control location in 2007 (ACG, 2008). These sites were selected in locations where reclamation will be undertaken progressively early in the mine life, and represent a range of aspects and slopes as proposed in the DDRP.

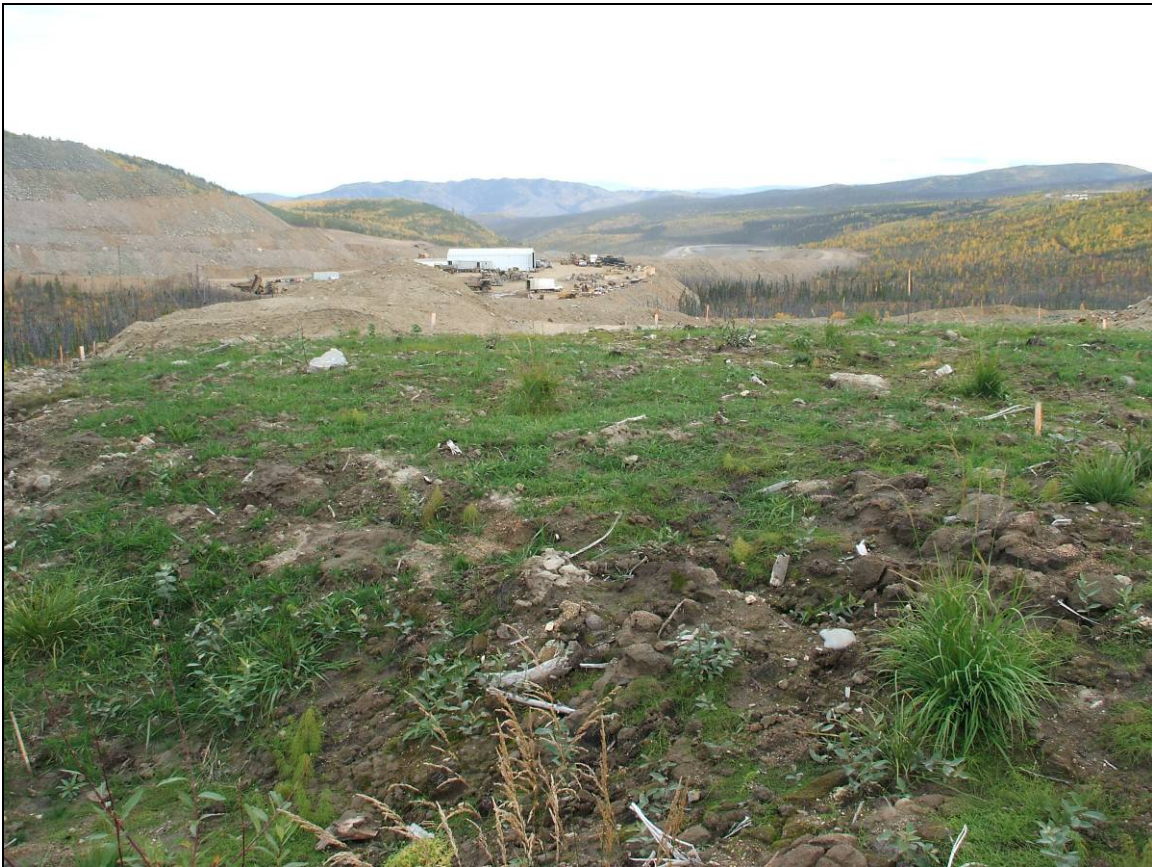
Plate 2. Revegetation at trial site R1 (IROD – Upper)

This site is located near the northern entrance to the ice-rich overburden dump on the top of the berm.

UTM Coordinates: 383501 E, 6944737 N  
Elevation: 886 m  
Slope: 15°  
Aspect: 80° (ENE)

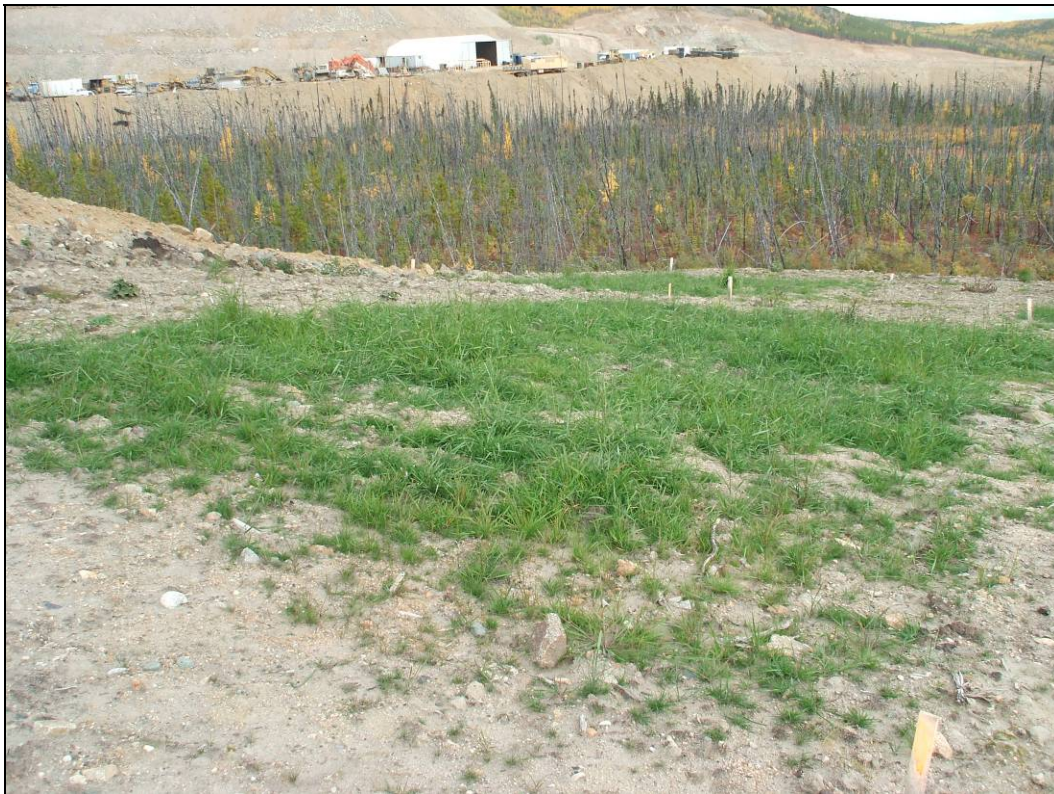
**Plate 3. Revegetation cover at R2 Trial Site (IROD – Lower)**

This site is located at the toe of the berm on the eastern extremity of the ice-rich overburden dump, and can be accessed from below via the contractor's work area.

UTM Coordinates: 383769 E, 6944612 N  
Elevation: 857m  
Slope: 18°  
Aspect: 80° (ENE)

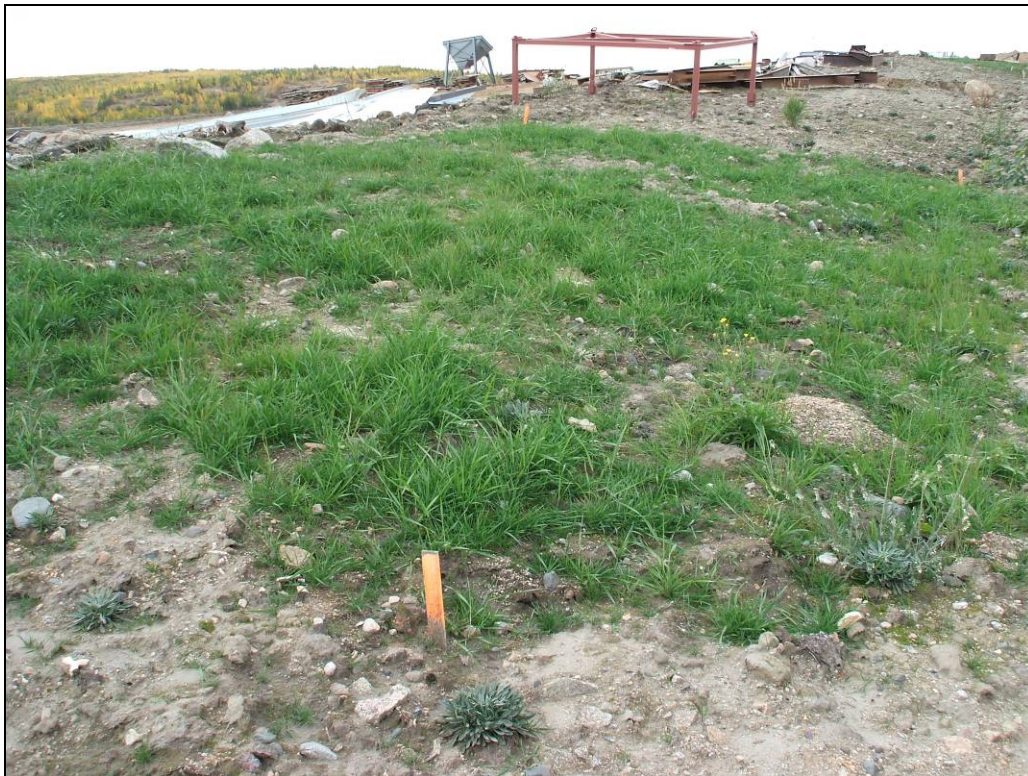
**Plate 4. Revegetation at trial site R3 (Toe of Tailings Starter Bench)**

UTM Coordinates: 385395 E, 6944986 N  
Elevation: 772 m  
Slope: 18°  
Aspect: 10° (NNE)

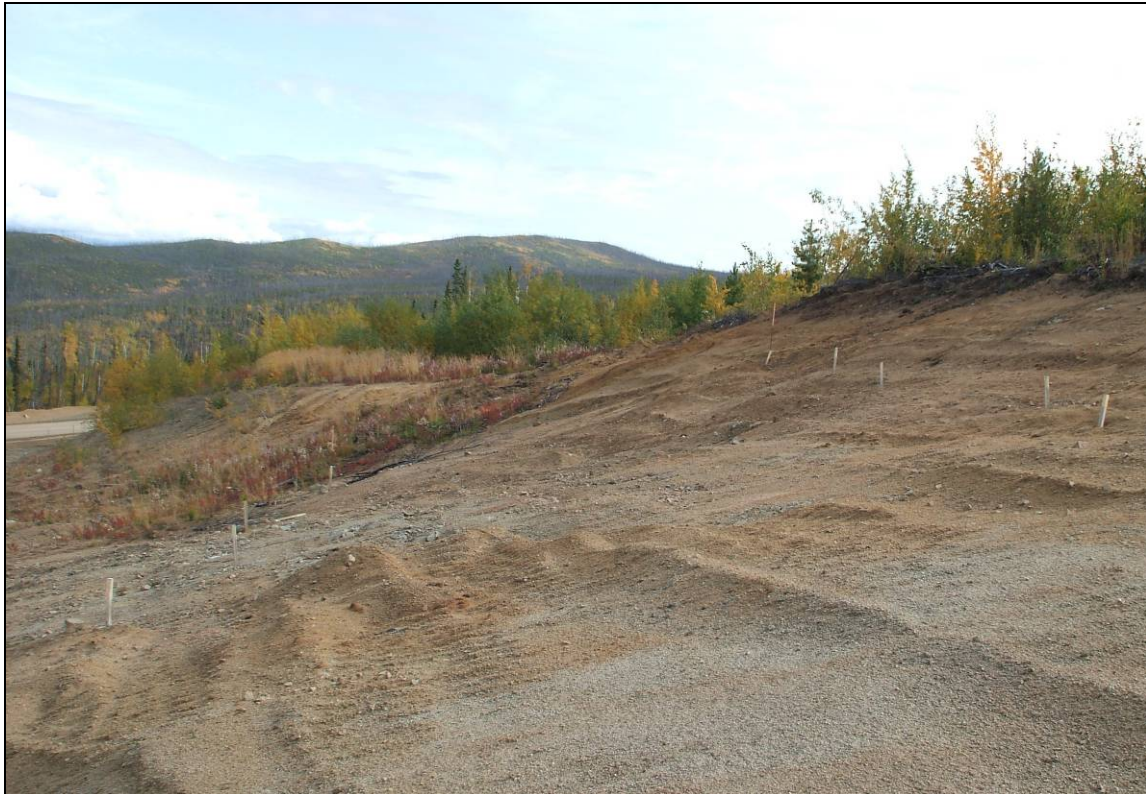
**Plate 5. Plots at control site R4 showing nil revegetation.**

UTM Coordinates: 386843 E, 6946494 N  
Elevation: 770 m  
Slope: 14°  
Aspect: 45° (NE)

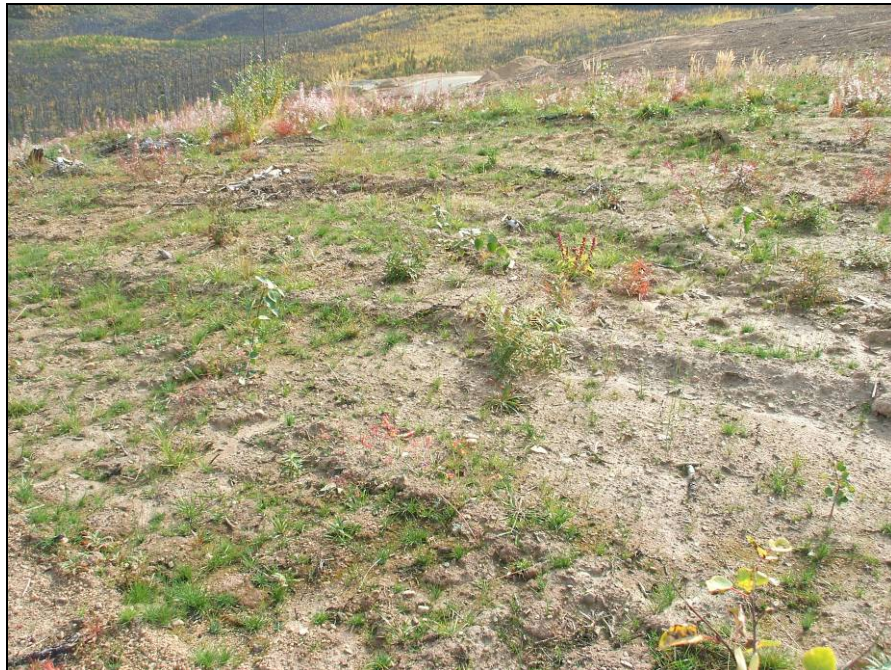
In September 2008, this area had a very sparse vegetative cover by the seeded grass species. The cover ranged from 5 to 15 % and included Violet Wheatgrass, Rocky Mountain Fescue, Glaucous Bluegrass, Barley and Rye (see photo below).

**Plate 6. Sparse revegetation on disturbed area along access road (Km 2).**

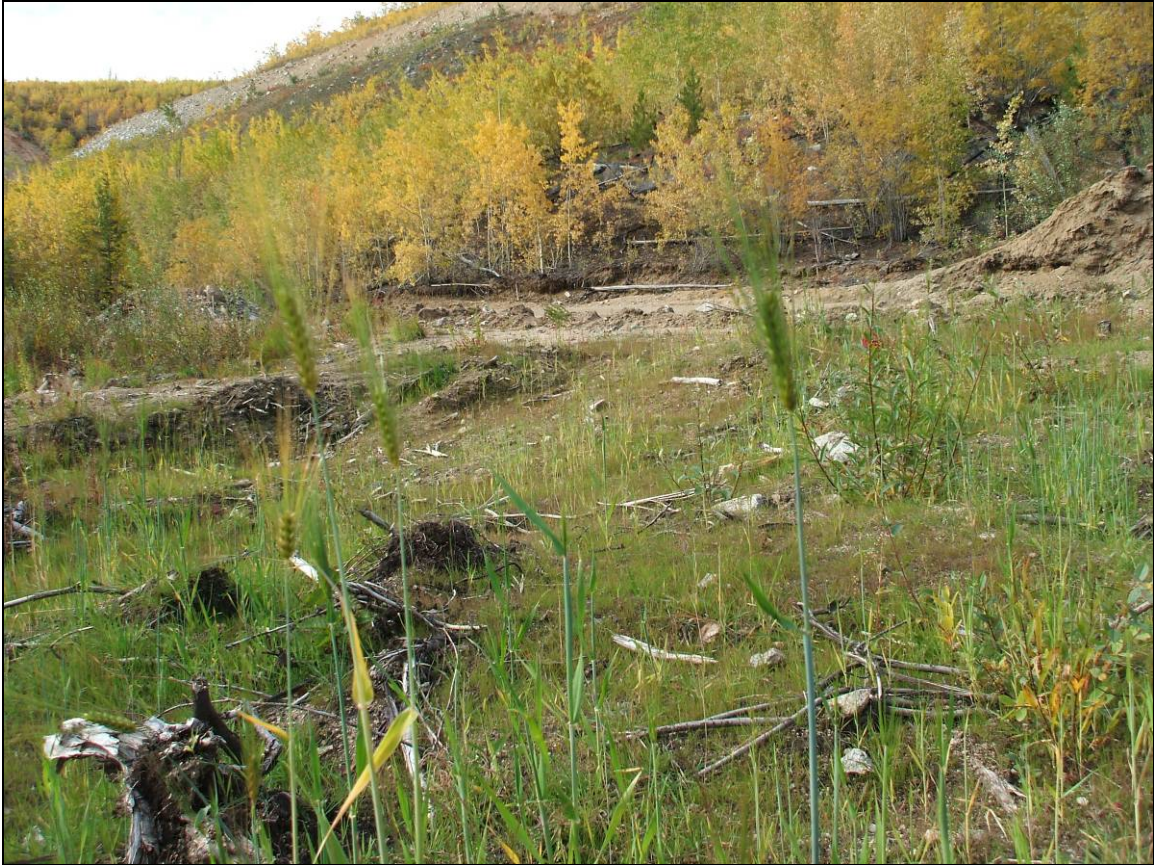
In September 2008, this area had a patchy vegetative cover by the seeded grass species averaging about 60%. Identifiable species included Violet Wheatgrass, Fowl Bluegrass, Rye and Barley. A few oats (probably from the Rye or Barley seed stock) were also found in this area. The vegetative mat has established well in this area.

**Plate 8. Revegetation of the riparian and roadside areas near W3.**

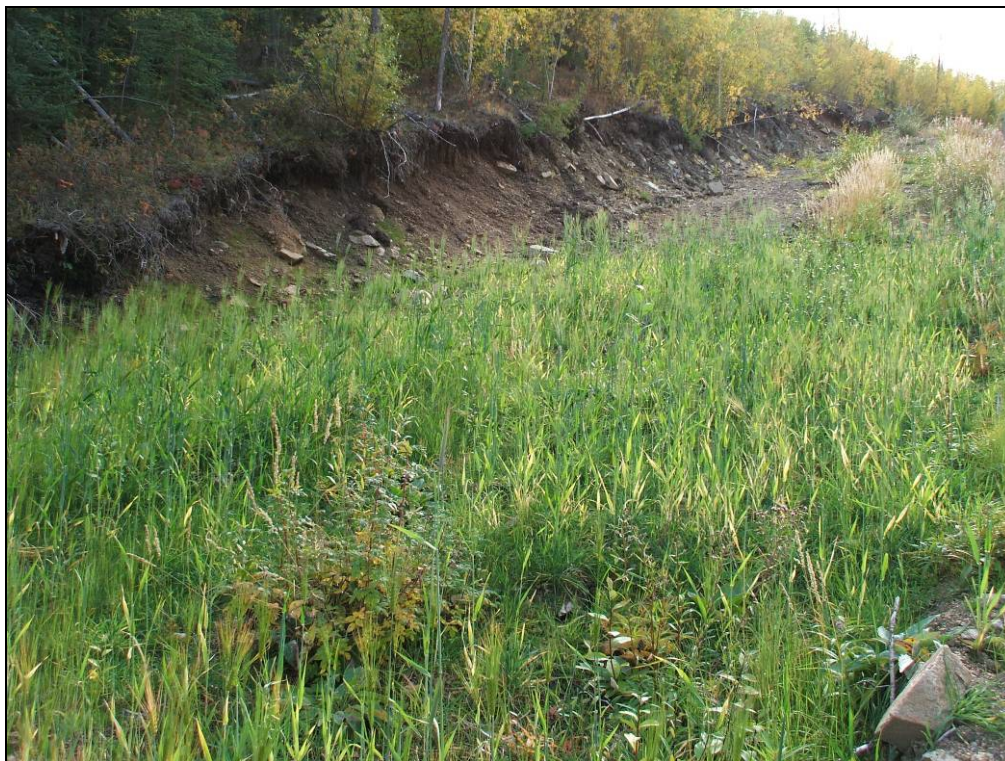
Plate 9. Revegetation of the margin of main dam – downstream side, south alignment.

In September 2008, this area had a very variable vegetative cover by the seeded grass species ranging from 10 to 70%. Identifiable species included Rye and Barley. Other seeded species were still too immature to identify. A few oats (probably from the Rye or Barley seed stock) were also found in this area.

Violet Wheatgrass	( <i>Agropyron violaceum</i> )	40 kg/ha
Sheep Fescue	( <i>Festuca ovina</i> )	20 kg/ha
Fowl Bluegrass	( <i>Poa palustris</i> )	10 kg/ha
Glaucous Bluegrass	( <i>Poa glauca</i> )	20 kg/ha
Tufted Hairgrass	( <i>Deschampsia caespitosa</i> )	10 kg/ha
Barley	( <i>Hordeum vulgare</i> )	40 kg/ha
Rye	( <i>Secale cereale</i> )	40 kg/ha
<b>Total</b>		<b>180 kg/ha</b>

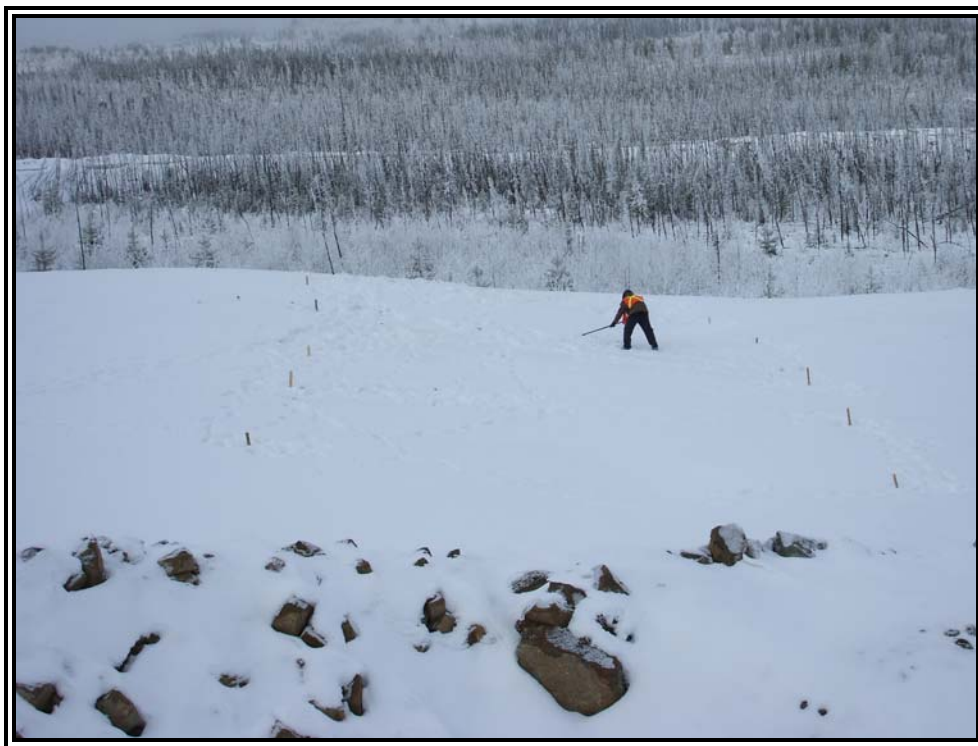
Plate 1. Raking in seed and fertilizer at trial site R1 (IROD – Upper)

UTM Coordinates: 383501 E, 6944737 N  
Elevation: 886 m  
Slope: 15°  
Aspect: 80° (ENE)

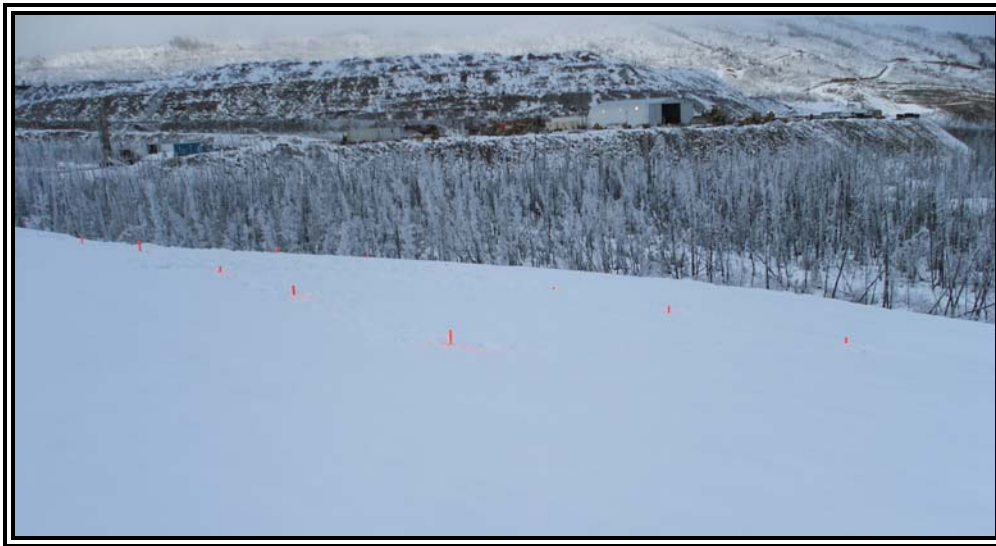
**Plate 2. Plots established on snow at R2 Trial Site (IROD – Lower)**

UTM Coordinates: 383769 E, 6944612 N  
Elevation: 857m  
Slope: 18°  
Aspect: 80° (ENE)

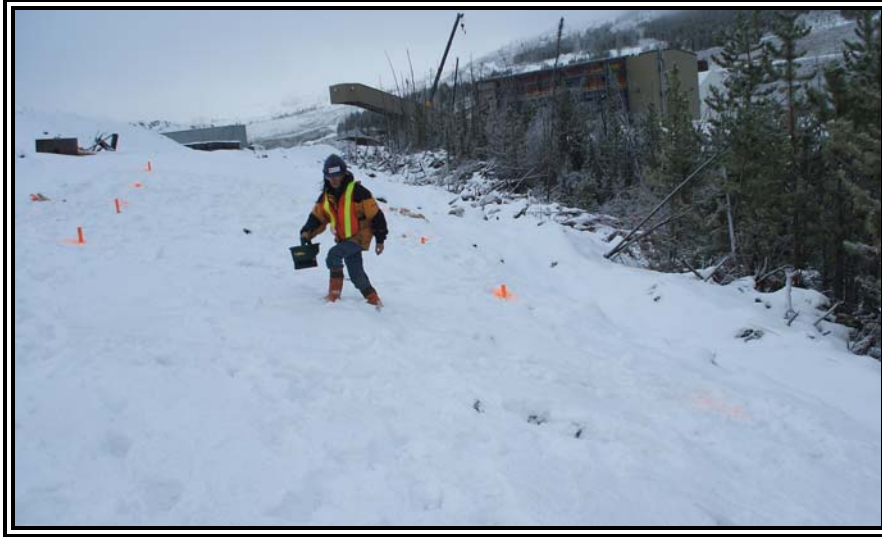
**Plate 3. Hand-broadcast seeding plots at trial site R3 (Toe of Tailings Starter Bench)**

UTM Coordinates: 385395 E, 6944986 N  
Elevation: 772 m  
Slope: 18°  
Aspect: 10° (NNE)

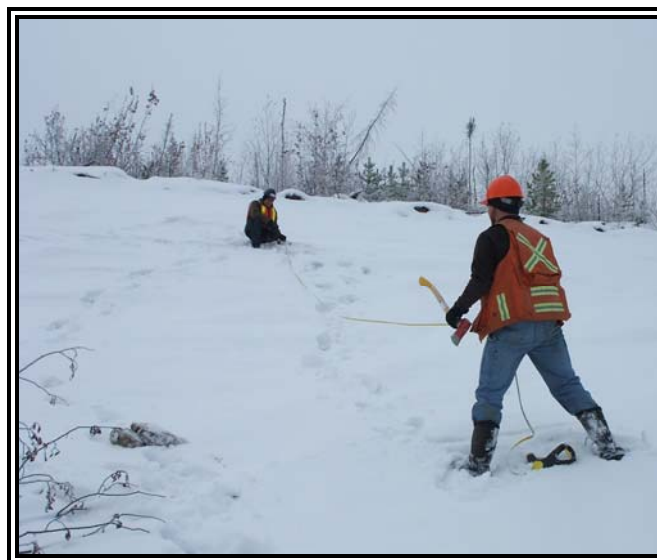
**Plate 4. Laying out plots at control site R4**

UTM Coordinates: 386843 E, 6946494 N  
Elevation: 770 m  
Slope: 14°  
Aspect: 45° (NE)

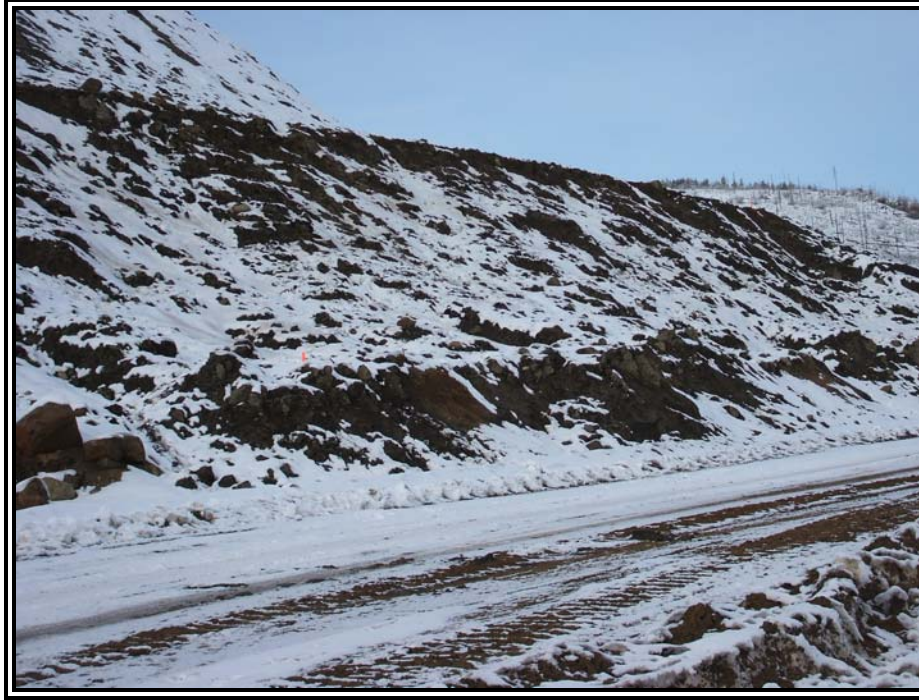
**Plate 5. Toe of waste rock dump progressive reclamation site**
