MINTO EXPLORATIONS LTD.
A Subsidiary of Capstone Mining Corp.

ENVIRONMENTAL MONITORING PLAN

June 2011

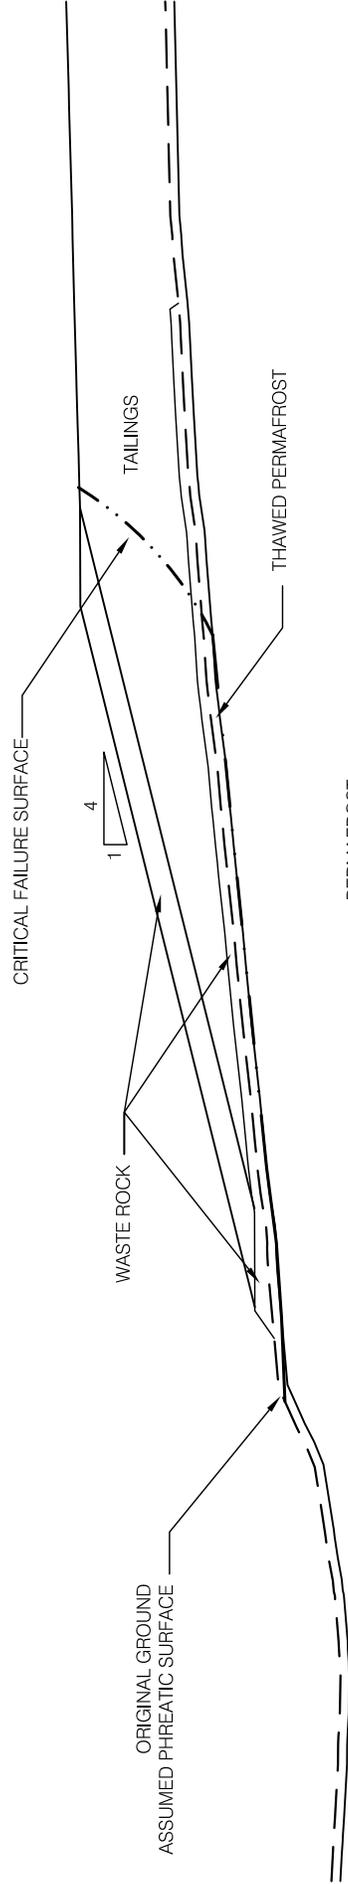
SECTION A-A'

MINIMUM FACTOR OF SAFETY DOWNSTREAM
STATIC, FINAL SECTION, $R_u = 0$	2.27
STATIC, FINAL SECTION, $R_u = 0.4$	1.45
EARTHQUAKE, FINAL SECTION, $R_u = 0$	1.84
EARTHQUAKE, FINAL SECTION, $R_u = 0.4$	1.16

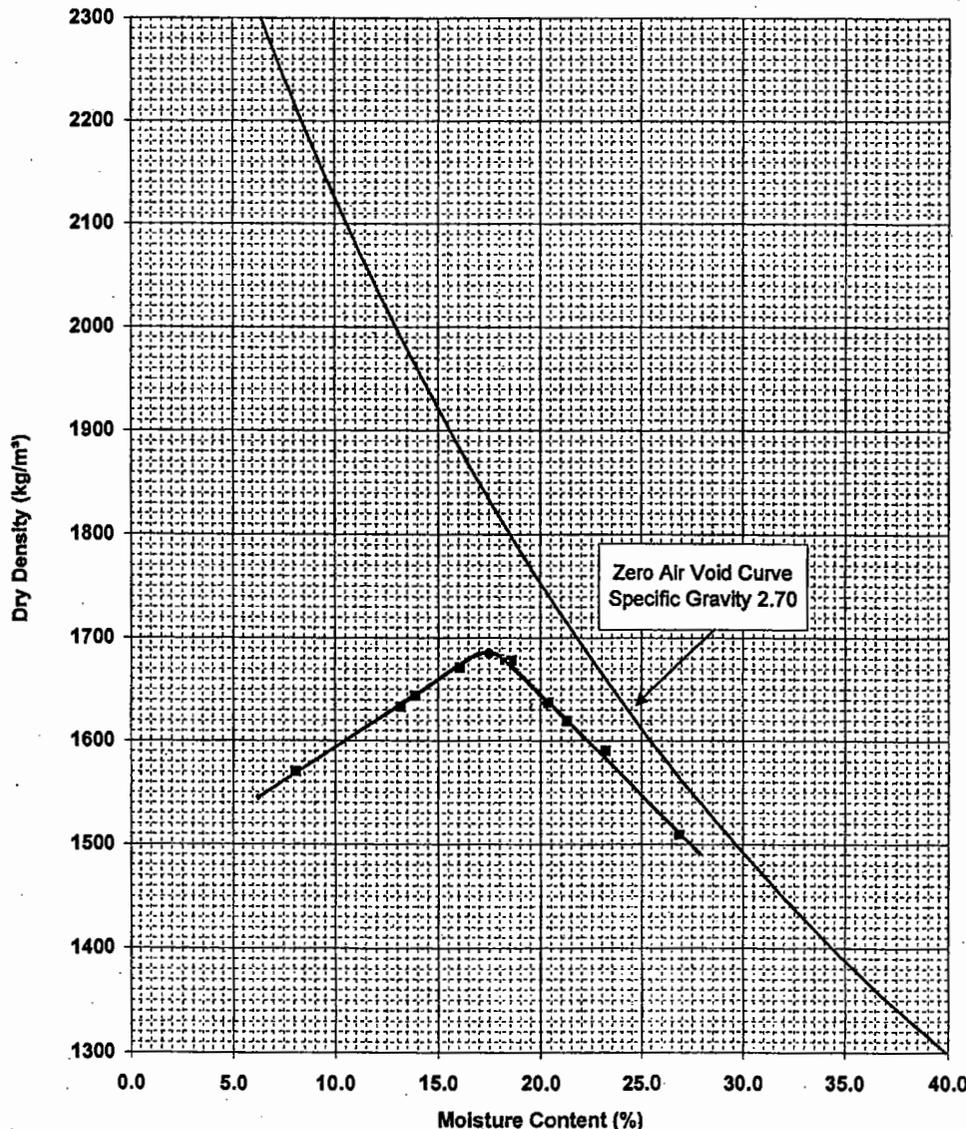
STANDARD PROCTOR ASTM D698

Optimum Moisture Content: 17.5%

Hammer Mass: 2.494 kg

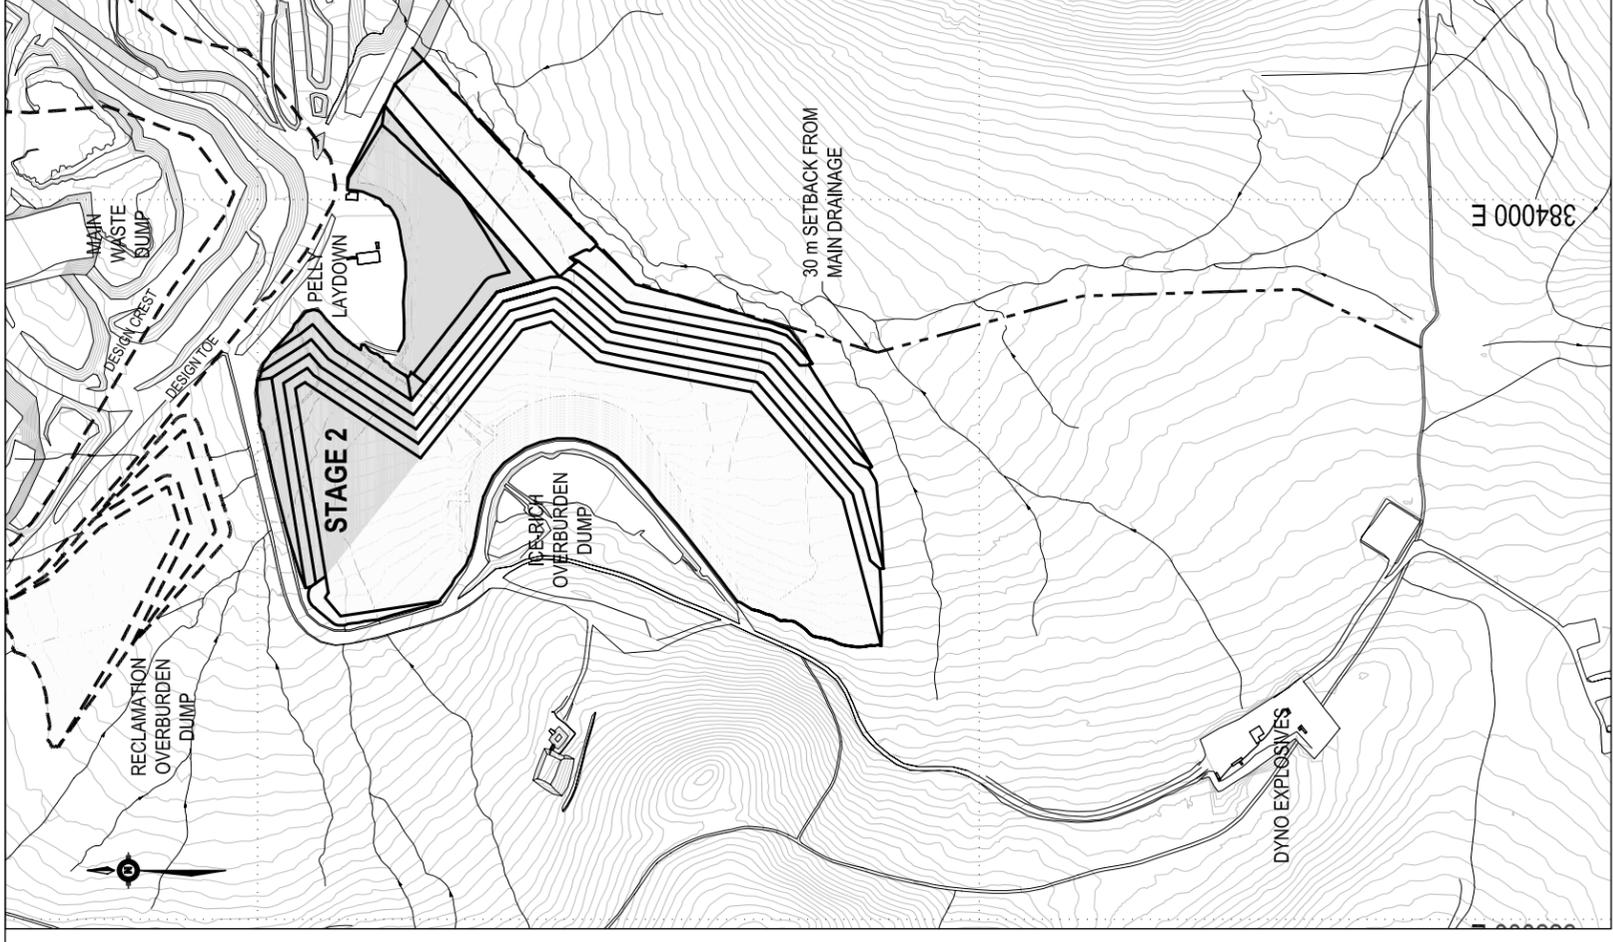
CLIENT		MINTO EXPLORATIONS LTD.	
PROJECT NO.		W14101068.005	
DWN	KJT	CHD	JPB
REV	0	DATE	AUGUST 22, 2008
OFFICE		WHSE	
STAGING PLAN			
PROPOSED SOUTHWEST WASTE DUMP MINTO MINE, YT			
EBA Engineering Consultants Ltd.		Figure 5

Figure 5 shows the SWD at several stages of construction. Stage 1 consists of the ramp from the haul road and the portion of the SWD directly east of the IROD. Stage 2 fills in the remainder of the north portion of the footprint while Stage 3 fills in the remainder of the south. During construction of Stage 3, Minto will need to address the required protocol of working adjacent to the Dyno site.

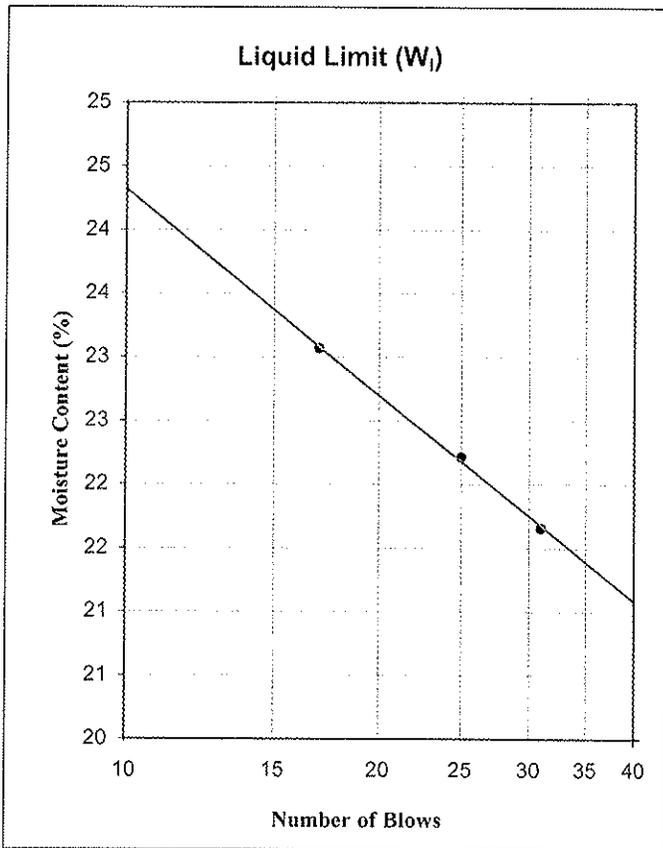
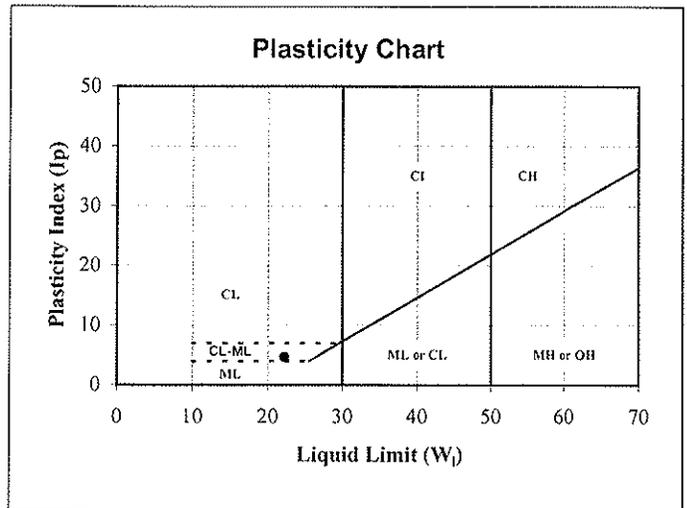
Liquid Limit Test			
Trial Number	1	2	3
No. of Blows	17	25	31
Tare Number	U-1	U-2	U-3
Wt. Wet Soil + Tare	31.97	20.79	19.57
Wt. Dry Soil + Tare	26.71	17.70	16.80
Wt. of Tare	3.91	3.79	4.01
Wt. of Water	5.26	3.09	2.77
Wt. of Dry Soil	22.80	13.91	12.79
Moisture Content (%)	23.1	22.2	21.7

LIQUID LIMIT (%) 22
 PLASTIC LIMIT (%) 18
 PLASTICITY INDEX (%) 5

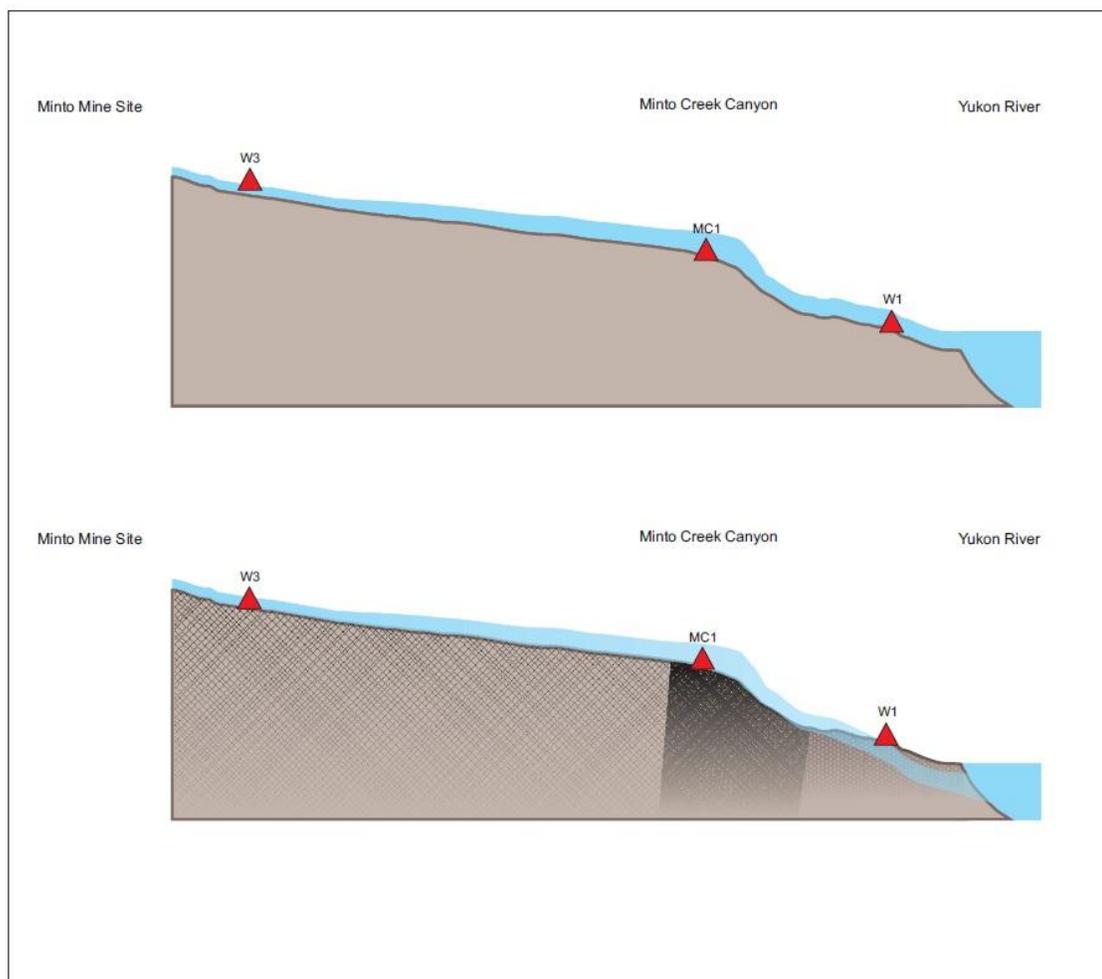
Since 2006 MintoEx has observed that, at certain times of the year (typically mid to late summer), discharges in Minto Creek at station MC1 (top of canyon) are greater than those just downstream (bottom of canyon) at stations W1 and W2. This suggests that Lower Minto Creek on the floodplain of the Yukon River is an area of substantial groundwater recharge or subsurface water flow. Figure 2-3 depicts this phenomenon where stream flows can be significant at MC1 but much lower (or even zero) at W2.

Figure 2-3 Surface and groundwater flow between MC1 and W2

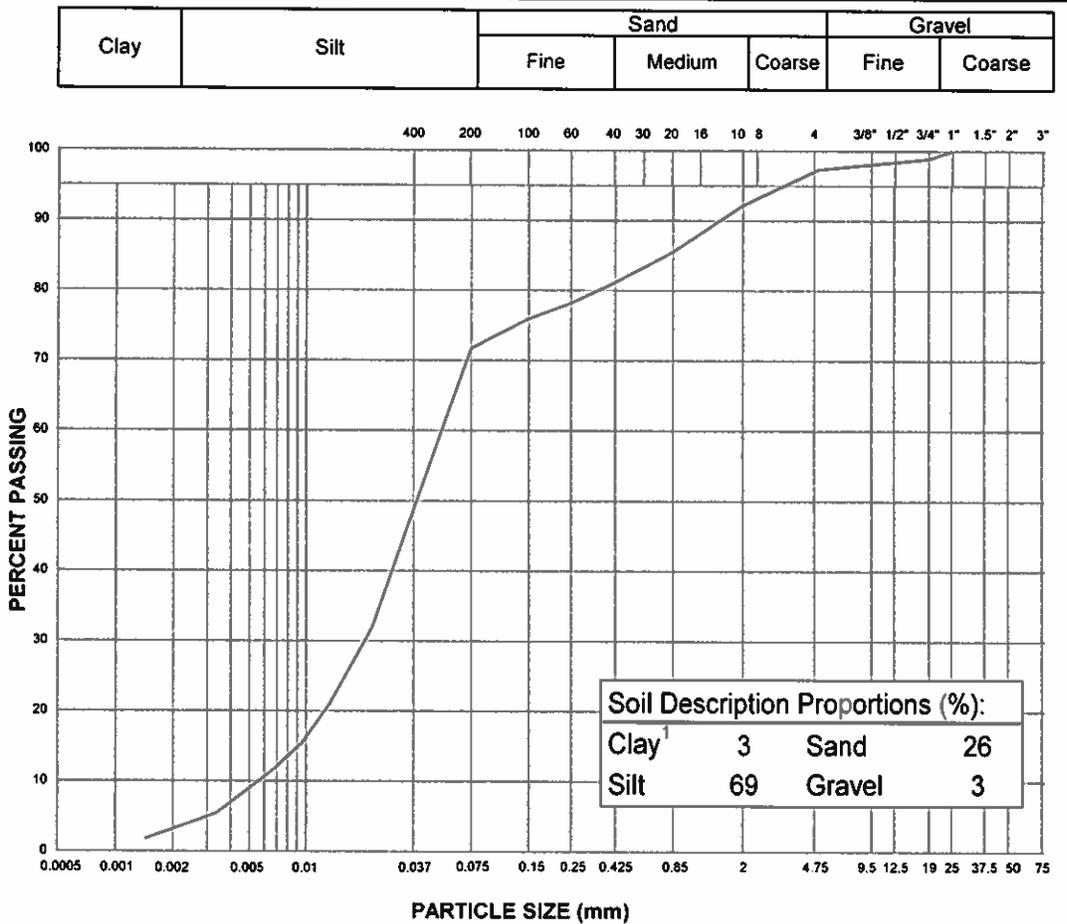
Particle Size (mm)	Percent Passing
75	
50	
38	
25	100
19	99
12.5	99
10	99
5	97
2	92
0.85	86
0.425	81
0.25	78
0.15	76
0.075	72
0.0336	45.7
0.0223	32.0
0.0133	21.0
0.0096	15.5
0.0069	11.9
0.0034	5.5
0.0014	1.8

Notes: ¹ The upper clay size of 2 um, per the Canadian Foundation Engineering Manual
² The description is based on the results of grain size testing

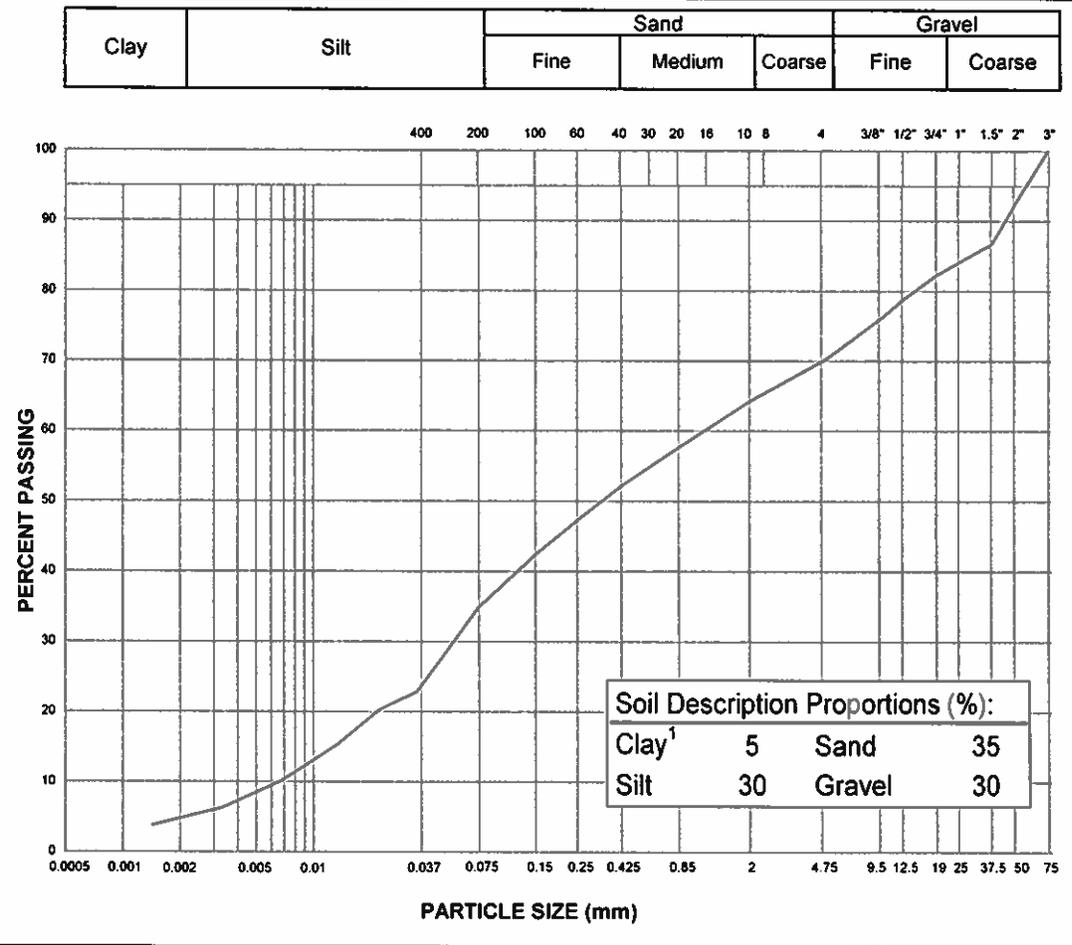
Particle Size (mm)	Percent Passing
75	100
50	
38	87
25	87
19	82
12.5	79
10	76
5	70
2	64
0.85	58
0.425	52
0.25	47
0.15	42
0.075	35
0.0351	22.9
0.0225	20.3
0.0133	15.3
0.0095	12.7
0.0068	10.2
0.0033	6.4
0.0014	3.8

Soil Description Proportions (%):			
Clay ¹	5	Sand	35
Silt	30	Gravel	30
