**Subject:** Ore Stockpiles – 2011 Annual Review, Minto Mine, YT

ORE STOCKPILE AREA - 2011 ANNUAL REPORT  
MINTO MINE, YUKON

SITE PLAN WITH OBSERVATIONS

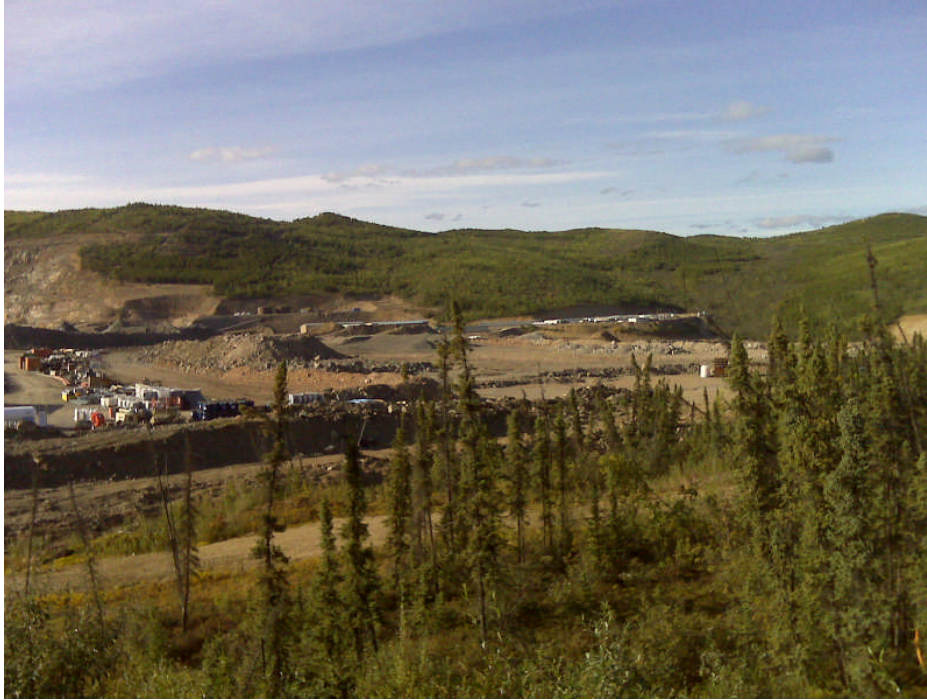
**Photo 1**

- The ore stockpile area consists of four main stockpile pads extend from just south of the Mill Water Pond and proceeding to the south along the Airport Road and Laydown Area. (Photos 1 and 2).
- Slopes appear consistent with original placement with no signs of slumping or bulging noted. Tension cracks were not observed during the site visit.
- No erosion was noted along the slopes or within the stockpiles.
- Safety berms were present in working areas along the crest of the slopes.

Looking north at the Ore stockpile area between the Dry Stack Tailing Storage Facility and Airport Road / Laydown Area  
(August 25, 2011)

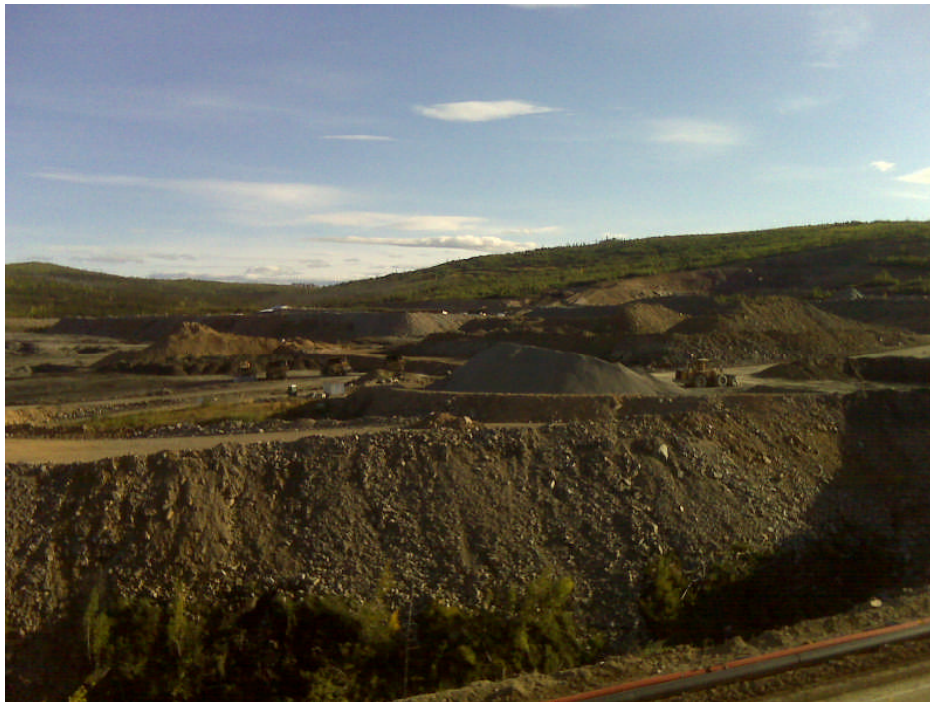
**Photo 2**

Looking south at the Ore stockpile area from the Camp site. (August 25, 2011)
