Subject: Reclamation Overburden Dump – 2011 Annual Review, Minto Mine, YT

As requested, this letter presents a report by EBA, A Tetra Tech Company (EBA) resulting from a site visit completed to examine the current condition of the Reclamation Overburden Dump (ROD) at Minto Mine, YT. The intent of the site visit was to provide a geotechnical engineering report on the condition of the ROD, in partial fulfillment of the requirements of the existing Quartz Mining Licence QML-0001.

**RECLAMATION OVERBURDEN DUMP - 2011 ANNUAL REVIEW
MINTO MINE - YUKON**

SITE PLAN WITH OBSERVATIONS

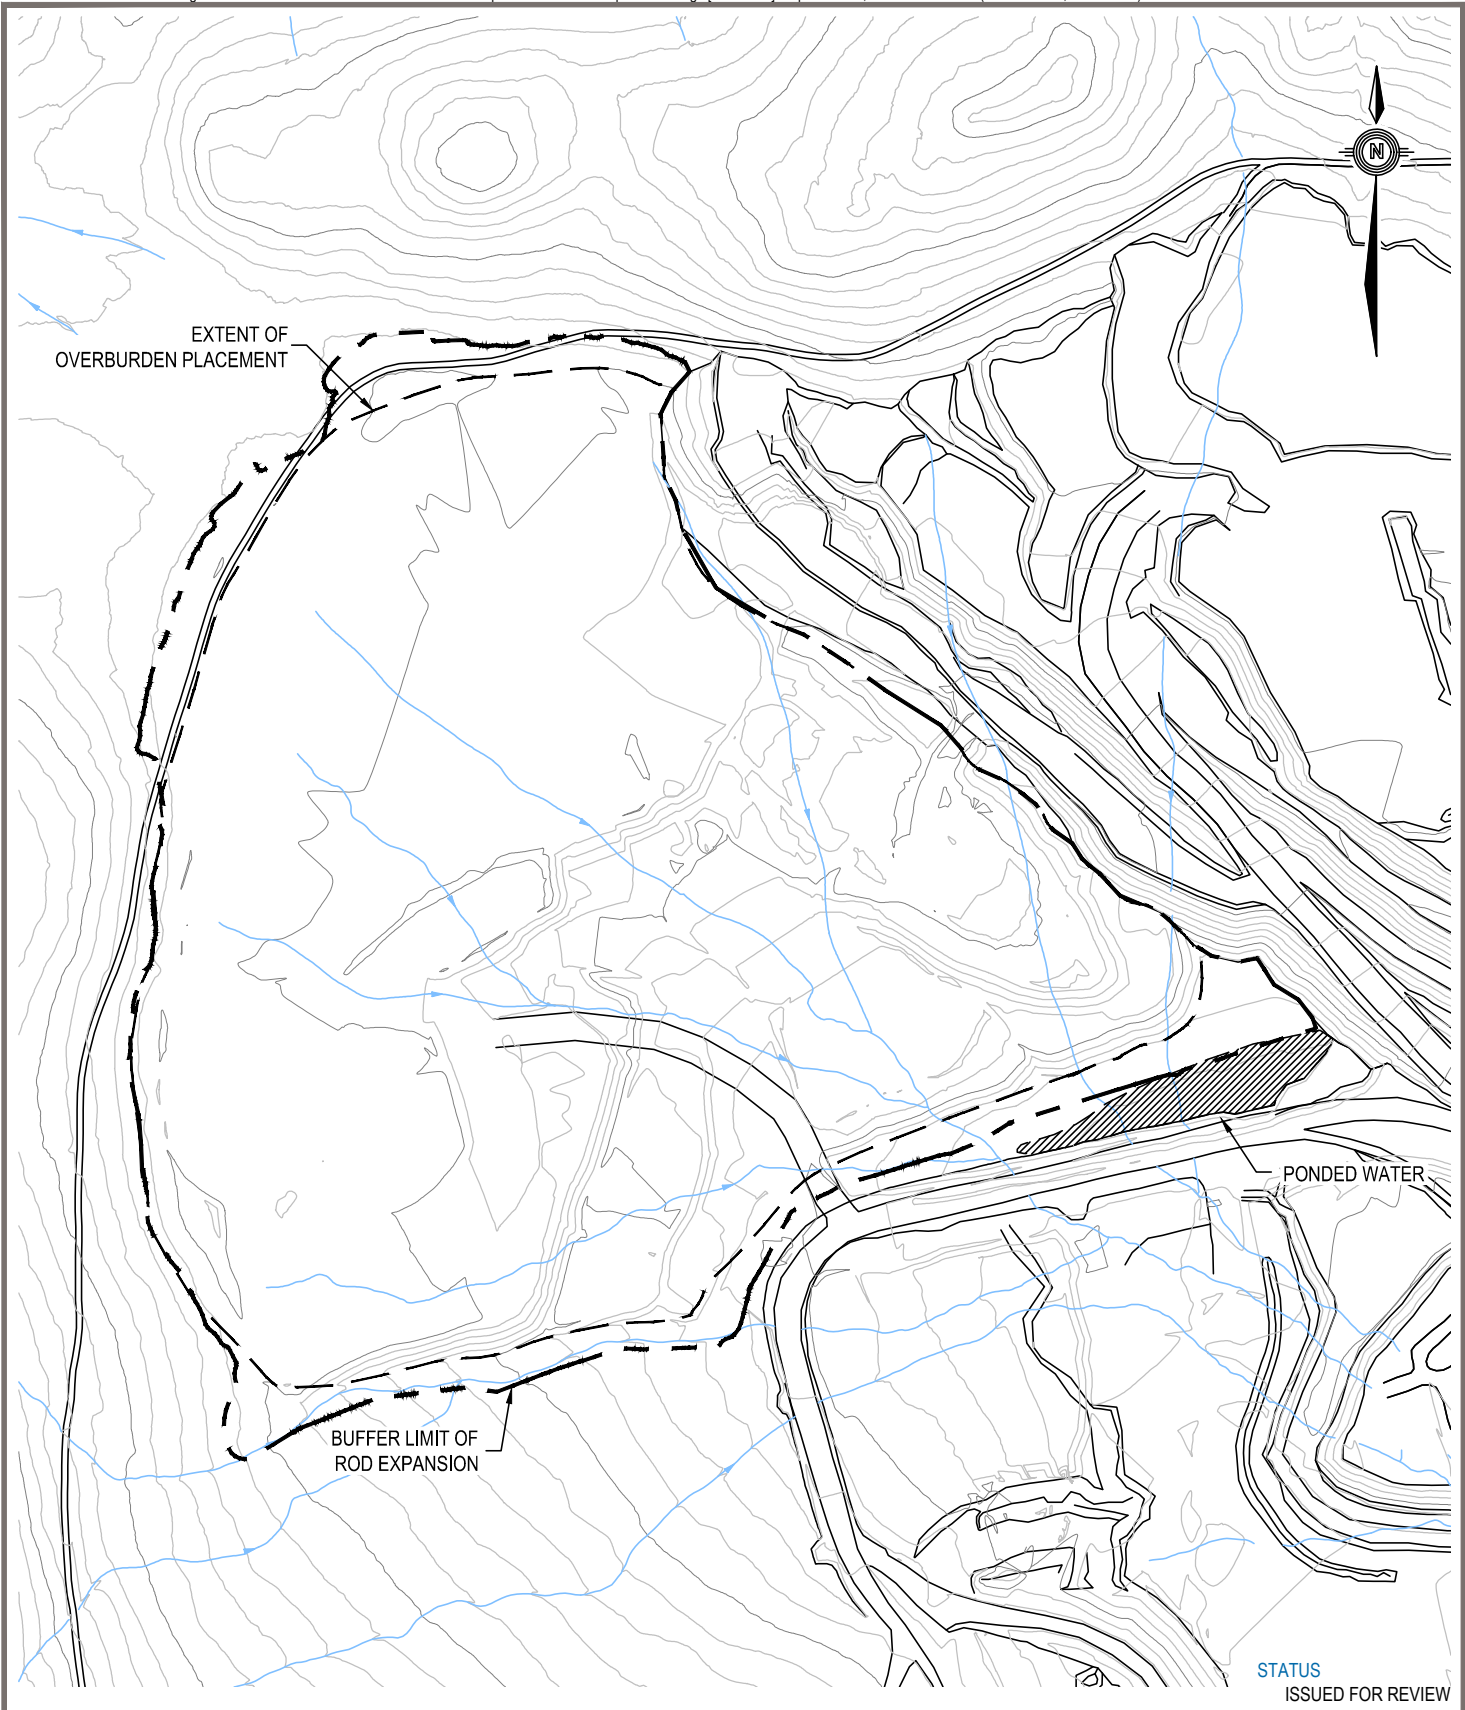
Figure 1

Mr. Chad Cowan P.Eng. of EBA's Whitehorse office completed a site visit on August 25, 2011. Specific details are presented below and are noted on Figure 1. Photographs were taken of the ROD during the visit. Selected photos are attached while the remainder are available for review in the EBA files, if desired.

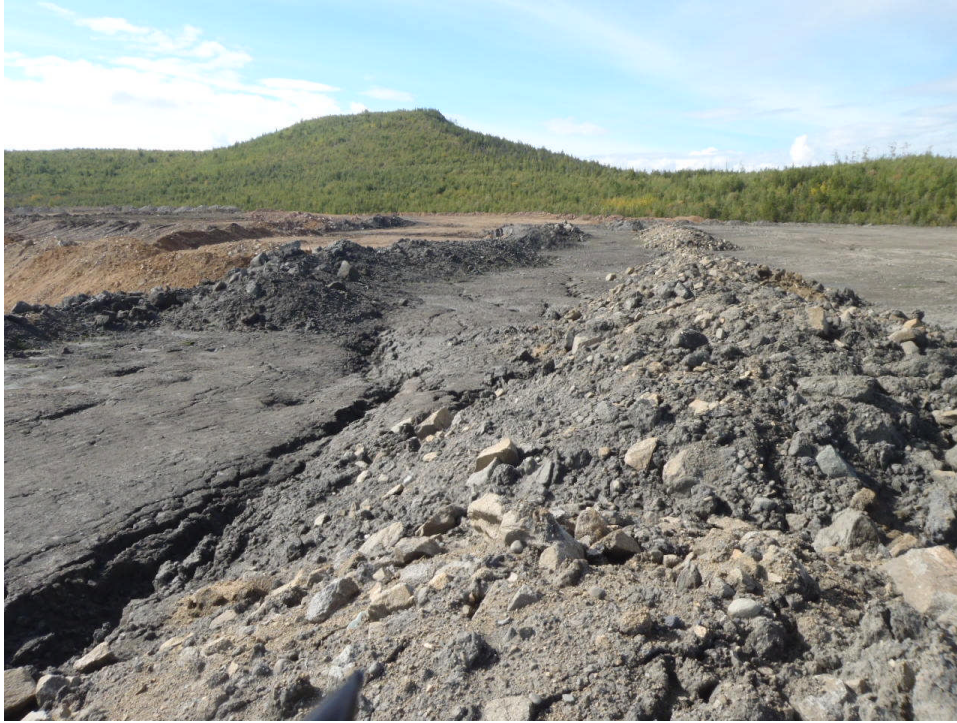
Photo 1

- The ROD is being constructed with non ice-rich frozen overburden that was placed during the 2008 winter and from 2010 winter to present. The material placed in 2008 has experienced four thawing seasons to date. It is unknown whether this entire fill has thawed, or whether zones of frozen overburden are still present within this area of the fill material.
- The majority of the slopes appear consistent with original placement with no major signs of slumping or bulging noted. There are minor areas of localized slumping along the perimeter slopes that were noted during the previous reporting period. Since the previous reporting period some areas have increased in size.
- Tension cracks were noted throughout the crest perimeter (Photo 1).
- Areas of settlement were noted throughout the surface of the ROD (Photo 2).

As mentioned in previous EBA observation report, localized slumping of the overburden fill was expected as per the design report.

Tension cracks along the crest perimeter of the ROD. (August 25, 2011)

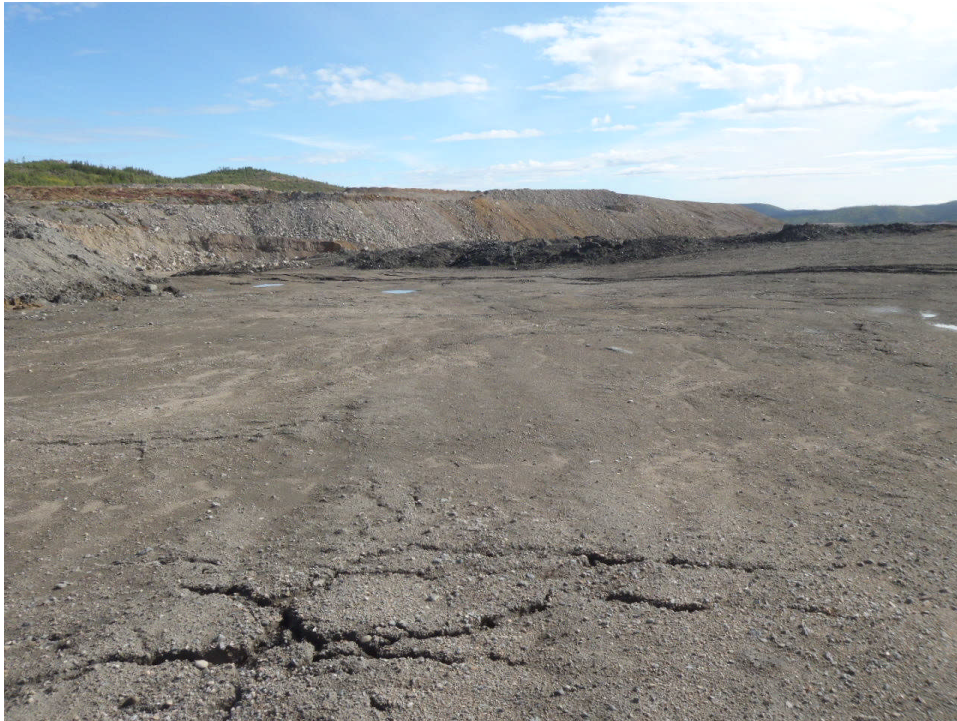
Photo 2

Noticeable areas of settlement throughout the crest of the ROD. (August 25, 2011)

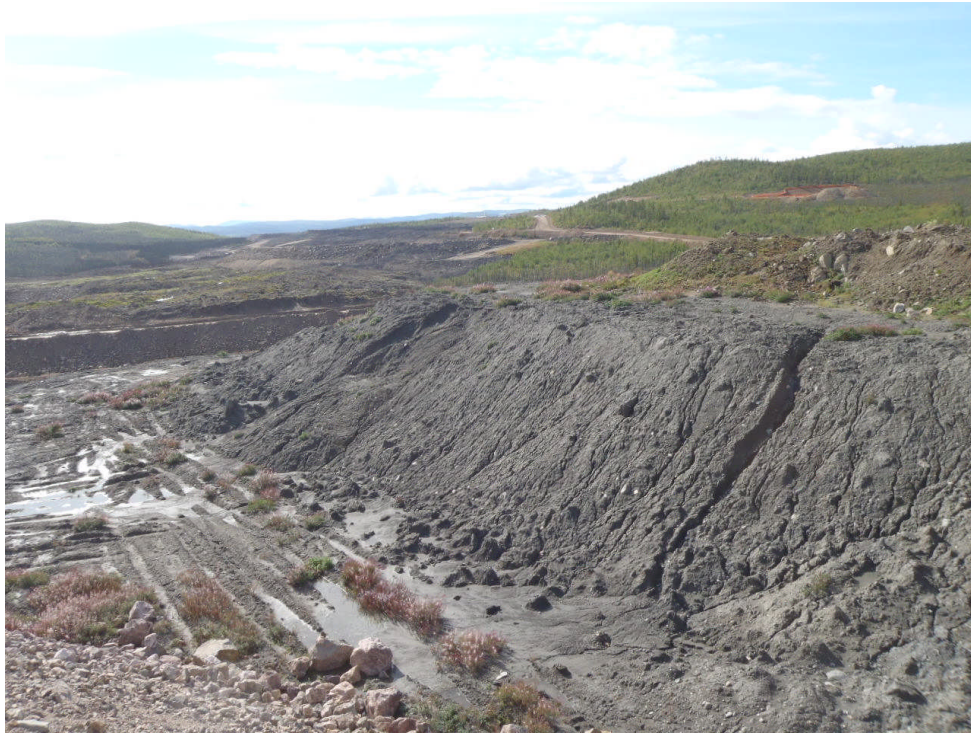
Photo 3

- Erosion channels were noted at several locations along the crest perimeter. These channels appear to have increased in size from erosion due to direct precipitation on the ROD (Photo 3).
- Ponded water was noted in one location (Photo 4) along the Dyno access road below the ROD.
- The toe of the dump should be surveyed at least annually to confirm it is within the permitted boundary.

Erosion channels along the perimeter of the ROD. (August 25, 2011)

It is recommended that the areas within the vicinity of the erosion channels noted on the perimeter slopes be regraded to promote surface water flow away to specific areas. These specific areas will then require the installation of a rip rap channel or “half culvert” down the slope to minimize slope erosion. Detailed construction recommendations can be provided at the time of construction.

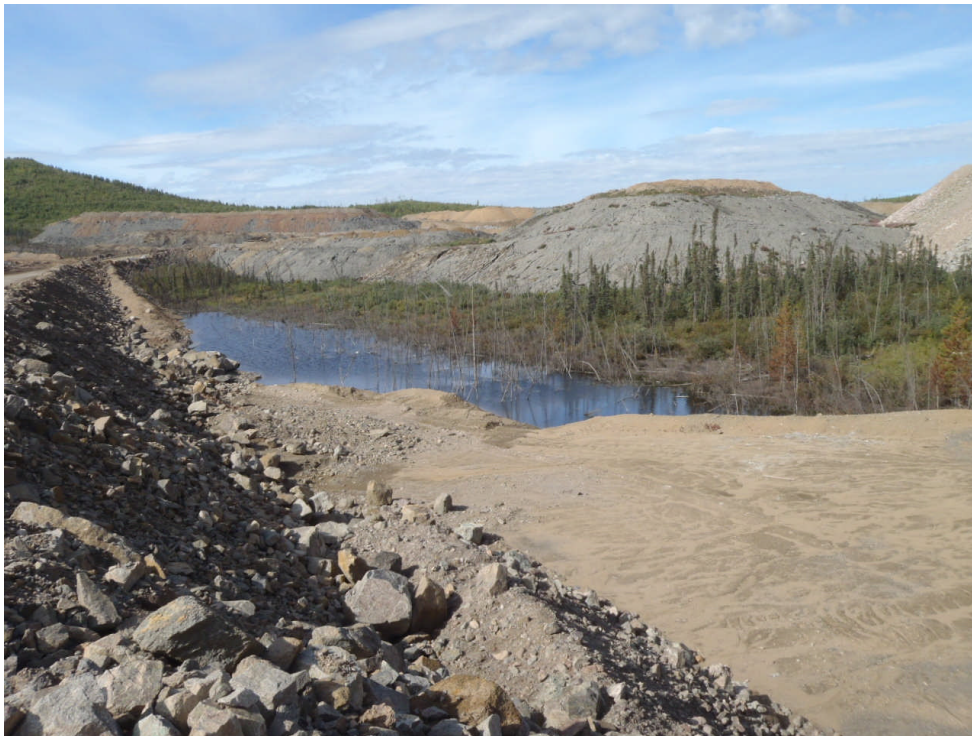
Photo 4

Ponded water between ROD toe and Dyno Access Road. (August 25, 2011)

The ponded water at the Dyno access road requires ongoing monitoring to ensure that the offset from the dump toe stipulated in the design report is maintained.
