ISSUED FOR USE
EBA FILE: W14101068.037

Subject: Southwest Waste Dump – 2011 Annual Review, Minto Mine, YT

As requested, this letter presents a report by EBA Engineering Consultants Ltd. (EBA) resulting from a site visit completed to examine the current condition of the Southwest Waste Dump (SWD) at Minto Mine, YT. The intent of the site visit was to provide a geotechnical engineering report on the condition of the dump, in partial fulfillment of the requirements of the existing Quartz Mining Licence QML-0001.

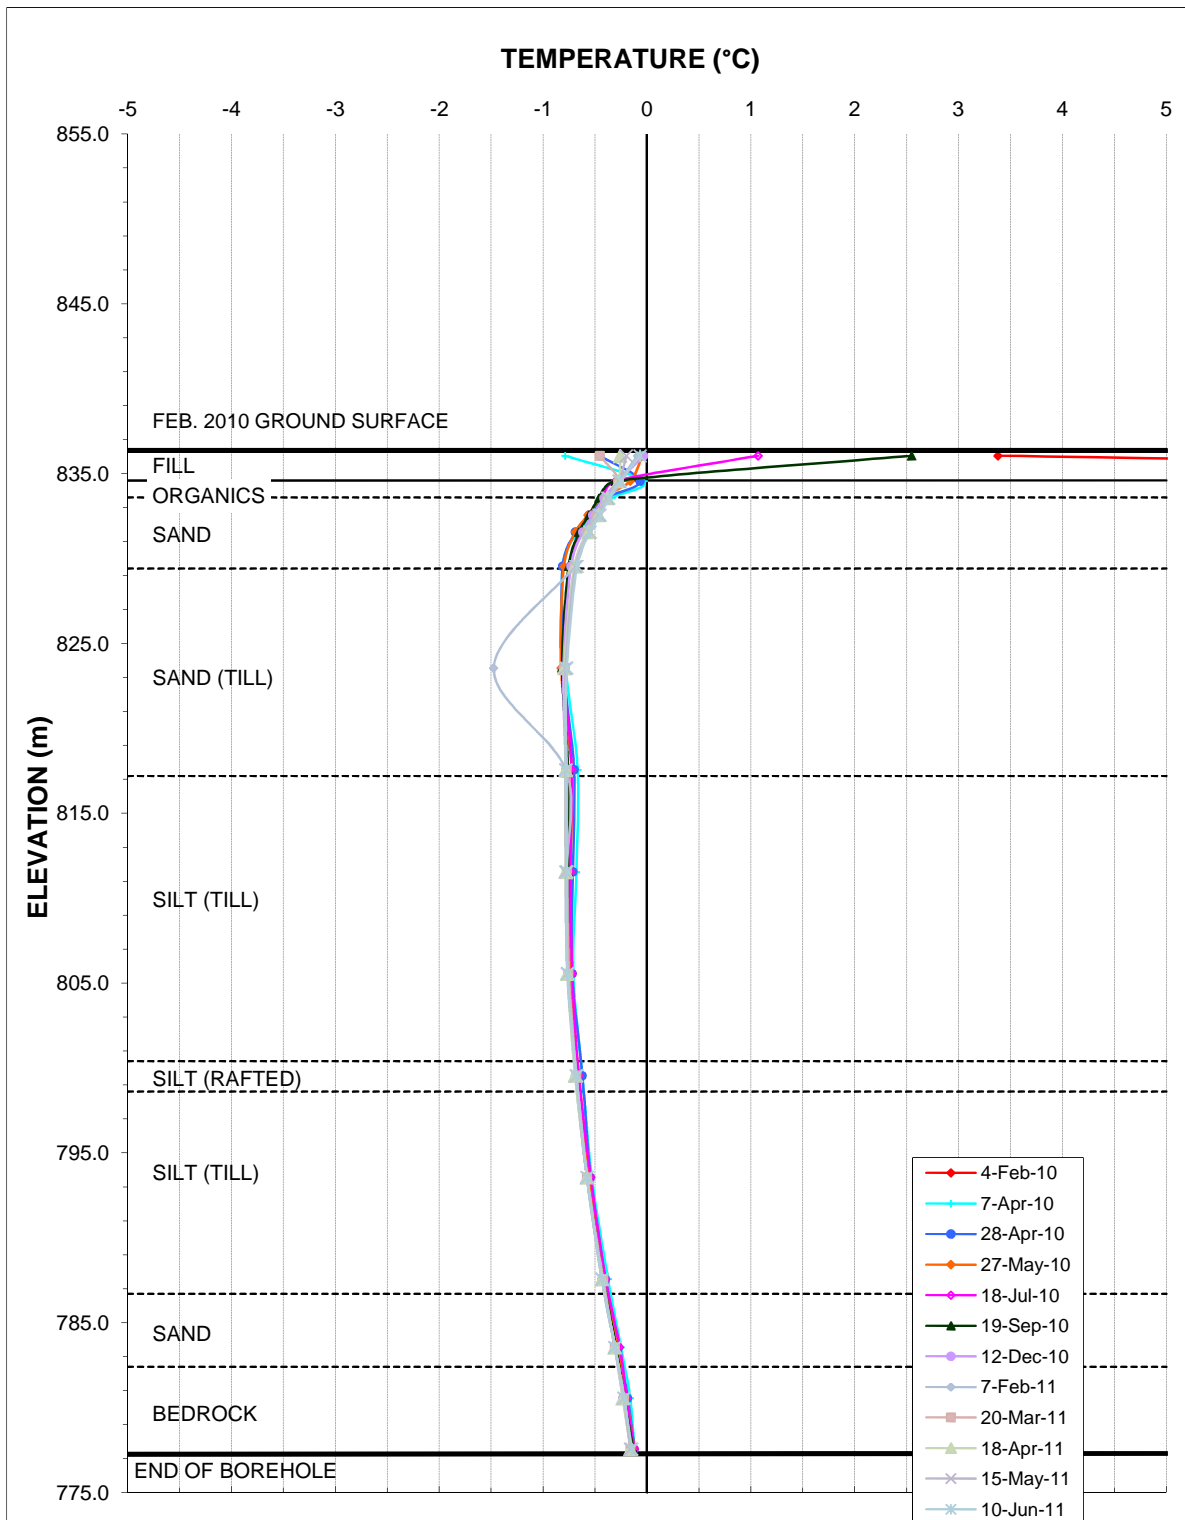
**Southwest Waste Dump
Ground Temperature Profile - SDT-1
Figure T1**

Ground temperature profiles from the four ground temperature cable locations (SDT-1, -2, -3 and -4) are presented in Figures T1, T2, T3 and T4. The four profiles show the readings that have been collected from the time of installation. The readings from each location indicate that the active layer depth ranges from 0.5 m to 1.0 m. Minto personnel should continue to take readings of these instruments every two months.

T1 indicates permafrost conditions throughout the overburden soils and in the bedrock. T2 through to T4 indicate permafrost conditions within the overburden soils, as the ground temperature cables terminate in the overburden soils and do not extend in to the bedrock.

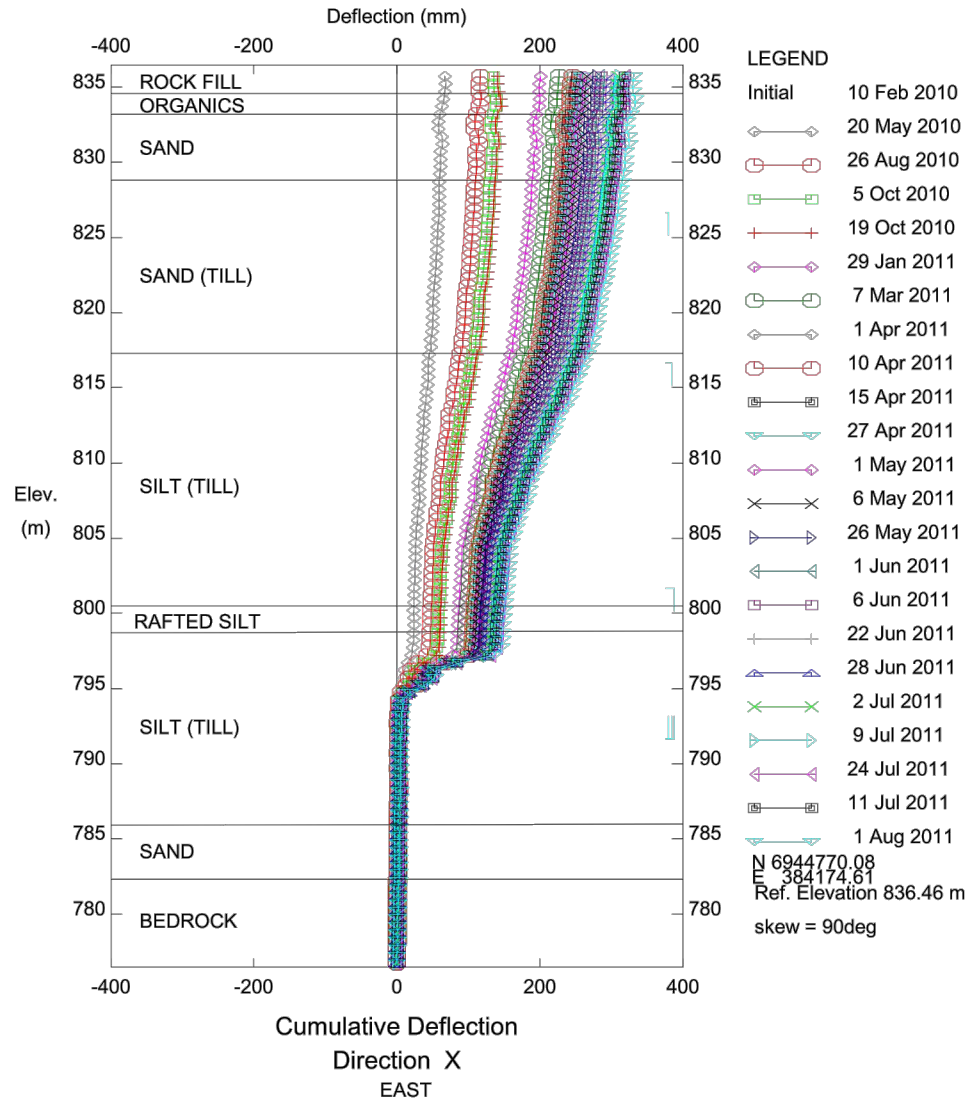
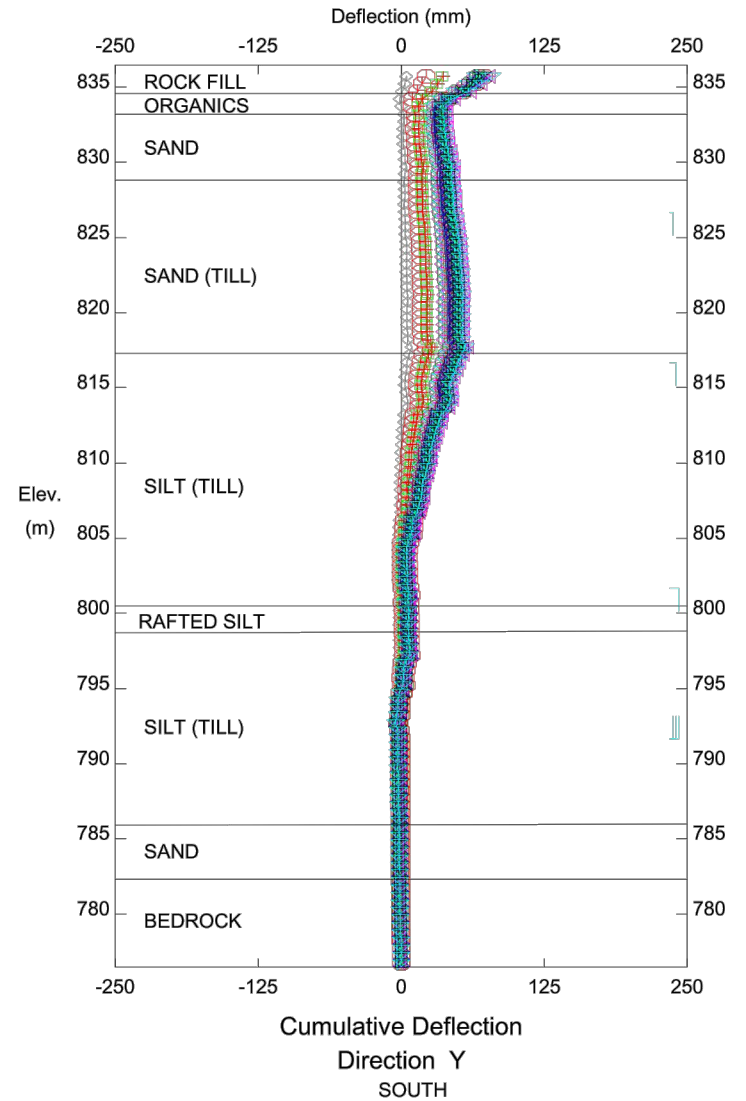
Figure SI-1

Profiles from the three inclinometer locations (SDI-1, -2 and -3) are presented in Figures SI1, SI1a, SI1b, SI2, SI3, SI3a and SI3b. SI1 shows continued marginal movement of the foundation soils in an easterly direction towards the Area 1 Pit. This movement is believed to be associated with the movements seen within the south wall of the Area 1 Pit. Up to February 25, 2011 SI2 showed marginal movement of the foundation soils and the rock fill in a south easterly direction. After February 25, 2011 readings have not been taken as there is refusal at the 2.5 m depth. SI3 shows next to no movement of the foundation soils and marginal movement of the rock fill in an easterly direction. Minto personnel should continue to take readings from these instruments monthly throughout the year.

CLIENT MINTO EXPLORATIONS LTD.	SOUTHWEST WASTE DUMP - 2011 ANNUAL REVIEW MINTO MINE, YUKON			
	SDI-1 INCLINOMETER PROFILE

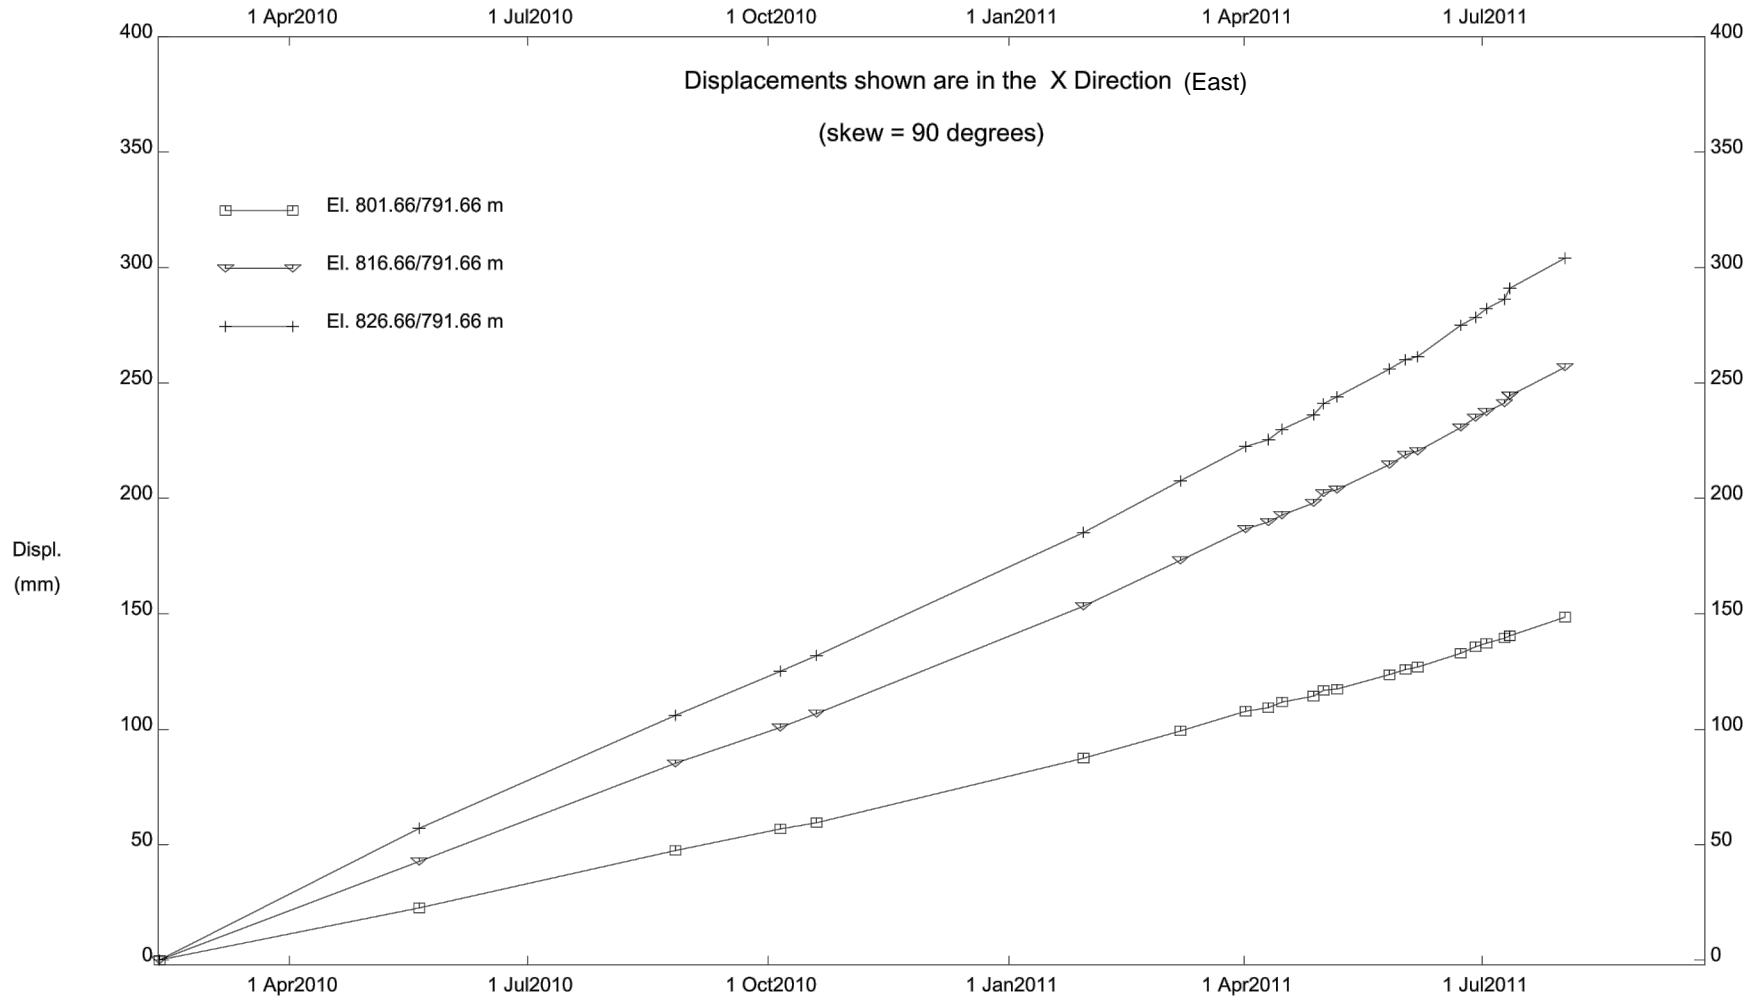
Figure SI-1a

CLIENT MINTO EXPLORATIONS LTD.	SOUTHWEST WASTE DUMP - 2011 ANNUAL REVIEW MINTO MINE, YUKON			
	SDI-1 INCLINOMETER DISPLACEMENT

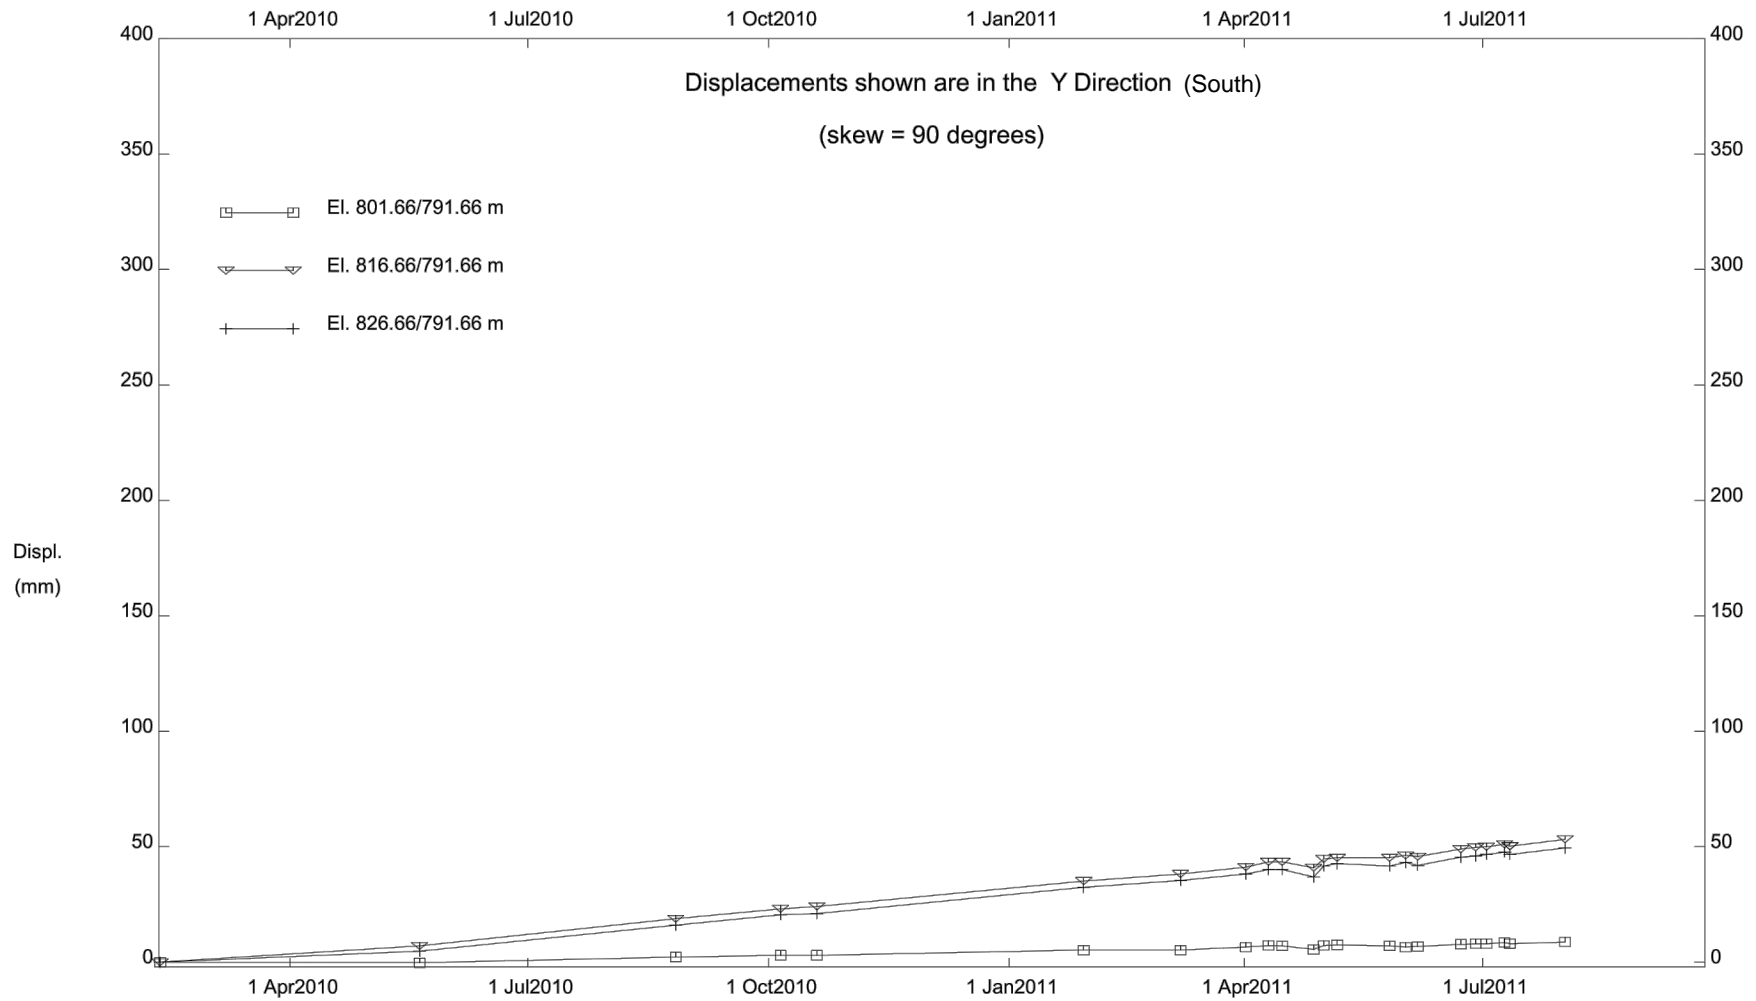
Figure SI-1b

CLIENT MINTO EXPLORATIONS LTD.	SOUTHWEST WASTE DUMP - 2011 ANNUAL REVIEW MINTO MINE, YUKON			
	SDI-1 INCLINOMETER DISPLACEMENT

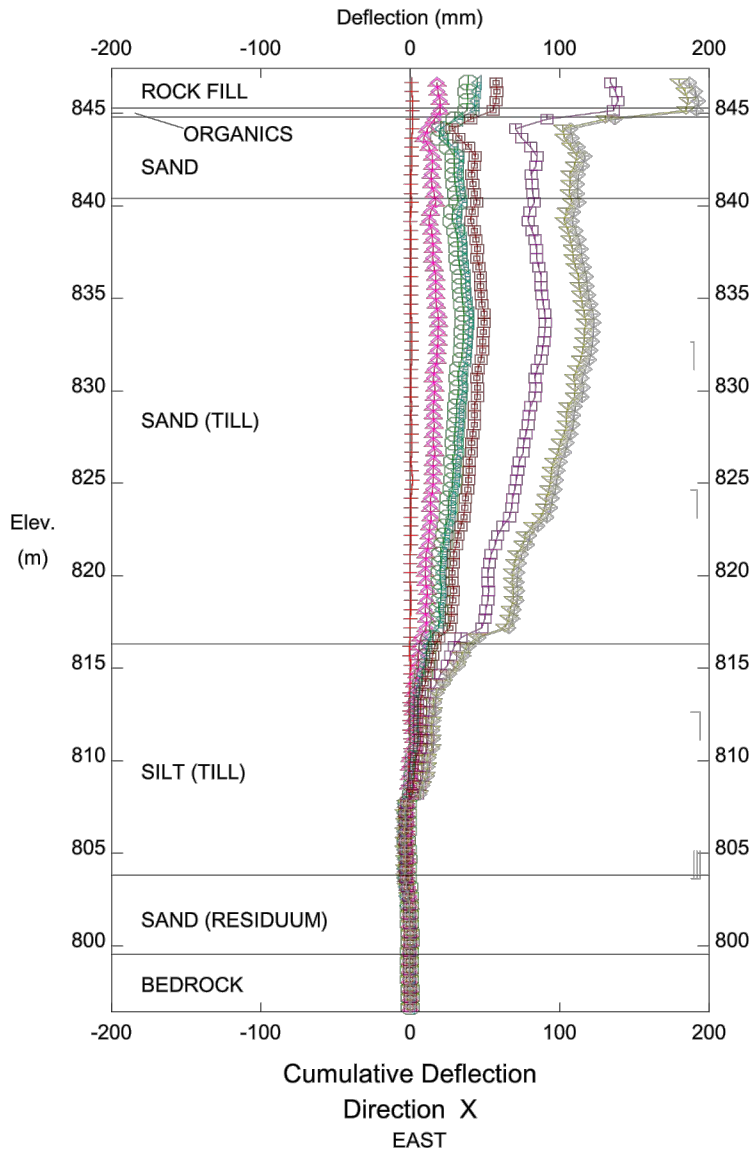
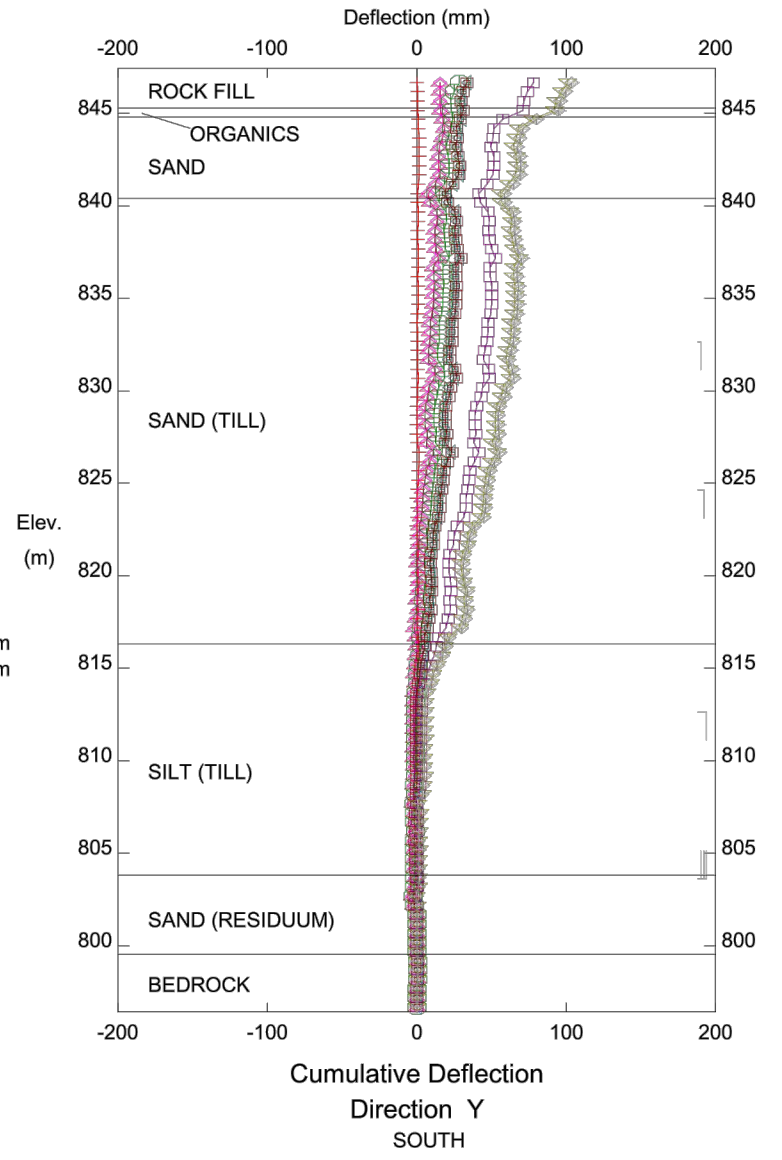
Figure SI-2

21 March 2010, probe refusal at 45.5m
 22 March 2010, probe refusal at 45.5m
 28 April 2010, probe refusal at 45.5m
 20 May 2010, probe refusal at 45.5m
 13 June 2010, probe refusal at 45.5m
 5 Oct 2010, probe refusal at 45.5m
 31 Jan 2011, probe refusal at 45.5 m
 23 Feb 2011, probe refusal at 45.5 m
 25 Feb 2011, probe refusal at 45.5m
 Data manipulated
 N 6944591.11
 E 383966.00
 Ref. Elevation 847.42 m
 skew = -44deg

CLIENT MINTO EXPLORATIONS LTD.	SOUTHWEST WASTE DUMP - 2011 ANNUAL REVIEW MINTO MINE, YUKON			
	SDI-2 INCLINOMETER PROFILE

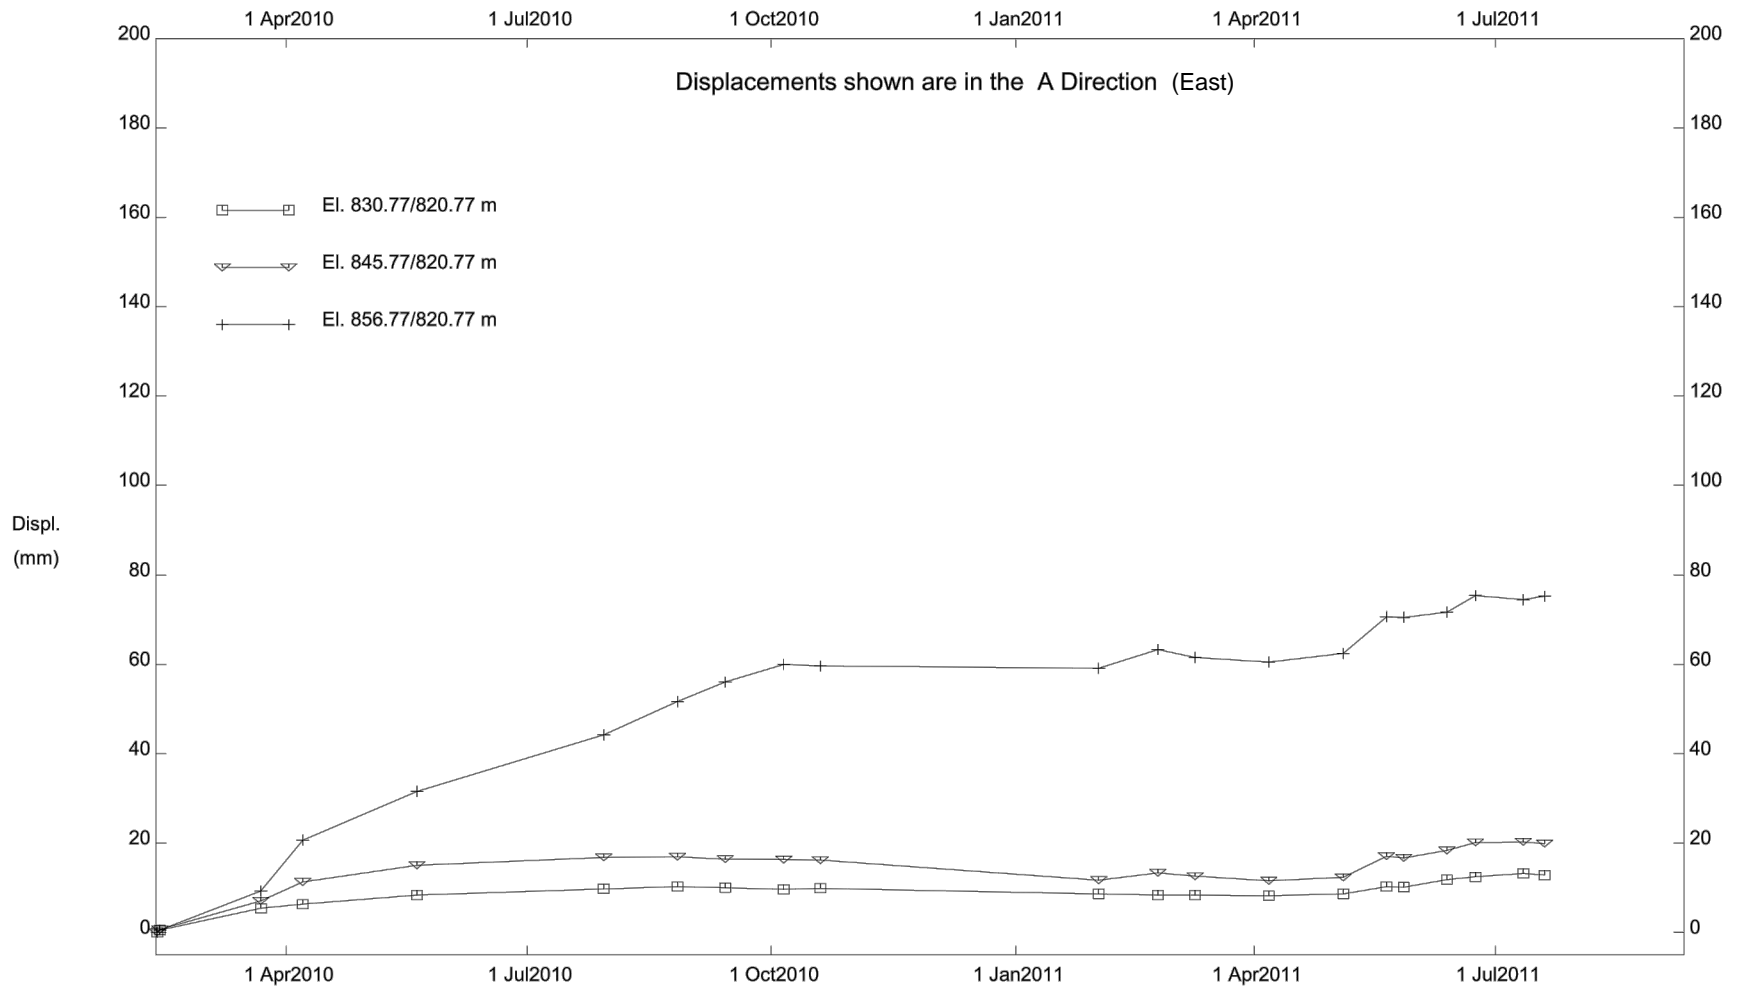
Figure SI-3a

CLIENT MINTO EXPLORATIONS LTD.	SOUTHWEST WASTE DUMP - 2011 ANNUAL REVIEW MINTO MINE, YUKON			
	SDI-3 INCLINOMETER DISPLACEMENT

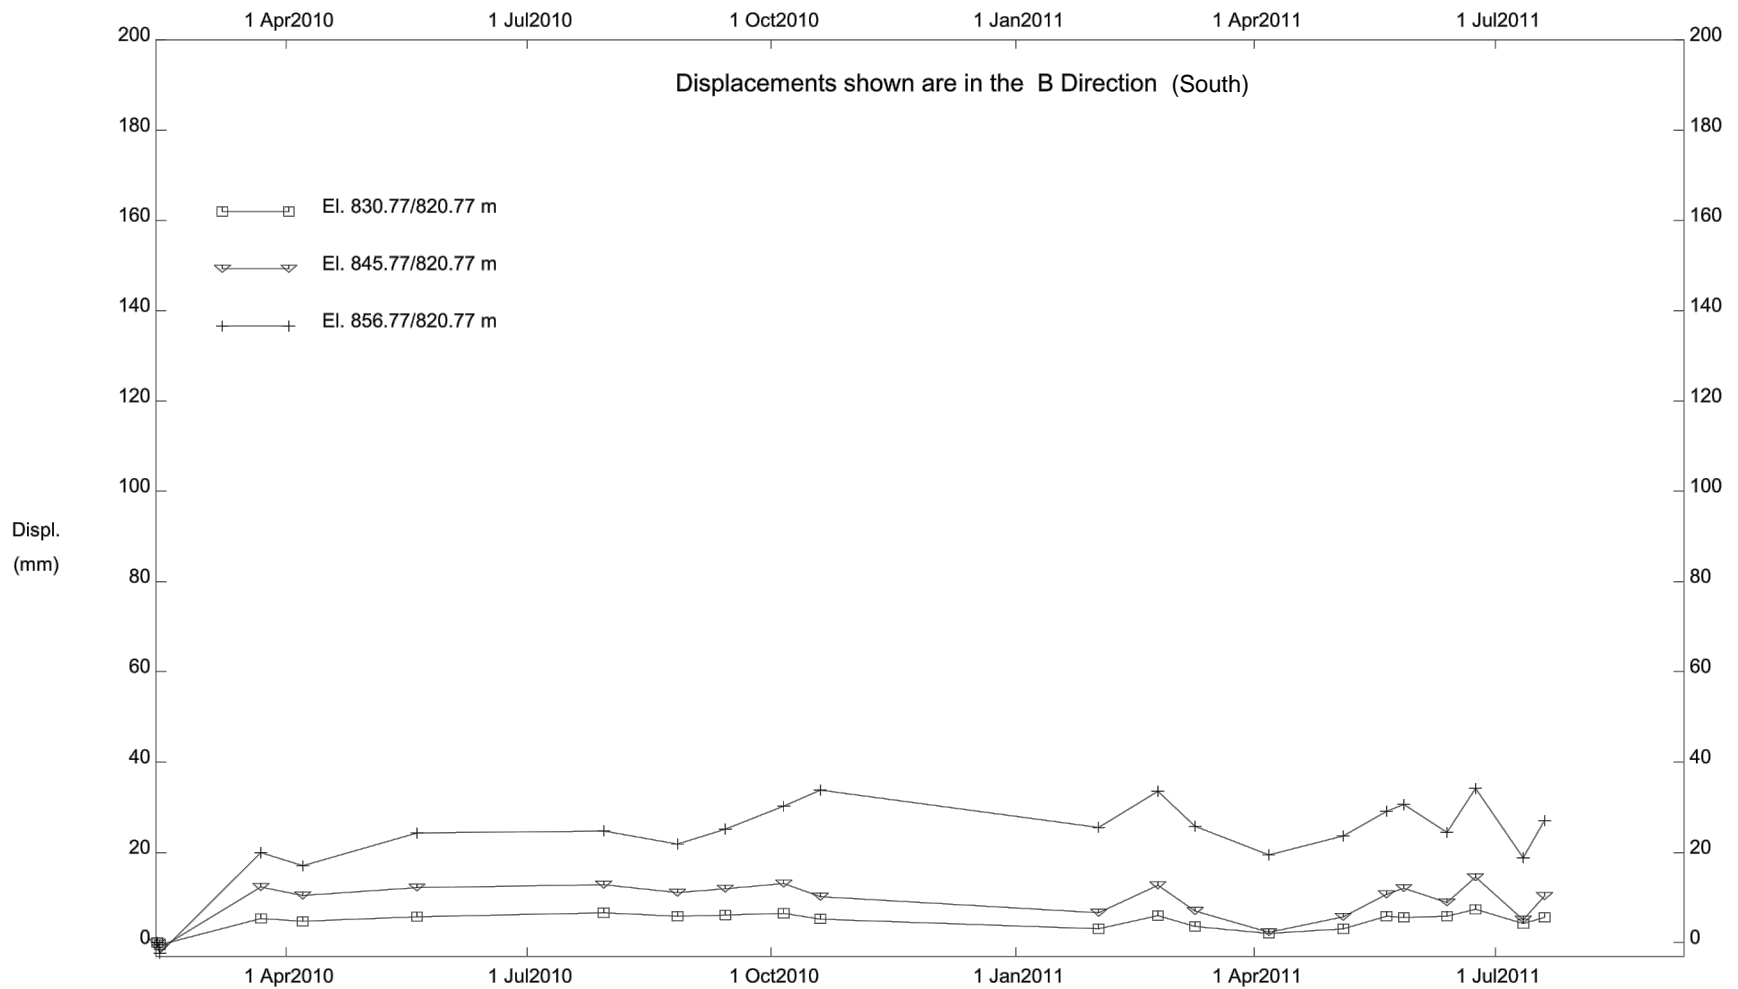
Figure SI-3b

CLIENT MINTO EXPLORATIONS LTD.	SOUTHWEST WASTE DUMP - 2011 ANNUAL REVIEW MINTO MINE, YUKON			
	SDI-3 INCLINOMETER DISPLACEMENT

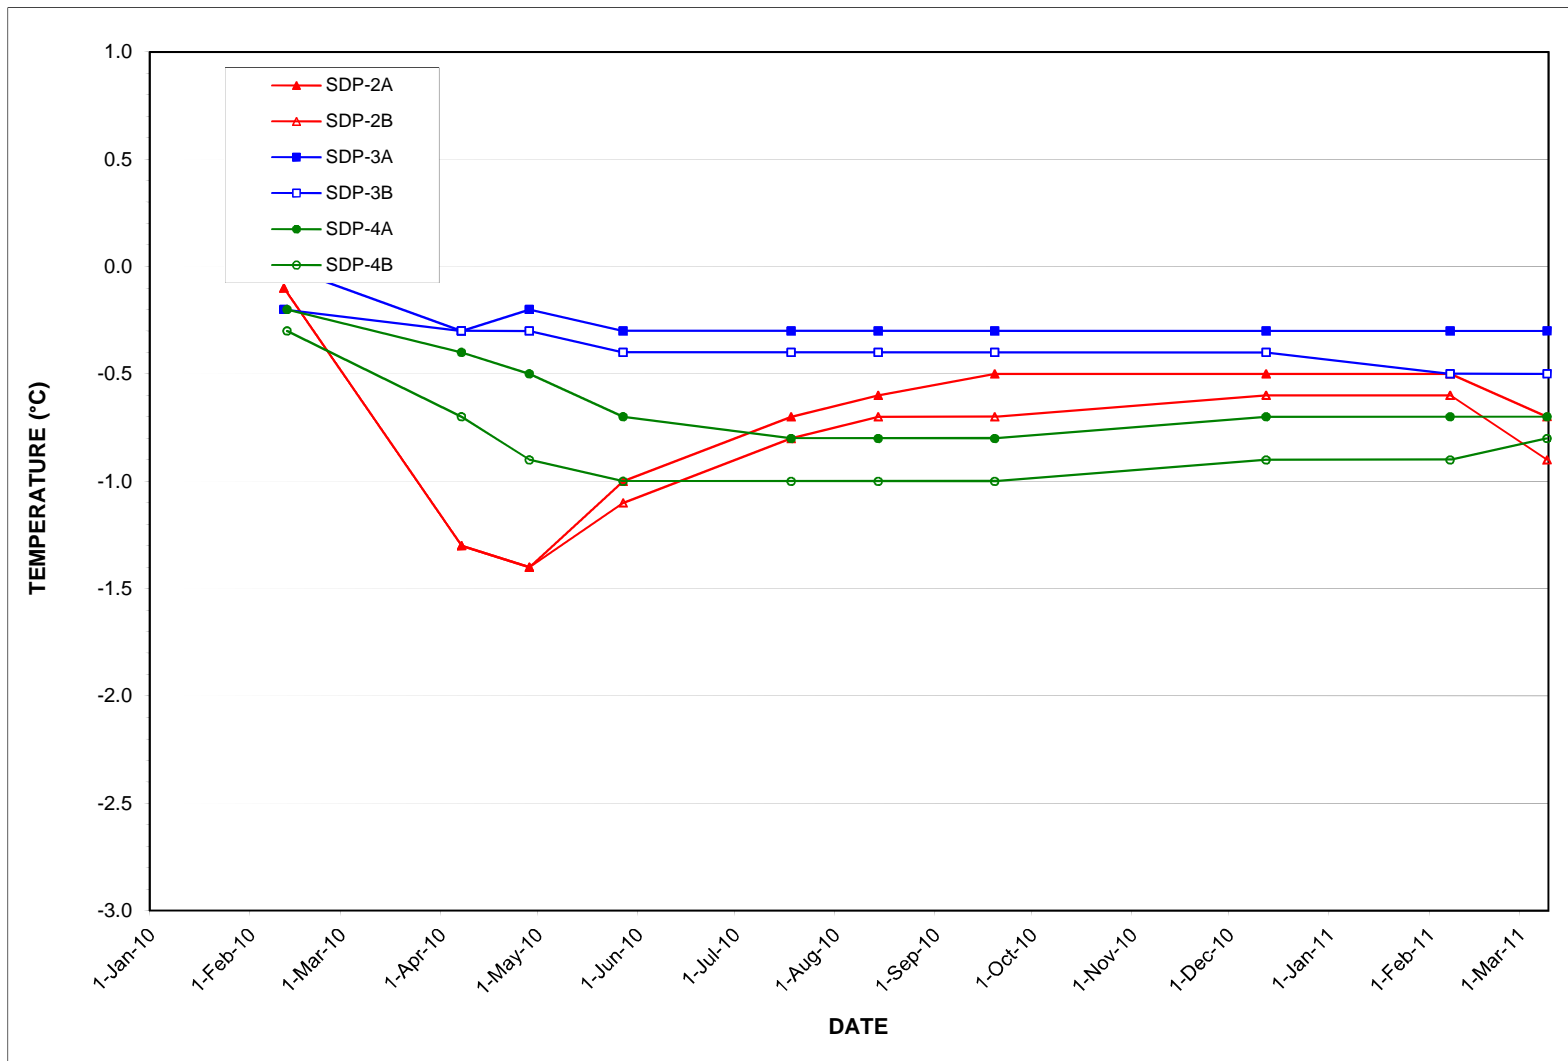
Only the temperature data from the vibrating wire piezometers (SDP-1, -2, -3 and -4) can be monitored at this time as the vibrating wire tips were installed in the permafrost. The temperature data confirms that the subsurface soils at each of the vibrating wire piezometer locations is frozen (Figure SP1).

Southwest Waste Dump
 Ground Temperature Profile of VW Piezometer - SDP-2A, SDP-2B, SDP-3A, SDP-3B, SDP-4A, SDP-4B
 Figure SP1

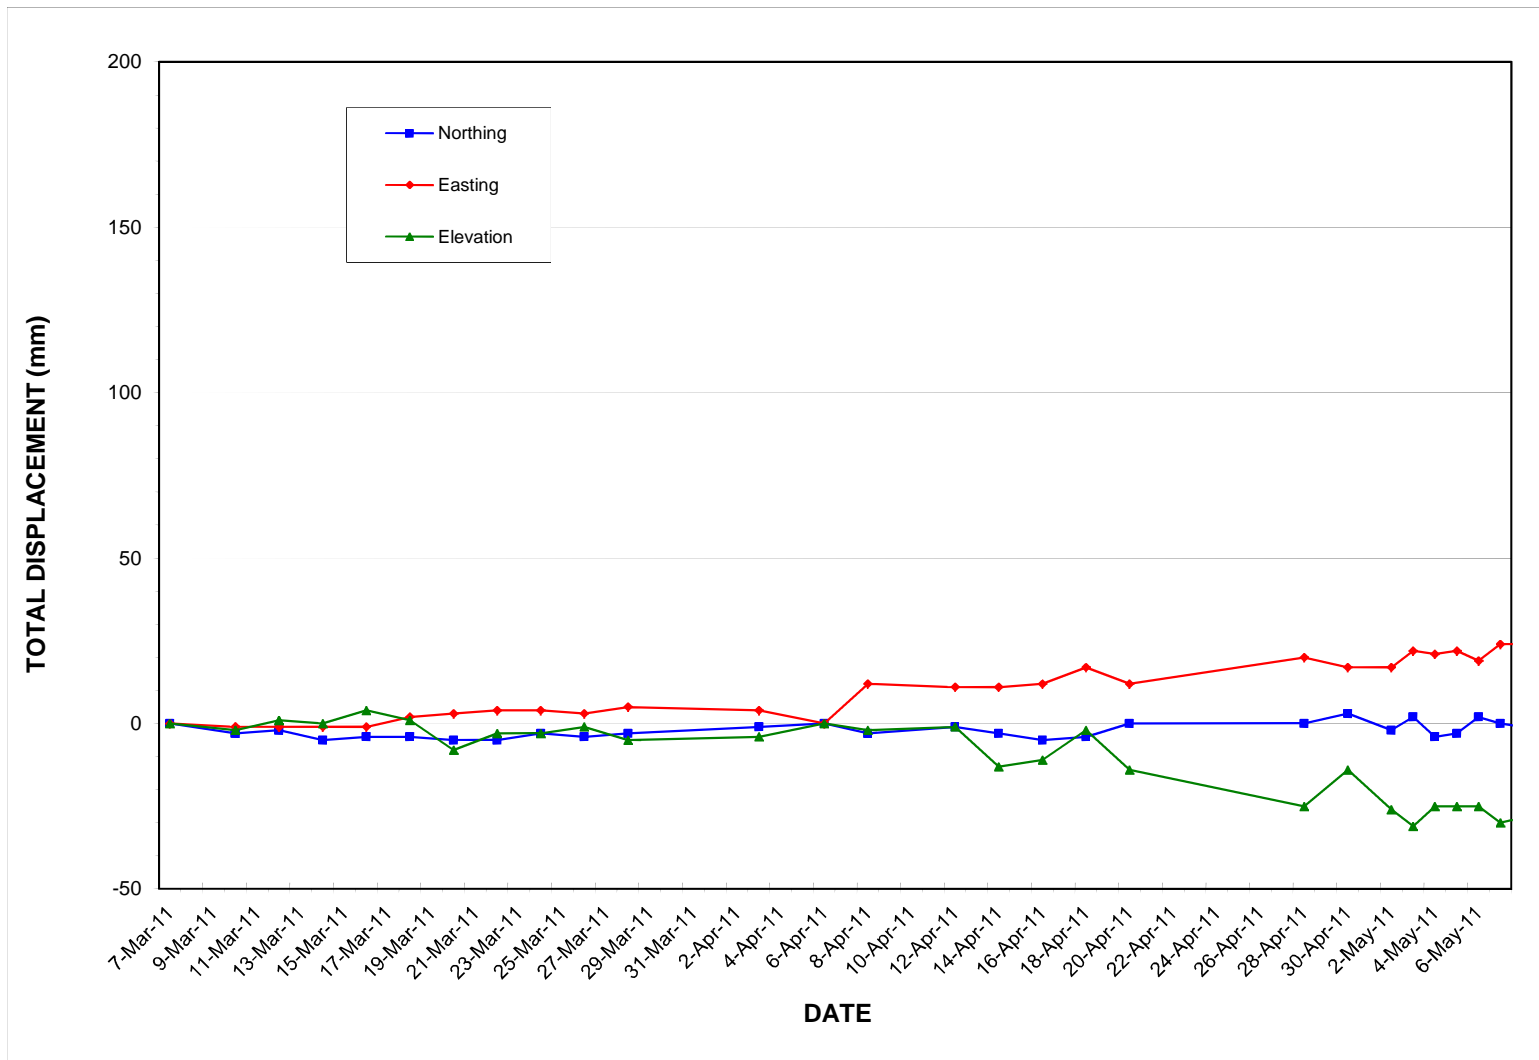
Movement data from the nine survey hub locations (SWD01, 01A, 02, 02A, 03, 03A, 04, 04A and-05A) are presented on the Figures SH1, SH1A, SH2, SH2A, SH3, SH3A, SH4, SH4A, SH5A. The data confirms that there is only noticeable movement at the north eastern corner (location closet to the Area 1 Open Pit). This movement is believed to be associated with the movements seen within the south wall of the Area 1 Pit.

Southwest Waste Dump
 Survey Hub-SWD01
 Figure SH1

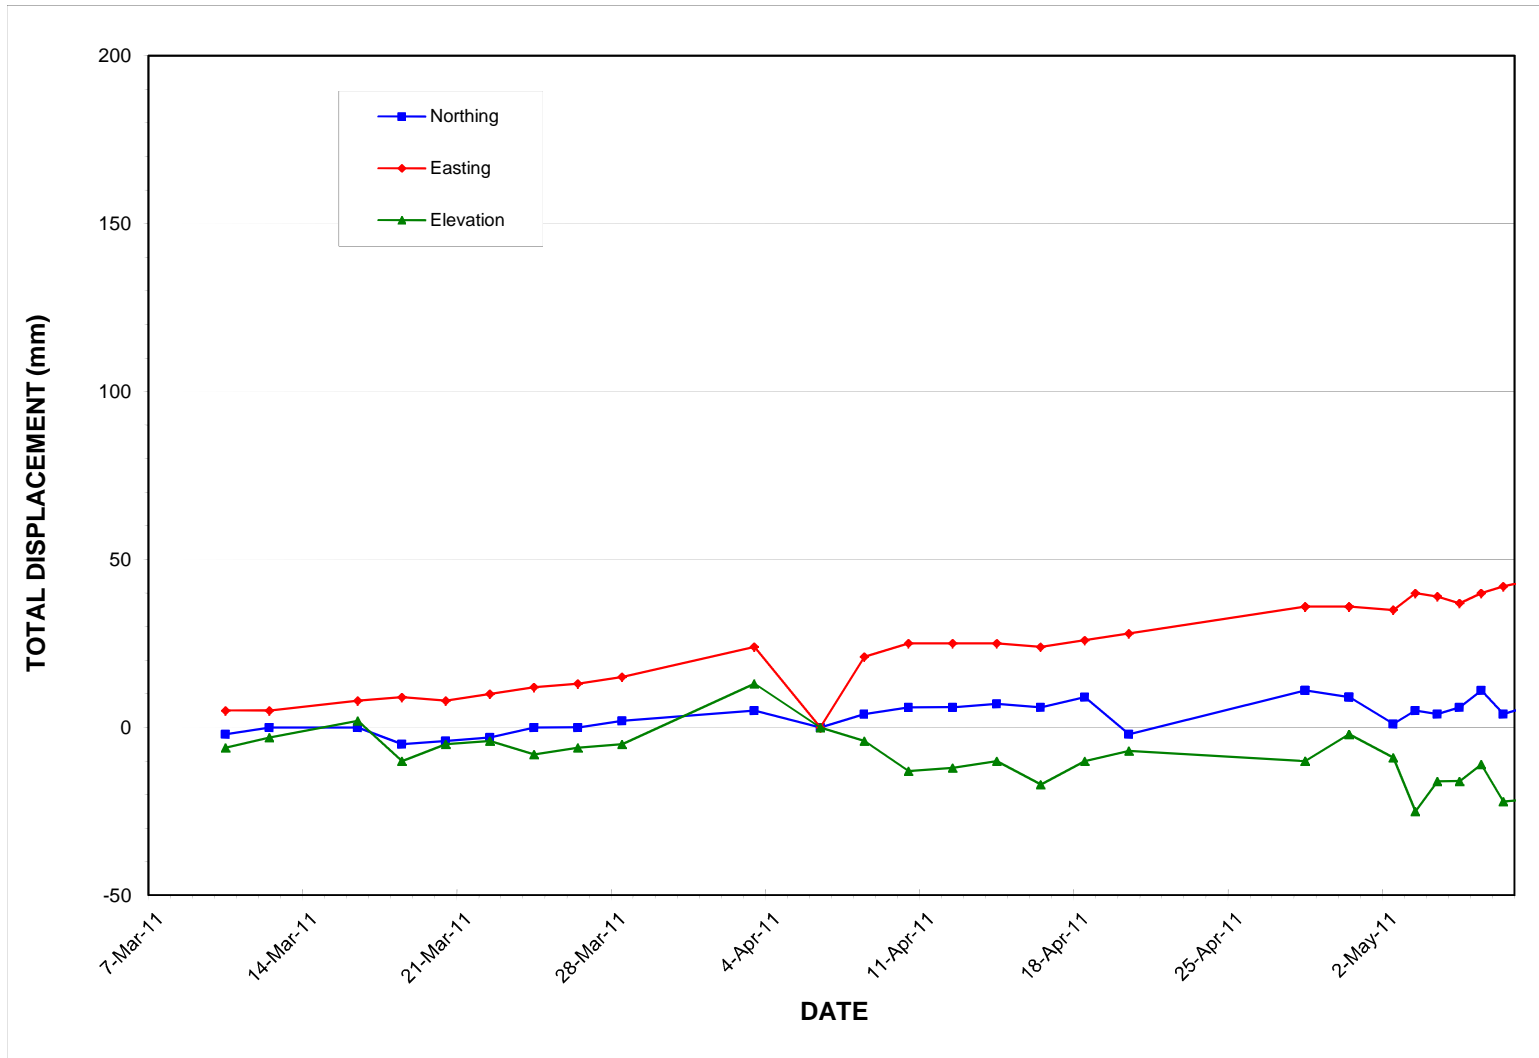
Southwest Waste Dump
 Survey Hub-SWD01A
 Figure SH1A

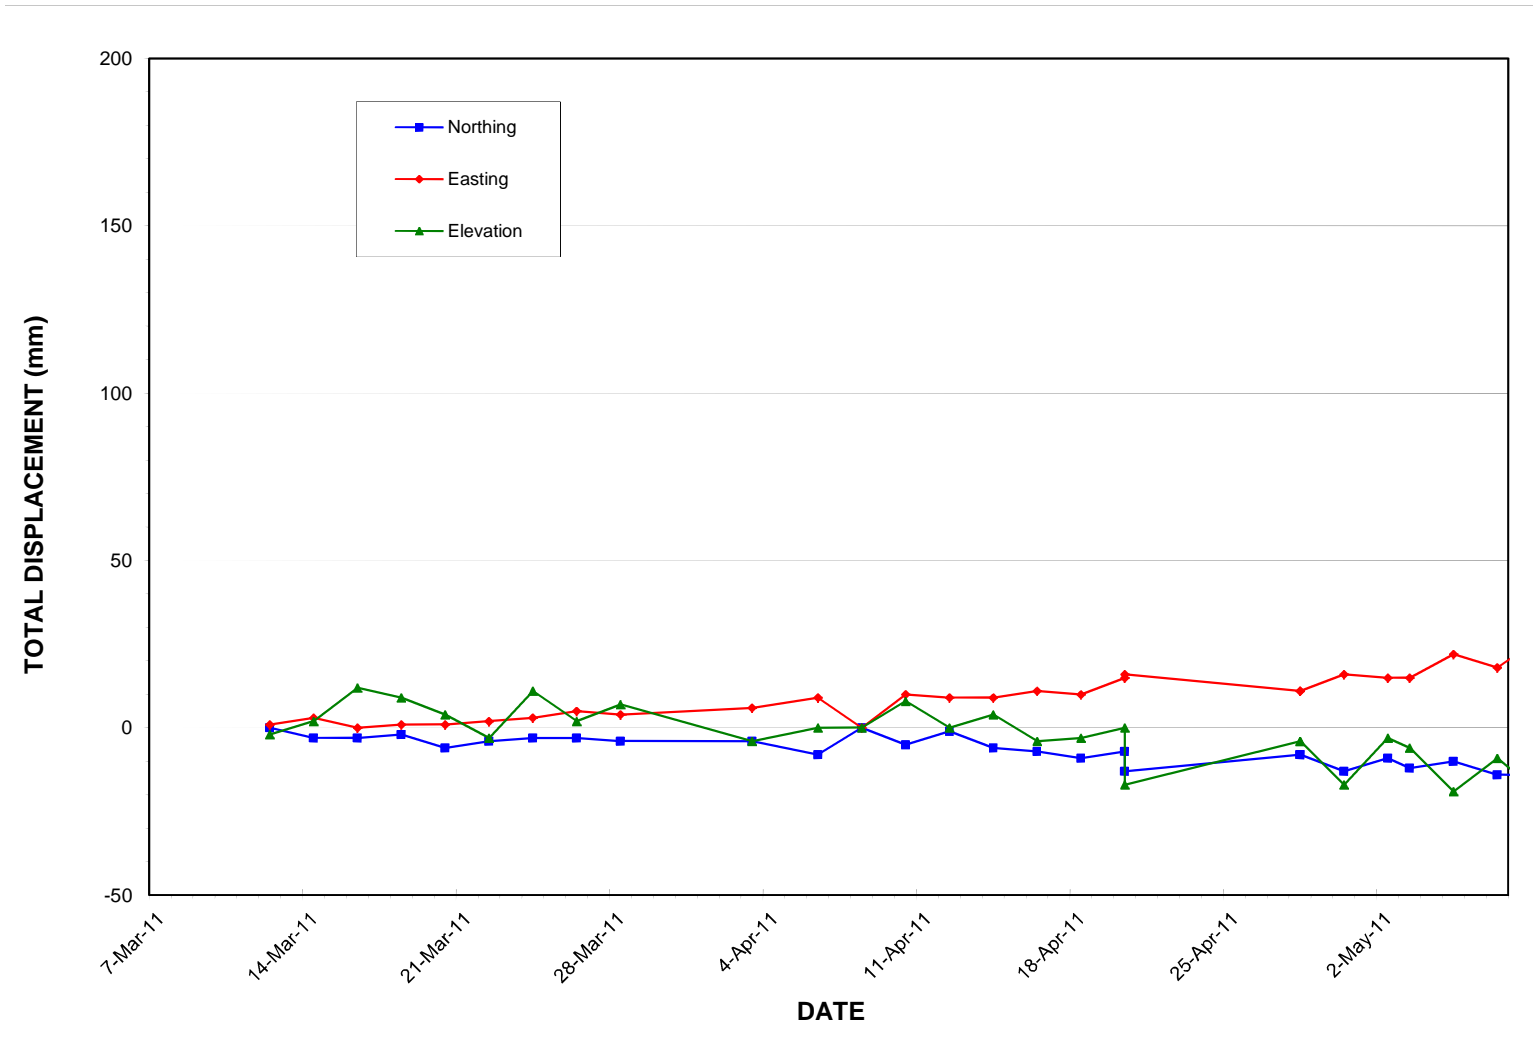
Southwest Waste Dump
 Survey Hub-SWD02
 Figure SH2

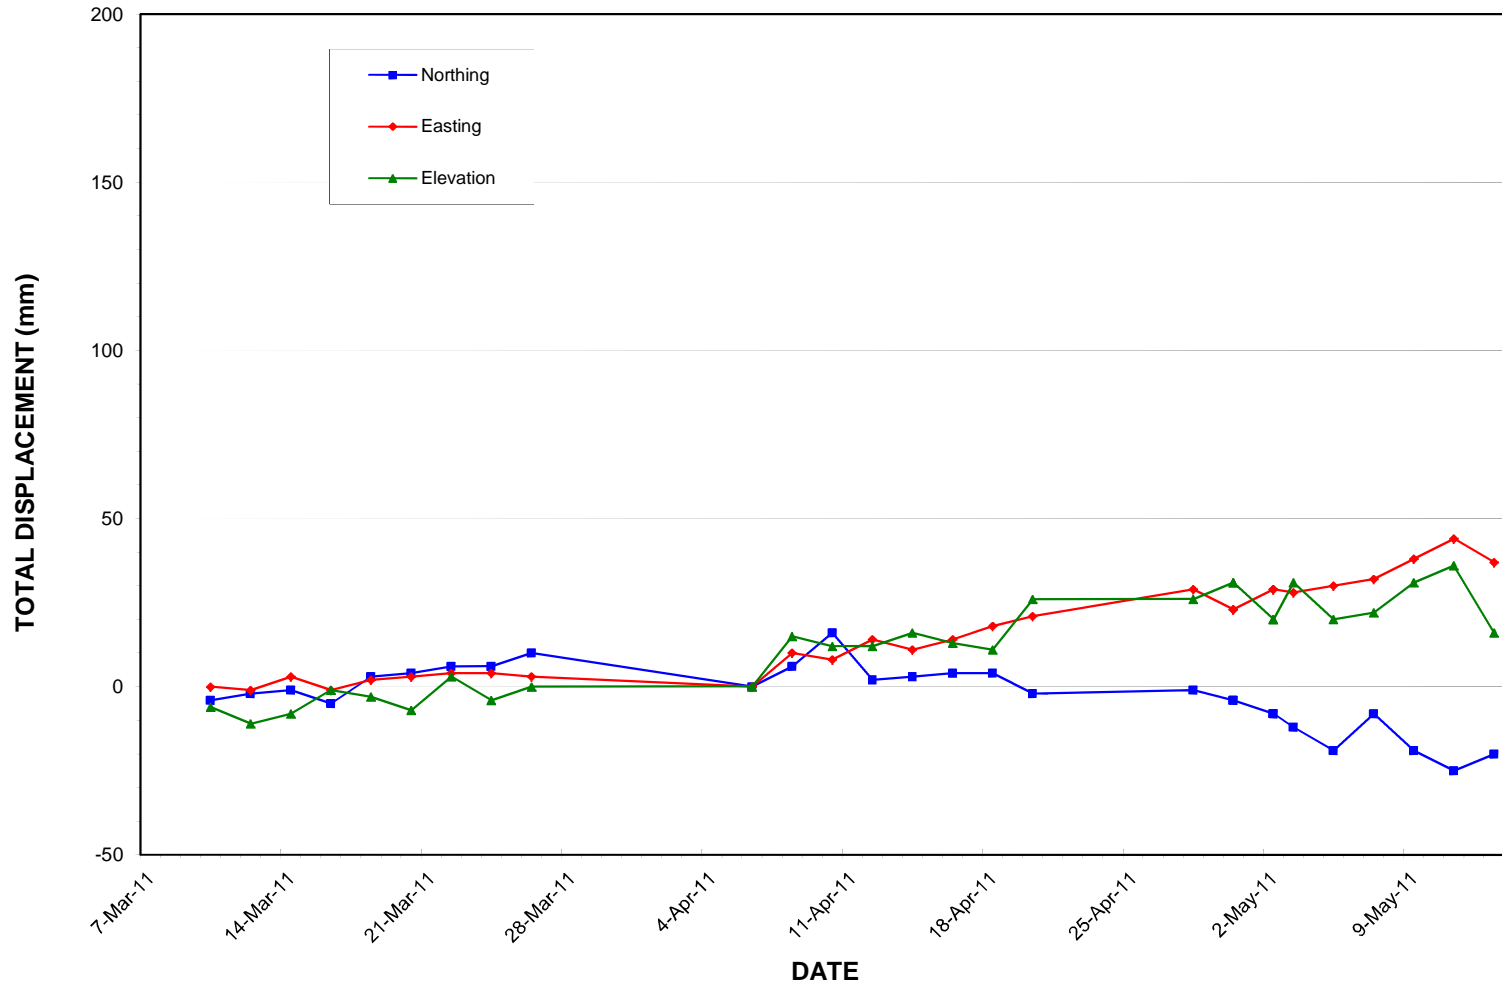
Southwest Waste Dump
 Survey Hub-SWD02A
 Figure SH2A
