ISSUED FOR USE
EBA FILE: W14101068.037

Subject: Southwest Waste Dump – 2011 Annual Review, Minto Mine, YT

As requested, this letter presents a report by EBA Engineering Consultants Ltd. (EBA) resulting from a site visit completed to examine the current condition of the Southwest Waste Dump (SWD) at Minto Mine, YT. The intent of the site visit was to provide a geotechnical engineering report on the condition of the dump, in partial fulfillment of the requirements of the existing Quartz Mining Licence QML-0001.

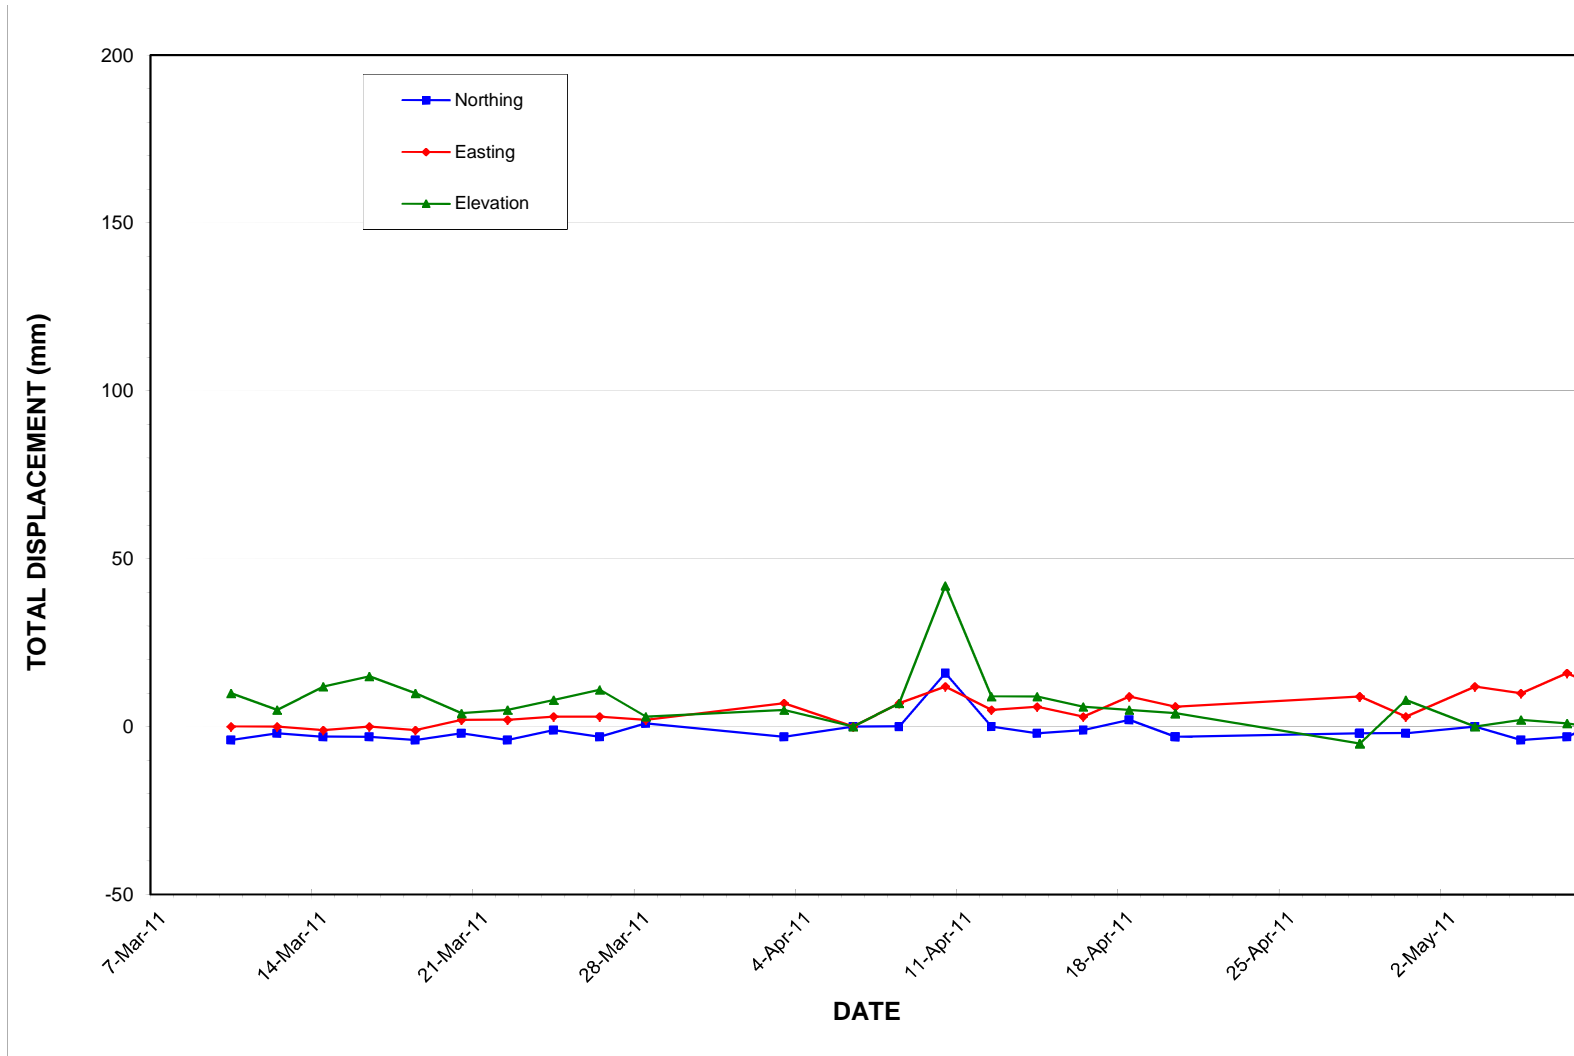
Movement data from the nine survey hub locations (SWD01, 01A, 02, 02A, 03, 03A, 04, 04A and-05A) are presented on the Figures SH1, SH1A, SH2, SH2A, SH3, SH3A, SH4, SH4A, SH5A. The data confirms that there is only noticeable movement at the north eastern corner (location closet to the Area 1 Open Pit). This movement is believed to be associated with the movements seen within the south wall of the Area 1 Pit.

Southwest Waste Dump
Survey Hub-SWD03
Figure SH3

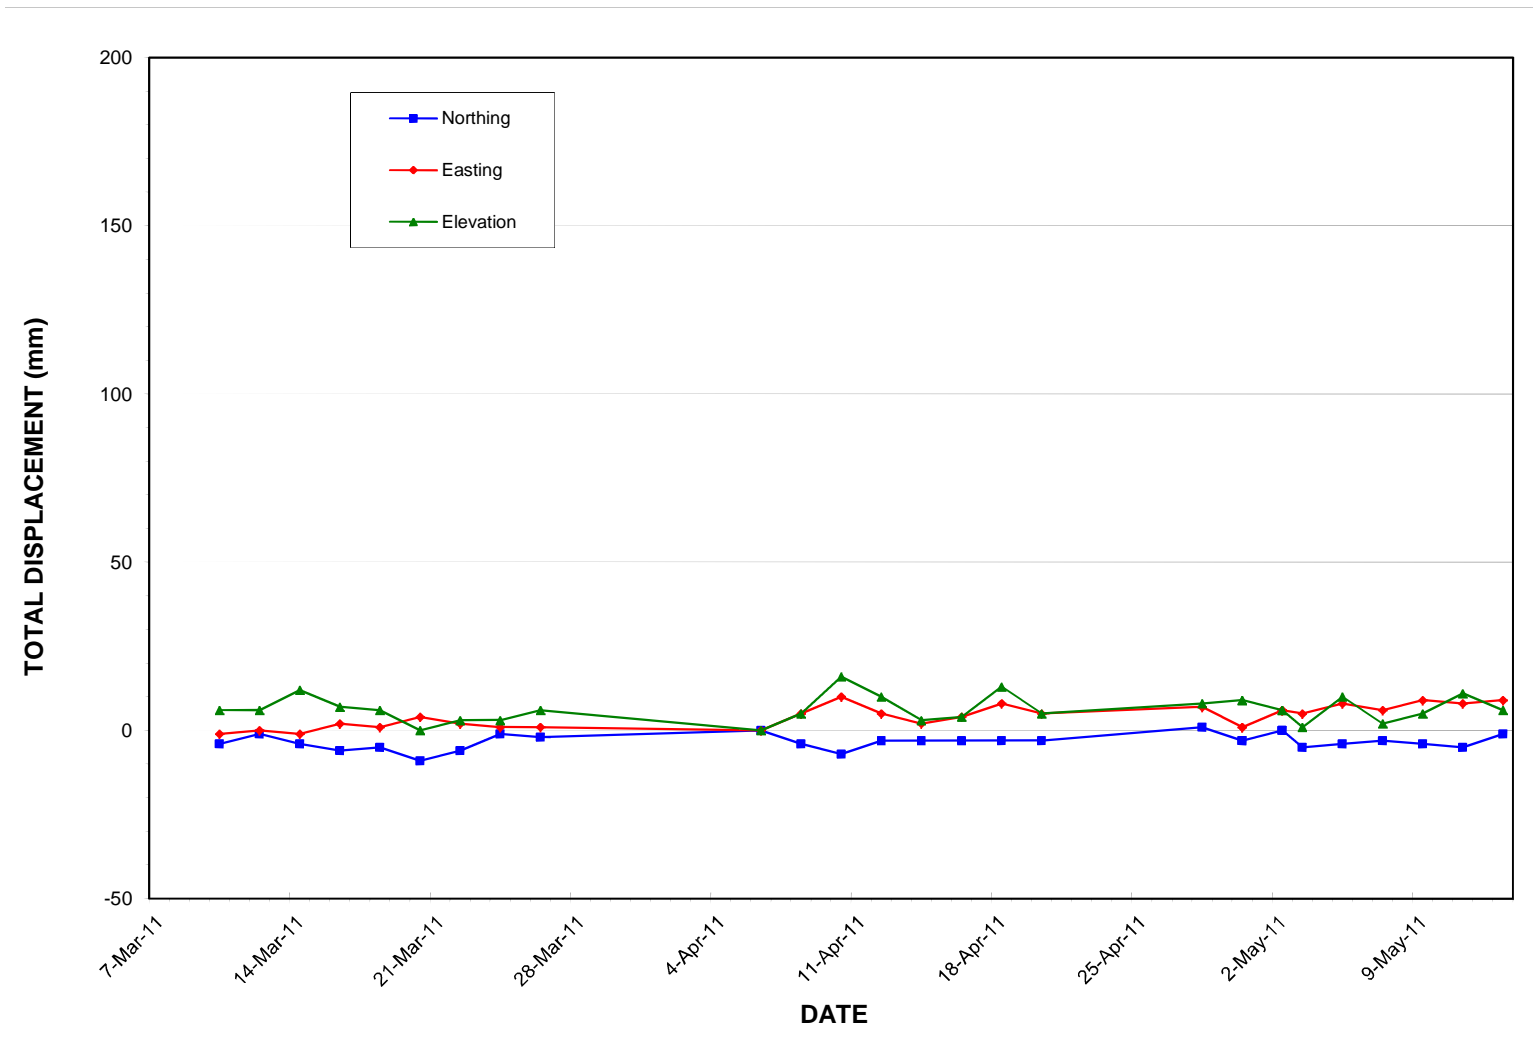
Southwest Waste Dump
 Survey Hub-SWD03A
 Figure SH3A

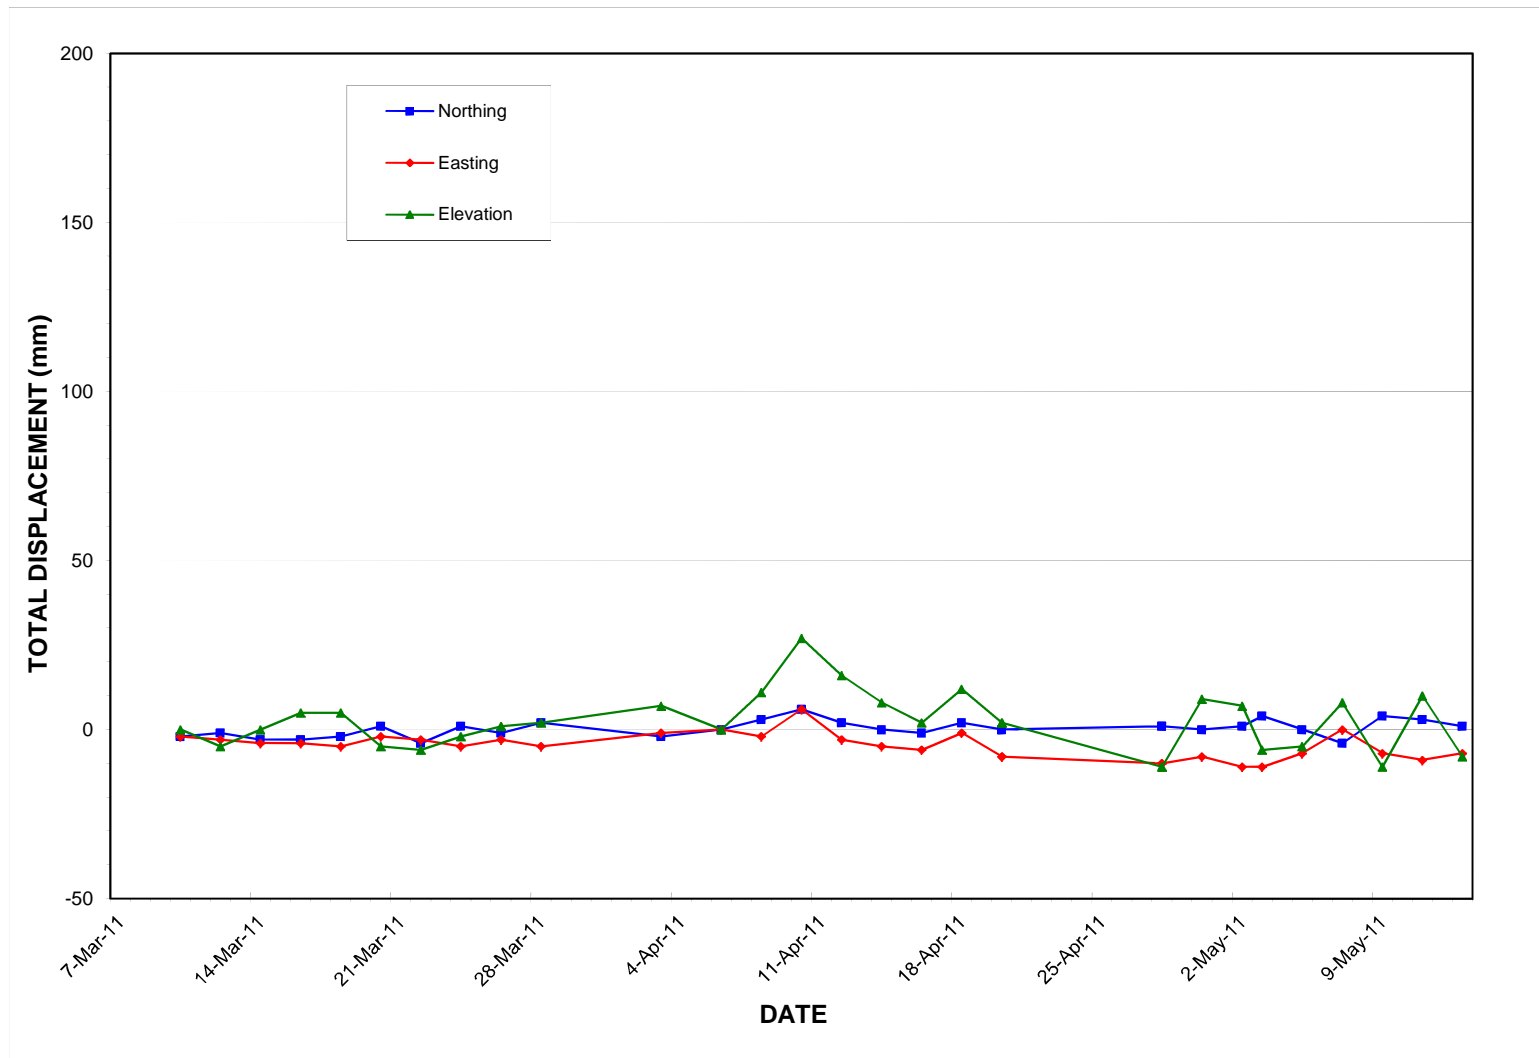
Southwest Waste Dump
 Survey Hub-SWD04
 Figure SH4

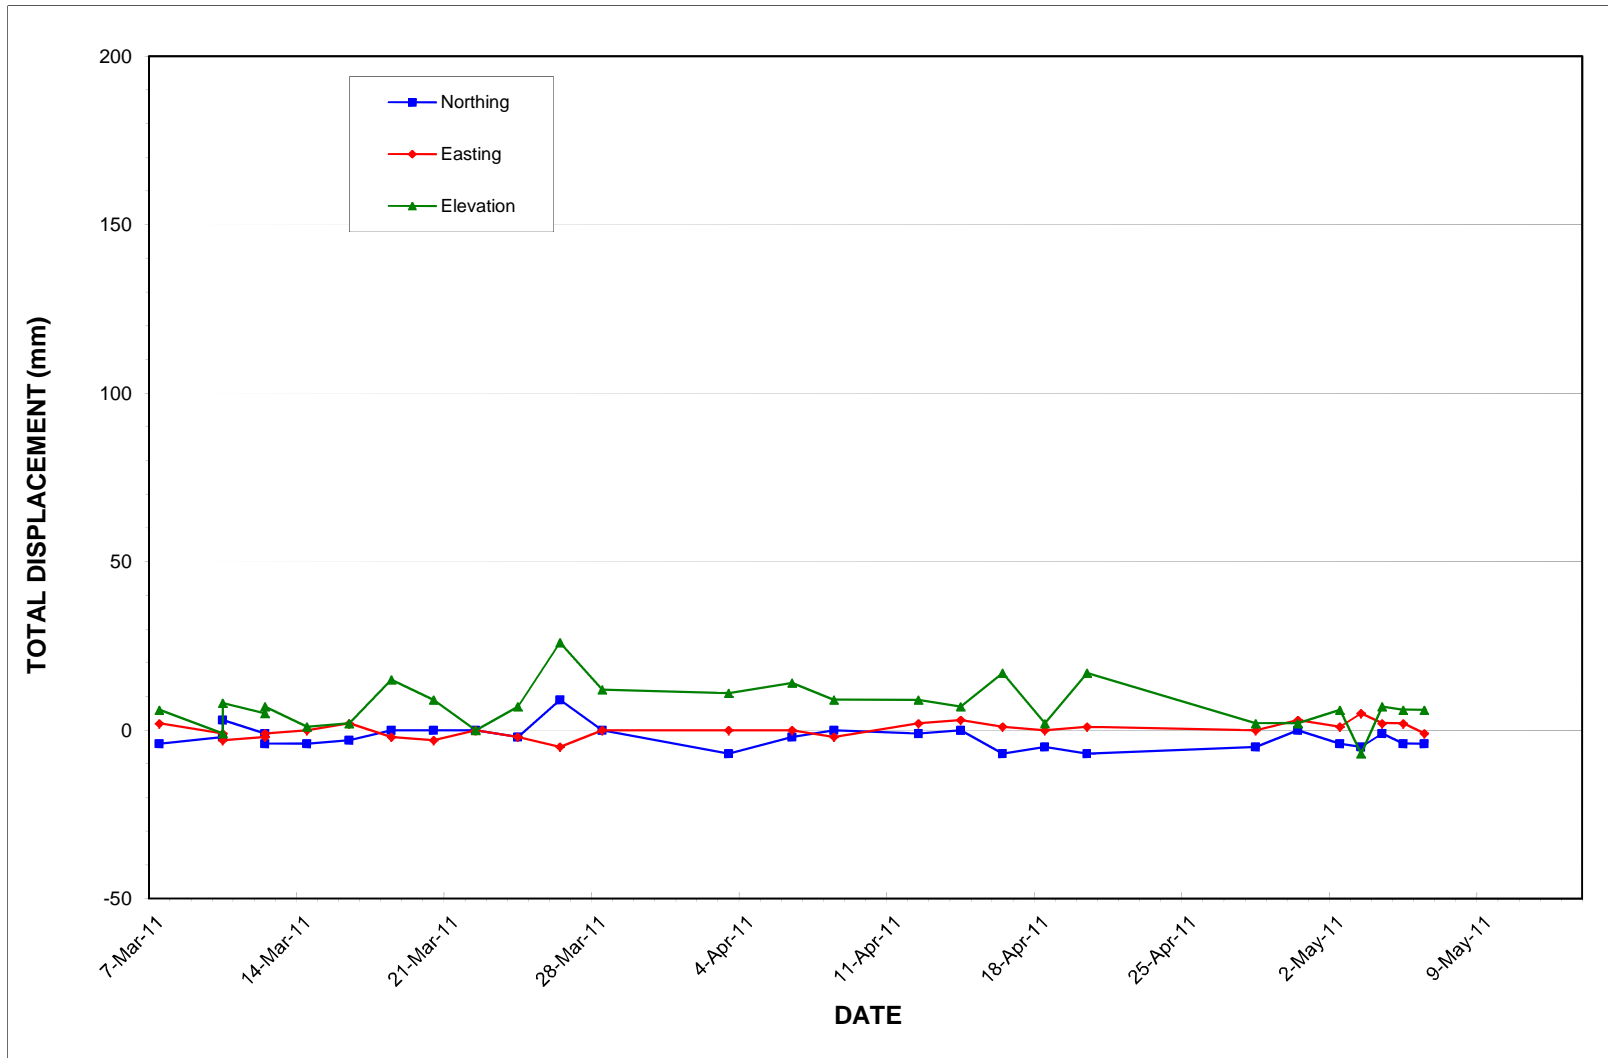
Southwest Waste Dump
 Survey Hub-SWD04A
 Figure SH4A

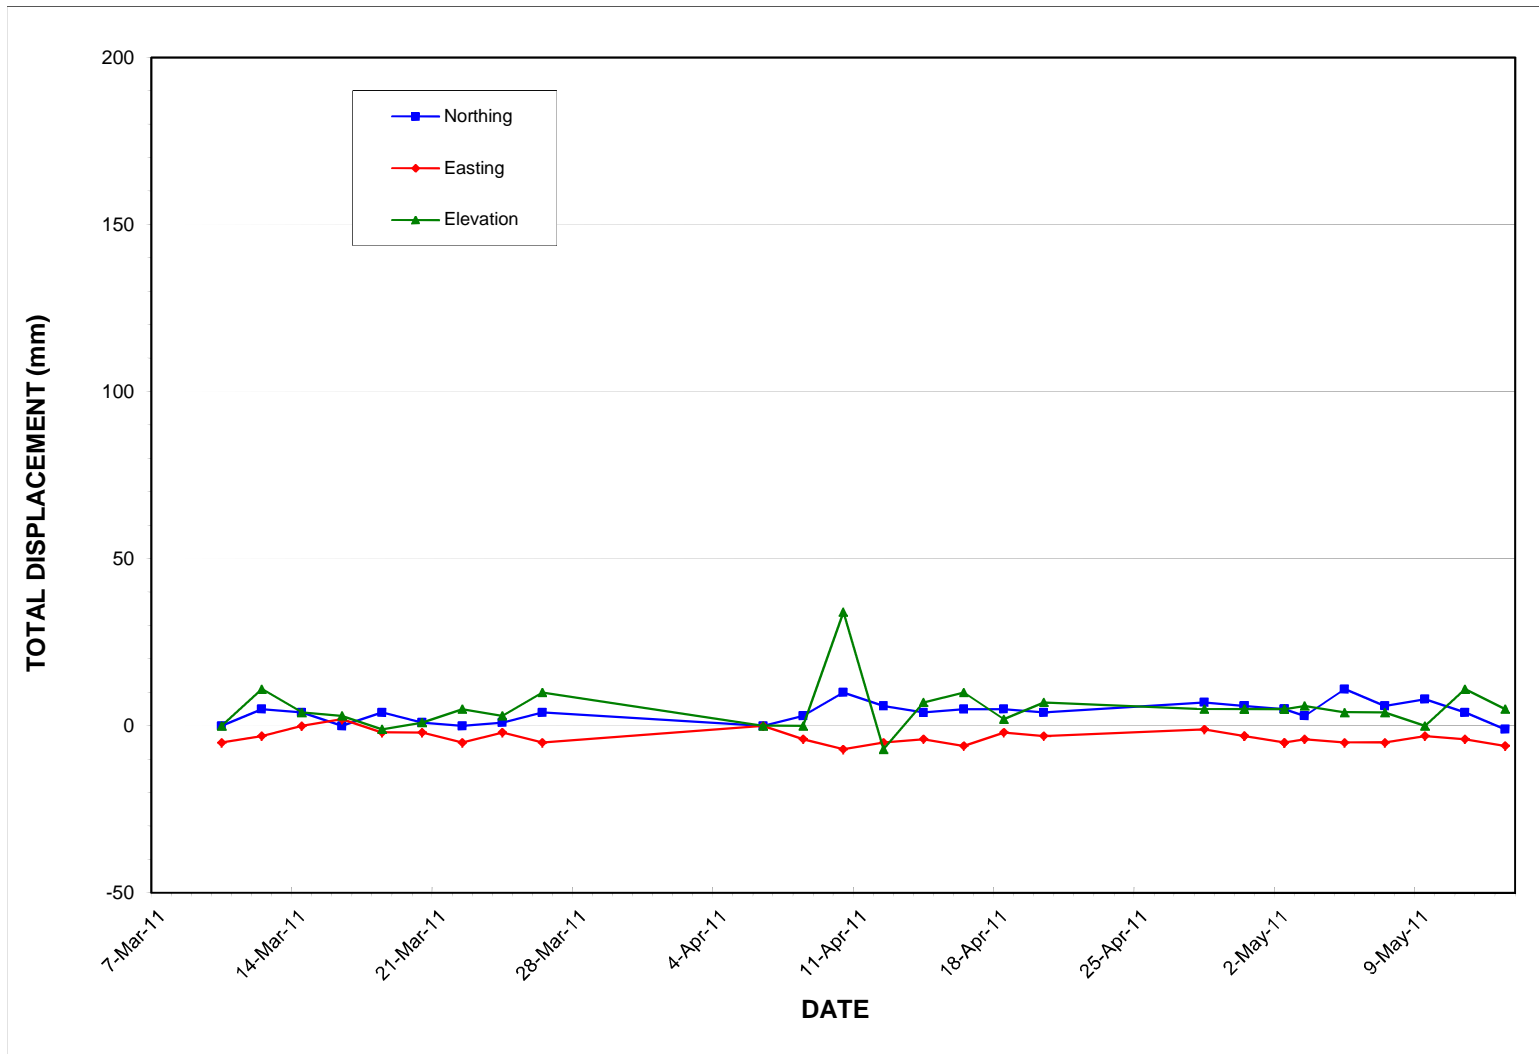
Southwest Waste Dump
 Survey Hub-SWD05A
 Figure SH5A

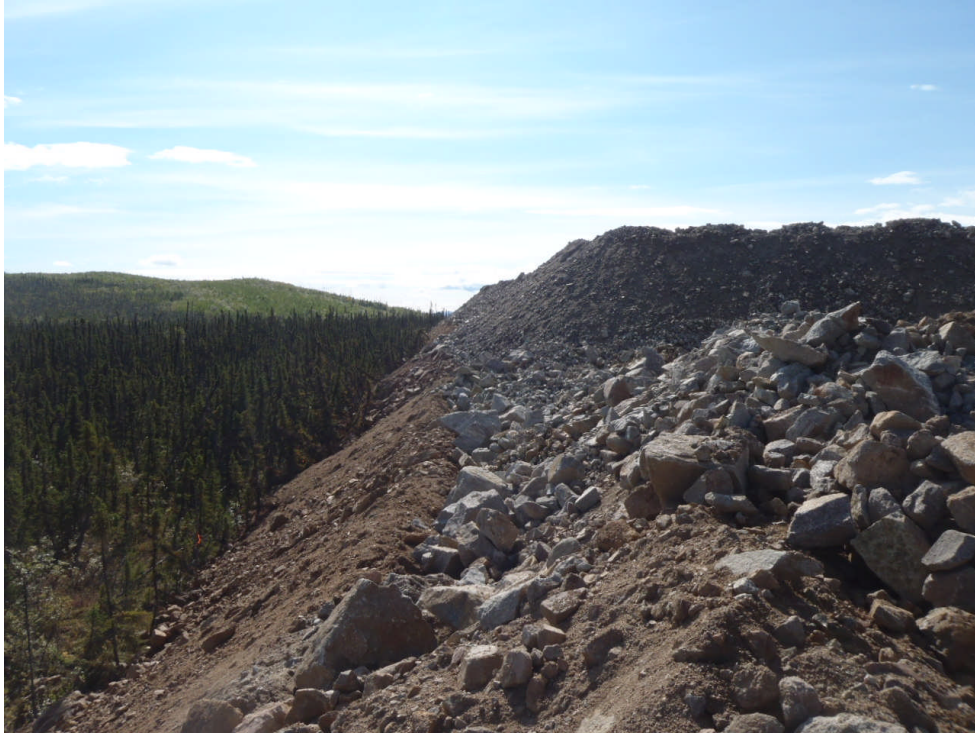
Photo 1

- Minto is utilizing a series of benches and setbacks during dump construction (Photos 1 and 2). Benches of finer grained non ice-rich waste have been constructed back of the overall crest of the facility. These benches are being and will continue to be capped with coarse waste rock until the ultimate dump dimensions are achieved. Therefore, the exterior slope will be constructed with coarse waste rock only. This construction method follows recommendations outlined in the design report.
- Many of the benches of finer grained non ice-rich waste had not been levelled and there were noticeable areas of ponded water (Photo 3).
- The slopes appear consistent with original placement; no signs of slumping, bulging, or tension cracks were noted. No erosion was noted along the toe or within the dump (Photo 4).

Looking south along the eastern perimeter of the SWD lower waste rock bench. (August 25, 2011)

The design report stipulates that only coarse waste rock should be used within the exterior slope of the dump (design toe to 30 m setback from ultimate design crest). Construction practices should account for this 30 m setback and the monitoring of material placement. Areas of overburden and waste rock should be surveyed to establish a clear record of material placement locations within the dump.

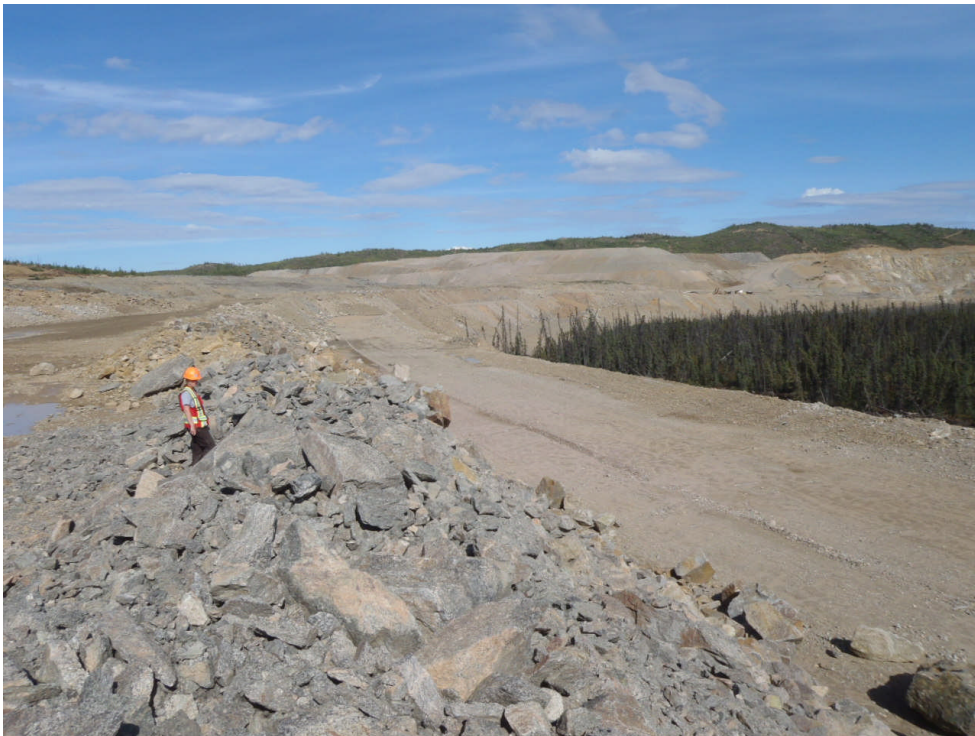
Photo 2

Looking northeast along the eastern waste rock benches. (August 25, 2011)

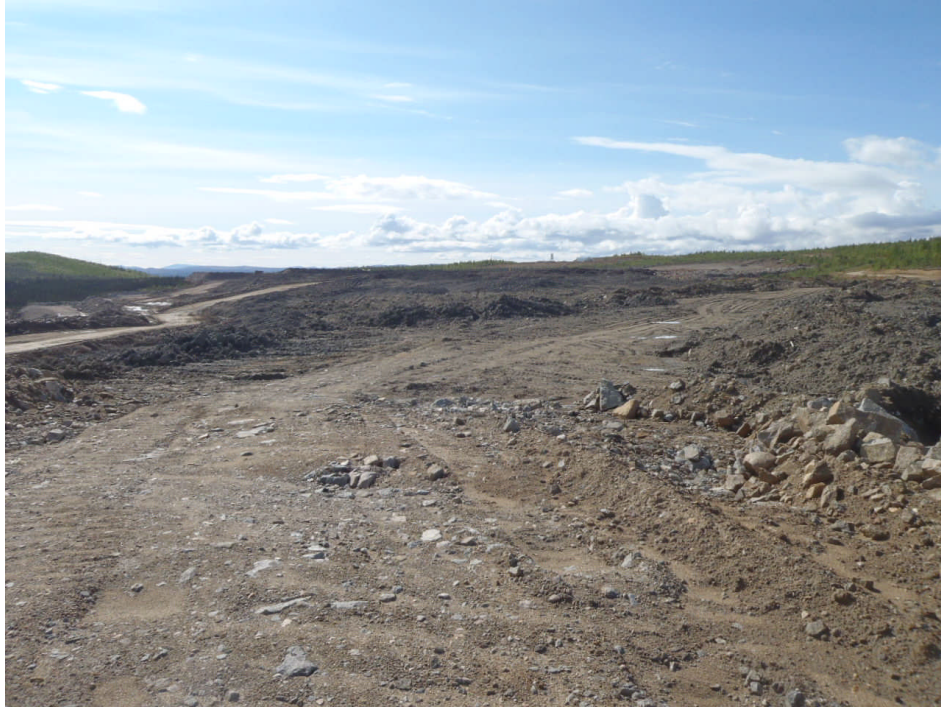
Photo 3

Looking south at the unlevelled non ice-rich waste on the crest of the SWD. (August 25, 2011)

Minto understands that it is common practice to grade each bench prior to moving to the next and not leave unlevelled end dump piles. It is recommended that this practice be continued to promote surface water to drain off the facility and not pond on the bench.

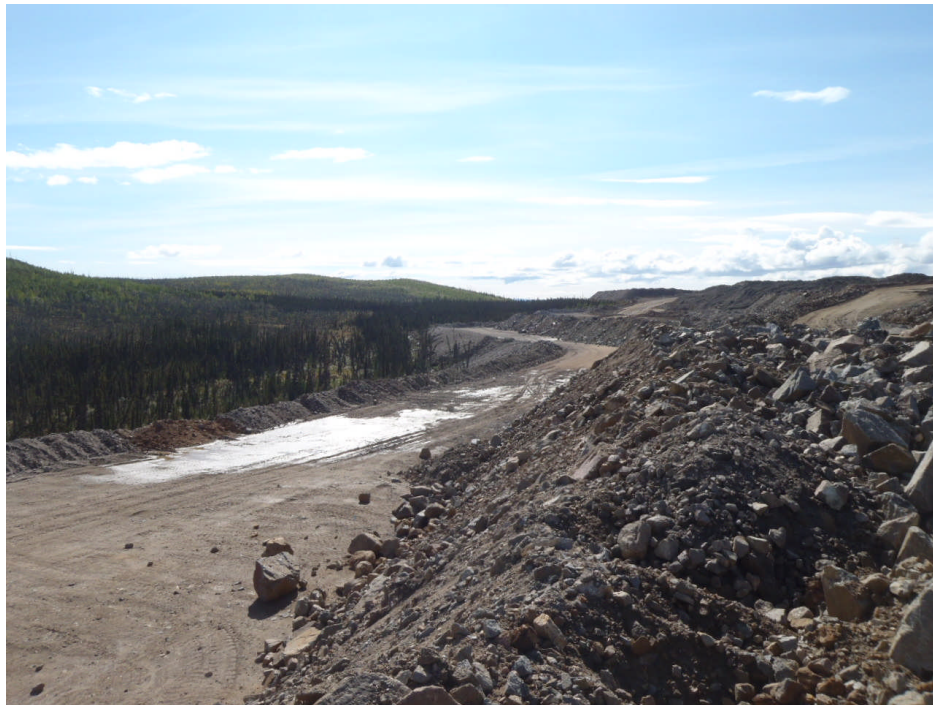
Photo 4

Looking south at the lower perimeter benches of the SWD. (August 25, 2011)
