# 2016 Geotechnical Annual Review, Minto Mine, YT

SRK Consulting (Canada) Inc.  
1CM002.048  
November 2016

On June 13-14, 2016, SRK Consulting (Canada) Inc. completed a geotechnical inspection of the Minto Mine site (Figure 1). The purpose of the inspection was to document the physical condition of the site based on visual observations and to provide geotechnical assessment, noting potential signs of physical instability such as erosion, differential settlement, sloughing or bulging of material, seepage, etc. The inspection is documented in the photographic compilation provided in Appendix A. This report summarizes the findings and recommendations.

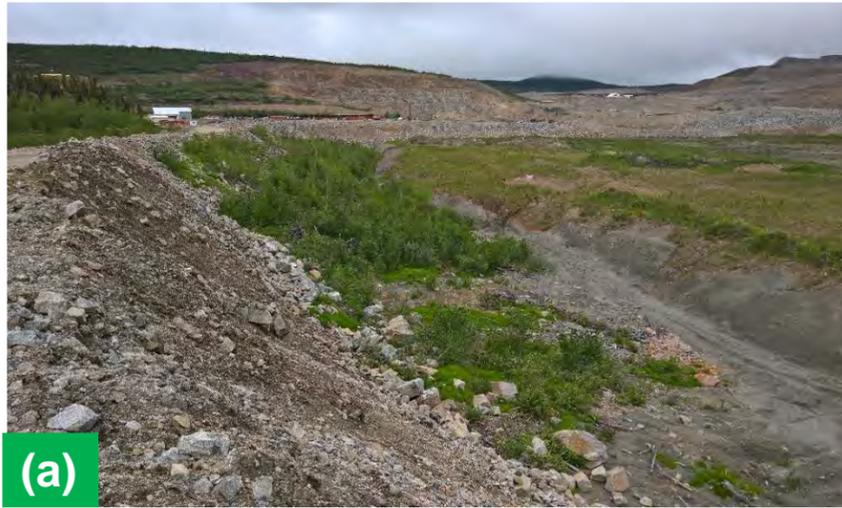
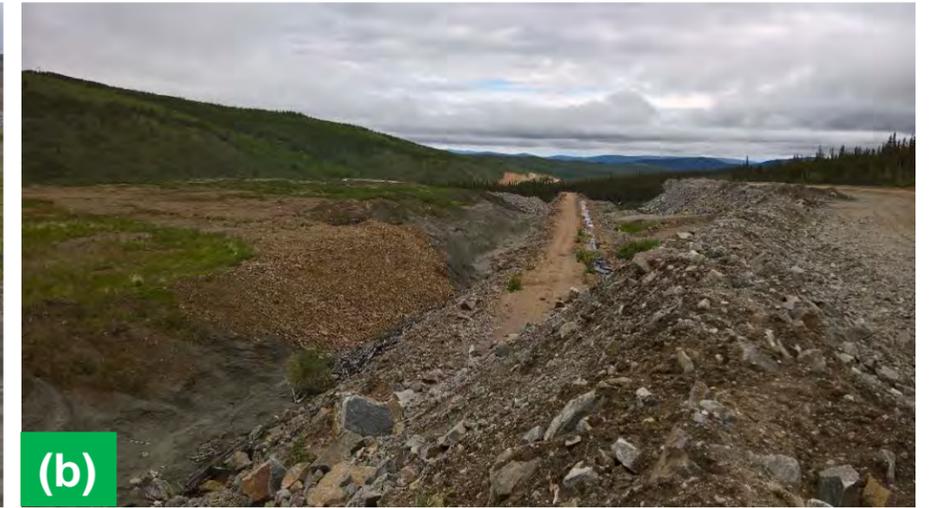
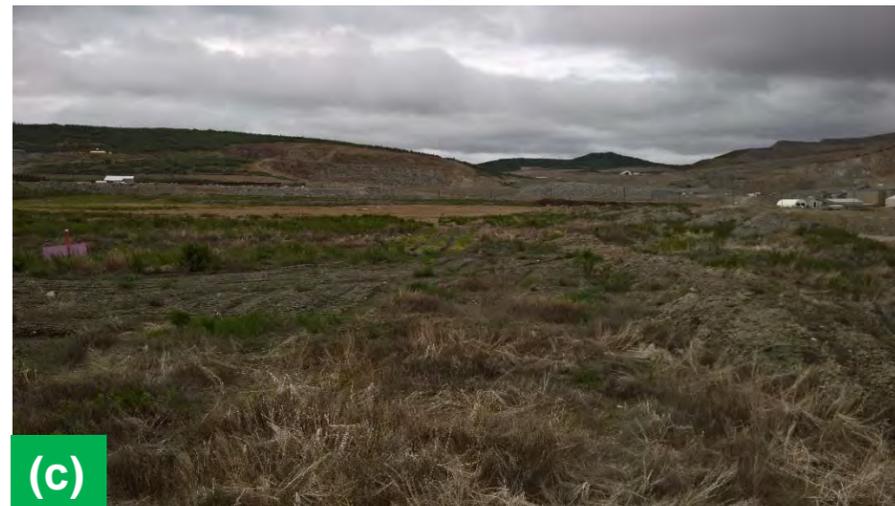
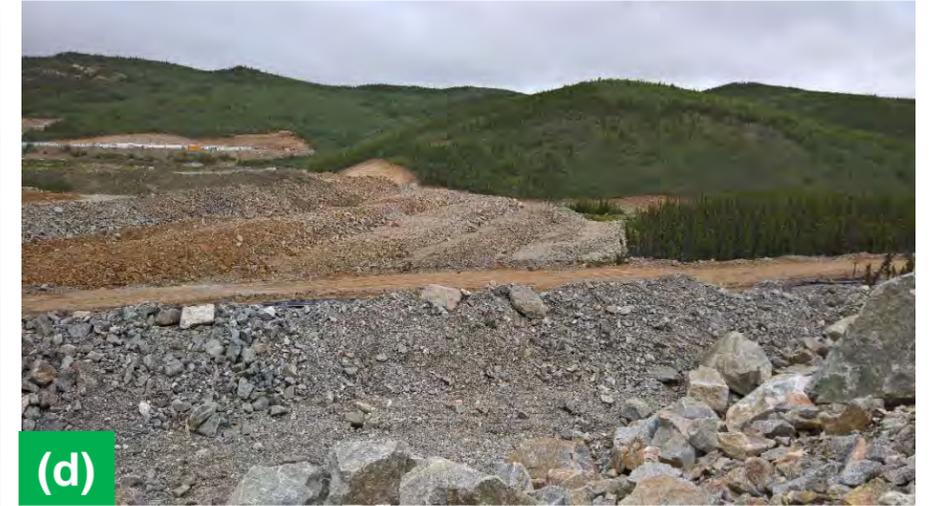
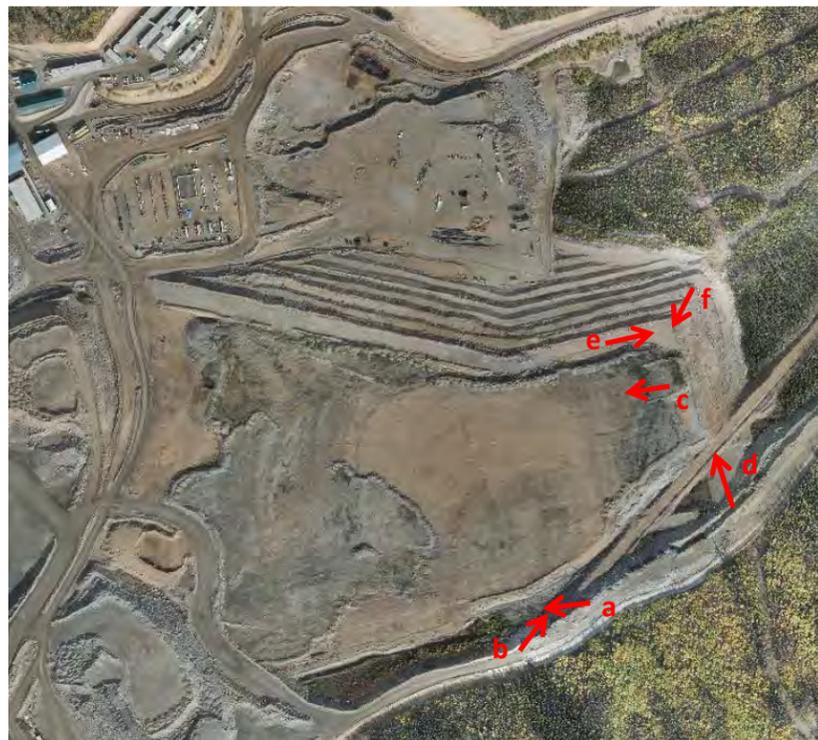
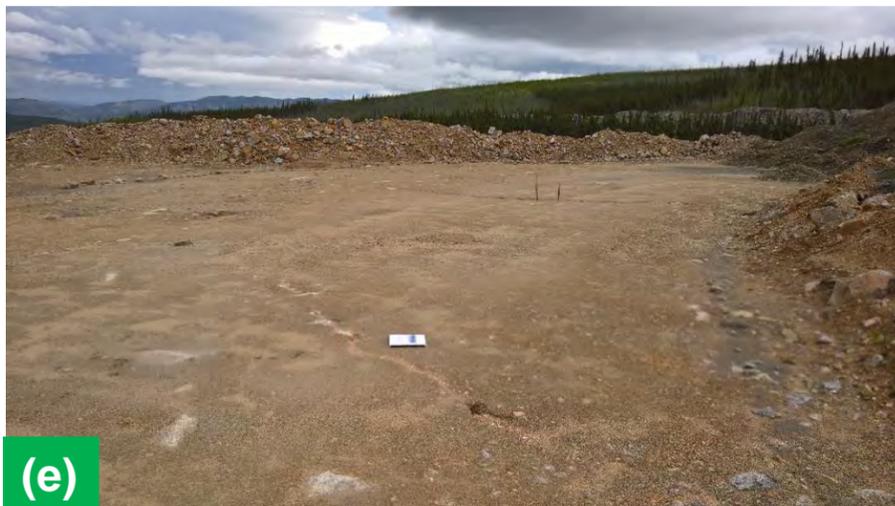
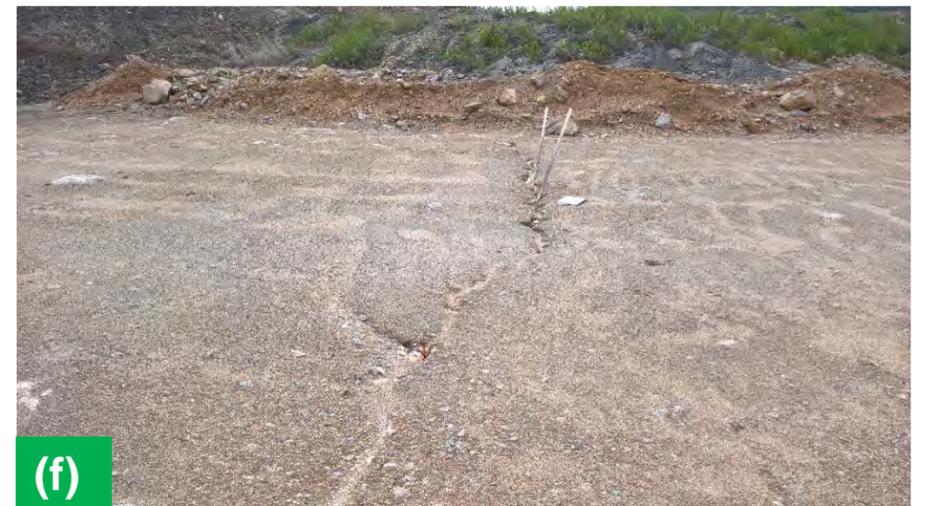
2016 Geotechnical Inspection		
		<b>Dry Stack Tailings Storage Facility</b>		
Job No: 1CM002.048 Filename: AppA_2016InspectionPhoto.pptx	Minto Mine	Date: Nov 2016	Approved: PHM	Figure: <b>2</b>

- Conditions are similar as the June 2015 inspection.
- Two survey hubs on the DSTSF cover that have experienced frost heave (DSSH 23 and DSSH 25) have been replaced by hubs DSSH 26 and DSSH 27 that are mounted on standard sized lock blocks.
- Photo (a) shows the south end of the DSTSF and exposed tailings from the TDD looking east.
- Photo (b) shows the former TDD and south end of the DSTSF.
- Photo (c) shows the vegetation growth at the eastern end of the DSTSF looking west.
- Photo (d) shows the east side of the waste rock shell
- Photos (e) and (f) show the crack on the WR shell at the north east corner of the DSTSF first observed in 2014. Compared to photographs from the June 2015 inspection, the crack is more continuous across the WR Shell crest. Pins have been set up to monitor crack width vs time.

- Continue to monitor the crack on the north-east corner of the DSTSF

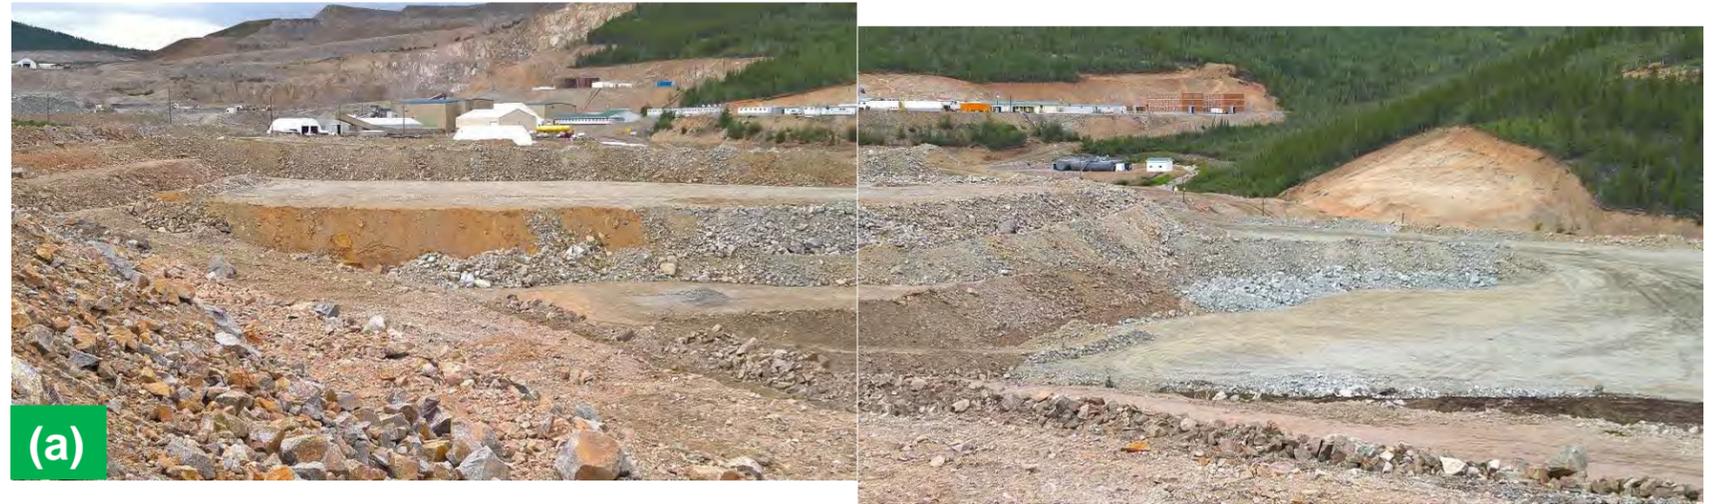
(a)

As a result of the high pore pressures, monitoring and inspection frequencies were increased during construction. In addition, two survey hubs (MV1 and MV2) were installed on the eastern slope of the MVFE Stage 2 in April 2016. Data from the survey hubs indicate an easterly movement of the slope at a rate of 0.3 mm/day and 0.8 mm/day. At this time, it is uncertain if this movement is related to the DSTSF movement, or due to the high pore pressures within the fine grained, near surface overburden (as observed at the Southwest Waste Dump).

No major signs of instability were observed at the time of the inspection.

- Photo (a): View of the top two tiers of the MVFE Stage 2.
- Photos (b), (c) and (d) show the eastern slope of the MVFE Stage 2 and the location of the survey hubs MV1 and MV2.

**Medium priority:** Additional survey hubs and inclinometers within the DSTSF and MVFE are planned. Some of this instrumentation, including at least one inclinometer near toe of the MVFE Stage 2 (near MV1), should investigate the cause of the observed movement.

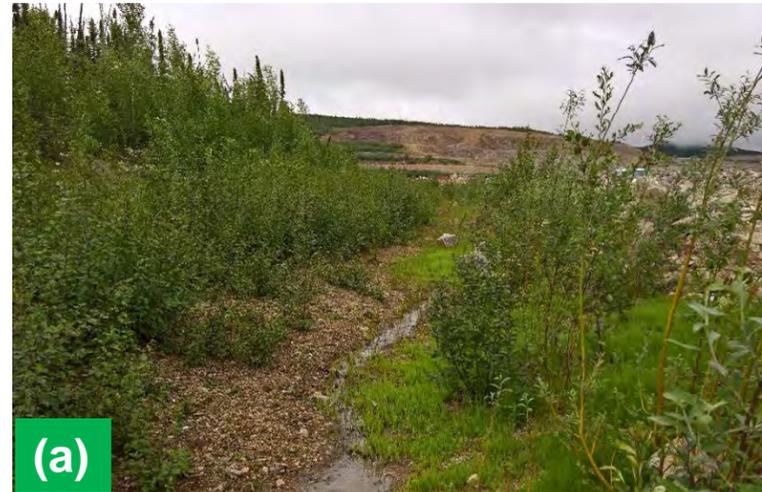
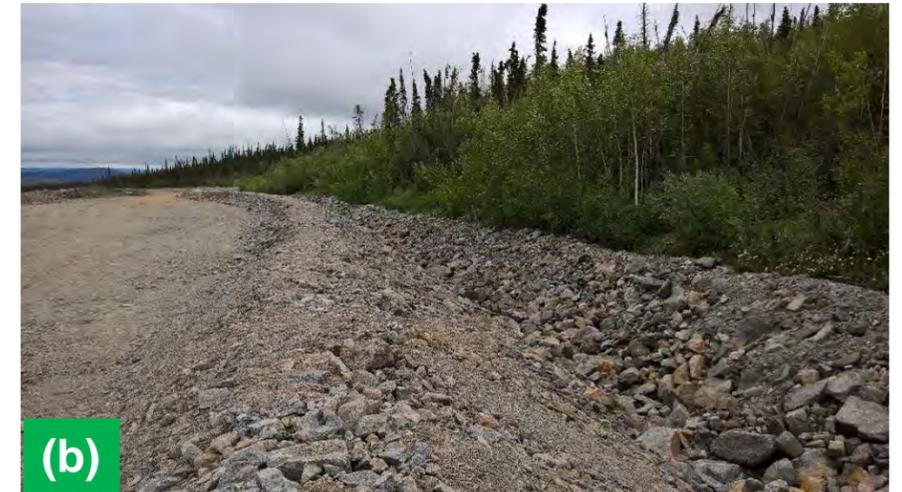
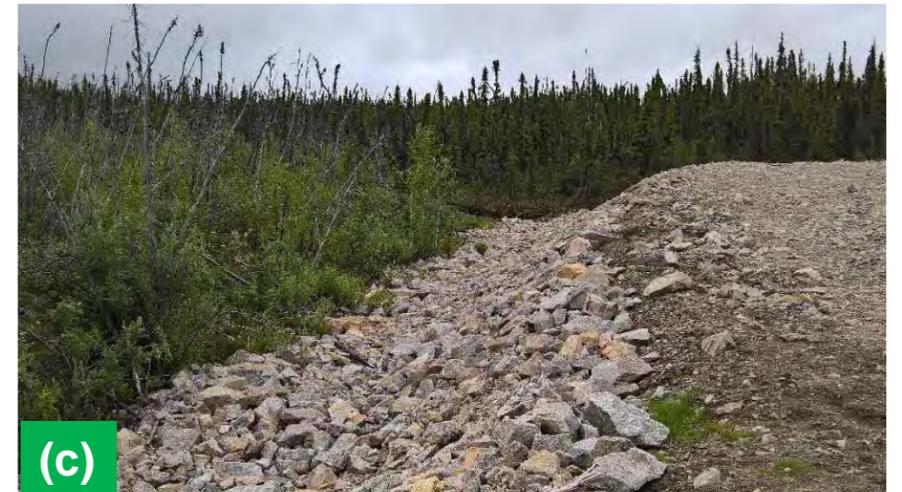
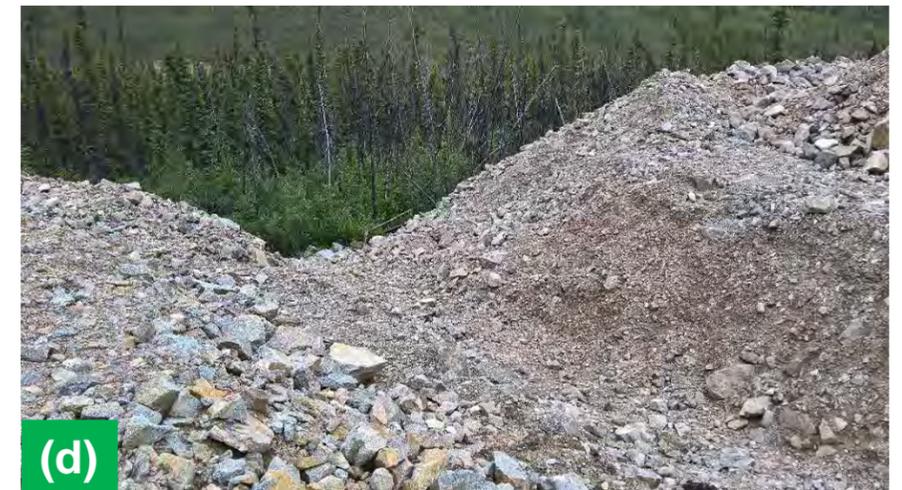
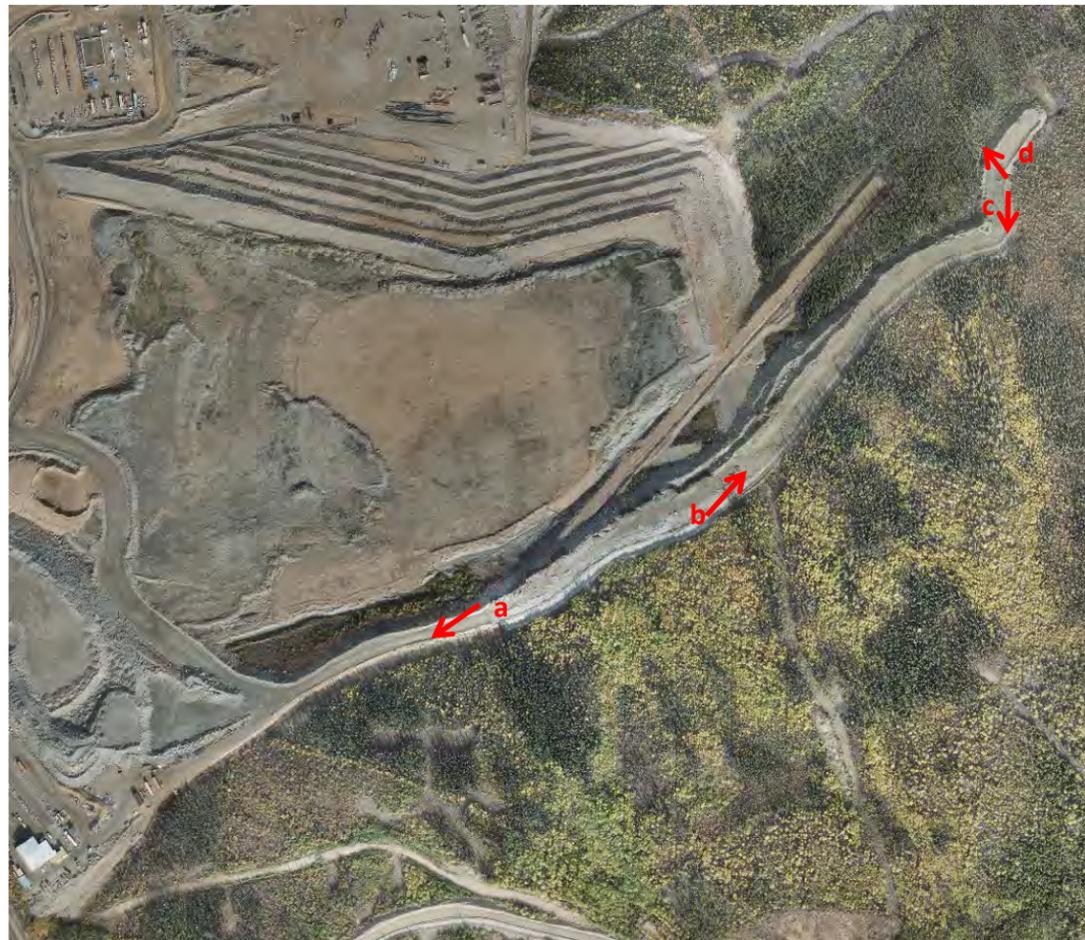
- In general, the berm and ditch appeared functional, with conditions in the western portion similar to those observed in previous inspections. No signs of instability or ditch obstructions were noted along the ditch alignment.
- The ditch outlet was excavated through placed waste rock. The slopes were steep, and a high amount of finer material was noted along the excavated slopes. This may be susceptible to erosion during large flow events.

- (a) View of the upper, unarmoured portion of the diversion ditch. Vegetation growth is significant over a small portion of the ditch, but is not believed to be impacting the flow capacity due to the excess design capacity of the ditch.
- (b) and (c) View of the lower, armoured diversion ditch. Rip-rap is well placed, and compacted, and the ditch is free of debris.
- (d) View of the ditch outlet

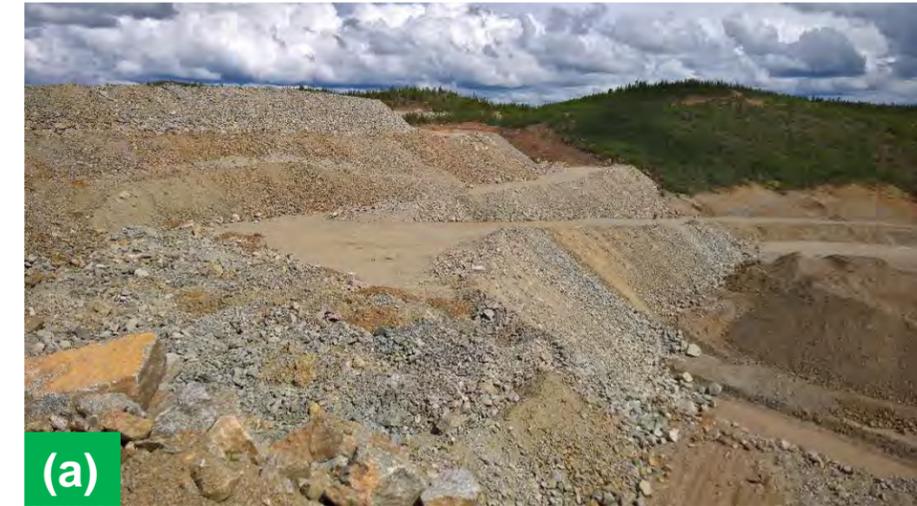
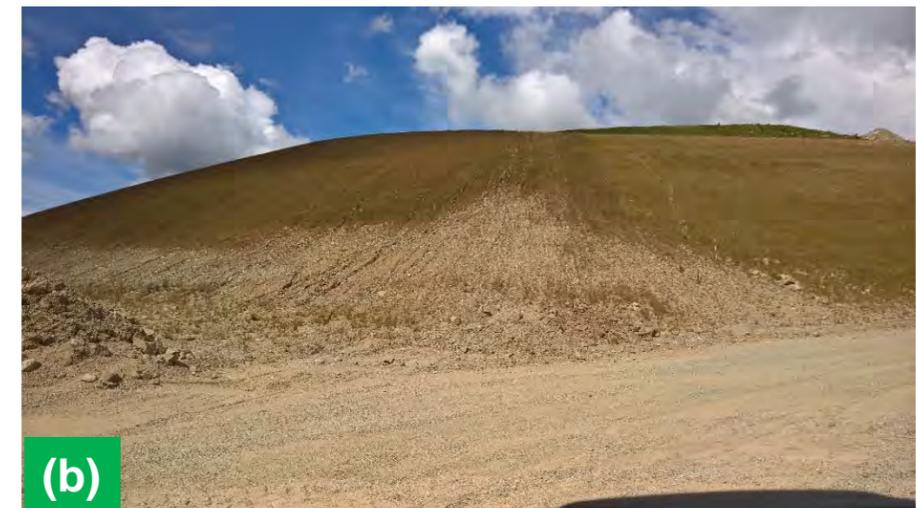
- Construction of the Main Waste Dump Expansion (MWDE) has been largely completed within the past year.
- No major signs of instability were observed.
- Minor cracking was observed near the crest of the MWDE (Photos (c) and (d)). Two parallel cracks approximately 15m long and 1 to 3 mm wide. The cracking is believed to be due to differential settlement of the waste rock due to differences in the fill height on either side of the cracks.
- Photo (a): Overview of the eastern face side of the MWDE looking northeast.
- Photo (b): View of the erosion visible on the regraded waste rock dump. Minor rills and gullies are present at the base of the regraded slope where vegetation is not yet established.

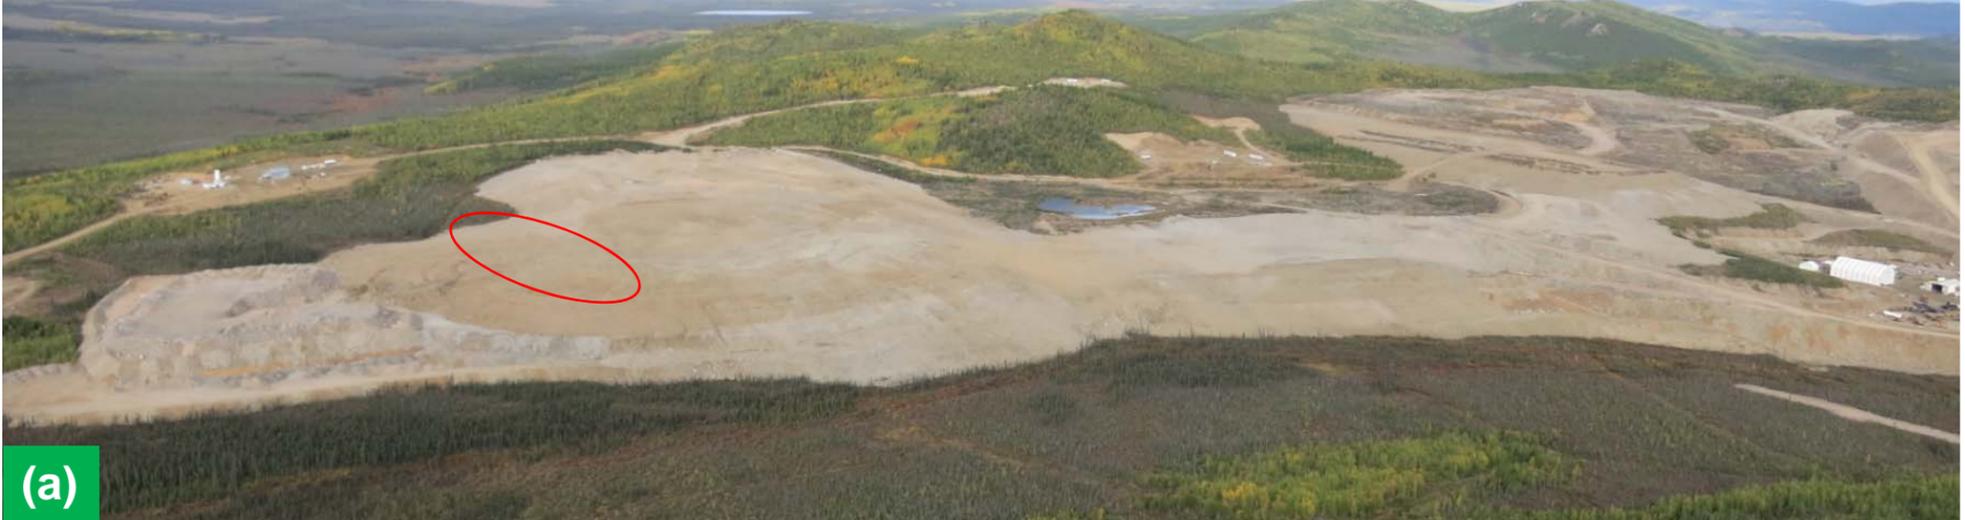
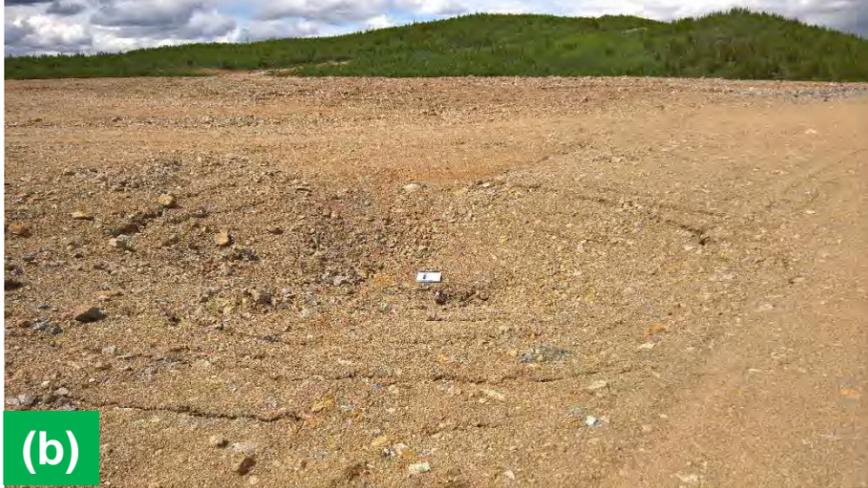
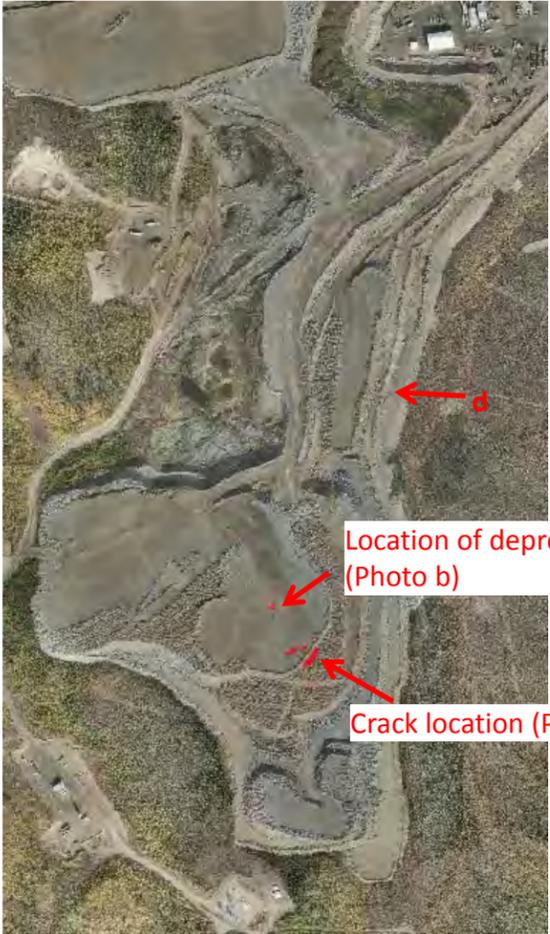
- Conditions of the Southwest Dump (SWD) are similar to those documented in the 2015 annual inspection.
- The crack noted in the 2015 inspection report has a length of 36 m, a width of 7.5m and a depth of 1 m.

- A depression (Photo (b)) was observed approximately 100 m northwest of the crack with a diameter of approximately 5 m and depth of 1 m.
- The approximate locations of these features are circled in Photo (a), with the surveyed locations noted on the 2014 orthophoto below. The orthophoto shows that the large crack occurs along a former angle of repose slope. The crack may be the result of settlement of fines with the coarse material near the base of the former angle of repose slope.

- Photo (d) shows an eroded slope as a result of dewatering of ponded water from the area south of the IROD. The pond is visible in Photo (a).
- Survey hub SWD-06 has been installed to replace SWD-01A that was impacted by frost heave. The remainder of the hubs that have experienced frost heave (SWD-02A, -03A, -04A, and -05A) have yet to be replaced due to accessibility issues.

Location of depression (Photo b)

Crack location (Photo c)

- Continue to monitor the observed crack and depression area.
- **Medium Priority:** The remainder of the survey hubs that have heaved should be replaced.

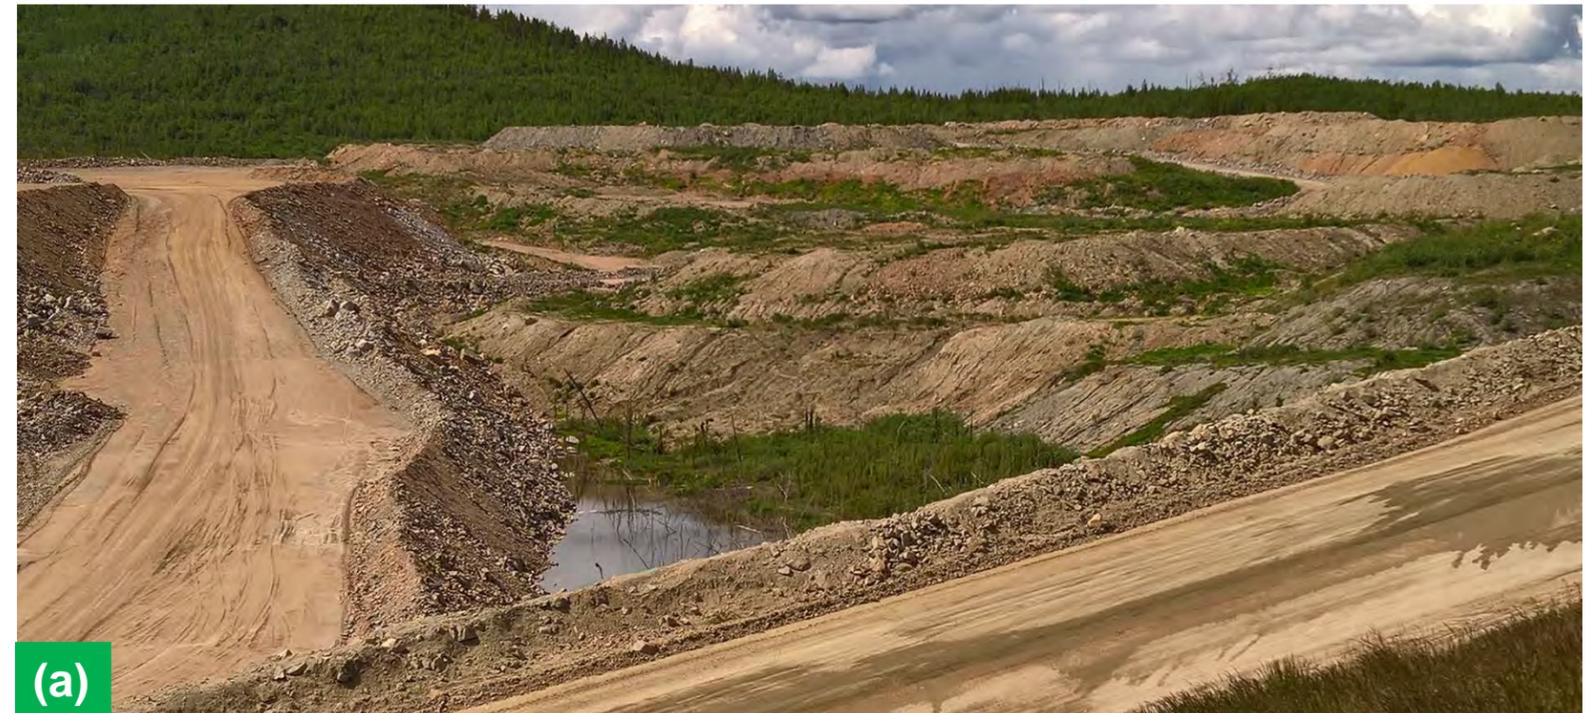
- Conditions at the Reclamation Overburden dump (ROD) remain the same as noted in previous years' inspections:
  - Slumping, settlement and tension cracks are expected in the dump as it is constructed with frozen overburden with thawing expected.
  - Discontinuous tension cracks and differential settlement observed along the perimeter crest.
  - Ground undulation is typically 0.3 m and is prevalent throughout the facility.
- Photo (a) shows a small slope failure first observed in 2014. The failure has not compromised the overall dump slope angle and as a result, the failure is not expected to reduce the overall stability of the dump. Historical vantage points for photographs were inaccessible by truck due to modified access road alignments.

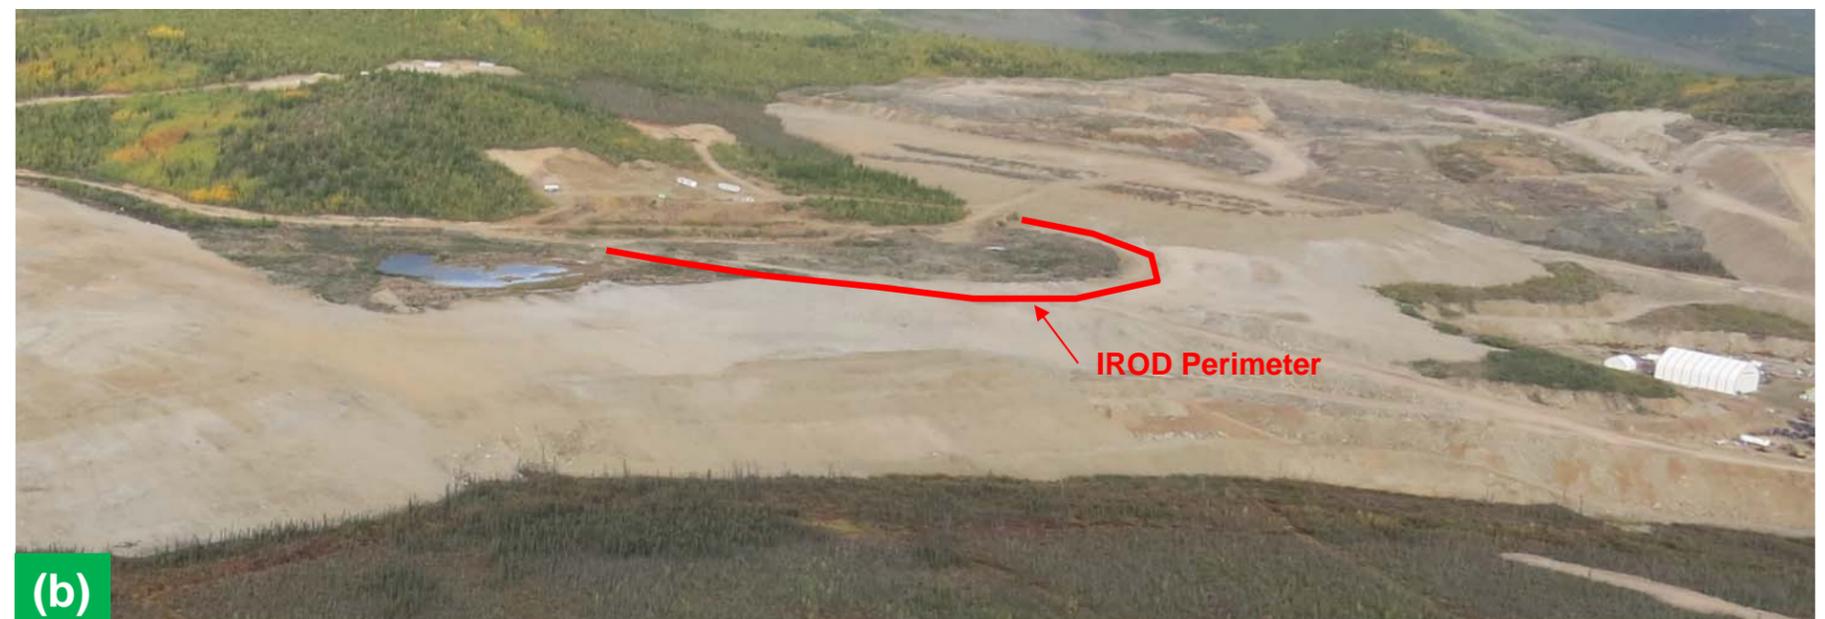
2016 Geotechnical Inspection		
		<b>Reclamation and Ice Rich Overburden Dumps</b>		
Job No: 1CM002.048 Filename: AppA_2016InspectionPhoto.pptx	Minto Mine	Date: Nov 2016	Approved: PHM	Figure: <b>7</b>

- The IROD is completely contained by the Southwest Dump.
- Photo (b) shows an aerial photo of the IROD taken September 2015.
- No pooled water was observed around the perimeter of the IROD indicating that water is able to drain as per the original design intent.

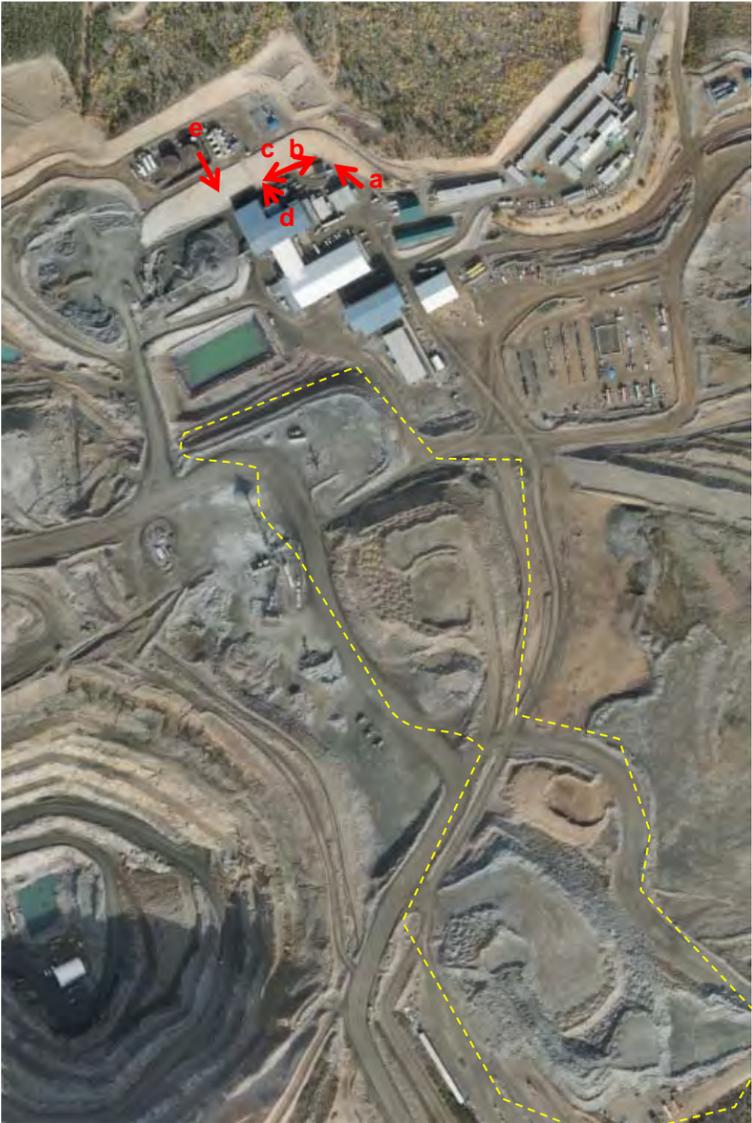
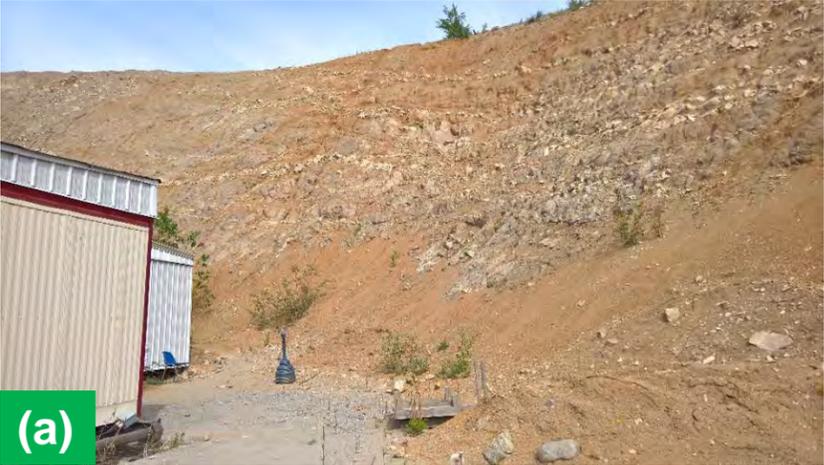
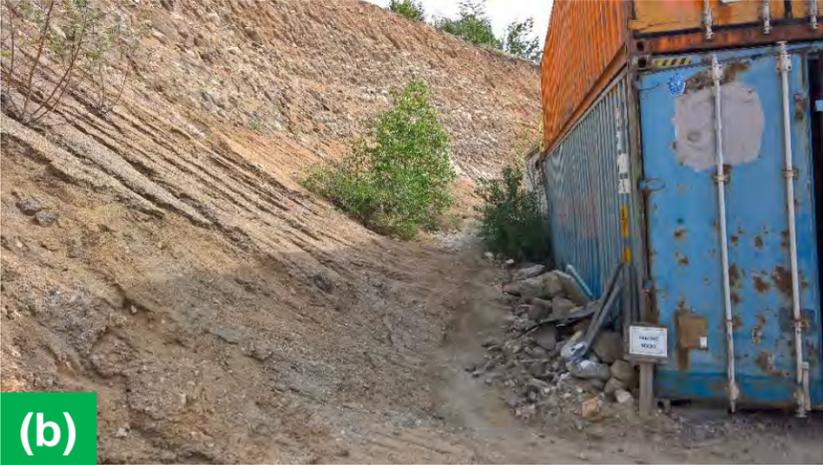
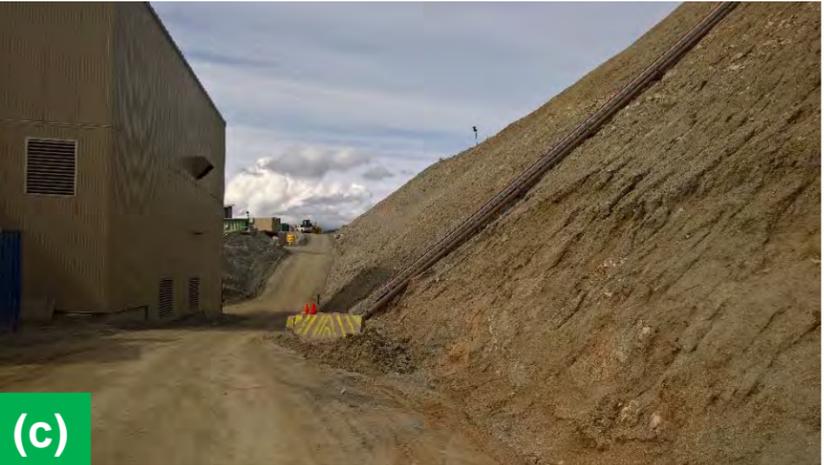
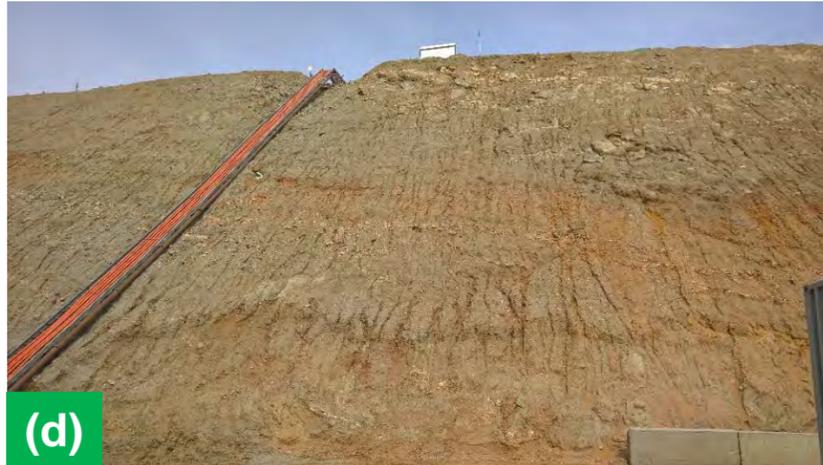
Conditions of the mill area are similar to those observed in previous inspections with minor ongoing erosion of the slope to the north of the mill, particularly near the location of the Seacans (Photos b and c) where cobble sized rocks have dented the Seacans.

- **High priority:** The 'falling rocks' warning sign (Photo b) is small and easy to miss. A larger sign should be placed with an additional warning sign placed at the opposite end near the Electrician Shop.

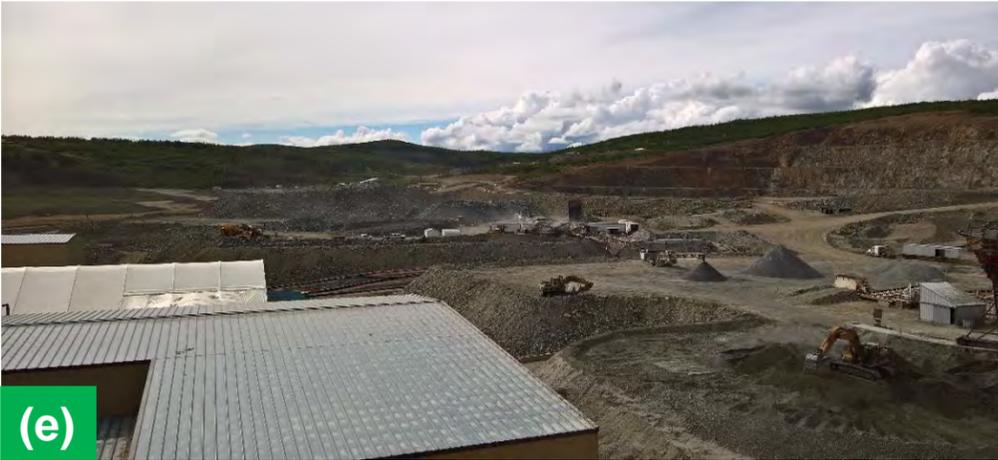
2016 Geotechnical Inspection		
		Mill Site and Ore Stockpiles		
Job No: 1CM002.048 Filename: AppA_2016InspectionPhoto.pptx	Minto Mine	Date: Nov 2016	Approved: PHM	Figure: 8

- The ore stockpiles were investigated briefly in passing. All slopes appeared in good condition: no slumping, bulges, cracks, or other signs of instability were observed.

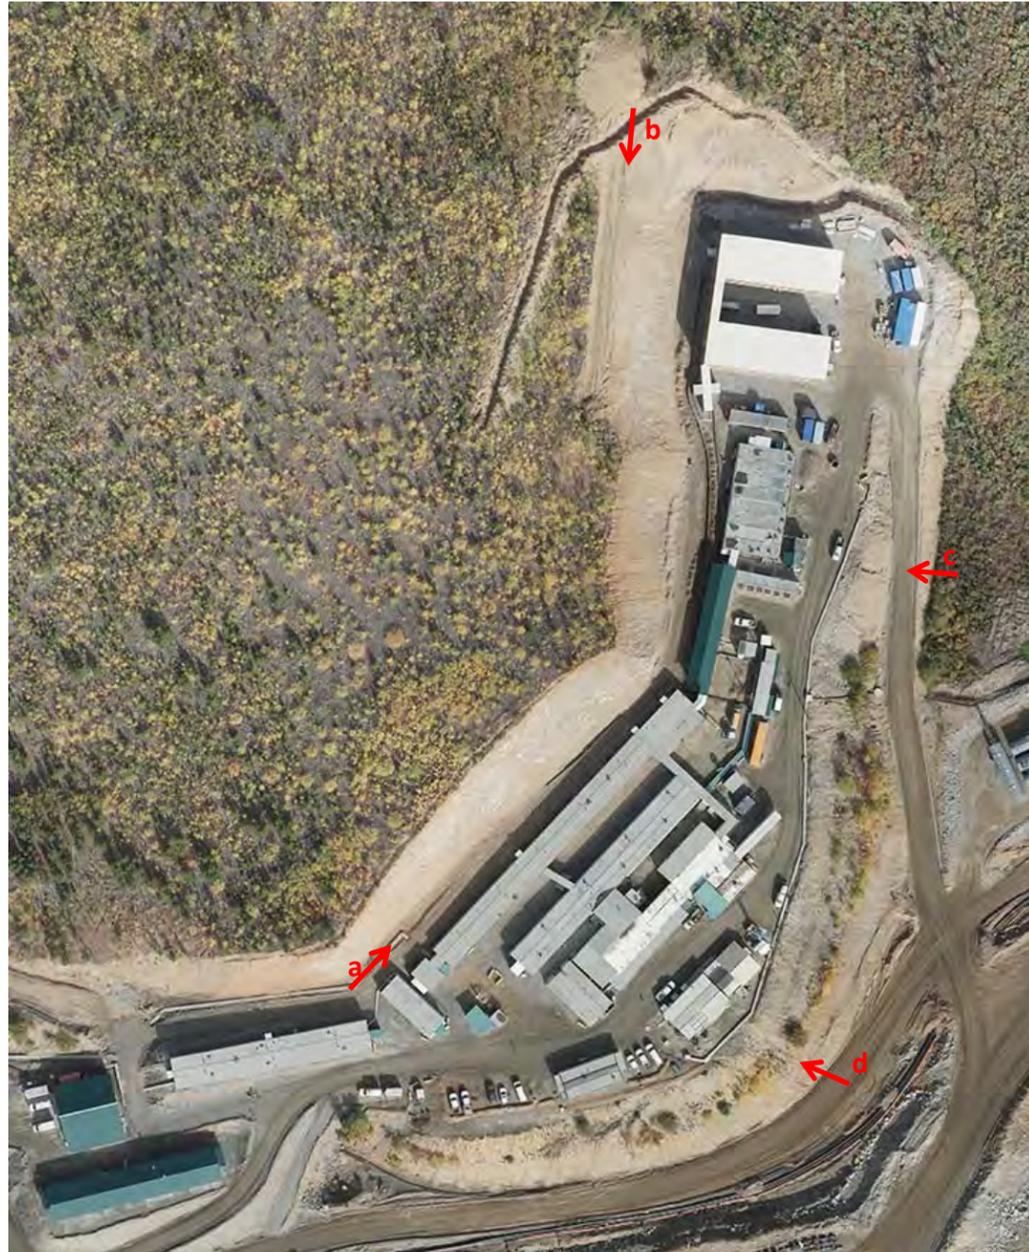
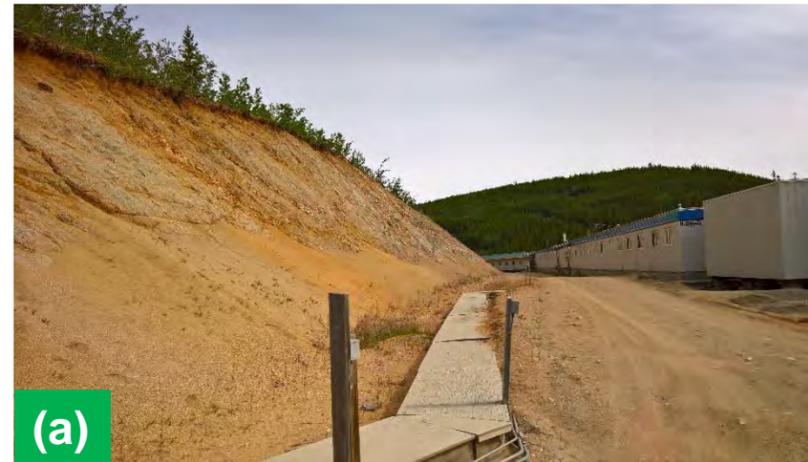
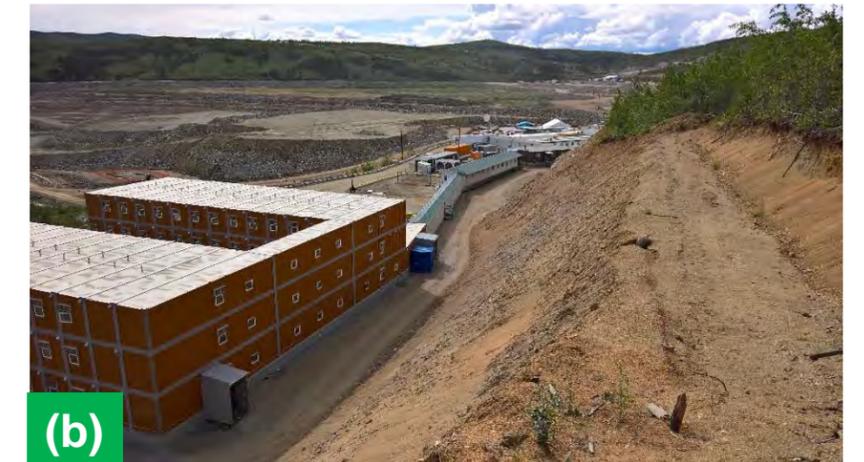
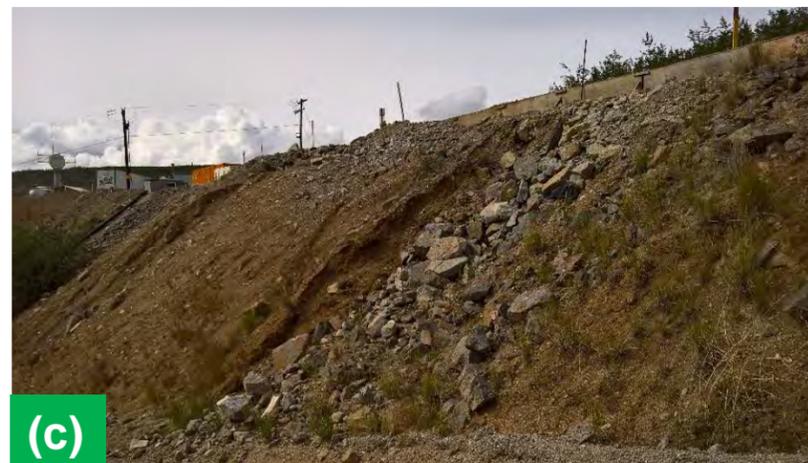
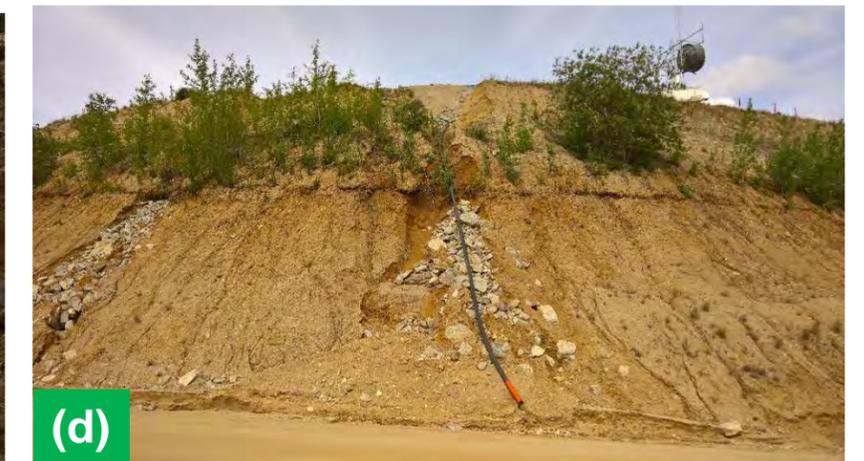
2016 Geotechnical Inspection		
		<b>Camp Site</b>		
Job No: 1CM002.048 Filename: AppA_2016InspectionPhoto.pptx	Minto Mine	Date: Nov 2016	Approved: PHM	Figure: <b>9</b>

Photo (a): Slope above the main camp site appears stable, with some minor erosion of sands and gravels observed. Eroded sand/gravel is generally present at the base of the slope with occasional cobbles/boulders up to 300 mm.

Photo (b): View of the crest of the slope above the expanded camp. The upper diversion ditch above the expanded camp pad is sloughing in areas, but is not impeding flow. No water was observed in the upper diversion ditch.

- Continue to monitor the erosion channels below the camp pad following larger rainfall events to evaluate if the remedial measures have been effective.

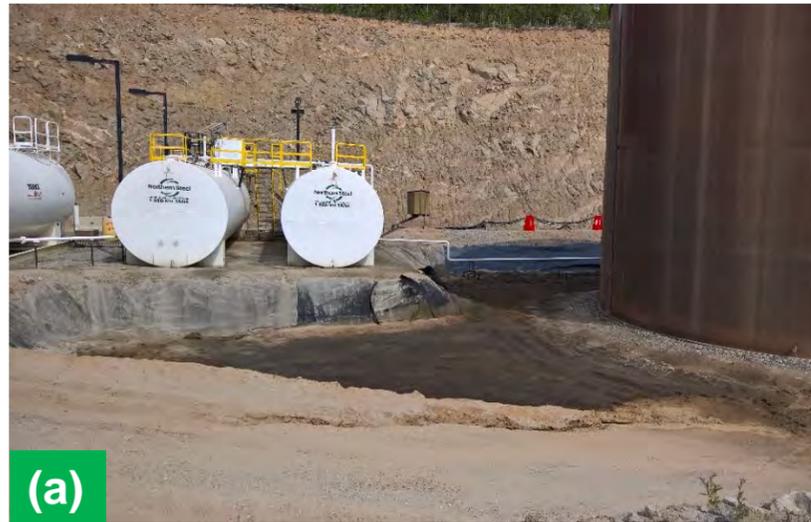
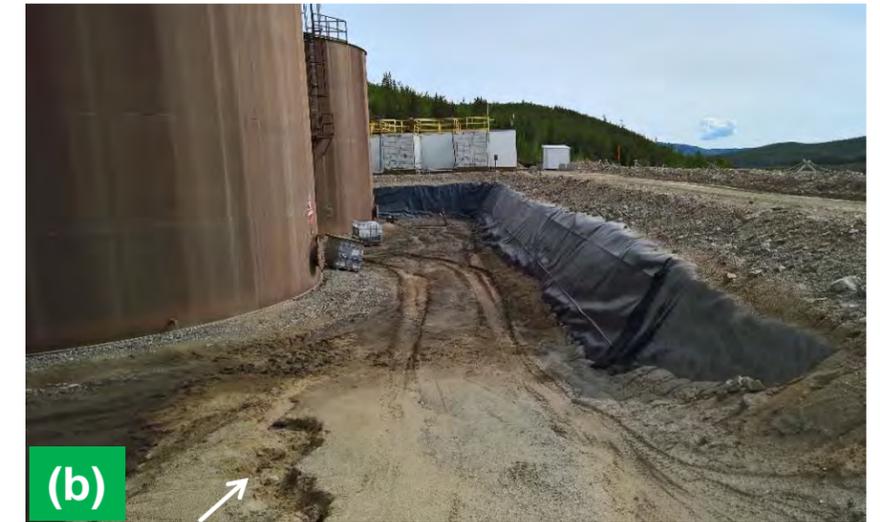
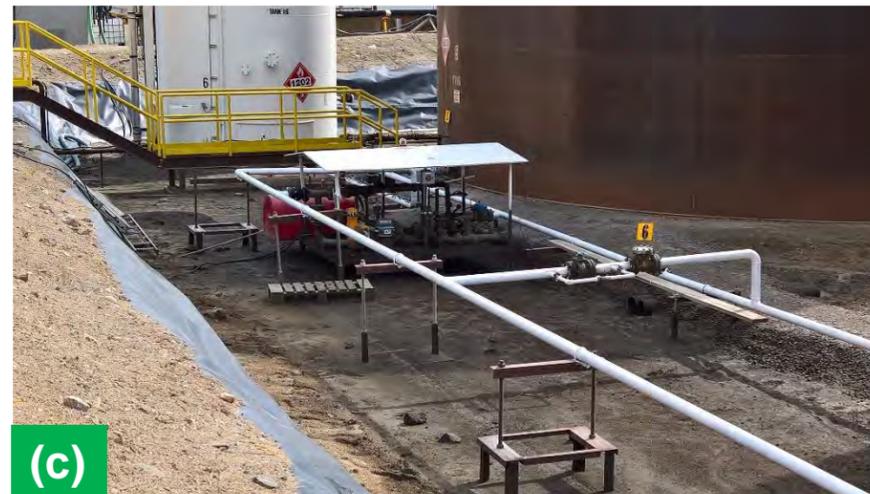
- Conditions at the fuel containment facility are unchanged from the previous inspection in June 2015.
- Photos (a) to (d) show the condition of the liner on each side of the facility.
- The erosion gully along the access ramp (Photos (a) and (b)) appears to be unchanged compared to the June 2015 photos.
- No tears or defects in the liner were observed.
- Minor pooling was observed. The facility appears to drain into containment area as per design.
- No new rutting observed. Ruts are present in the southern half of the facility. Rutting is significant (approximate 2-3 inches deep) between the two tanks where equipment was turning. No liner is exposed as a result of the trafficking.

- The bedding layer over the geomembrane (150 mm thick) was not meant for heavy equipment. Vehicle access should be limited to the occasional visit with low ground pressure equipment.
- No actions required.
