# 2016 Geotechnical Annual Review, Minto Mine, YT

SRK Consulting (Canada) Inc.  
1CM002.048  
November 2016

On June 13-14, 2016, SRK Consulting (Canada) Inc. completed a geotechnical inspection of the Minto Mine site (Figure 1). The purpose of the inspection was to document the physical condition of the site based on visual observations and to provide geotechnical assessment, noting potential signs of physical instability such as erosion, differential settlement, sloughing or bulging of material, seepage, etc. The inspection is documented in the photographic compilation provided in Appendix A. This report summarizes the findings and recommendations.

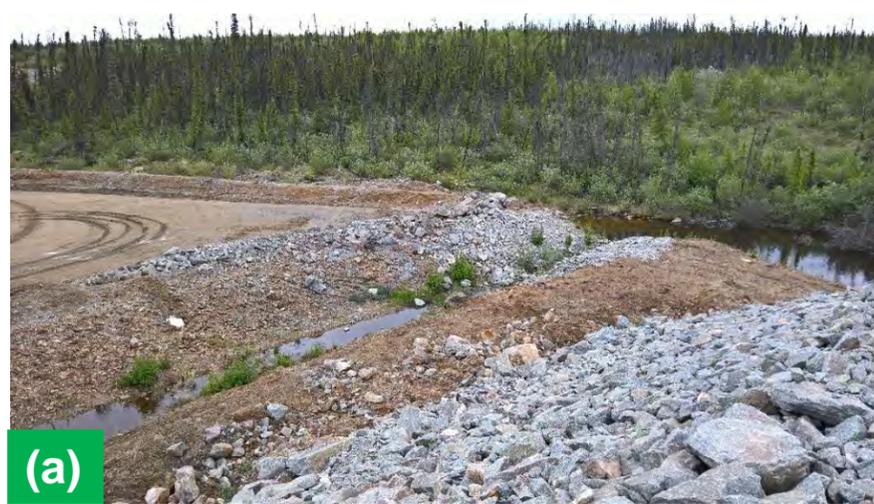
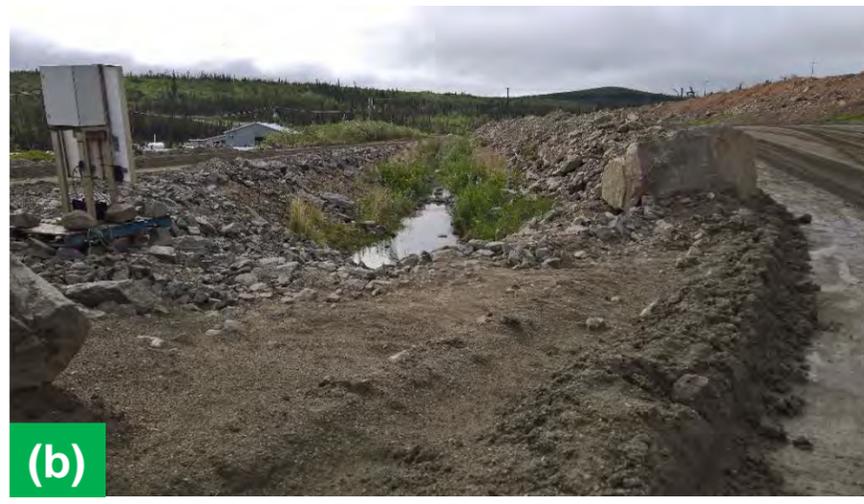
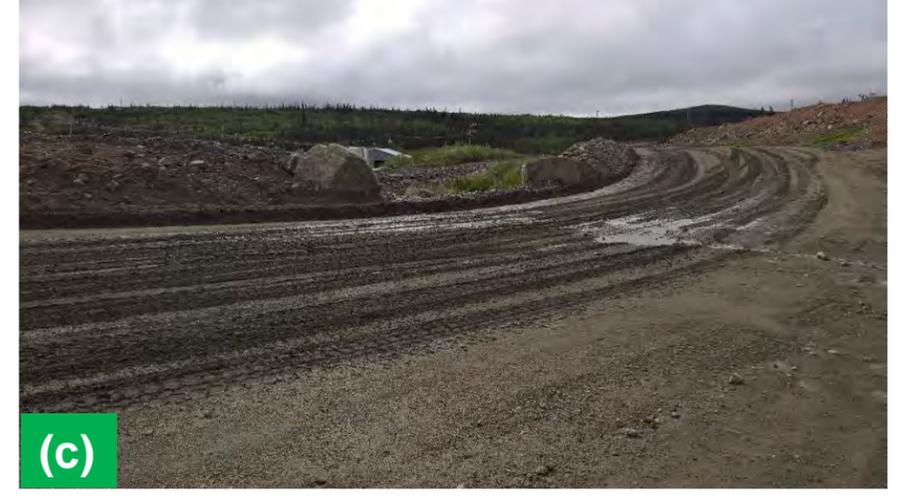
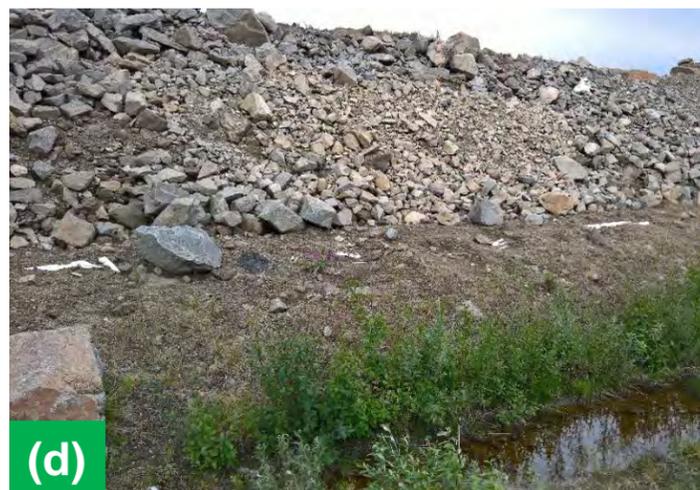
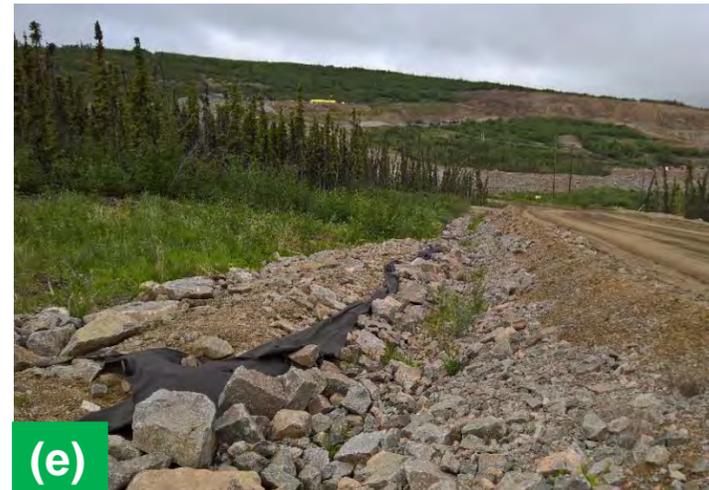
- The South Diversion Ditch was inspected between the overflow spillway and the intake structure. The ditch along the Airport Access road was also inspected. The pipeline alignment between the overflow spillway and the Main Pit Confluence area was not inspected during the site visit.

- No signs of instability were noted along the side-slopes.
- Vegetation growth continues within the ditch (Photo (b) and (d)), but the impact on flow capacity is inconsequential at this time.

South Diversion Ditch	<ul style="list-style-type: none"> <li>• <b>(High Priority): Clean the overflow spillway on both sides of the access road.</b></li> </ul>
Southwest Waste Dump	<ul style="list-style-type: none"> <li>• (Low Priority): Surveys of the crack and depression locations should be compared to past dump surfaces to complement the assessment of the source/cause of the cracking (e.g. edge of historical waste rock bench?)</li> <li>• <b>(Medium Priority): The remainder of the survey hubs that have heaved should be replaced.</b></li> </ul>
South Wall Buttress / In-Pit Dump / SAT Dump	<ul style="list-style-type: none"> <li>• <b>(High Priority):</b> <ul style="list-style-type: none"> <li>○ <b>M84 should be monitored on a minimum weekly basis during periods of active construction of the SAT Dump located to the north of the In-Pit dump.</b></li> <li>○ <b>Visual inspections of the In-Pit Dump above the SAT dump should be incorporated into the daily visual inspections that occur when SAT material is being placed in the SAT Dump.</b></li> <li>○ <b>An extensometer should be installed across the main crack to monitor displacement.</b></li> <li>○ <b>The crack endpoints should continue to be spray painted in order to monitor potential crack propagation.</b></li> </ul> </li> <li>• Continue to limit access to the In-Pit Dump area near M84.</li> </ul>

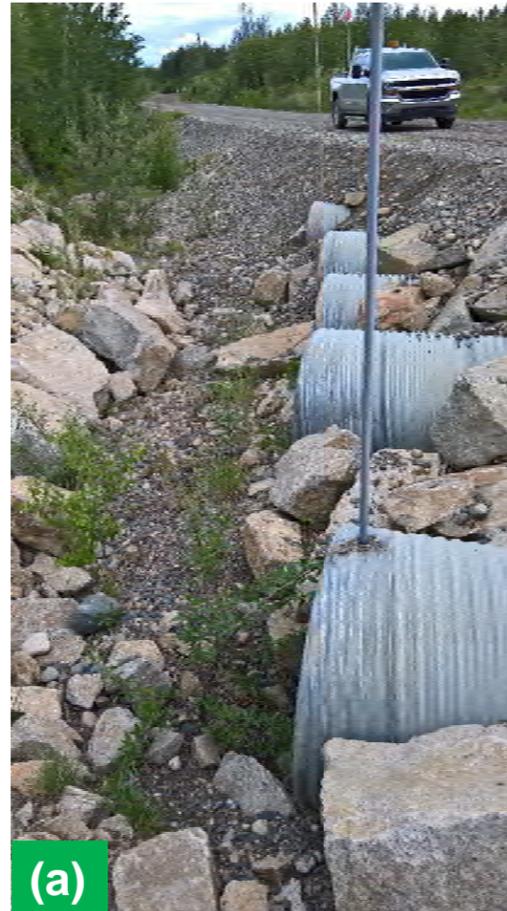
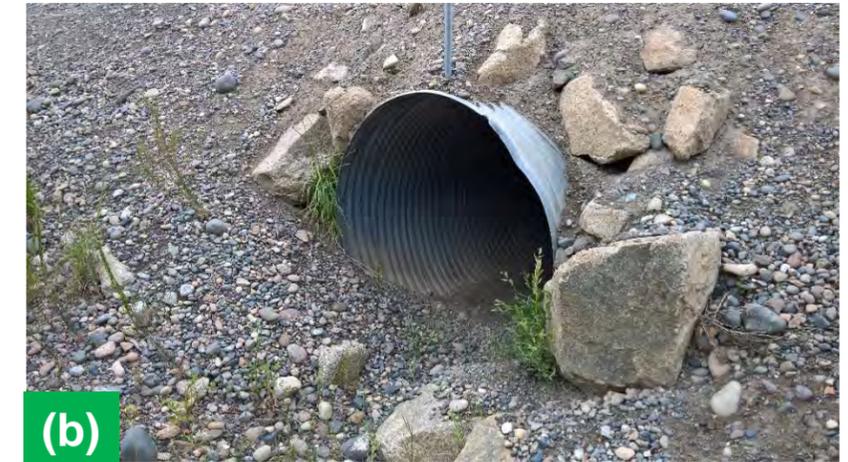
2016 Geotechnical Inspection		
		<b>Big Creek Bridge</b>		
Job No: 1CM002.048 Filename: AppA_2016InspectionPhoto.pptx	Minto Mine	Date: Nov 2016	Approved: PHM	Figure: <b>13</b>

- Conditions of the culverts are unchanged since the previous June 2015 inspection. The first culvert west of the bridge is in satisfactory condition.
- Photo (a) shows the downstream end of the group of 5 culverts, each with diameter of 1.1 m. The culverts are in satisfactory condition, with no blockages at either end. Exposed geotextile on the south side should be repaired.
- Photo (b) shows the downstream end of the 2<sup>nd</sup> culvert west of the bridge. Sediment accumulation should continue to be monitored and cleaned out if sediments continue to accumulate.
- Ditch Blocks #2 to #5 are unchanged from previous inspections and are in satisfactory condition. Ditch Block #1 has not been constructed.
- Photos (c) and (d) show the east and west abutments, respectively. The bridge abutments and road approaches are in good condition, with no signs of instability observed.

- Continue regular annual monitoring of sediment accumulation in the culverts, and clean out if sediments continue to accumulate.

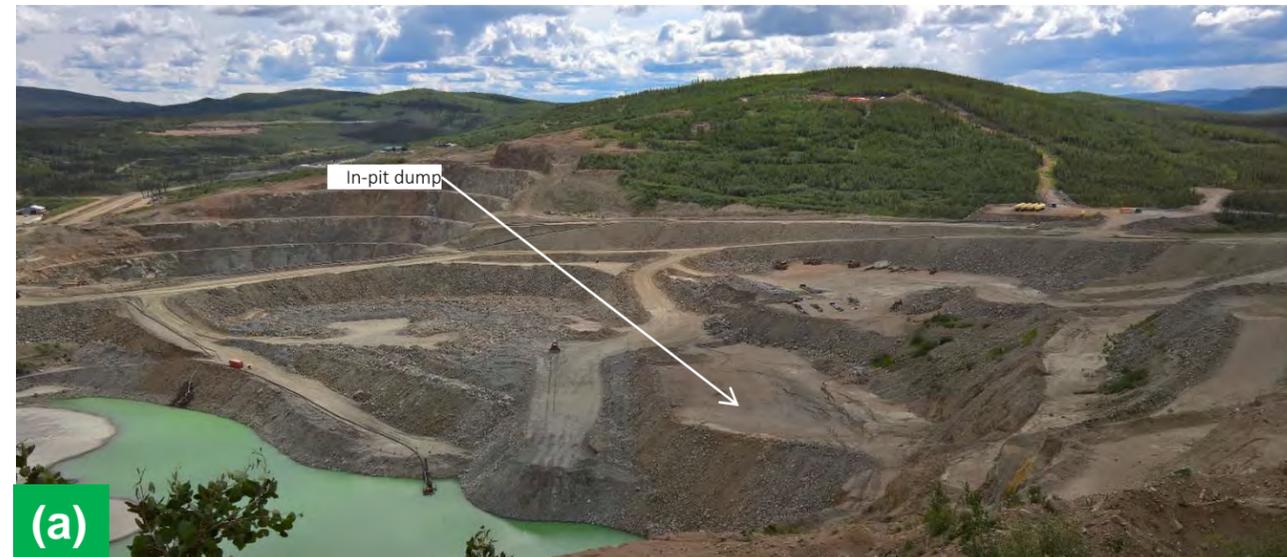
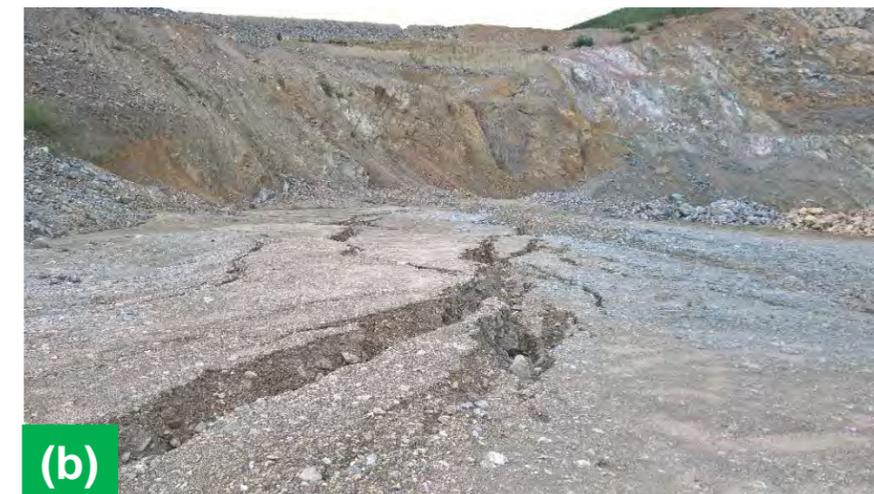
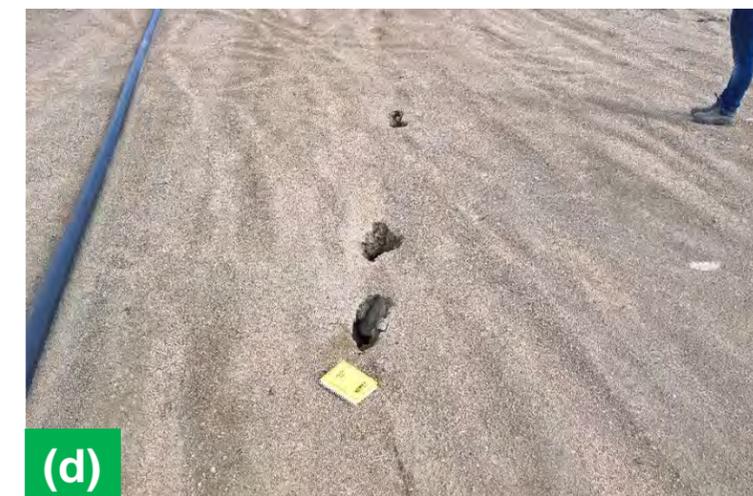
Conditions in the Main Pit are similar to those documented in the June 2015 inspection report. Since the last inspection, one additional survey hub (M87) has been installed on Level 821 of the In-Pit Dump to monitor movement. Construction of the SAT dump located to the north of the In-Pit Dump began in April 2016.

The movement rate at survey hub M84, located near the crest of the In-Pit Dump has increased from 0.2 mm/day in the 2015 inspection report to 0.7 mm/day in May 2016. The direction of movement is to the east (bearing 104 degrees) and approximately perpendicular to Pit Wall (Appendix B). The remainder of survey hubs show steady or decelerating movement rates that range from 0 to 0.65 mm/day. The increase in movement rates may be due to undercutting of the slope during construction of the SAT dump ramp. A photo provided by Minto on July 30, 2016 indicates the undercut material has been replaced.

Additional cracking was observed along the former haul road south of the Main Pit between survey hubs M73 to M75. The crack locations are shown in the 2015 orthophoto below in yellow and in Photos (c) and (d). The cracking is parallel to the pit wall and is located approximately above the ultimate pit rim. The cracking is believed to be due to settlement of the waste rock within Main Pit.

- **High Priority:**
  - M84 should be monitored on a minimum weekly basis during periods of active construction of the SAT Dump located to the north of the In-Pit dump.
  - Visual inspections of the In-Pit Dump above the SAT dump should be incorporated into the daily visual inspections that occur when SAT material is being placed in the SAT Dump.
  - An extensometer should be installed across the main crack to monitor displacement.
  - The crack endpoints should continue to be spray painted in order to monitor potential crack propagation.
- Continue to limit access to the In-Pit Dump area near M84.

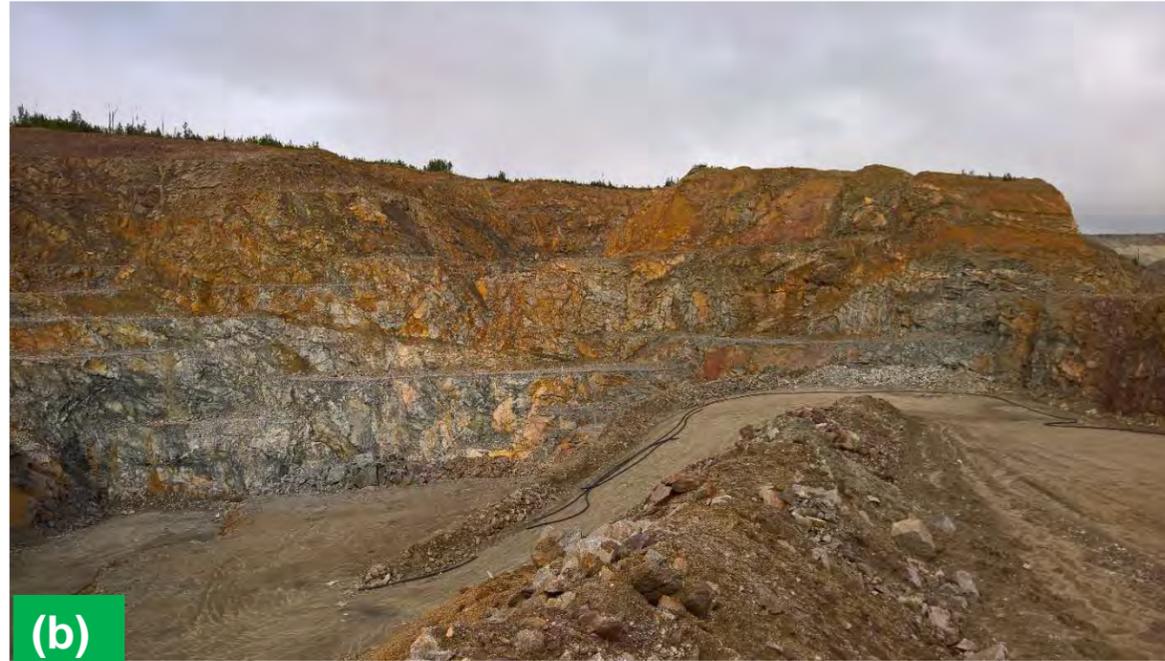
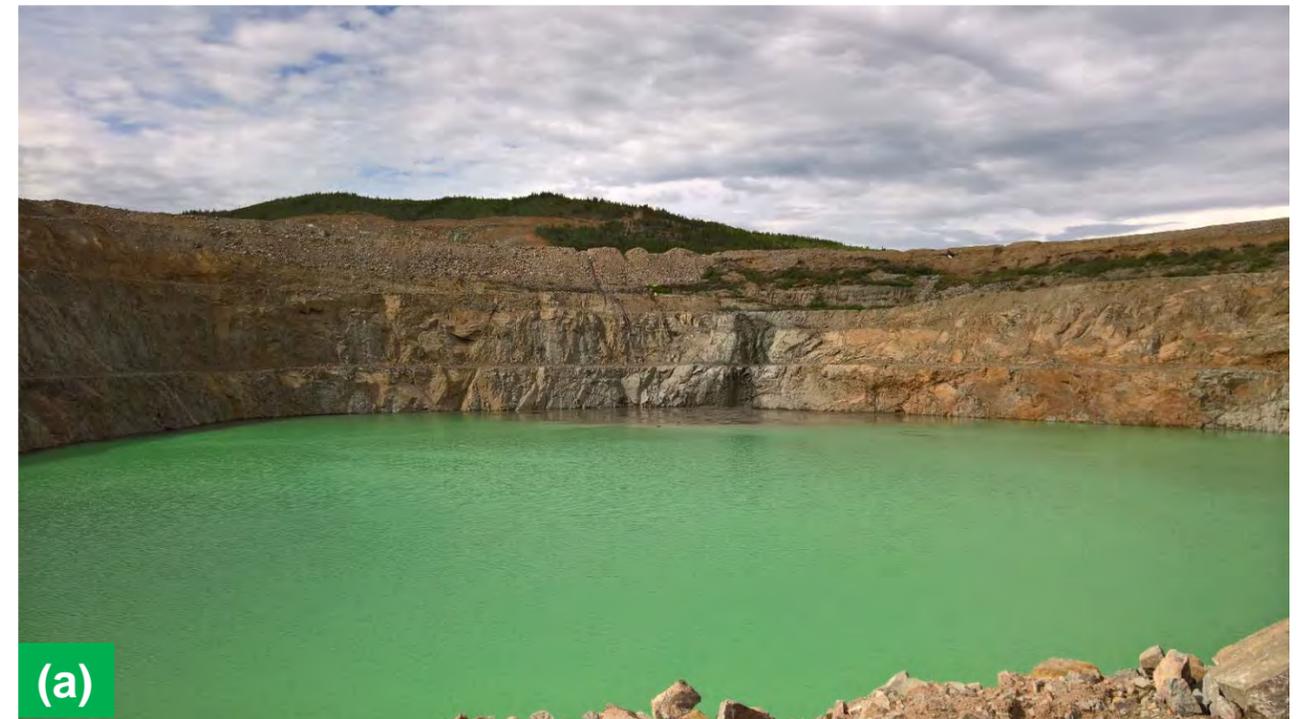
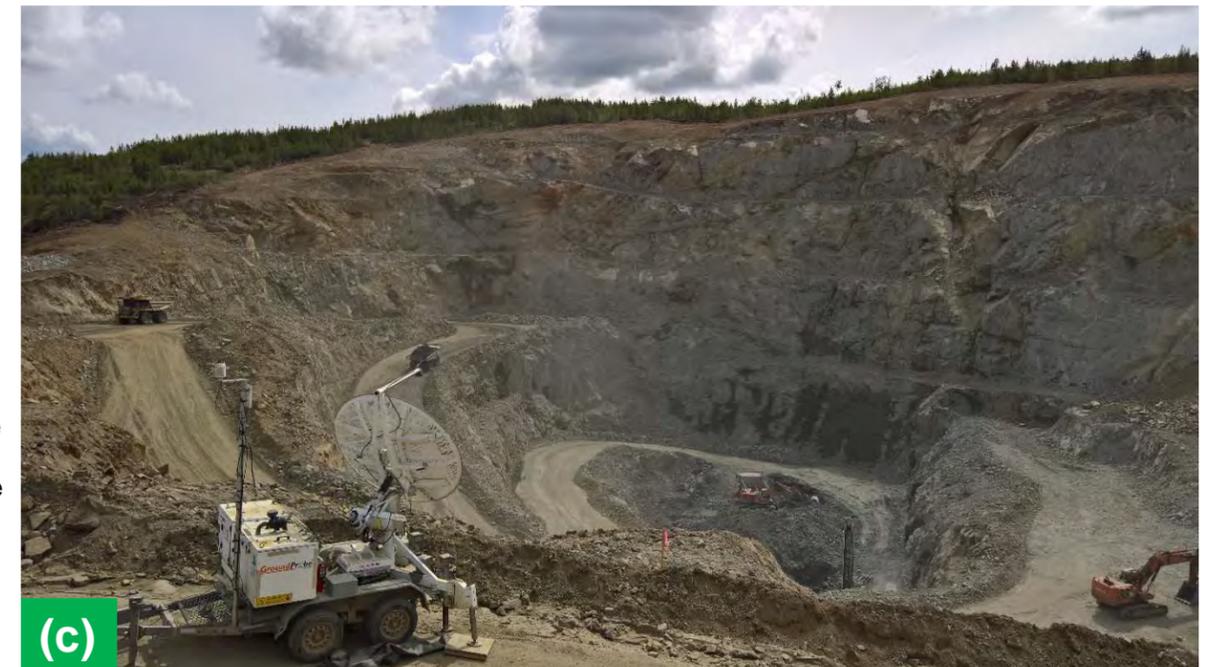
No signs of instability were observed at the Area 2 and 118 Pits

Photo a: View of the Area 2 Pit taken from the south side looking north.

Photo b: View of the Area 118 Pit looking west.

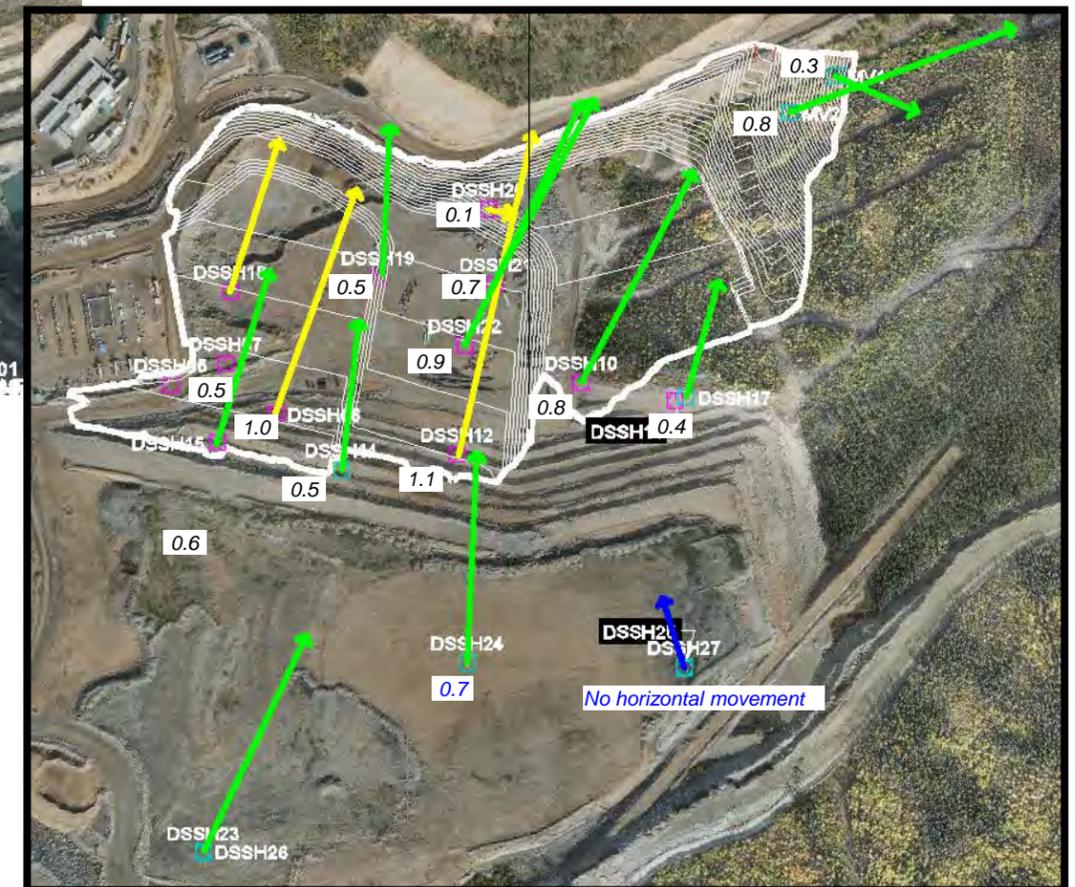
b) Dry Stack Tailings Storage Facility

Survey hubs DSSH23, DSSH24, and DSSH25 show signs of seasonal settlement. Each of these hubs were installed in 2013 over the tailings cover on the DSTSF. Hubs DSSH26 and DSSH27 were installed in 2016 to replace DSSH 23 and DSSH 25. The replacement hubs are mounted on standard lock blocks placed on the tailings surface. Data is currently being collected from both the old and new hubs to compare performance of the installation methods. Data collected during the first spring indicates some seasonality effects and settlement of the new lock blocks, but less so compared to the grouted survey hub posts.

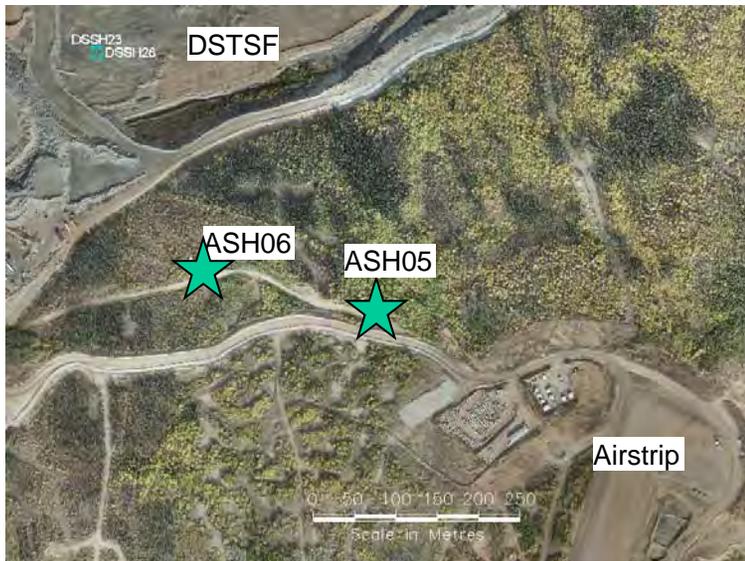
Survey Hubs – ASH05 and ASH06

Minor movement observed at ASH06 appears to be seasonal and suspected to be related to freeze-thaw effects near the surface.

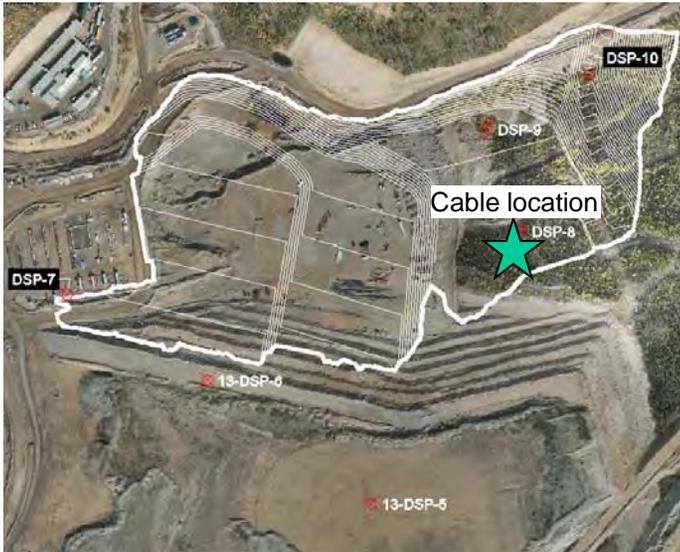
Date: August 2016	Prepared by PHM	Figure: <b>21</b>
----------------------	--------------------	----------------------

1. Negative pressure readings are plotted at the elevation of the sensor in order to indicate dates readings were taken. Readings at Sensor 4 have been negative since February 2016.
2. The increase in pore pressure readings in Sensors 2, 3, 5, and 6 is estimated to be approximately 50% of the total stress added as a result of placement of the MVFE Stage 2 fill.
3. The pore pressure in Sensor 1 has increased by approx. 600 kPa during the MVFE Stage 2 construction. This sensor is located closest to surface (depth of 5m). Since the construction was completed over the sensor location, the readings appear to have peaked and pressure is beginning to dissipate. The temperature at Sensor 1 has also dropped significantly compared to the other sensors at DSP-08. The higher pore pressures at Sensor 1 may be the result of freezing and the expansion of pore water into ice.

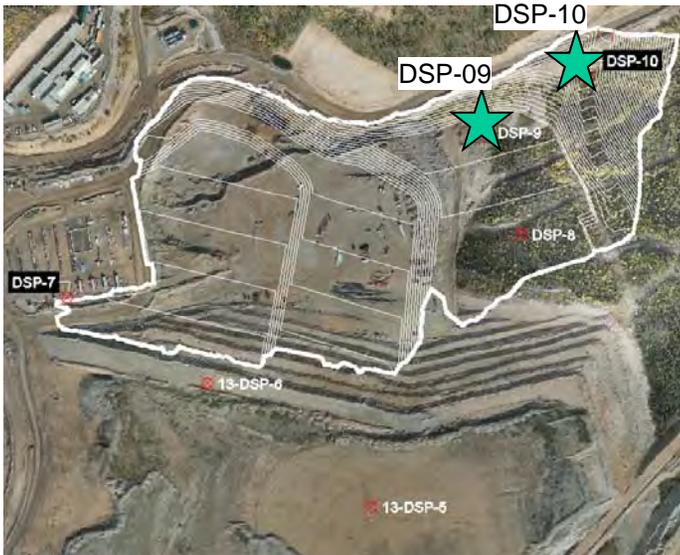
DSTSF Instrumentation Data		
		<b>Piezometer – DSP-08</b>		
Job No: 1CM002.048 Filename: ApD_DSTSFLandscape.pptx	Minto Mine	Date: August 2016	Prepared by PHM	Figure: <b>22</b>

1. The pore pressure sensors at DSP-9 and 10 are located approximately 5 m below original ground.
2. DSP-09 malfunctioned with the last reading on March 1, 2016
3. The large increase in pore pressure at DSP-10 is related to the fill placement over the sensor (approximately 23 m thick).
4. Since fill placement has been completed, the rate of increase in pore pressure is low.
5. Flow meter readings at the Minto Creek Detention Sump indicate that the blanket drain is functional and no water is building-up at the base of MVFE Stage 2.
6. Similar to DSP-08 Sensor 1, the temperature readings at DSP-10 show a slight cooling trend between April and July and the pore pressure increase since April may be due to ongoing freezing of the active layer.

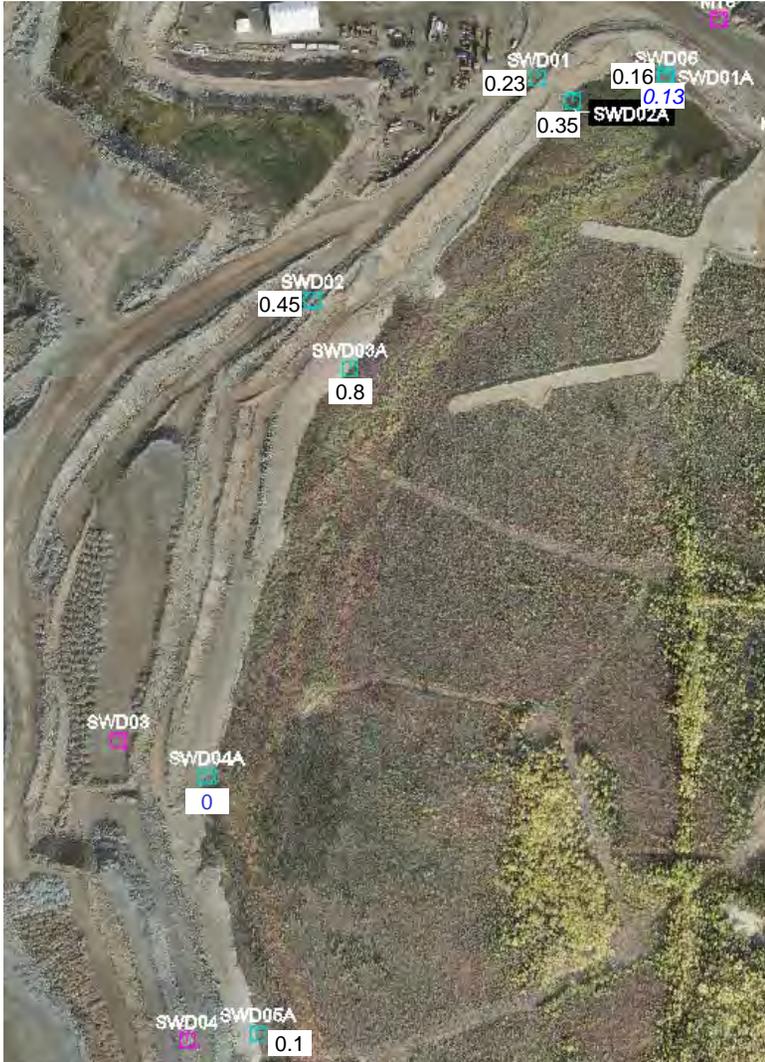
SWD Instrumentation Data		
		<b>Southwest Dump Survey Hub Summary</b>		
Job No: 1CM002.048 Filename: ApF_SWD Instrumentation.pptx	Minto Mine	Date: August 2016	Prepared by PHM	Figure: <b>1</b>

Survey Hub	Last Reading	Movement Rate (mm/day)		Bearing (Cumulative)	Comments
		June 15	June 16		
SWD-01	5/9/2016	0.30	0.23	111	
SWD-01A	5/9/2016	0.00	0.13	116	Horizontal movement rate listed. Instrument is disturbed due to frost heave and is to be replaced by SWD-06
SWD-02	5/9/2016	0.45	0.45	103	
SWD-02A	5/9/2016	0.40	0.35	113	Instrument is disturbed due to frost heave.
SWD-03A	5/9/2016	1.7	0.80	121	Instrument is disturbed due to frost heave and is leaning.
SWD-04A	5/9/2016	0.00	0.00	95	Horizontal movement rates listed. Instrument is disturbed due to frost heave.
SWD-05A	5/9/2016	0.30	0.10	72	Instrument is disturbed due to frost heave.
SWD-06	5/9/2016		0.16	125	SWD-06 is a replacement hub for SWD-01A

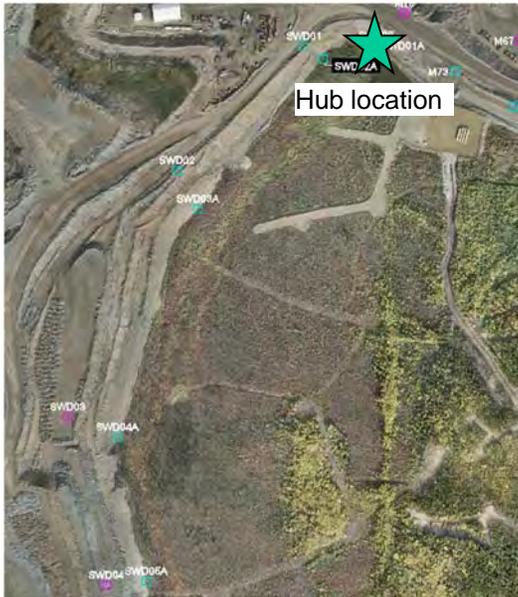
Minto Mine	SWD Instrumentation Data		
		Survey Hub – SWD-01A		
Date: August 2016	Prepared by PHM	Figure: 3

- Hub is disturbed (frost heave) and to be replaced by SWD-06

1. New hub is to replace SWD-01A that is disturbed by frost heave.

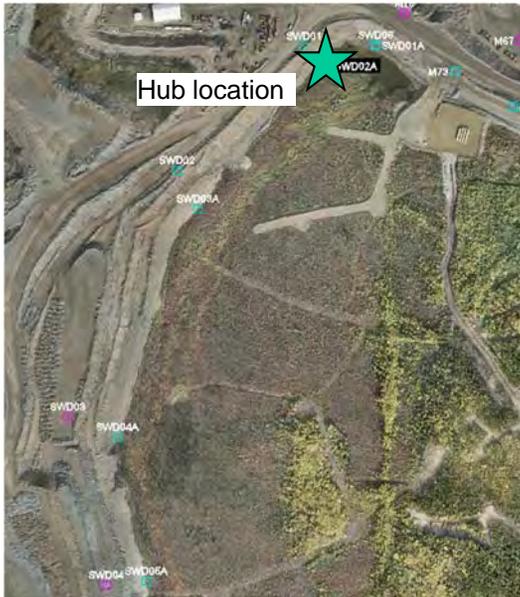
SWD Instrumentation Data		
		Survey Hub – SWD-02		
Job No: 1CM002.048 Filename: ApF_SWD Instrumentation.pptx	Minto Mine	Date: August 2016	Prepared by PHM	Figure: 4

### SWD02A - Northing Vs. Easting Movement Plot

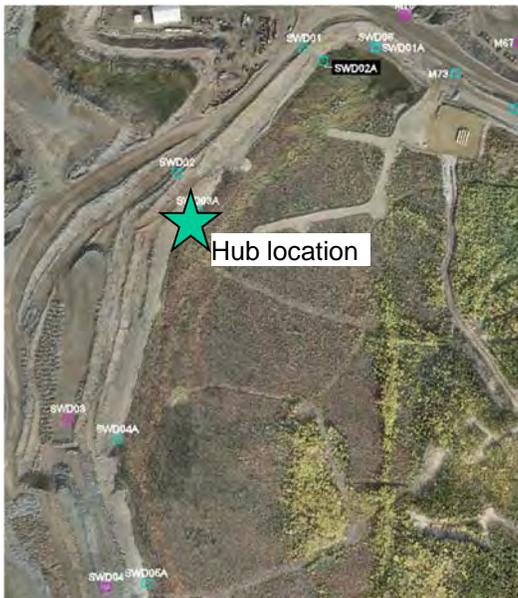
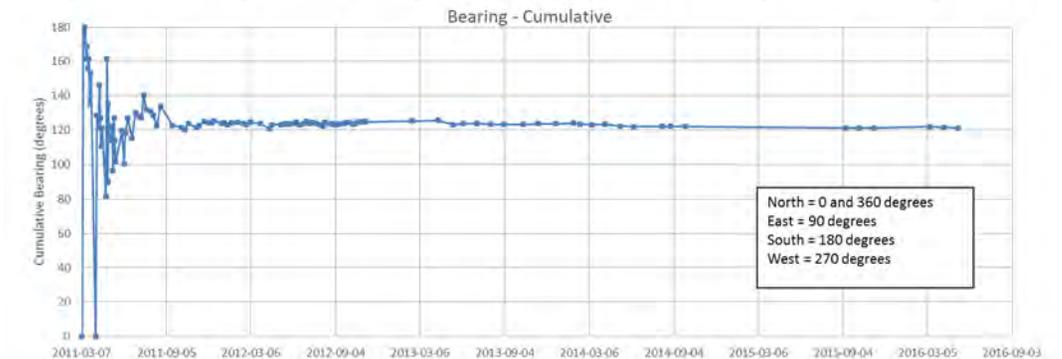
SWD Instrumentation Data		
		<b>Survey Hub – SWD-02A</b>		
Job No: 1CM002.048 Filename: ApF_SWD Instrumentation.pptx	Minto Mine	Date: August 2016	Prepared by PHM	Figure: <b>5</b>

SWD03A - Northing Vs. Easting Movement Plot

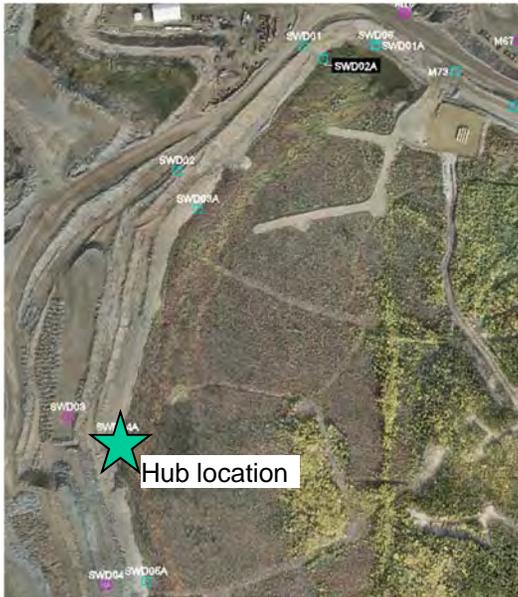
SWD Instrumentation Data		
		<b>Survey Hub – SWD-03A</b>		
Job No: 1CM002.048 Filename: ApF_SWD Instrumentation.pptx	Minto Mine	Date: August 2016	Prepared by PHM	Figure: <b>6</b>

### SWD04A - Northing Vs. Easting Movement Plot

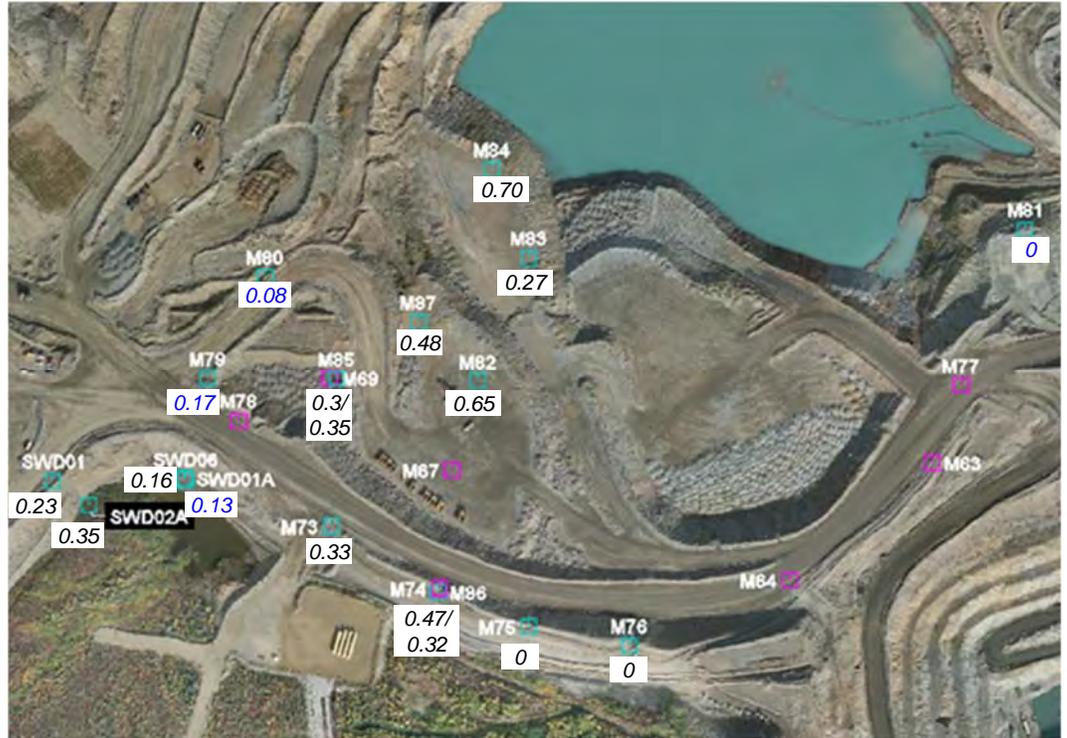
Southwest Dump Piezometers and Ground Temperature Cables

1. Values in black are total movement rates in units of mm/day
2. Values in blue are horizontal movement rates in mm/day.
3. Survey hubs in cyan color are active.
4. Survey hubs in magenta area destroyed.
5. Survey hubs with no movement rates listed have been inactive for over one year.

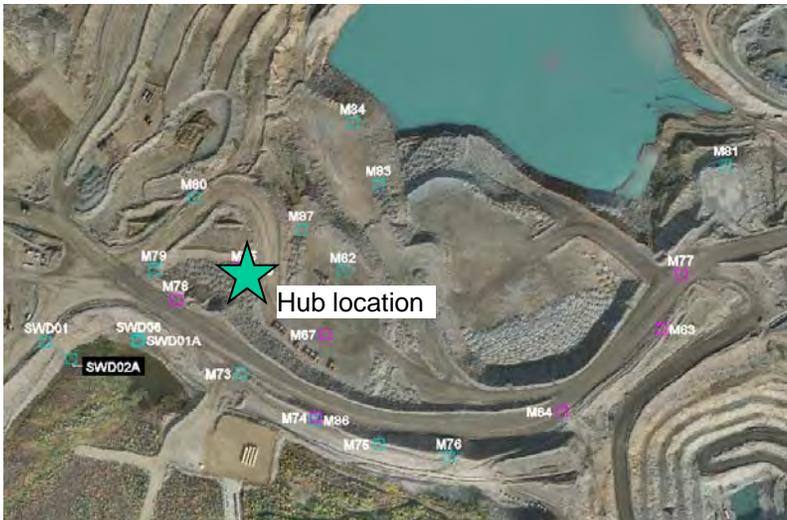
- Hub is to be replaced by M85.

### M69 - Total Displacement (m)

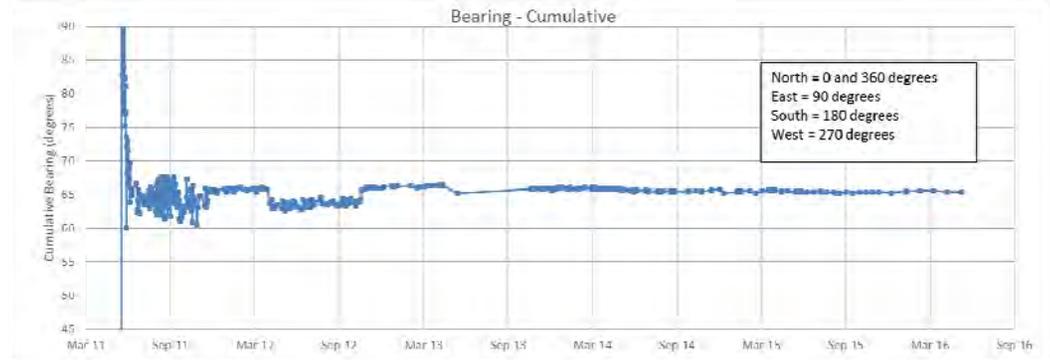
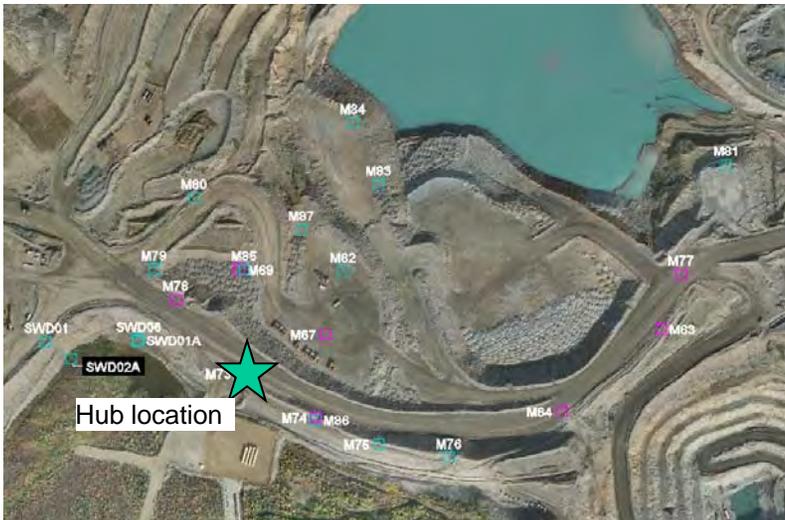
Figure: 2

M73 - Northing Vs. Easting Movement Plot

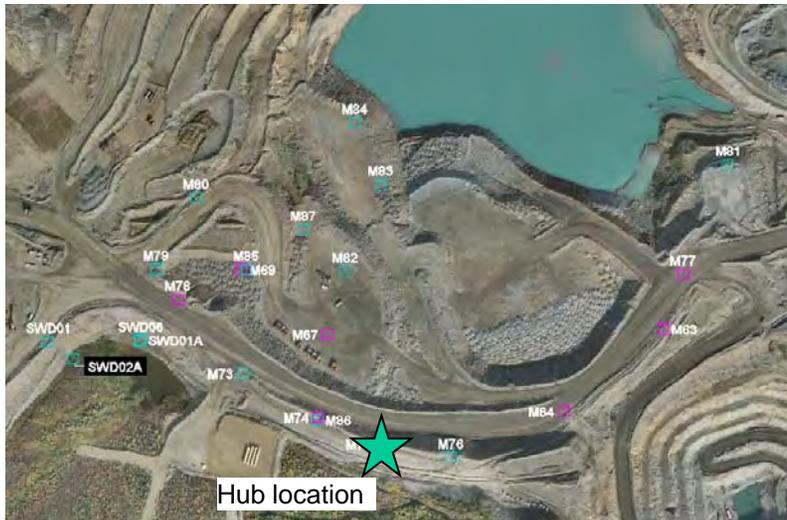
MINTO MINE OPERATED BY MINTO EXPLORATIONS LTD.	Main Pit Instrumentation Data		
		Survey Hub – M75		
Job No: 1CM002.048 Filename: ApG_MainPitInstrumentation.pptx	Minto Mine	Date: August 2016	Prepared by PHM	Figure: 5

- Hub is to be replaced by M86.

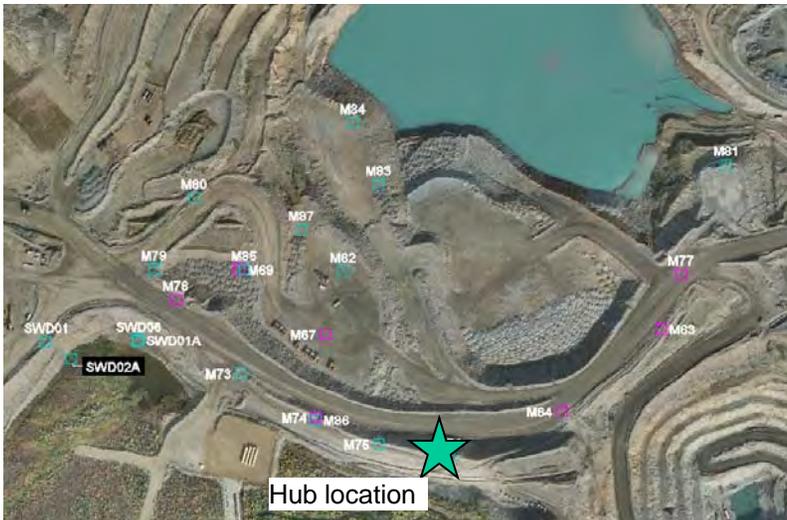
MINTO MINE OPERATED BY MINTO EXPLORATIONS LTD.	Main Pit Instrumentation Data		
		<b>Survey Hub – M76</b>		
Job No: 1CM002.048 Filename: ApG_MainPitInstrumentation.pptx	Minto Mine	Date: August 2016	Prepared by PHM	Figure: <b>6</b>

### M76 - Northing Vs. Easting Movement Plot

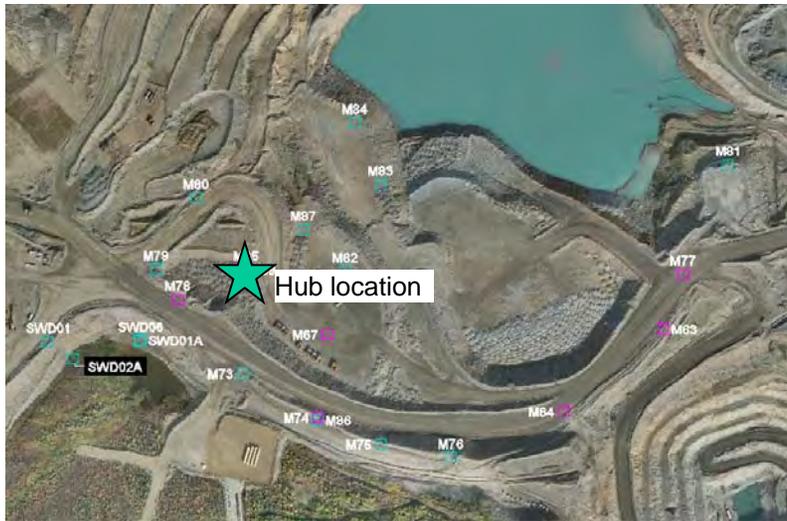
Figure: 12

M85 - Northing Vs. Easting Movement Plot
