Mill Valley Fill Extension Stage 2 Final Design Report

Minto Explorations Ltd.

SRK Consulting (Canada) Inc.
1CM002.040
September 2015

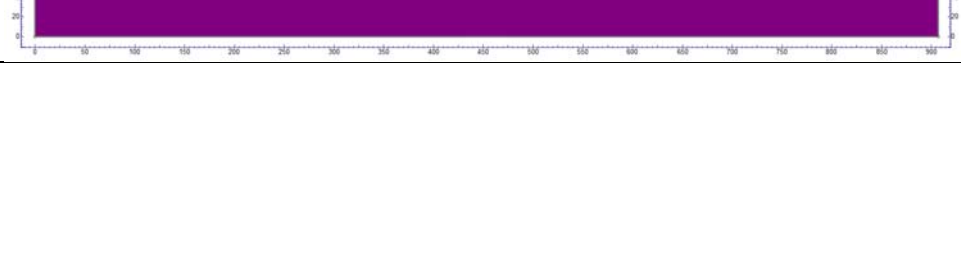
44	F_Stage2_01_3 H1V_Cu35	E	Deep Seated Stability	Reclamation	35	0.057g	1.0	1.23	Deep seated failure within undrained clay at depth
