# Mill Valley Fill Extension Stage 2 Preliminary Design Report – Final

Minto Explorations Ltd.

SRK Consulting (Canada) Inc.  
1CM002.027  
June 2014

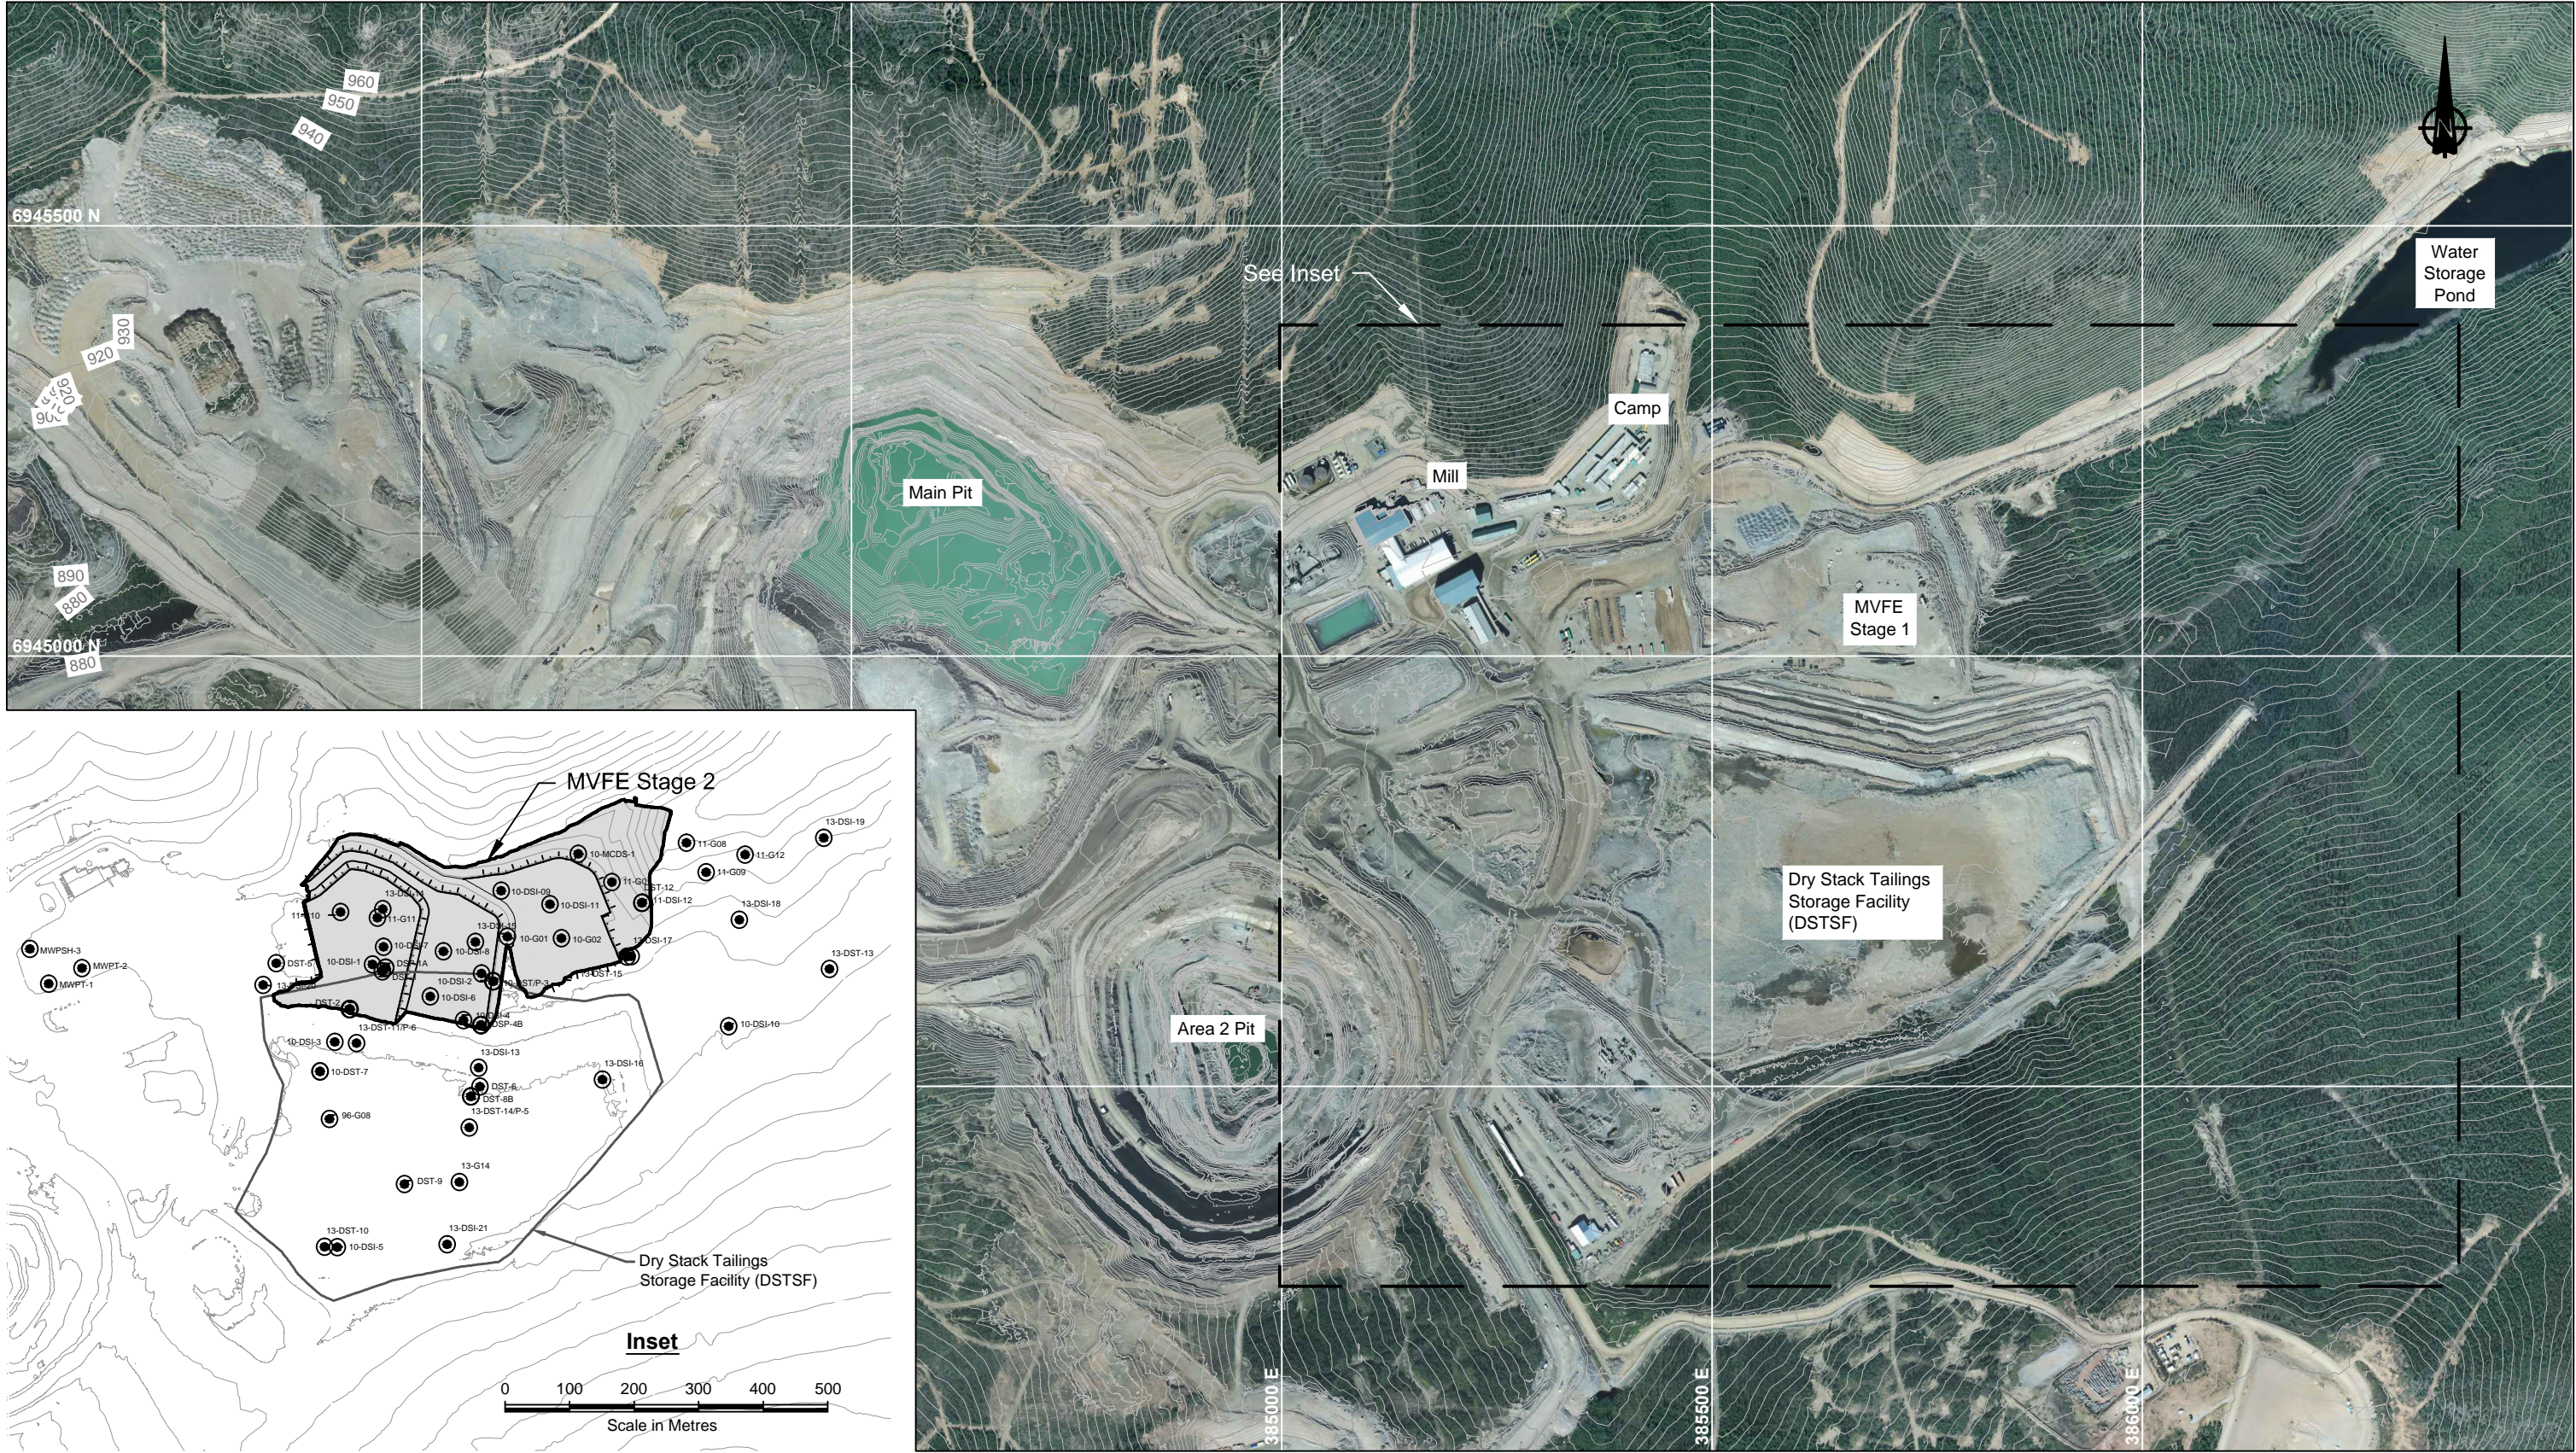
DATE: May 2014 APPROVED: IM FIGURE: 1

**General Arrangement**

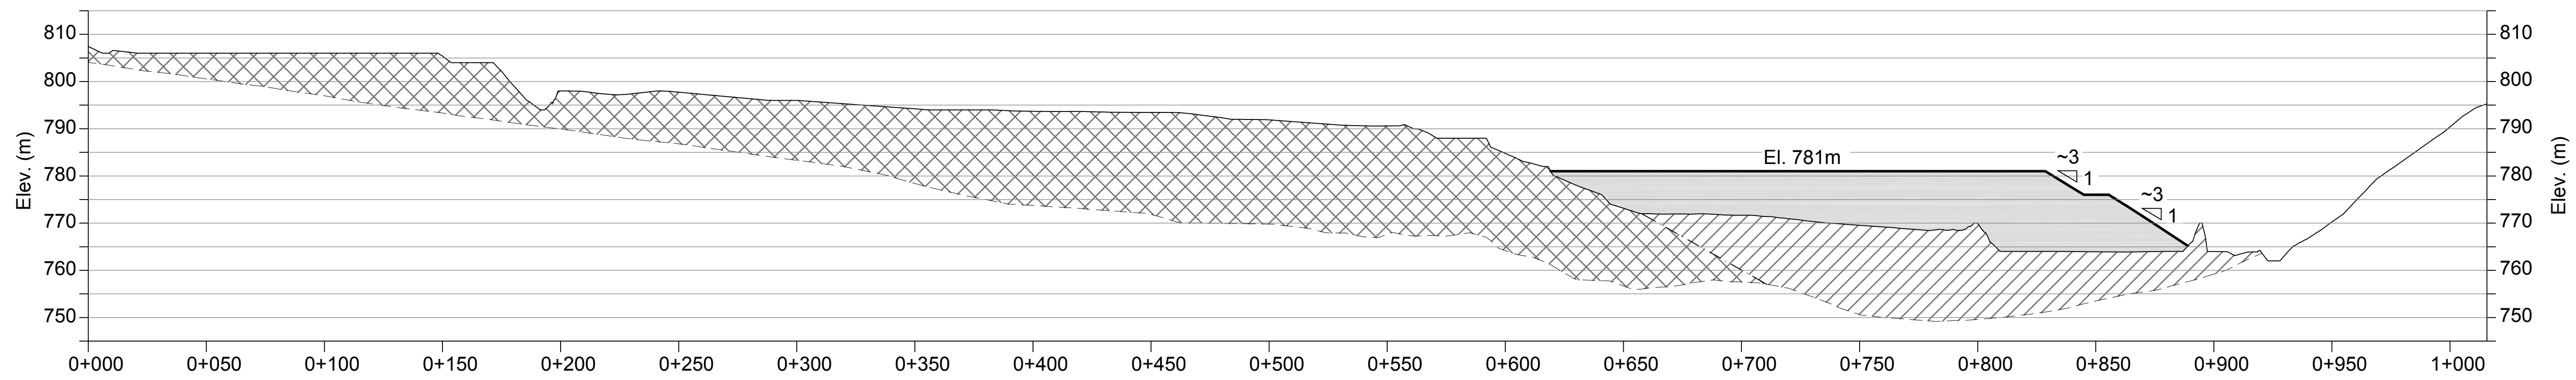
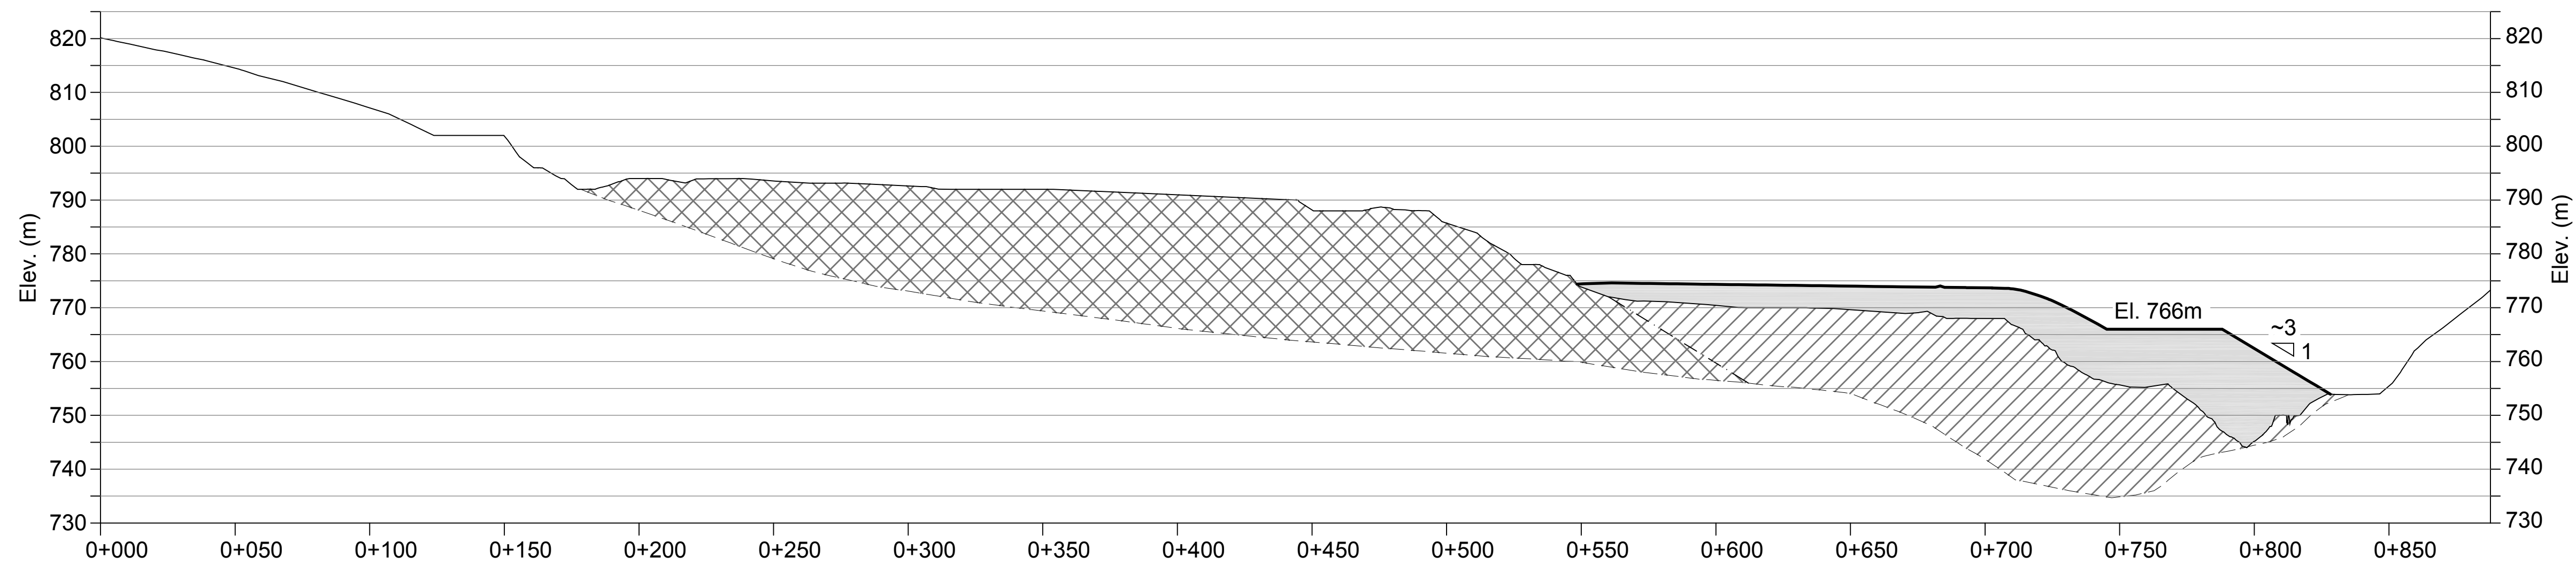
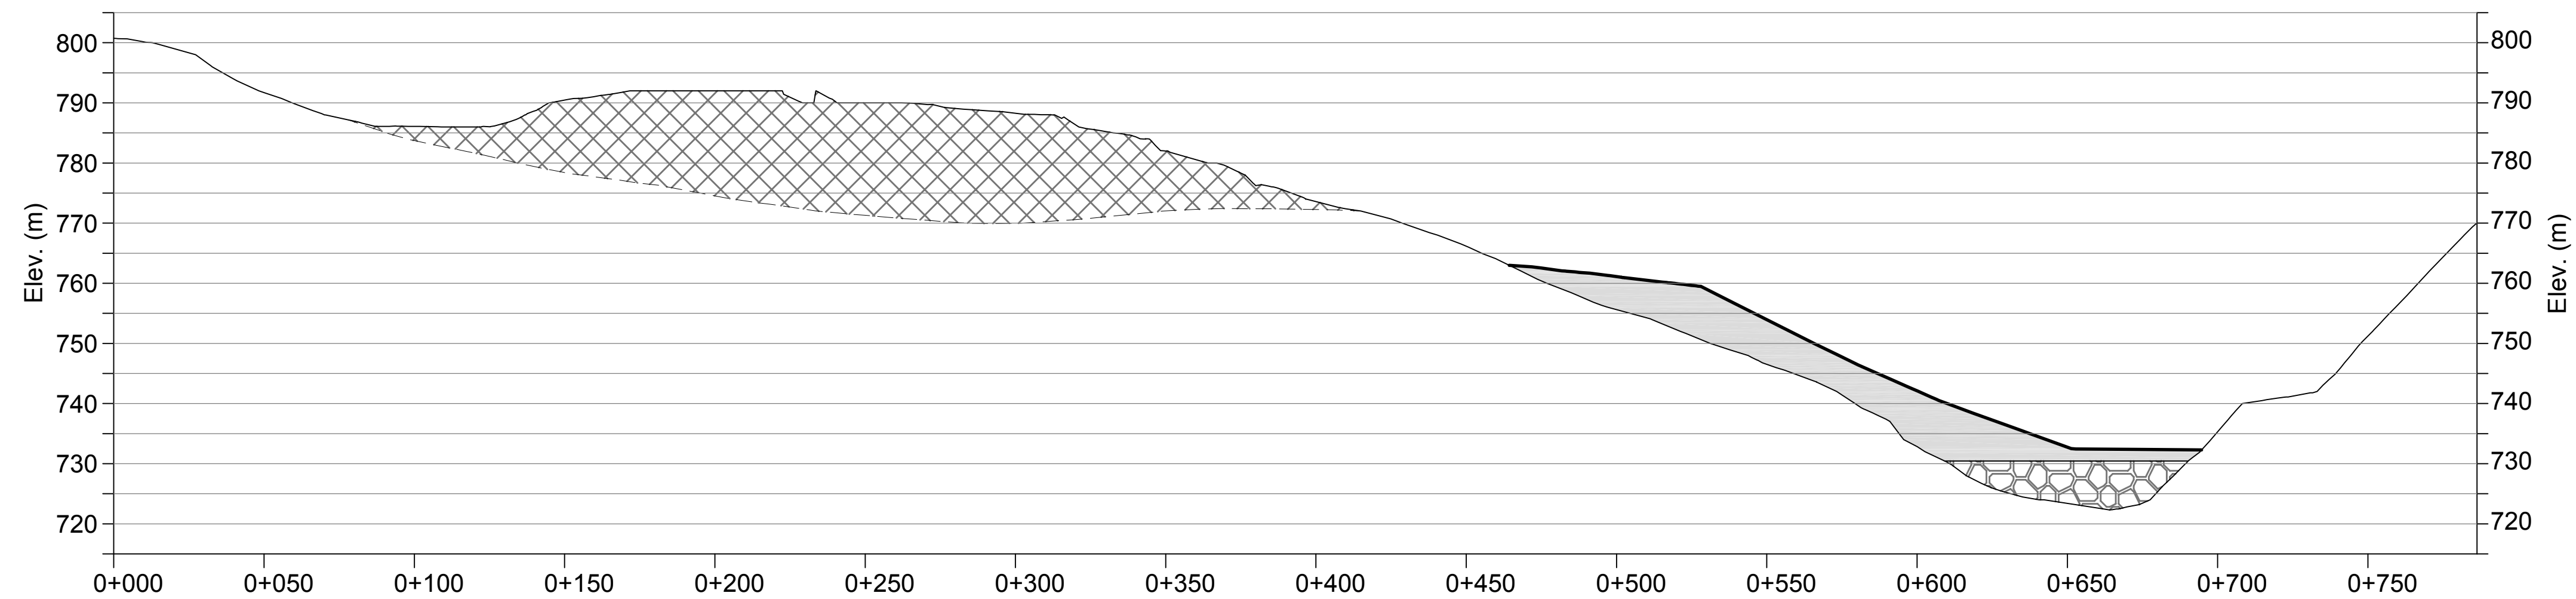
DATE: May 2014  
APPROVED: IM  
FIGURE: 3

**A** SECTION  
Fig 2 2x Vertical Exaggeration

**B** SECTION  
Fig 2 2x Vertical Exaggeration

**C** SECTION  
Fig 2 2x Vertical Exaggeration

MVFE STAGE 2  
PRELIMINARY DESIGN  
Transverse (Cross-Valley)  
Sections from Conceptual Design

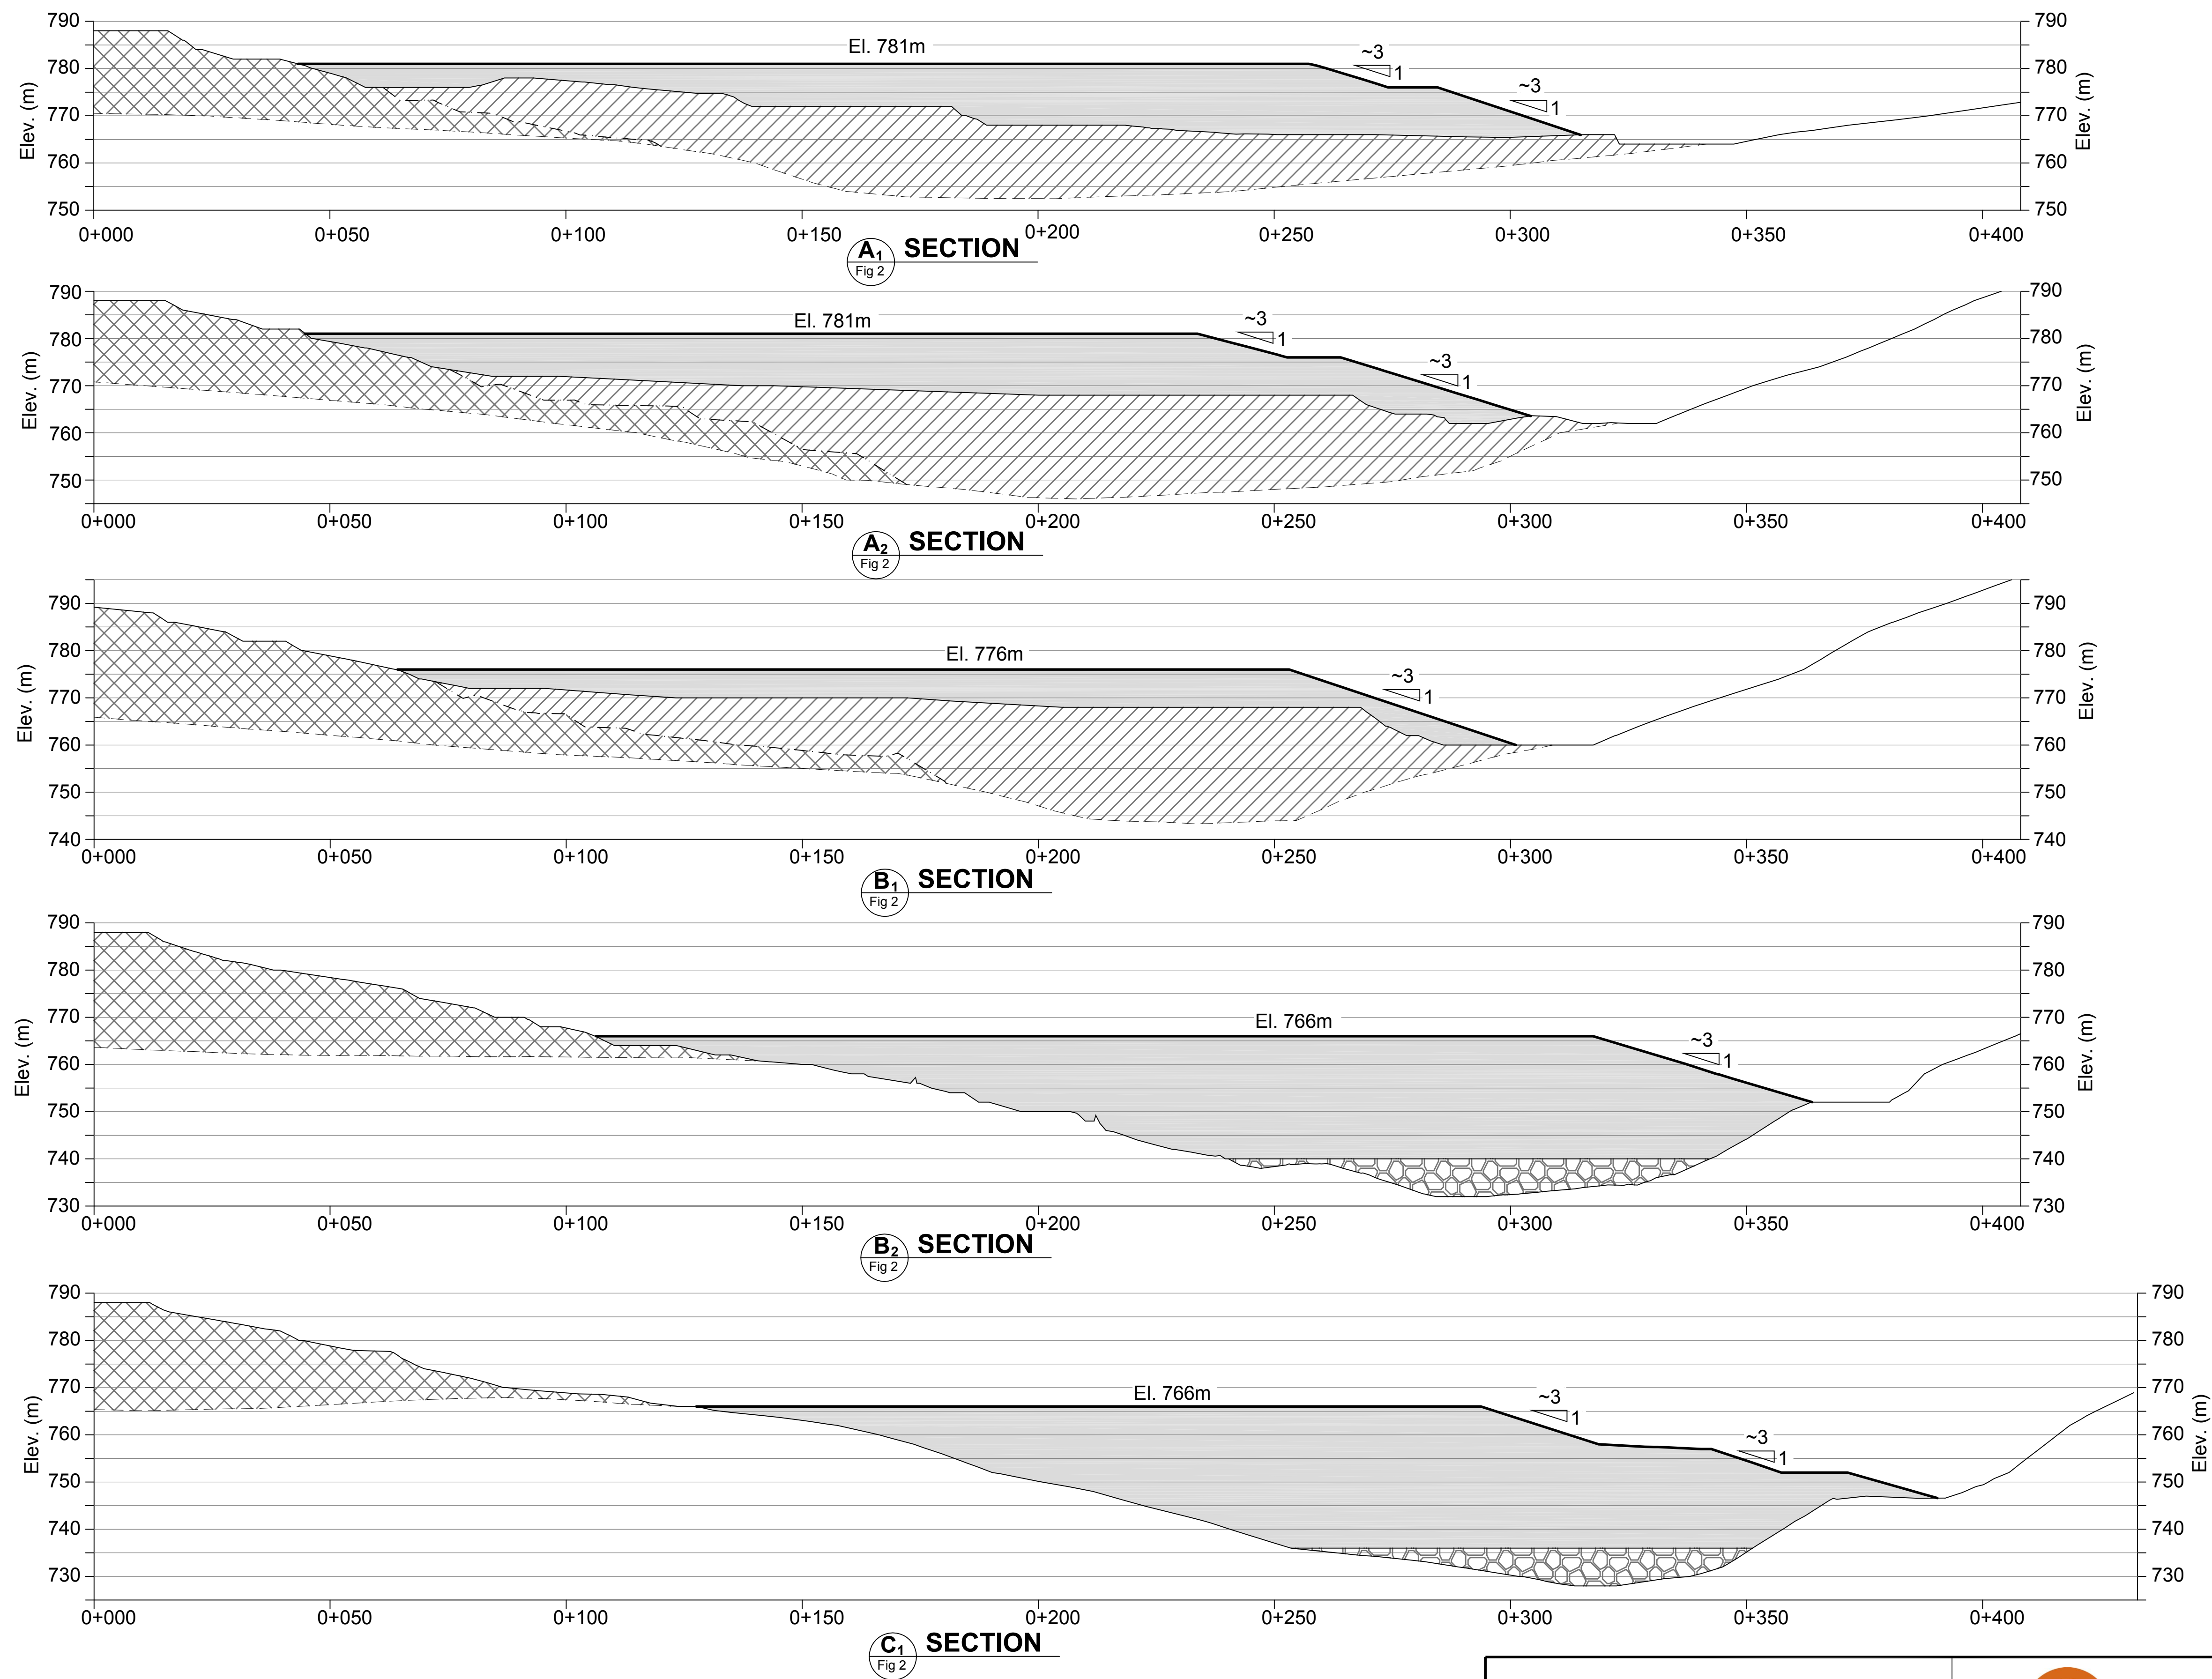
DATE:	APPROVED:	FIGURE:
May 2014	IM	4

- MVFE Stage 2
- 2013 Ground Surface
- Tailings Storage Facility
- Pre-Mining Ground Surface
- Mill Valley Fill Extension Stage 2
- Mill Valley Fill Extension Stage 1
- Tailings Storage Facility
- Coarse Rock Fill

In addition to the sections completed in the conceptual design, an additional five representative cross sections (A1, A2, B1, B2 and C1) were developed for the cross-valley stability analysis. These sections were 50 m to 150 m apart and were oriented approximately in the direction of the identified movement (north-south). Two cross sections (E and F) were developed to evaluate the down-valley (east-west) stability. The section locations can be found in Figure 2 while Appendix B-1 presents the stratigraphic sections.

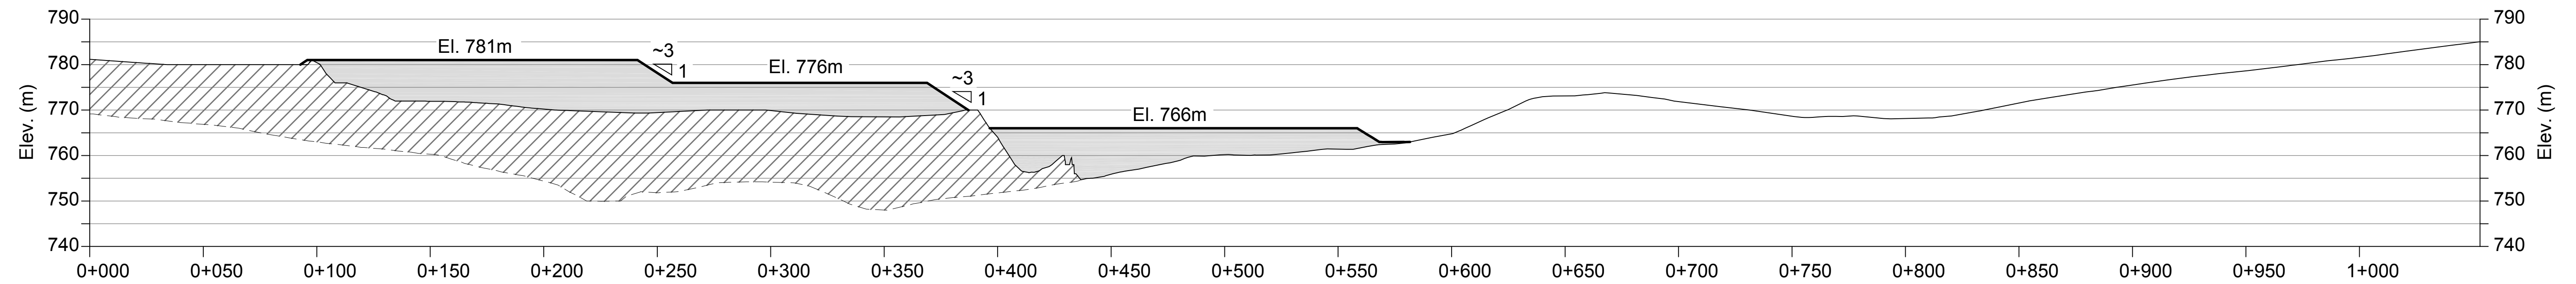
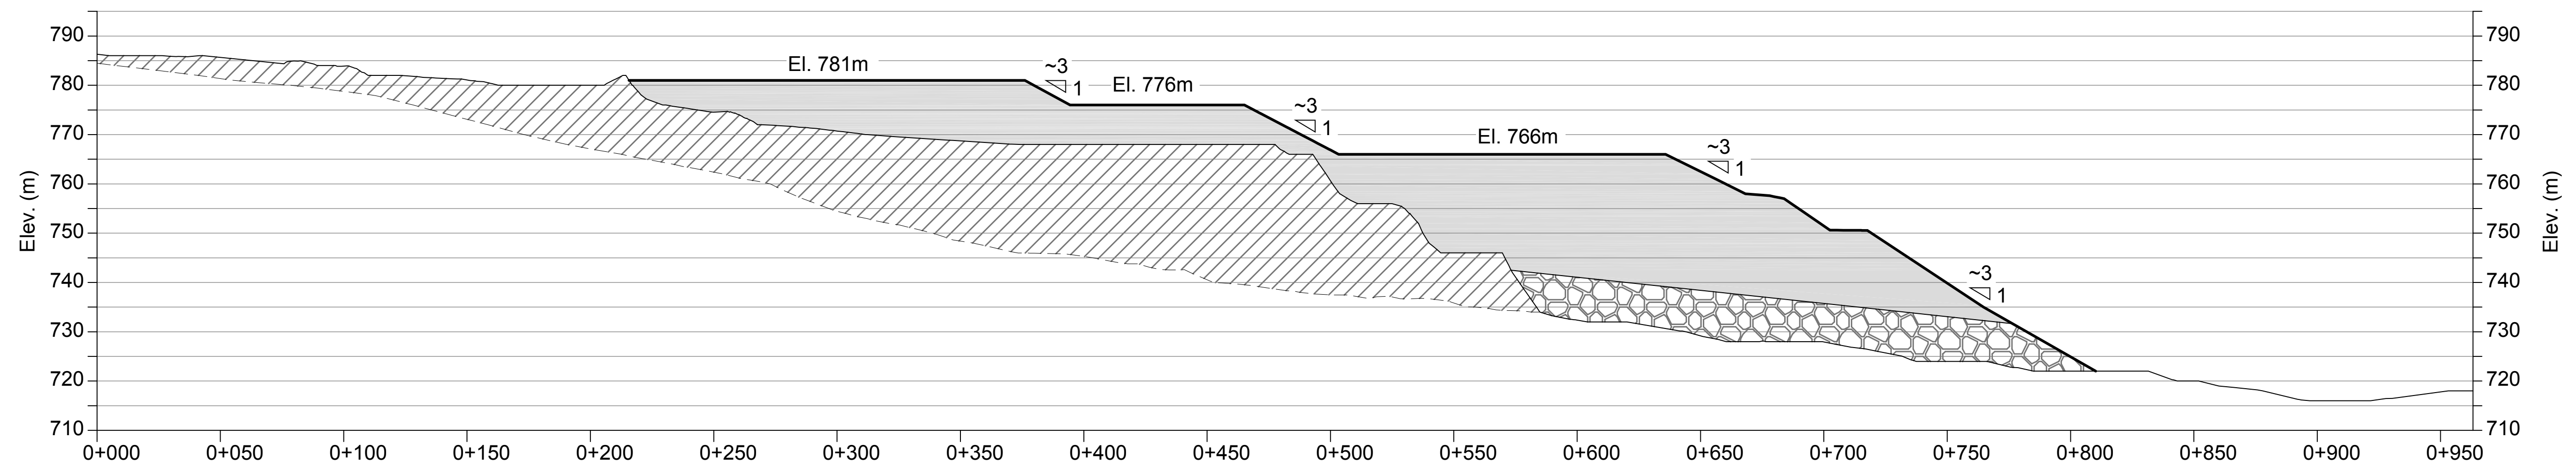
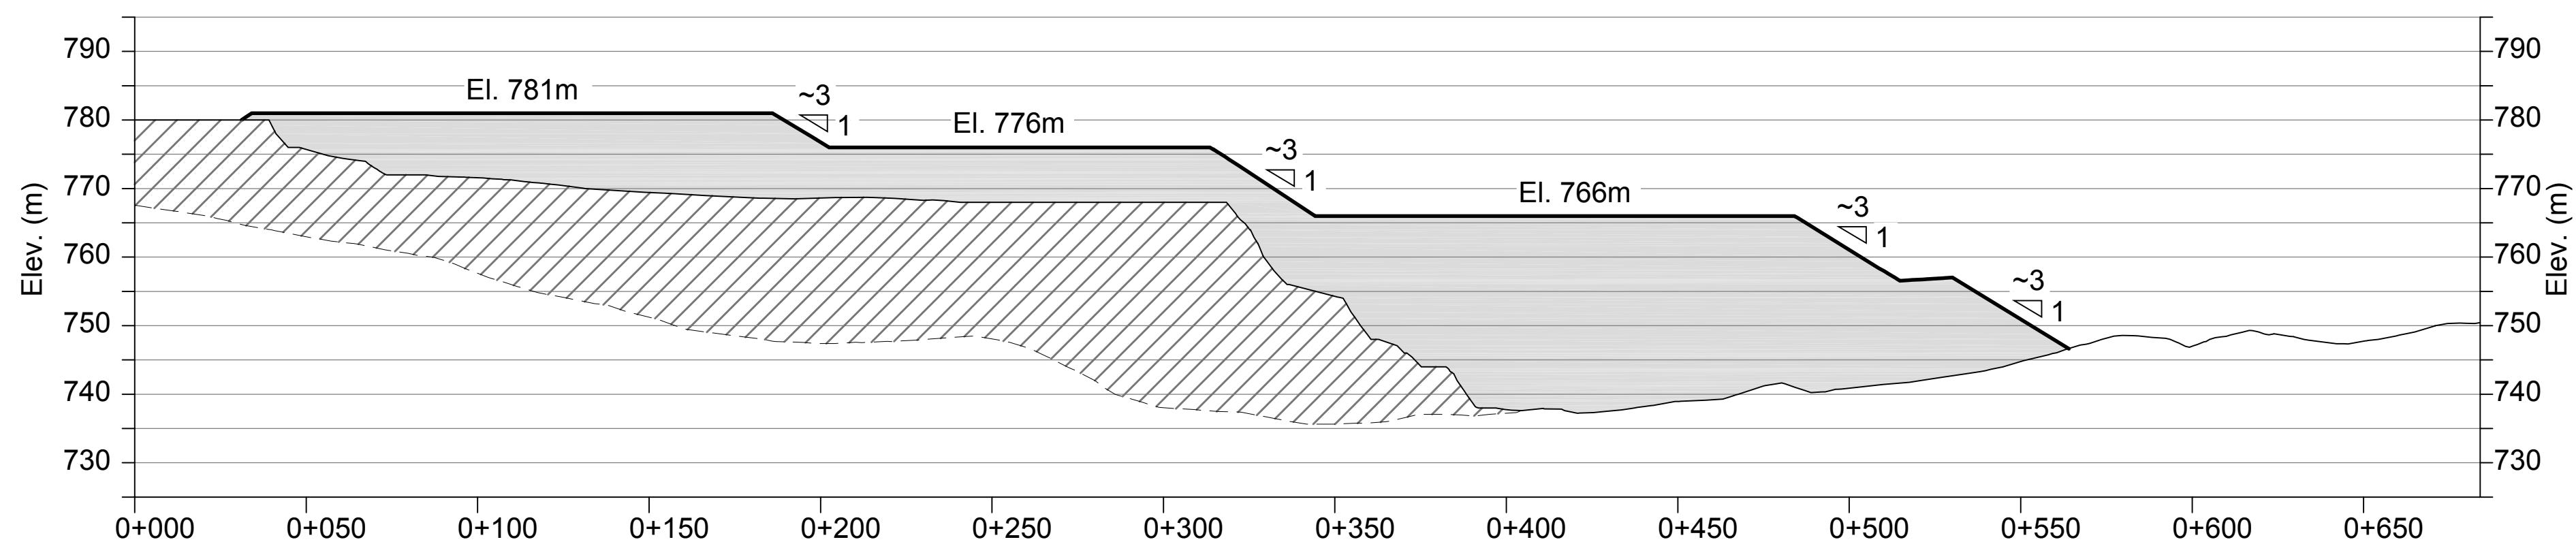
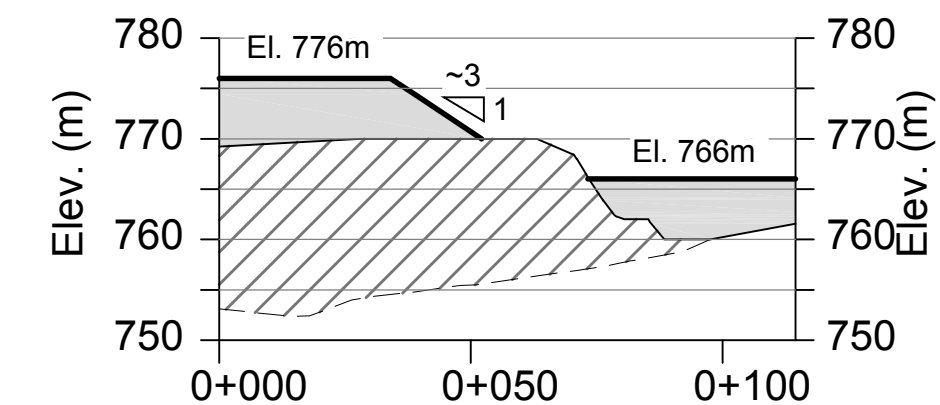
DATE: May 2014	APPROVED: IM	FIGURE: 5
-------------------	-----------------	--------------

**E SECTION**  
Fig 2 2x Vertical Exaggeration

**F SECTION**  
Fig 2 2x Vertical Exaggeration

**G SECTION**  
Fig 2 2x Vertical Exaggeration

**H SECTION**  
Fig 2 2x Vertical Exaggeration

MVFE STAGE 2  
PRELIMINARY DESIGN  
Longitudinal (Down-Valley)  
Sections

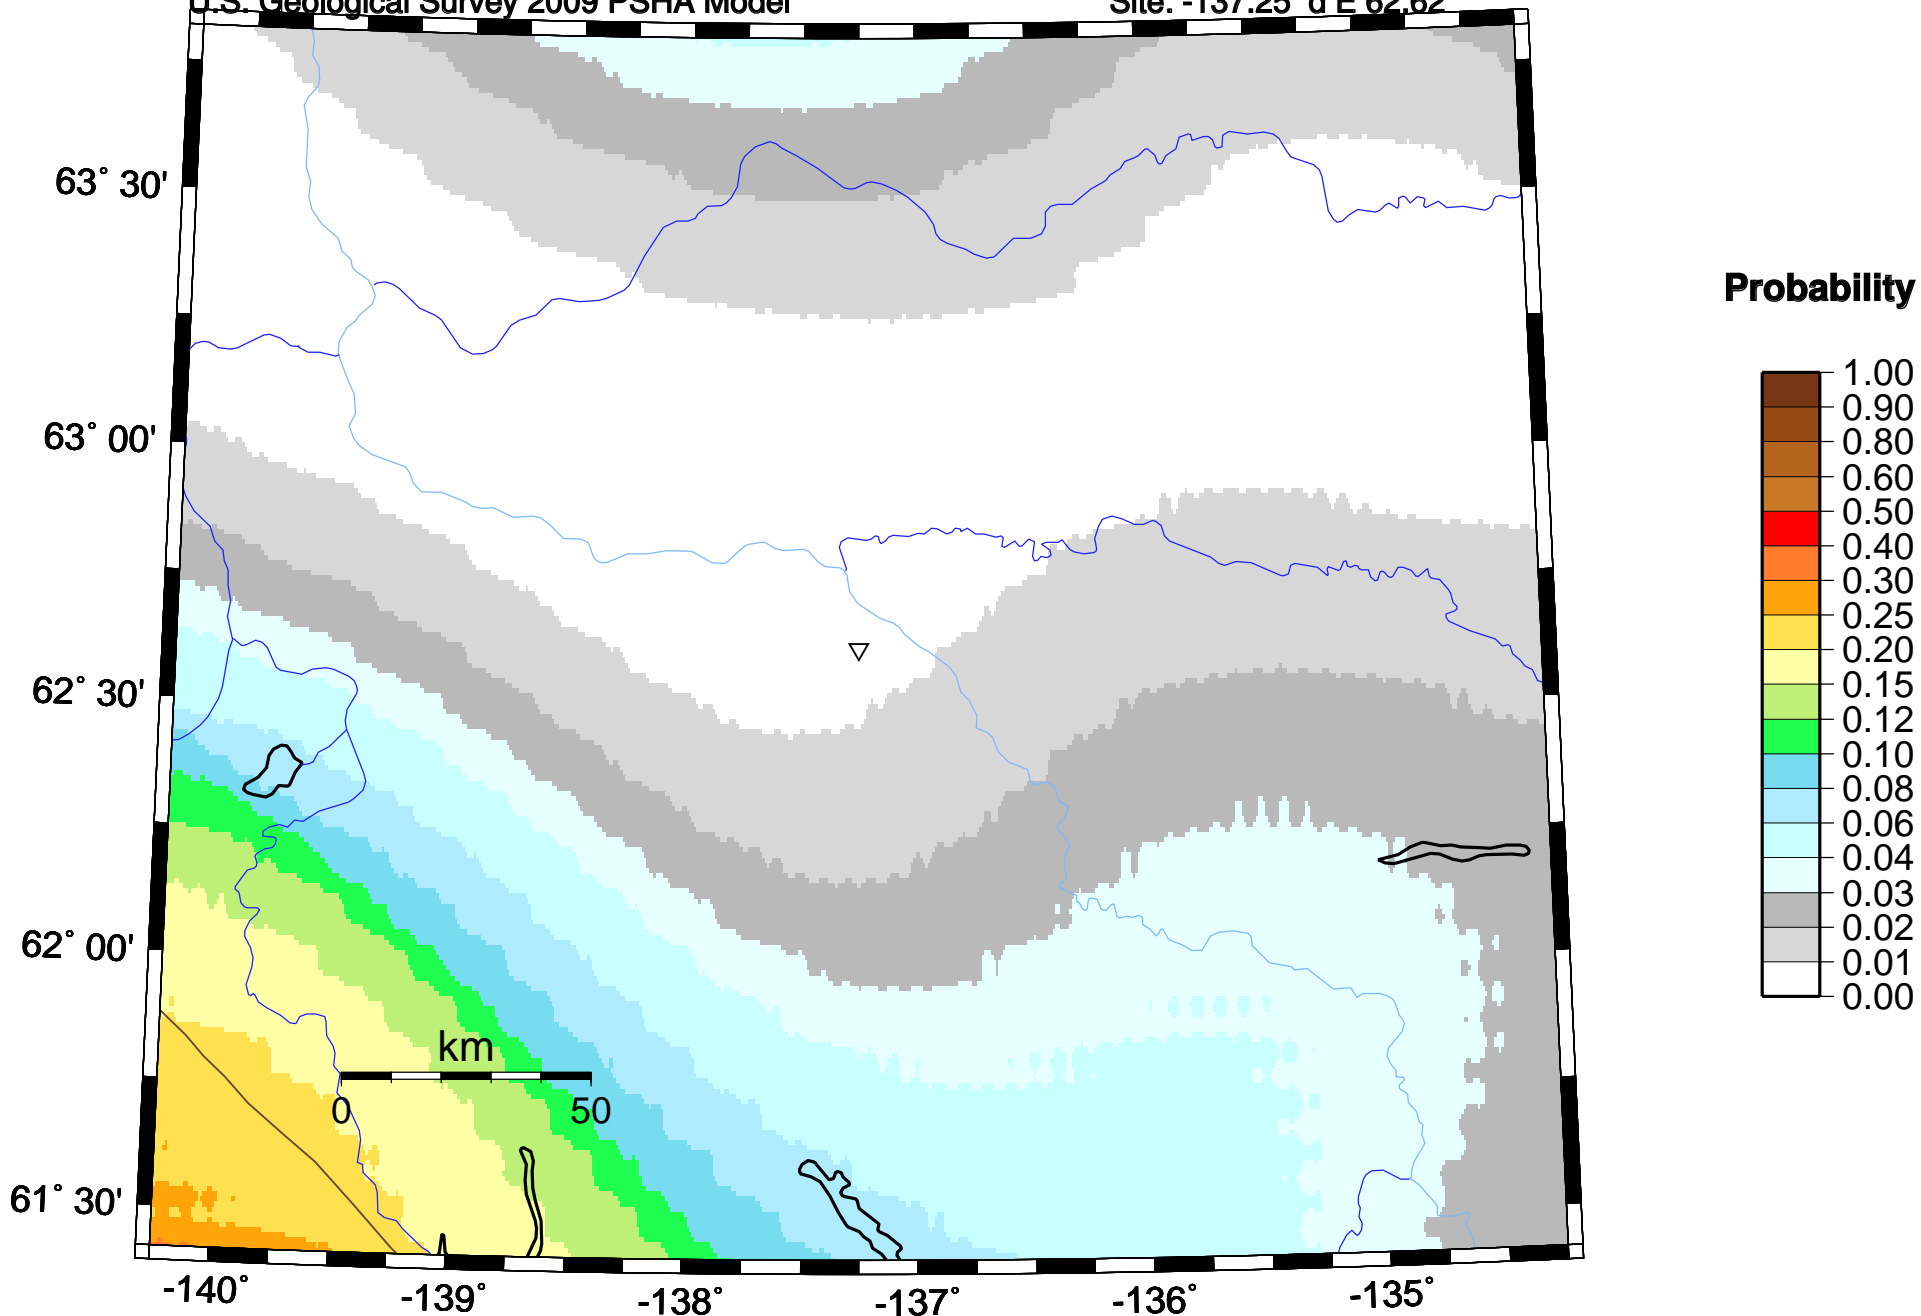
# Probability of earthquake with $M > 5.0$ within 10 years & 50 km

U.S. Geological Survey 2009 PSHA Model

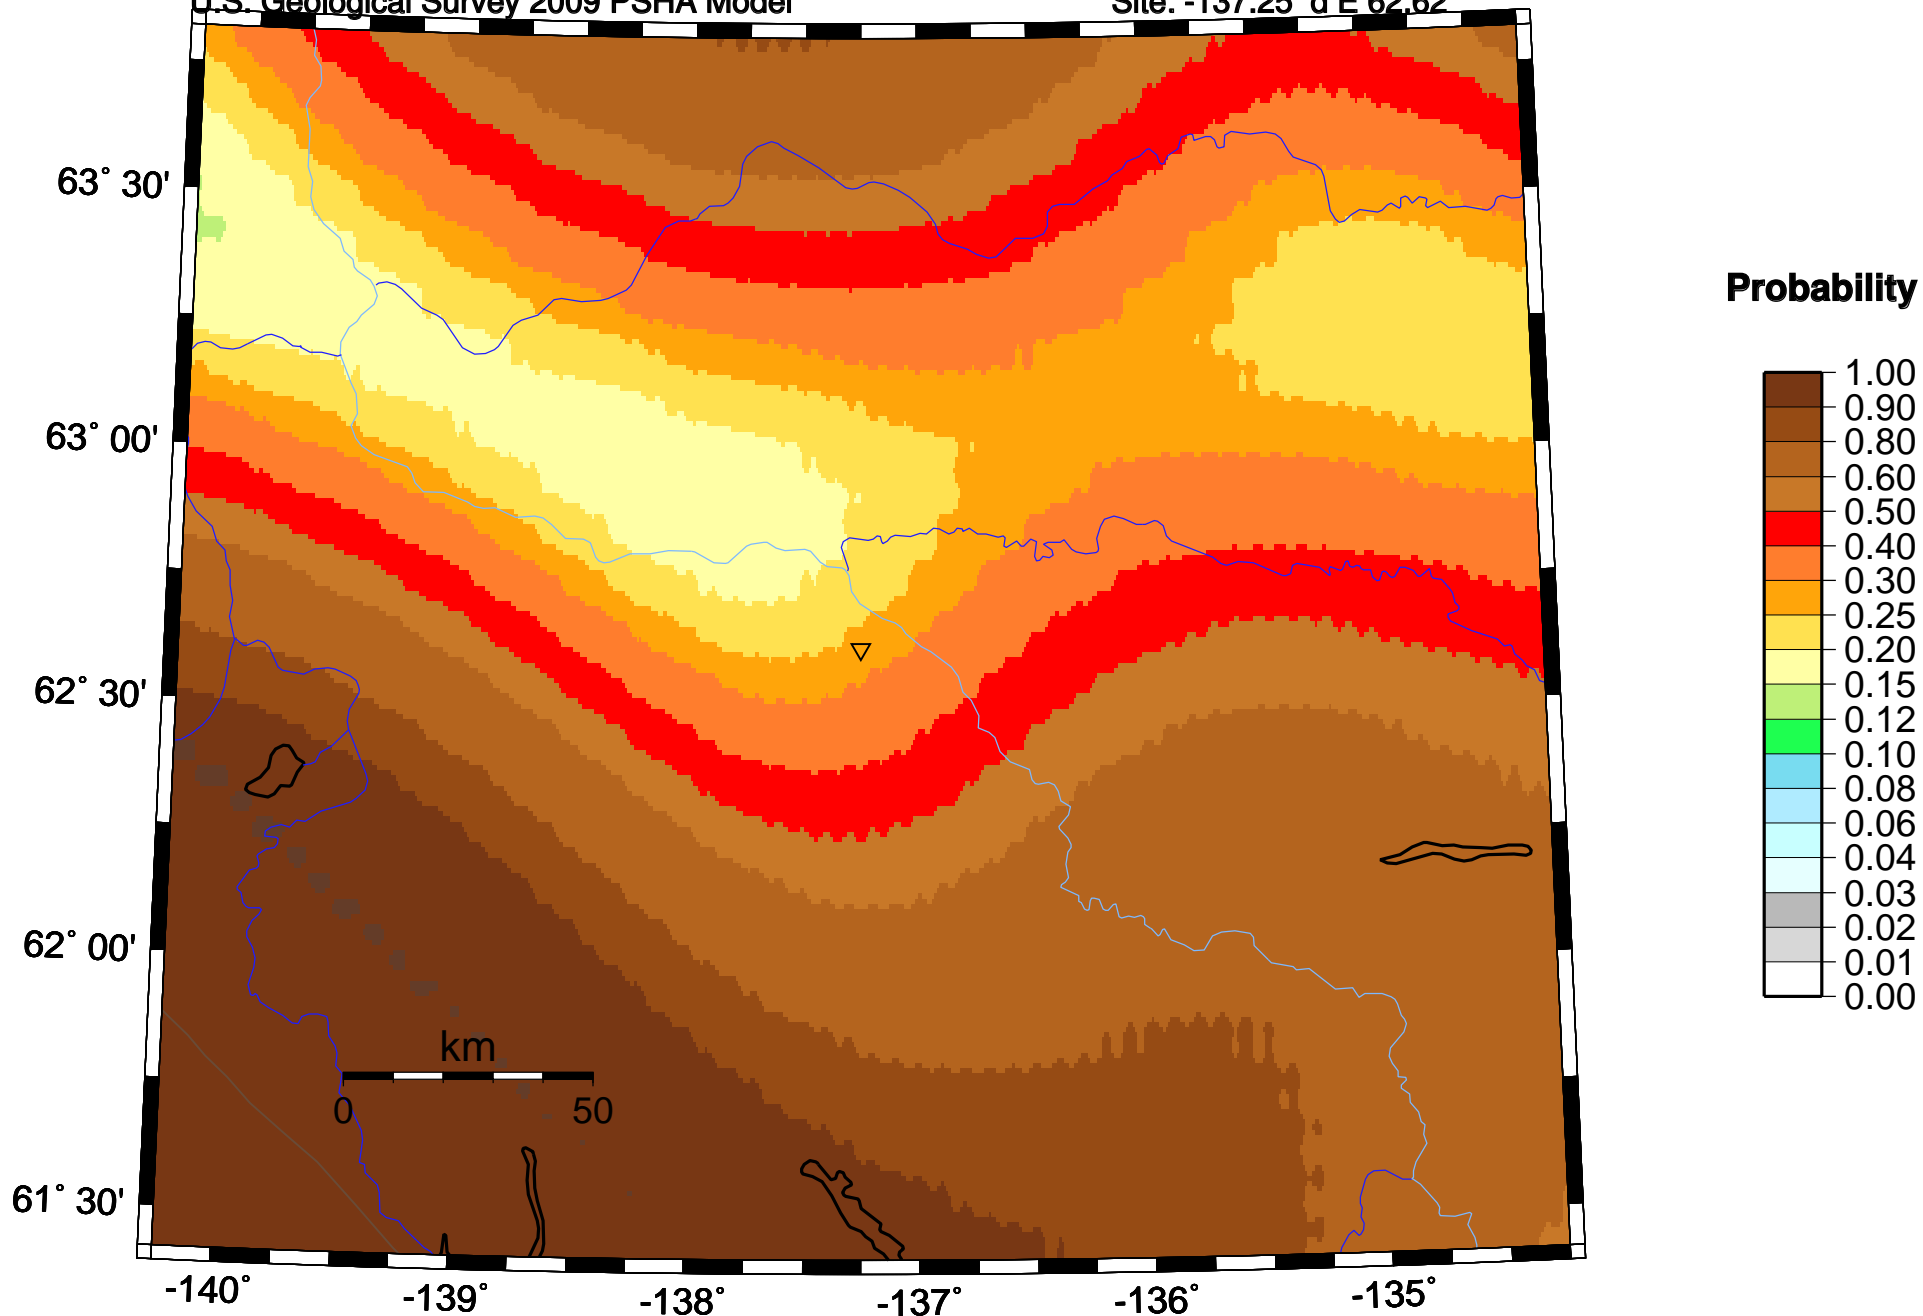
# Probability of earthquake with $M > 6.0$ within 2475 years & 50 km

U.S. Geological Survey 2009 PSHA Model

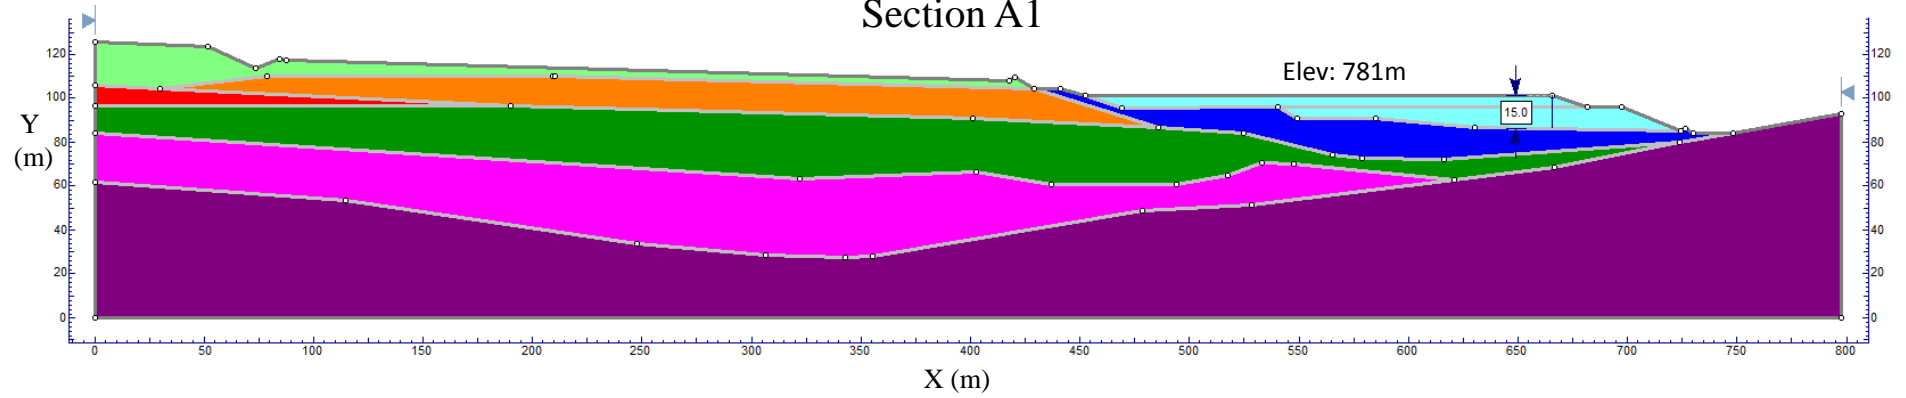
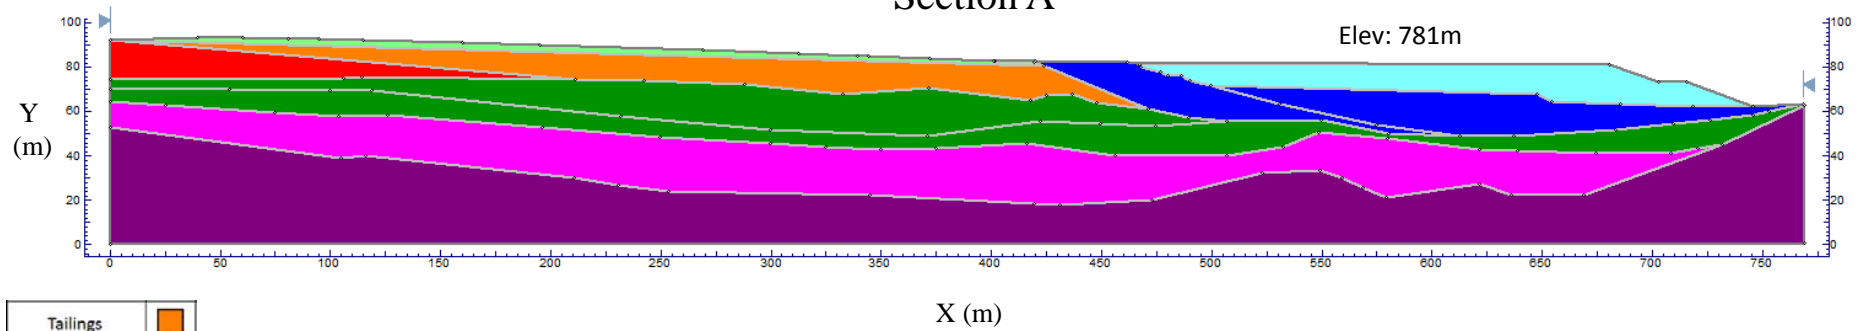
MVFE Stage 2 Geotech Analysis		
		Sections A1 & A		
Job No: 1CM002.027 Filename: Figures2-7_Rev1	Minto	Date: May 2014	Approved: KK	Figure: 1

## Section A1

## Section A

Tailings	
Mixed OVB	
Top OVB	
Clay (Drained)	
Clay (Undrained)	
Stage 2 Fill	
Bedrock	
Existing Fill
