# Mill Valley Fill Extension Stage 2 Preliminary Design Report – Final

Minto Explorations Ltd.

SRK Consulting (Canada) Inc.  
1CM002.027  
June 2014

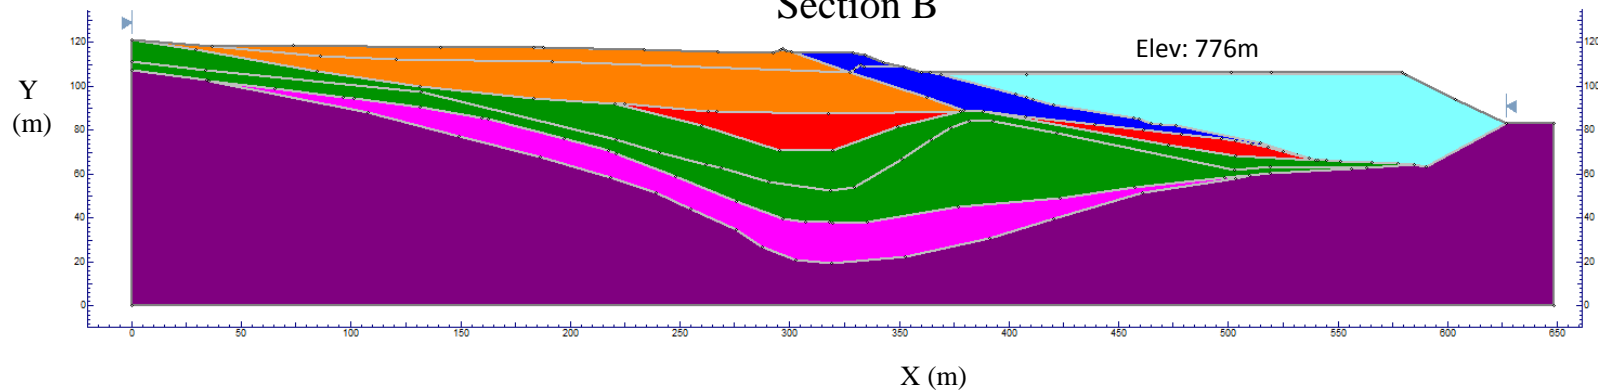
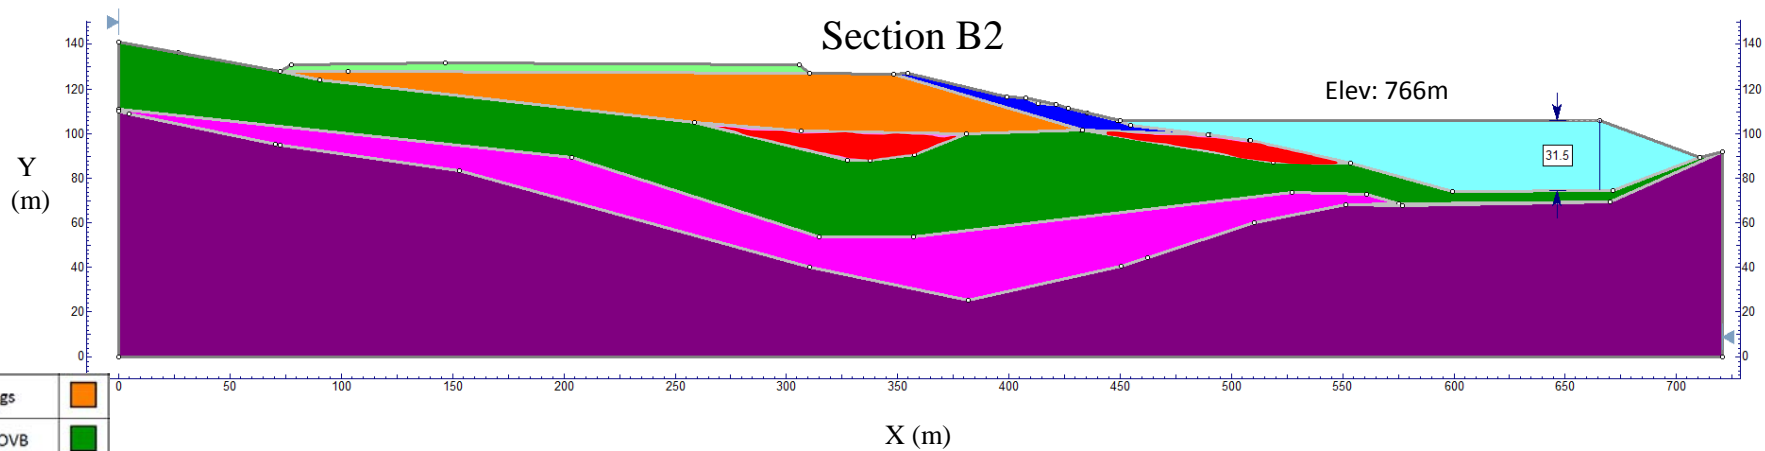
MVFE Stage 2 Geotech Analysis		
		Sections B & B2		
Job No: 1CM002.027 Filename: Figures2-7_Rev1	Minto	Date: May 2014	Approved: KK	Figure: 3

## Section B

## Section B2

Tailings	Orange
Mixed OVB	Green
Top OVB	Light Green
Clay (Drained)	Red
Clay (Undrained)	Magenta
Stage 2 Fill	Cyan
Bedrock	Purple
Existing Fill	Blue

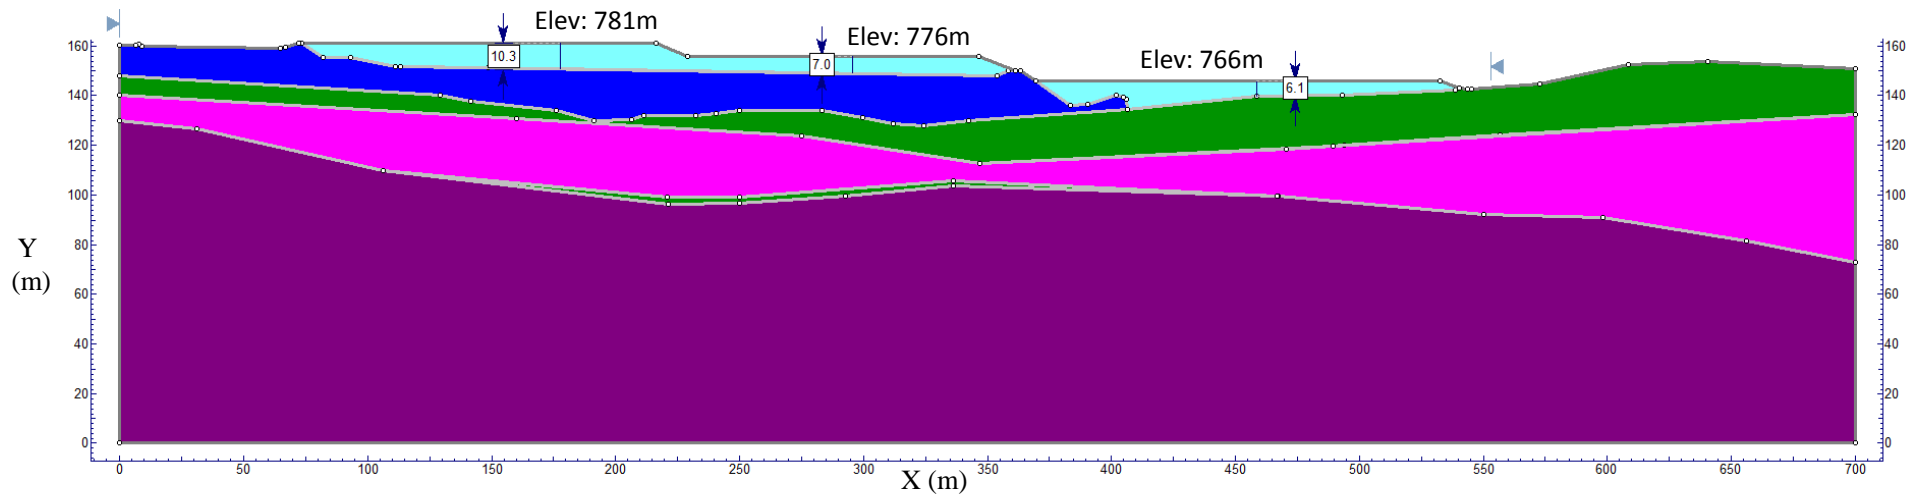
Job No: 1CM002.027 Filename: Figures2-7_Rev1	 OPERATED BY MINTO EXPLORATIONS LTD. Minto	MVFE Stage 2 Geotech Analysis		
		Section E		
		Date: May 2014	Approved: KK	Figure: 5

## Section E

Tailings	
Mixed OVB	
Top OVB	
Clay (Drained)	
Clay (Undrained)	
Stage 2 Fill	
Bedrock	
Existing Fill

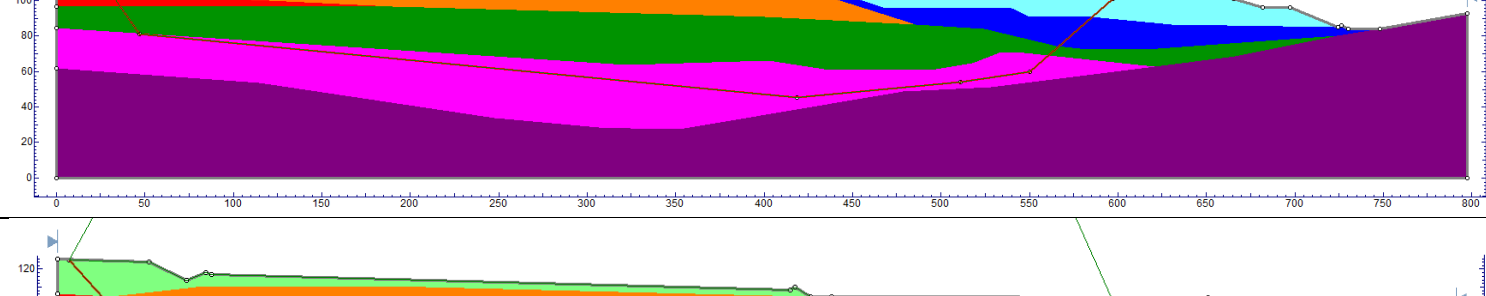
5	A1	A1_Stage2_03_Cu50	MVFE Stage 2	781	50	3.36	79%

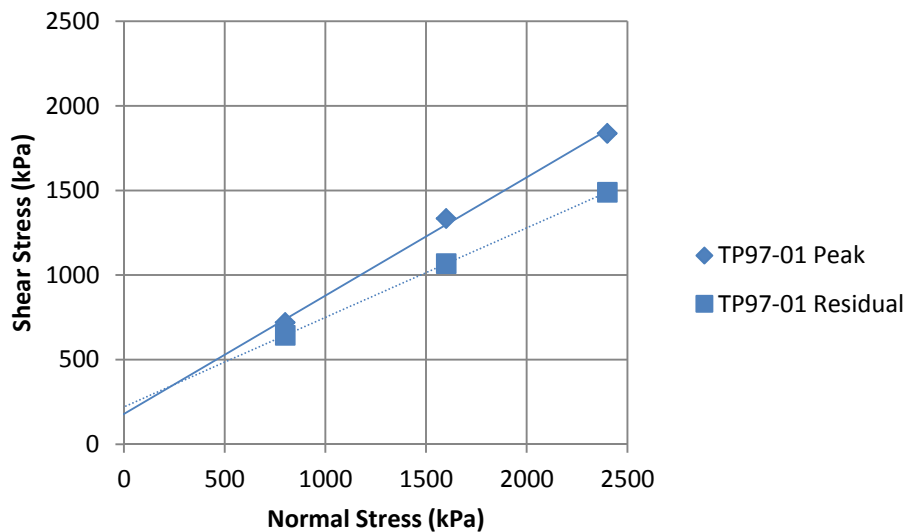
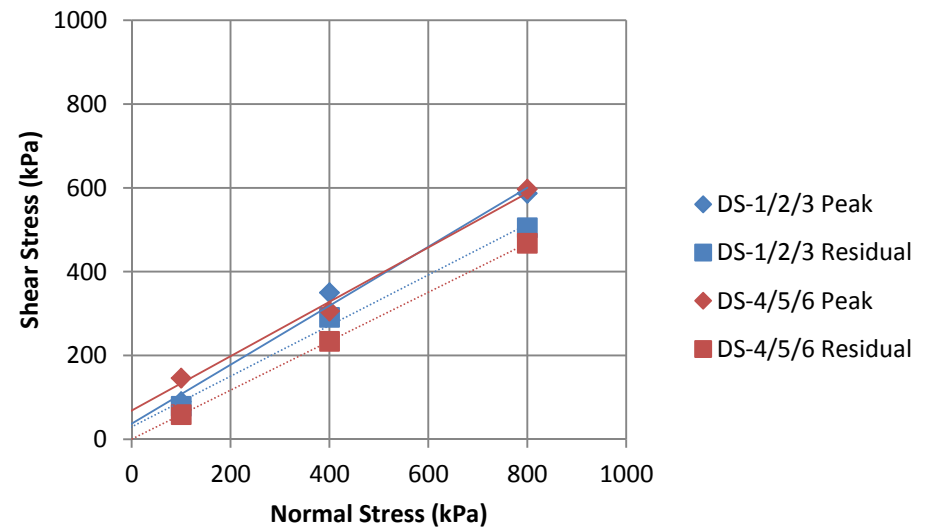
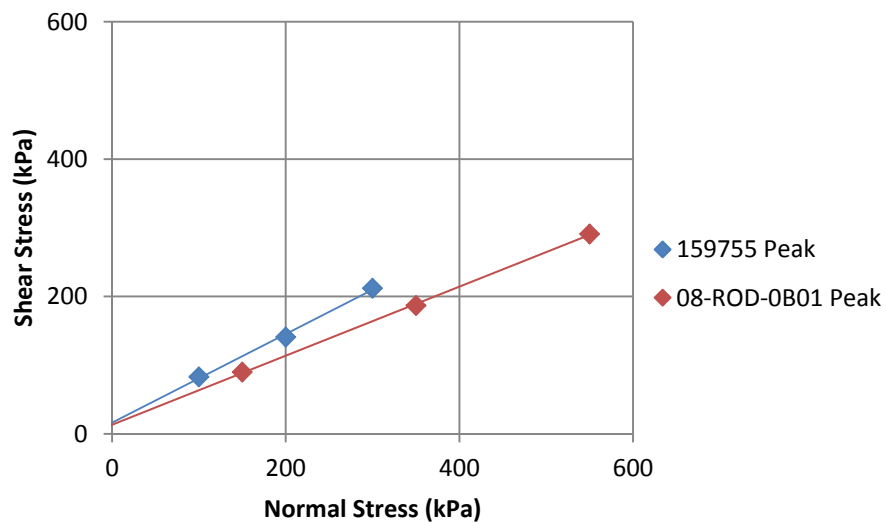
a) EBA (1998) Results

b) EBA (2009) Results

c) SRK (2013) and EBA (2008) Results

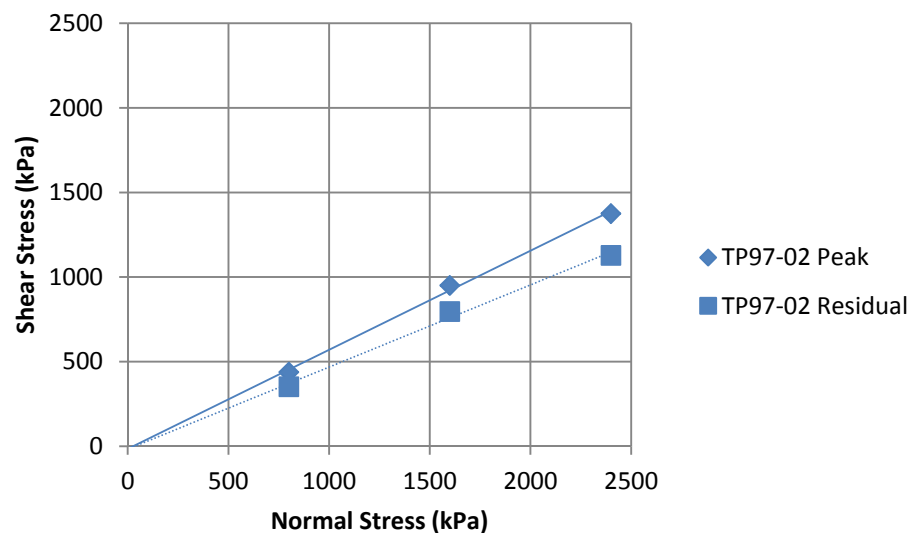
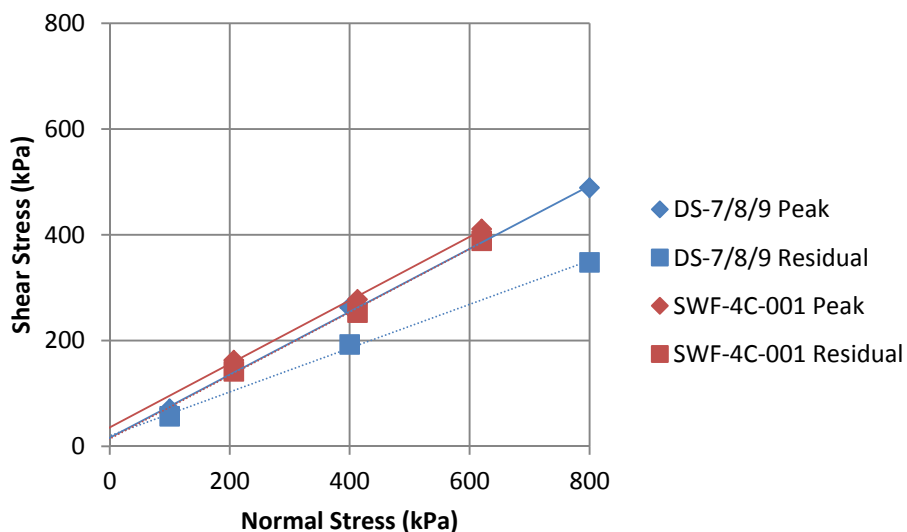
Figure:  
**2**

a) EBA (1998) Results – Main Waste Dump Area

b) EBA/SRK (2009) Results – South Wall Failure Area

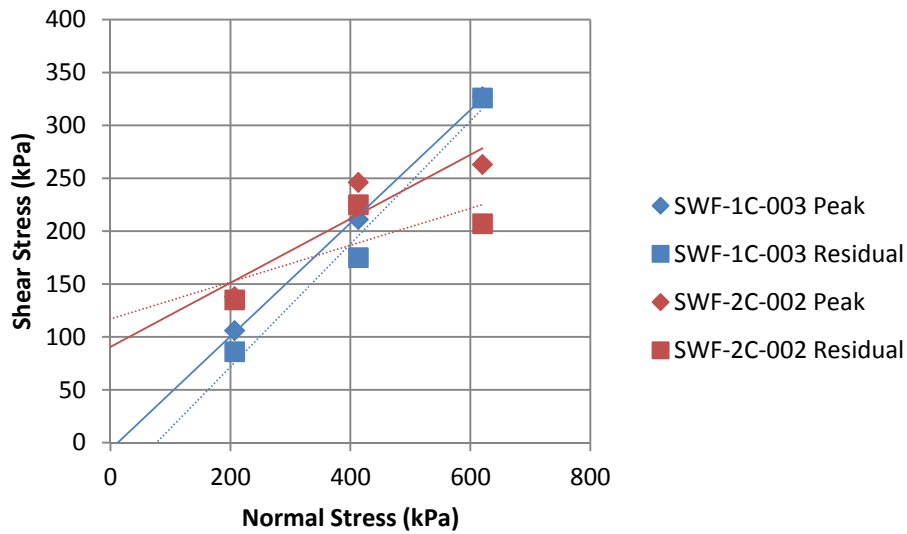
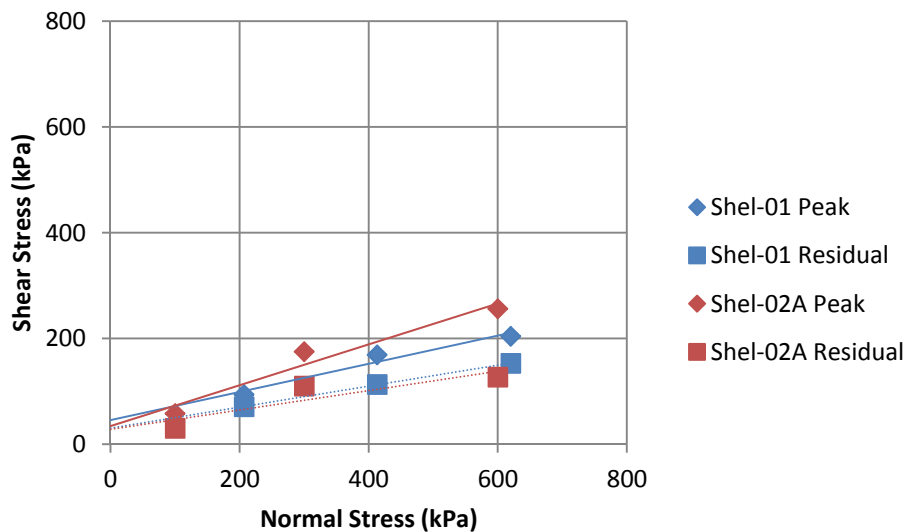
a) SRK and EBA (2009) Results – South Wall Failure Area

b) SRK and EBA (2009) Results – South Wall Failure Slide debris
