Updated Closure Cover Design for the Minto Mine 2016 Reclamation and Closure Plan

SRK Consulting (Canada) Inc.
1CM002.049
August 2016

Updated Closure Cover Design for the Minto Mine 2016 Closure and Reclamation Plan Update

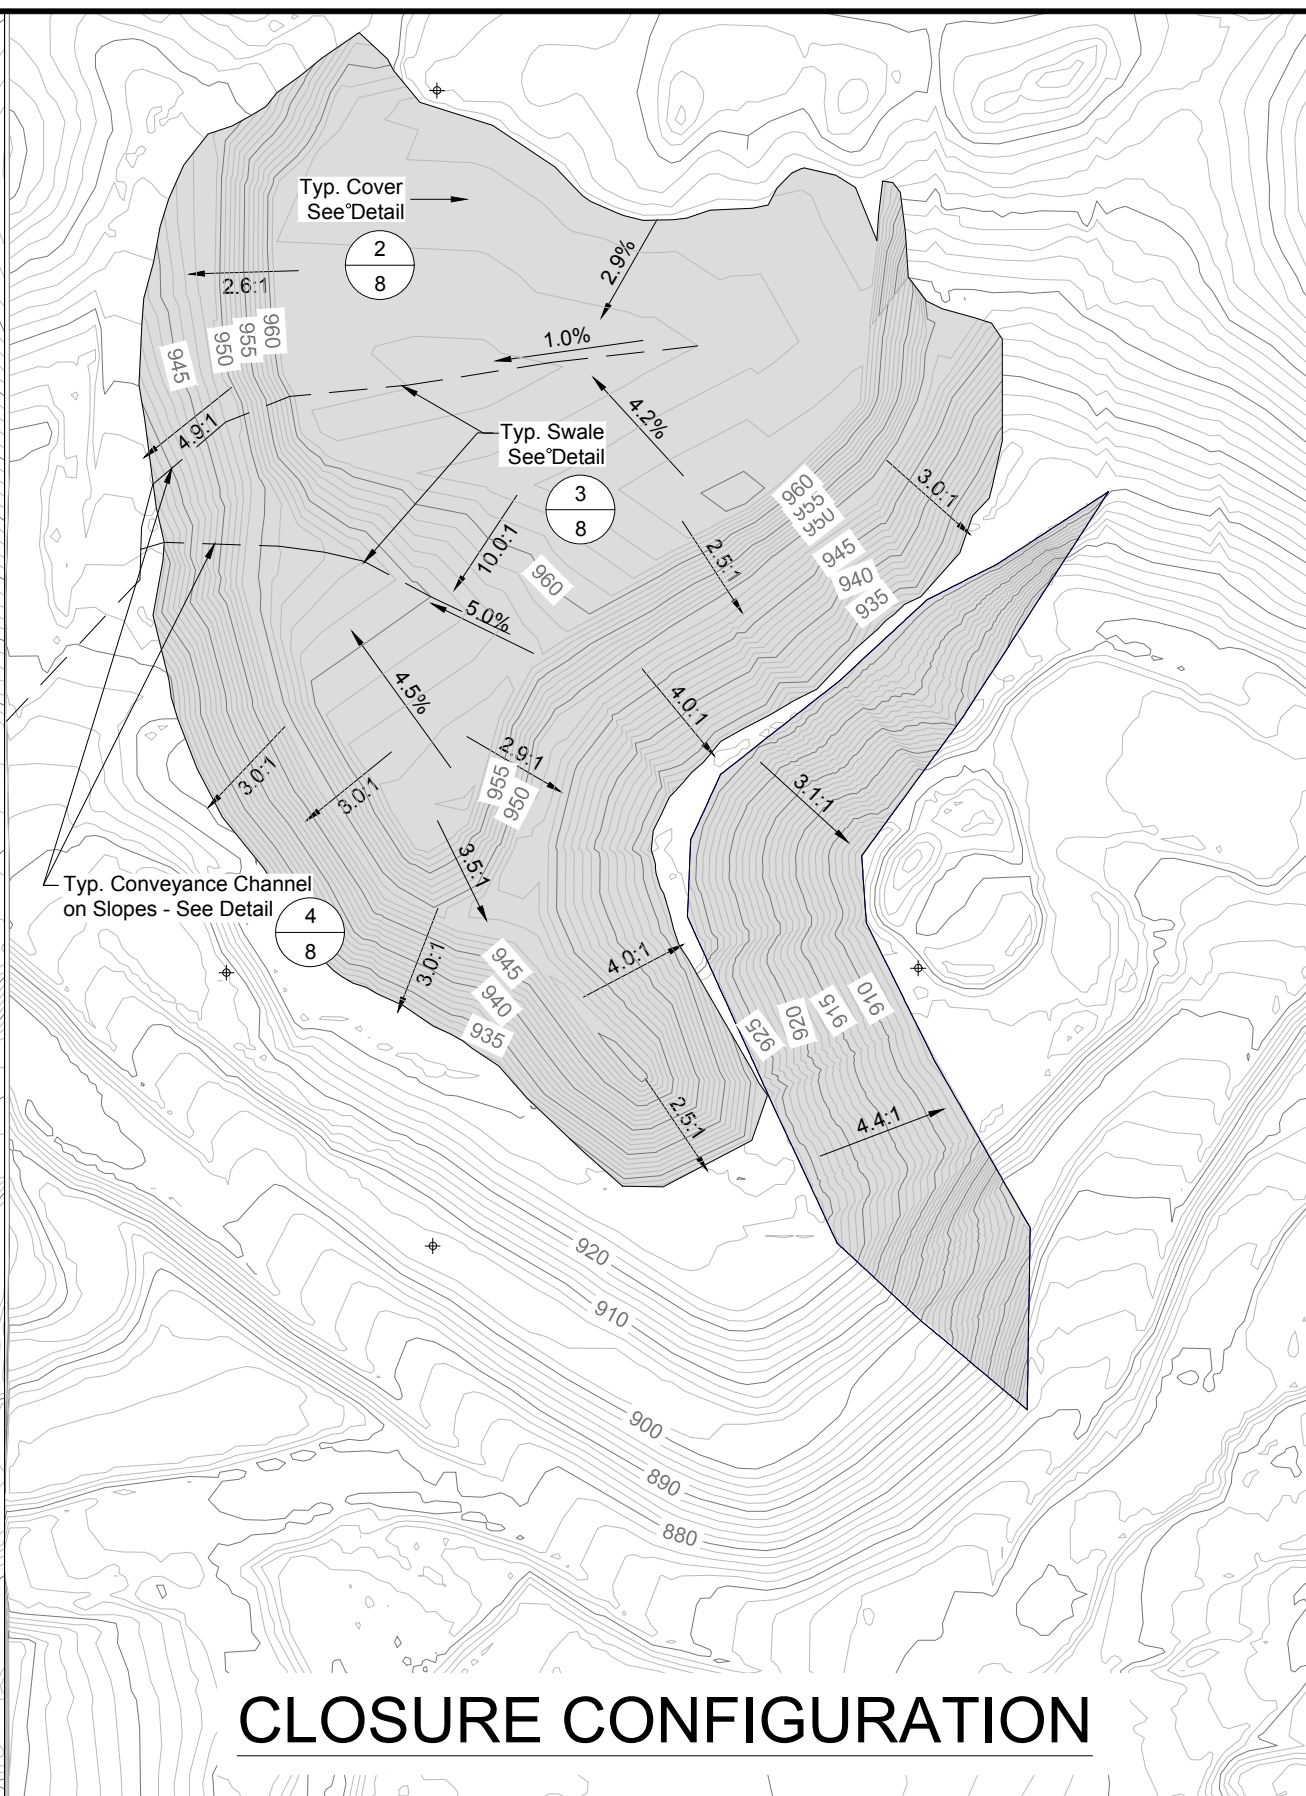
DATE: JULY 2016	APPROVED: EPK	FIGURE: 5
--------------------	------------------	--------------

EXISTING CONDITION

CLOSURE CONFIGURATION

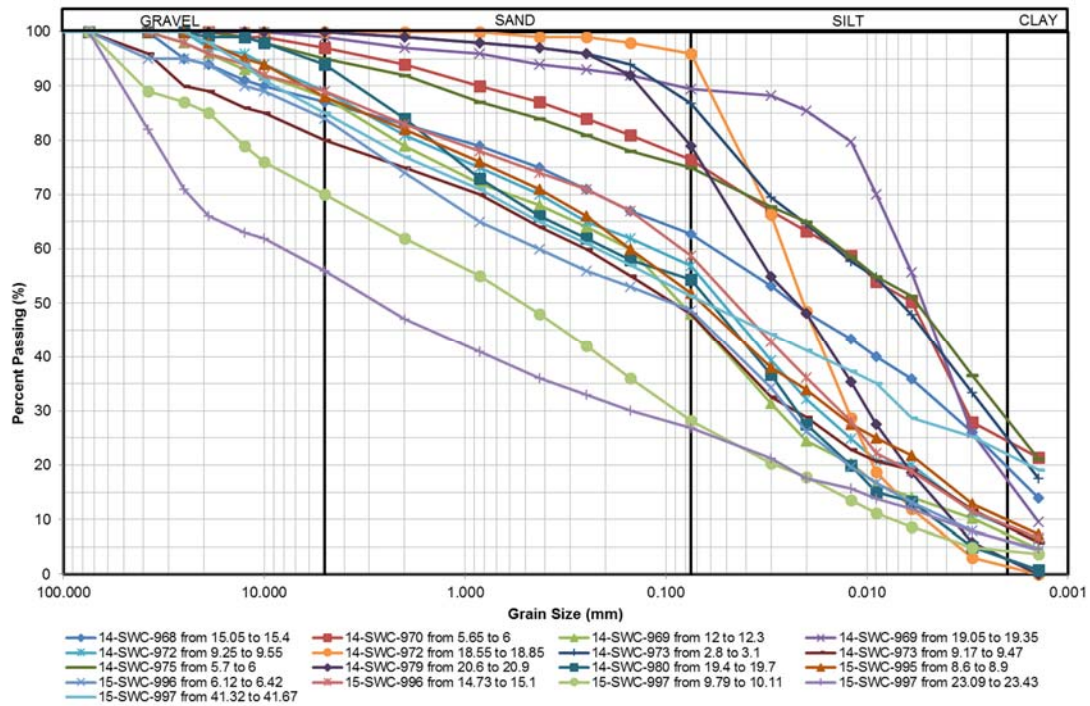
Figure 1: Particle Size Distribution Analysis Results

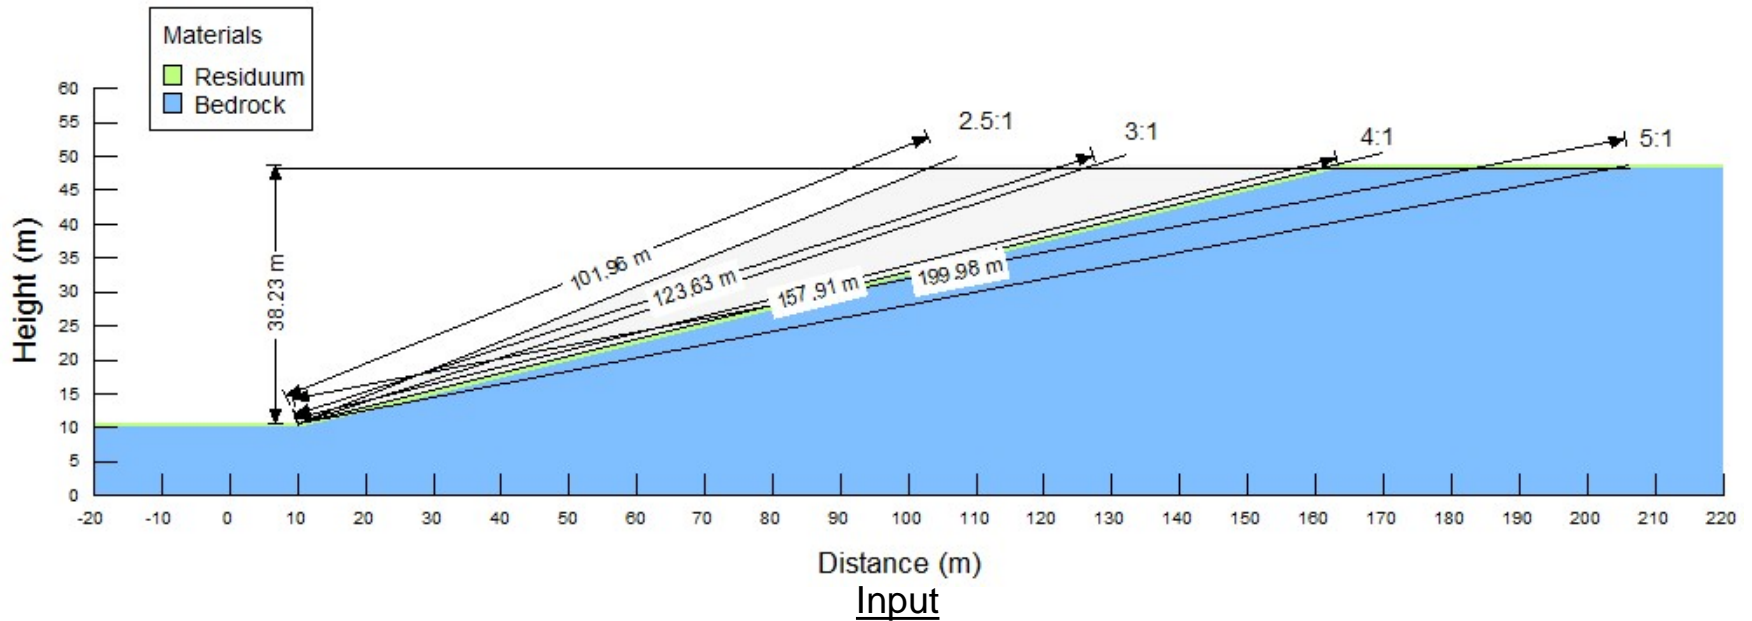
Stability Assessment		
		Scenario 1		
Job No: 1CM002.049 Filename: StabilityAnalysis-Figures-1CM002-049_REV0-EK.pptx	Minto Closure Cover Design	Date: July 2016	Approved: EK	Figure: 1

SRK completed a 2-dimensional limit equilibrium analysis stability analysis as described in Appendix D. The analyses were focused on base case scenarios where a piezometric surface was placed midway through the cover thickness, and the material underlying the cover was considered impenetrable to force the cover failure either through the cover material, or along the interface. Two sets of analyses were completed to demonstrate the effect of a cover constructed of residuum material versus a cover constructed of silty sand material. Analyses were completed for slopes of 2.5H:1V, 3H:1V, 4H:1V, and 5H:1V. Various sensitivity analysis were completed, which indicated that the models were most sensitive to the piezometric surface in the cover.

All of the base case scenarios met the minimum target factor of safety with the exception of the placement of a silty sand cover material on a 2.5H:1V slope. Additional analyses to evaluate the impact of a variable piezometric surface in the cover placed over a 2.5H:1V slope were completed as the base case conditions for the silty sand cover did not meet the minimum target factor of safety. The results indicated that increases in the piezometric surface decreased the factor of safety below the base case, while decreases in the piezometric surface increased the factor of safety above the target criteria.

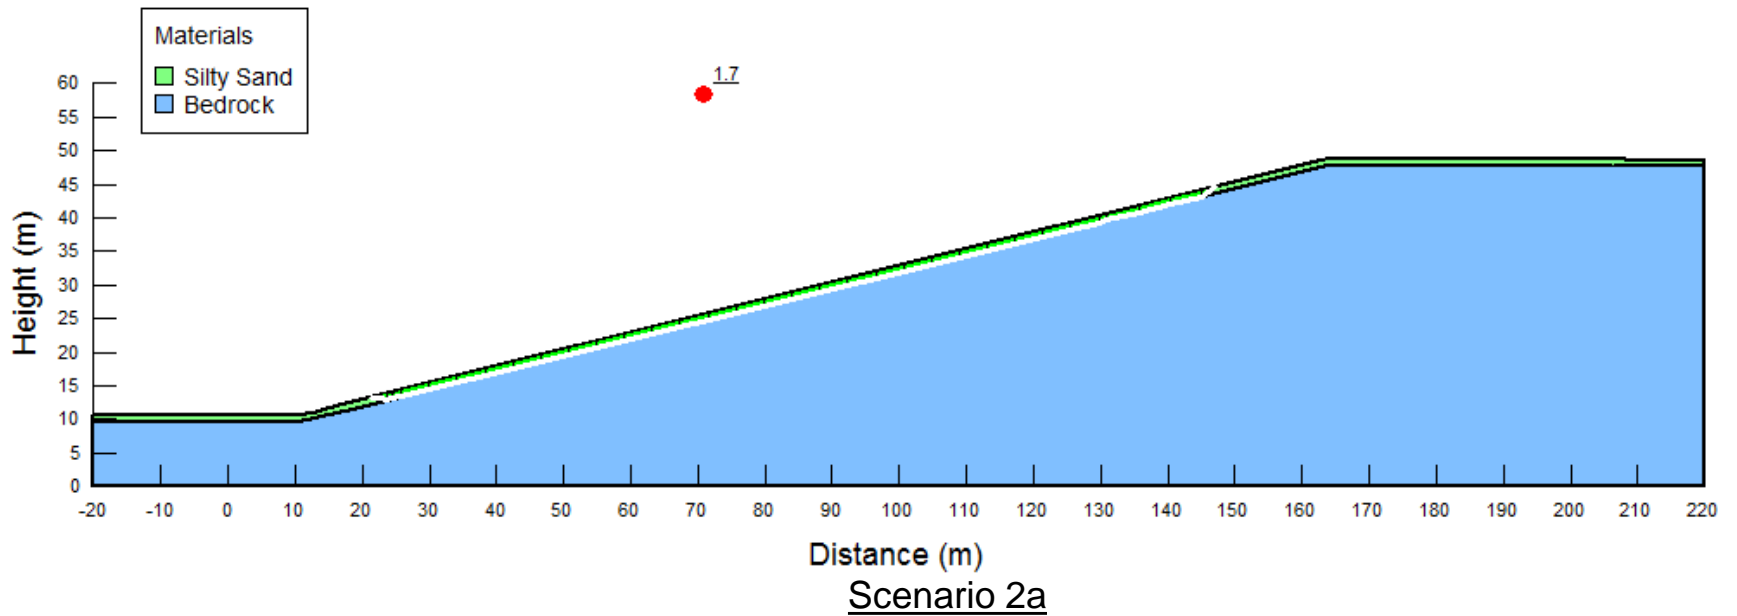
Stability Assessment		
		Scenario 2 Sensitivity		
Job No: 1CM002.049 Filename: StabilityAnalysis-Figures-1CM002-049_REV0-EK.pptx	Minto Closure Cover Design	Date: July 2016	Approved: EK	Figure: 8
