Closure Landform Design and Reclamation Landform Units for the Minto Mine

Minto Explorations Ltd.

SRK Consulting (Canada) Inc.
1CM002.031
May 2016

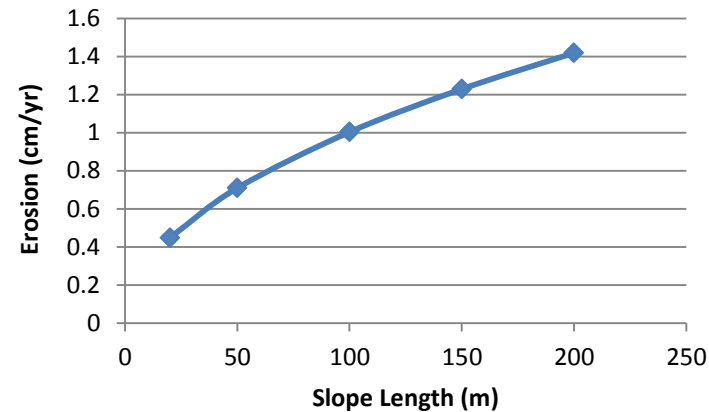
Closure Landform Design and RLUs		
		Erosion Analysis		
Job No: 1CM002.031 Filename: Fig03_ErosionAnalysis_rev02.pptx	Minto Mine	Date: April 2016	Approved: EKH	Figure: 3

Average particle size distribution of soil in the ROD falls into the Sandy Loam category (USDA classification)

Erosion by soil type

Slope length (m) vs Erosion (3H:1V)

Slope (%) vs Erosion

Erosion by cover type

Note: Erosion modeling using USLE assumes uniform soil loss arising from sheet erosion – it does not address local gully erosion, and the results presented here are comparative rather than absolute. Density of soil was assumed to be 1.9 t/m³ in calculations.

For the soil erodibility factor, it was assumed that cover material will be sourced from the reclamation overburden dump (ROD) or from stripping related to the Phase V/VI pit development activities. On average, the ROD material has an average of 17% gravel, 46% sand, 27% silt, and 10% clay (SRK 2013). Removing the gravel proportion, this equates to normalized sand, silt, and clay percentages of 55, 33, and 12, respectively, which means the fine portion of the material falls into the Sandy Loam soil category and is on the fine end (Figure 3 (a)). Several sources provide soil erodibility factors for loam soils that fit this general soil type. A factor of 0.54 was chosen as the average between sandy loam (0.31) and loam (0.71) (Stone and Hilborn 2015). However, the factor was varied for different cover soil types as illustrated in Figure 3 (b).

A base case for erosion at the Minto site was defined in order to allow comparison of erosion rates for differing soil types, vegetation, and slope lengths and gradients. Erosion for the base case was calculated for a sandy loam on a slope 100 m long at 18° (3H:1V) with no vegetation or support management. The base case estimated an annual erosion of 270 tonnes/hectare, which is considered severe in terms of crop soil loss. Single parameter values were then varied in the equation from the base case in order to illustrate the influence of each parameter on the final landform performance. Comparative graphs of the erosion estimates are shown in Figure 3 (b) through (e).

The analysis showed that erosion can be minimized by reducing slope lengths and gradients, using sandy covers, and ensuring thorough revegetation. The relationship between the amount of erosion and slope length is clear and almost linear – as slope length increases, so does erosion. As slope gradient decreases, erosion decreases; however, the effect becomes less pronounced at slope gradients shallower than 11° (5H:1V). This is important to note as regrading large, steep slopes to long, flat ones can be costly. From this analysis, it appears that short slopes covered with sand and densely vegetated with an angle of 11° or less will yield the least erosion from final landforms at Minto. This analysis shows that flatter slopes lead to reduced erosion.

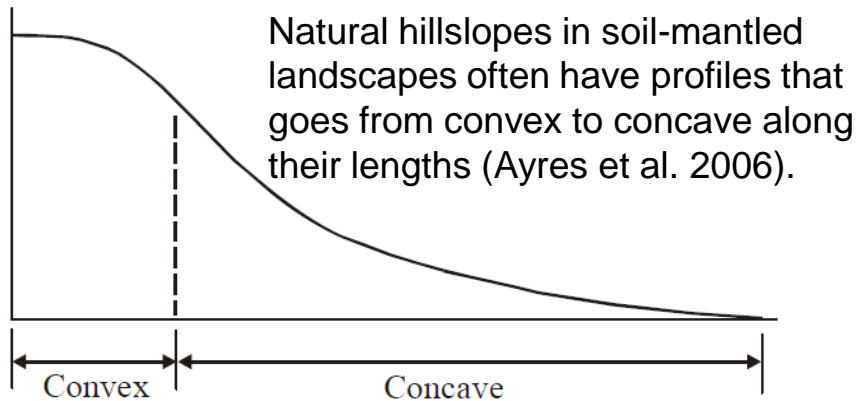
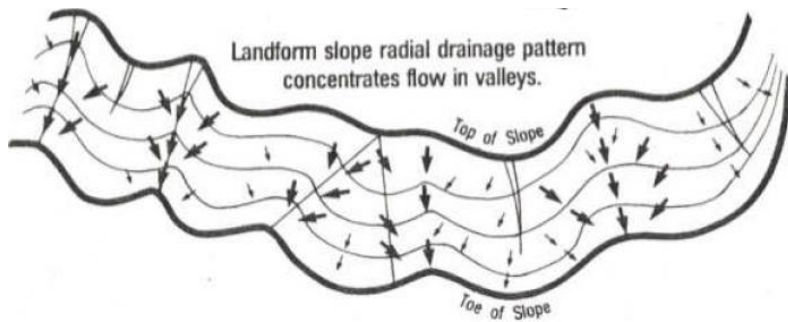
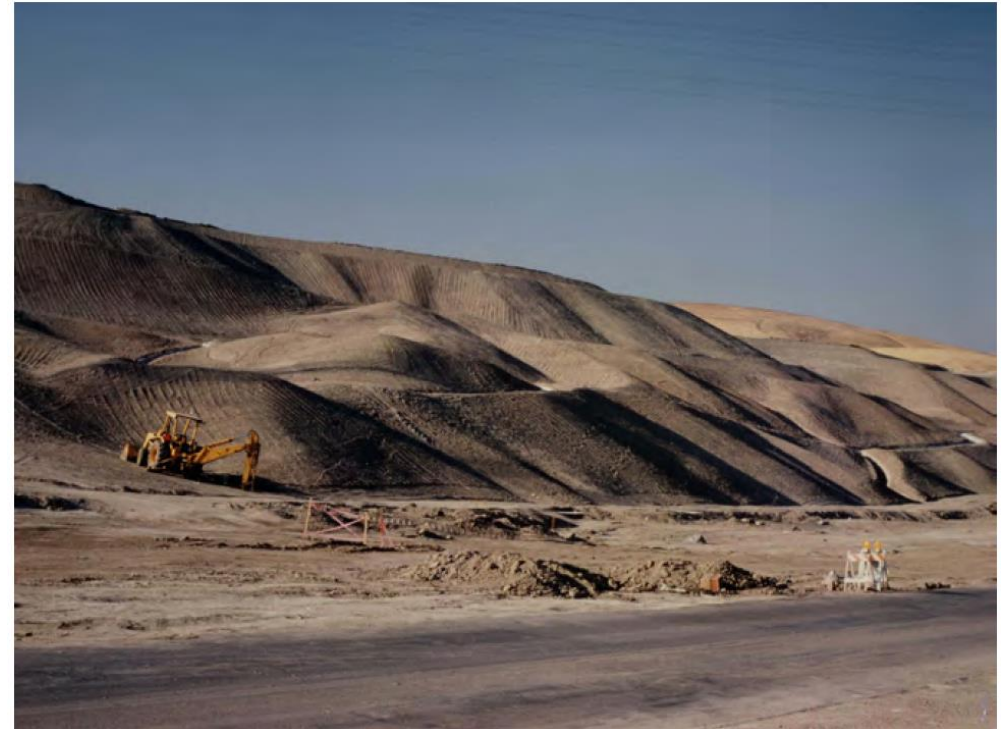
Date: April 2016
 Approved: EKH
 Figure: 4

Landform-designed slopes have a radial drainage pattern that concentrate flow in valleys (Michael et al. 2010).

Landform-designed slopes are broken up into smaller drainage areas in order to limit the maximum overland flow path and resulting erosion (Schor and Gray 2013).

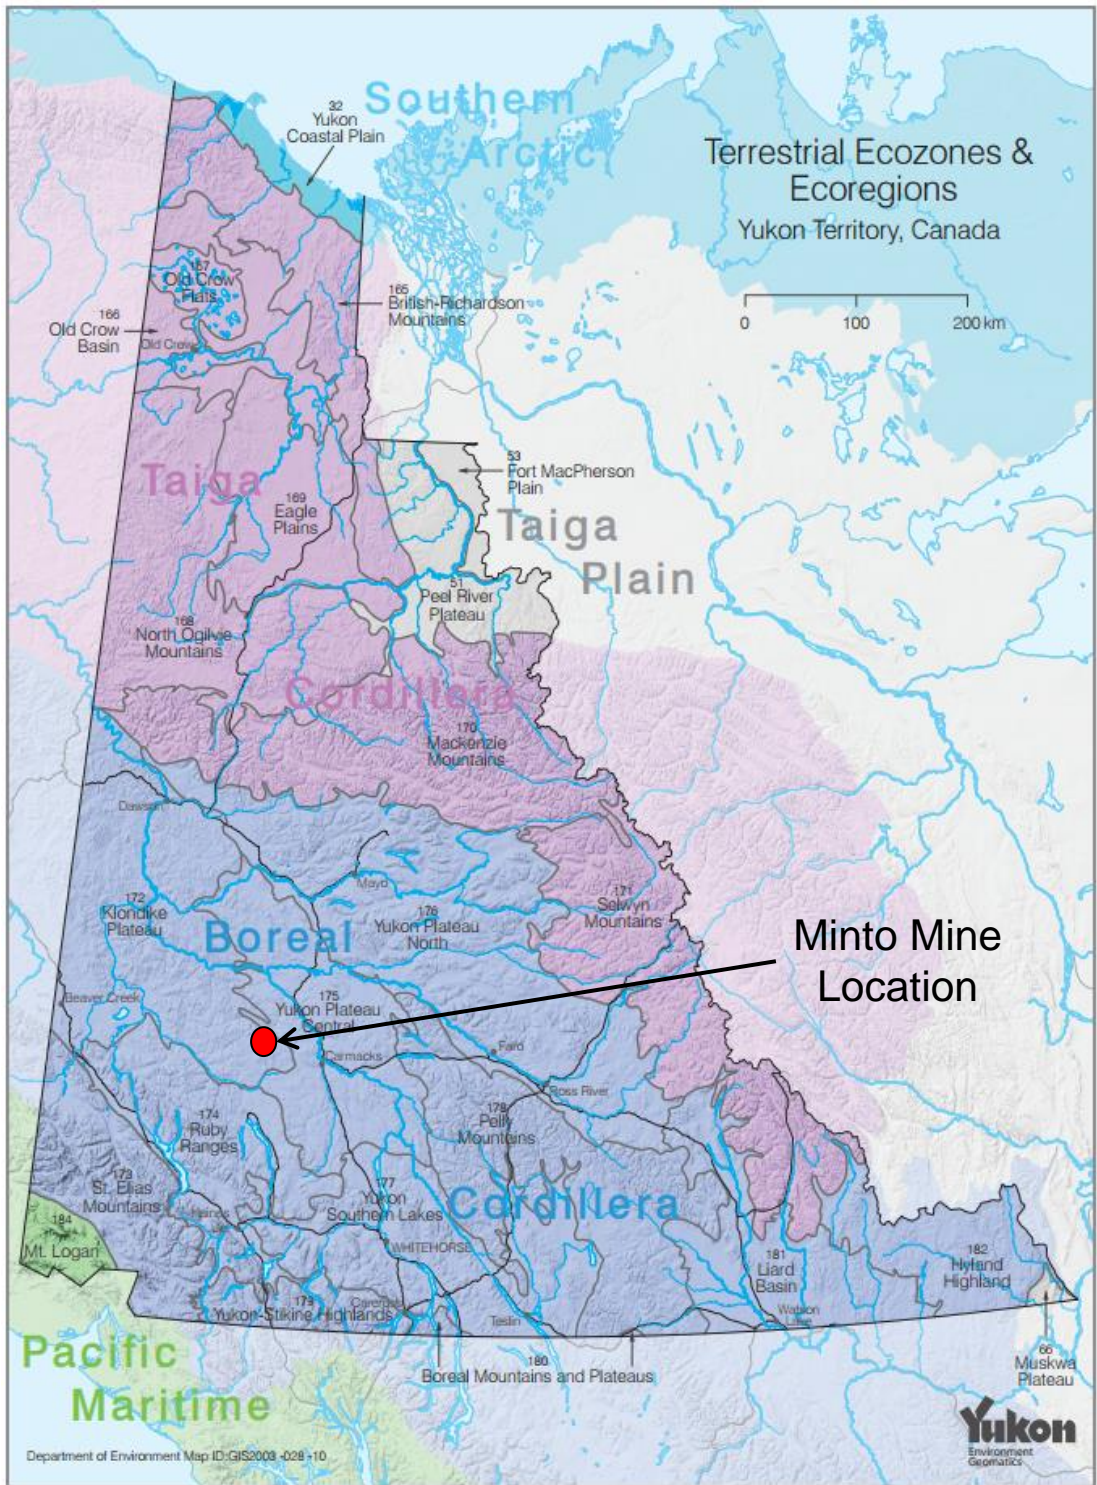
Closure Landform Design and RLUs		
		Terrestrial Ecozones of the Yukon		
Job No: 1CM002.031 Filename: Fig14_TerrestrialEcozones_rev02.ptx	Minto Mine	Date: April 2016	Approved: EKH	Figure: 14

Source: Smith, C.A.S., Meikle, J.C., Roots, C.F. (2004). *Ecoregions of the Yukon Territory: Biophysical Properties of Yukon Landscapes*. Agriculture and Agri-Food Canada, PARC Technical Bulletin No. 04-01, Summerland, British Columbia, 313 p. Retrieved from: http://www.env.gov.yk.ca/animals-habitat/documents/ecoregions_of_yukon_reduced.pdf

Delineation of reclamation land units is often based on end land use, initial and final surface configuration, and likely vegetation patterns (Bowman and Baker 1998). It is useful therefore to understand the land and vegetation patterns and existing biogeoclimatic zones defined within the given project area. Maps can be a valuable tool for achieving this. Biogeoclimatic zones are generally defined by superposition of the terrestrial ecozones and ecoregions, ecoclimatic regions, and the bioclimatic zones of a specific target area. The Minto Mine area is characterised as part of the Yukon Plateau ecoregion within the Boreal Cordillera ecozone (Figure 14), while from an ecoclimatic perspective, the mine area is part of the Northern Cordilleran High Boreal region (Figure 15).

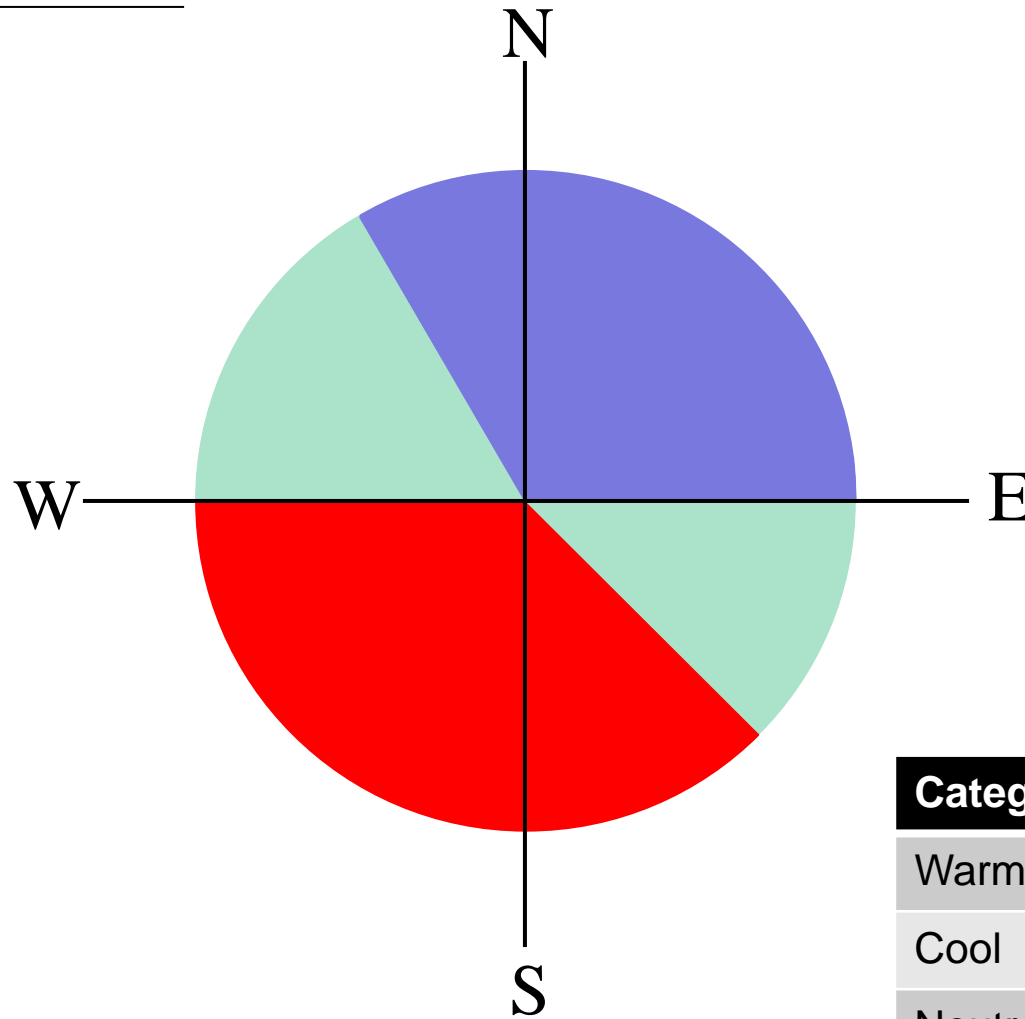
Date: April 2016	Approved: IM	Figure: 17
------------------	--------------	------------

Category	Azimuth Range (°)
Warm	135 – 270
Cool	330 – 90
Neutral	90 – 135, 270 – 330
