Minto Mine  
Reclamation and Closure Plan  
2016-01

Prepared by:  
Minto Explorations Ltd.  
Minto Mine  
August 2016

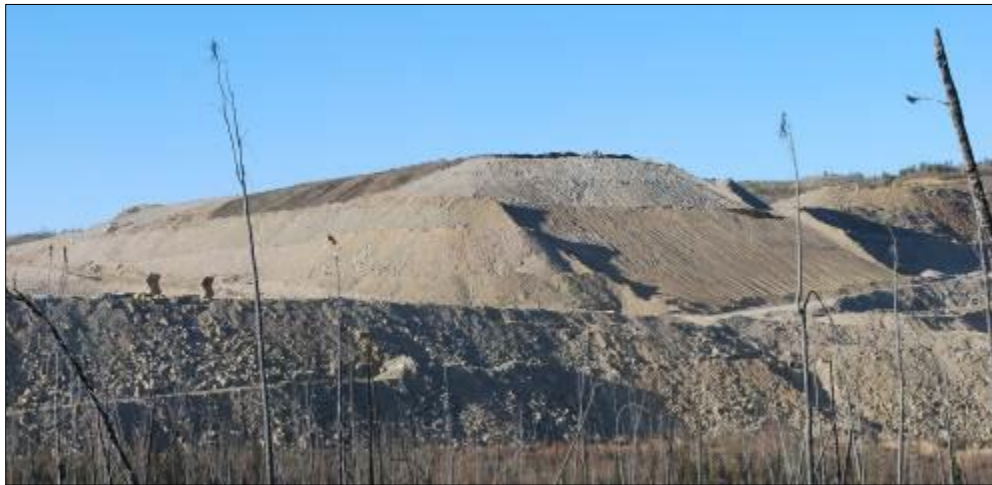
**Figure 2-2: Main Waste Dump near the End of Construction Season 2011 (September)**

Figure 2-2 shows the reclamation work that Minto Mine completed on the Main Waste Dump in 2011. At the beginning of the 2012 summer Minto completed the re-contouring of the slopes placed 1m of overburden over the re-contoured slopes (Figure 2-3). As sections of the overburden were placed, they were hand seeded and fertilized (depending on plot amendment) (Figure 2-4). Vegetation established within a couple of growing seasons and established vegetation cover is shown in Figure 2-5.

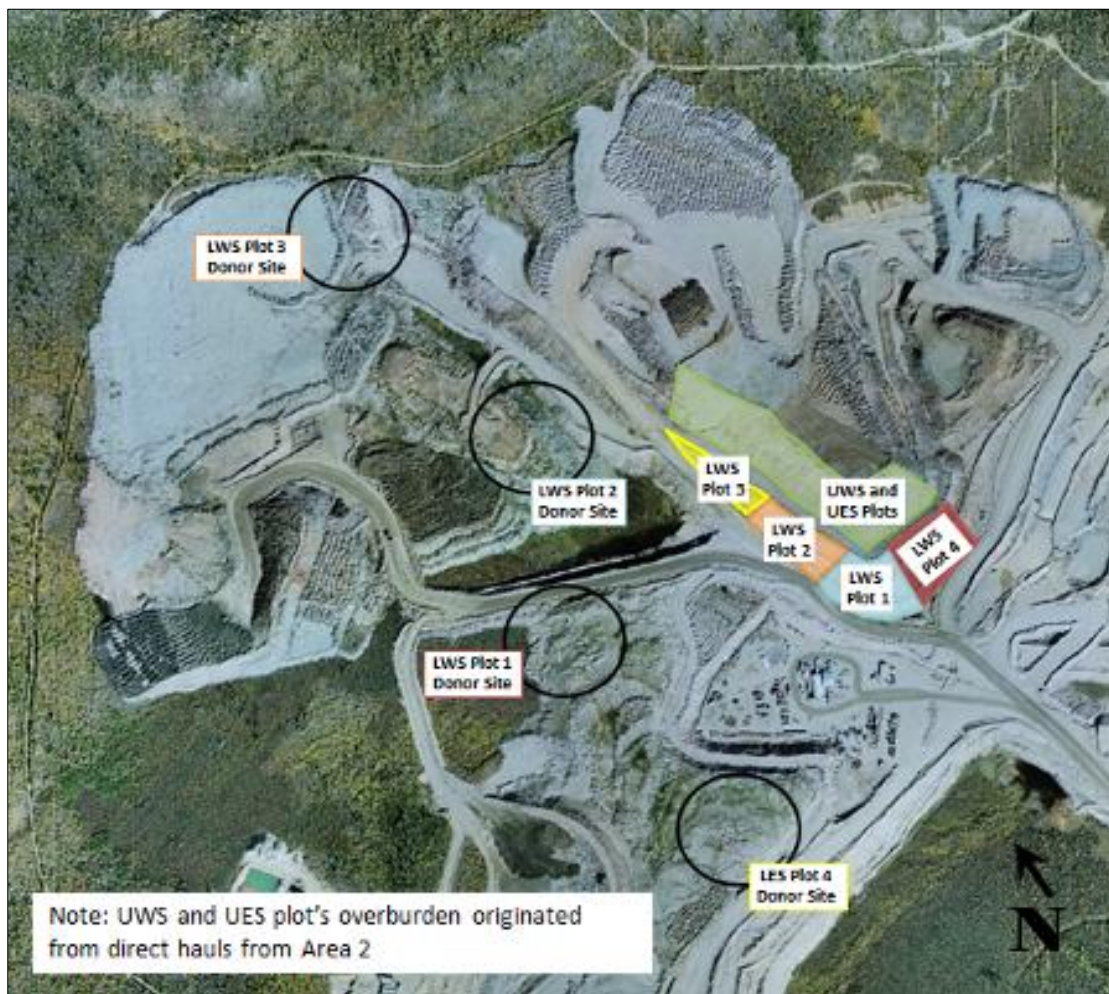
Figure 2-6: Origin of Overburden Material from ROD Placed in Distinct plots on the MWD Re-contoured Rock Surface

Plot size was chosen to balance the minimum area required to gather scientifically sound information, initiating enough diverse treatments to analyze different scenarios, and field fitting the plots for the most efficient use of space. Each overburden plot was chosen to represent materials available from the overburden stripping that occurred in Main and Area 2 pits. The upper slope plots were capped with material directly excavated and hauled from Area 2 pit development indiscriminately, without much segregation. A selection method occurred for the lower slope's plots within the ROD area. Sites were chosen to represent a wide range of materials on site (gravelly and sandy overburden, to loam-textured, to overburden containing high clay content pockets). Stockpiles and pads of materials were surveyed for material types using field observations (hand texturing, colour comparison, visual estimation of coarse to fine material composition).

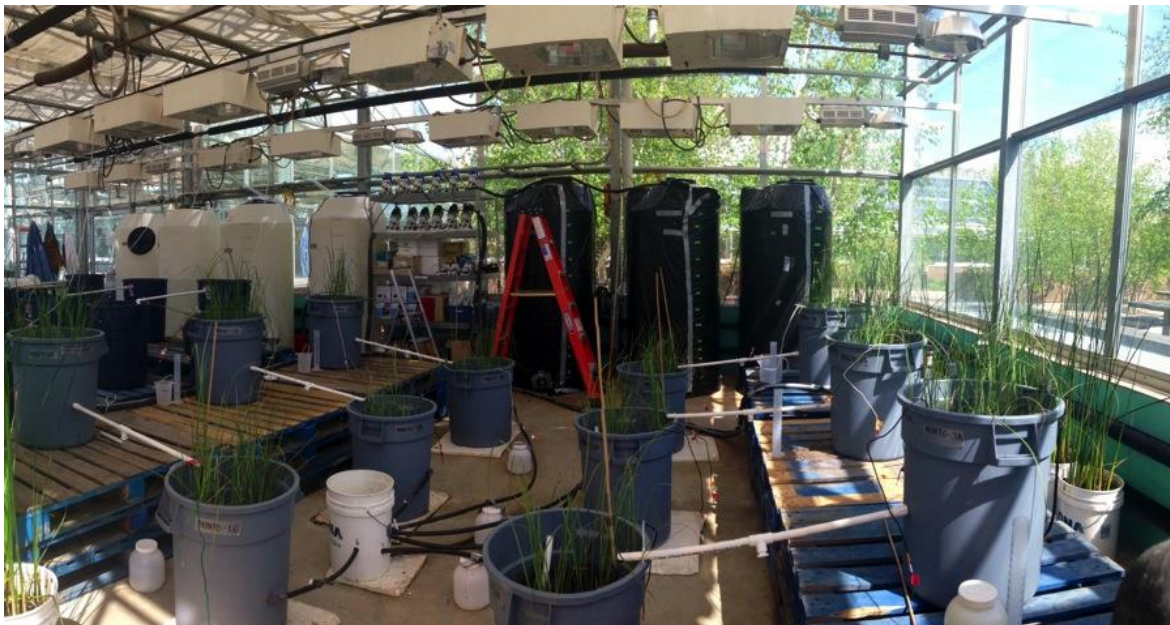
Figure 2-7: Pilot Scale Setup in Contango's Saskatoon Lab

A pilot-scale passive CWTS using local wetland plants from the Minto site was tested in three designs and under various operating conditions to measure the effectiveness of metal, metalloid, and nutrient removal. The pilot-scale CWTS was operated over the course of thirty-seven weeks from October 2013 through July 2014 (Table 2-5). Three pilot-scale CWTSs designs were built in duplicate to evaluate the performance of different designs for selenium and copper treatment (Figure 2-7). The pilot-scale CWTS were planted and amended as follows:

- System 1 and 2: *Carex aquatilis*
- System 3 and 4: *Carex aquatilis* and aquatic moss; and
- System 5 and 6: *Carex aquatilis* and aquatic moss, soil amended with biochar.

All systems effectively decreased contaminant loads from the water. Systems containing aquatic mosses performed better than those without, so moss was retained in the designs. Biochar did not have any significant effect on performance, and therefore was not brought forward in the design. It was learned that the CWTS could have solid organic material (e.g., straw, hay) added to further enhance treatment, but at a trade-off of operational costs. Testing demonstrated the range of conditions required for effective copper and selenium treatment and highlighted the robustness and adaptability of the design. Based on performance, expected longevity, and cost effectiveness, the system with *Carex aquatilis* and aquatic mosses and sand substrate (no biochar) was progressed to the next phase, on-site demonstration-scale testing.

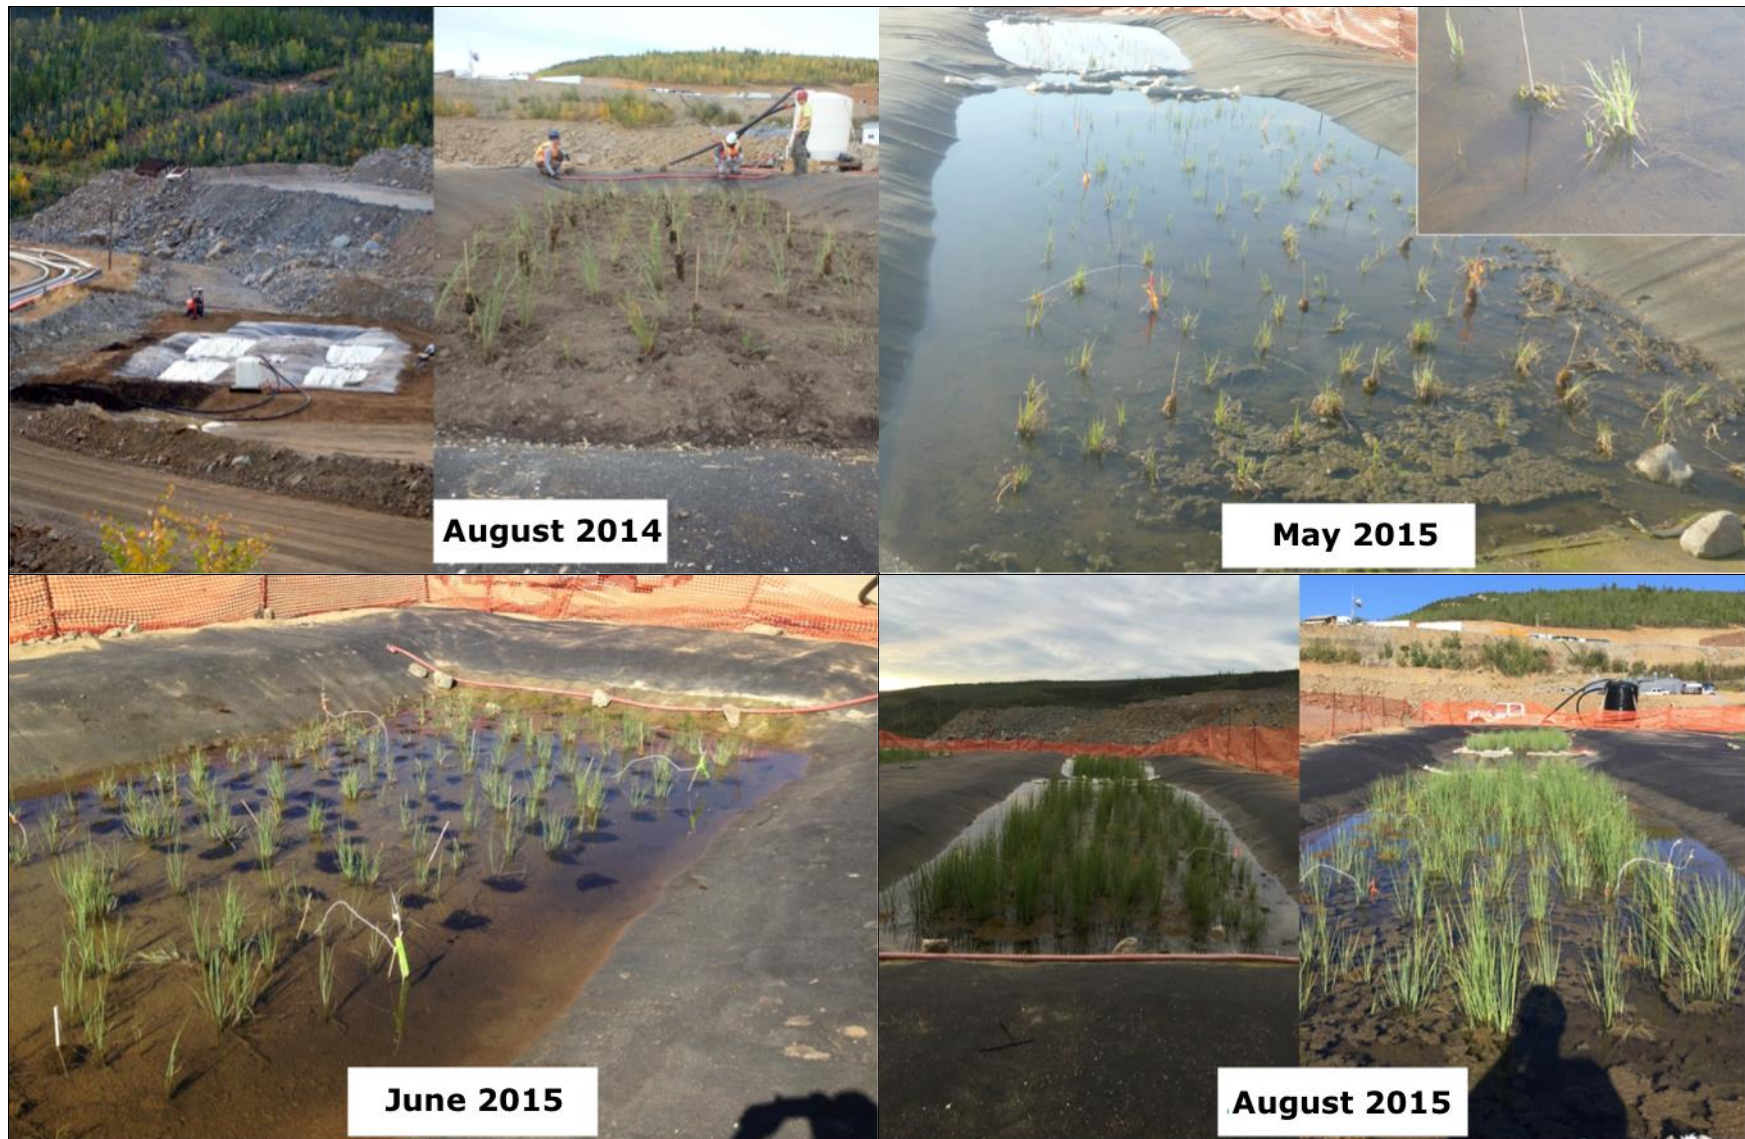
Figure 2-8: Time Lapse Photos of Demonstration Scale Treatment Wetlands at Minto Mine.

Detailed study design and construction report for the Demonstration Scale CWTS are included in Appendix A3 with a 2015 update provided in Appendix A4. Upon completion and following the results of the off-site pilot-scale CWTS, Minto constructed a demonstration-scale CWTS on site in August 2014. The demonstration-scale CWTS was built with two systems in parallel, with two cells in each series and a final catchment basin that both systems flow into on waste rock fill was prepared and selected for the CWTS and a base of residuum material was placed in compacted lifts to allow for shaping of the structure to design specifications. The demonstration-scale CWTS was planted with *Carex aquatilis* (Sedge) and mosses, as was determined by pilot-scale testing as being the best design for this site and application (Appendix A2 Contango, 2014) (Figure 2-8 and Figure 2-9).

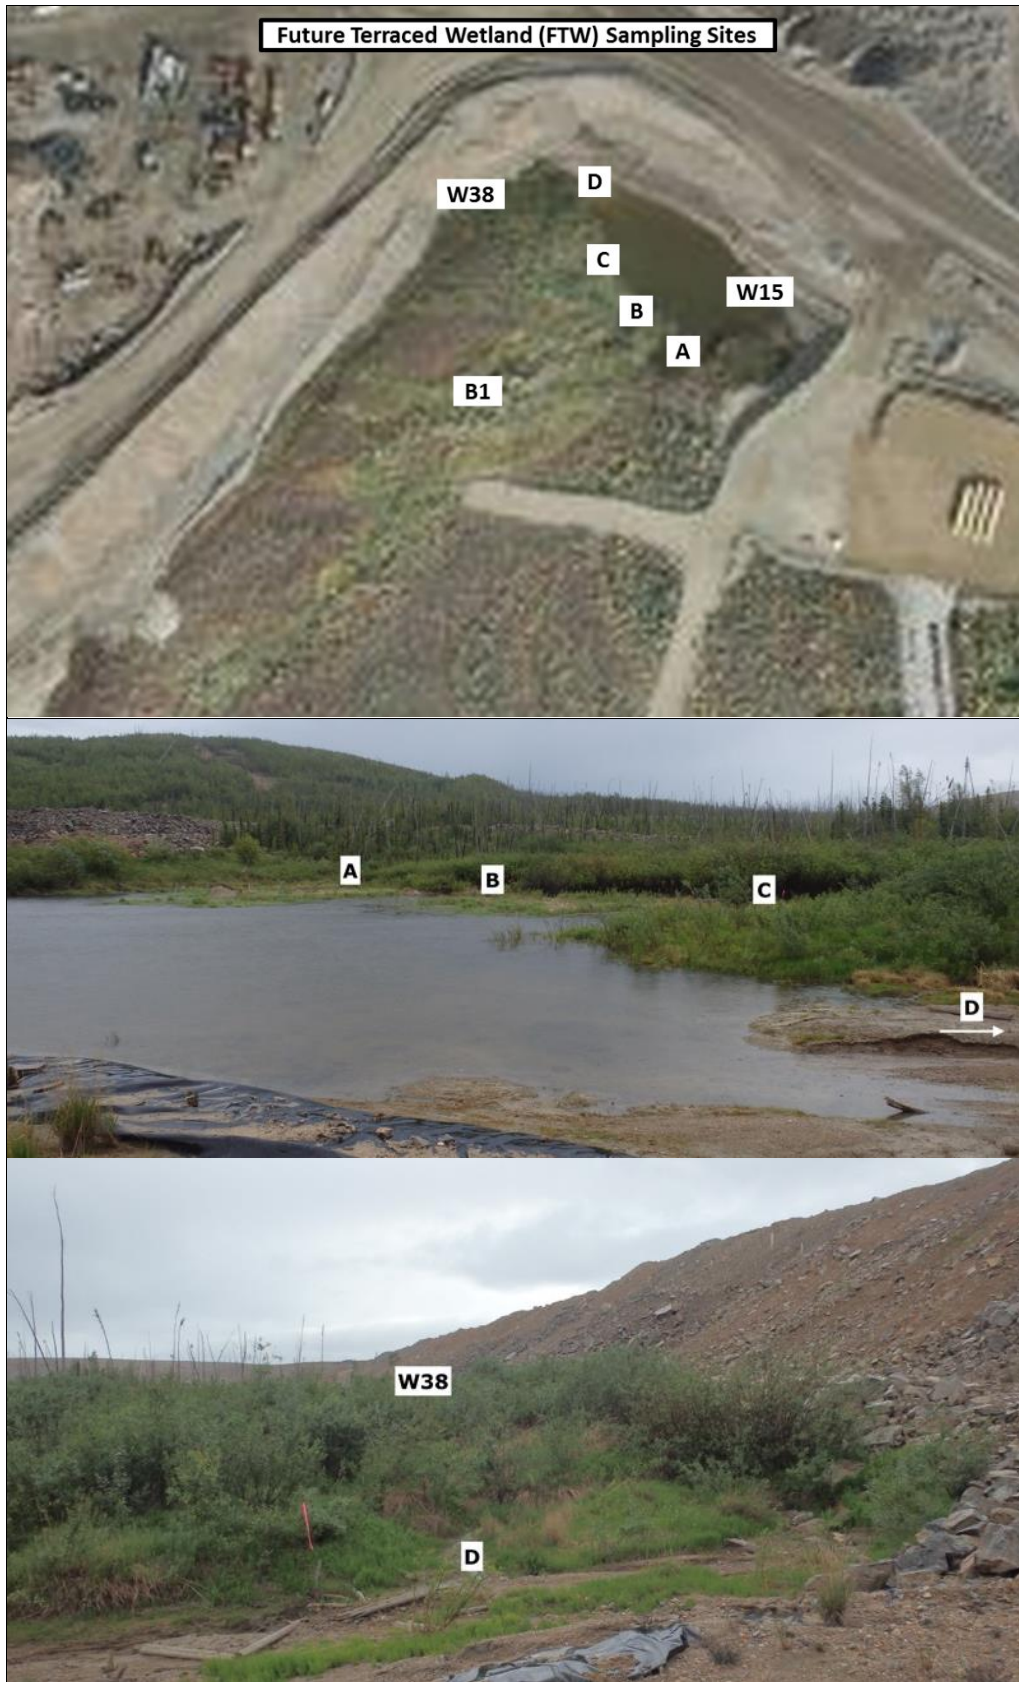
Figure 2-10: New Sampling Sites for the 2016 Research Plan.

Based on the results of the 2016 baseline monitoring, designs will be developed to target specific seep areas and optimize treatment processes in the area. Conceptually, these may be similar to terraced landforms, providing greater water retention and areal contact in the wetland areas than currently afforded by the existing wetland/ creek complex- an example layout is shown in Figure 2-11. Construction is anticipated to occur in 2017, with testing of performance and explanatory parameters through 2017 and 2018 similar to that which has been undertaken for the on-site demonstration-scale constructed wetland.

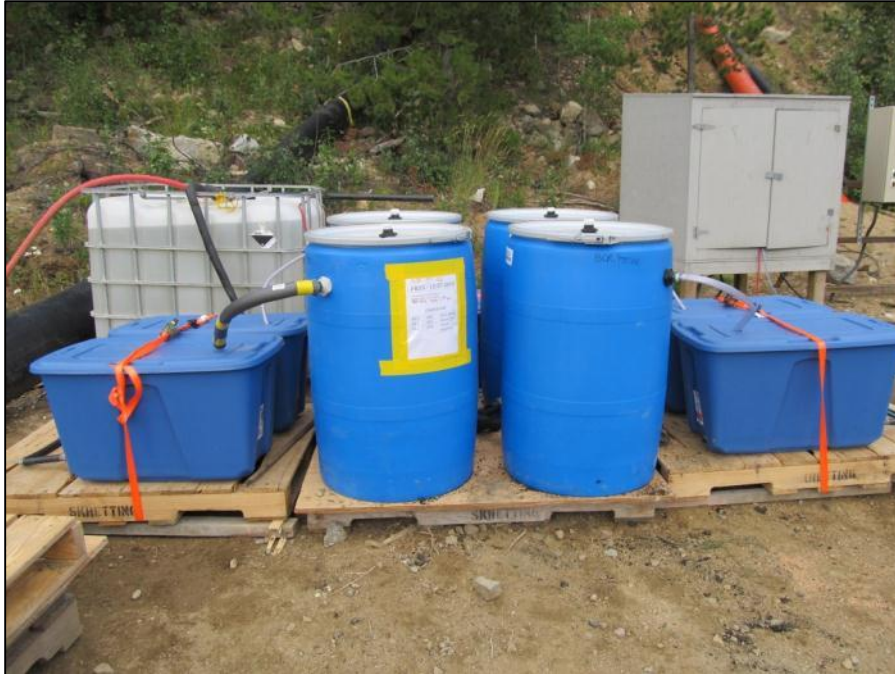
Figure 2-12: Pilot-Scale Bioreactors at Minto Mine (Picture taken in August 2014)

- No exceedance of the mine effluent discharge limits were observed for  $NO_2$  and  $NH_3$ , although high  $PO_4$  (not regulated) was observed in the effluent of the biochar amended reactor.

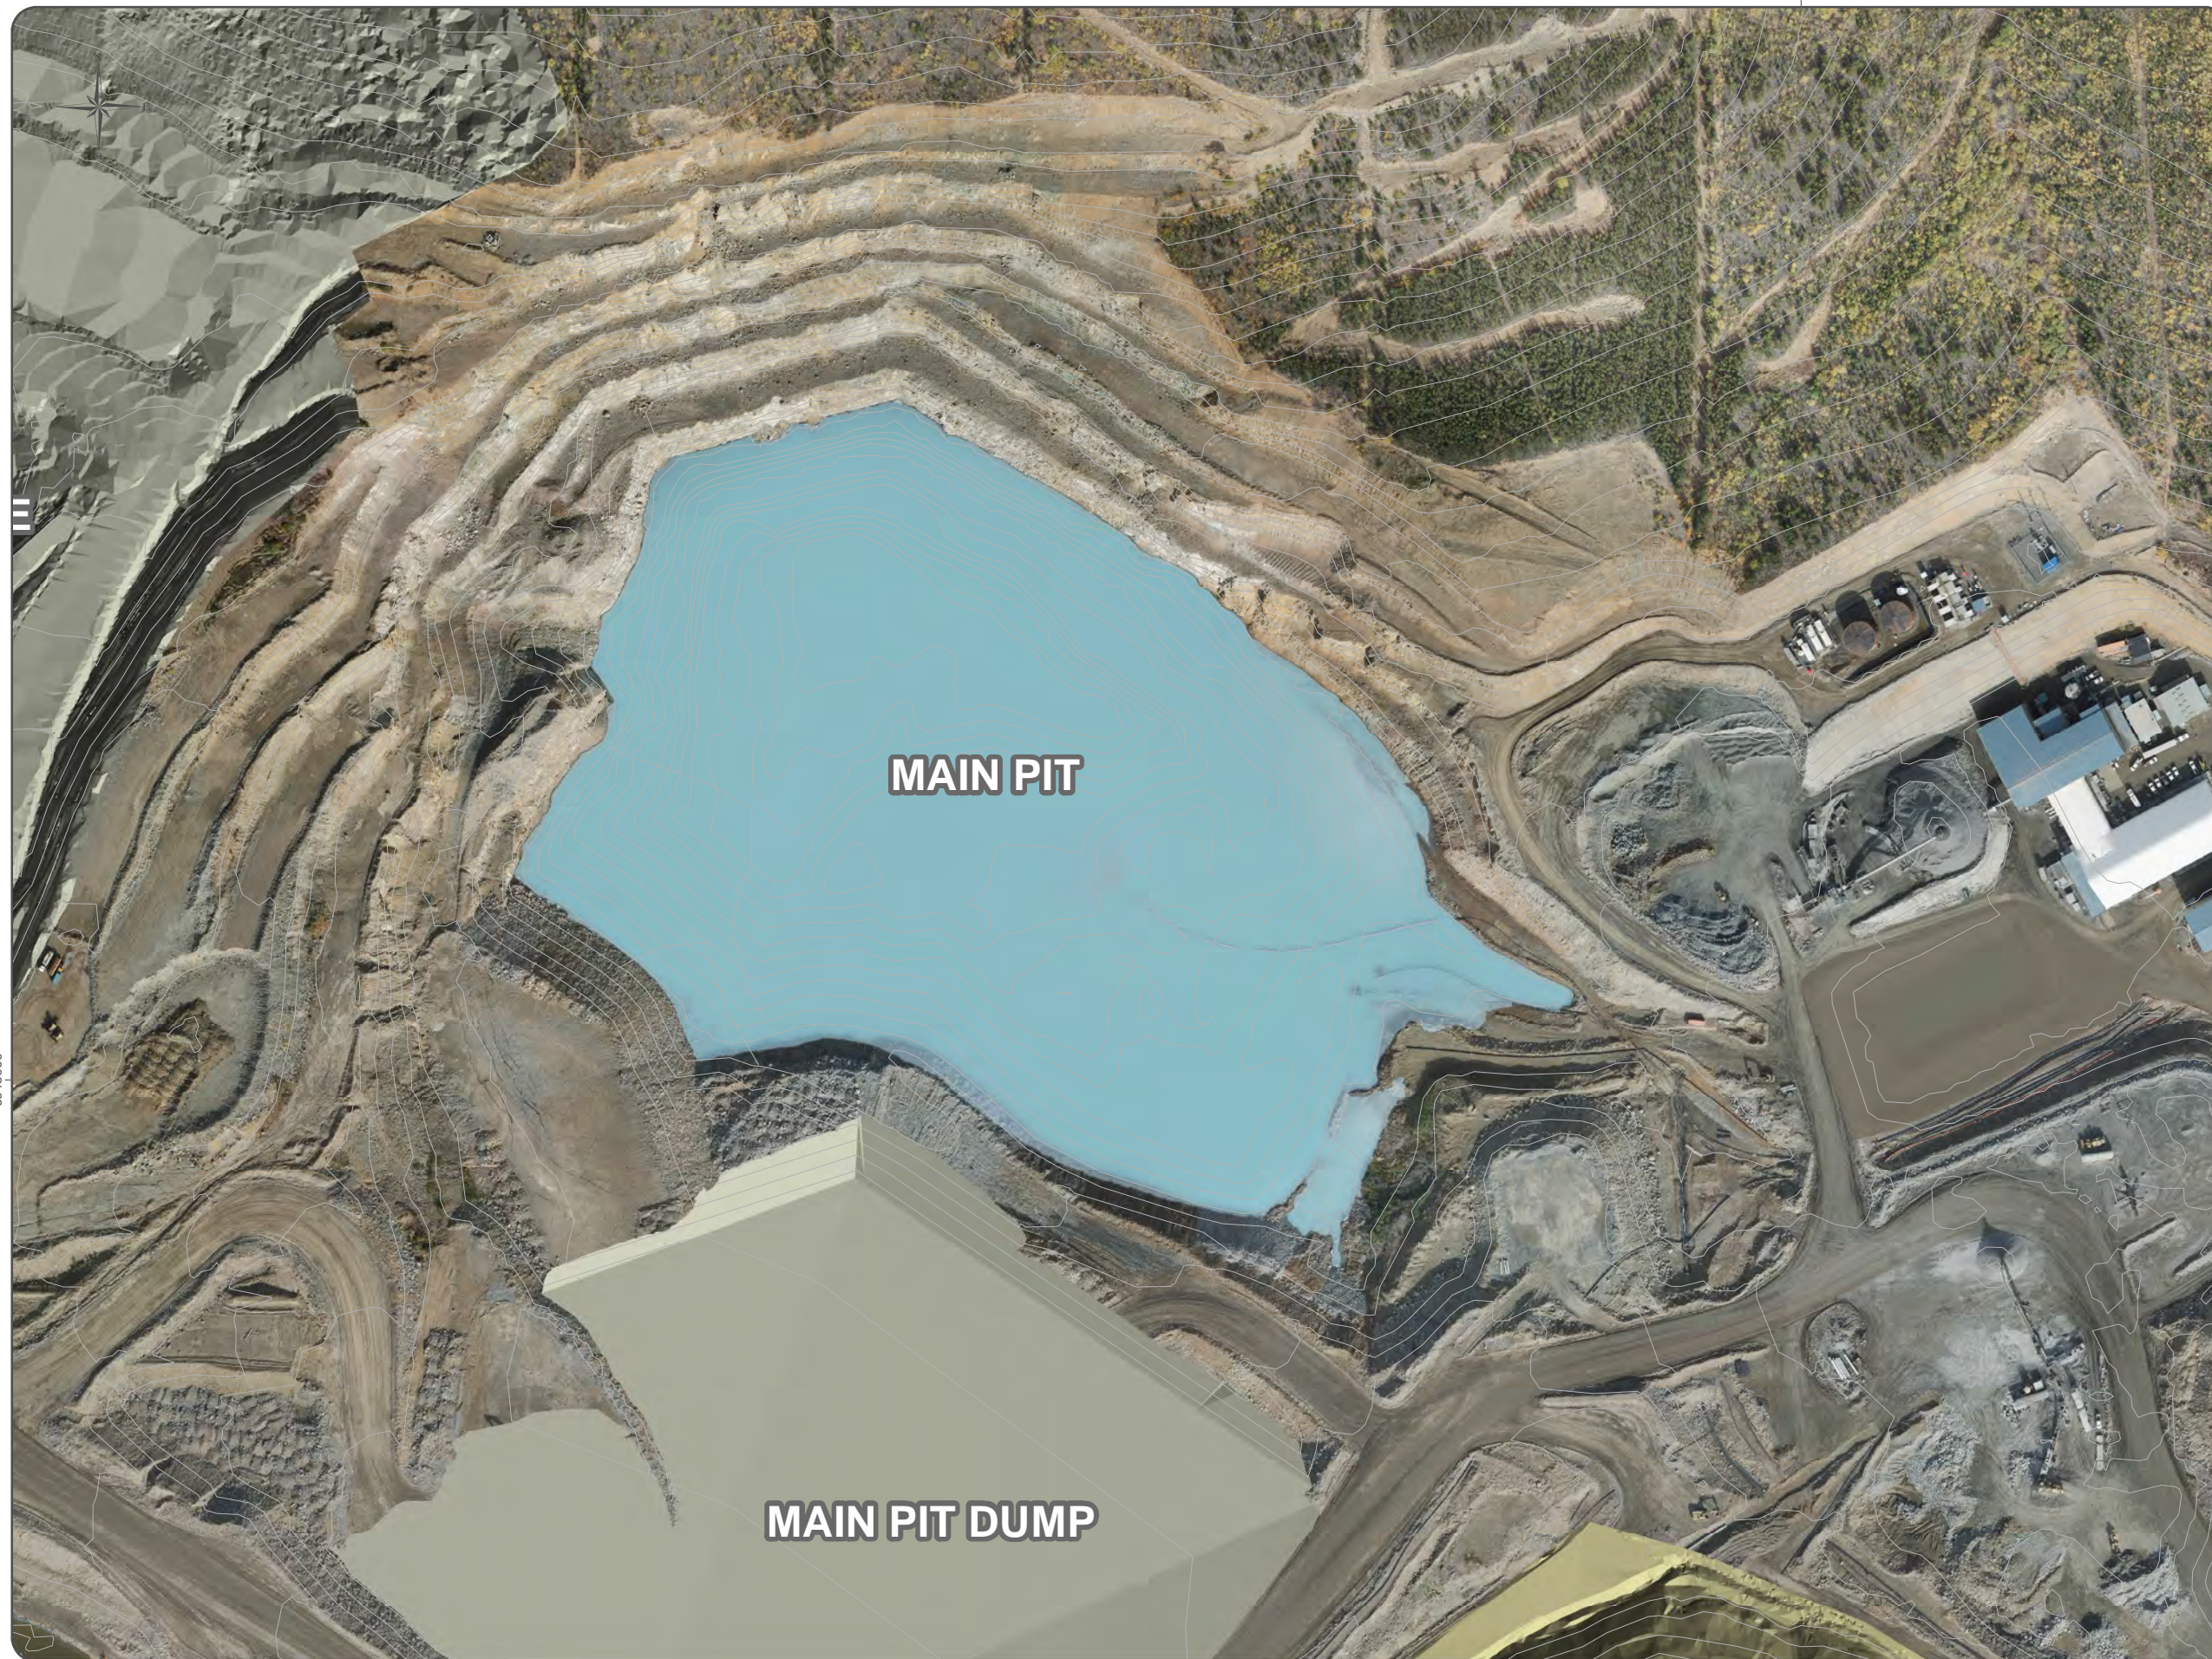
**FIGURE 5-4**

**OVERVIEW OF OPEN PITS**

The Ridgetop North and Ridgetop South pits were added to the reserve as part of a technical report prepared in June 2008 and updated in subsequent prefeasibility studies. These pits were assessed as part of the Phase V/VI Project Proposal but have since been removed from the mine plan at current market conditions. The configuration of the open pits are shown in Figure 5-4.

The Main Pit was exhausted in April 2011. A description of the pit layout and operations is provided in Section 5 (Figure 5-4, Figure 5-5). Details of the pit design, including the slope and bench stability assessment, can be found in the SRK report "Pit Slope Evaluation for Area 1 Open Pit, Minto Mine, YT" dated July 2007.

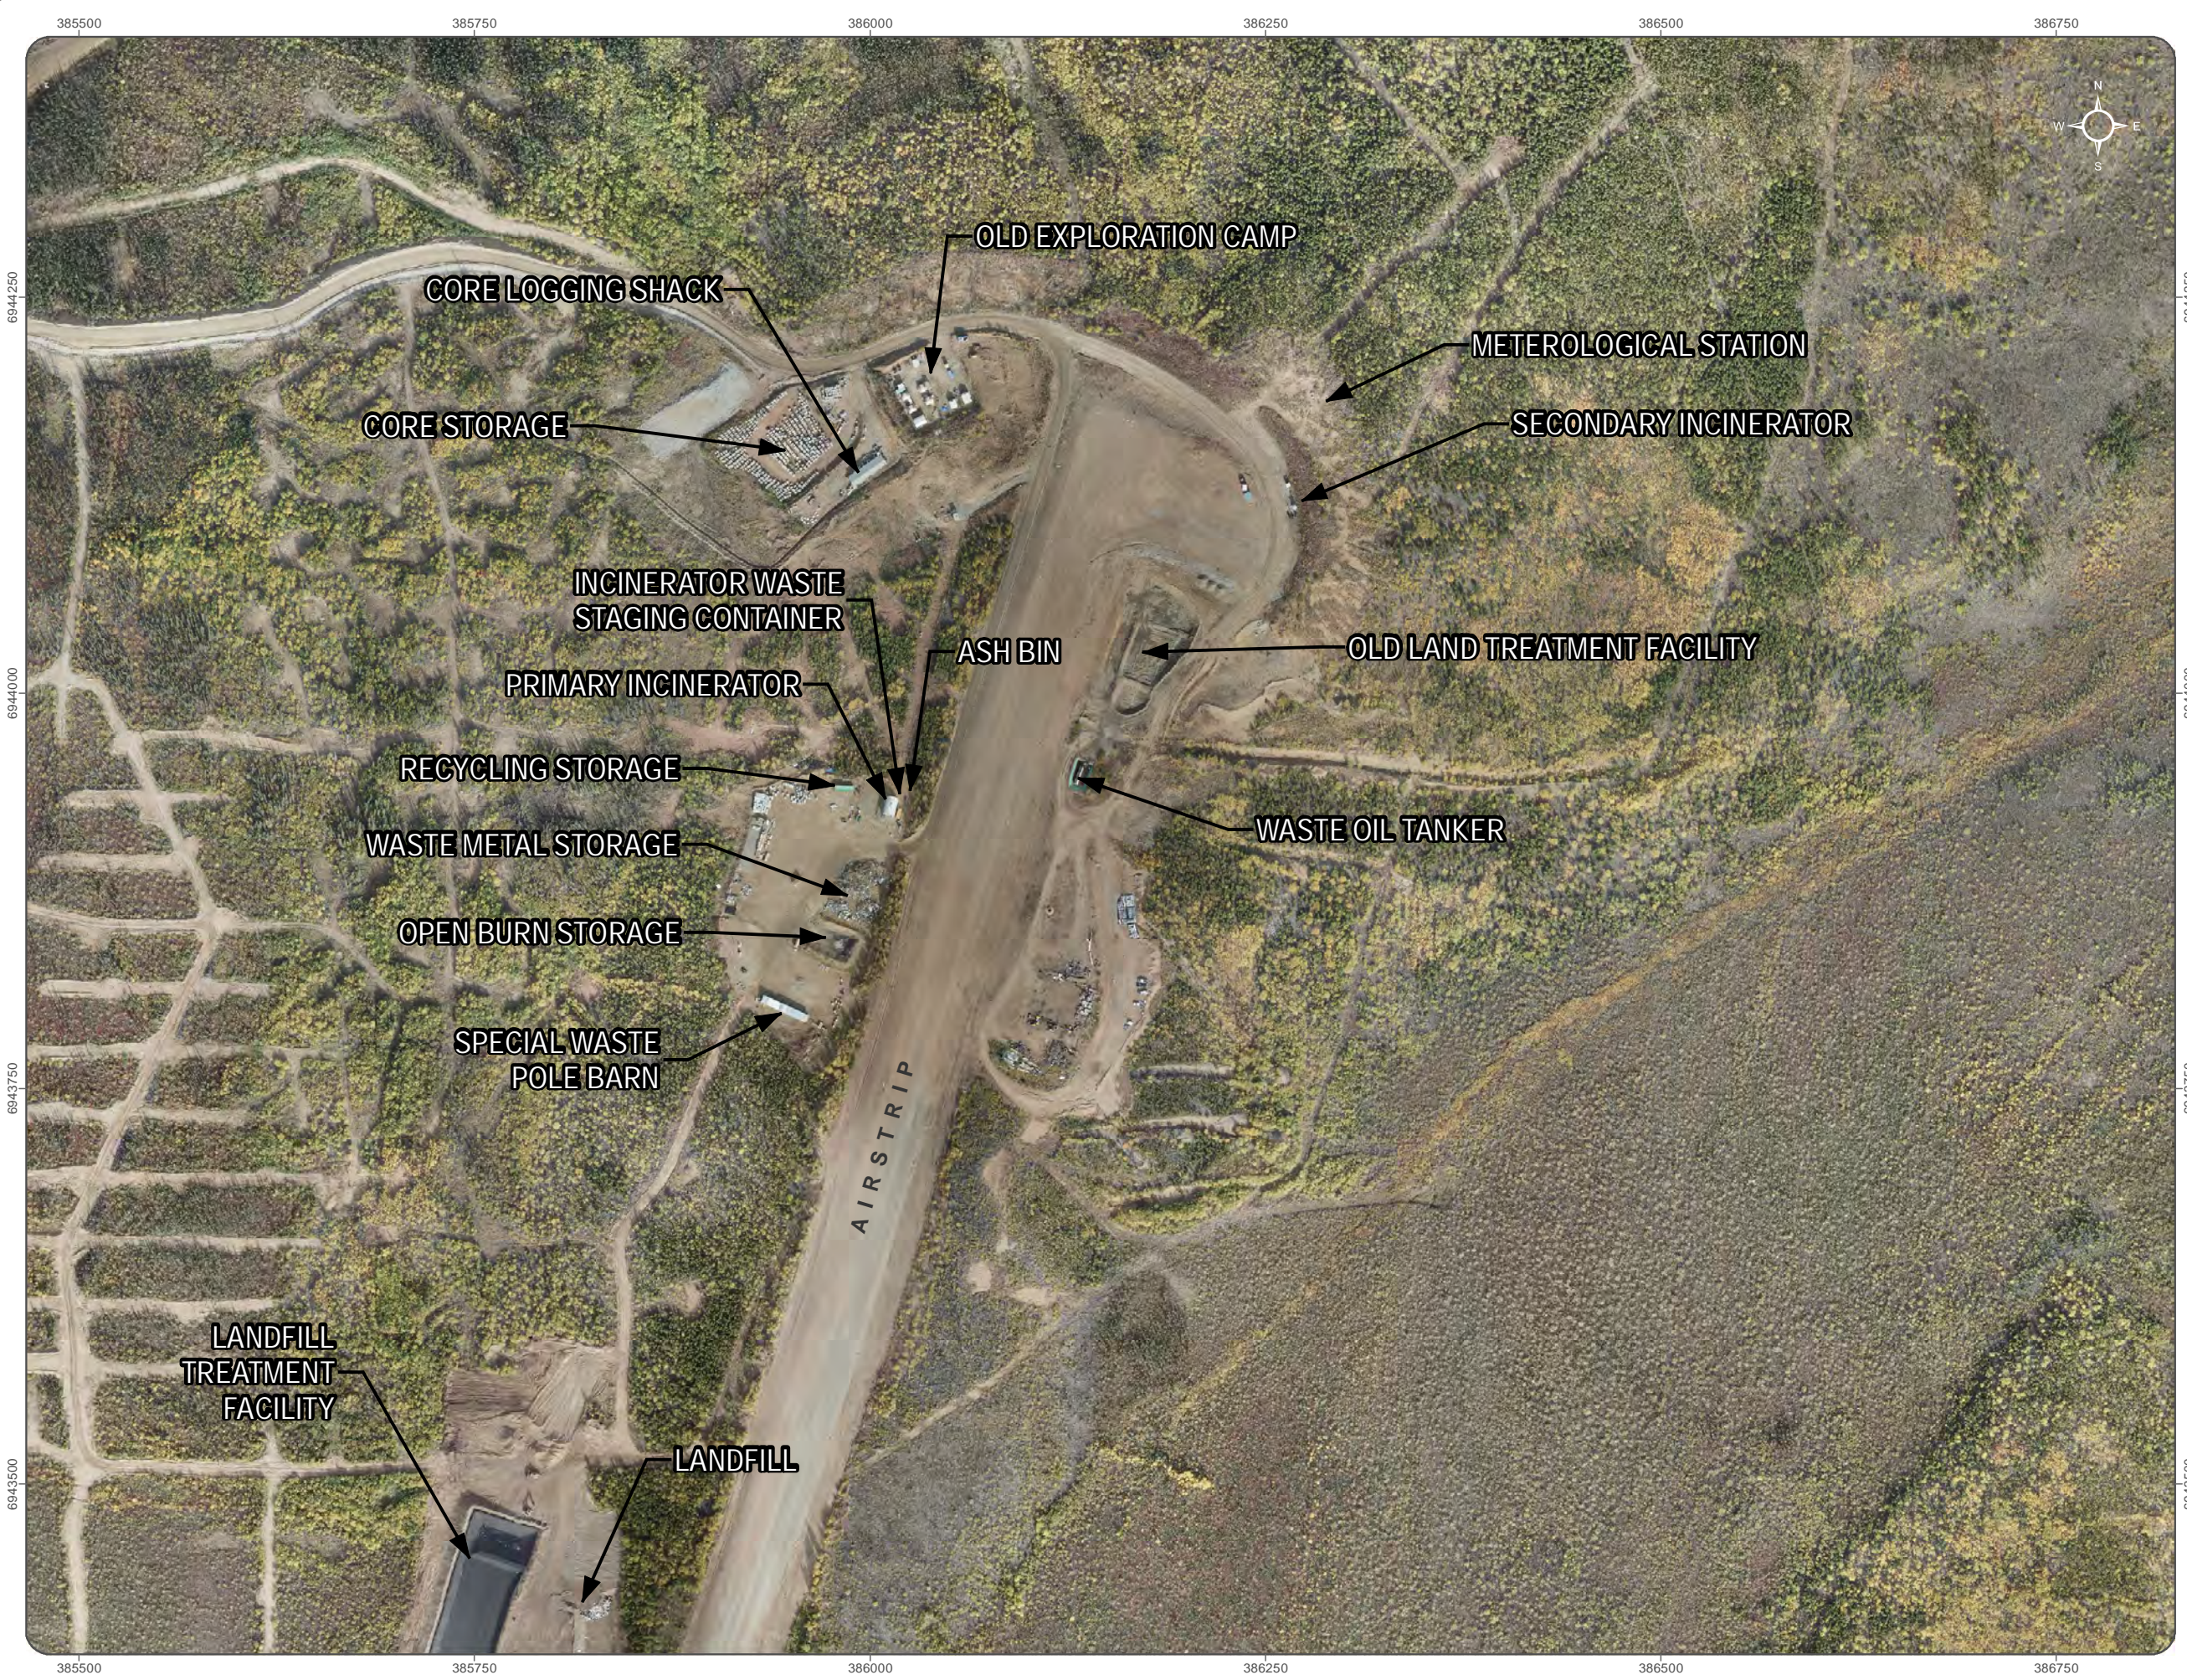
**FIGURE 5-8**  
**SOLID WASTE MANAGEMENT**  
**INFRASTRUCTURE**

Minto Mine operates a solid waste facility under Commercial Dump Permit # 81-005 issued by YG, Department of Environment, Environmental Programs Branch. The facility includes a burning pit for untreated wood and paper waste, a construction waste disposal area, metal and rubber tire disposal areas and an incinerator for food waste and other wastes. No material is placed in the landfill that could potentially be an animal attractant. The burn pit and incinerator are surrounded by an exclusion (bear) fence. Figure 5-8 below shows the current locations of all the waste management facilities on site.

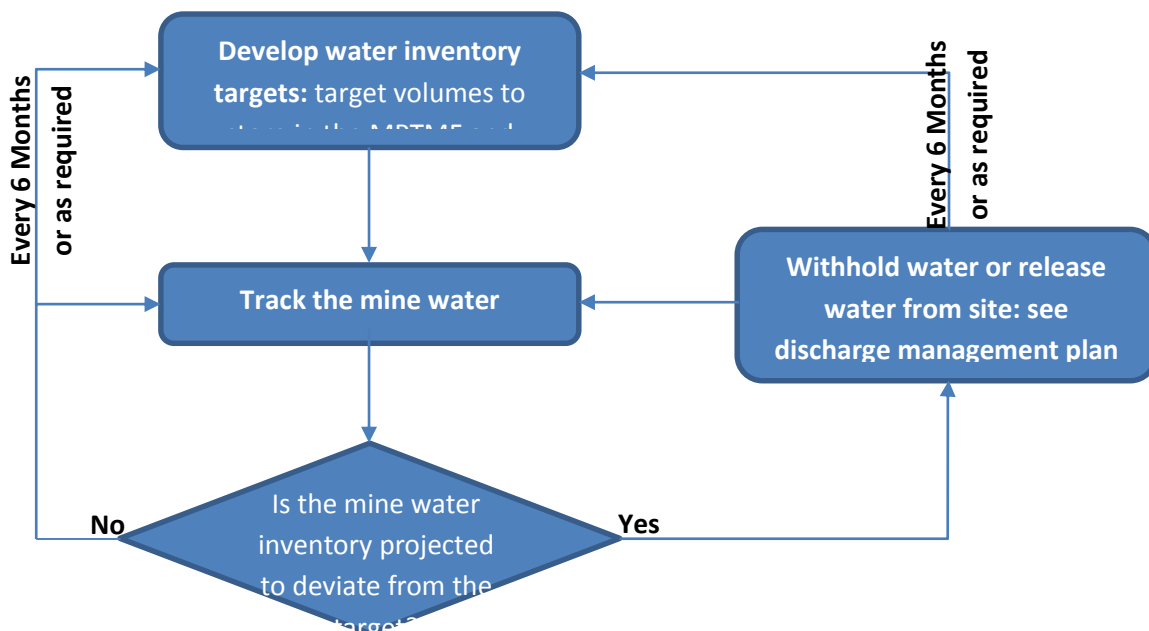
Figure 5-12: Water Management Plan Workflow

**Step 3. Update the water inventory target every 6 months, or as required** and repeat Step 2. Operational, physical or water quality changes may change the water demand, storage requirement, availability of reservoirs or other elements that was used as a basis for defining the water inventory target. Therefore, the inventory target will be updated regularly.

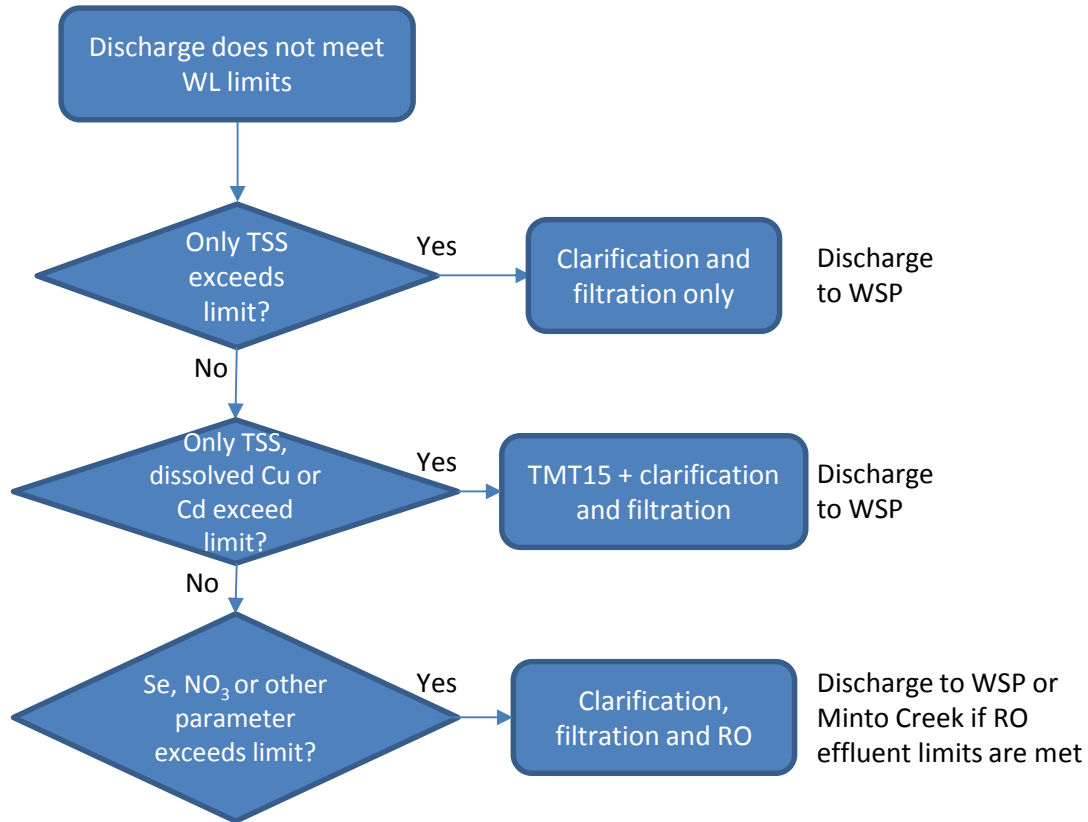
Figure 5-18: Water Treatment Selection Chart

Figure 5-18 shows a decision chart to guide the selection of water treatment process options when water treatment is required. The analysis of feed water quality can be based on on-site assays or off-site laboratory analysis, depending on the parameter of concern and the relative confidence in the analytical results. Discharge will not commence unless Minto has confidence in the analytical results.

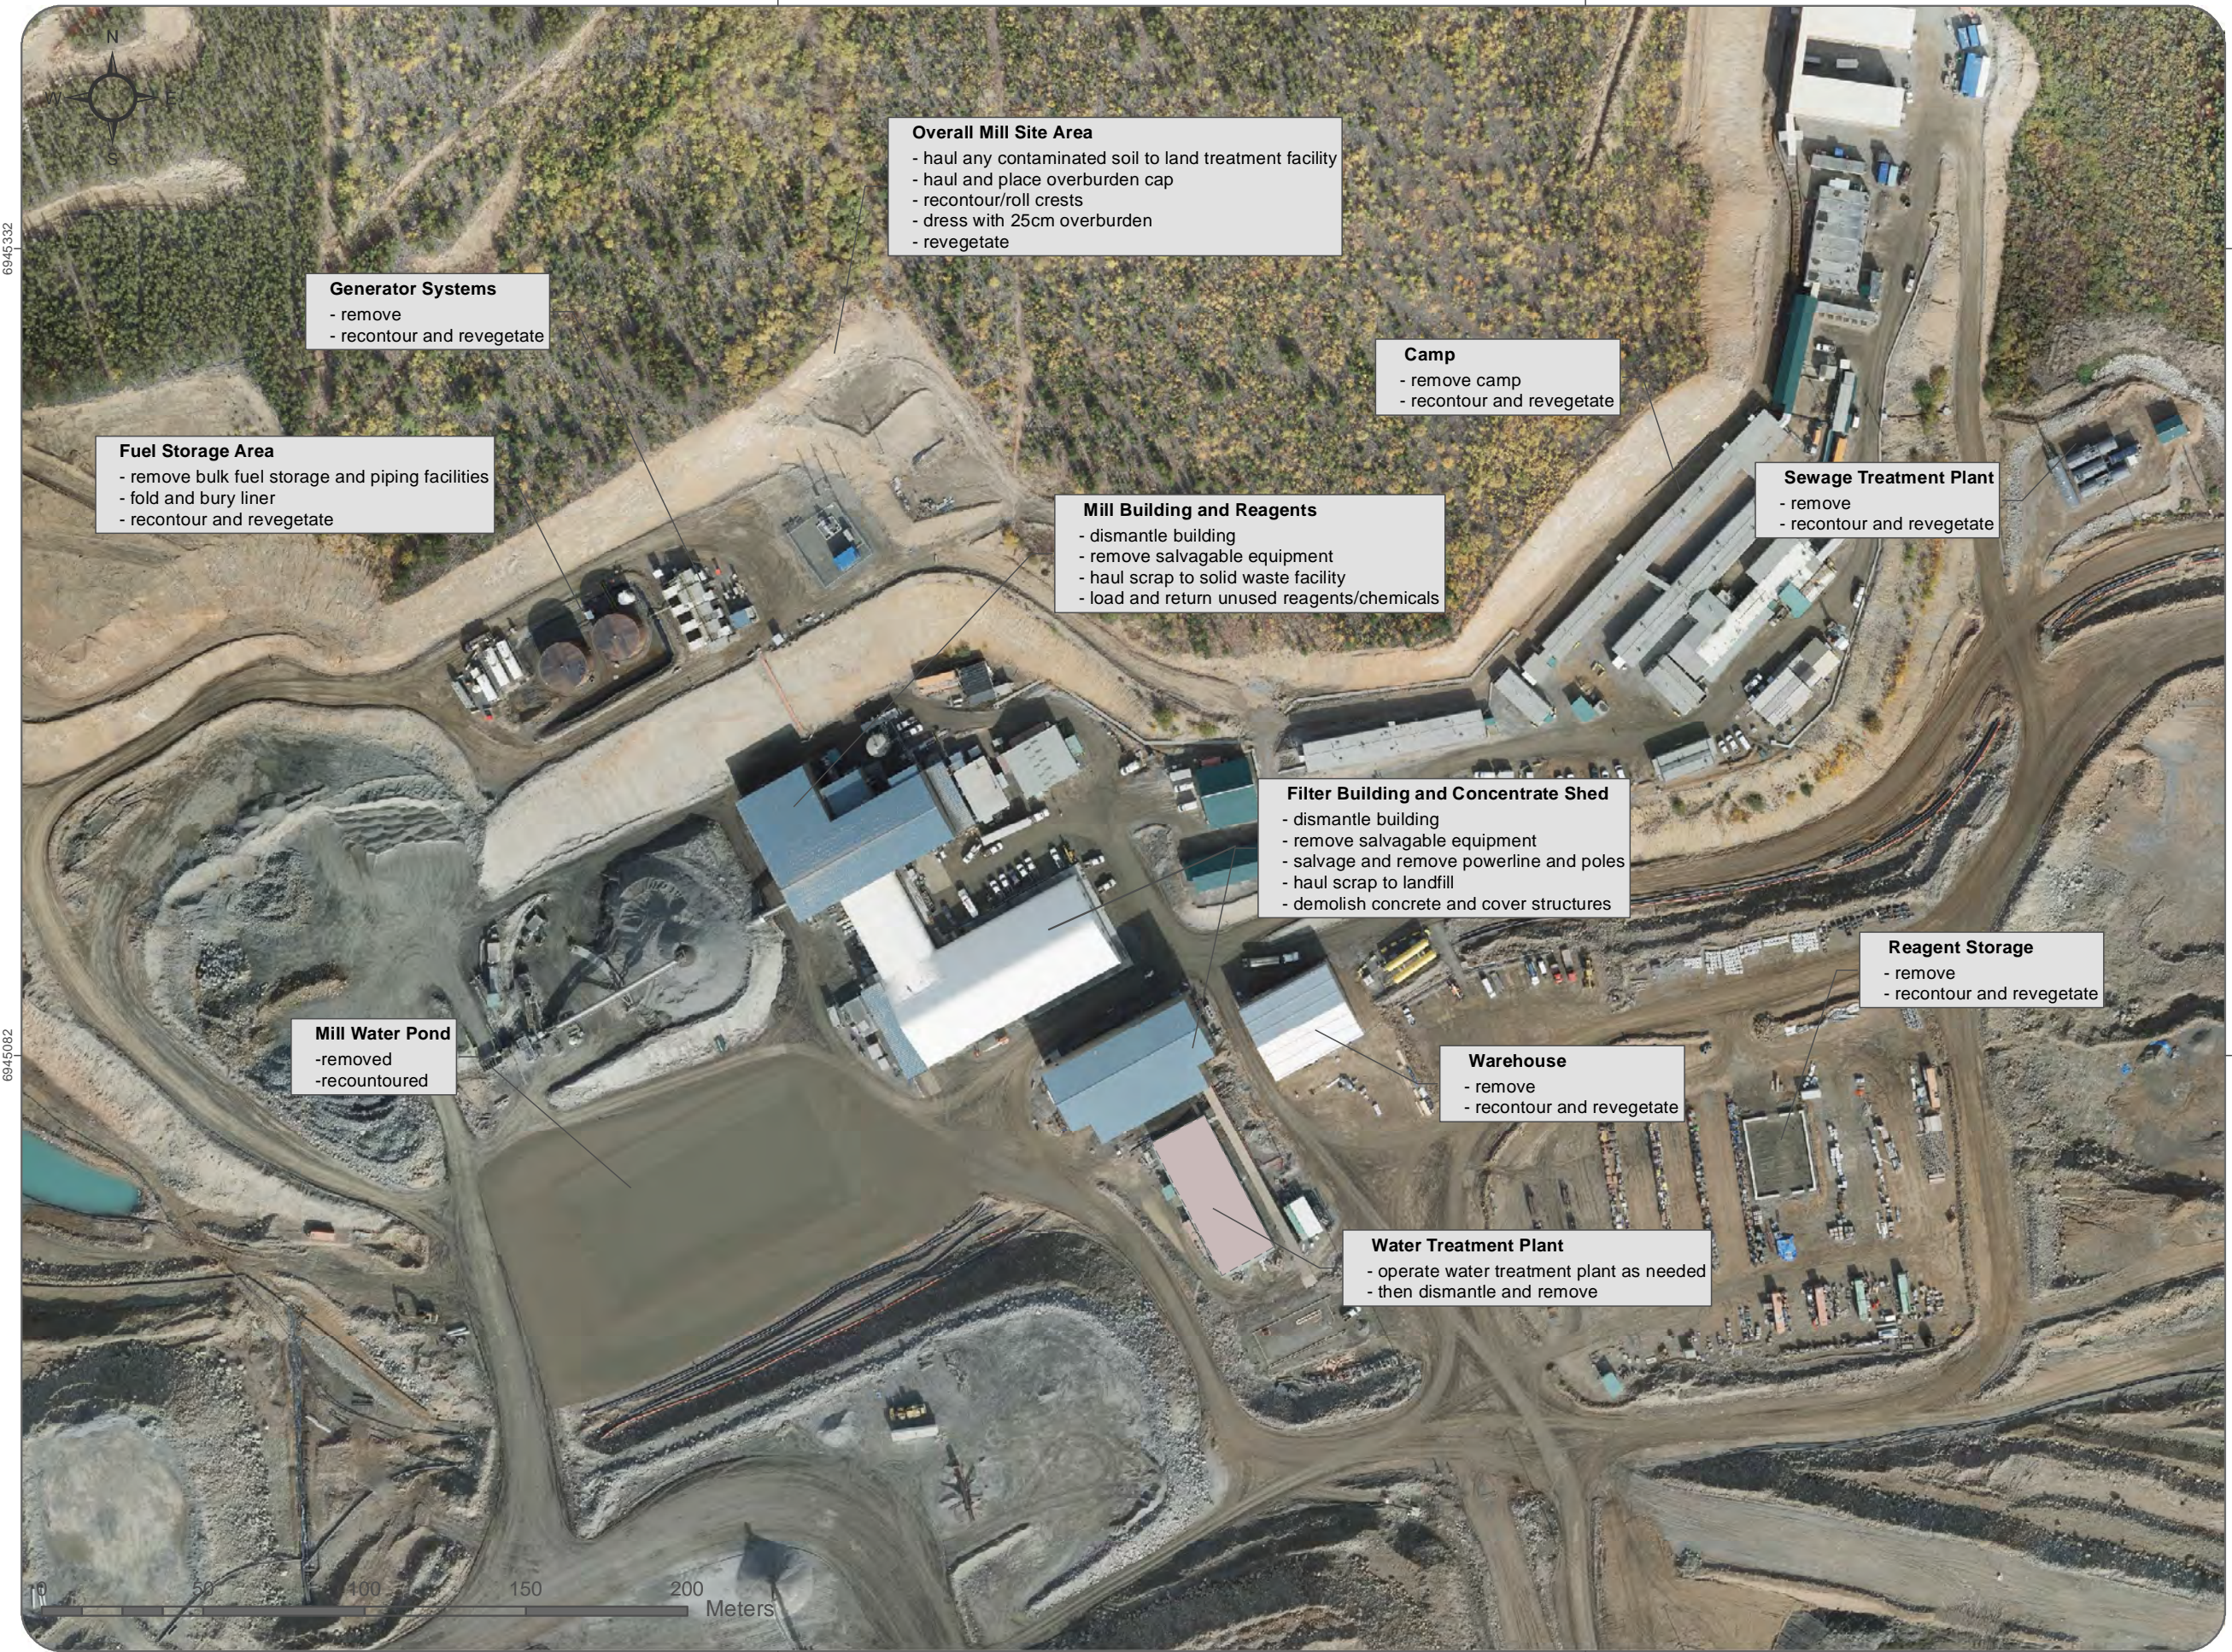
**Overall Mill Site Area**  
 - haul any contaminated soil to land treatment facility  
 - haul and place overburden cap  
 - recontour/roll crests  
 - dress with 25cm overburden  
 - revegetate

**Generator Systems**  
 - remove  
 - recontour and revegetate
