Minto Mine  
Reclamation and Closure Plan  
2016-01

Prepared by:  
Minto Explorations Ltd.  
Minto Mine  
August 2016

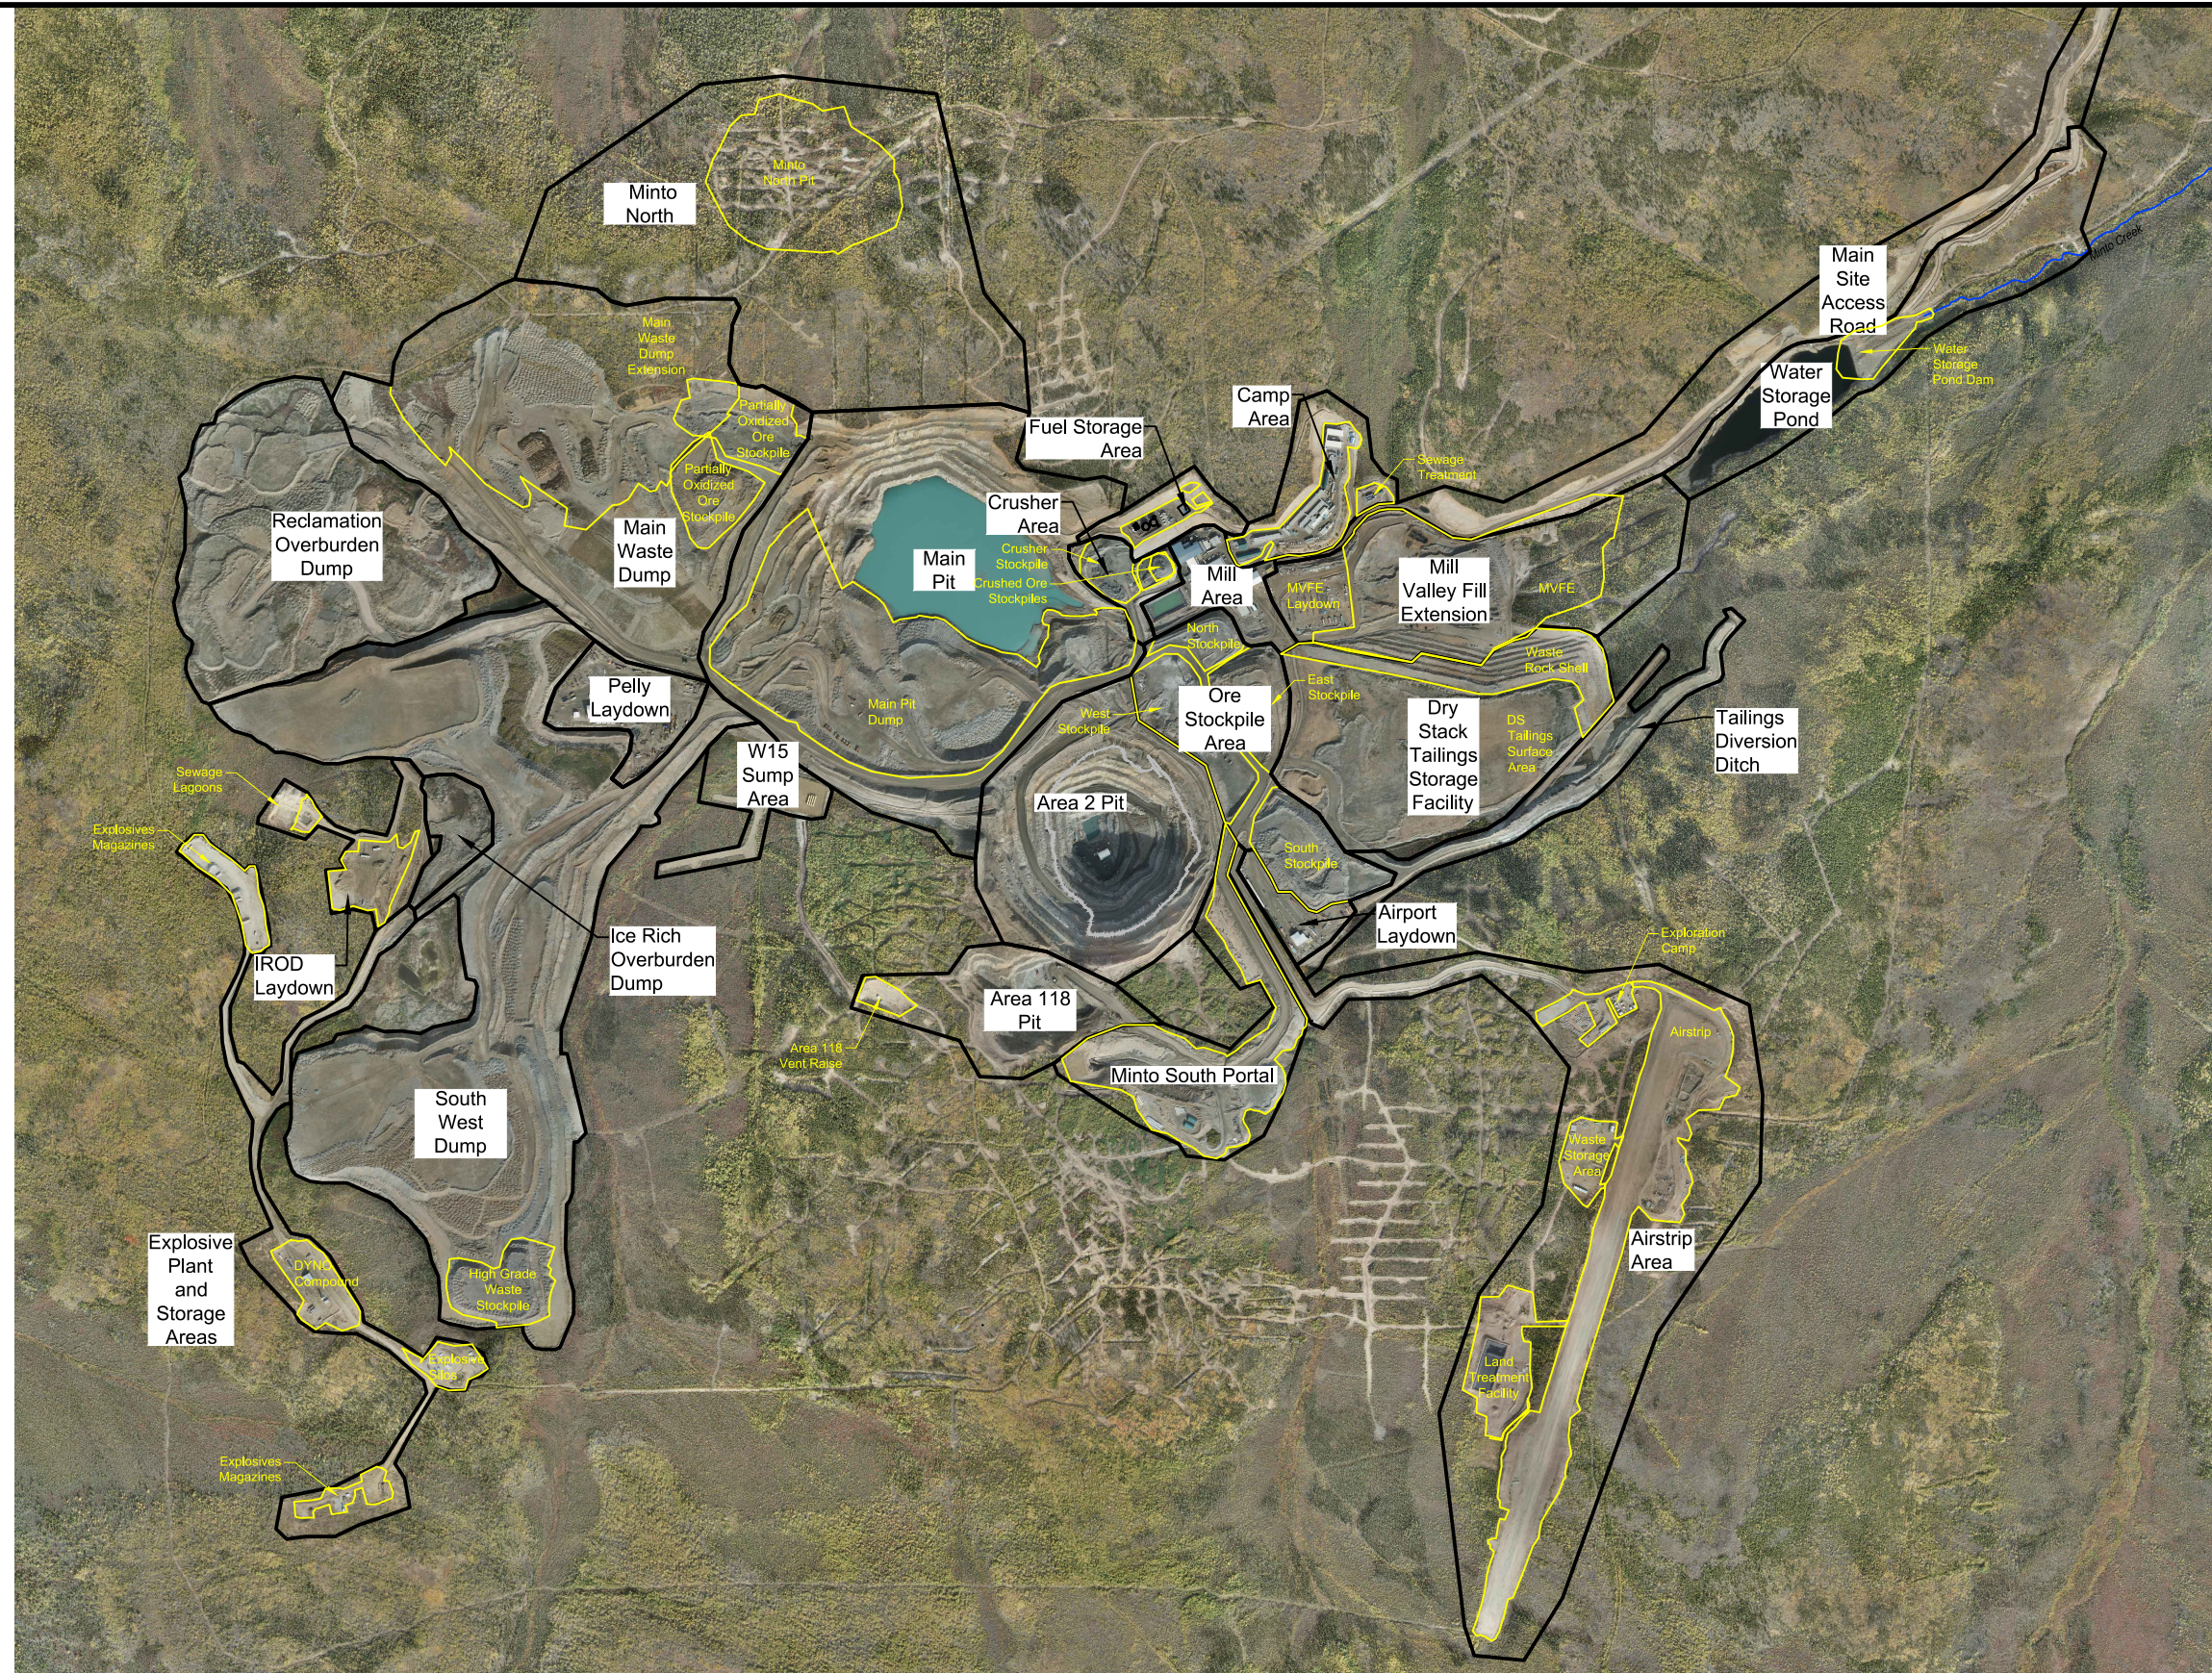
MINTO CLOSURE PLAN		
		Cost Estimate Reclamation Areas		
SRK JOB NO.: 1CM002.044 FILE NAME: 1CM002-45_ClosureQuantities_rev03-Figure.dwg	MINTO	DATE: July 2016	APPROVED:	FIGURE: 9.1

For the Minto Mine, the peak liability is the same as the Year 0 liability estimate and as a result, two estimates are presented. The Year 0 liability estimate assumes that mining at Minto North is complete, and that mining of the Area 2 Stage 3 Pit has yet to begin. This point of time is the peak liability as the closure cost is expected to be reduced as overburden stripped from the Area 2 Stage 3 Pit will be placed as covers over completed waste dump facilities. The end-of-mine life closure liability occurs following completion of mining in the Area 2 Stage 3 Pit in 2018.

Closure implementation is estimated to take 3 years for both liability estimates with construction occurring between April and September each year. The site is estimated to be access by air during the spring, and by barge following spring break-up. Two years of interim care and maintenance is assumed to be required after mining ceases and prior to implementation of the final closure plan for the Year 0 liability estimate. These costs are not included in the EOM estimate as the closure plan would be finalized at the end-of-mining.
