Appendix B

SFN Stakeholder & Regulator Engagement Table

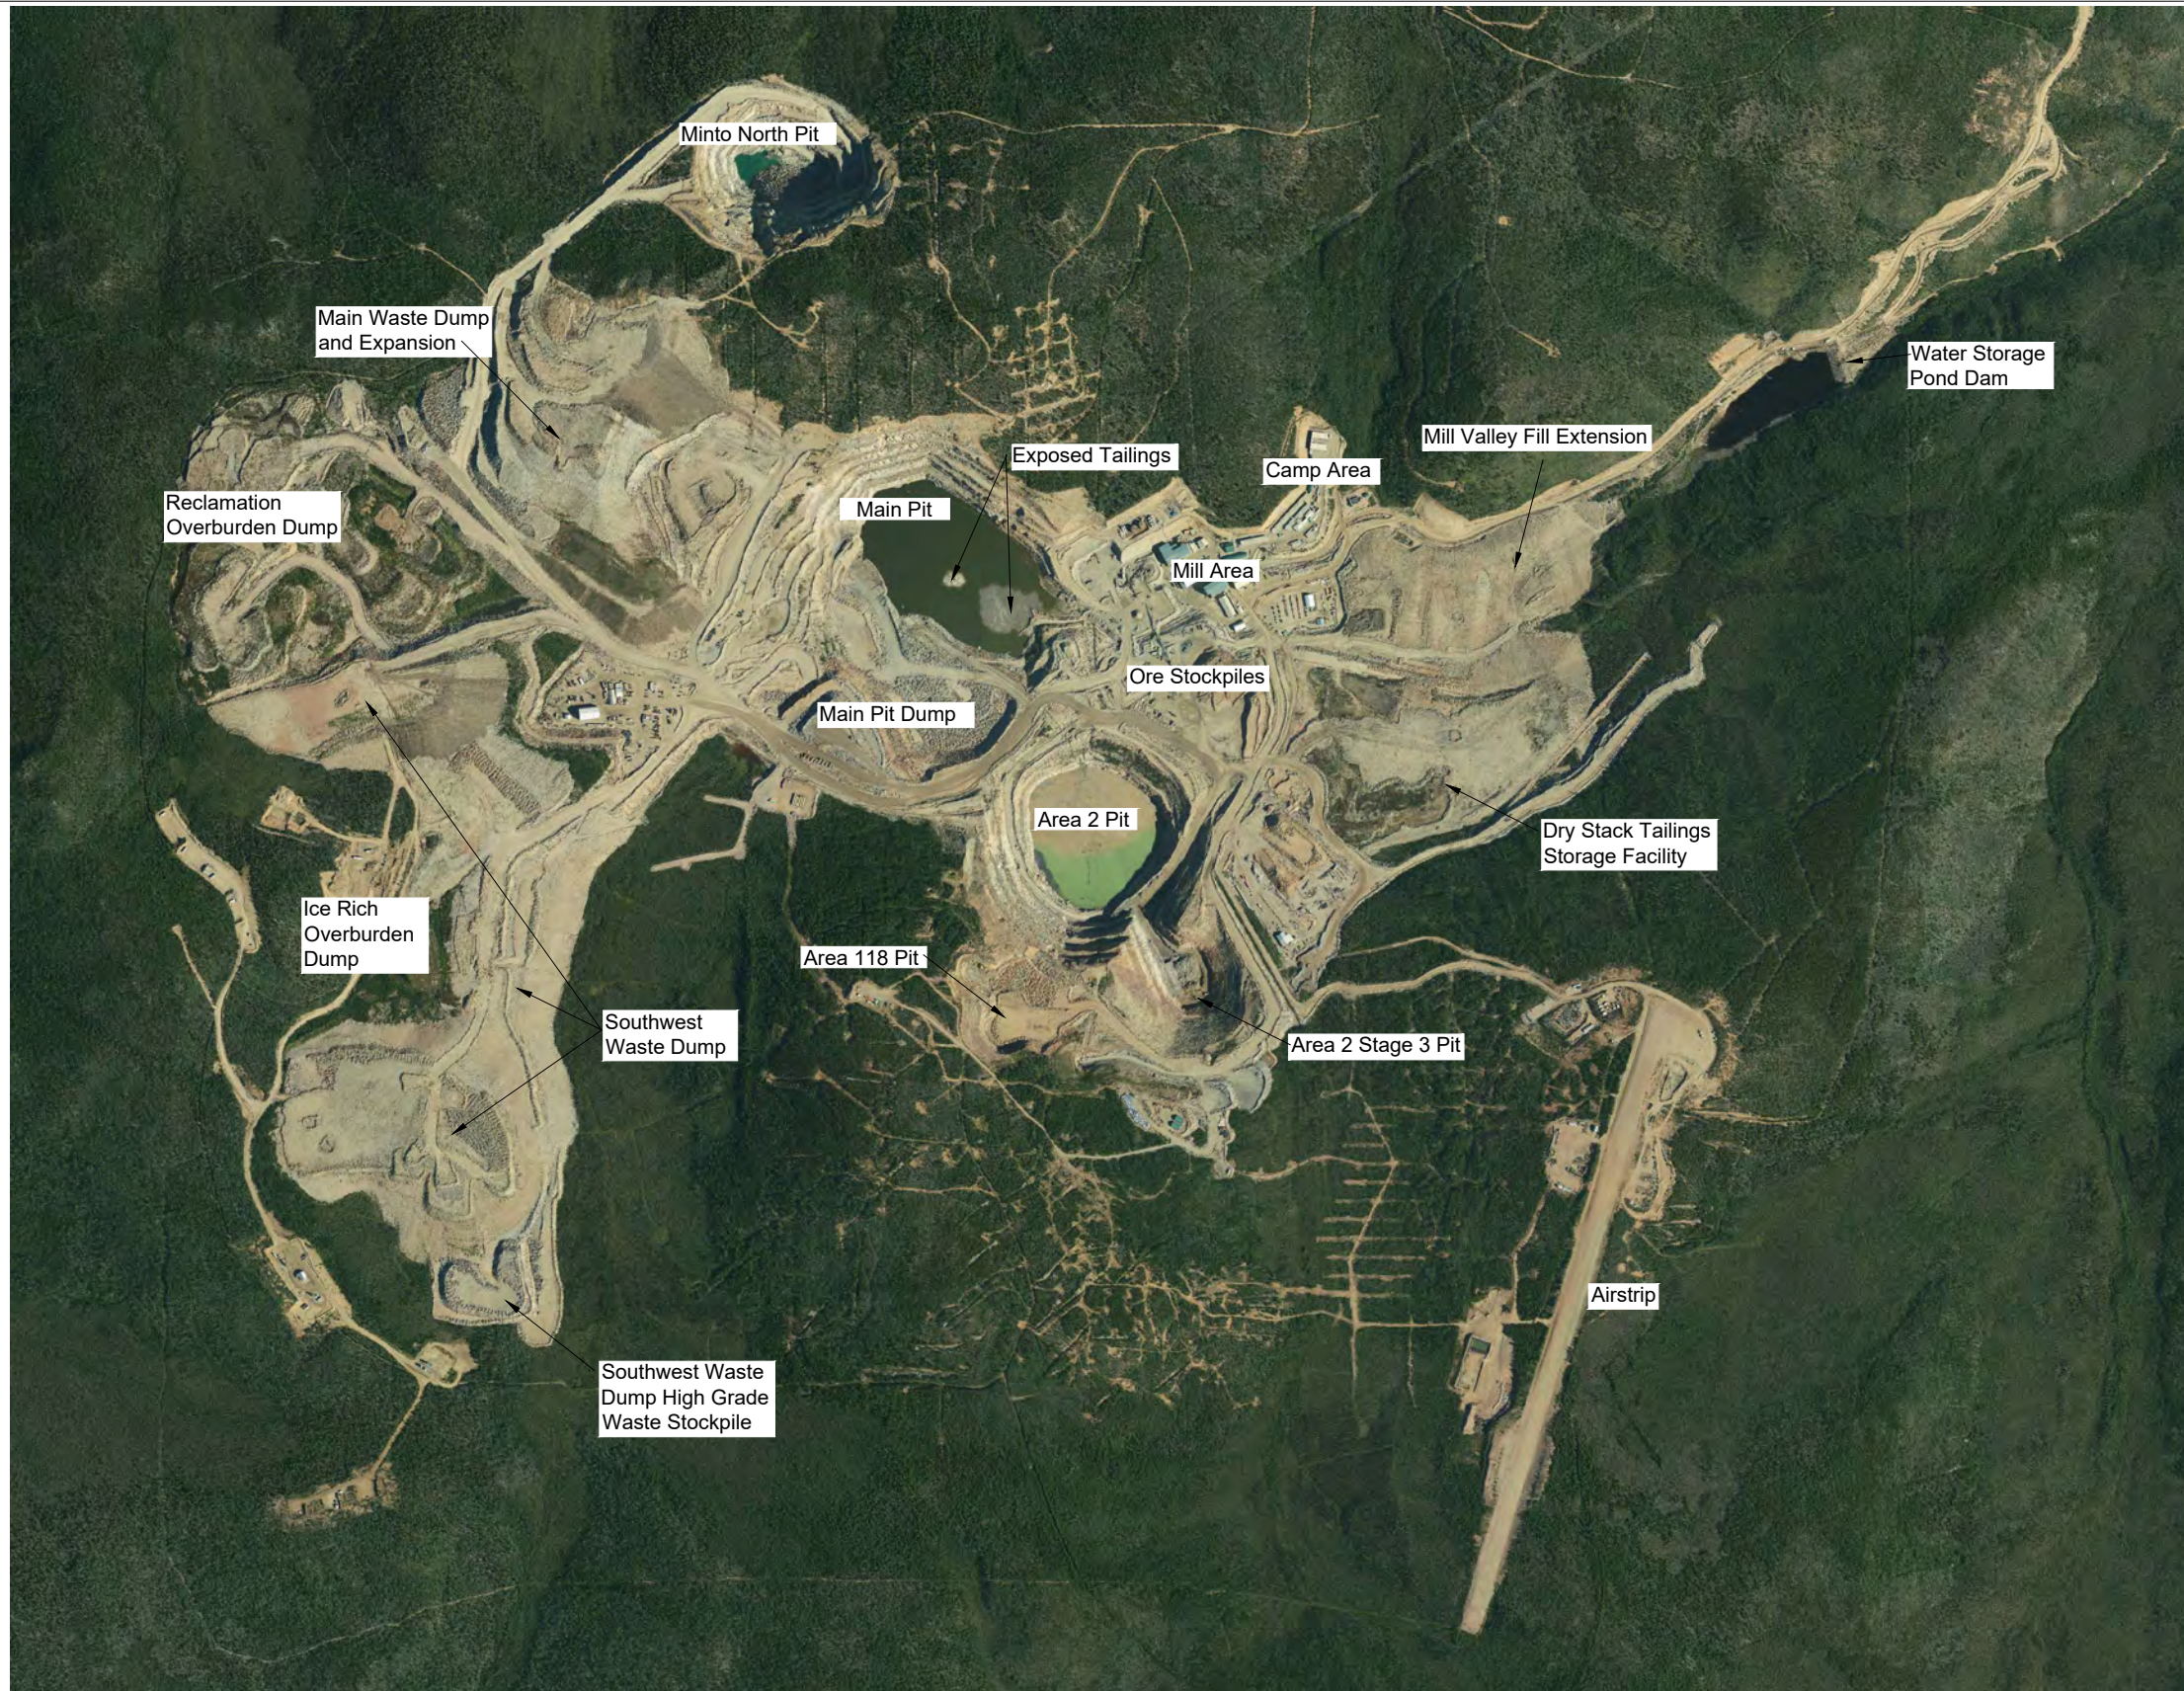
1. Orthophoto date August 2017 and provided by Minto.
2. This figure should be read in conjunction with the Updated Closure Cover Design for the Minto Mine 2018 Reclamation and Closure Plan Report. Dated January 2018.

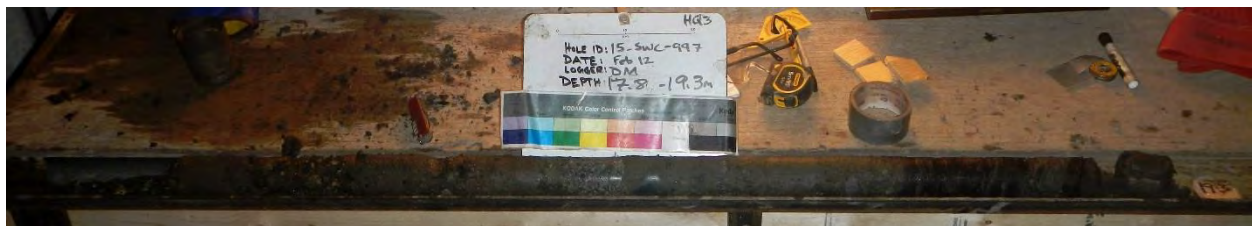
15-SWC-997: 16.9 m contact

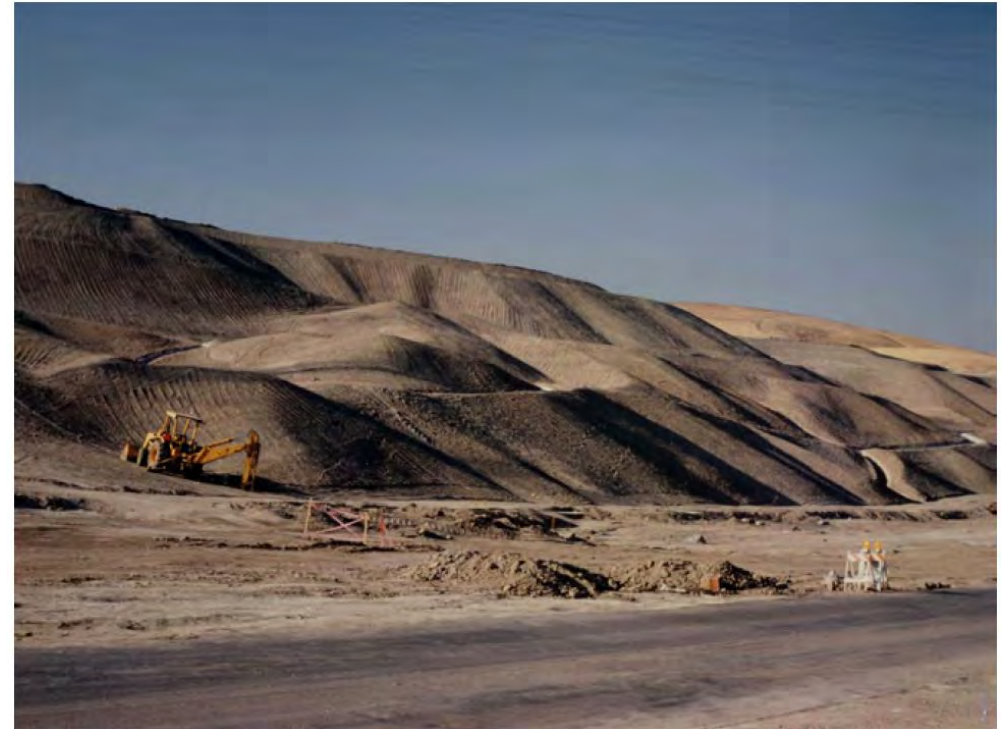
Landform-designed slopes have a radial drainage pattern that concentrate flow in valleys (Michael et al. 2010).
