**Re: Sa Dena Hes Mine Water Licence QZ99-045 – Submission of Decommissioning
and Reclamation Summary Report – November 2014**

Sä Dena Hes Mine
Decommissioning and Reclamation Status Report - November 2014
Yukon Water Licence QZ99-045 and Quartz Mining License QML-0004

- Attachment 1 - AMEC 2014 Reclamation Activities and As-Built Summary Memo
Attachment 2 - Photographs
Attachment 3 - Special Waste Disposal Items

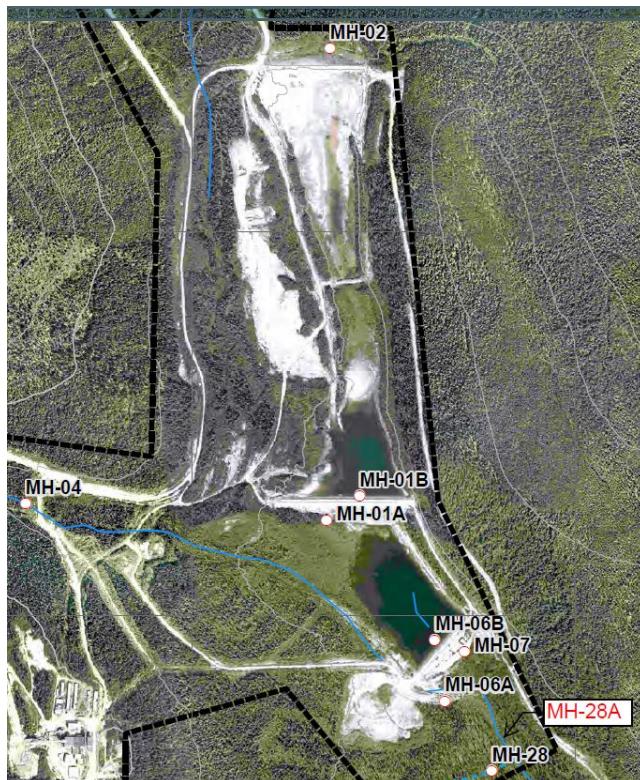
Figure 1: Monitoring Locations

Additional monitoring was also conducted during the Tailings Dam Decommissioning as per the Environmental Monitoring Plan and was also reported monthly. This included daily and weekly sampling at five locations as described below in Table 1 and shown in Figure 1.

Sampling Location	Description	Monitoring
MH-01B	Tailings Ponded Water	Tailings Water
MH-02	North Dam Seepage	Tailings Water
MH-04	Upper Camp Creek	Mill Run-off
MH-06A/B	Reclaim Pond Spillway/Ponded Water	Reclaim Pond
MH-28A	Camp Creek above Portal Creek	New location located in Camp Creek approx. 100 m downstream from the Reclaim dam but above Portal Creek.

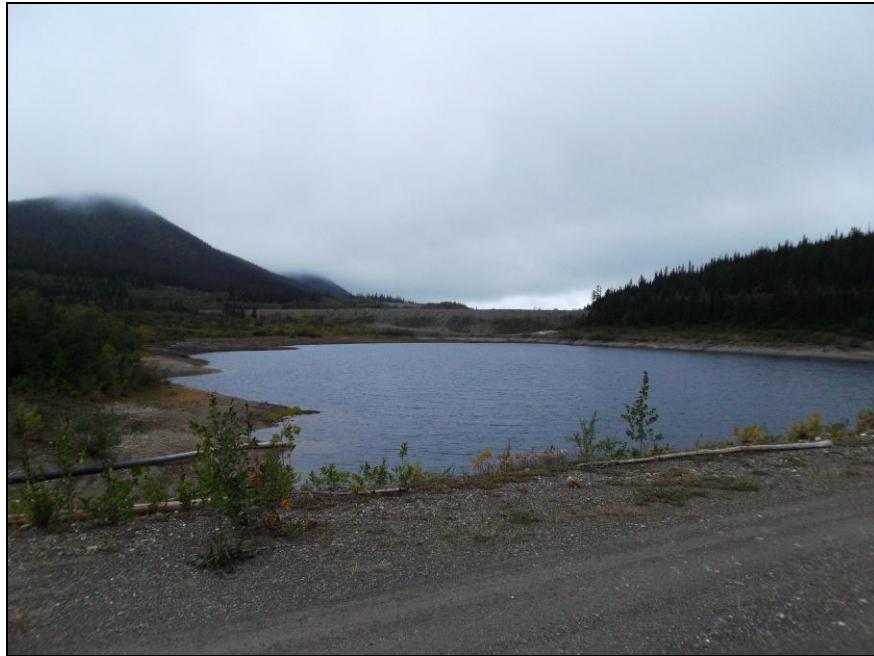
Photo 1: View of Reclaim Pond prior to decommissioning

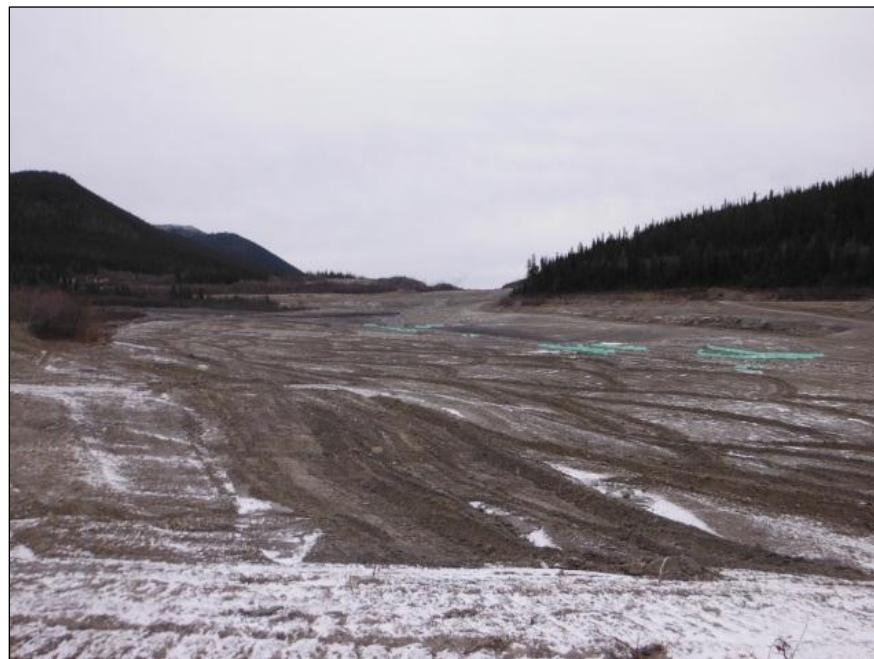
Photo 2: Reclaim Pond after decommissioning

- The decommissioning included de-watering the Reclaim and South Ponds. Active pumping occurred from May 15 to August 4, 2014 with a cumulative discharge volume of 163,002 m³.

- Once the ponds were drained the South and Reclaim dams were removed and their fill was either stockpiled or used for capping.
 - Deconstruction of the South and Reclaim Dams

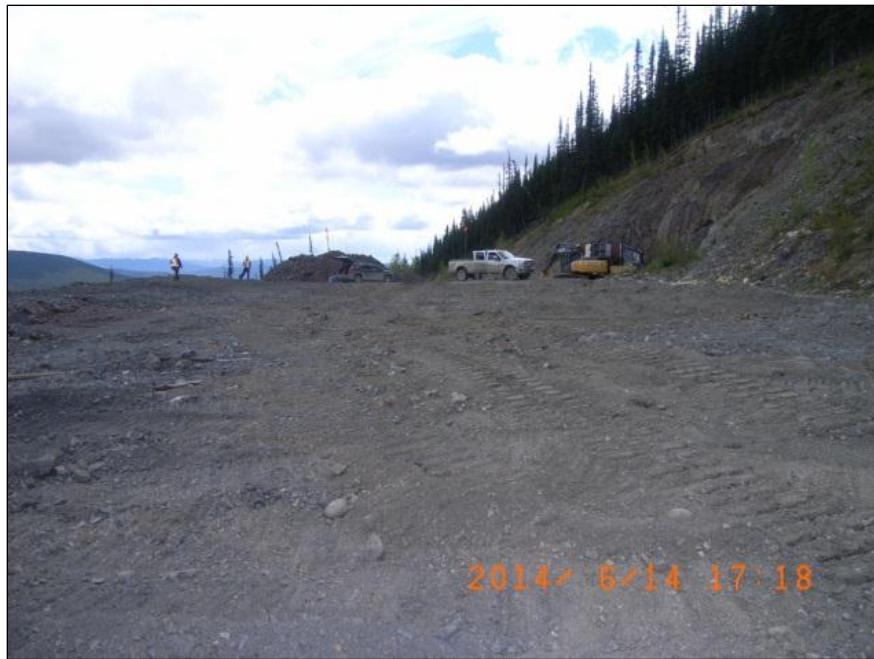
Photo 3: Burnick portal and waste dump before closure

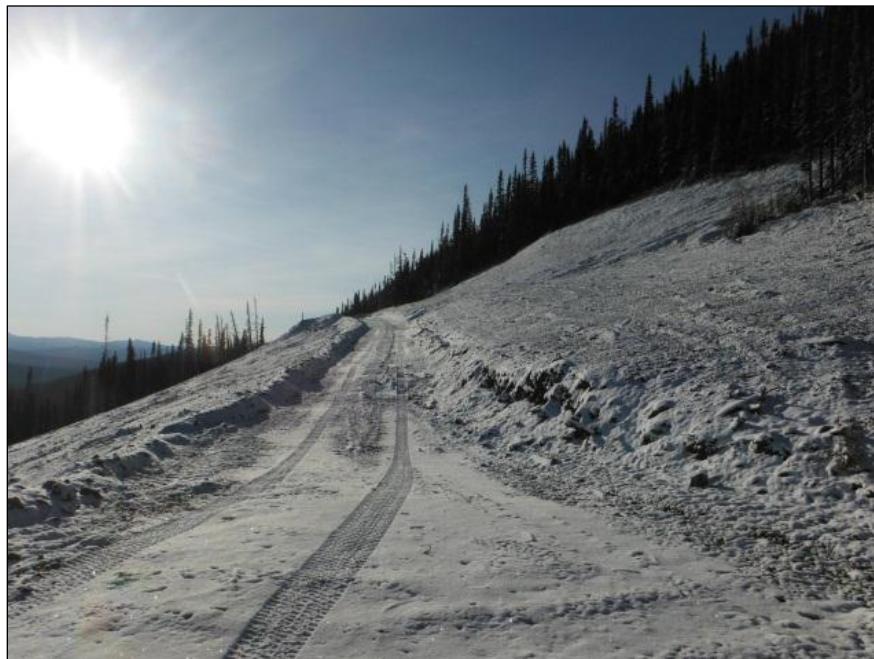
Photo 4: Burnick portal and waste dump after closure

The Burnick 1200 portal had previously been sealed with a non-engineered plug. The plug was removed using an excavator going in as far as safely possible. Material to be used for the plug was sourced from the Burnick 1200 Waste Rock Dump. Plug material was screened to +100 mm. Two HDPE ventilation pipes were installed approximately 9 m into the portal opening using an excavator. The pipes were separated by a vertical distance of 1 m and covered using the plug material. The pipes extended out from the plug and were cut off from where there were found protruding from the reshaped slope. The ends of the pipes were capped with a wire mesh to prevent blockage. After the pipes were installed the remaining +100 mm material was used to plug the portal and re-shape the plug slope 2H:1V.

The Burnick 1300 portal had previously been sealed with a non-engineered plug. The plug was removed using an excavator going in as far as safely possible. Material to be used for the plug was sourced from the Burnick 1300 Waste Rock Dump screened to +100 mm. Two HDPE ventilation pipes were installed approximately 9 m into the portal opening using an excavator. The pipes were separated by a vertical distance of 1 m and covered using the plug material. The pipes extended out from the plug and were cut off from where there were found protruding from the reshaped slope. The ends of the pipes were capped with a wire mesh to prevent blockage. After the pipes were installed the remaining +100 mm material was used to plug the portal and re-shape the plug slope to 2H:1V.

The two waste rock dumps reshaped at Burnick were the 1200 Waste Rock Dump and the 1300 Waste Rock Dump and these were reshaped using the same procedure as Jewelbox with ventilation / drainage pipes from the 1200 portal, 1200 ventilation portal and 1300 portal protruding from the reshaped slopes. At Burnick 1200, Golder had identified zones of hydrocarbon contamination in the waste rock dump and these zones were covered with material from lower portions of the waste rock dump and the cover was tied into the overall waste rock dump reshaping effort.

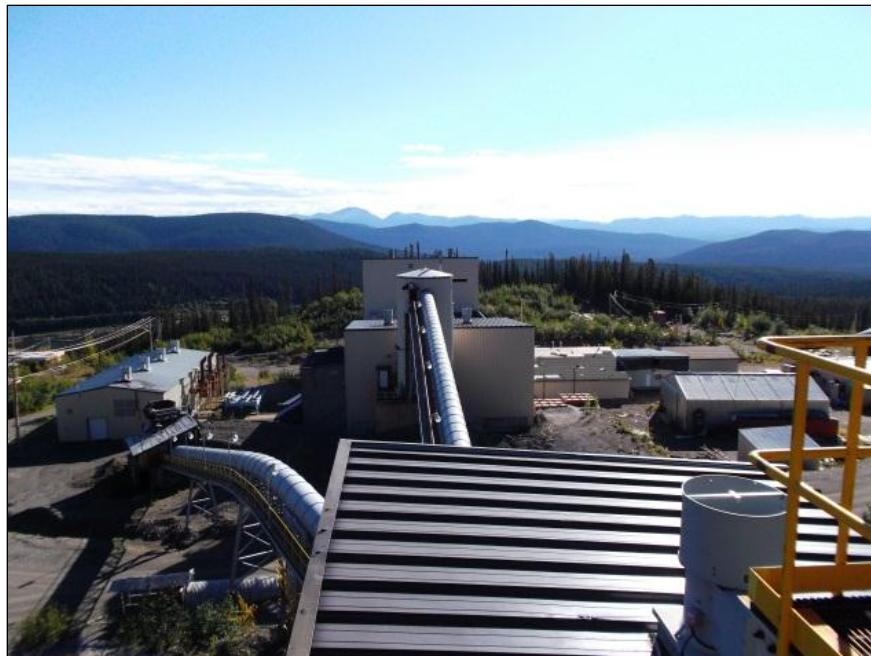
Photo 5: Mill before dismantling

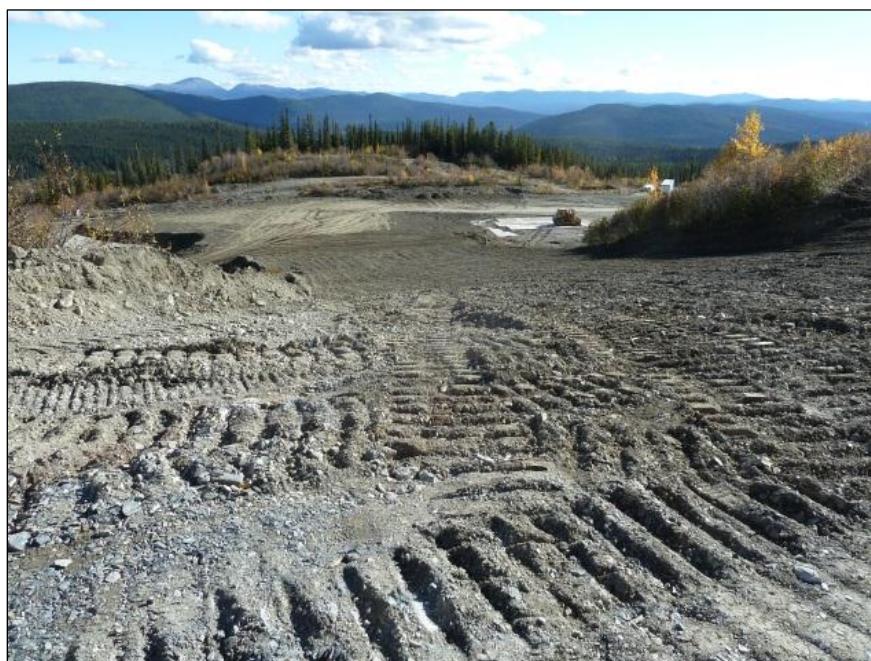
Photo 6: Mill after dismantling and re-shaping

In order to carry out capping and shaping operations of the mill area, a portion of the concrete foundations and walls from the former mill infrastructure were crumbled and brought down to an elevation that would allow capping operations to take place without requiring a substantial amount of fill or create steep slopes. Concrete breaking was carried out using an excavator with hydraulic hammer attachment. The main concrete work involved bringing down walls from the former coarse ore bin and from the vertical crusher deck wall.

Capping operations began once concrete breaking was completed. An excavator was used to load fill material from the former camp facilities area into tandem trucks. The trucks hauled the material to the mill site which was spread across the concrete foundations using a bulldozer. In addition to importing material from the former camp facilities area, bulldozers were used to knock steep slopes down around the mill area and tie them into the newly constructed cover across the mill site.

Cover construction across the mill foundations was completed to a minimum 1 m thickness. In some areas, much more than 1 m of material was used to cap the mill site. The material was placed in such a manner as to promote drainage from the area and the cover was constructed with subtle undulations to slow the velocity of water shedding from the mill area. Drainage from the surface of the cover was promoted generally to the south and to the north. Once the material haul from the former camp facilities was completed, bulldozers worked at shaping the camp area and tied it into the newly constructed cover across the mill site for aesthetic purposes.

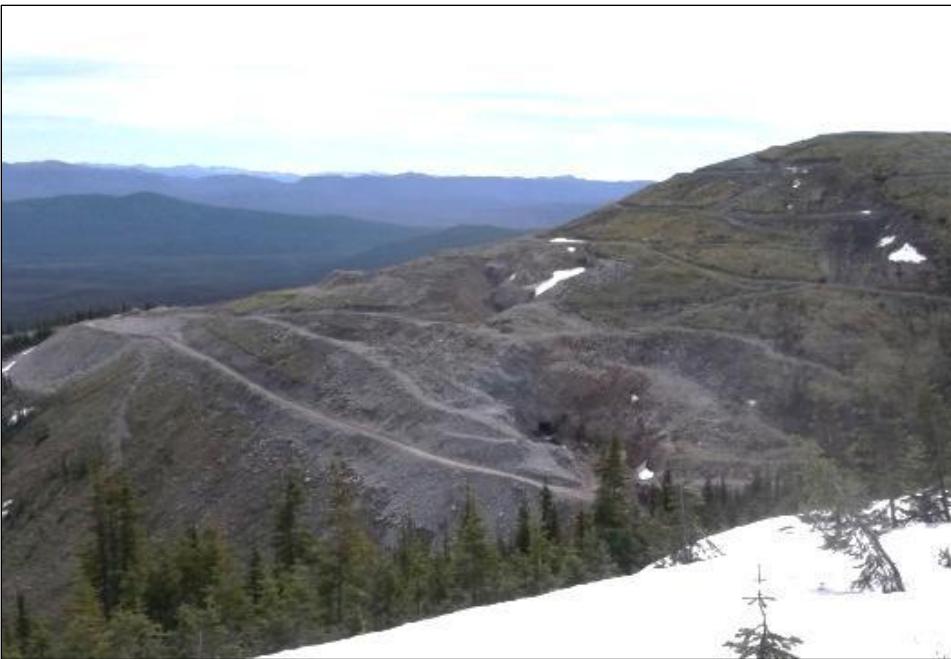
Photo 7: View of Jewelbox and Main Zone Open Pits before filling

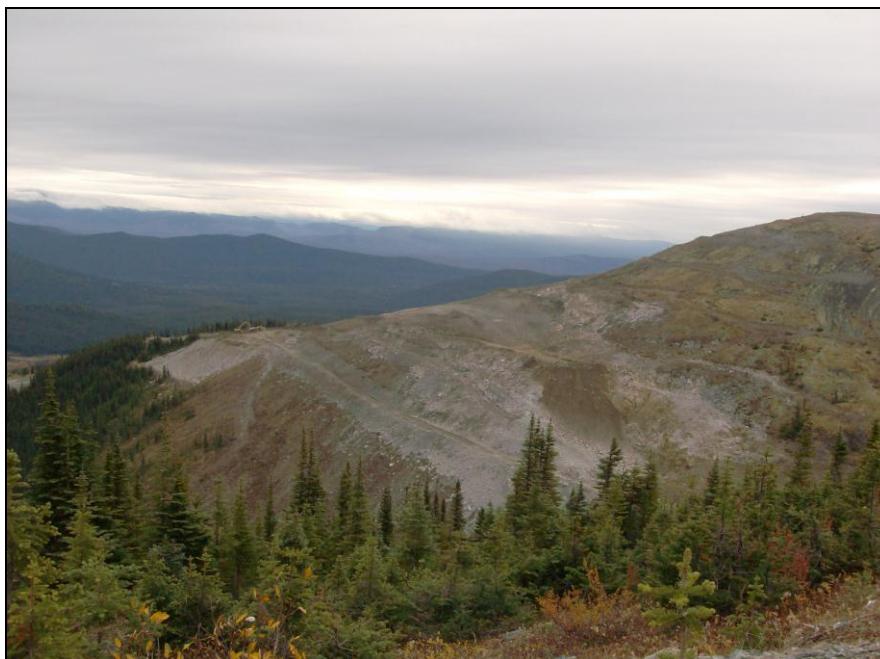
Photo 8: Jewelbox Open Pits after filling

- Infilling of Jewelbox and Main Zone open pits.
 - Reshaping of waste rock dumps at both Burnick and Jewelbox.
- Decommissioning and removal of electrical infrastructure.

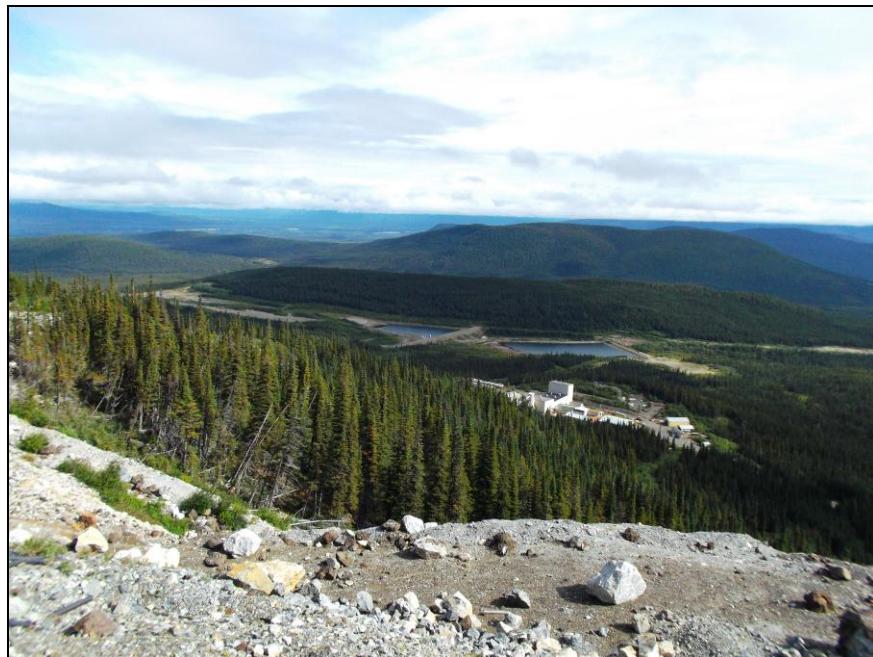
Photo 9: View of Mill and Tailings Management Facility before decommissioning

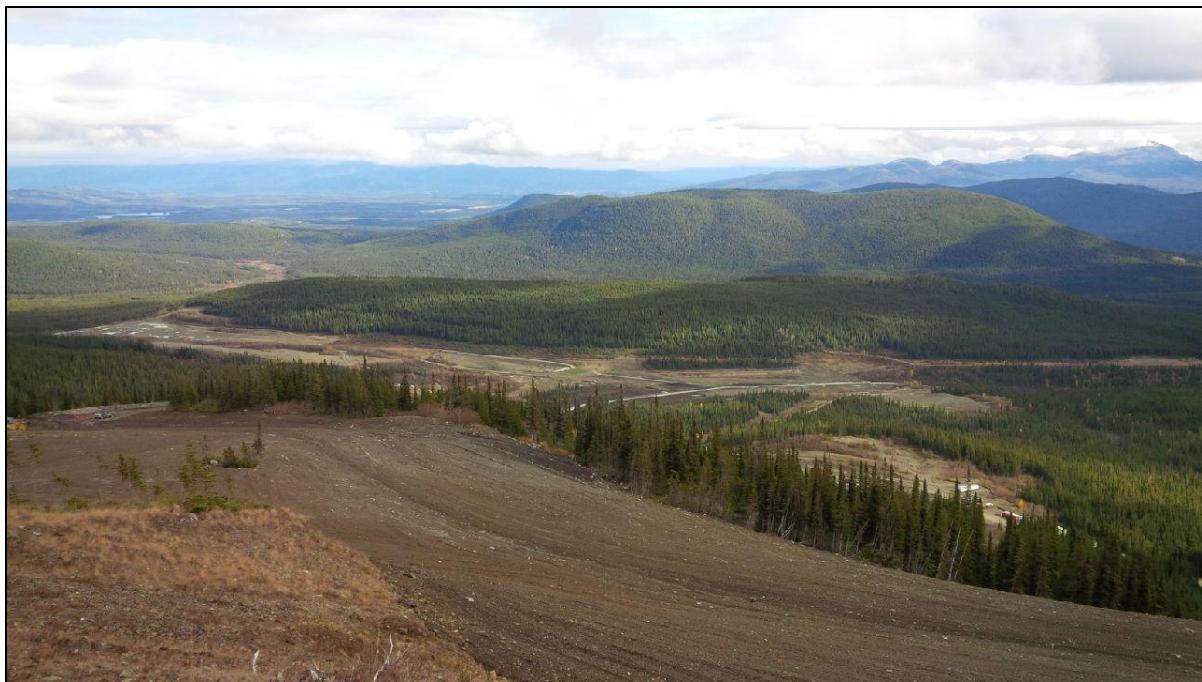
Photo 10: View of Mill and Tailings Management Facility after decommissioning
