**2005 Winter Trail Decommissioning Report
for
The Tsa da Glisza Project Area,
Yukon Territory, Canada**

2005 Winter Trail Decommissioning Report

The current report is a summary of the decommissioning of the True North Gems 2005 winter trail to the Tsa da Glisza (formerly Regal Ridge) Project area.

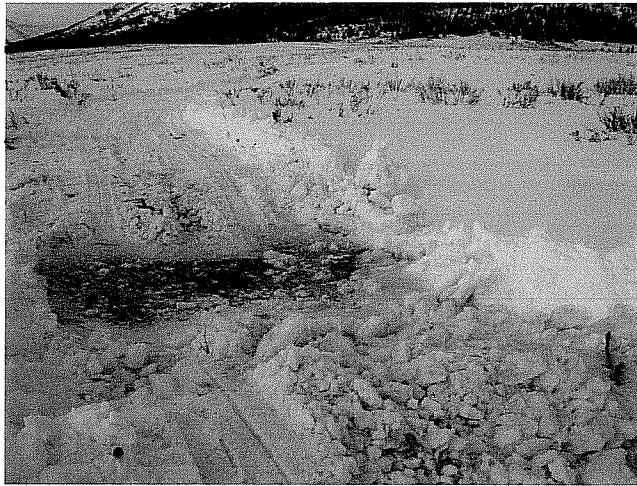
There were four creeks inspected between Km 46 to Km 25. Creek 1 is at Wolf Creek at the base of Regal Ridge east of the Confluence of the North River and Mosquito Creek (412414E/ 6797848N). On the winter trail, this creek was not entirely exposed but consisted of thick slush and ice chunks. Creek 2 flows into the North River from the south end of North Lakes (413245E/ 6804672N). This creek has been open and freely flowing throughout the winter trail operations. Care was taken not to disturb sediment. Creek 3 is the tributary to North Lakes at the northwest end of North Lakes (412980E/ 6805394N). There is no visible evidence of a creek other than previous knowledge and a slight gully. Creek 4 is the tributary into the north end of the North Lakes at the intersection of 2 valleys (415950E/ 6809699N). There is also no visible evidence of this creek other than previous knowledge and a slight gully.

Photo 1: Creek 1: Wolf Creek at the base of Regal Ridge east of the confluence on the North River and Mosquito Creek, before inspection.

From km 46 to km 25, many of the creeks crossed along the trail remained covered in ice and snow; however a few became exposed. Care was taken when crossing these creeks to prevent disruption of sediment. Map 1 and Photos 1 to 7 below show the winter trail and the creeks that were inspected. The creeks were inspected for signs of potential blockage of spring meltwater due to windrows created during trail construction. The creeks were inspected from south to north heading from Regal Ridge to the KZK Gatehouse. Windrows made during construction were pulled back and hand dug trenches were built to ensure water and sediment blockages would not occur during the spring melt.

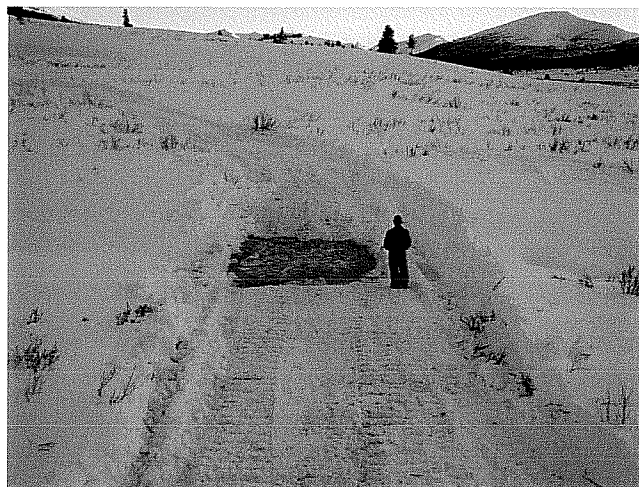
Photo 2: Creek 1: Wolf Creek at the base of Regal Ridge east of the confluence on the North River and Mosquito Creek, after inspection.

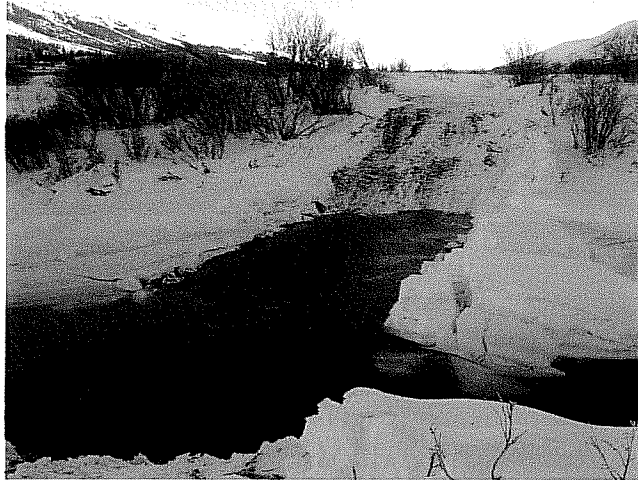
Photo 3: Creek 2: Creek flowing into North River at the south end of North Lakes, looking north, before inspection.

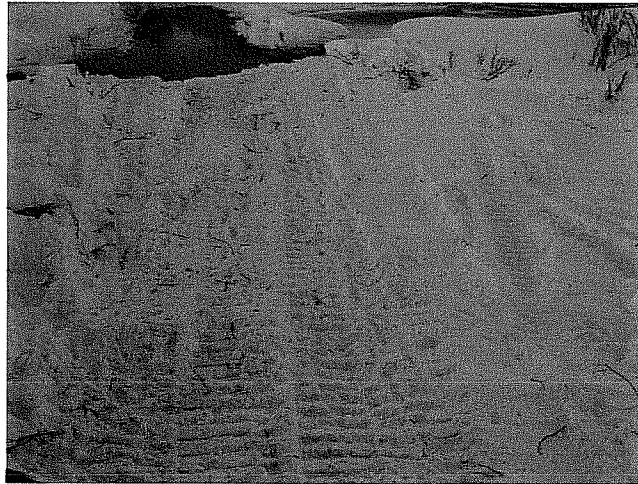
Photo 4: Creek 2: Creek flowing into North River at the south end of North Lakes, looking north after inspection.

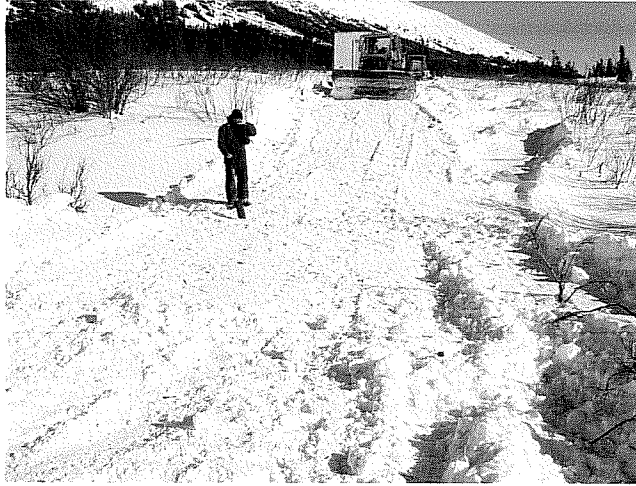
Photo 5: Creek 3: Tributary to North Lakes in the north west side of North Lakes, looking north, before inspection.

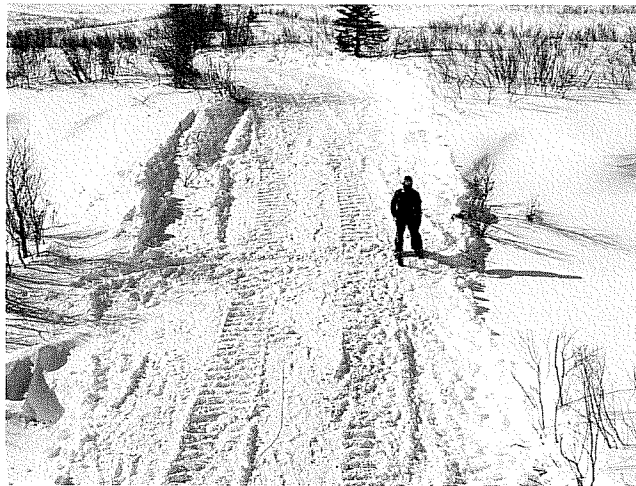
Photo 6: Creek 3: Tributary to North Lakes in the north west side of North Lakes, looking south, after inspection.

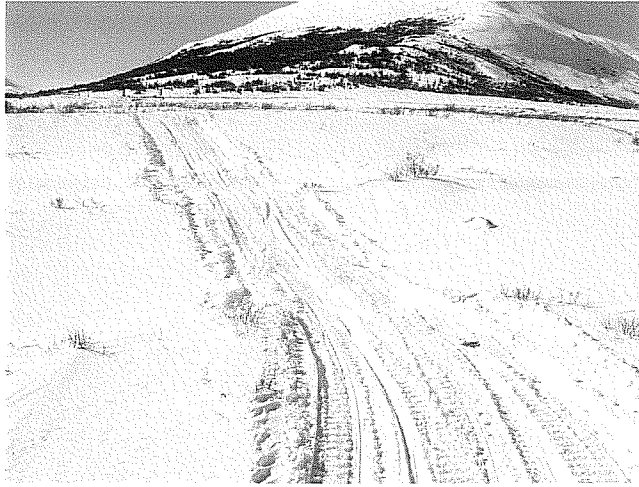
Photo 7: Creek 4: Tributary into the north end of the North Lakes at the intersection of 2 valleys, after inspection.
